Report on
Desktop Geotechnical Assessment

Proposed Health Services Facility
31 - 33 Smith Street, Charlestown

Prepared for
GPV Property Group

Project 210780.00
November 2022

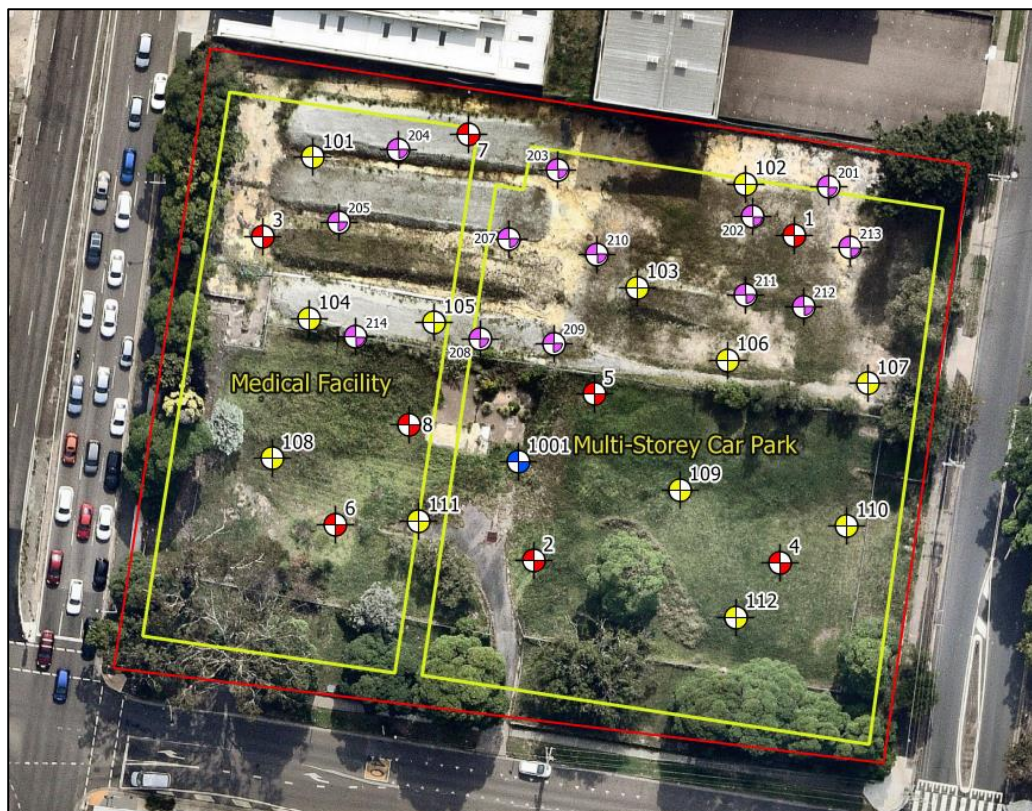
Figure 1: Location of previous bores undertaken by DP on site

The results of the previous investigation included fill to depths of up to 0.95 m, underlain by clayey sand or clay to depths ranging from 0.95 m to 3.5 m. The underlying bedrock was initially extremely low to low strength, becoming medium to high strength from about 4.25 m to 9.5 m depth, and continued to termination of the bores at depths ranging from 10.15 m to 11.64 m.

The approximate location of the previous DP bores are shown in Figure 1 below and also on Drawing 1 in Appendix C.

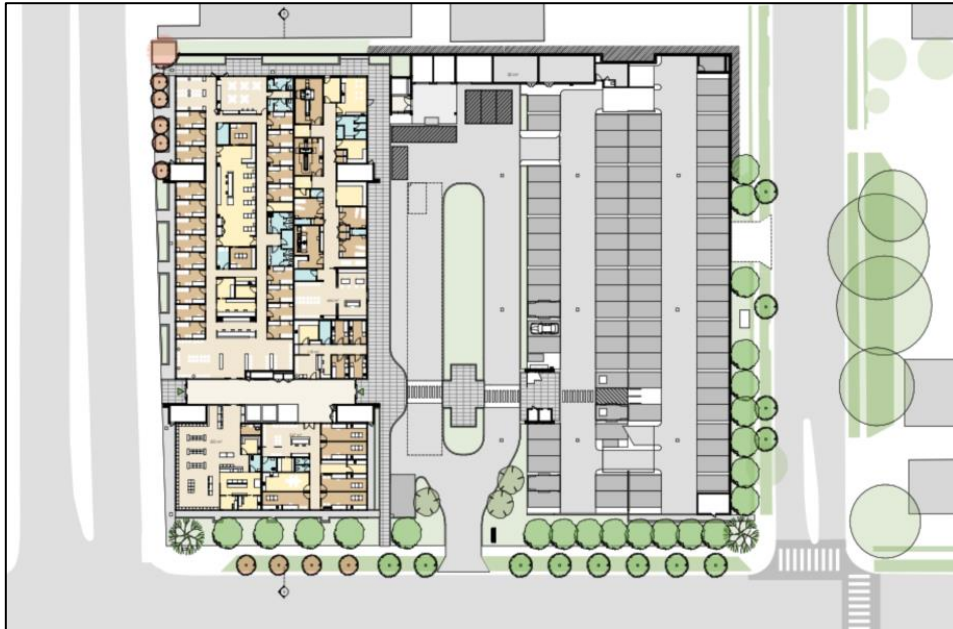
Figure 9: Layout of proposed development

It is understood that the proposed development will include construction of a new four-storey health care facility with rooftop plant fronting the Pacific Highway and a multi-deck car park structure facing Smith Street (refer Figure 9 and Figure 10). The development will require excavation to 105.6 m AHD (about 3 m depth along Smith Street).

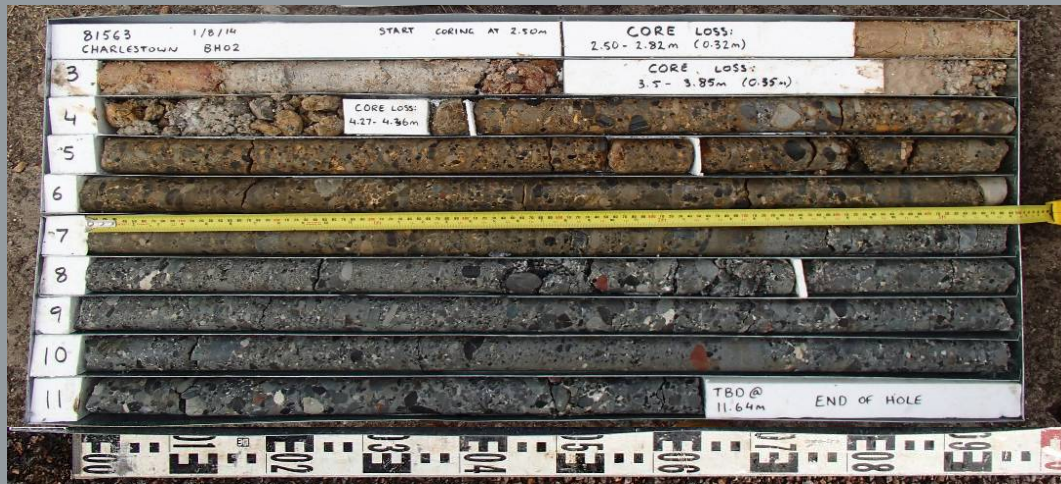
BORE 2

2.5 m – 11.64 m
