Re: **Preliminary Site Investigation**

**Lot 2 in DP1022771 63 – 69 Lake Road Tuggerah  
Dumpers Handybin**

## REVISED PRELIMINARY SITE INVESTIGATION (PHASE I ENVIRONMENTAL SITE ASSESSMENT) WITH TARGETED SOIL SAMPLING AND TESTING, AND WATER QUALITY MONITORING PLAN

Lot 2 in DP1022771

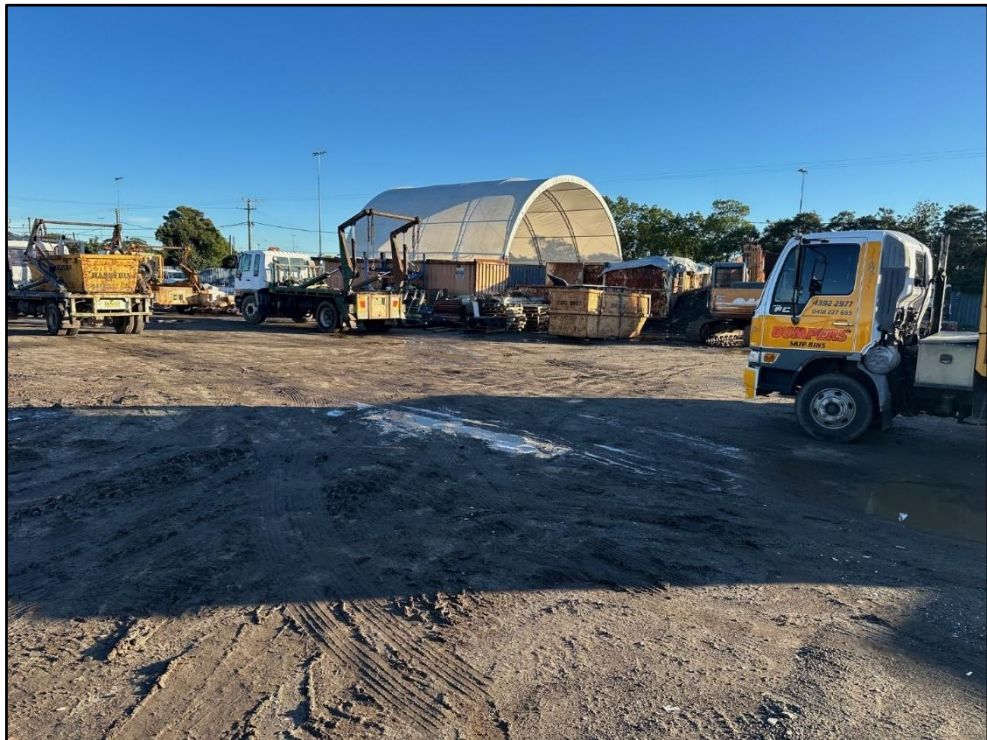
**Plate 1** Hardstand – Looking Northwest

The soil material is generally grey to pale brown, gravelly semi-dense and moist (recent rain (see **Plate 1**)) blend comprising angular to sub-angular fragments of rock with common amounts of pale brown quartz-dominant sandy loam and uncommon sub-angular fragments of quartz sandstone to 30 mm, average 15 mm.

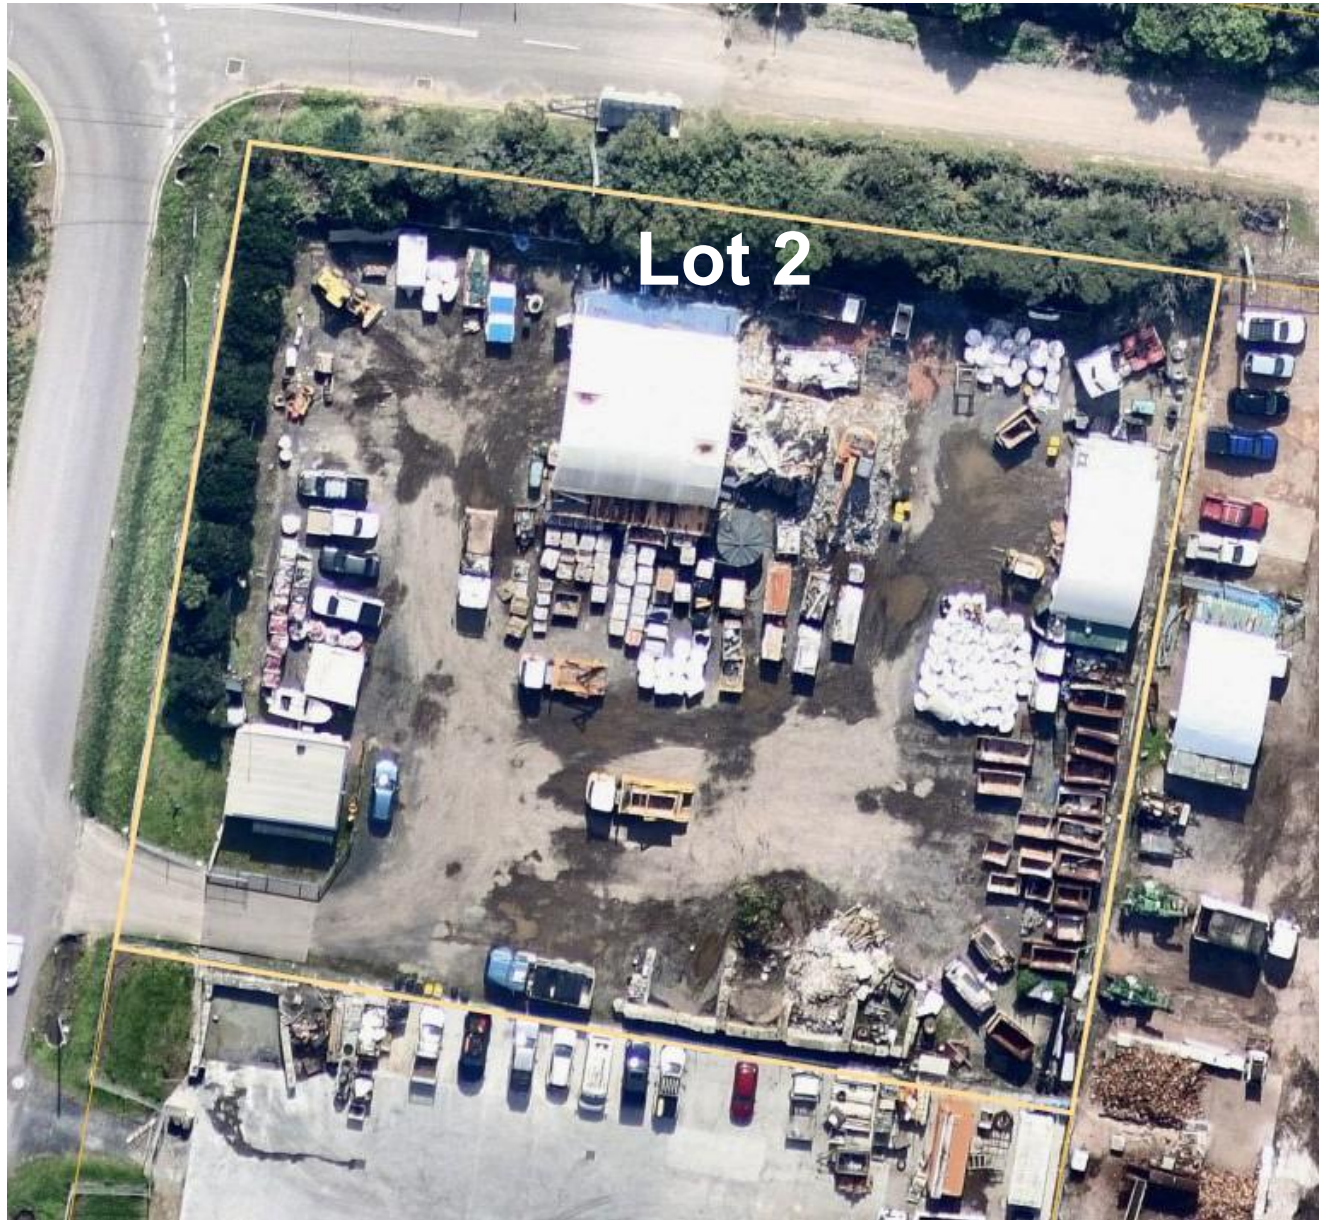
**FIGURE 1**

*Larry Cook Consulting* (LCC) was commissioned by *Dumpers Bin* (the owner), on behalf of the owner, in June 2024 to carry out environmental site investigations on the potential for contamination in Lot 2 in DP1022771 63 – 69 Lake Road Tuggerah (the Site). The location of the Site is shown in a *Near Map* lot plan in **Figure 1** and in a *Six Maps* topographic plan presented in **Figure 2**.
