Report on  
Geotechnical Investigation

School Upgrades  
Hunter River High School, 36 Elkin Avenue, Heatherbrae

Prepared for  
NSW Department of Education

Project 216008.00  
August 2022

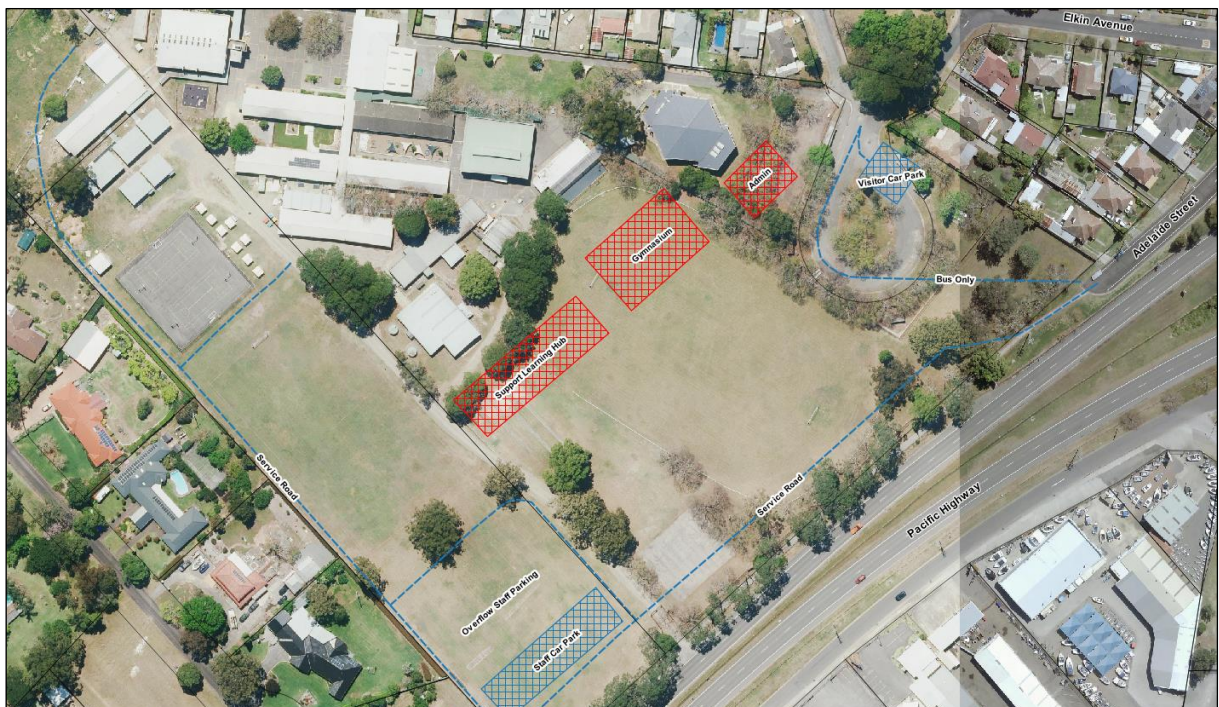
**Figure 2: Aerial photo of the site, proposed building footprints in red, and proposed car parks and internal roads in blue. Source – Metromap (19 September 2021).**

At the time of investigation, the site was predominantly surfaced with short grass in the sports fields, and covered by asphalt in the staff car park. The site was relatively flat and level with surface levels ranging from 6.7 AHD to 7.1 AHD at field test locations.

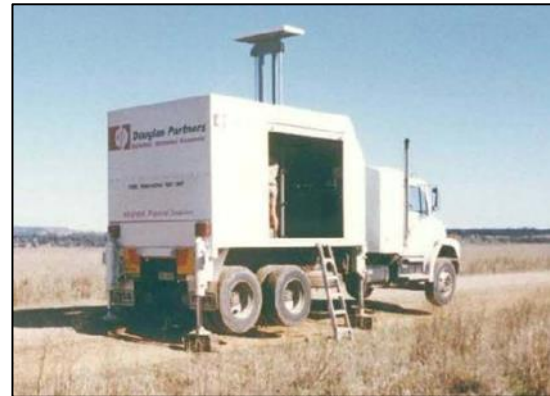
Figure 2: Purpose built CPT rig

The cone is thrust into the ground at a steady rate of about 20 mm/sec, usually using the hydraulic rams of a purpose built CPT rig, or a drilling rig. The testing is carried out in accordance with the Australian Standard AS1289 Test 6.5.1.
