# **ACID SULPHATE SOIL ASSESSMENT (ASSA)**

105, 109, 111, 121 Hunter Street, 3 Morgan Street, 66-74 King Street & 22 Newcomen Street, Newcastle NSW

East End Stage 3 Pty Ltd

April 2023

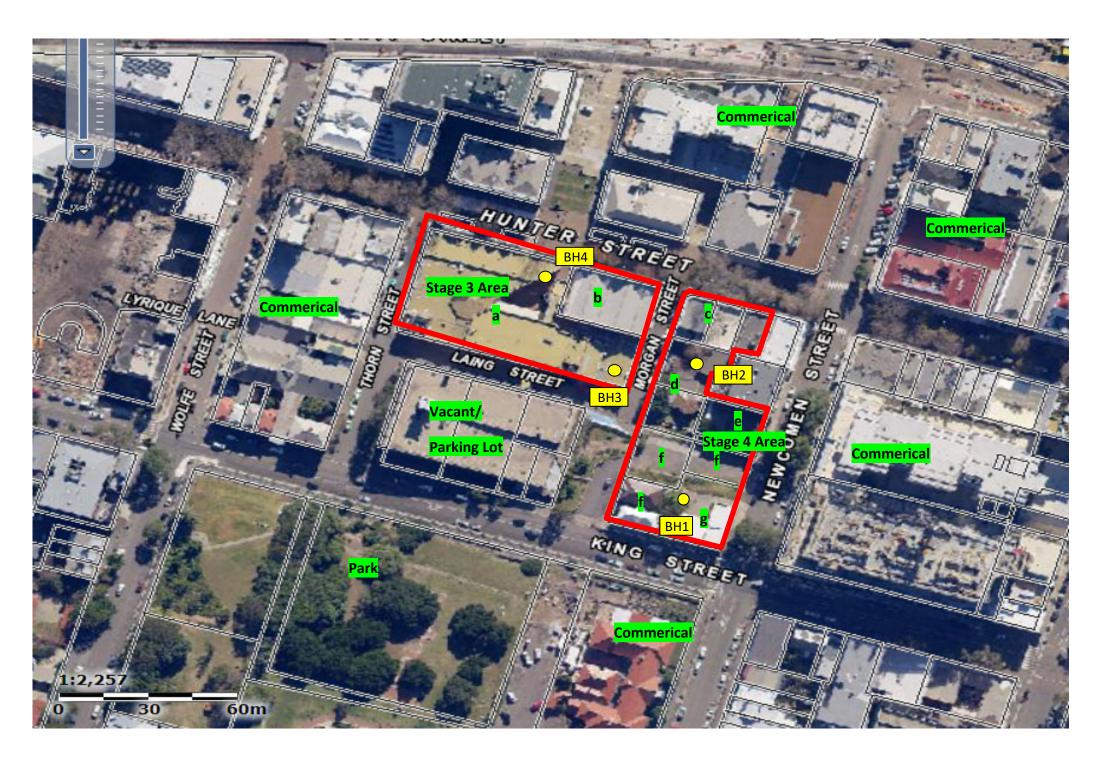
## FIGURE 2: SITE FEATURES AND BOREHOLE LOCATION PLAN

Feature No	Details
а	Commercial & Office
b	Commercial & Basement
С	Residential & Commercial
d	Church
e	Dance Hall
f	Residential
g	Commercial / Office

collected from four boreholes within the site. The borehole locations are presented

in **Figure 2** – Site Features and Borehole Location Plan.
