Heritage Impact Statement (Amended)

Newcastle East End

Blocks 3 & 4 (Demolition &
Development DAs)

Newcomen, Hunter, Thorn, Laing and King Streets

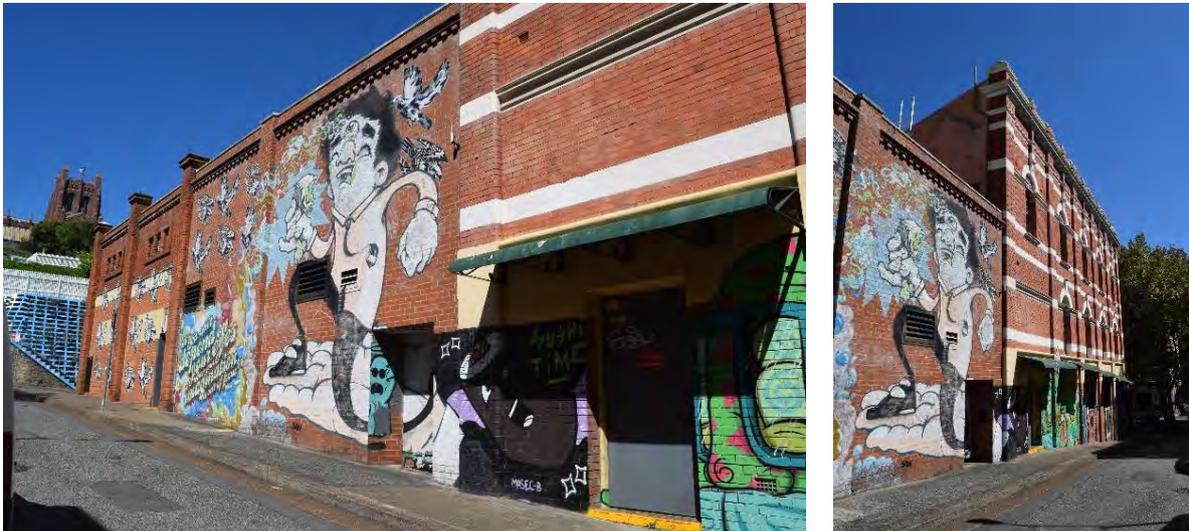
Figure 19: Detailed views of the south eastern façade of the building.

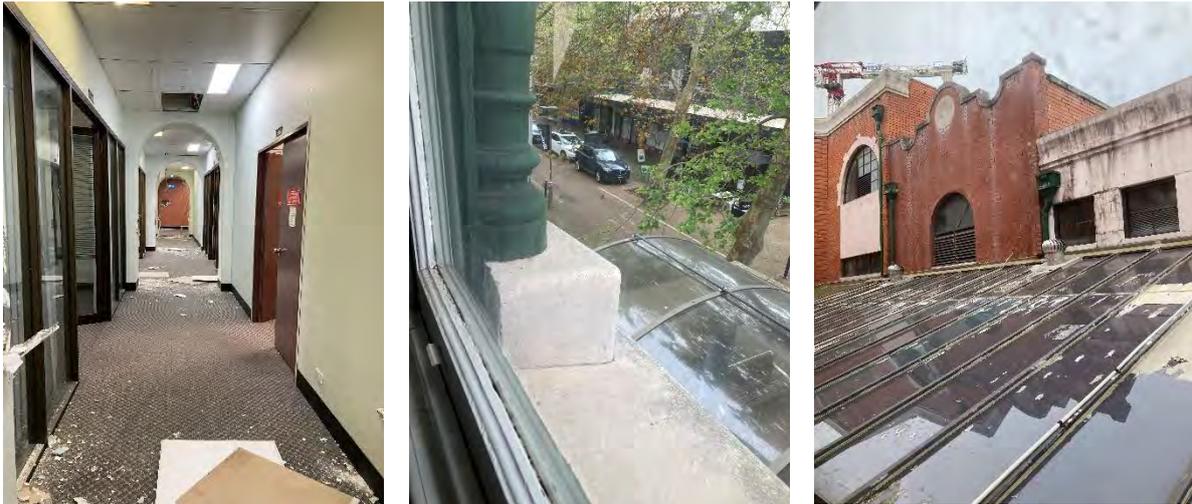
Figure 21: Internal views of the former Municipal building showing a central hallway (left), detail of a window facing Hunter Street (centre) and entrance leading to a later 1980s overpass extension (right).

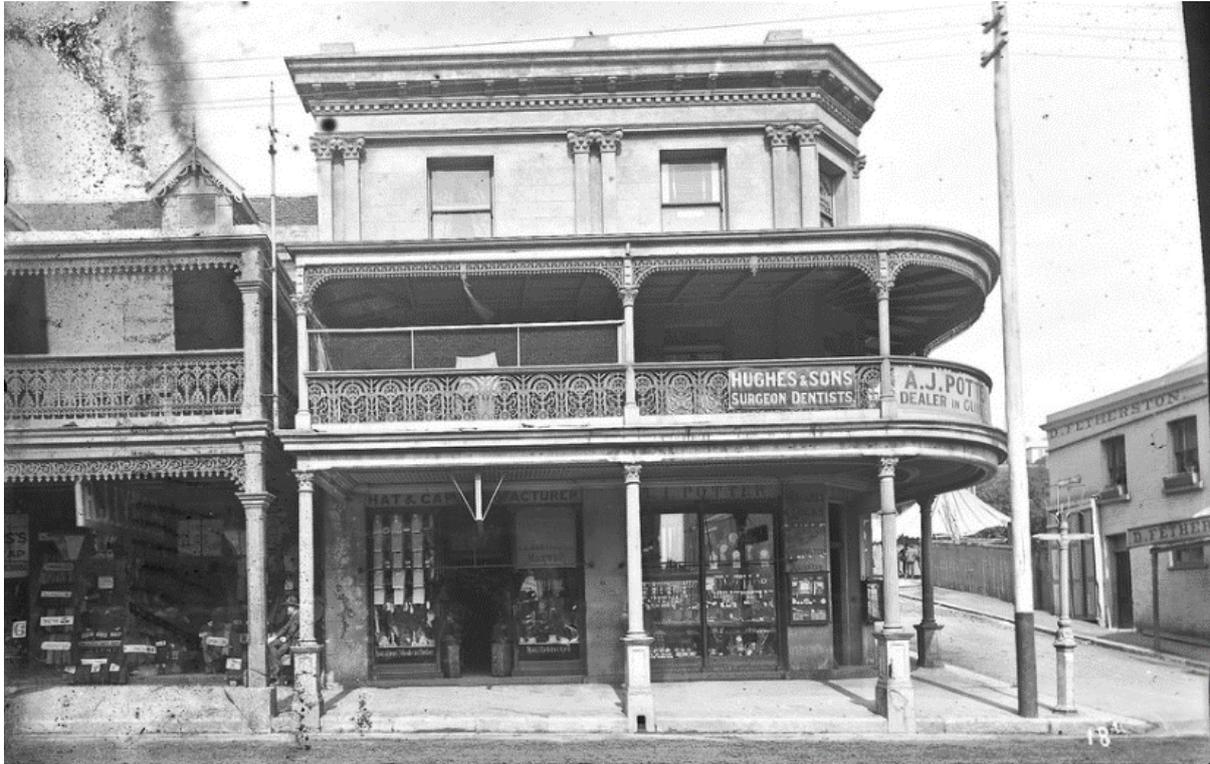
Figure 31: Ralph Snowball photograph from April 1891 showing the building at 111 Hunter Street, prior to removal of the awning and balcony. At the time the site is occupied by a dentist, jeweller and hat/cap manufacturer. (Source: University of Newcastle Cultural Collections, accessed 21 March 2017 via <https://www.flickr.com/photos/uon/4862444616/in/photostream/>).

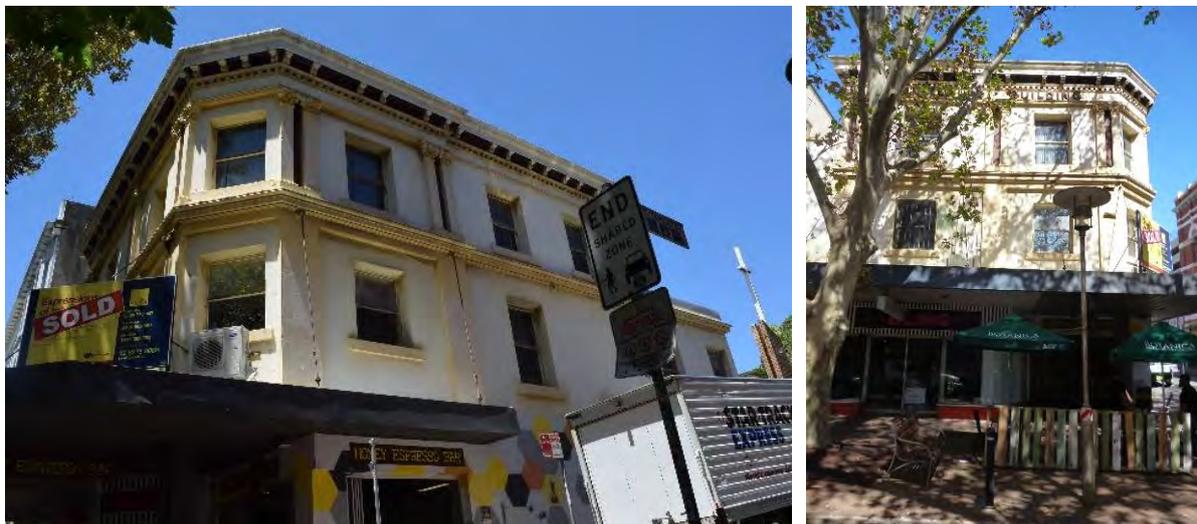
Figure 32: View of 111 Hunter Street showing the geometric form and detailing to the first and second floors (left) and a full view that shows the contrast between the modified ground level and upper levels (right).

The building consists of three stories, with the ground floor having been modified numerous times since construction to accommodate the various requirements of previous ground floor commercial tenancies including a jeweller, hat and cap manufacturer and a café. In addition, there was once a wrap-around veranda as seen in Figure 32, which was later removed along with the awning posts. The awning is a later replacement.

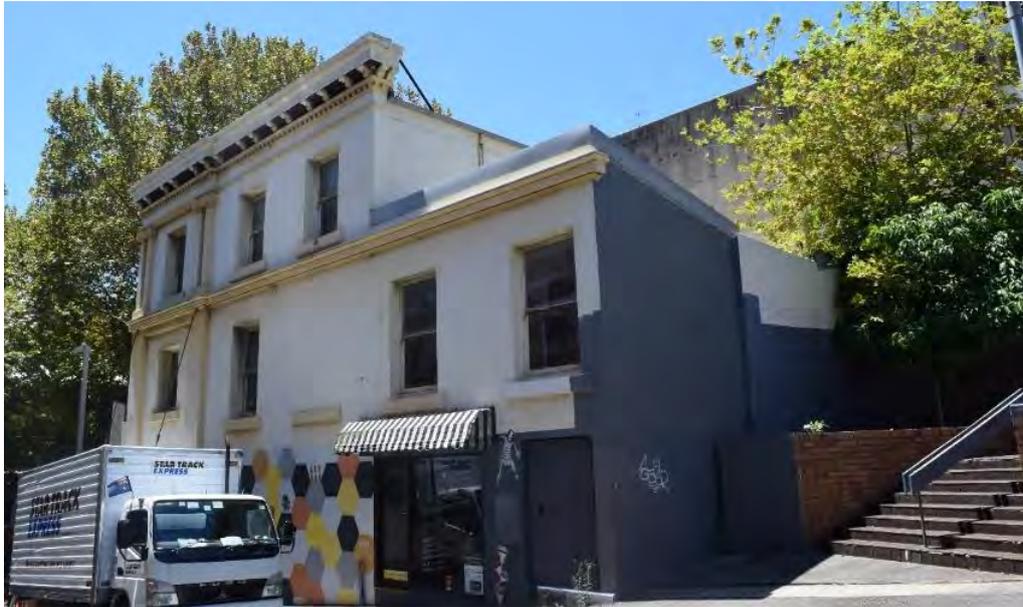
Figure 33: View from Morgan Street of the rear of 111 Hunter Street showing the infilled window to the ground floor, the difference in length of the levels and the high parapet (left).

It should also be noted that the first floor of the building extends further south along Morgan Street than the second storey, as evident in Figure 34. There is also an air conditioning unit attached externally to the awning and first floor window on the corner.

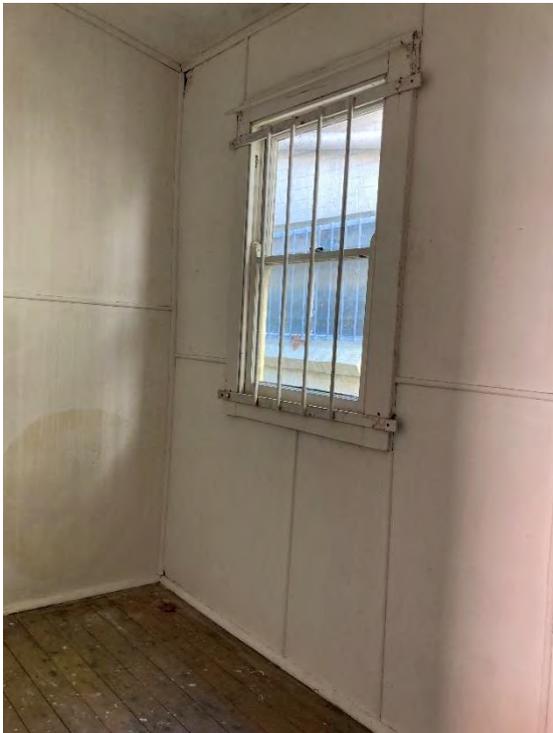
Figure 37: Timber framed single-hung windows with metal grill.

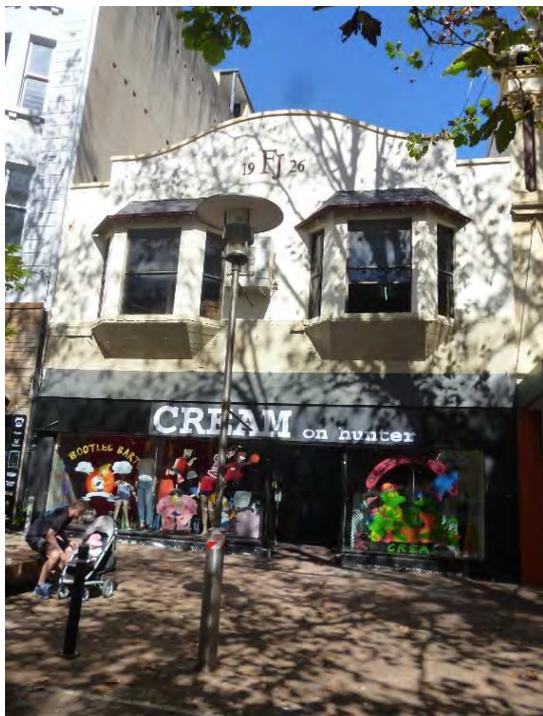
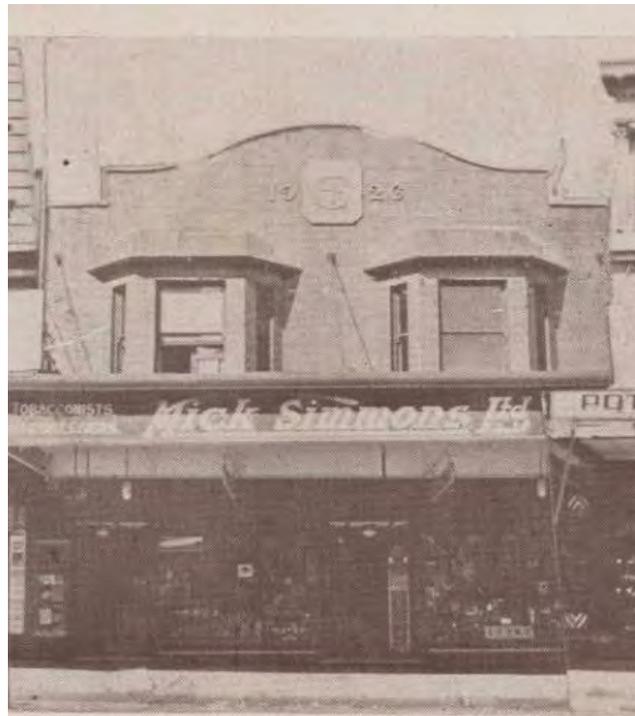
Above the awning are two faceted bay windows with sloped roofs and metal framed double hung windows to each side. The bay windows are reconstruction of the original windows, following removal in the 1970s when the façade was clad over. Above is a simple arched parapet and a central foundation date of 1926 with the letters "FJ," referring to the store Fletcher Jones, which once occupied the site. The original foundation date and name plate had a different font, making and logo than the current plates. Between the bay windows is a centrally placed air conditioning unit.

Figure 39: View looking south east towards the Hunter Street façade of 109 Hunter Street (left). The image on the right dates from 1938 and shows the original shopfront below the awning, bay windows and panel between the original foundation date (right). (Source: Newcastle University Cultural Collections, accessed 21 March 2017 via <https://www.flickr.com/photos/uon/8641073669/in/photostream/>)

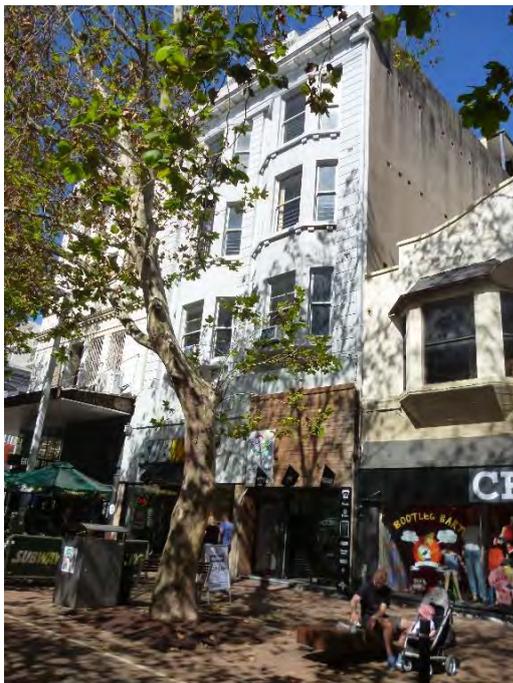
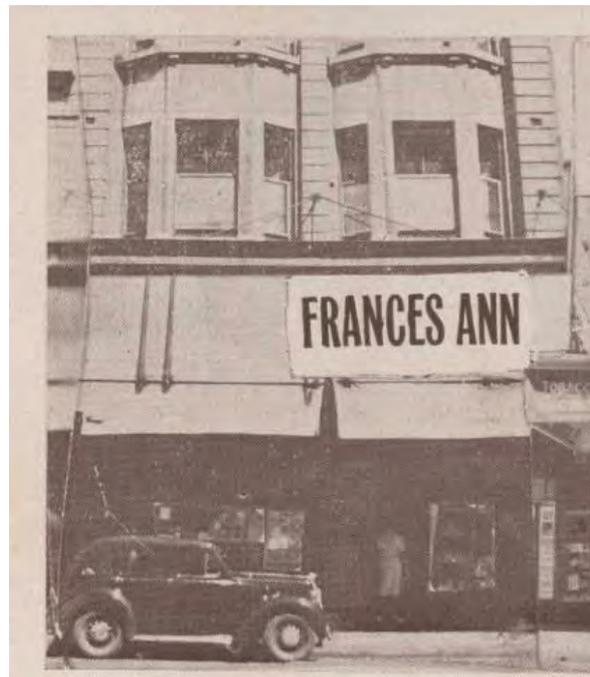
Figure 40: View looking south east towards the Hunter Street façade of 105 Hunter Street (left). The image on the right shows a partial view of the building from 1938. (Source: Newcastle University Cultural Collections, accessed 21 March 2017 via <https://www.flickr.com/photos/uon/8641073669/in/photostream/>)

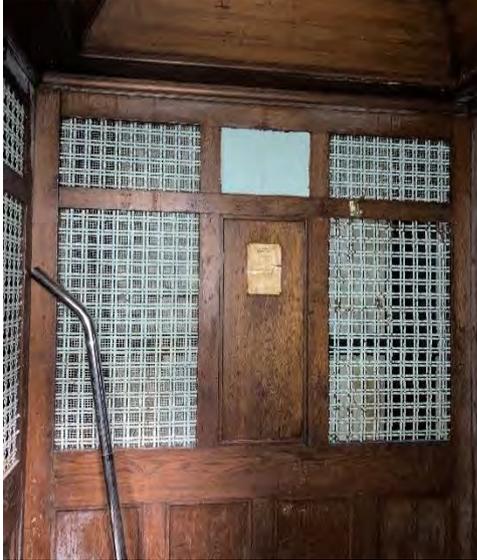
Figure 41: Timber automatic elevator from Standard-Waygood Limited.

The subject building (109 Hunter Street) is a double-storey structure connected via an early timber automatic elevator from Standard-Waygood Limited. The first floor has varied studio spaces with amenities such as laundry and toilets connected via a corridor. The ceiling and cornices on the first floor are highly decorative, with contemporary light fittings. The walls and ceilings have started to acquire

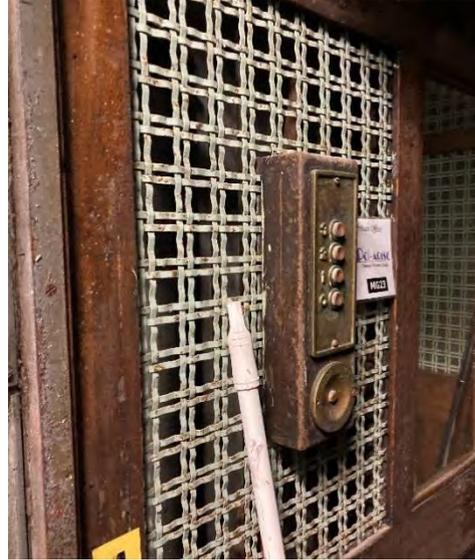
Figure 42: Timber automatic elevator from Standard-Waygood Limited.

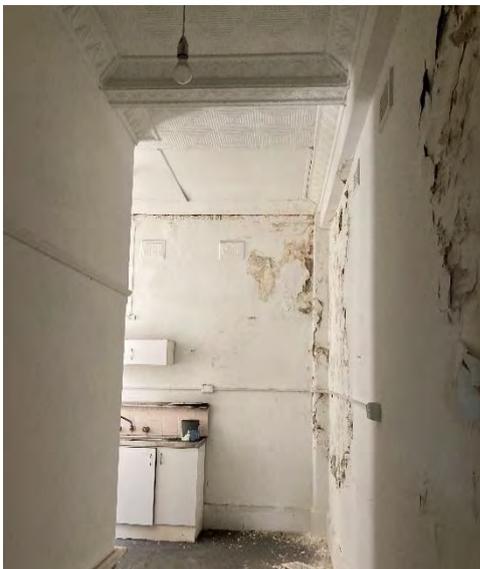
Figure 43: Decorated ceiling and cornice in the corridor.

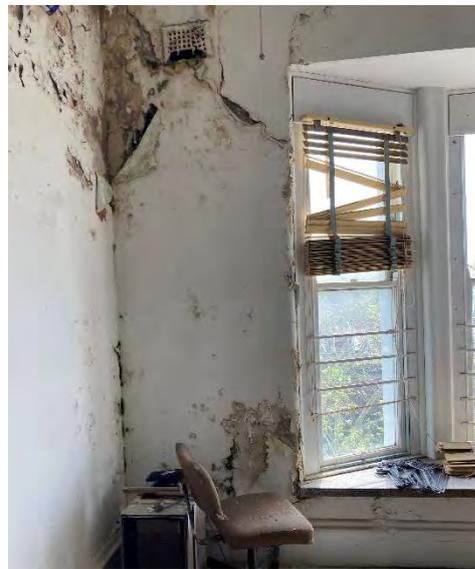
Figure 44: Dampness along the internal walls with peeled-off plaster.

dampness, causing the plaster to peel off. The subject building has timber-framed, single-hung windows with clear glazing and metal grills over the lower window panel attached to the window frame.

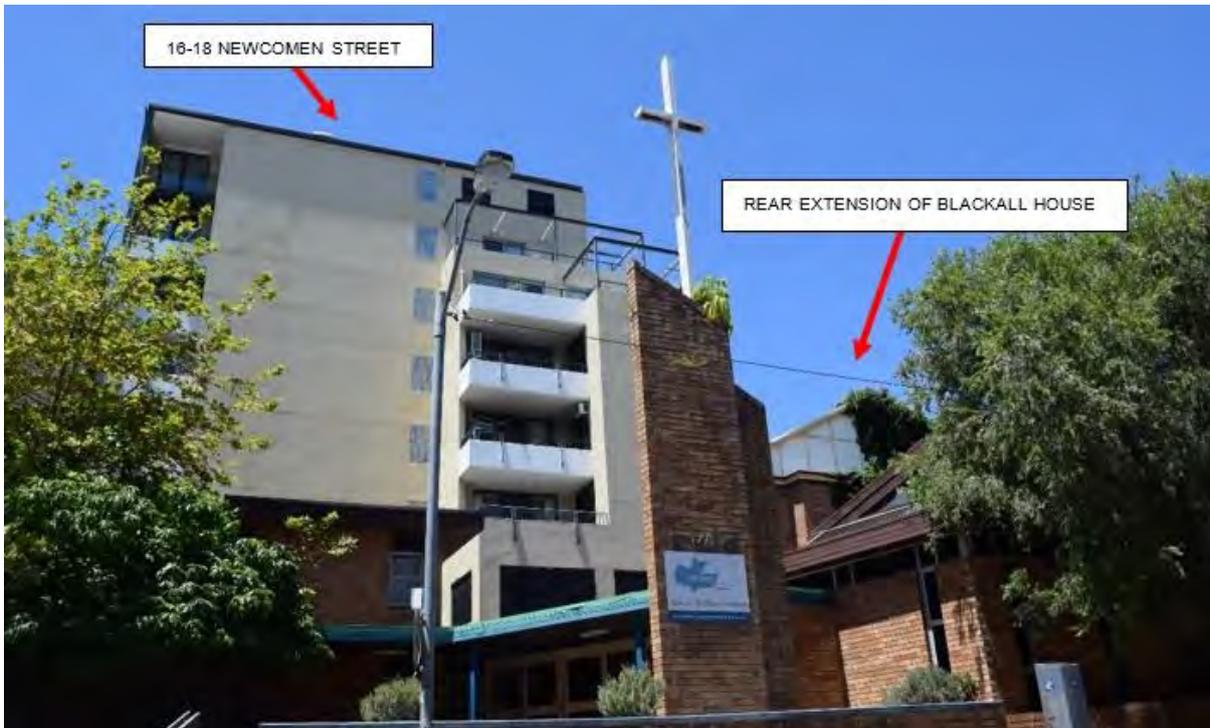
Figure 47: View looking east of the northern section of 3 Morgan Street looking towards the principal elevation of the Calvary Chapel. Note the development to the rear and pitched roof of the Blackall House rear extension.

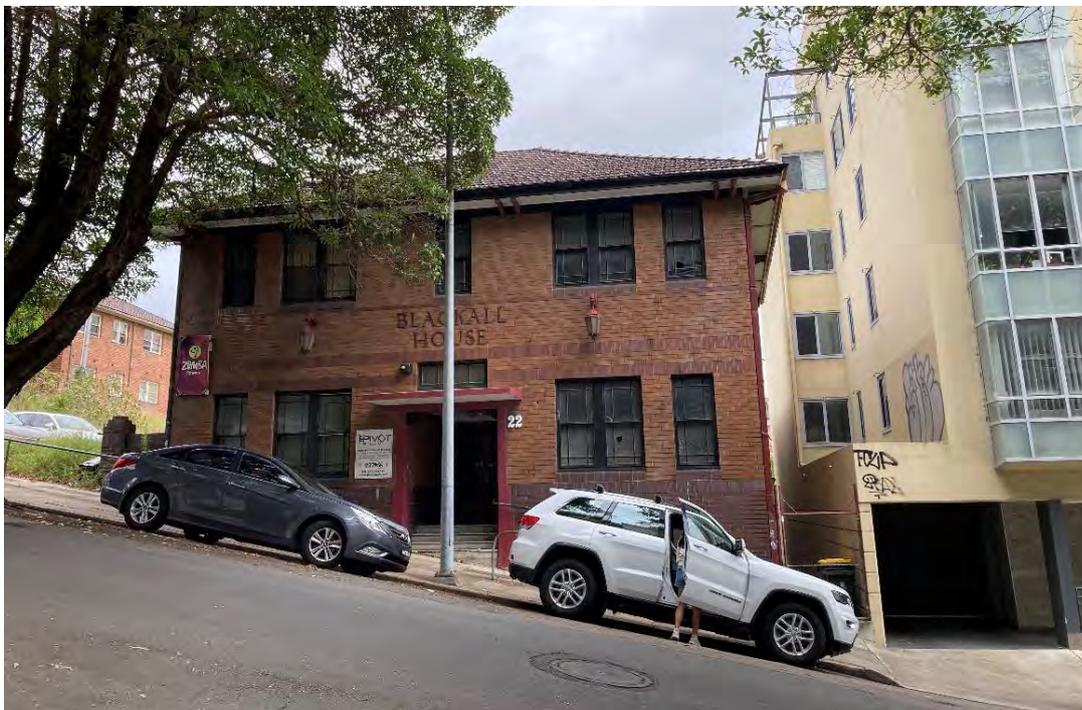
Figure 48: View looking southwest towards the Newcomen Street elevation of Blackall House. Note the margin casement windows and pattern in the façade brickwork which employs red and orange bricks.

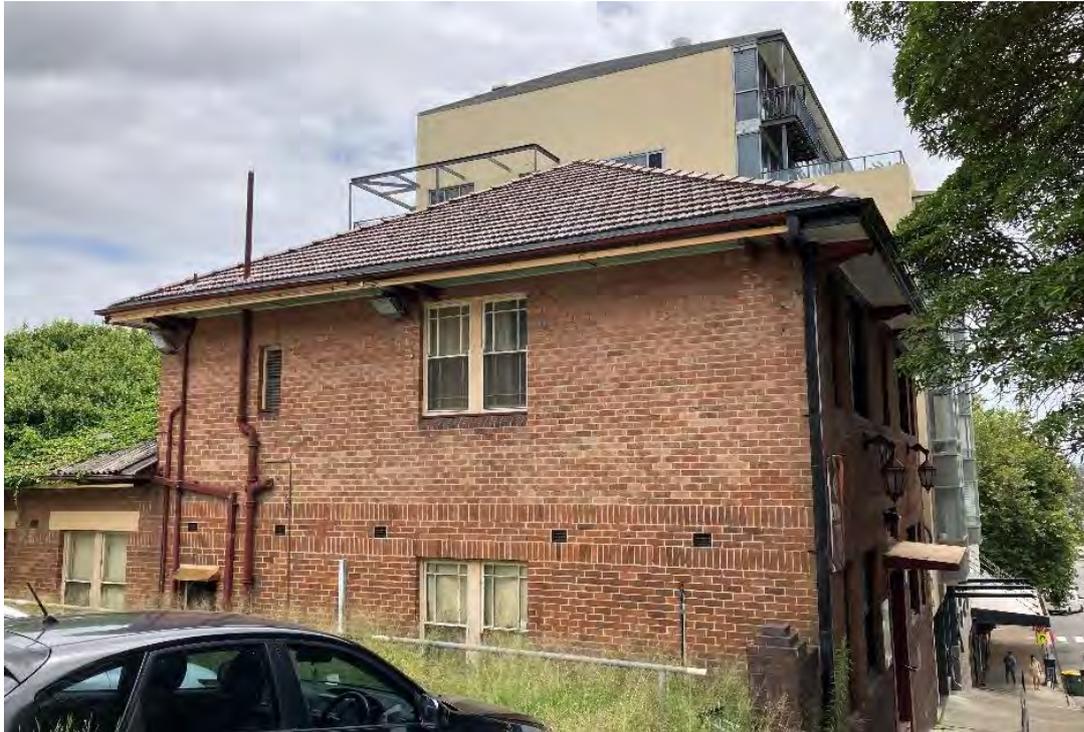
Figure 49: View looking northwest towards the Newcomen Street façade and southern elevation. The topography of the site partially obscures the southern elevation from view.

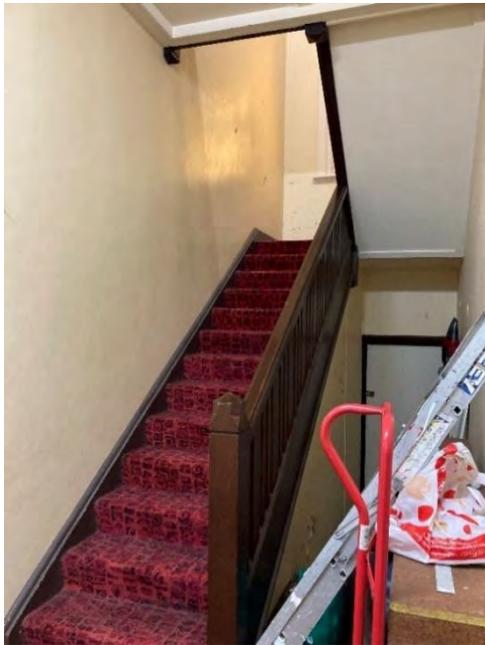
Figure 52: Dog-legged timber Staircase adjacent to the entrance hallway.

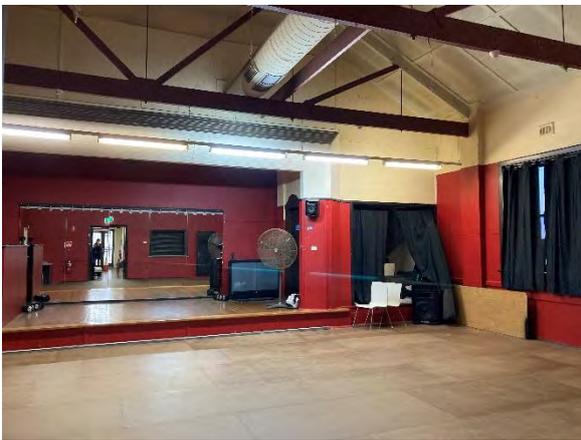
Figure 56: Ground floor studio with painted walls and raised timber platform.

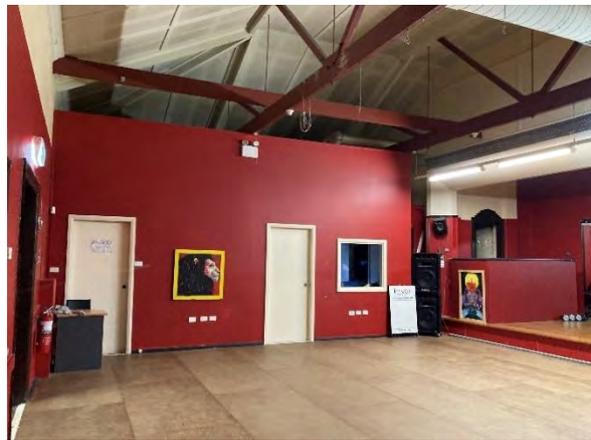
Figure 57: Ground floor studio with painted walls and sloped ceiling with early timber beams and bracing.

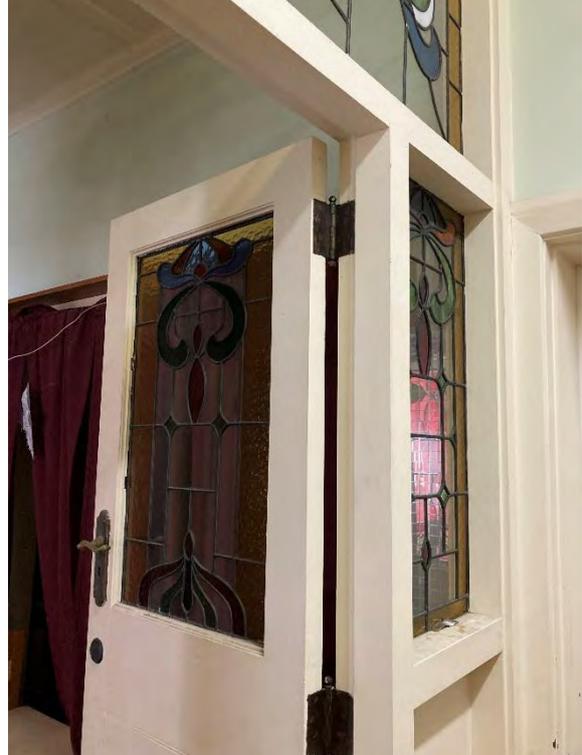
Figure 59: Timber framed doorway, transom and sidelights with decorative lead light glazing.

At the end of the staircase on the first floor is another doorway with double doors, sidelight, and transom, all with decorative leadlight textured glazing. Past the main doorway is a buffer space with a decorative plastered niche on the wall. The buffer space leads to another studio space with similar window openings. The studio space on the upper floor has a simple, flat ceiling with a pattern formed using timber battens. The studio has multi-paned, timber-framed single-hung windows, similar to the ones on the ground floor. A toilet facility is also located adjacent to the upper floor studio space with similar tessellated floor tiling partly damaged along the doorway.

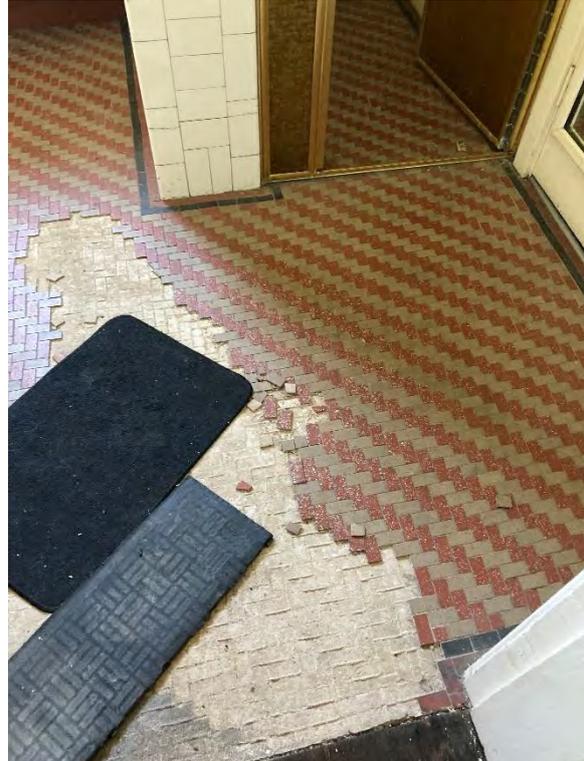
Figure 63: Damaged tessellated floor tiling at first floor toilet facility.

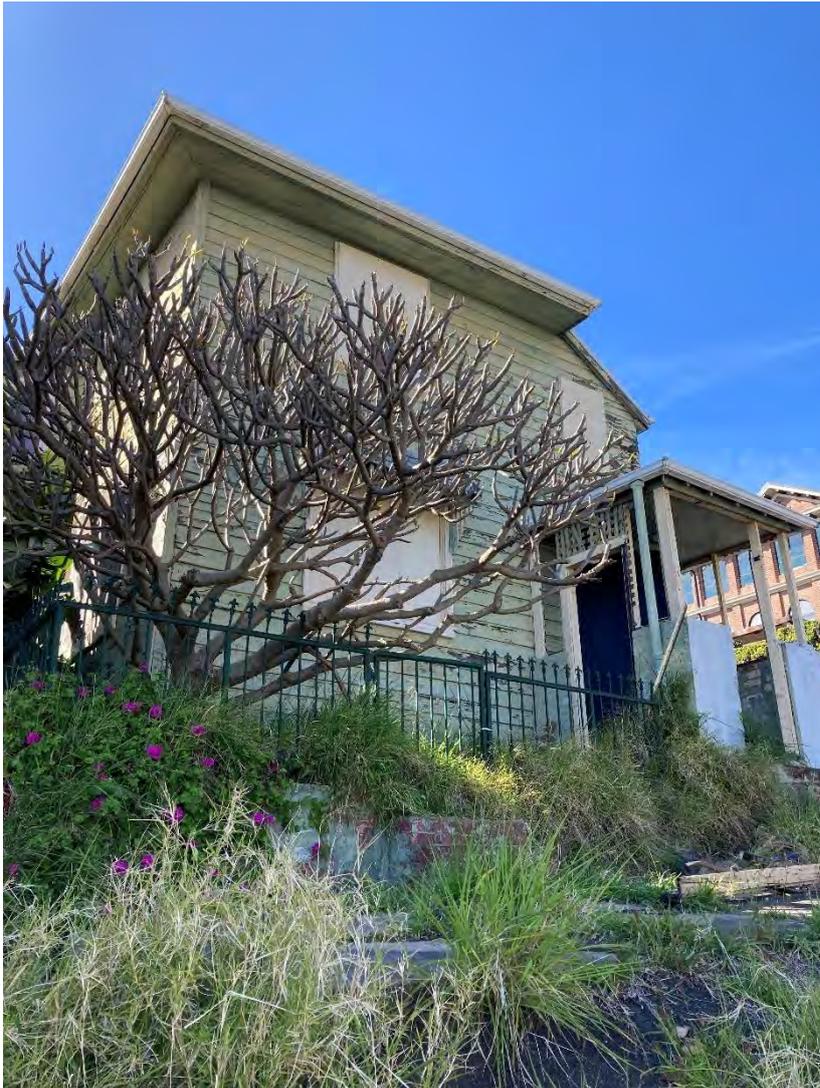
Figure 65: Western Elevation of weatherboard residence at 74 King Street.

The Morgan Street façade, as with the King Street façade, has been partially boarded up and only the ground floor window has retained its timber shingle eyelid. There is also a covered and partially enclosed porch to the entrance with a painted brick base, timber posts and low pitched pyramid hipped roof clad in corrugated metal. The façade is asymmetrical in form and there is a small garden adjoining the porch, with a low brick fence, central set of stairs and metal palisade fence.

The northern façade features timber bay windows to the first and second floors with double hung sash windows to each facet of the bays.

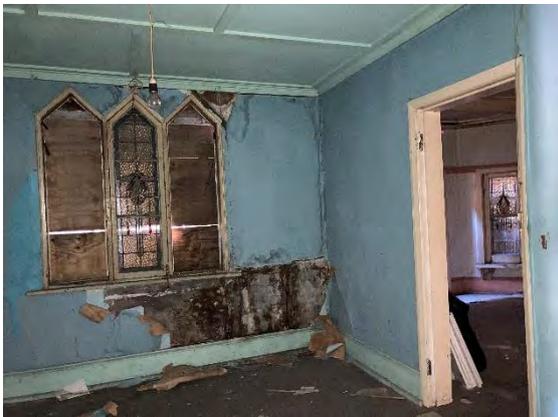
The drawing room, adjacent to the entrance hallway, has a series of triangular arched windows with leadlight glazing. Some of the windows are internally covered with timber boards to prevent unauthorised access to the residence. The room has painted timber cornices and skirting with curved beading. The living room adjacent to the hallway has a series of rectangular doors and windows with similar decorative leadlight glazing. The windows are also partly covered with timber boards, similar to the ones in the dining room. Adjacent to the living room entrance is a fireplace with a broken mantel and surround. A

Figure 66: Decorated windows in drawing room.

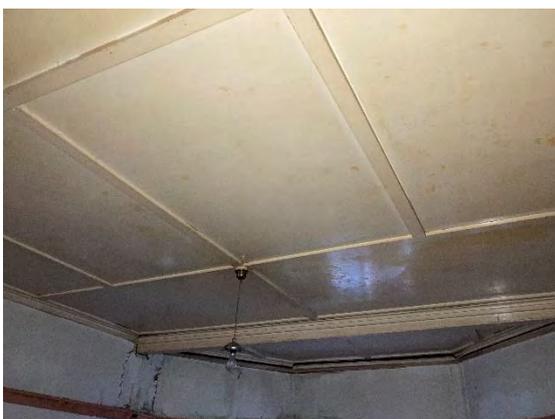
Figure 68: Timber ceiling with cornice in living room.

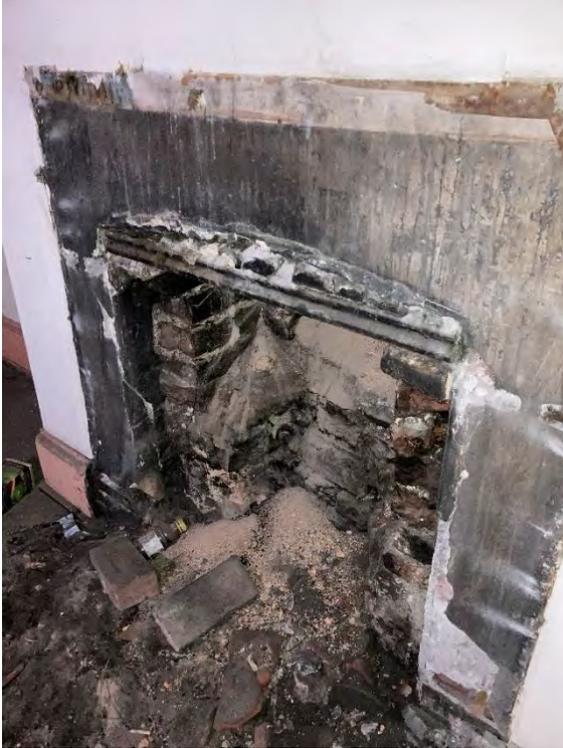
Figure 70: Fireplace in the living room with broken mantel and surround.

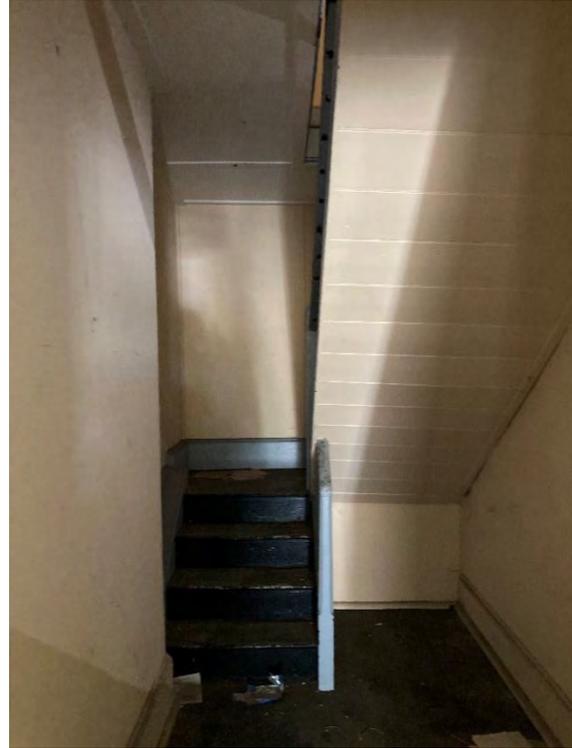
The timber staircase past the entrance hallway has a low-height timber balustrade and timber string. The staircase at the upper level has a few broken and missing balusters. The staircase further leads to the upper-level corridor connected to the bedrooms. The bedrooms have a similar cornice and skirting detailing with timber-framed triangular arched windows. Some of the upper floor rooms have rectangular timber framed singular windows. But, other than the various forms of window frames, all the windows have similar leadlight glass detailing. The external walls in the bedrooms also have wall air vents. One of the upper-floor bedrooms also has a fireplace with a broken mantel and surround.

Figure 71: Timber staircase at the end of the entrance hallway.

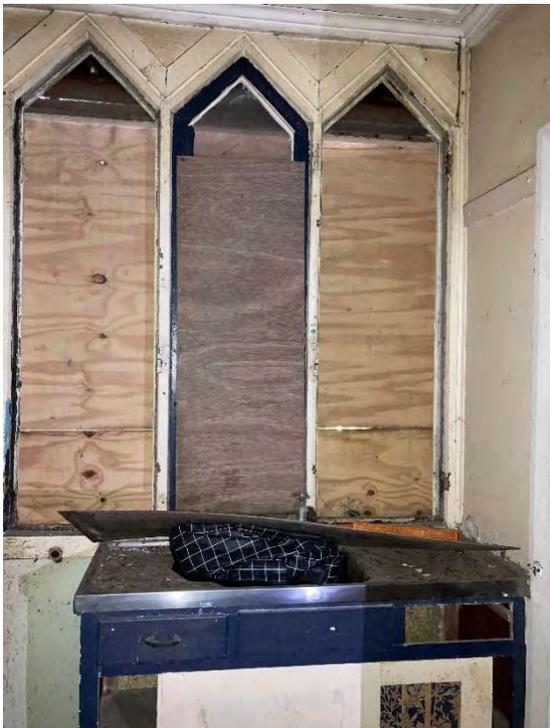
Figure 72: Triangular arched windows in the kitchen.

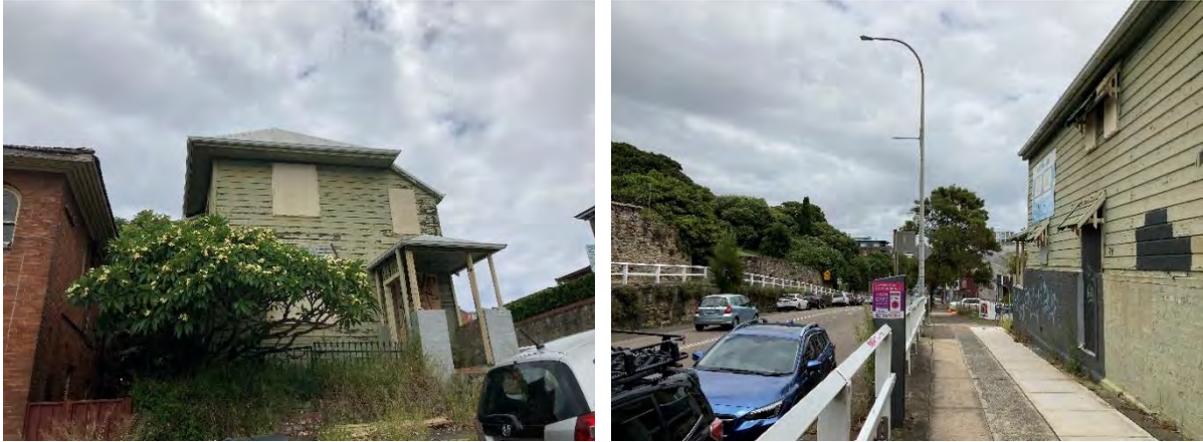
Figure 77: Views looking east and north west towards the Morgan Street (left) and King Street (right) facades of 74 King street.

Building/ Element	Site	Significance	Commentary	Photo
74 King Street façade		Little	The timber residence at 74 King Street is a typical example of its kind and is not considered of particular significance.

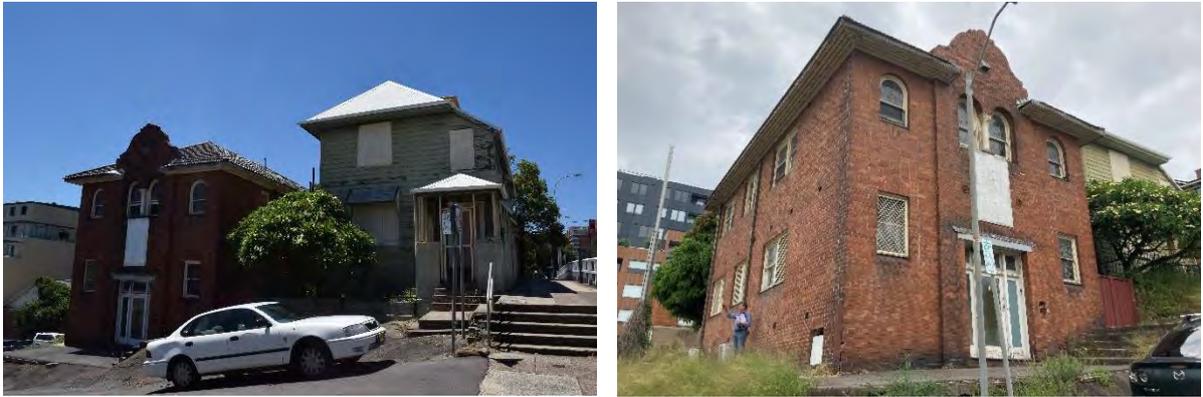
Figure 78: View looking east towards 1 Morgan Street and 74 King Street (left). The image on the right is a view looking south east towards the apartment building located at 1 Morgan Street.

The site of 1 Morgan Street is occupied by a two storey Inter-War red brick apartment building with a primary façade to Morgan Street. The Morgan Street façade is highly symmetrical with a central timber entrance, flat roof awning and brickwork arranged horizontally and vertically to create a border pattern around the windows. At ground floor level there are two double hung windows, one infilled with security mesh and in the other, a floral stained glass pattern is visible. To the first floor are two central arched double hung windows, featuring the same stained glass pattern, and two similar arched windows to either side. The two centre windows are separated by a central Corinthian style column, painted in the same cream colour as the window frames.

The roof form of the building is in a pyramid hipped shape and is clad in brown coloured tiles. Above the first floor windows, centrally placed, is a tall decorative brick parapet with scalloped edges.

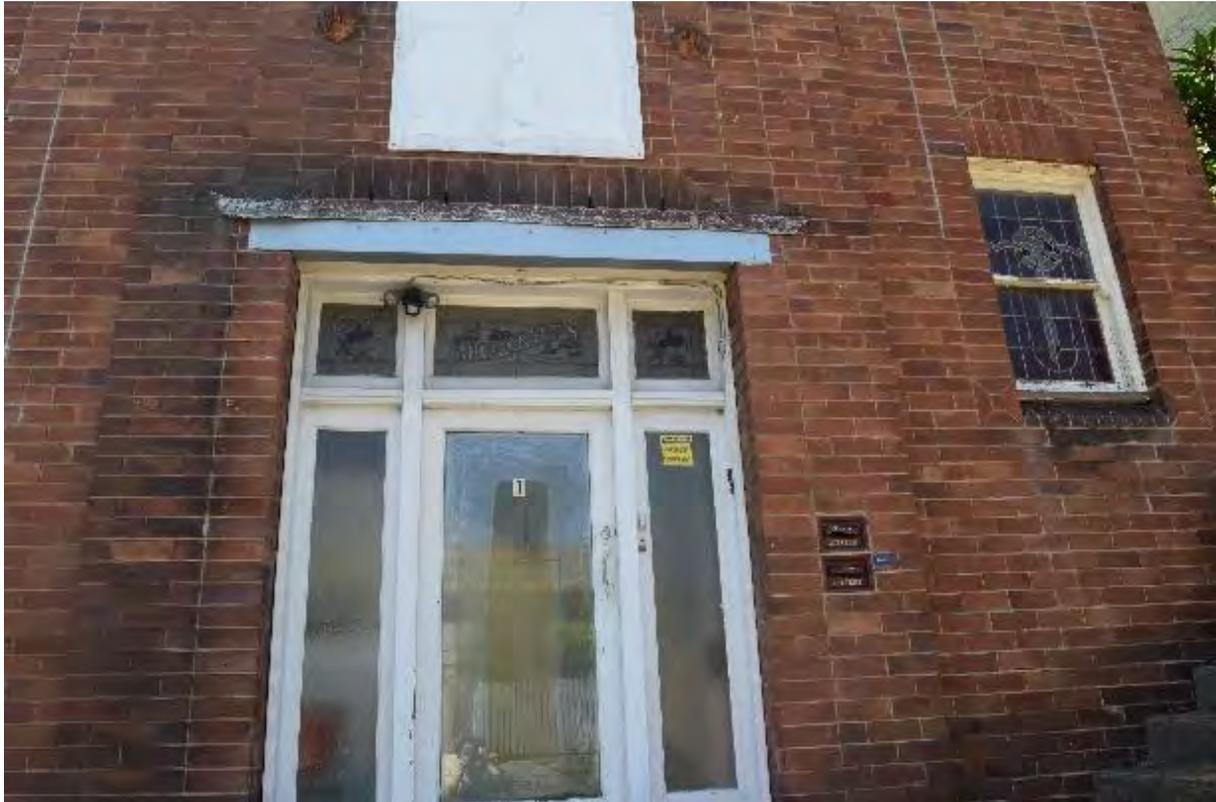
Figure 79: Detailed view of the front entrance to "Arcadia Flats" located at 1 Morgan Street. Note the stained glass detailing in the windows and main entrance transepts.

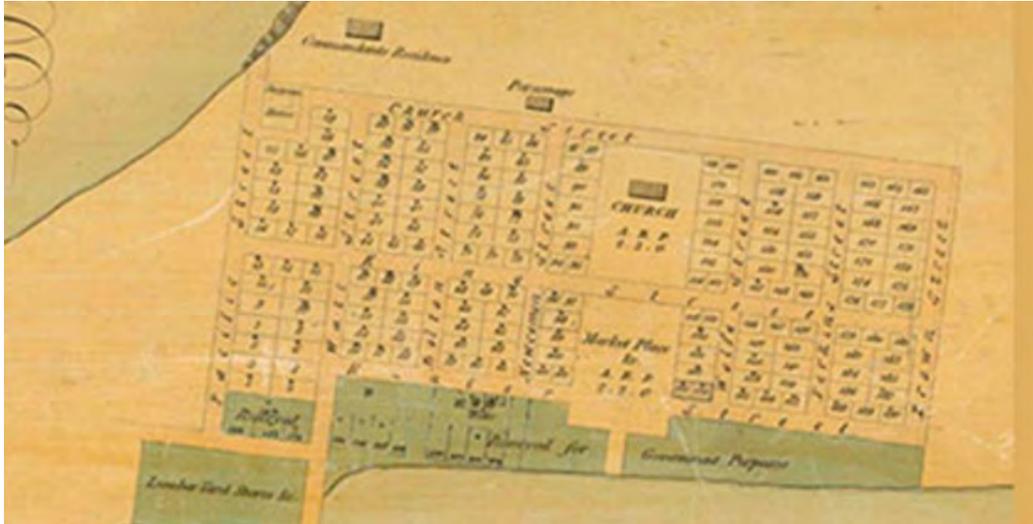
Figure 88: Henry Dangar's plan from 1823 showing the original layout of Newcastle. (Source: Newcastle Region Local Studies Library, accessed 12 April 2017 via <http://www.newcastle.nsw.gov.au/Library/Heritage-History/Search-the-Collection>)

Church site (Figure 88). The layout seen in the 1823 plan does not directly reflect the existing layout of the city street blocks of Newcastle and was modified numerous times over the subsequent years. For example, Thorn and Morgan streets (located within the Precinct) were not designated as reserved roads until 1887 and were originally part of the overall market reserve identified in Dangar's plan.

The development of Block 3 is directly related to the development of the Market Place and the Borough Markets, which were designated as Crown Land in Henry Dangar's 1823 plan (see [Figure 88](#)). Unlike Blocks 2 and 4, the site of Block 3 at the time had not been subdivided and allocated to various individuals, but rather, was designated purely for use as a Market Place. Originally the plan included a large market reserve that was later subdivided and reduced in size.

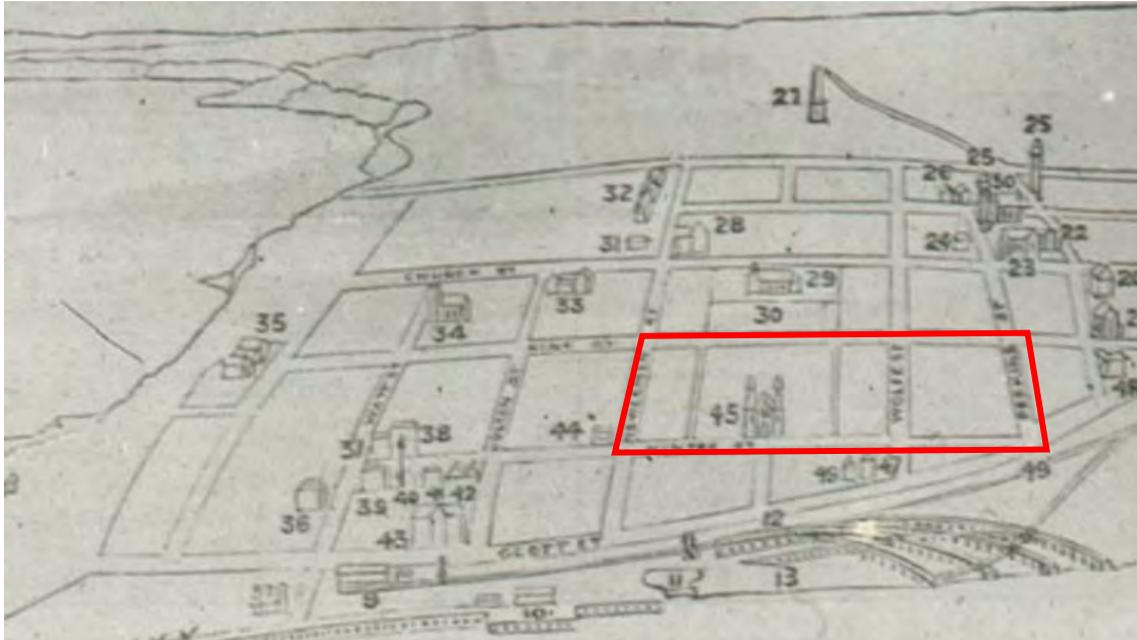
Figure 92: An early Newcastle map that appeared in the *Illustrated Sydney News* on 8 April 1875 showing various historic landmarks including the Borough Markets, located within the study area. (Source: University of Newcastle Cultural Collections, accessed 5 April 2017 via <https://www.flickr.com/photos/uon/6913820773/in/photostream/>)

By 1869 the block had been subdivided and altered to include a smaller central space for the Newcastle Borough Market, which was surrounded by a series of smaller establishments predominately facing Hunter Street. These include H Simpson's Northumberland Hotel, J Hunter's Boot Shop, R Gibb's Newmarket Hotel, two Milliners and a Butcher. A few properties and establishments had developed to the rear including stable buildings, a Council owned property and the Blue Bell Hotel owned by C Nelson. These early buildings and residents can be seen in [Figure 92](#) alongside the Borough Market building.

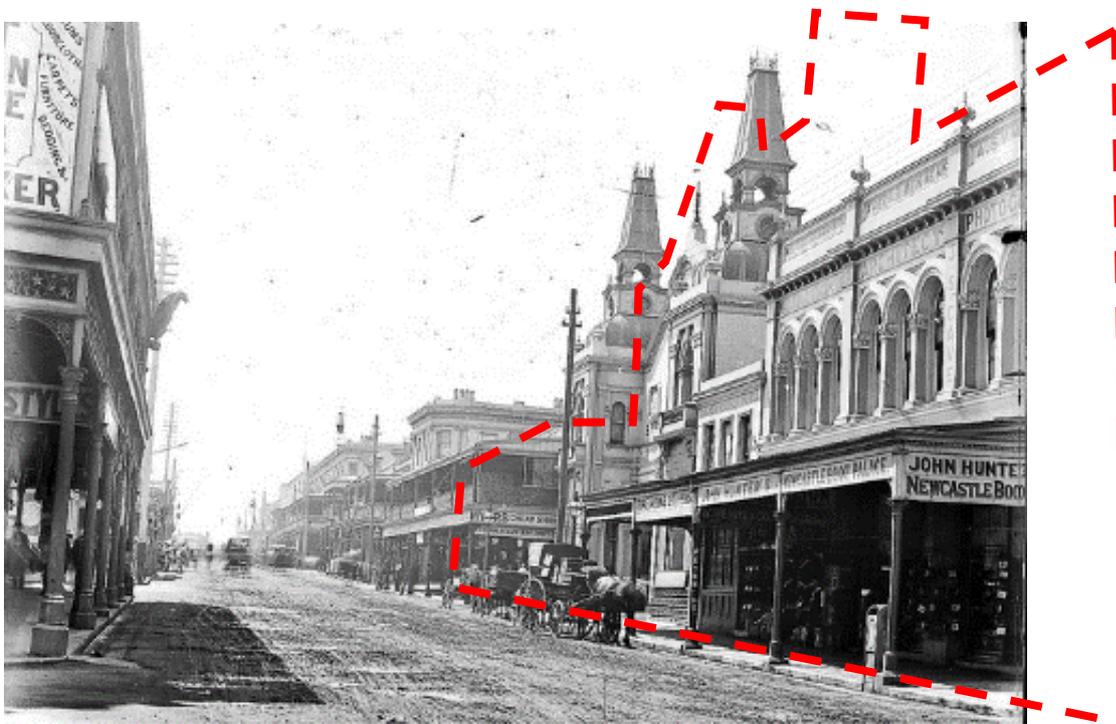
Figure 96: View looking east along Hunter Street on 21 January 1891 with Block 3 visible to the right and outlined in red. Note the Borough Market building and surrounding buildings that were demolished prior to construction of the existing buildings. (Source: University of Newcastle Cultural Collections, accessed 5 April 2017 via <https://www.flickr.com/photos/8571926@N06/4861819693>)

Prior to the development of this building, the site was occupied by a two-storey commercial building, which can be seen in Figure 96. The building was located alongside the Borough Market building and was later demolished to make way for the existing Municipal Building.

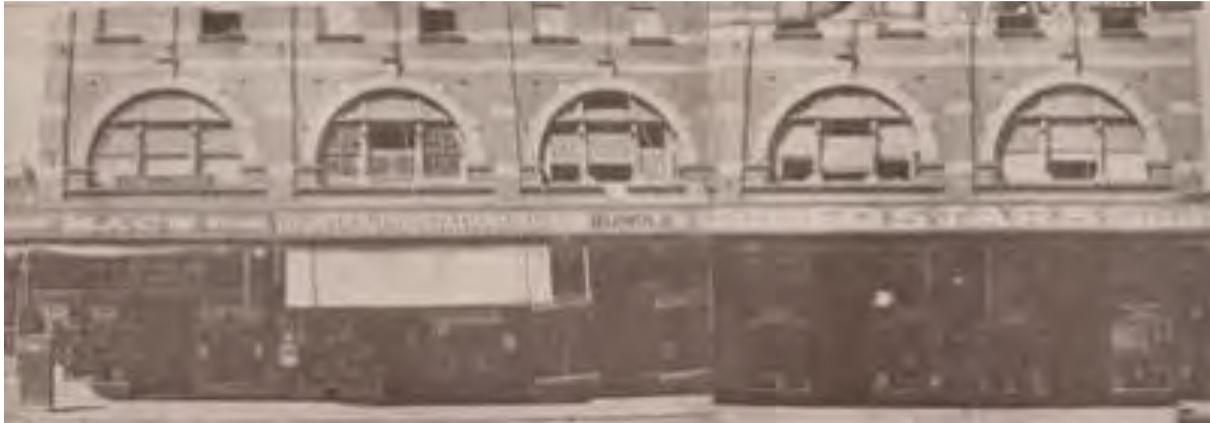
Figure 103: Photograph of the ground and first floor of the Municipal Building in 1938. At the time the ground floor commercial space was occupied by Hunter the Stationer Ltd. (Source: Newcastle University Cultural Collections, accessed 5 April 2017 via <https://www.flickr.com/photos/uon/8641077883/>)

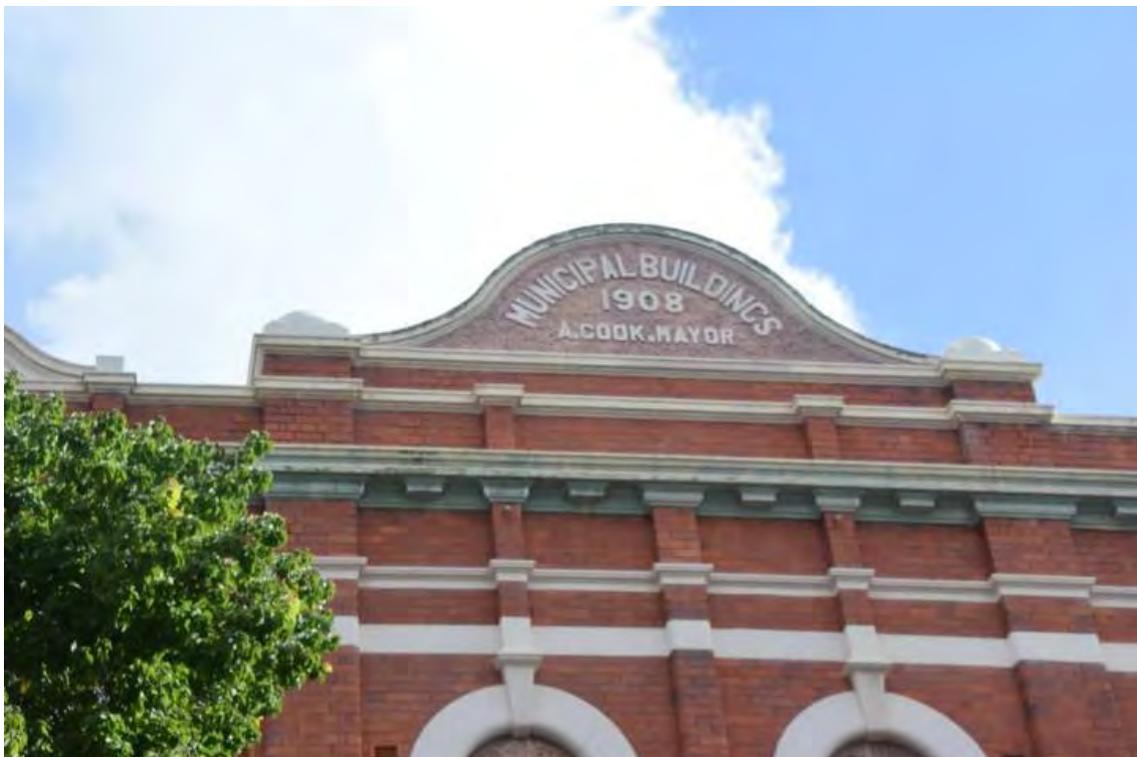
Figure 106: Municipal Building, designed by T.W. Silk in 1908. Shows the pediment of the building. (Source: The Newcastle Herald, accessed 16 March 2017 via <http://www.theherald.com.au/story/4499372/chaotic-meeting-after-a-mystery-resignation/#slide=2>).
