Heritage Impact Statement (Amended)

Newcastle East End

Blocks 3 & 4 (Demolition &
Development DAs)

Newcomen, Hunter, Thorn, Laing and King Streets

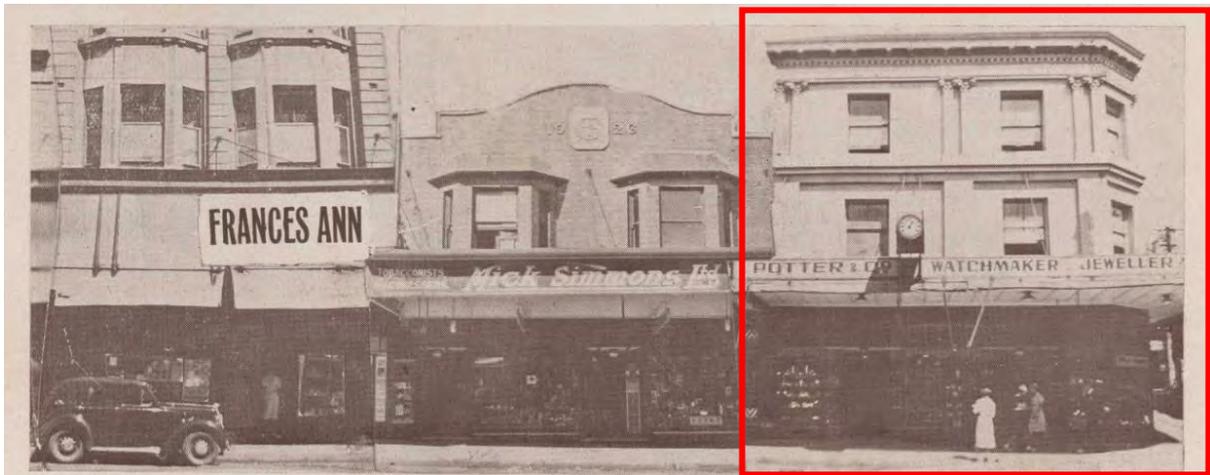
Figure 117: Photograph of 105-111 Hunter Street with 111 Hunter Street visible to the right. Attached above the awning in this photograph is a clock that later appears at 109 Hunter Street. Dated 1938. (Source: Newcastle University Cultural Collections, accessed 21 March 2017 via <https://www.flickr.com/photos/uon/8641073669/in/photostream/>)

In a photograph from 1938 ([Figure 117](#)) Potter & Co Jeweller and Watchmaker are clearly identified as occupying the ground floor of the building, with a clock prominently visible above the awning, most likely produced by the company. By this time the first floor balcony and original awning had been removed and the "Sanitarium Building" sign had not yet been installed.

Fletcher Jones operated at 109 Hunter Street for several decades and in an image from 1972 ([Figure 123](#)), the façade above the parapet was clad over and the building given a completely new streetscape appearance. It is unclear at the time whether the two bay windows to the first floor were removed, however, given the amount of cladding required to create a flush appearance, removal of the windows seems likely. The bay windows and the original façade above the awning have since been reinstated. Prior to this and as evident in [Figure 119](#) and [Figure 120](#), the building was occupied by Mick Simmons Ltd in c.1917. In an image from 1938 ([Figure 117](#)) the foundation date is visible in addition to a plaque that is no longer present.

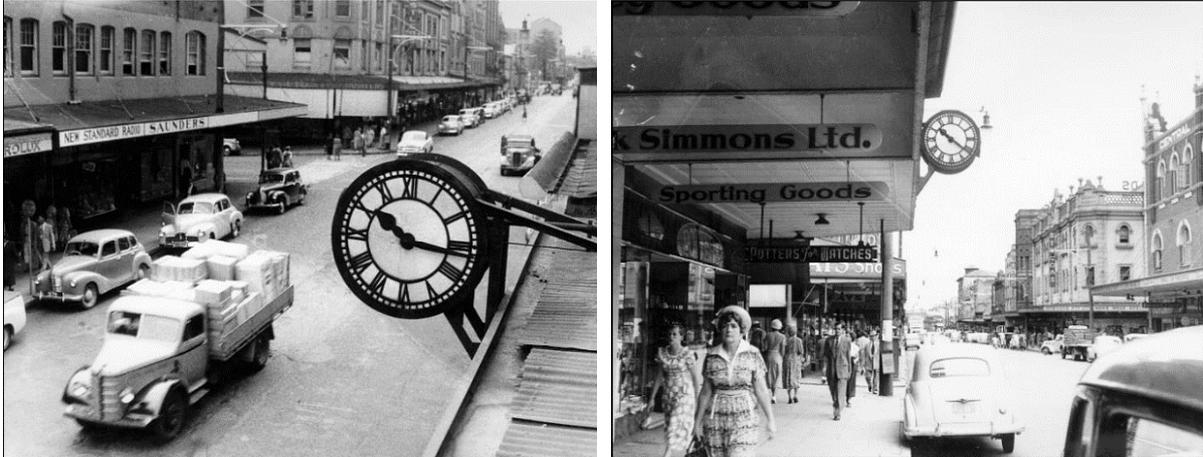
Figure 122: Photographs dating from 1952 of the parapet and façade below the awning. Also note the clock that appears in several early images. (Source: Newcastle Region Library, registration no.'s 104 001829 and 104 001828, accessed 20 March 2017 via <http://collections.ncc.nsw.gov.au/keemu/pages/nrm/Display.php?irn=31426&QueryPage=%2Fkeemu%2Fpages%2Fnrm%2Findex.htm> and <http://collections.ncc.nsw.gov.au/keemu/pages/nrm/Display.php?irn=31425&QueryPage=%2Fkeemu%2Fpages%2Fnrm%2Findex.htm>)

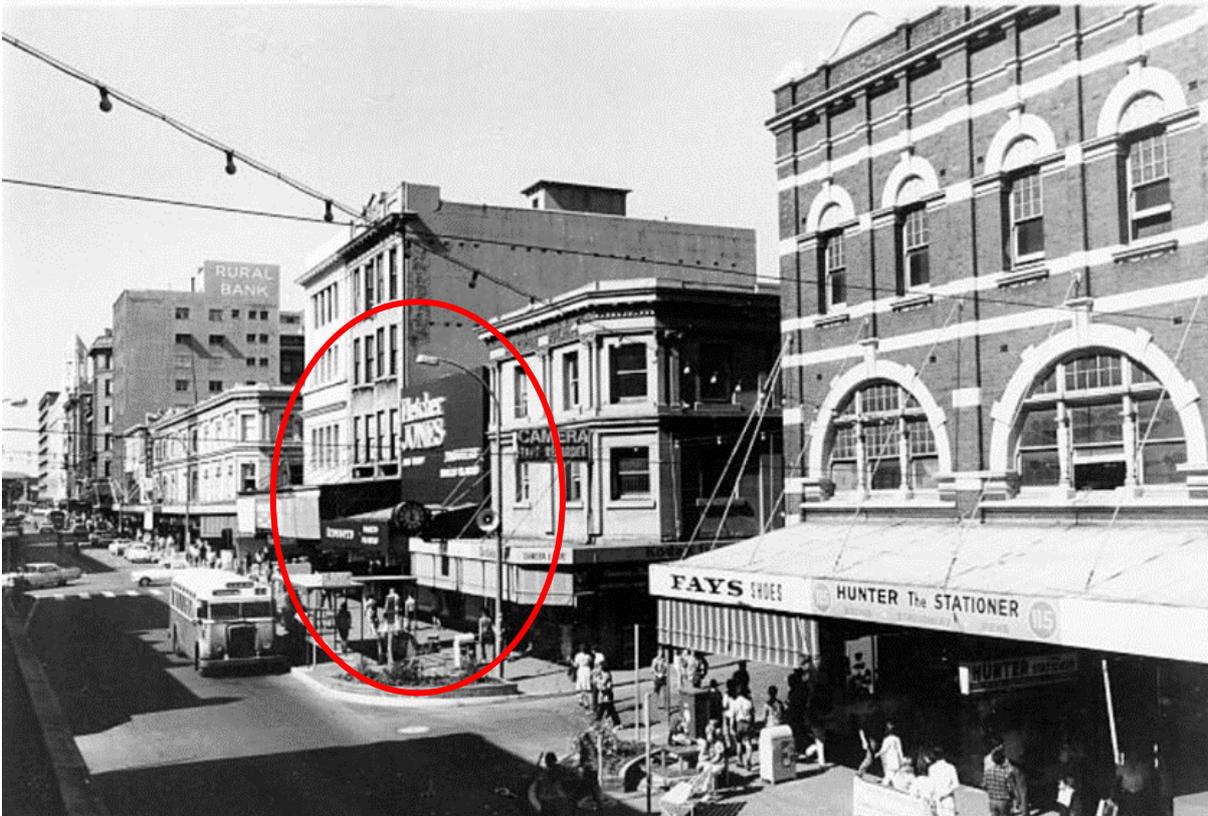
Figure 123: View looking east in 1972 with the subject sites circled in red. (Source: Newcastle Region Library, registration no. 047 000009, accessed 20 March 2017 via <http://collections.ncc.nsw.gov.au/keemu/pages/nrm/Display.php?irn=25935&QueryPage=%2Fkeemu%2Fpages%2Fnrm%2Findex.htm>)

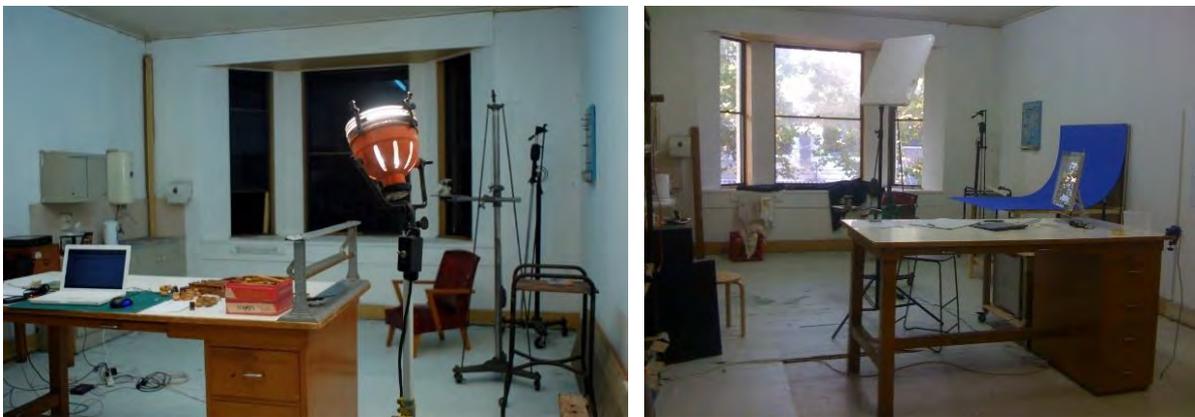
Figure 127: Internal views of the first floor studio used by Jane Shadbolt during production of "The Cartographer." Dated c. 2008. In these views the bay window is clearly visible in the background. (Source: Courtesy of Professor Jane Shadbolt)

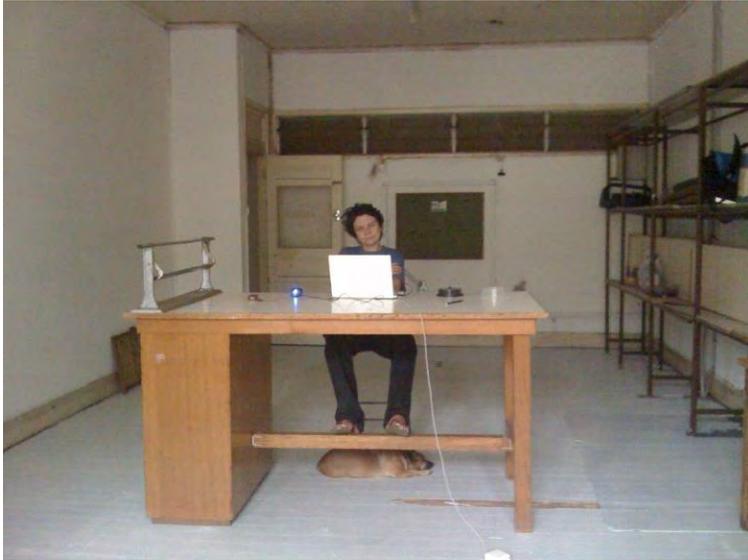
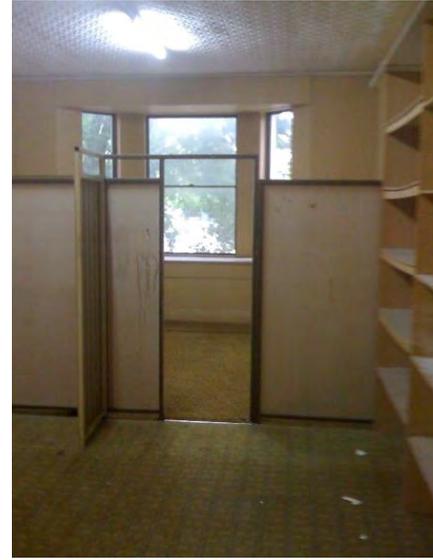
Figure 128: Internal views of the first floor studio used by Jane Shadbolt during production of "The Cartographer." Dated c.2008. The image on the right shows the workspace following painting works and some old shoe storage racks and the image on the right shows the original monogrammed carpet. (Source: Courtesy of Professor Jane Shadbolt)

Following closure of the store, the building was unoccupied for a period of time before being used as a studio space for artists as part of the Renew Newcastle project which was responsible for activating many old buildings within Newcastle's city centre and attempting to resurrect Newcastle's city centre. As part of the Renew Newcastle project, Professor Jane Shadbolt and her team produced a short film within the space, known as "The Cartographer." While the building does not feature in the film, it was used as the main workspace for the project over a number of years, as seen in [Figure 127](#) - [Figure 129](#). Of particular note in these images are the Fletcher Jones monogrammed carpet, racks for shoe boxes and interior views of the bay windows⁵¹.

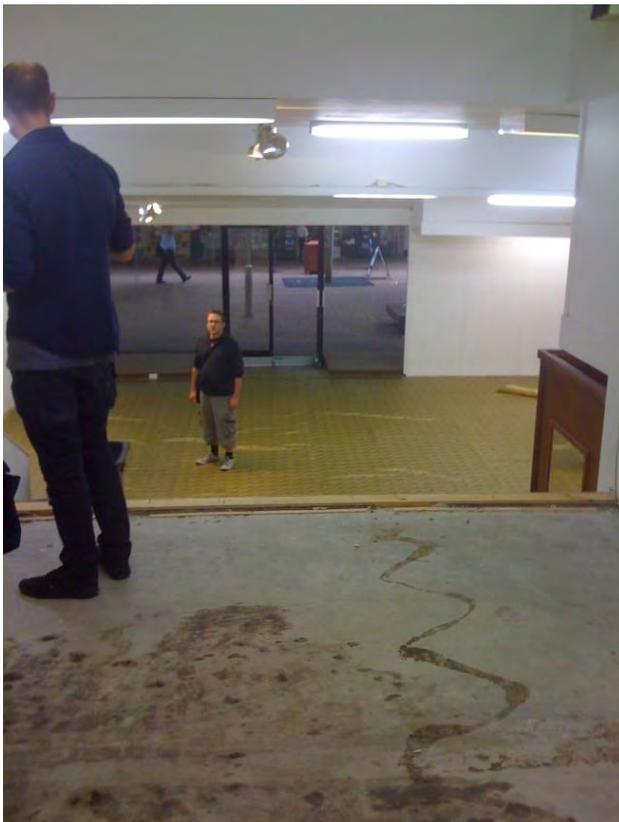
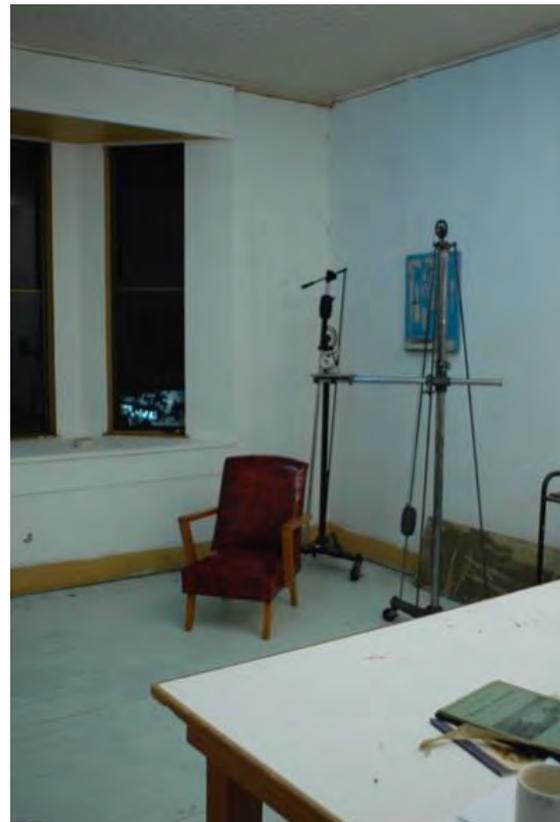
Figure 129: Internal views of the first floor studio used by Jane Shadbolt during production of "The Cartographer." Dated c.2008 the image on the left is of the ground floor of the building and the image on the right is of the first floor studio space with the pressed metal ceiling clearly evident. (Source: Courtesy of Professor Jane Shadbolt)

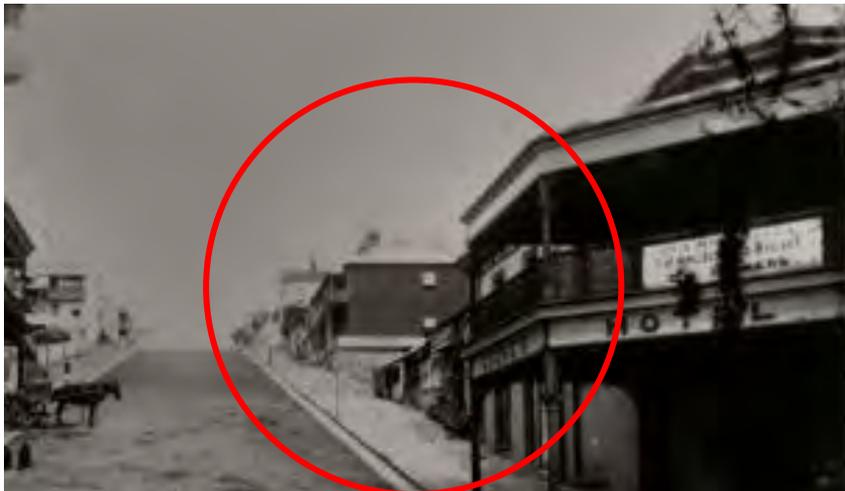
Figure 137: Detailed view from a photograph of Newcomen Street dated c.1880s. Note the terrace houses located where Blackall House now stands. (Source: University of Newcastle Cultural Collections, M4874 – Panel 28, accessed 20 March 2017 via <https://www.flickr.com/photos/8571926@N06/6067476827>)

In a photograph from the 1880s (Figure 137), Newcomen Street at the time was populated by a series of terraces houses. The terraces present at 22 Newcomen Street were demolished to make way for "Blackall House," designed as a welfare centre for the Newcastle branch of the Adult Deaf and Dumb Society⁵⁶.

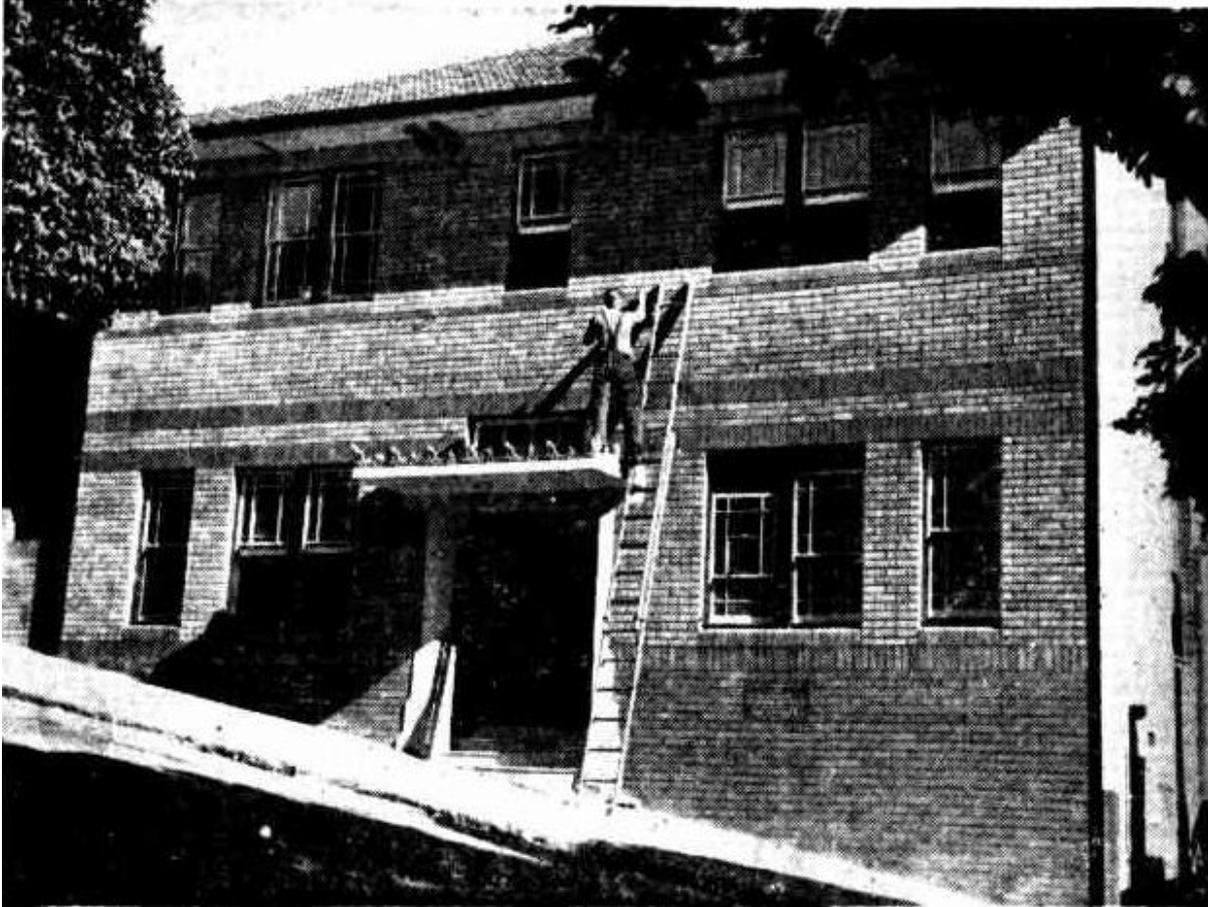
Figure 138: Photograph of Blackall House prior to completion in 1936. (Source: "Deaf and Dumb Society Building Near Completion," *Newcastle Morning Herald and Miners' Advocate*, Saturday 1 August 1936, p.7, accessed 22 March 2016 via <http://trove.nla.gov.au/newspaper/article/140506739?searchTerm=Blackall%20House%20Newcastle&searchLimits>)

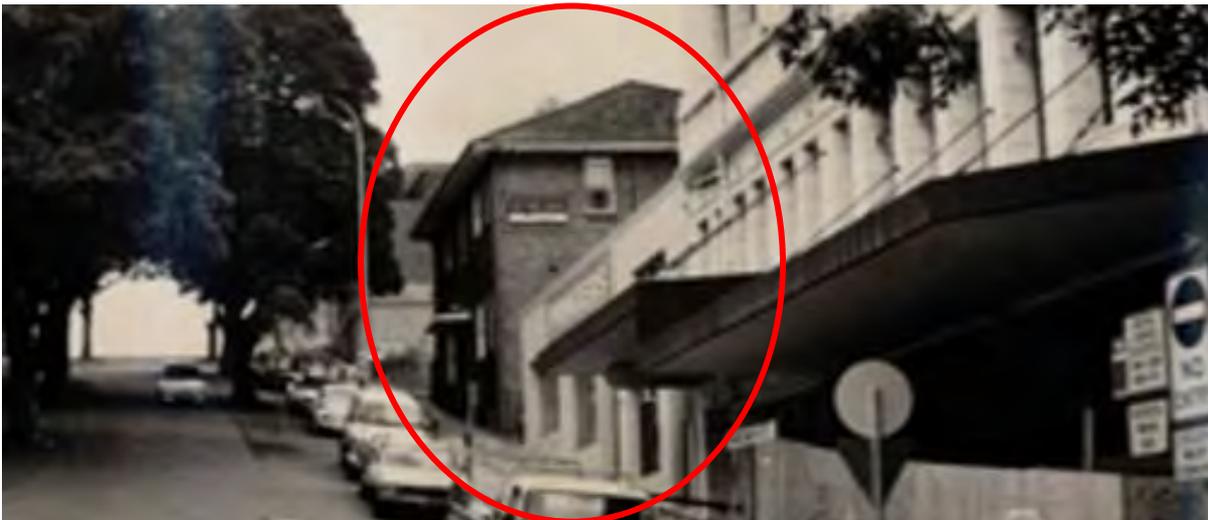
Figure 139: Photograph from 1992 of Blackall House showing the northern façade which has since been partially obscured by a recent neighbouring apartment building development. (Source: *University of Newcastle Cultural Collections*, M4874 – Panel 28, accessed 20 March 2017 via <https://www.flickr.com/photos/8571926@N06/6067476827>)

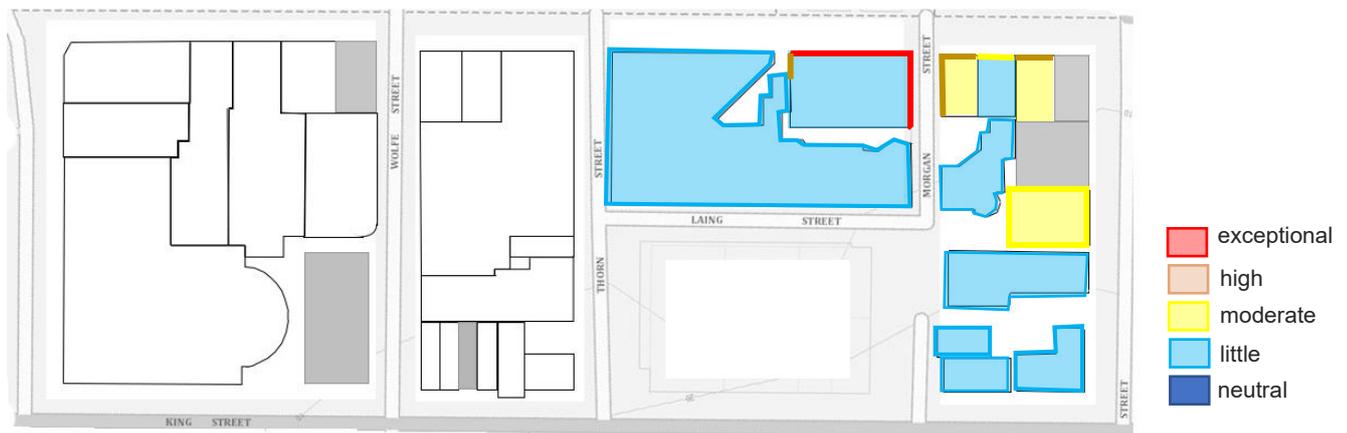
Figure 141: General site plan showing the overall significance ranking of each built element present within Blocks 3 and 4 of the Newcastle East End Precinct. The ranking on this plan does not reflect the individual walls or the facades of the Municipal Building (the Heritage Item) rather it relates to the overall significance of the building while the remainder ranking for Contributory buildings reflect their respective street facades. Refer to Section 8.6.3 for detailed significance ranking of each building.

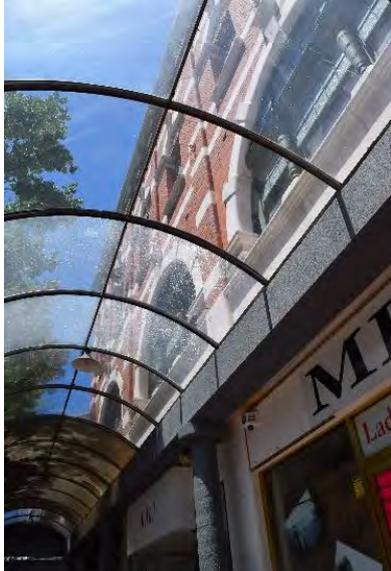
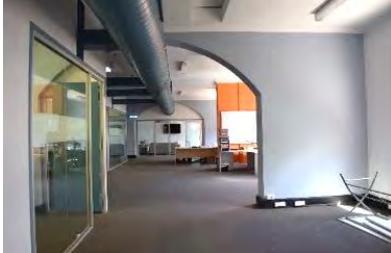
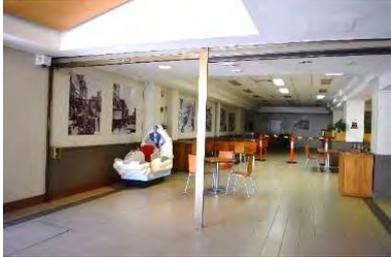
Former Municipal Building interior	<p>Little</p>	<p>The interior of the former Municipal building has been significantly modified and there is very little surviving original fabric.</p> <p>Recent investigations into the building's internal partitions and arches have revealed</p>

Building/ Site Element	Significance	Commentary	Photo
		<p>that the arched openings on Level 2, which extend to approximately 4m from the Hunter Street façade of the building are not original and have been created as part of the single commercial tenancy fitout</p> <p>The remainder of the interiors are essentially later partition walls smaller office spaces.</p>

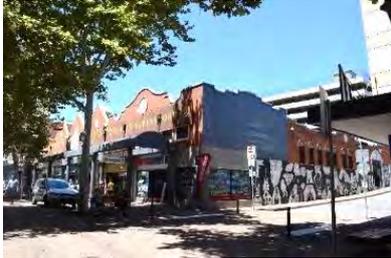
113-121 Hunter Street façade & interiors	Little	<p>The exterior of 113-121 Hunter Street is not considered of significance as it is a later development with no aesthetic character of note. Similarly, interiors of the building are of Low heritage value.</p>

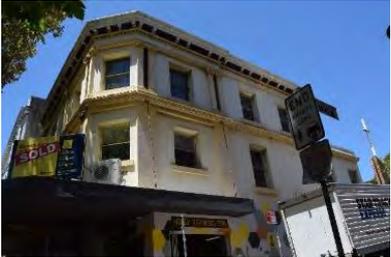
Building/ Site Element	Significance	Commentary	Photo
111 Hunter Street exteriors	<p>High (north & east elevations at Levels 1 and 2)</p> <p>Little (south, west and rear two-storey wing)</p>	<p>The north and east facades of the former Sanitarium building are considered of High significance as a contributory building dating from c.1890. Aesthetically it is a representative example of the Victorian Free Classical style and directly reflects the characteristics of heritage items located in proximity.</p> <p>The rear (south) and west side elevations of the building together with the rear two-storey wing are assessed being of Little heritage value.</p>

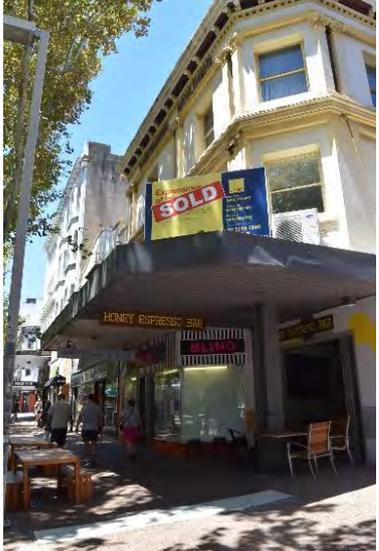
Building/ Element	Site	Significance	Commentary	Photo
	Little (Ground floor facades)	<p>Ground floor façade and shop windows have been heavily modified and therefore are not considered of significance.</p> <p>The awning is also a later addition.</p> <p>Interiors of the building were not accessible and therefore have been ranked as being of moderate significance to allow for appropriate archival recording in a future internal demolition.</p>

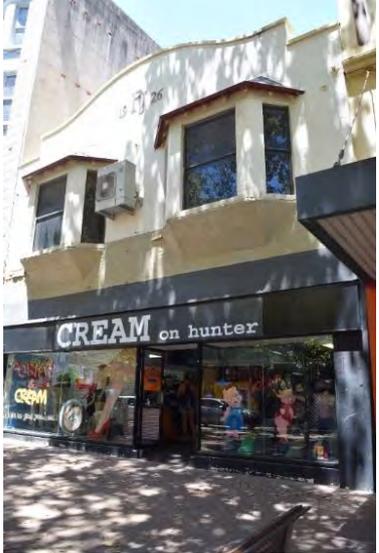
109 Hunter Street facade	Moderate	<p>The façade of the commercial terrace located at 109 Hunter Street is considered of moderate significance, as a typical example of Inter-War building that was reconstructed matching the details of the original building dating from 1926.</p>

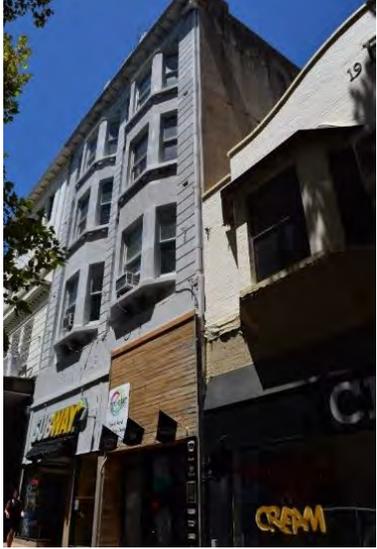
Building/ Element	Site	Significance	Commentary	Photo
		Little	<p>Ground floor façade and shop windows have been heavily modified and therefore are not considered of significance.</p> <p>The original awning has also been removed.</p>

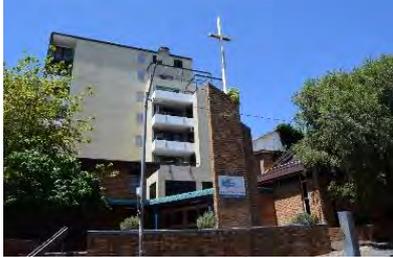
3 Morgan Street façade		Little	<p>The Calvary Chapel building is not considered of particular significance, dating from a later period of development. It does not contribute to the streetscape.</p>

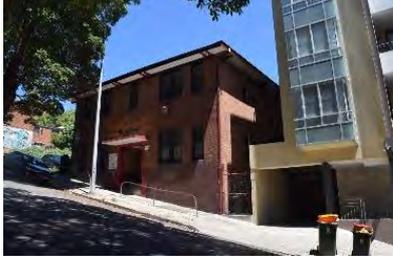
Blackall House façade	House	Moderate (exterior) Little (interiors)	<p>Blackall House is of Moderate significance as a building dating from the Inter-War period. It is a typical example of a community facility with simple architectural aesthetics.</p> <p>Interiors of the building have been significantly modified with no discernible layout of the original or earlier configuration remaining, and therefore they are of Low significance. There are some detailing of interest including leadlight glazing.</p>

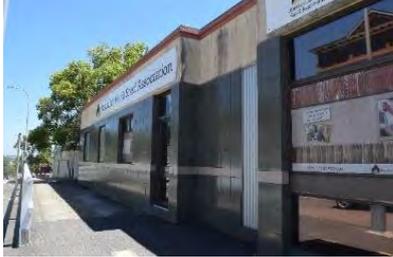
66 King Street façade		Little	<p>The building located at 66 King Street is a more recent development and is not considered of particular significance. It is not considered to positively contribute to the streetscape.</p>

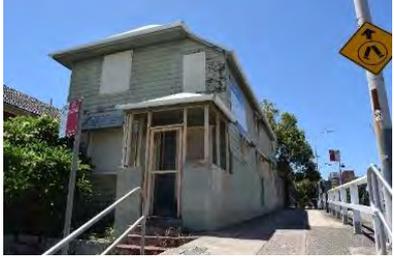
Building/ Element	Site	Significance	Commentary	Photo
74 King Street façade		Little	The timber residence at 74 King Street is a typical example of its kind and is not considered of particular significance.

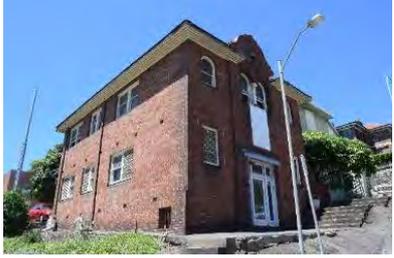
1 Morgan Street façade		Moderate (exterior) Little (interiors)	The "Arcadia Flats" building is an example of an Inter-War residential flat building on a small scale (consisting of four apartments). The character of the building reflects the character of Blackall House, which it has a direct relationship with due to the topography of Block 4. Although there are some internal features remaining in scattered form within the building, its overall integrity is Low.

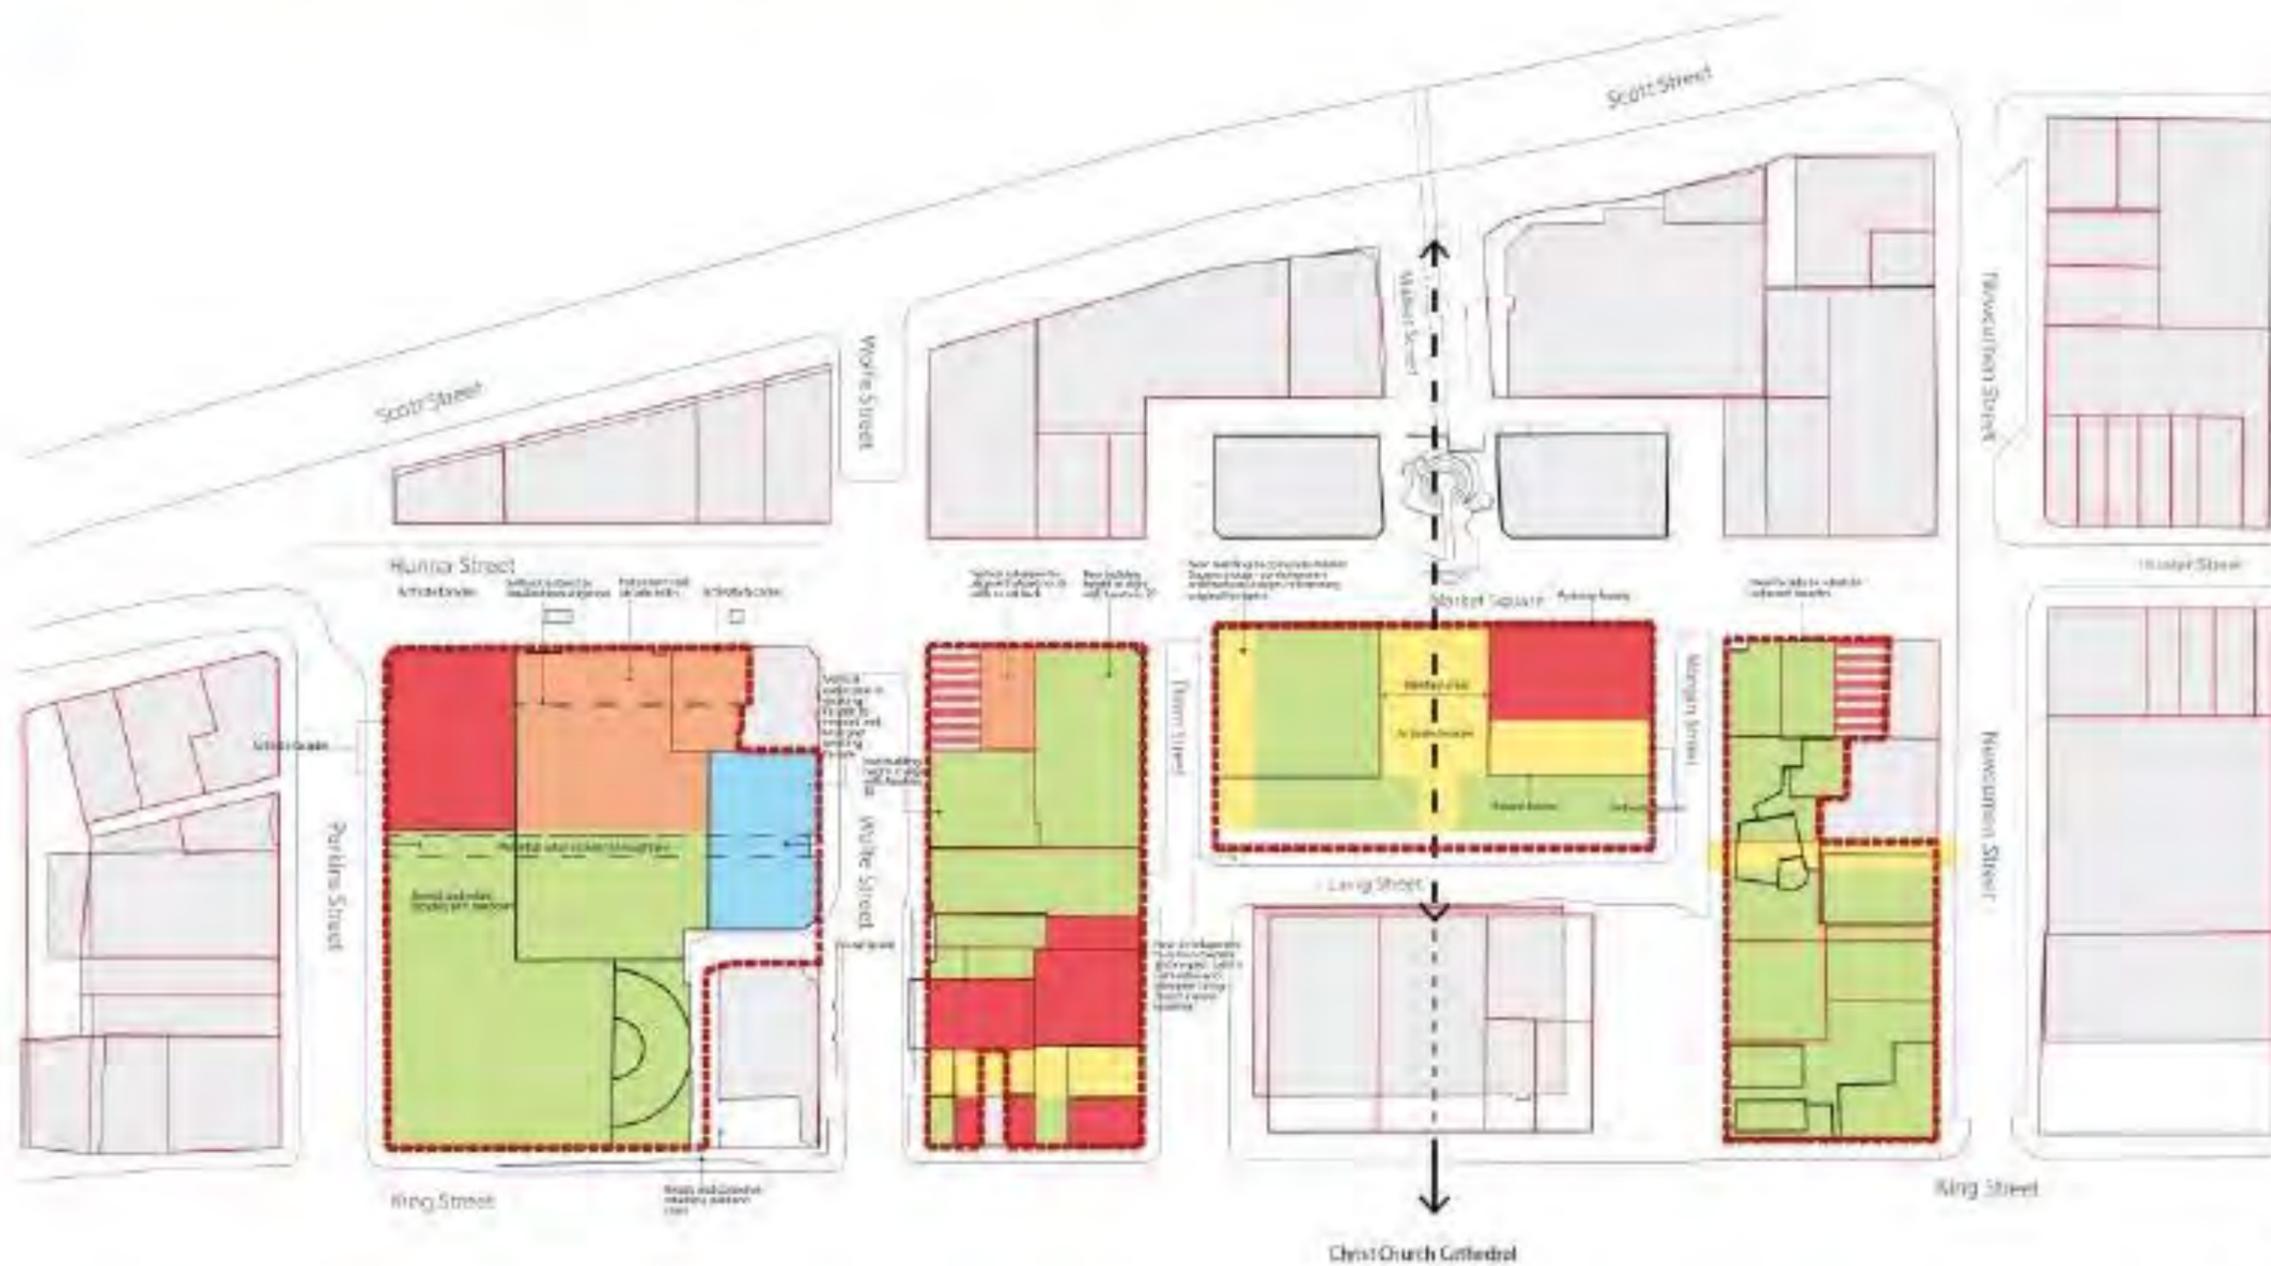
Figure 52 Newcastle East End Plan indicating general actions for heritage buildings.
Source: TKD Architects

- Legend
- Facade conservation and adaptive re-use of interiors
 - Investigate potential for adaptive reuse of interiors
 - Facade conservation and new construction behind with modest vertical addition to align with adjacent facades
 - Facade conservation and substantial new development behind with major vertical addition
 - Create open space/pedestrian access
 - Demolish existing building, substantial new development with improved architectural and functional relationships with adjacent buildings

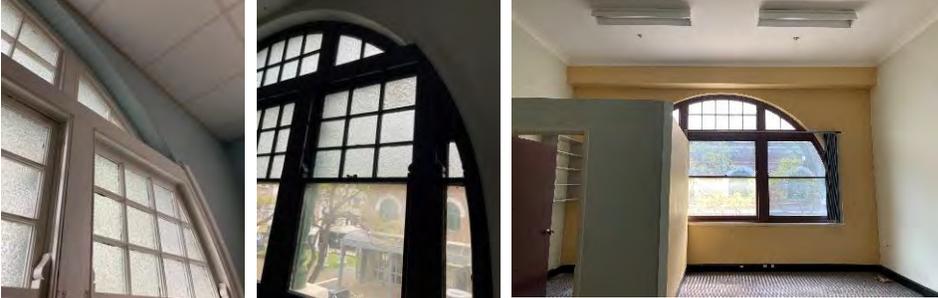
<p>Views of the existing internal partitions in the Municipal Building prior they have been damaged.</p>

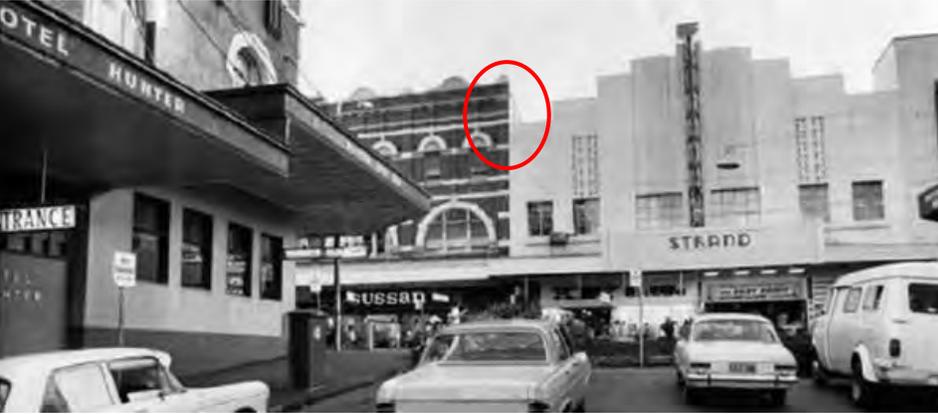
<p>1972 photograph of the Strand Theatre a few years before its demolition - note the Municipal building to its left. The western wall of the Municipal Building was adjacent to the theatre's wall with only top of the tapering parapet is visible. Refer to the aerial image on the next page showing the west elevation after the demolition of the Strand Theatre (Source: Newcastle Region Library)</p>

<p>The western elevation of the building as noted previously was built as part of the 1980s additions to the west resulting in a new external configuration that is unclear if it was reflecting the original detailing of the building or not. The western elevation was adjacent to the demolished Strand Theatre as seen in a 1972 photograph taken from Market Street. An aerial of Block 3 taken after the demolition of Strand Theatre reveals the western elevation of the Municipal Building. Drawings and renders will be amended to reflect this consistent approach. The proposed treatment of the western elevation of the Municipal Building is considered acceptable from a heritage perspective as it will clearly be understood as a new element.</p>

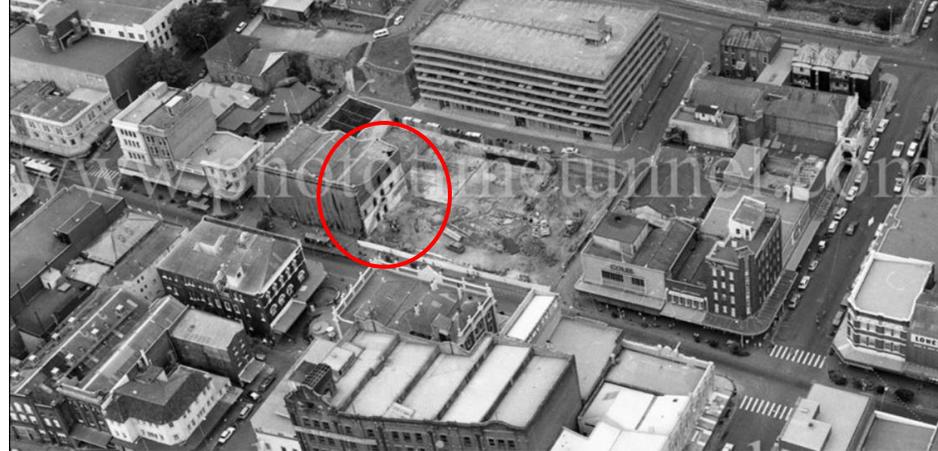
<p>Aerial view of NEE Block 3 showing the demolition site of Strand Theatre with the western elevation of the Municipal Building exposed. Note the several arched windows and the tapered and straight parapet of the building that is similar to that of proposed. (Source: https://www.phototimetun.net/product/aerial-view-of-strand-cinema-demolition-site-newcastle-nsw-january-19-1980)</p>

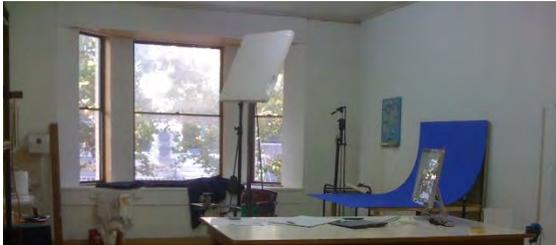
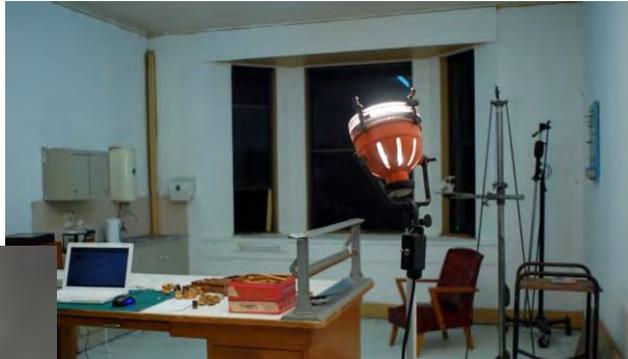
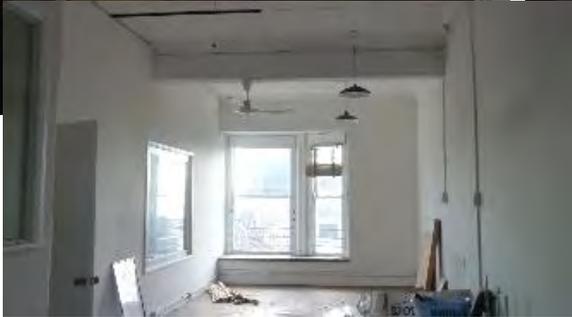
Internal images of 109 Hunter Street (above) showing the tucked on the window opening unlike the original window bay of 105 Hunter Street on the left. Note the partition wall abutting the window mullion to the left.

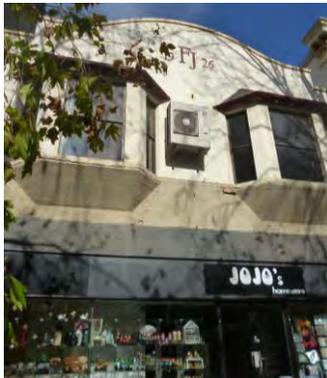
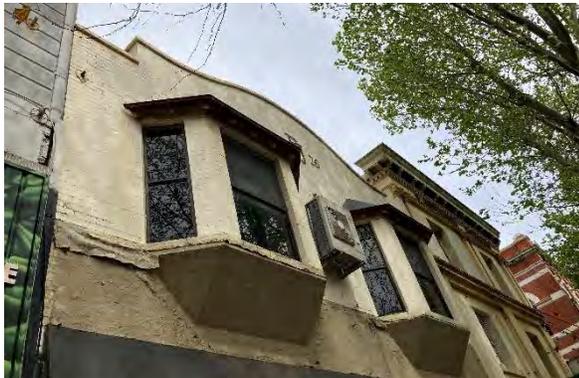
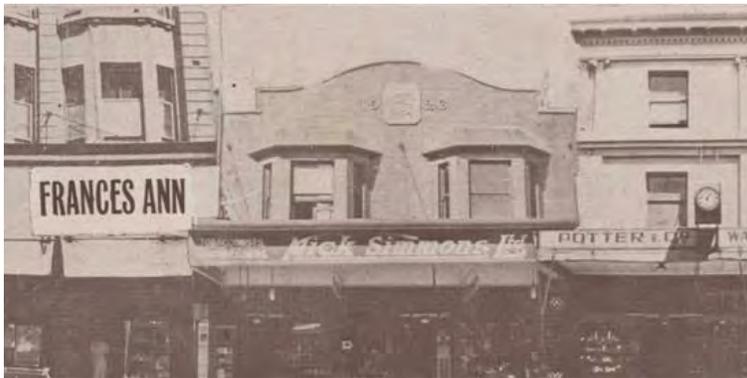
External images of 109 Hunter Street (top) showing the tucked on the window bay to reflect the original window bays of the building that were removed in the early 1970s. Also note the building name plate and date as well as the capping edge of the parapet that was originally covering both the horizontal and vertical ends of the parapet. The current parapet capping is only included on the horizontal edges.

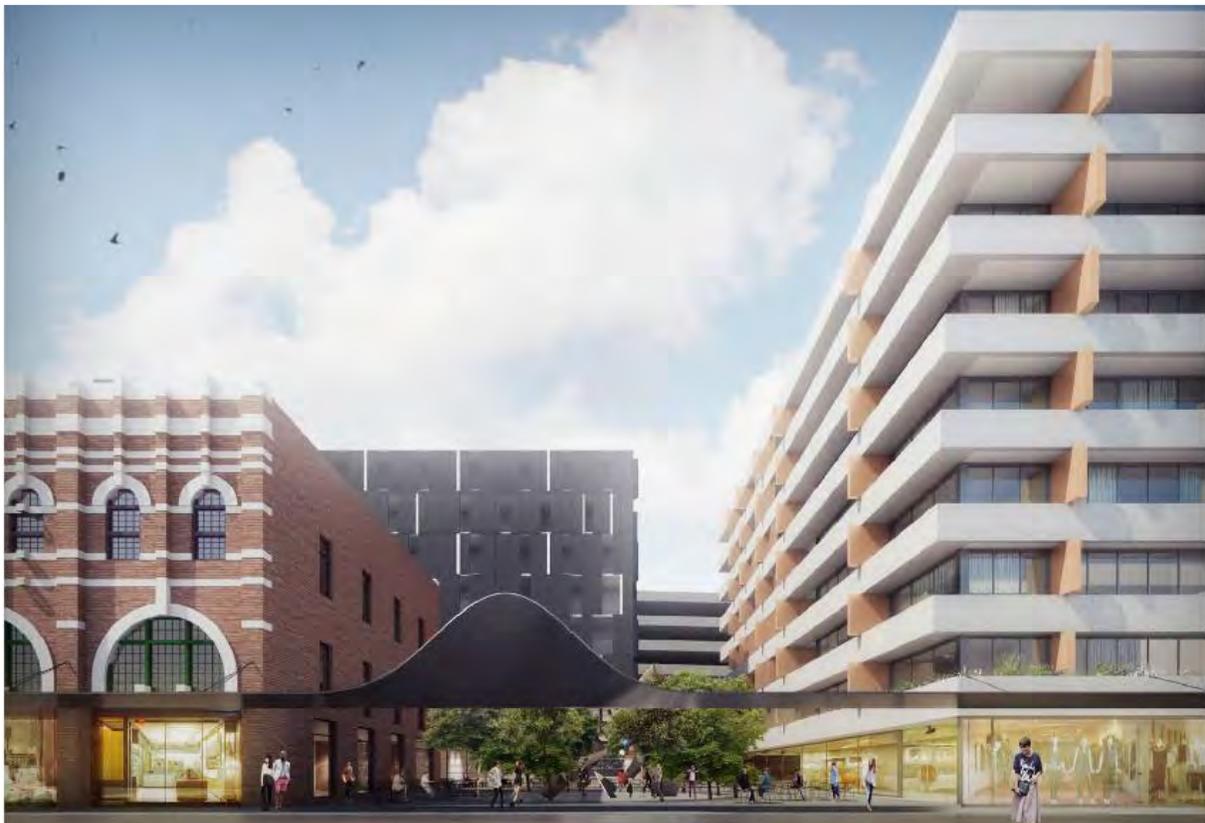
Artist impression of 8 Market Street included in the Concept Plan Scheme Analysis showing the blocked view of the Cathedral (Source: SJB Architects, Newcastle East End Staged Development Application Concept Proposal Design and SEPP65 Report section 5.8.5, p.67).

Heritage Referral Comments	CPH's Responses
	<p>that there will be a changed visual impact than those the Concept Plan building envelopes, the views to the Cathedral will not be diminished rather will be narrowed from the eastern side but remain framed. The Concept Plan did not have any view south of the Cathedral - the proposed outcome reflected in the DA is a far better outcome - a change that Iris accommodated at the request of City of Newcastle. It should be noted that the approved Concept Plan had a building on Block 3 that blocked 80% of the Market Street corridor which blocked the view of the Cathedral almost in its entirety as seen below.</p>

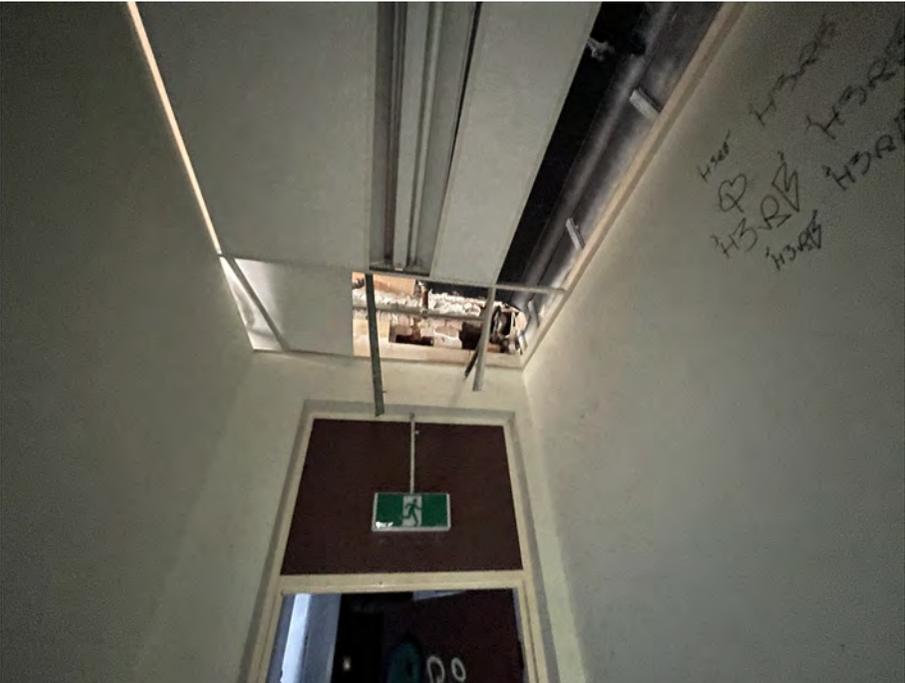
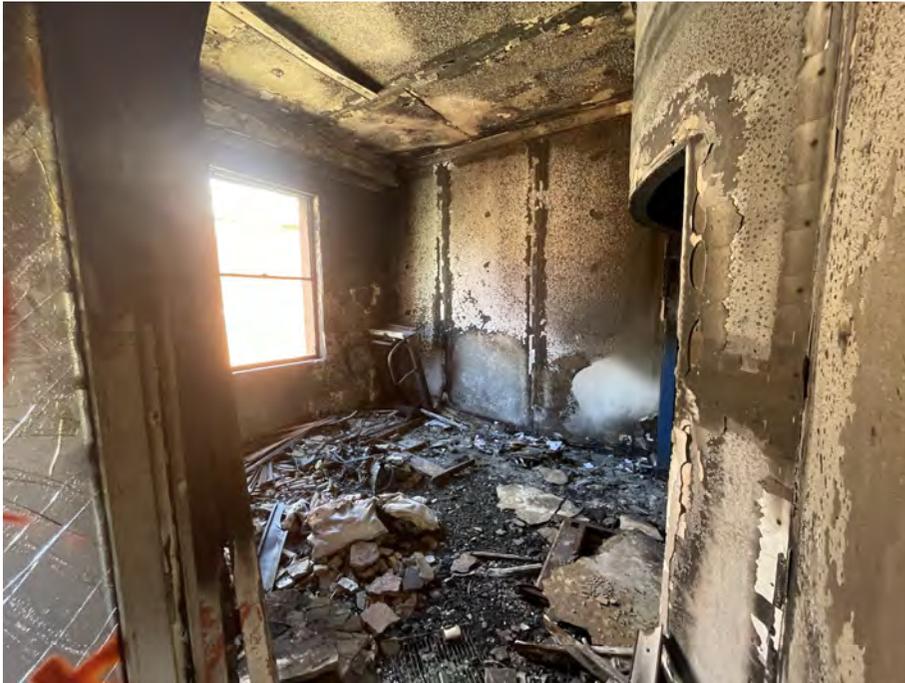
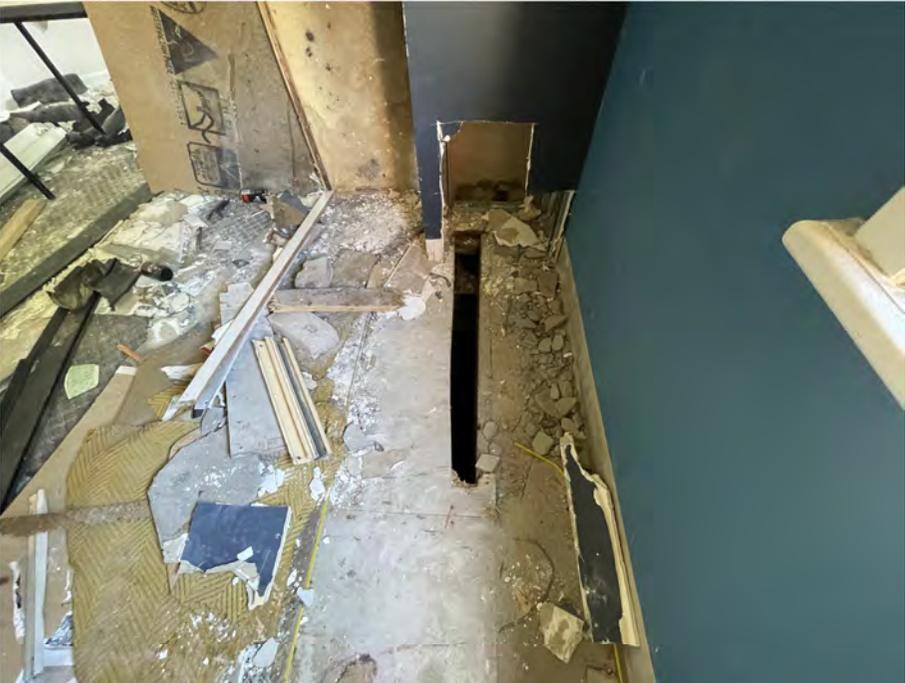
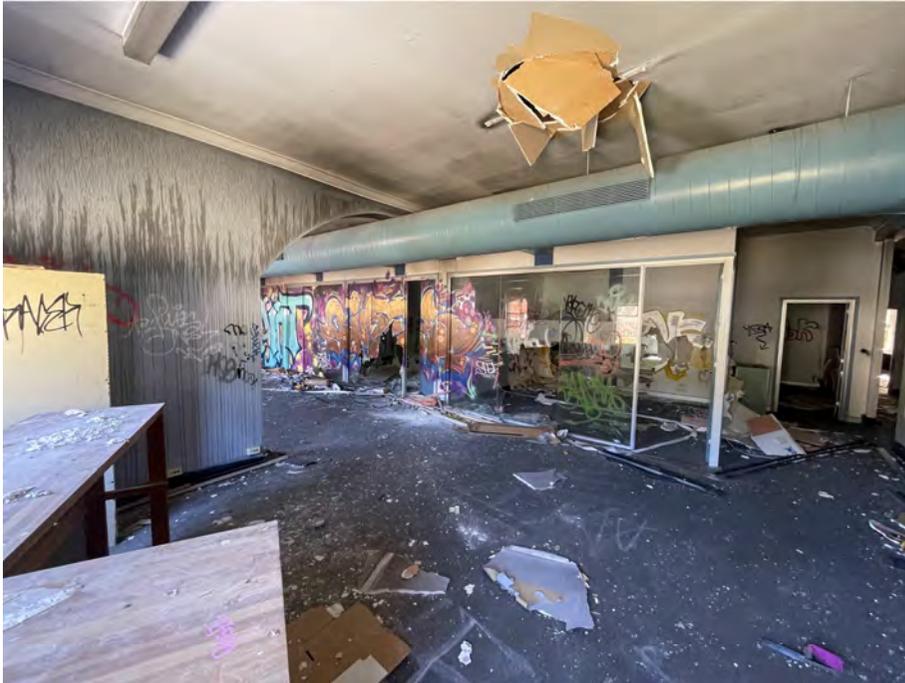
121 HUNTER STREET, NEWCASTLE - MUNICIPAL BUILDING AFTER VANDALISM / DATED 18 OCTOBER 2023

As noted in the Response to the partial RFI for Building 3E, the Municipal Building has been subject to antisocial behaviour resulting almost all of its internal elements including partition walls, masonry walls, floors and ceilings have been damaged. The damage exposed fabric that was not previously visible, which now enables clarification of the materials, integrity and originality of the internal fabric and structural elements of the building.

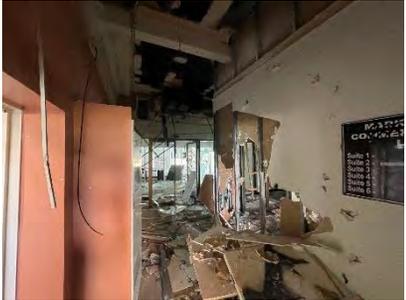
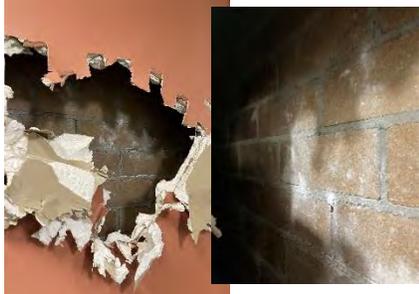
Element	Condition Description	Photo
LEVEL 1		
Room L1-1 Entrance hall	<p>Material: West wall is a reconstructed brick with the remainder of the walls to the east, south and north being lightweight partition walls. Floors are lightweight timber with Masonite/plywood sheeting and carpet finish. Ceiling is similar lightweight structure with fire-rated panels.</p> <p>Condition: In poor condition with claddings being teared off and metal partition wall framing being damaged. The nibs are hollow riser boxes.</p> <p>Similarly, the ceiling panels and floors are damaged in most areas</p>

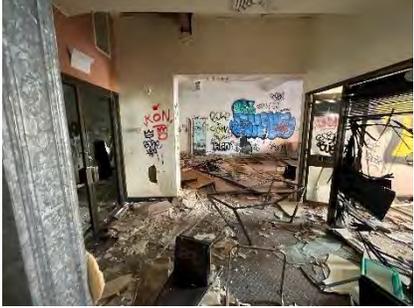
Element	Condition Description	Photo
<p>Corridor (Looking east)</p>	<p>Material: Walls are lightweight partition walls with east wall being masonry with large openings and glazed metal doors/partitions. Floors are lightweight timber with Masonite/plywood sheeting and carpet finish. Ceiling is similar lightweight structure with fire-rated panels. Arched way is a later opening with cladding over masonry wall</p> <p>Condition: In poor condition with claddings being teared off and metal partition wall framing being damaged.</p> <p>Similarly, the ceiling panels and floors are damaged in most areas and pipes/cabling and ducting exposed/removed.</p>

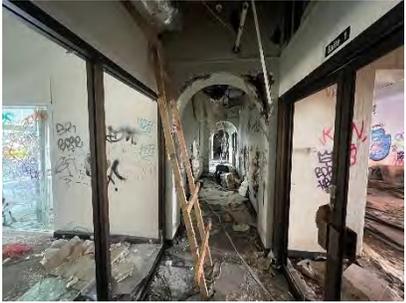
<p>Room L1-9</p>	<p>Material: West and east walls masonry with rendered and painted finish. The west wall has a large opening. Remaining walls are lightweight partition walls with large openings and glazed metal doors/partitions. Floors are lightweight timber with Masonite/plywood sheeting and carpet finish. Ceiling is similar lightweight structure with fire-rated panels.</p> <p>Condition: In very poor condition with claddings being teared off and metal partition wall framing being damaged.</p> <p>Similarly, the ceiling panels and specially the floors are damaged in most areas and pipes/cabling and ducting exposed/removed.</p>

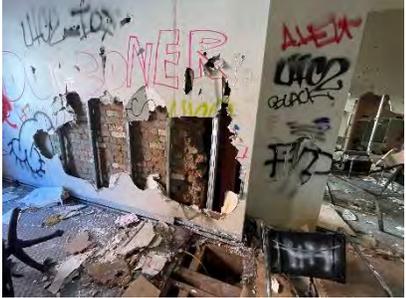
Room L1-9	Looking towards south wall also reconstructed wall or largely modified rear wall of the building

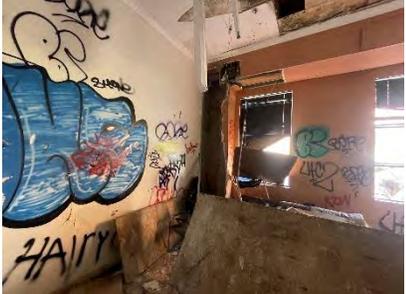
Room L1-9	Looking towards east wall with a door opening. Note the removed bricks from the threshold area of the door opening. Floors are damaged and the architrave ripped off

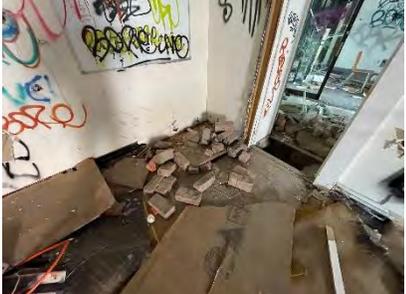
Room L1-9	Looking towards east wall door opening in detail - down to the ripped of threshold hole. Note the hollow section to the underside of the floors of Room L1-10. Floors are damaged and the architrave ripped off
