Heritage Impact Statement (Amended)

Newcastle East End

Blocks 3 & 4 (Demolition &
Development DAs)

Newcomen, Hunter, Thorn, Laing and King Streets

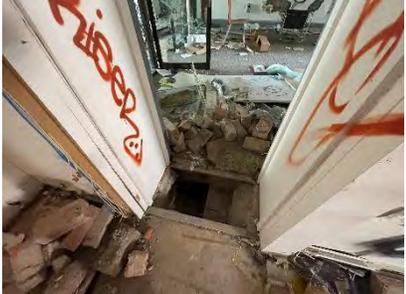
Room L1-9	Looking towards east wall door opening in detail - down to the ripped of threshold hole. Note the hollow section to the underside of the floors of Room L1-10. Floors are damaged and the architrave ripped off

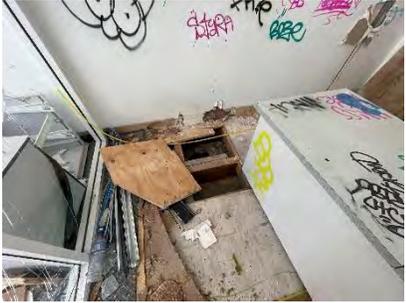
Room L1-10	<p>Material: West and east walls masonry with cladding finish. Remaining walls are lightweight partition walls with large openings and glazed metal doors/partitions. Floors are lightweight timber with Masonite/plywood sheeting and carpet finish. Ceiling is similar lightweight structure with fire-rated panels.</p> <p>Condition: In poor condition with claddings being teared off and metal partition wall framing being damaged.</p> <p>Similarly, part of the ceiling panels and the floors are damaged and pipes/cabling and ducting exposed/removed.</p>

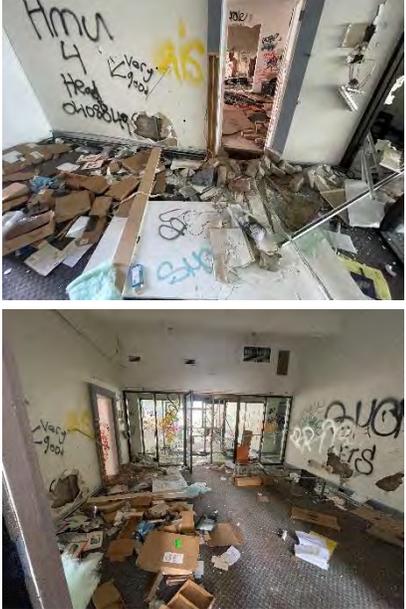
Element	Condition Description	Photo
<p>Corridor - east end</p>	<p>Material: All walls are lightweight partition and glazed walls with the exception of the arched wall opposite (east) is masonry with cladding finish. Floors are lightweight timber with Masonite/plywood sheeting and carpet finish. Ceiling is similar lightweight structure with fire-rated panels and ducting air circulation and mechanical systems.</p> <p>Condition: In poor condition with claddings being teared off and metal partition wall framing being damaged.</p> <p>Similarly, the ceiling panels and the floors are damaged and pipes/cabling and ducting exposed/removed.</p>

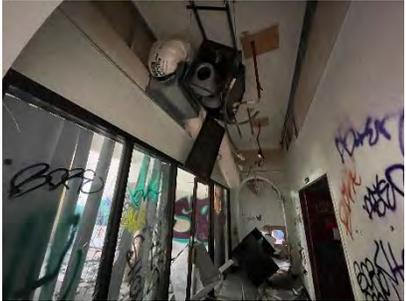
<p>Room L1-17</p>	<p>Material: With the exception of east masonry wall with arched windows (facing Morgan Street) all remaining walls are lightweight partition walls with large openings. Floors are lightweight timber with Masonite/plywood sheeting and carpet finish. Ceiling is similar lightweight structure with fire-rated panels and ducting. Note the riser box appears to be a wall nib but it is revealed that an empty riser box, which are scattered around the floor levels of the building confirming that there are no cross-beams throughout the building. Only the beams over the walls running perpendicular to the Hunter Street provide the structural framing. Hence, the significance ranking plans have been amended accordingly in particular for the Basement level and where nibs were noted as being part of the main structural walls.</p> <p>Condition: In very poor condition with claddings being teared off and partition wall framing being damaged.</p> <p>Similarly, part of the ceiling panels and the floors are damaged and pipes/cabling and ducting exposed/removed.</p>

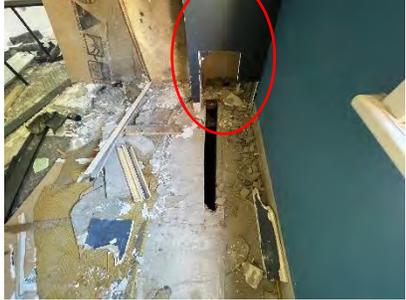
<p>Room L1-18 (corridor to escape/fire stairs)</p>	<p>Material: With the exception of west masonry wall all remaining walls are lightweight partition walls leading towards the exit. Floors are lightweight timber with Masonite/plywood sheeting. Ceiling is similar lightweight structure with fire-rated panels and ducting. Note the exposed earlier ceiling panels with off-the shelf concave cornice exposed above the suspended ceiling frame indicating the sandwich type flooring, which is lightweight timber flooring with top and underside covered by Masonite/plywood panels.</p> <p>Condition: In poor condition with claddings being teared off and partition wall framing being damaged.</p> <p>Similarly, part of the ceiling panels and the floors are damaged and pipes/cabling and ducting exposed/removed.</p>

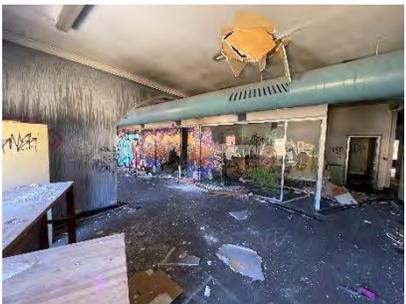
Element	Condition Description	Photo
LEVEL 2		
Room L2-3	Material: West, east and north (fronting Hunter Street) are masonry walls with two large arched openings appears to be created after the conversion of the building to commercial offices in the 1980s. The wall to the south is lightweight glazed partition. The west wall is a reconstructed wall as seen in Room L1- 1 above. Floors are lightweight timber with Masonite/plywood sheeting and plastic/lino finish. Ceiling is similar lightweight structure with off-shelf concave cornices

Element	Condition Description	Photo
	<p>and Gyprock panels. Ducting is exposed and run throughout the northern side offices that are connected to each other by large arched/or square-cut openings.</p> <p>Condition: In very poor condition with claddings being teared off and partition wall framing being damaged. It is unclear what the stain falling down/rising up the arched wall is - part fire damage as the room nearby (L2-2) is fire damaged - see below.</p> <p>Similarly, part of the ceiling panels and the floors are damaged and pipes/cabling and ducting exposed/removed.</p>	
<p>Room L2-2</p>	<p>Material: With the exception of east masonry wall all remaining walls are lightweight partition walls. Floors are lightweight timber with Masonite/plywood sheeting and plastic/lino finish. Ceiling is similar lightweight structure with off-shelf concave cornices and Gyprock panels.</p> <p>Condition: In a very poor condition with claddings being burnt down by fire and teared off with partition wall framing being damaged and glazing smashed. The whole space is</p> <p>Similarly, part of the ceiling panels and the floors are damaged and pipes/cabling and ducting exposed/removed.</p>

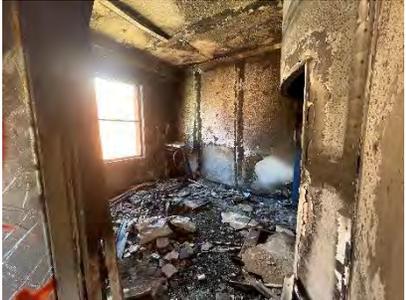
<p>Room L2-7</p>	<p>Material: West, east and south (rear elevation) are masonry walls with cut large openings also appear to be created after the conversion of the building to commercial offices in the 1980s. The wall to the north is lightweight glazed partition. Ceiling is similar lightweight structure with off-shelf concave cornices and Gyprock panels. Ducting is exposed and run throughout the northern side offices that are connected to each other by large arched/or squared-cut openings.</p>

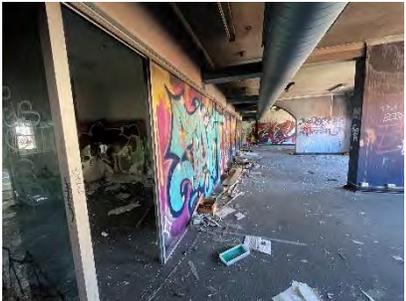
Element	Condition Description	Photo
	<p>Condition: In poor condition with claddings being teared off and partition wall framing being damaged. Similarly, part of the ceiling panels and the floors are damaged and pipes/cabling and ducting exposed/removed within and beyond this space.</p>	
<p>Room L2-1 (entrance hall to Level 2)</p>	<p>Material: With the exception of east masonry wall , all remaining walls are lightweight glazed partitions. Floors are lightweight timber with Masonite/plywood sheeting and plastic/lino finish. Ceiling is similar lightweight structure with off-shelf concave cornices and Gyprock panels. Ducting is exposed and run throughout the northern side offices that are connected to each other by large arched openings.</p> <p>Condition: In very poor condition with claddings being teared off and partition wall framing being damaged.</p> <p>Similarly, part of the ceiling panels and the floors are damaged and pipes/cabling and ducting exposed/removed. The image towards Room L2-1 shows the fire damaged space as noted above.</p>

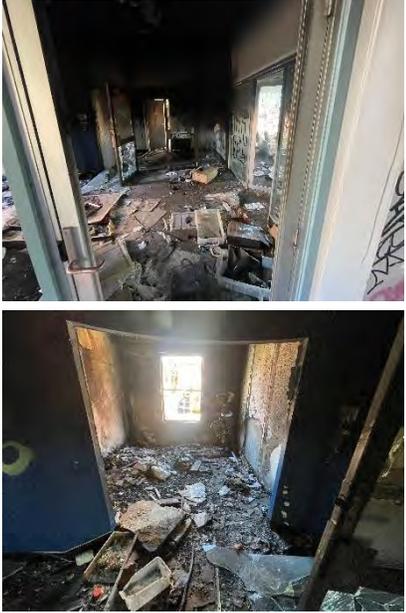
<p>Room L2-3</p>	<p>Material: West, east and north (fronting Hunter Street) are masonry walls with two large arched openings that were created after the conversion of the building to commercial offices in the 1980s. The west wall with glass block window is reconstructed wall as seen in Room L1- 1 above and the ripped off cladding hole to the right. The wall to the south is lightweight glazed partition. Floors are lightweight timber with Masonite/plywood sheeting and plastic/lino finish. Ceiling is similar lightweight structure with off-shelf concave cornices and Gyprock panels. Ducting is exposed and run throughout the</p>

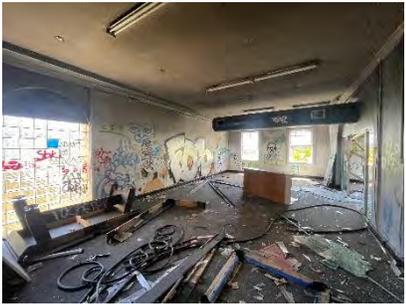
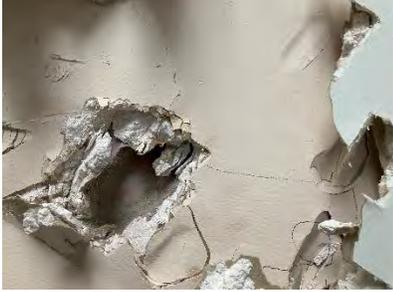
Element	Condition Description	Photo
	<p>northern side offices that are connected to each other by large arched openings.</p> <p>Condition: In very poor condition with claddings being torn off and partition wall framing being damaged. Similarly, part of the ceiling panels and the floors are damaged and pipes/cabling exposed/removed.</p>

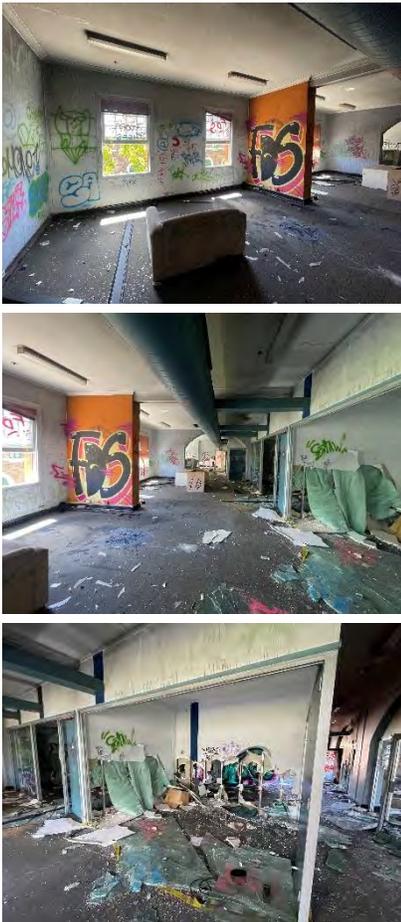
Element	Condition Description	Photo
<p>Room L2-13</p>	<p>Material: It is essentially the same space as above running parallel to Hunter Street frontage looking in the opposite west direction.</p> <p>West, east and north (fronting Hunter Street) are masonry walls with large arched/or cut openings that were created after the conversion of the building to commercial offices in the 1980s. The wall to the south is lightweight glazed partition. Floors are lightweight timber with Masonite/plywood sheeting and plastic/lino finish. Ceiling is similar lightweight structure with off-shelf concave cornices and Gyprock panels. Ducting is exposed and run throughout the northern side offices that are connected to each other by large arched openings.</p> <p>Condition: In very poor condition with claddings to the adjoining connecting rooms being teared off and partition wall framing being damaged. Similarly, part of the ceiling panels and the floors are damaged and pipes/cabling exposed/removed.</p>

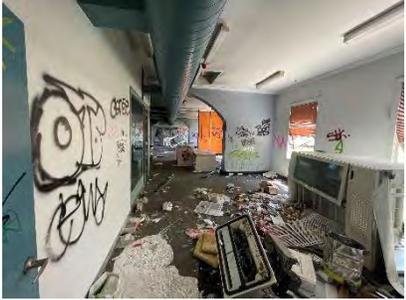
<p>Room L2-18 East corridor - escape pathway</p>	<p>Material: With the exception of west masonry wall all remaining walls are lightweight glazed partitions. Floors are lightweight timber with Masonite/plywood sheeting and plastic/lino finish. Ceiling is similar lightweight structure with off-shelf concave cornices and Gyprock/ or fire-rated panels.</p> <p>Condition: In poor condition with claddings to the adjoining connecting rooms being teared off and partition wall framing being damaged. Similarly, part of the ceiling panels and the floors are damaged and pipes/cabling exposed/removed.</p>

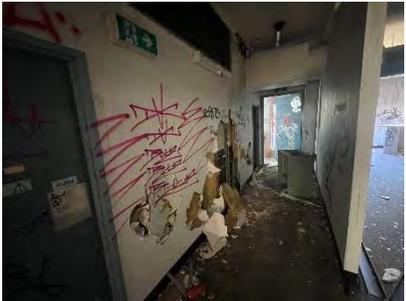
Element	Condition Description	Photo
Room L2-17	<p>Material: With the exception of west and east masonry walls all remaining walls are lightweight glazed partitions. Floors are lightweight timber with Masonite/plywood sheeting and plastic/lino finish. Ceiling is similar lightweight structure with off-shelf concave cornices and Gyprock/ or fire-rated panels.</p> <p>Condition: In poor condition with claddings to the adjoining connecting rooms being teared off and partition wall framing being damaged. Similarly, part of the ceiling panels and the floors are damaged and pipes/cabling exposed/removed.</p>

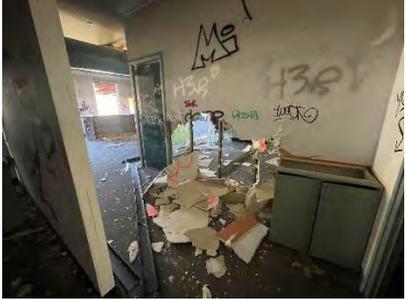
Room L2-17	<p>Material: With the exception of west and east masonry walls all remaining walls are lightweight glazed partitions. Floors are lightweight timber with Masonite/plywood sheeting and plastic/lino finish. Ceiling is similar lightweight structure with off-shelf concave cornices and Gyprock/ or fire-rated panels.</p> <p>Condition: In poor condition with claddings to the adjoining connecting rooms being teared off and partition wall framing being damaged. Similarly, part of the ceiling panels and the floors are damaged and pipes/cabling exposed/removed.</p>

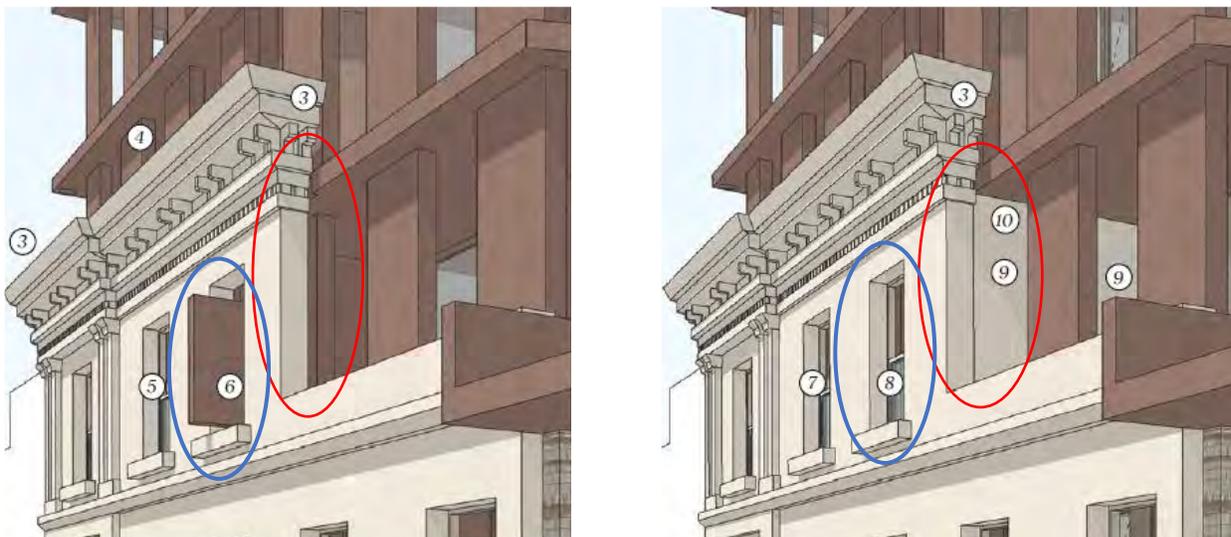
Comparative elevations showing the amended design presented at the Workshop (left) and the further amended design for Hunter Street elevation respectively. Three-dimensional wall, which has never been exposed before is slightly modified (red circle), and structural column pushed back opening up views further to the historic façade of 111 Hunter Street (blue circle)

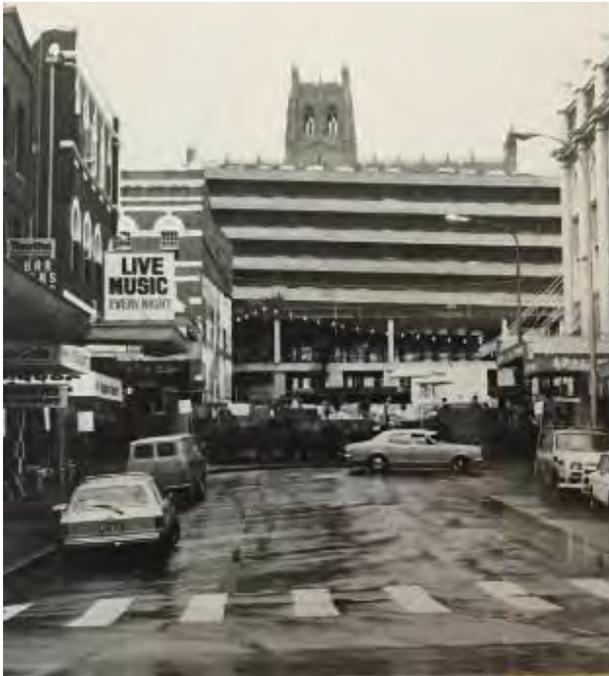
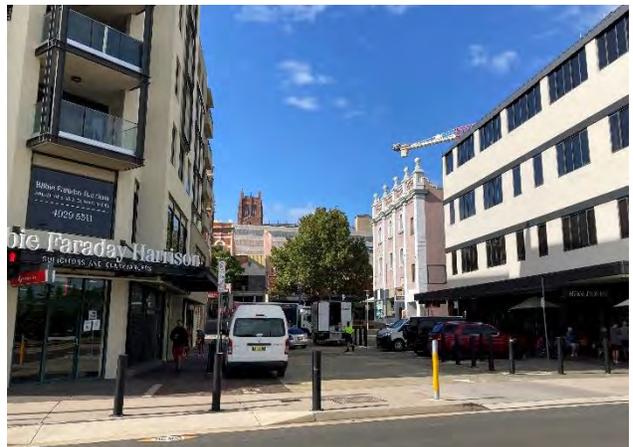
Figure 7: Images of the Cathedral above the Council car park following demolition of the Strand Theatre and prior to the construction of the Market Square shopping centre (left); and during to the demolition of the Council car park taken by the undersigned. (Source to the left image: Scanlon, Mike, "Change and the city of Newcastle," 8 January 2016 accessed 5 April 2017 via <http://www.theherald.com.au/story/3647883/city-of-great-change/>)

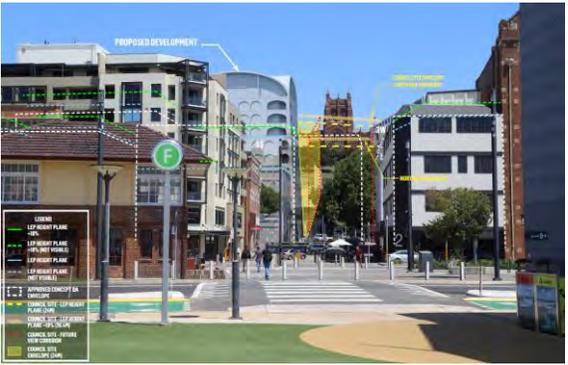
Concept DA analysis	Newcastle DCP 2023	Photomontage (Urbis VIA report - April 2023)
<p>A - CBD from Queens Wharf</p>	<p>15 - Wharf Road to Market Street</p>

<p>Discussion:</p> <p>As explored under Point 3 above the close public view corridor to the Cathedral were not available until the demolition of the Market Square shopping centre and the buildings that occupied the Hunter Street Mall frontage of the site - terminating Market Street on the south. The proposed MOD provides an opportunity to create the clear unobstructed view corridor 'Harbour to Cathedral' link as desired by the Council. This link will reinstate the visual axis that was included in Dangar's 1823 plan of Newcastle. As noted earlier, this is a significant improvement and enhancement to the views towards the cathedral that were long not available along the public</p>

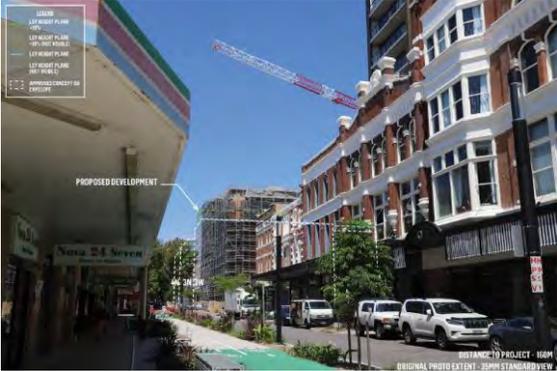
Concept DA analysis	Newcastle DCP 2023	Photomontage (Urbis VIA report - April 2023)
<p>B - Perkins Street to Cathedral</p>	<p>N/A - no views identified from this direction</p>	<p>domain, rather the upper section of the nave and the tower were visible from the distant views.</p>

<p>Discussion:</p> <p>While the Concept DA analysis identifies a view corridor from the corner of Perkins Street towards the Cathedral there is no clear view towards the cathedral currently. The buildings along Hunter Street do not allow any visual glimpse to the Cathedral.</p>
<p>View from the corner of Hunter Street Mall & Thorn Street to the Cathedral</p>

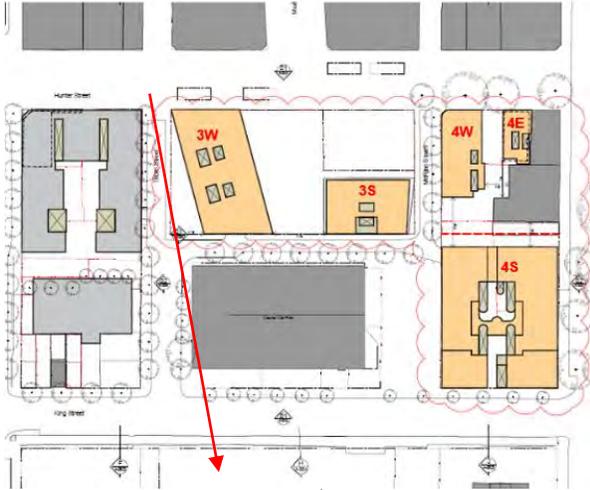
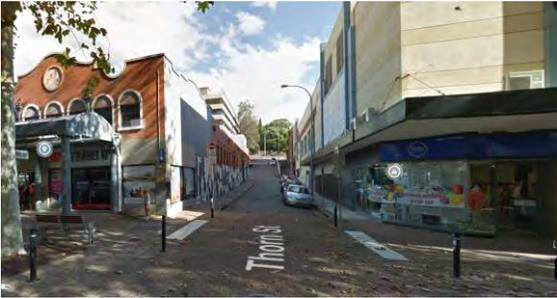
<p>Discussion:</p> <p>View from the corner of Hunter Street Mall and Thorn Street towards the Cathedral and grounds was not available as seen in the above Google Street view taken prior to the demolition of the Council car park. Hence, they were not included in the DCP 2023 key views map. The current design/orientation of the new building at this corner (3W) has been specifically tapered in southeast direction opening up views to the Cathedral as seen in the below photomontage.</p>

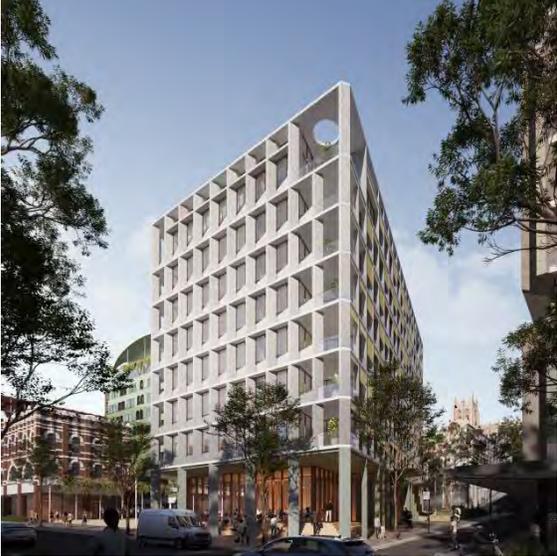
Concept DA analysis	Newcastle DCP 2023	Photomontage (Urbis VIA report - April 2023)
		<p>This new view corridor together with the Market Square 'Harbour to Cathedral' link creates additional opportunities to view the Cathedral from Hunter Street Mall public domain that were not available to date.</p>

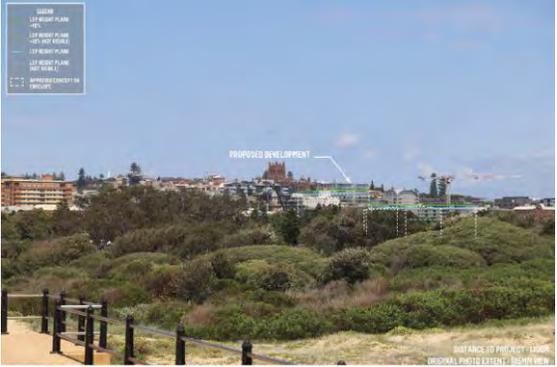
<p>C - From Nobby's pedestrian walkway</p>	<p>N/A - no views identified from this direction</p>

<p>Discussion:</p> <p>The distant view to the Cathedral from the Nobby's pedestrian walkway will not be affected by the proposed MOD design. The new development largely set to the northeast of the</p>

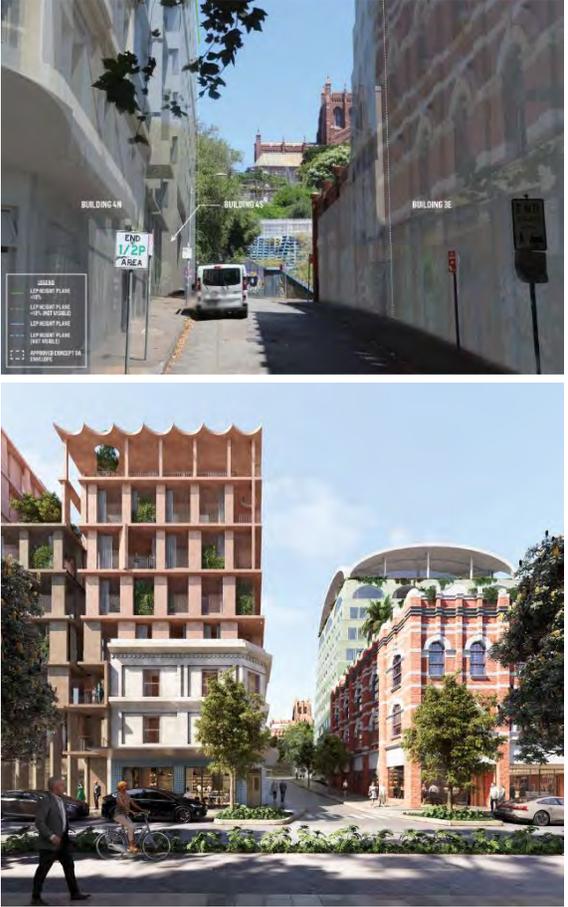
Concept DA analysis	Newcastle DCP 2023	Photomontage (Urbis VIA report - April 2023)
		<p>Cathedral's views in this direction. The views are preserved from the Nobby's.</p>
<p>D - from Cnr Hunter and Morgan Streets</p>	<p>17 - Hunter Street Mall - cnr Morgan Street</p>

<p>Discussion:</p> <p>The views to the Cathedral from the corner of Hunter Street Mall and Morgan Street will remain almost the same. The new building (3S) at the back of the Municipal Building will be slightly setback from Morgan Street then the existing rear addition of the Municipal Building, which will be demolished under the proposal.</p>

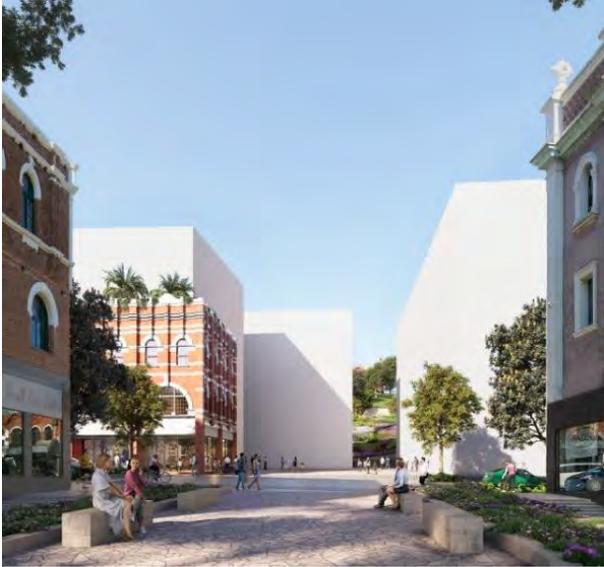
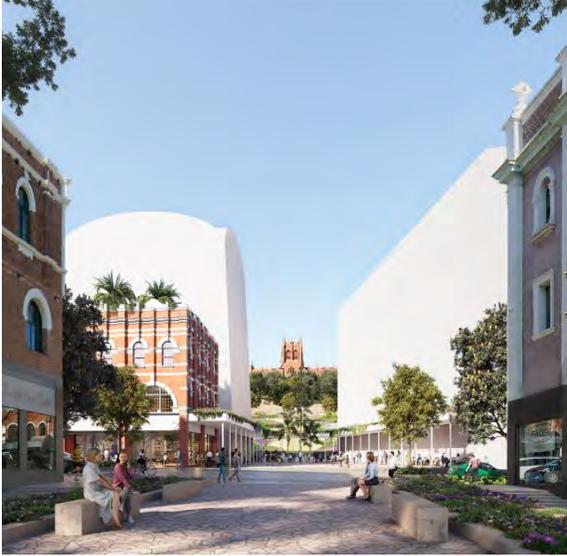
<p style="text-align: right;"><i>Concept DA</i></p>	<p>15 - Wharf Road to Market Street</p>

<p style="text-align: right;"><i>Amended DA</i></p> <p>Discussion:</p> <p>As noted under Concept DA view 'A' above, the views to the Cathedral were not available from this direction (see the photomontage to the left). The Concept DA would completely be blocking the views to the Cathedral as evident here and above. Re-distribution of the building mass across the site by taking the opportunity of the Council's car park's demolition, which was not in consideration at the time of the Concept DA, allowed for the creation of a new view corridor 'Harbour to Cathedral' link. This view corridor will provide improved dominance and dramatic setting of the Cathedral and as such enhancing its State level heritage values.</p>

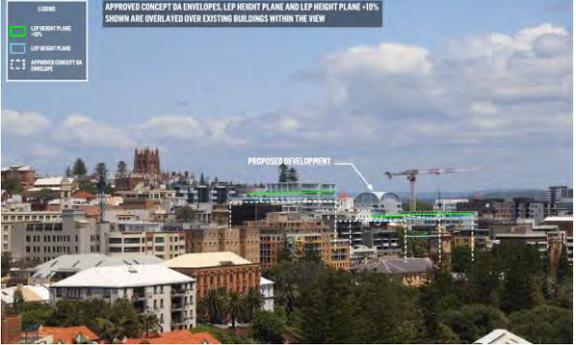
Concept DA analysis	Newcastle DCP 2023	Photomontage (Urbis VIA report - April 2023)
N/A	20 - Parade Ground, Fort Scratchley

<p>Discussion:</p> <p>Views from Fort Scratchley Parade Grounds to the Cathedral will not be affected by the proposed MOD design. The height of the development is clearly below the key elements (nave & Tower) of the Cathedral and as such maintains its dominant setting at the backdrop of the new development.</p>
N/A	21 - Stockton Ferry Wharf

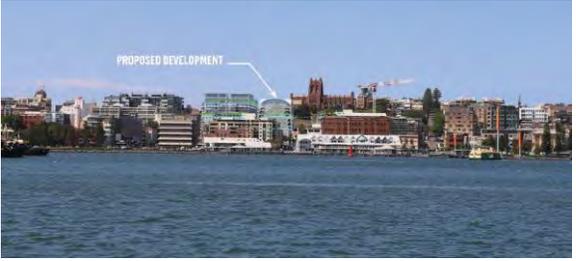
<p>Discussion:</p> <p>Similar to the views from Fort Scratchley, the views from Stockton Ferry towards the Cathedral will not be adversely affected. Only lower part of the rest park will be marginally obscured, which was already blocked in the Concept DA. The new development will sit side-by-side to the east of the Cathedral but at a lower scale preserving the dominance and defining the skyline of Newcastle city centre. The Tower and the entire Cathedral including the upper parts of the rest park remains unblocked.</p>

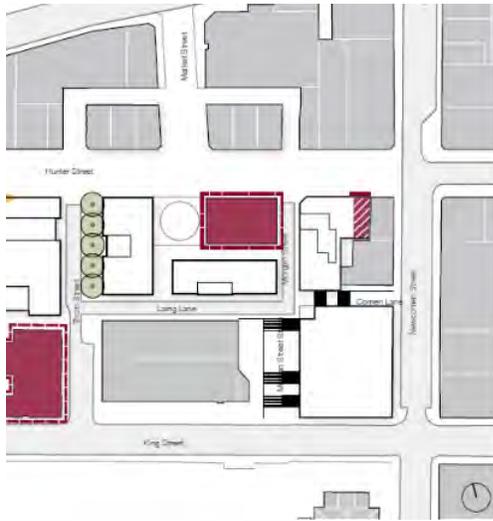
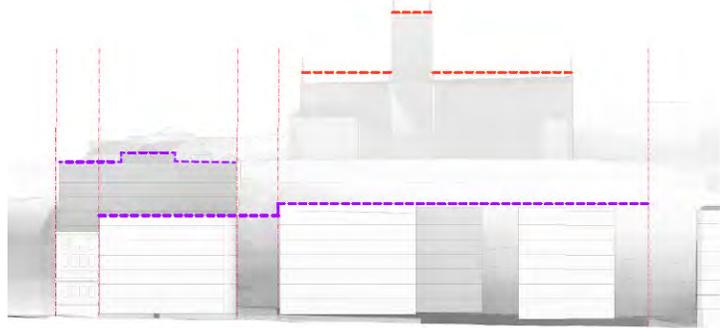
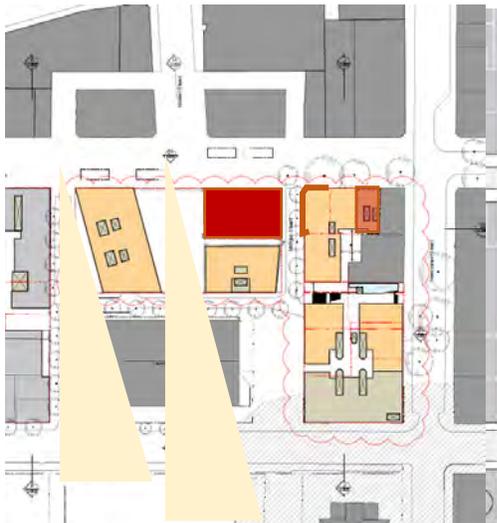
Concept DA

Amended DA

It is understood that there have been concerns on cluttering the curtilage of the Cathedral and its grounds due to the amended DA and increased height at the southern portion of Blocks 3 and 4. In order to discuss

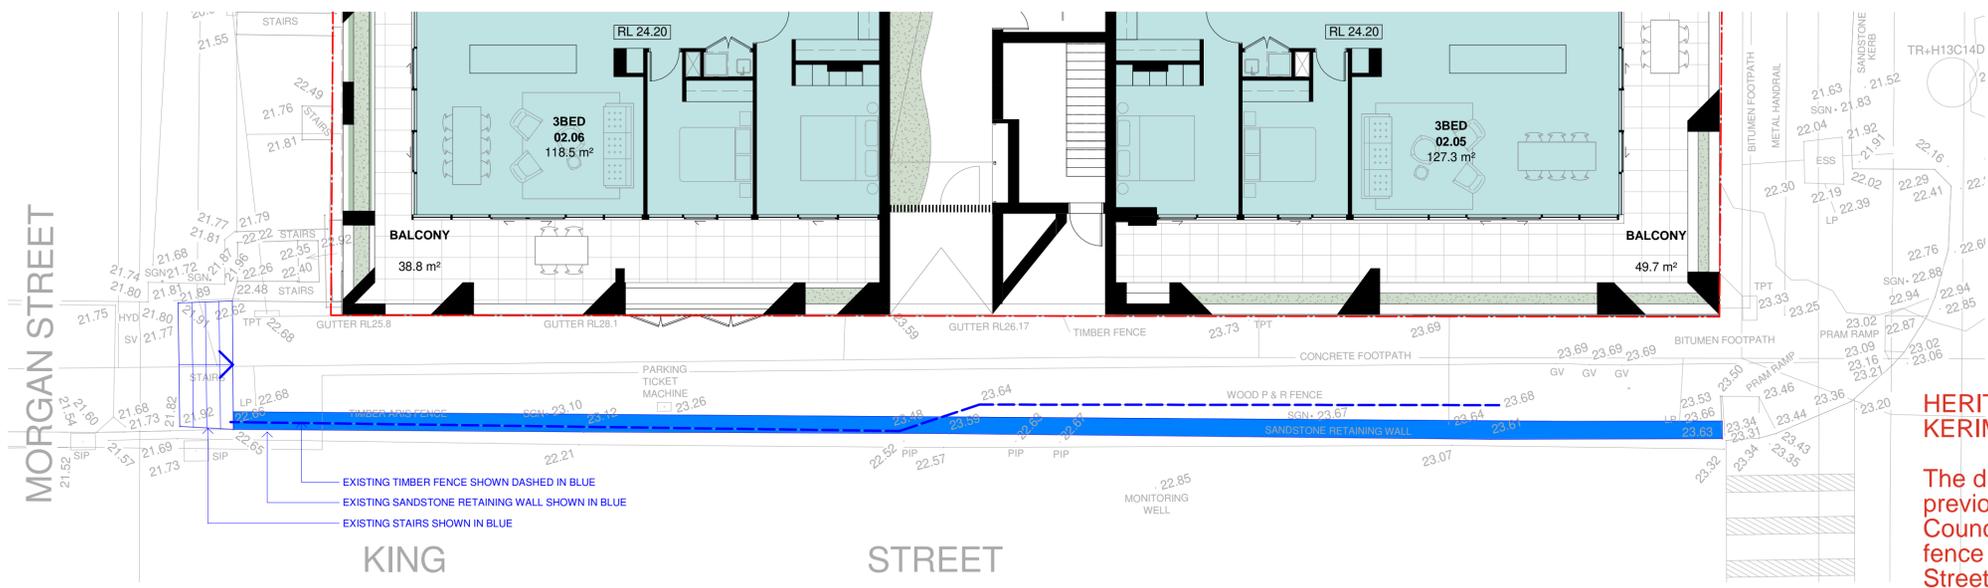
2 PLAN LEVEL 02 (KING ST) - PROPOSED LEVELS SCALE 1:100

The drawing below has been amended to reflect the previous responses & design modifications agreed with the Council's Heritage Officer for the removal of the timber fence and retain the sandstone retaining wall along King Street footpath.
