# **Three Mile Hill Waste and Resource Management Facility**

## **Road Safety Assessment**

Prepared for Three Mile Hill Pty Ltd

September 2024

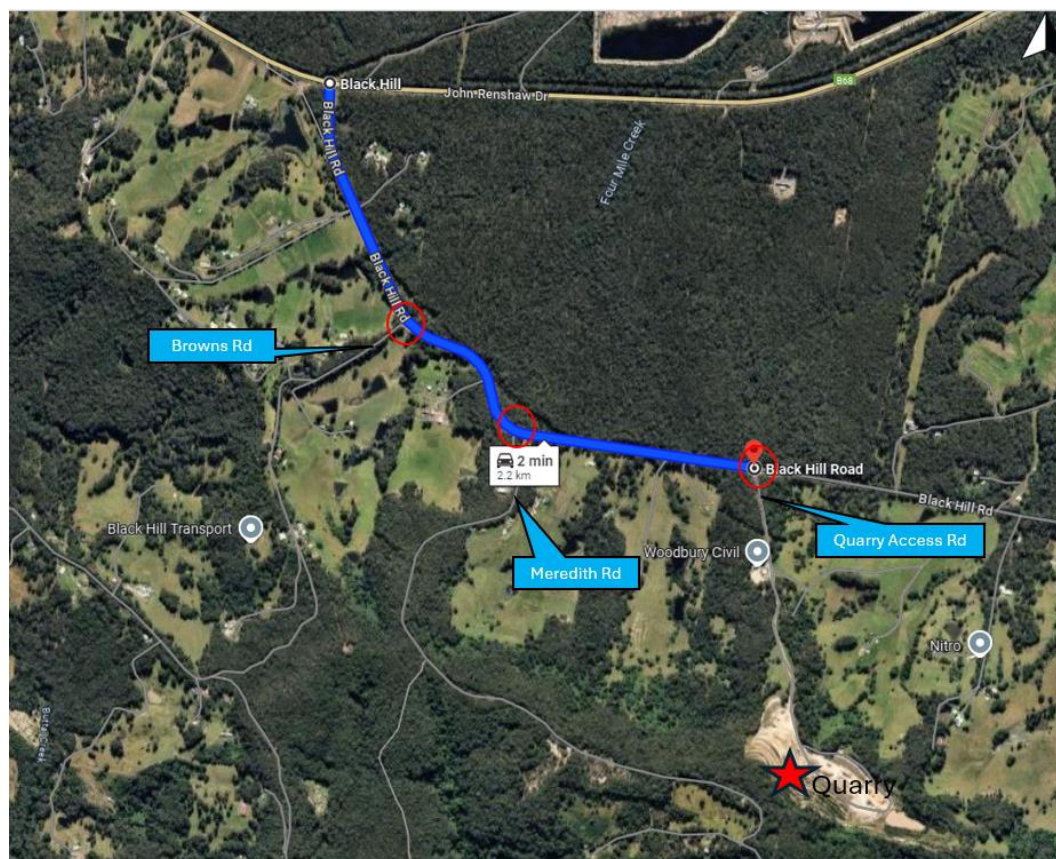
**Figure 1.1**      **Analysed section of Black Hill Road**

The total section of Black Hill Road that has been assessed is approximately 2.2 km long and the following three key intersections have been investigated (Figure 1.1):

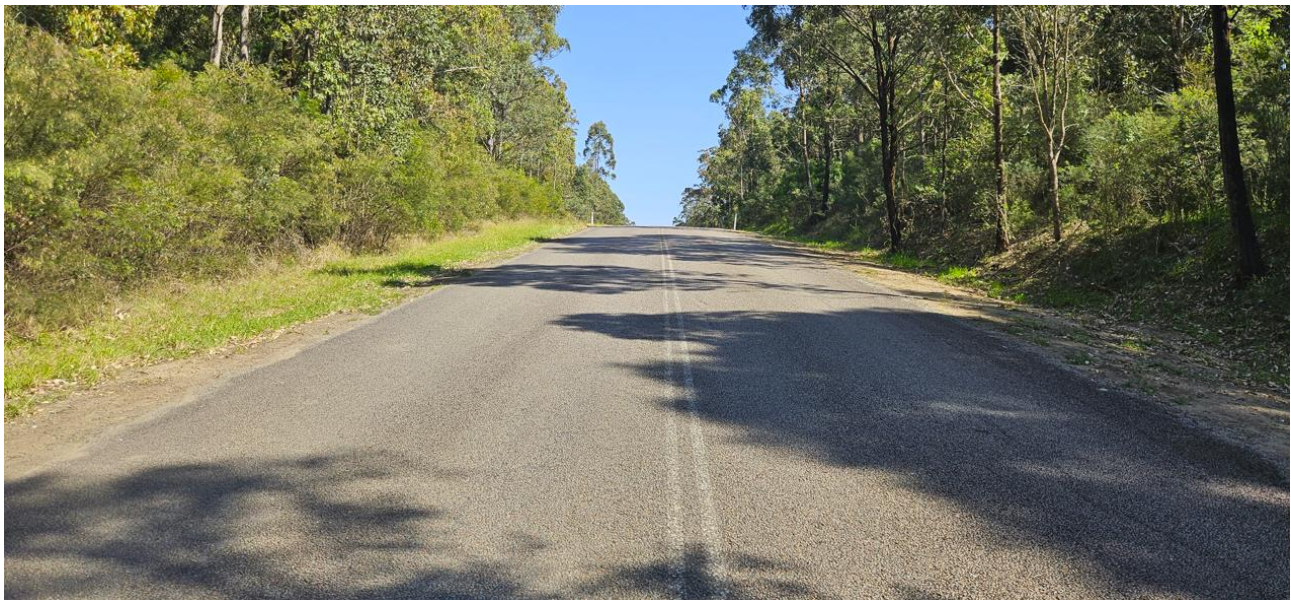
**Plate 2.1** Black Hill Road (looking west at east approach to the Quarry Access Road)

The existing condition of Black Hill Road is provided Table 2.1 and Plate 2.1.

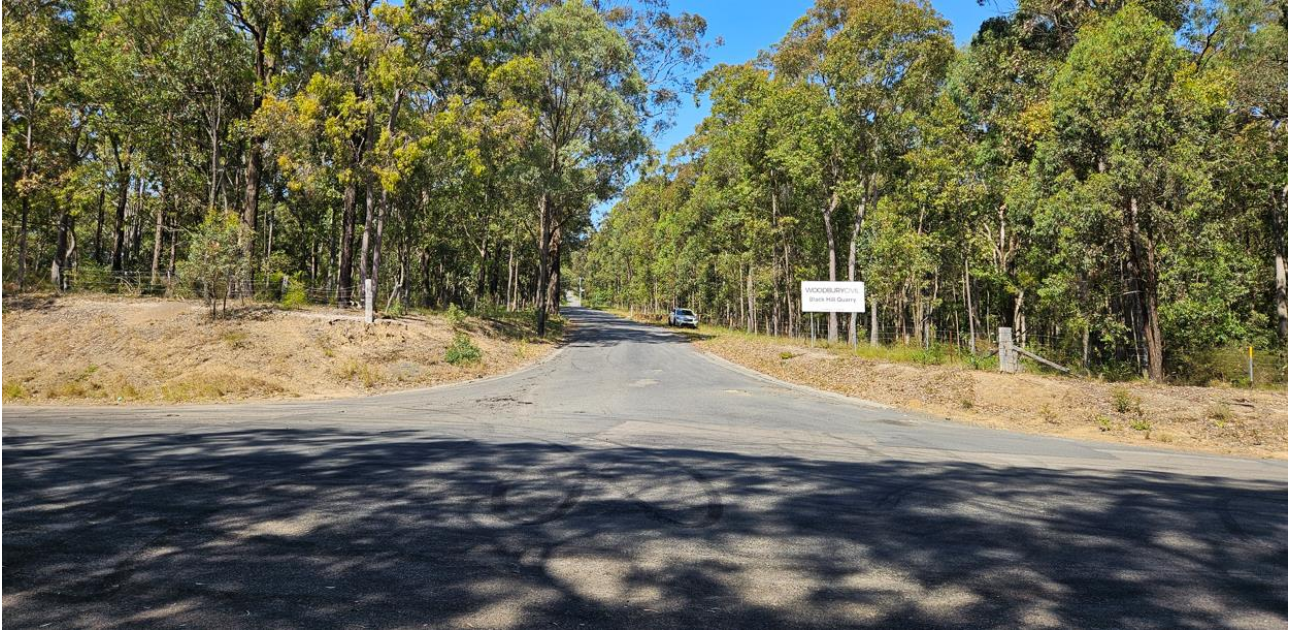
**Plate 3.1** Black Hill Road/Quarry Access Road intersection

The Black Hill Road/Quarry Access Road has a large intersection geometry which facilitates turning truck movements by large trucks, without any difficulty. At this intersection, both the approaches of Black Hill Road are approximately 15 m wide, and the Quarry Access Road is approximately 6.5 m wide (Plate 3.1).

The Quarry Access Road forms a T-intersection with Black Hill Road but there is currently no sign control at this intersection.

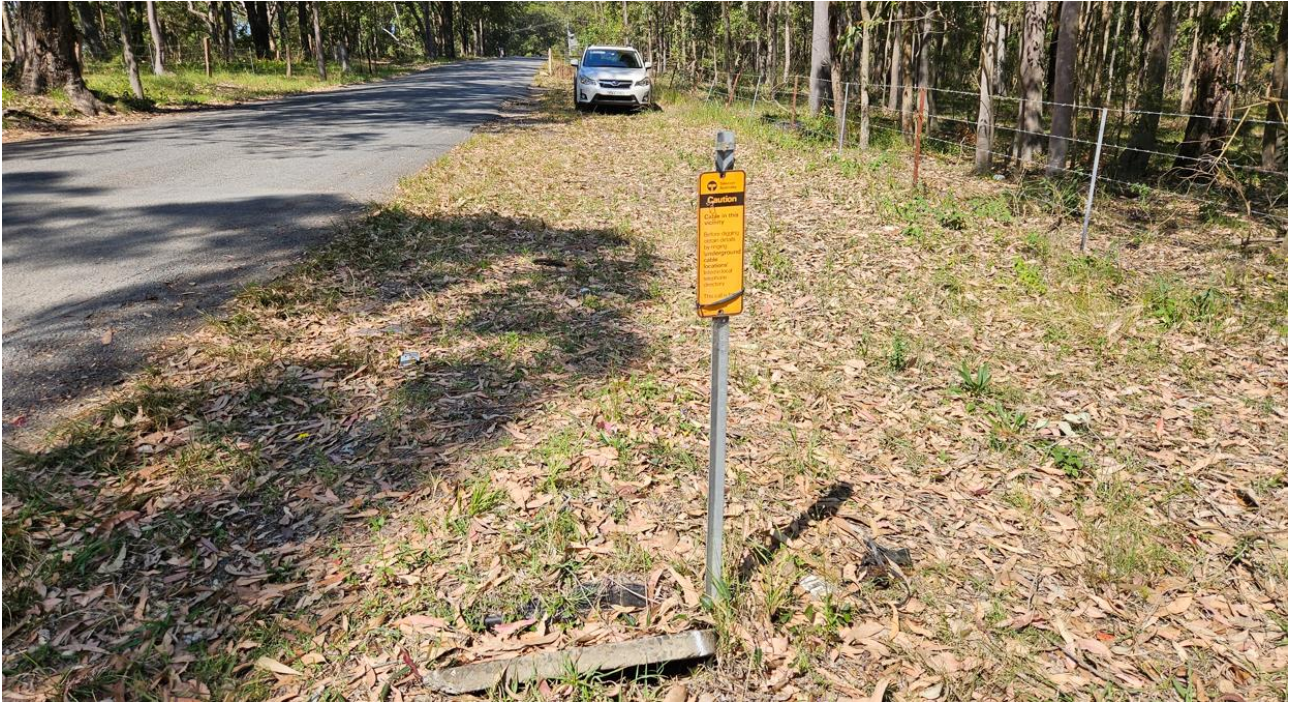
**Plate 3.2**      **Utility services at the southwest corner of Black Hill Road/Quarry Access Road**

There are underground utility services at southwest corner of this intersection (Plate 3.2). During the intersection upgrade work, these services need to be considered.

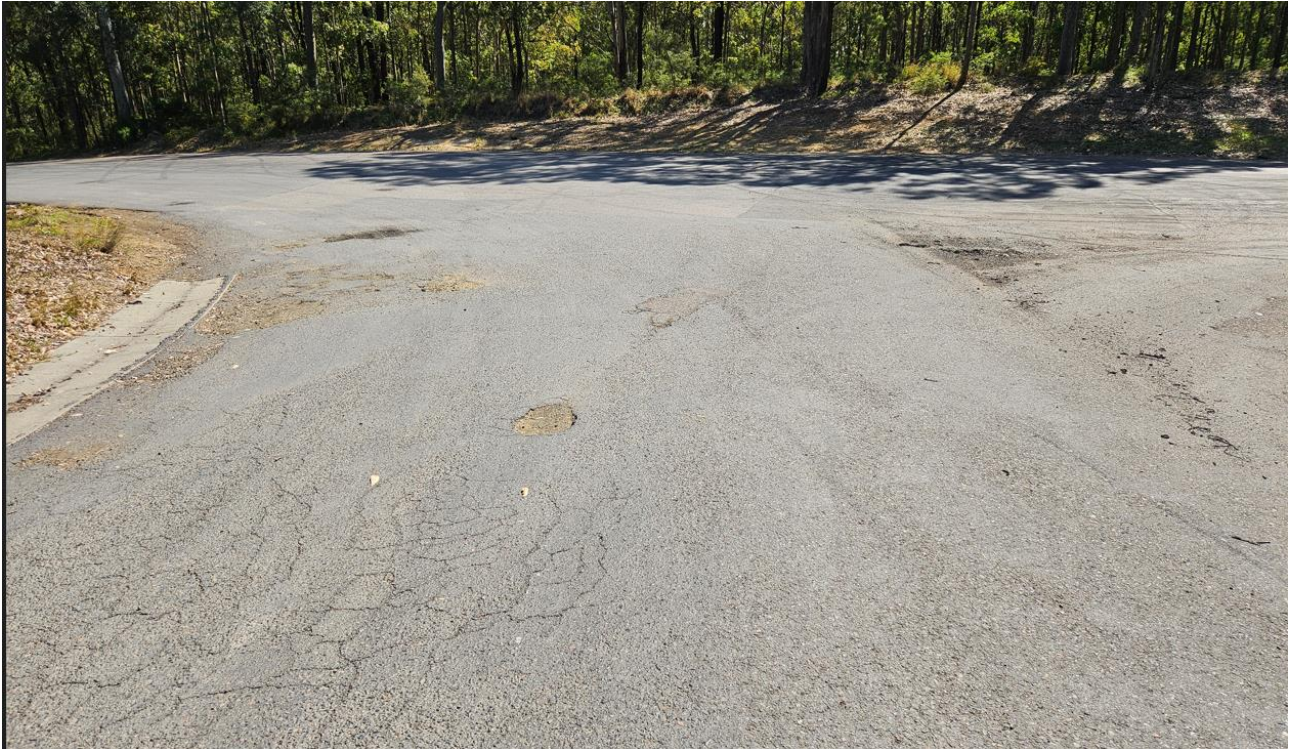
**Plate 3.3** Pavement cracks on Quarry Access Road at Black Hill Road intersection

During the inspection, the road pavement condition on Black Hill Road at and near this intersection was generally found to be in good condition. However, there are some hairline cracks and small potholes on Quarry Access Road, possibly due to wear and tear for continuous turning trucks at this intersection (Plate 3.3). Although the pavement cracks do not cause any immediate concern, over time, with rain, these cracks will allow water to penetrate the pavement subbase and subgrade layers. Any work to fix structural pavement damage could be expensive. Therefore, Cessnock City Council (CCC) should be requested to inspect the road immediately. Subject to inspection by the Council's pavement engineer, localised patching or resealing may be necessary to fix the current defects.

| Item no. | Issue | Location | Suggested mitigation measure | Responsibilities | Indicative timeframe |
|---|---|---|---|---|---|
| 2 | Existing potholes and cracks on the pavement | Black Hill Road/Quarry Access Road intersection | Repair existing potholes and cracks at the intersection (Plate 3.3) | Cessnock City Council | Short term |

- there are existing pavement defects at the Black Hill Road/Quarry Access Road intersection which need to be fixed immediately before further damage is caused by water ingress and the turning trucks to/from the quarry;

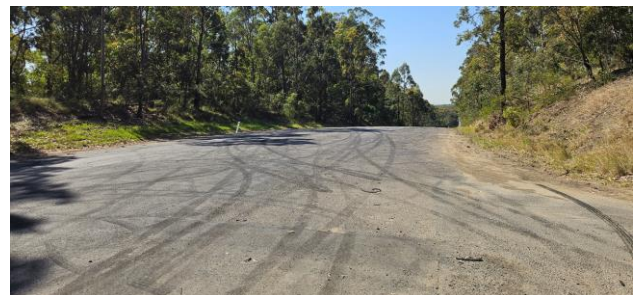
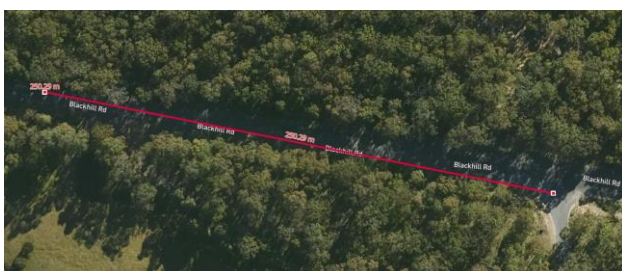
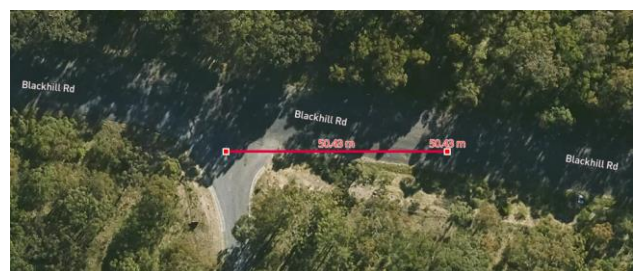
### Plate 3.4 Sight distance from Black Hill Road

As stated earlier, for 90 km/h intersection design speed, a minimum 214 m sight distance is required from the Quarry Access Road in each direction along Black Hill Road. The sight distance to the left is approximately 250 m which meets the minimum Austroads requirement, however, due to the existing vertical curve, the sight distance to the right is only approximately 50 m which does not meet the Austroads requirement (Plate 3.4).

However, truck drivers have a better light of sight (2.4 m eye height), compared to light vehicle drivers (1.15 m). The recommended sight distance still needs to be achieved for all type of vehicles. Where the sight distance can't be achieved, appropriate risk mitigation measures must be put in place.

Sight distance to the left (approx. 250 m)

Sight distance to the right (approx. 50 m)

To mitigate the sight distance issue and improve traffic safety, a vehicle activated warning sign is recommended to be installed with the existing Truck Warning sign (Figure 3.1). The flashing lights will start to operate for certain duration as soon as there is an exiting vehicle on the Quarry Access Road approaching Black Hill Road. As this sign is solely for the purpose of the quarry, the cost of the signage is to be borne by the quarry operator.

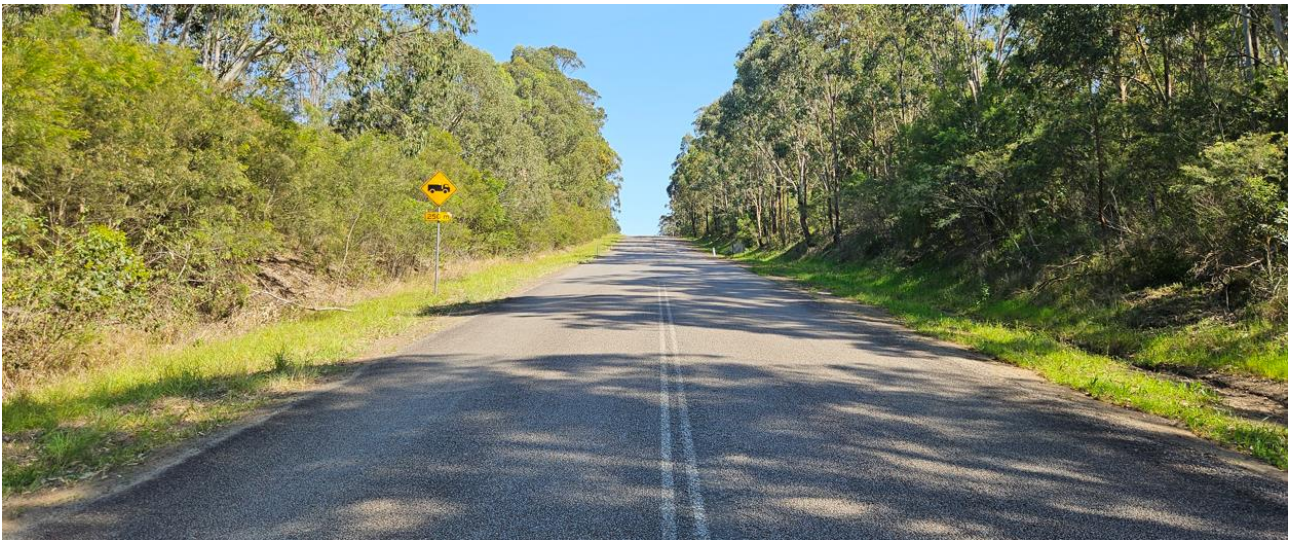
**Plate 3.5** Truck warning sign on Black Hill Road (looking west)

TfNSW's Centre for Road Safety crash statistics do not show any recorded crash at this intersection. During the site inspection a Truck Warning sign was in place approximately, 250 m east of the intersection (Plate 3.5).

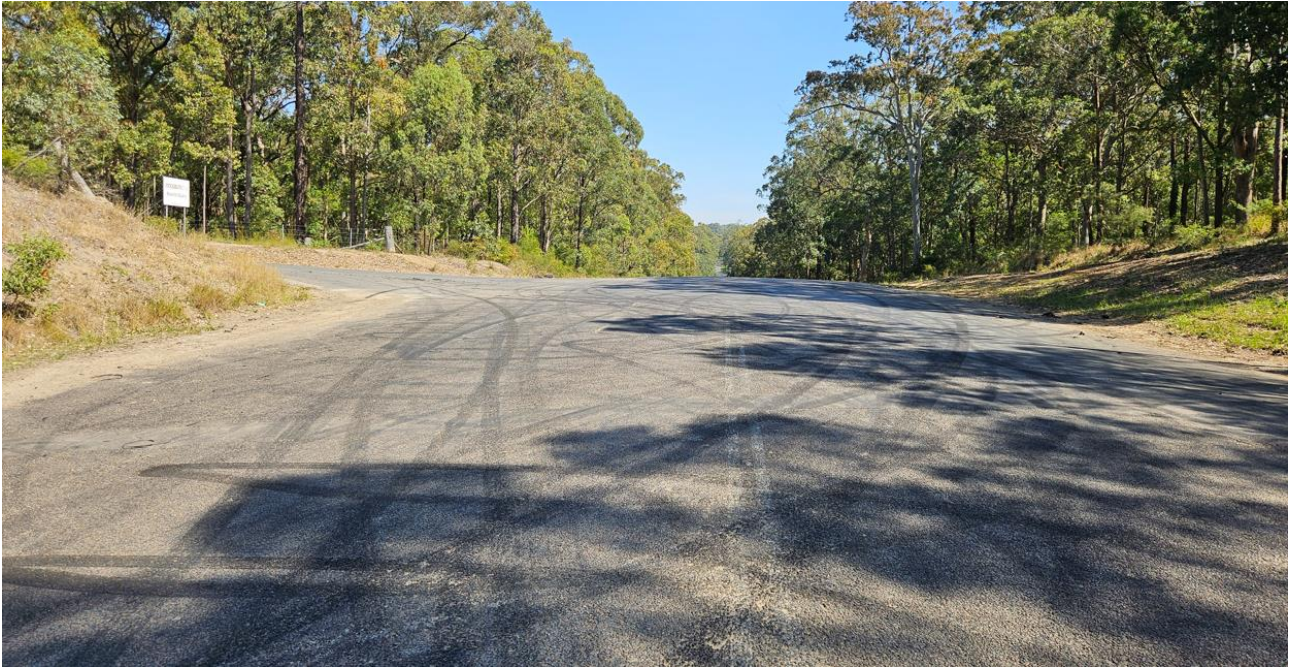
**Plate 3.6** Existing faded centre line on Black Hill Road

There is currently no sign or line marking at this intersection, except the Quarry signage at the front (Plate 3.1). The existing centre line (BB line) on Black Hill Road is faded and is not clearly visible to motorists (Plate 3.6).

In the short term, to improve the safety and accessibility at this intersection, the following additional sign and line marking treatments are recommended (Figure 3.2).

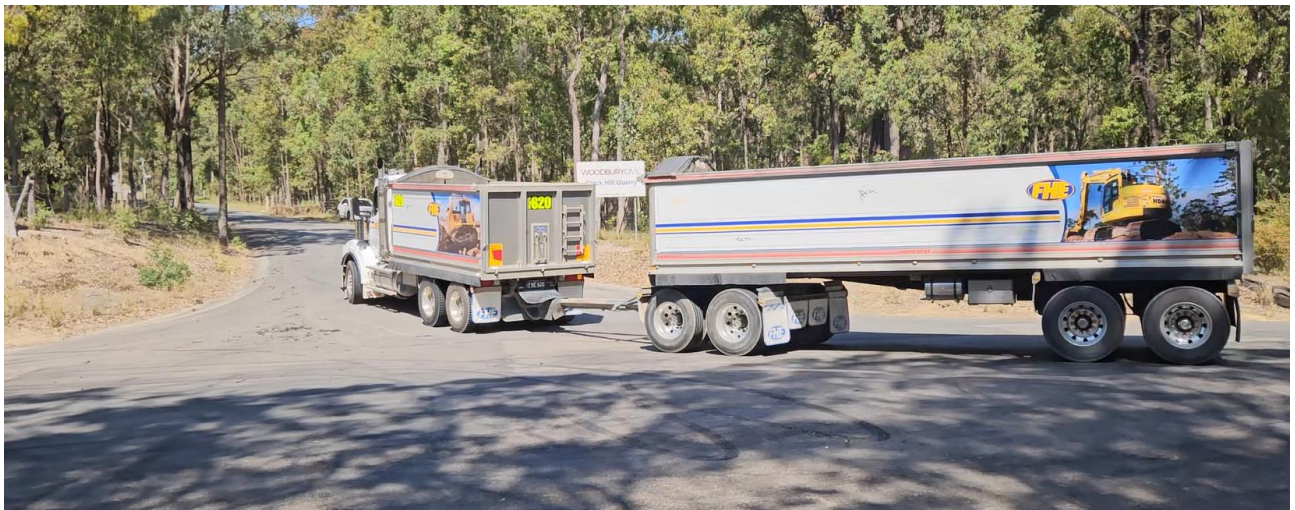
**Plate 3.7** Trucks turning into Quarry Access Road from Black Hill Road

During the site inspection it was noted that inbound trucks turning at this intersection occupy most of Quarry Access Road (Plate 3.7). This is acceptable currently due to the low daily volumes of trucks accessing this quarry. However, as part of the development proposal, the intersection needs to be widened so that two simultaneous trucks can turn to/from the quarry without encroaching to each other's path.

In the longer term, the intersection should be upgraded with Austroads Basic Left and Right Turn treatments as outlined in Table 5.9 of the original Traffic Impact Assessment (<sup>1</sup>TIA) report as part of the proposal including a swept path assessment undertaken for the longest vehicles, 19-m semi-trailer, accessing the proposed waste facility. To accommodate the two simultaneous semi-trailer movements in opposite directions, some widening of the Quarry Access Road will be required. However, as there will be no truck access to/from the east of the quarry along Black Hill Road, the centre line on Quarry Access Road can be disproportionately angled towards the west to minimise any unnecessary road widening.

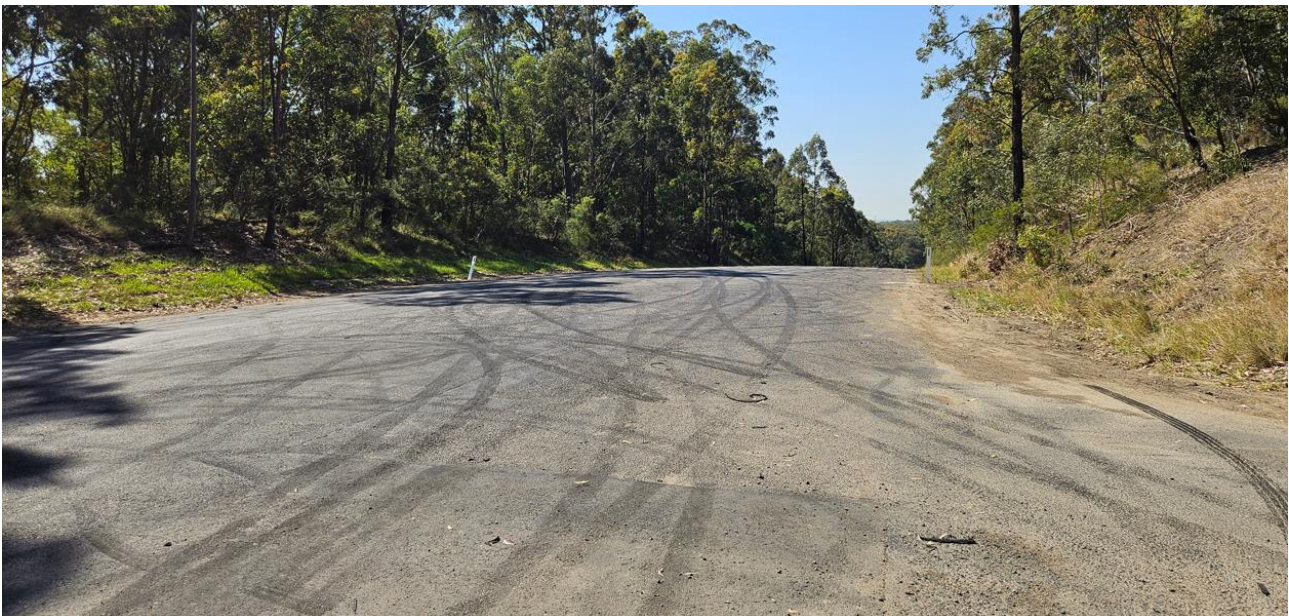
**Plate 3.8**      **Tire marks at Black Hill Road/Quarry Access Road intersection**

However, numerous tire marks were noted at this intersection which represent anti-social behaviour by car drivers (Plate 3.8). Some of the road shoulder guideposts near this intersection was also broken.

An intersection upgrade with fresh line marking may not be sufficient to prevent this type of anti-social behaviour. Therefore, consideration should be given to install a central median island as part of the intersection upgrade for the reasons stated above.

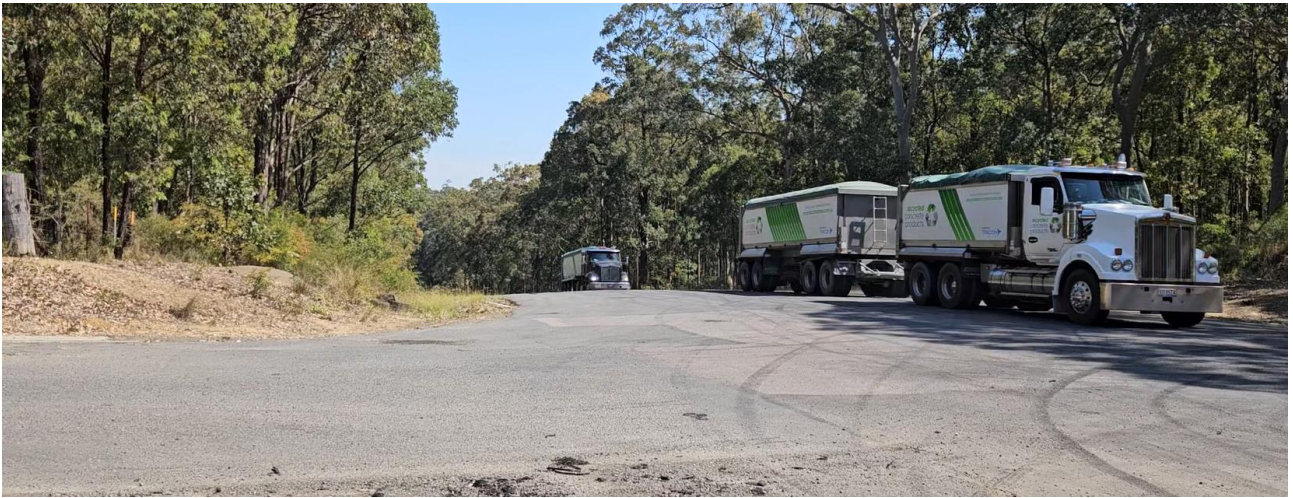
**Plate 3.9**      **Truck travelling eastbound along Black Hill Road**

Other trucks not related to the Black Hill quarry were observed to travel further east along Black Hill Road, beyond the Quarry Access Road (Plate 3.9). As Black Hill Road is a designated <sup>2</sup>heavy vehicle route, heavy vehicle should not be using Black Hill Road, east of the Quarry Access Road without a valid local origin or destination. This matter should be brought to the attention of Cessnock City Council and the community.

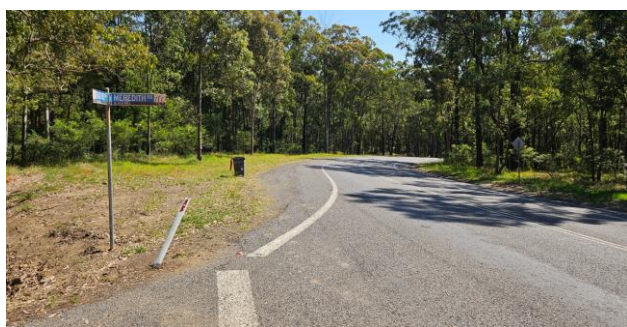
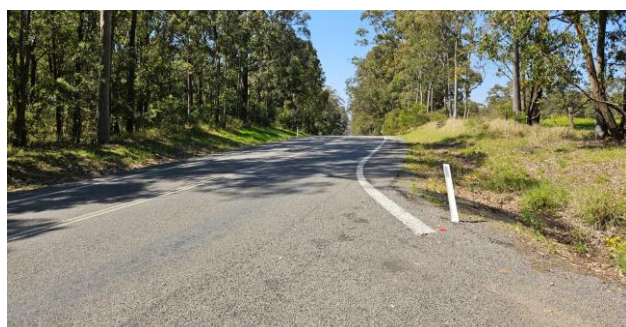
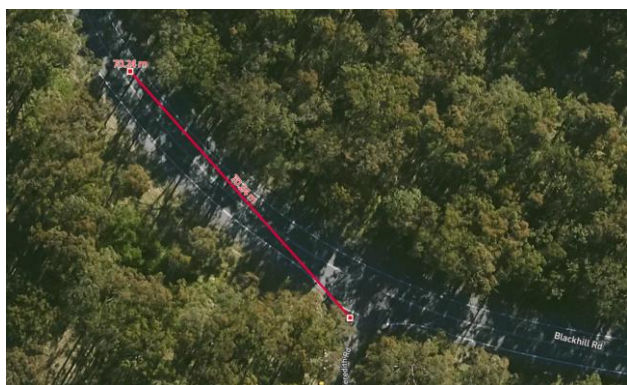
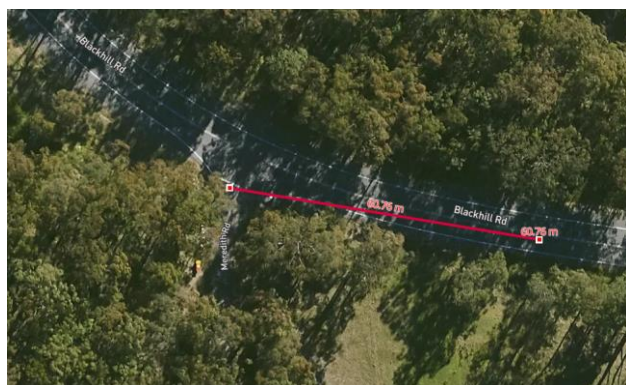
### Plate 3.12 Sight distance from Black Hill Road

Due to the presence of the horizontal and vertical curves, the sight distance does not meet the minimum requirement of 214 m to the left or right (Plate 3.12).

Sight distance to the left (approx. 70 m)

Sight distance to the right (approx. 60 m)

Based on the crash data, the current intersection geometry and existing warning signs, there are sufficient risk mitigation measures currently in place to mitigate the traffic safety risks for the sight distance deficiency at this intersection and no additional risk mitigation measure is warranted.

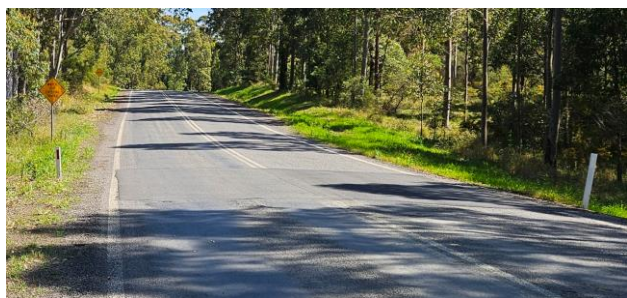
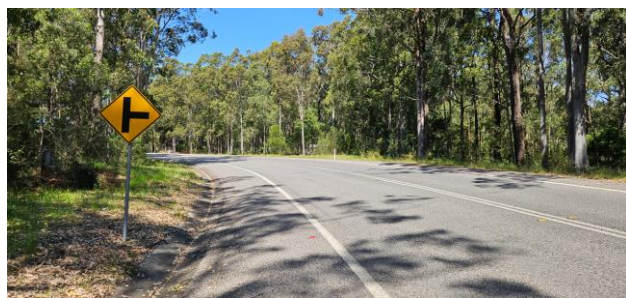
To mitigate traffic safety risks there are existing warning signages on both approaches of the intersection (Plate 3.13). In addition, TfNSW's Centre for Road Safety crash statistics do not show any recorded crash at this intersection over the last five years.

Warning signs on east approach of the intersection

Warning sign on west approach of the intersection

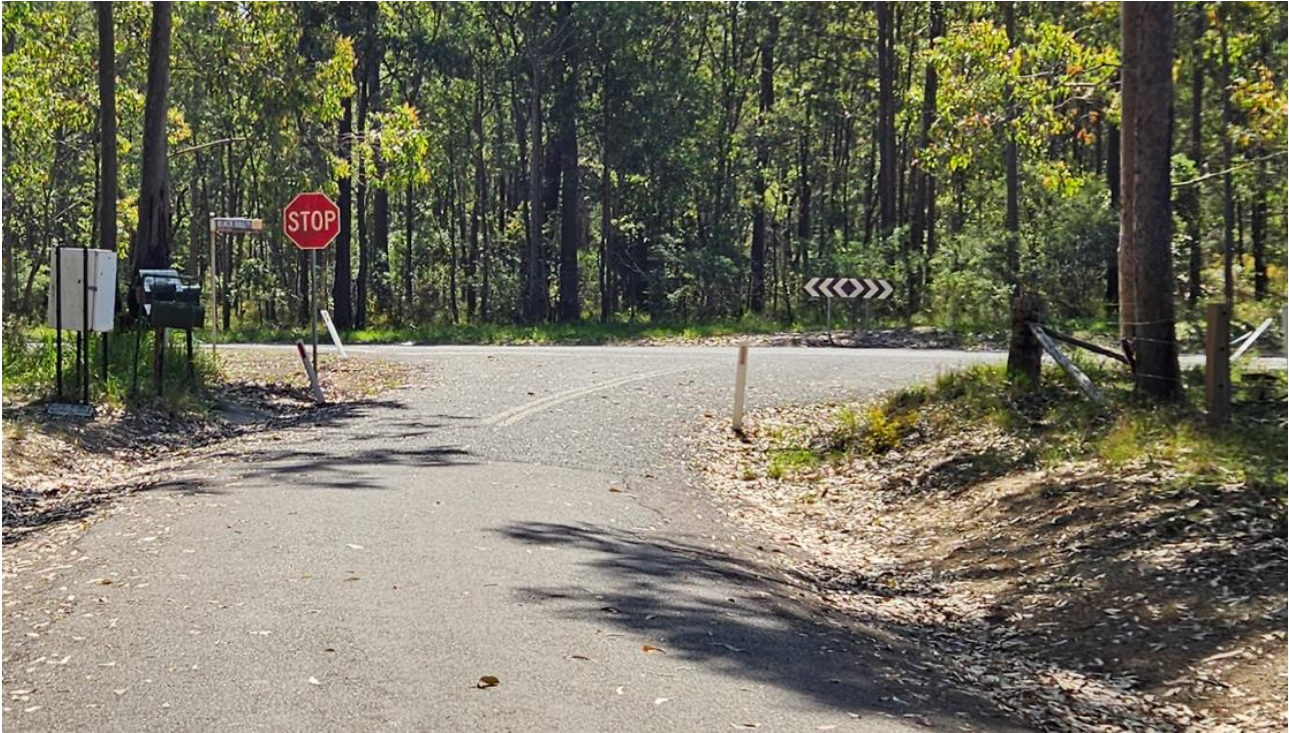
**Plate 3.14** Existing signs and line marking at Black Hill Road/Meredith Road intersection

The existing signs and line marking was found to be adequate at this intersection (Plate 3.14) and no additional signs or line marking is required.

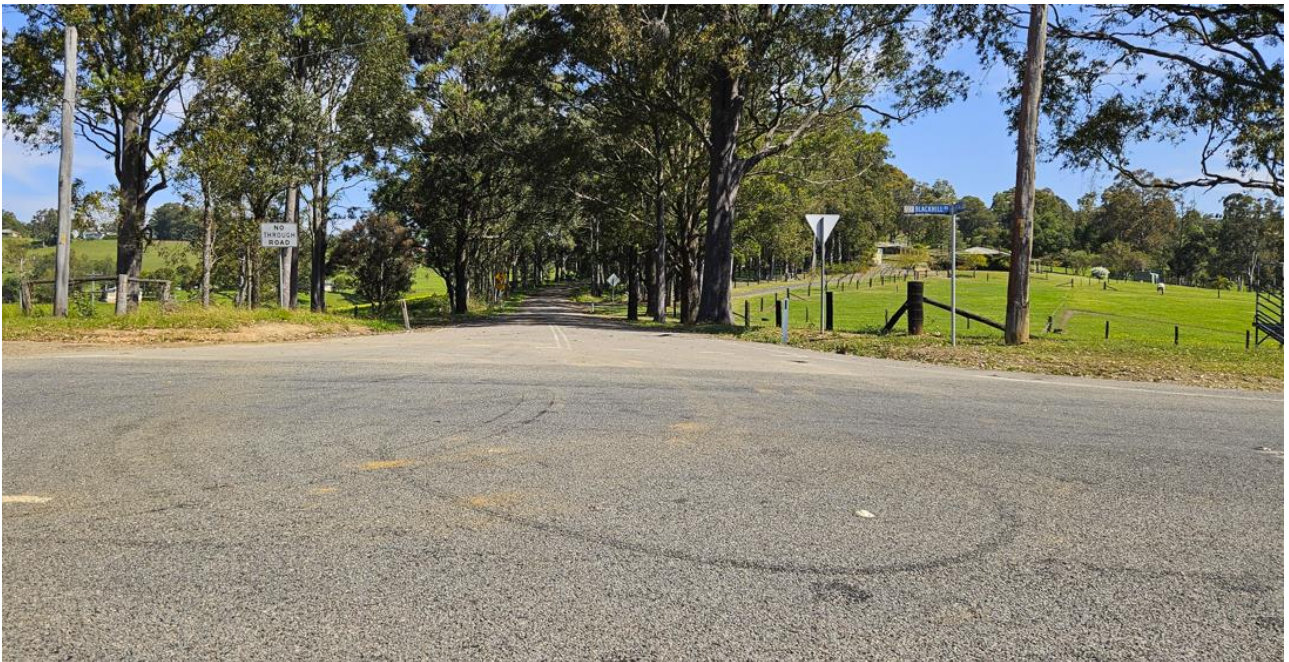
**Plate 3.15** View of Browns Road from Black Hill Road

The Black Hill Road/Browns Road intersection is located approximately 1.35 km west of the Quarry Access Road intersection (Figure 3.4). It is a 'Give Way' access controlled 'No Through' which primarily provides access to the residential properties (Plate 3.15).

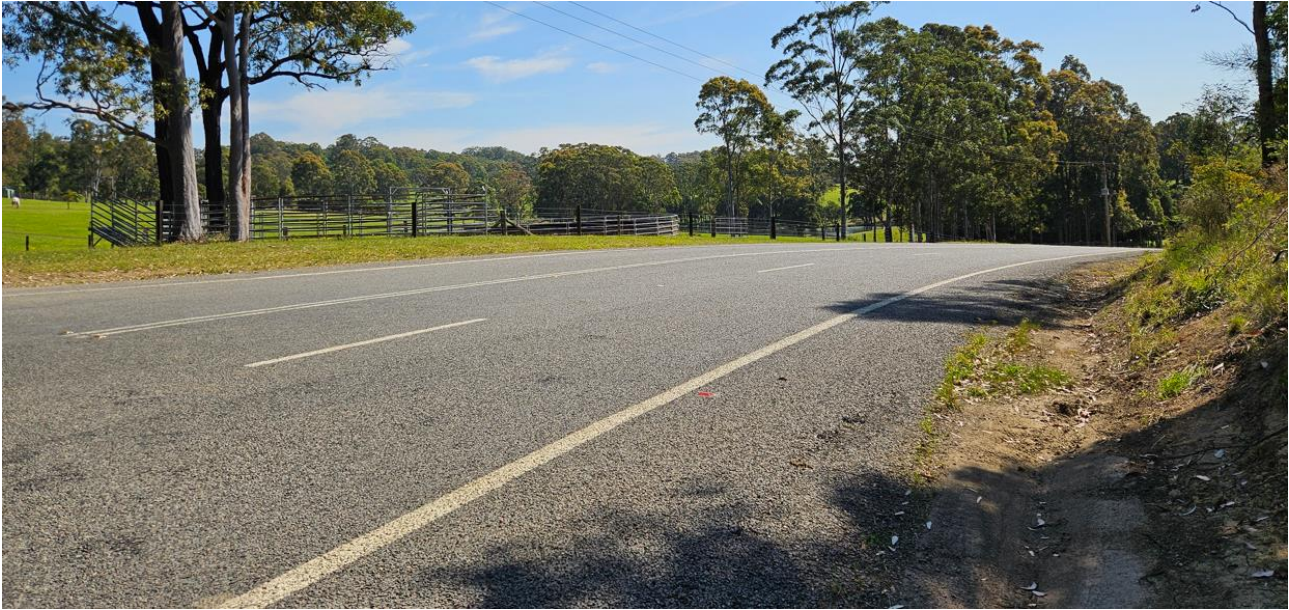
**Plate 3.16**      **Shoulder widening on opposite side of Browns Road**

The intersection turning geometry is moderate, suitable for light vehicle access. Heavy vehicles will not generally require access to travel along Browns Road. There is sufficient shoulder widening along Black Hill Road, which is suitable for turning vehicles. There is no Basic Right Turn (BAR) treatment, however, there is sufficient shoulder widening provided opposite side of Browns Road (Plate 3.11), for through traffic to pass a stationary right turning vehicle.

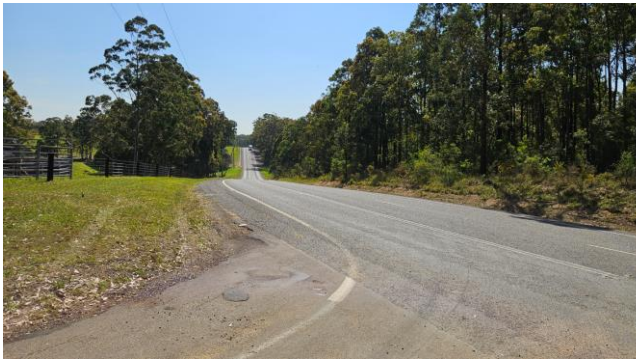
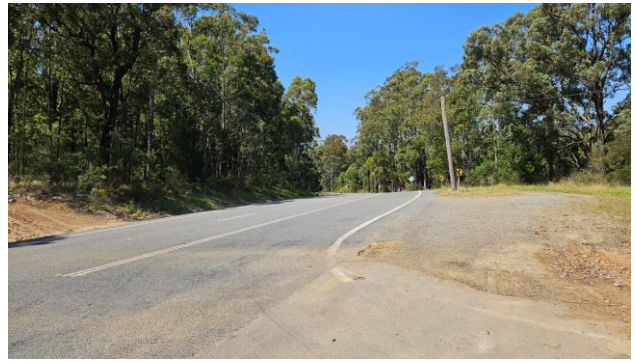
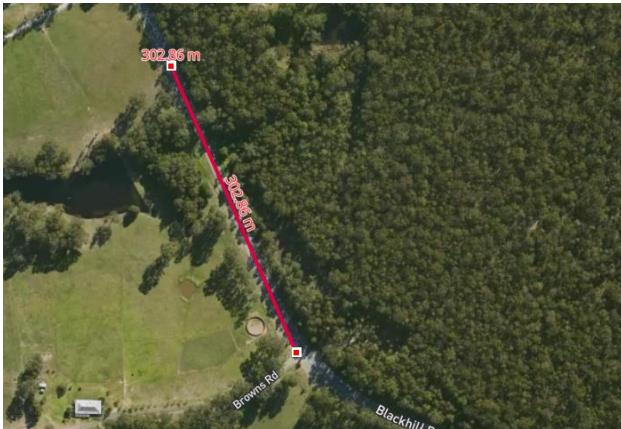
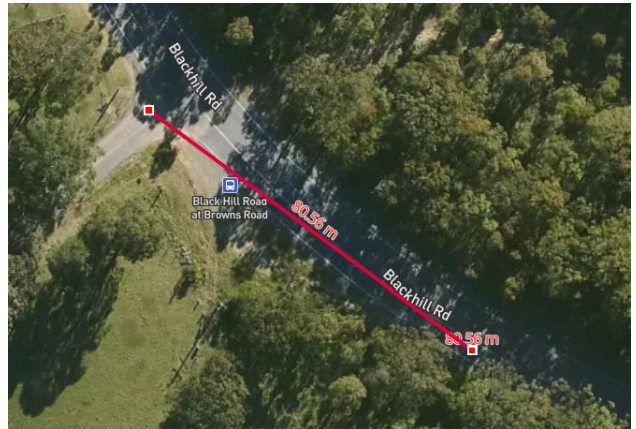
To mitigate the traffic safety risks, there is an existing warning signage on east approach of the intersection. In addition, TfNSW's Centre for Road Safety crash statistics do not show any recorded crash at this intersection over the last five years.

Sight distance to the left (approx. 300+ m)

Sight distance to the right (approx. 80 m)

Based on the crash data, intersection geometry and existing warning signs, there are sufficient risk mitigation measure in place for the sight distance deficiency at this intersection and no additional traffic safety risk mitigation measure is warranted.

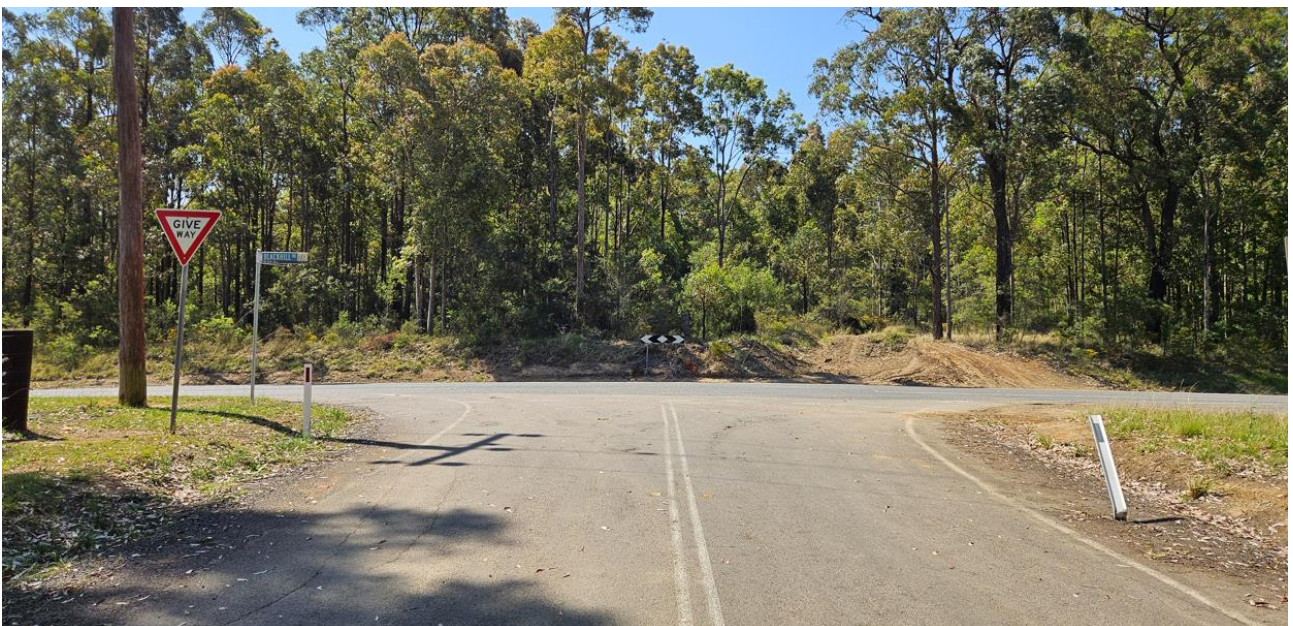
**Plate 3.18** Existing signs and line marking at Black Hill Road/Browns Road intersection

The existing signs and line marking are found to be adequate at this intersection (Plate 3.14) and no additional signs or line marking is required.

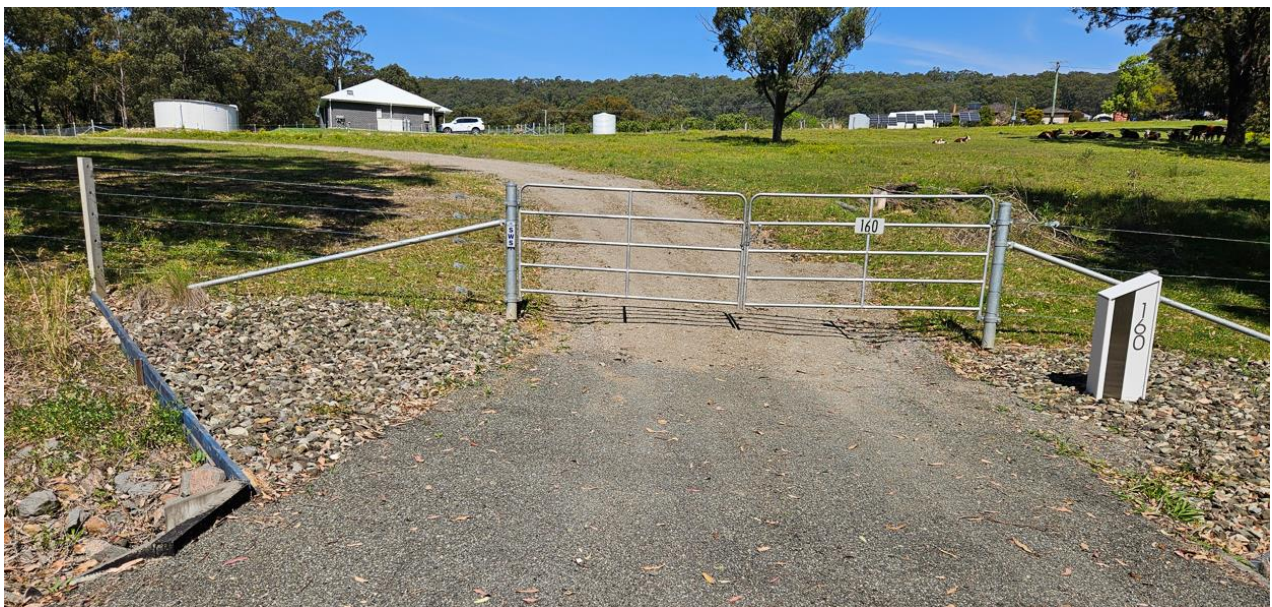
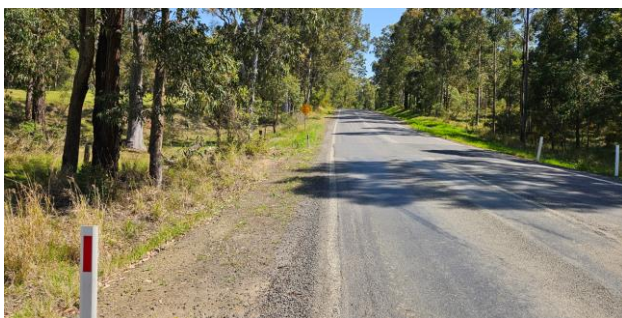
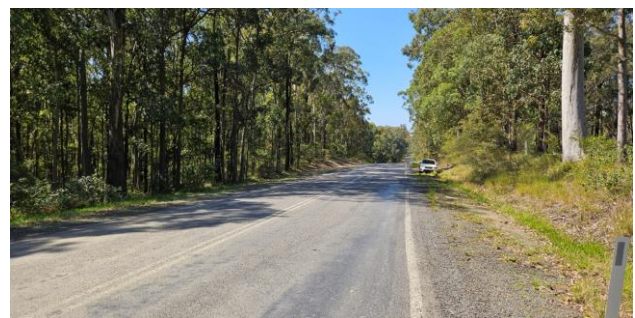
**Plate 3.19**      **160 Black Hill Road**

During the site inspection, other properties which also have direct vehicular access on Black Hill Road, between the Quarry Access Road and John Renshaw Drive were also inspected. All the inspected driveways were in a good condition with adequate sight distance to the left and right. There is no apparent traffic safety issue. Photographs of three of the driveways are shown below in Plate 3.19 to Plate 3.21.

Sight distance to the left

Sight distance to the right

- there are no existing traffic safety issues at the existing residential driveways at the surveyed section of Black Hill Road;
- to improve traffic safety at Black Hill Road/Quarry Access Road intersection, vehicle activated flashing lights are recommended approximately 250 m east of the Quarry Access Road;

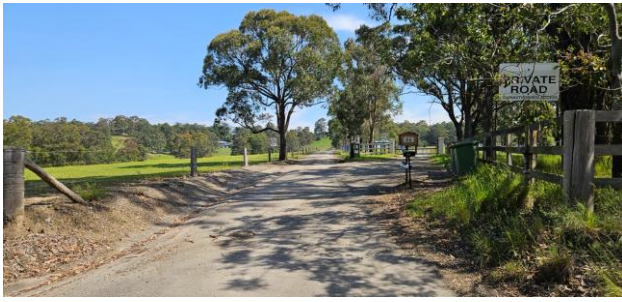
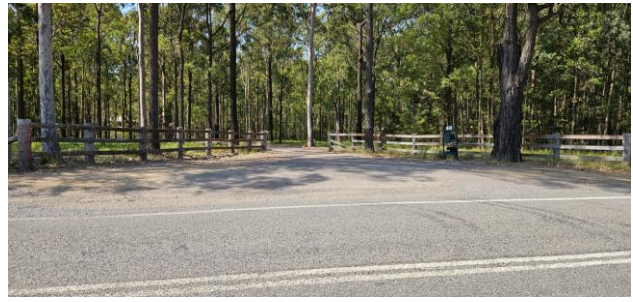
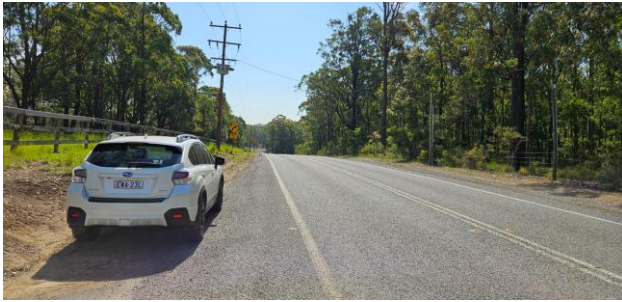
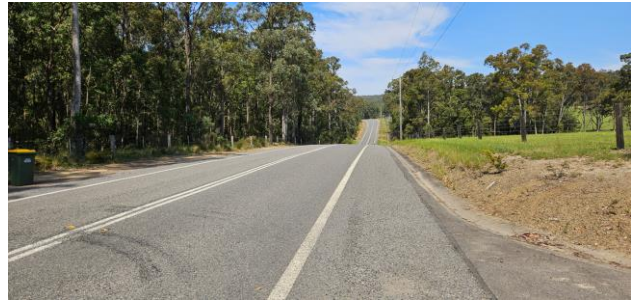
**Plate 3.20**      **45 and 46 Black Hill Road**

Sight distance to the left

Sight distance to the right

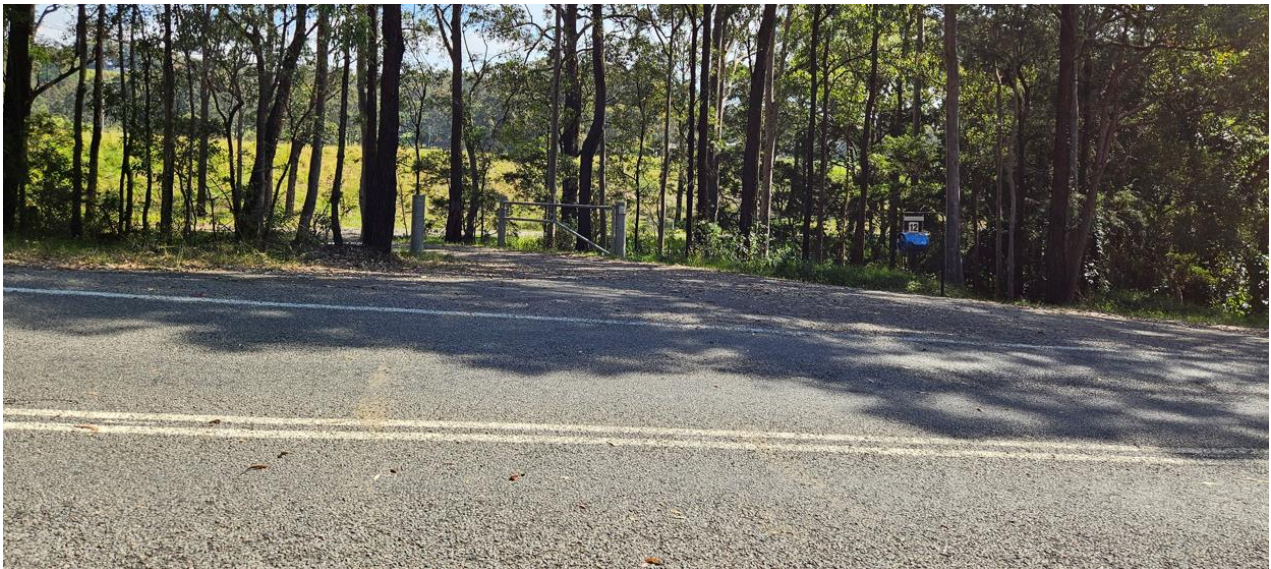
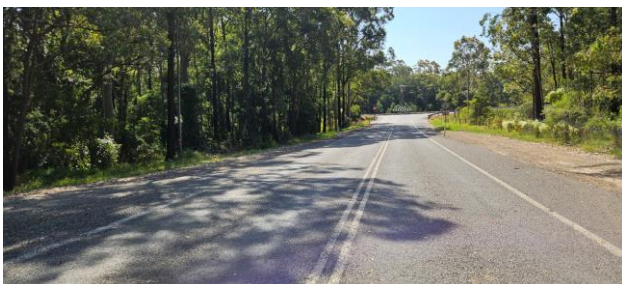
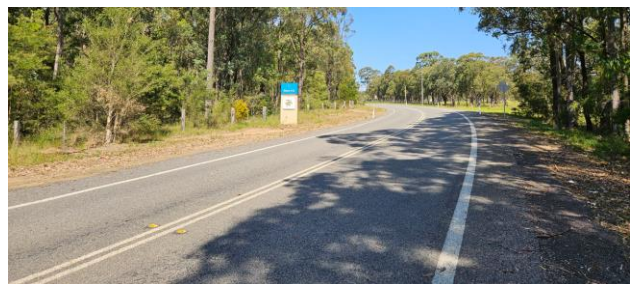
Sight distance to the left

Sight distance to the right
