Acid Sulfate Soil Management Plan

42 Fullerton Cove Road,
Fullerton Cove

NEW20P-0178-AD
31 May 2024

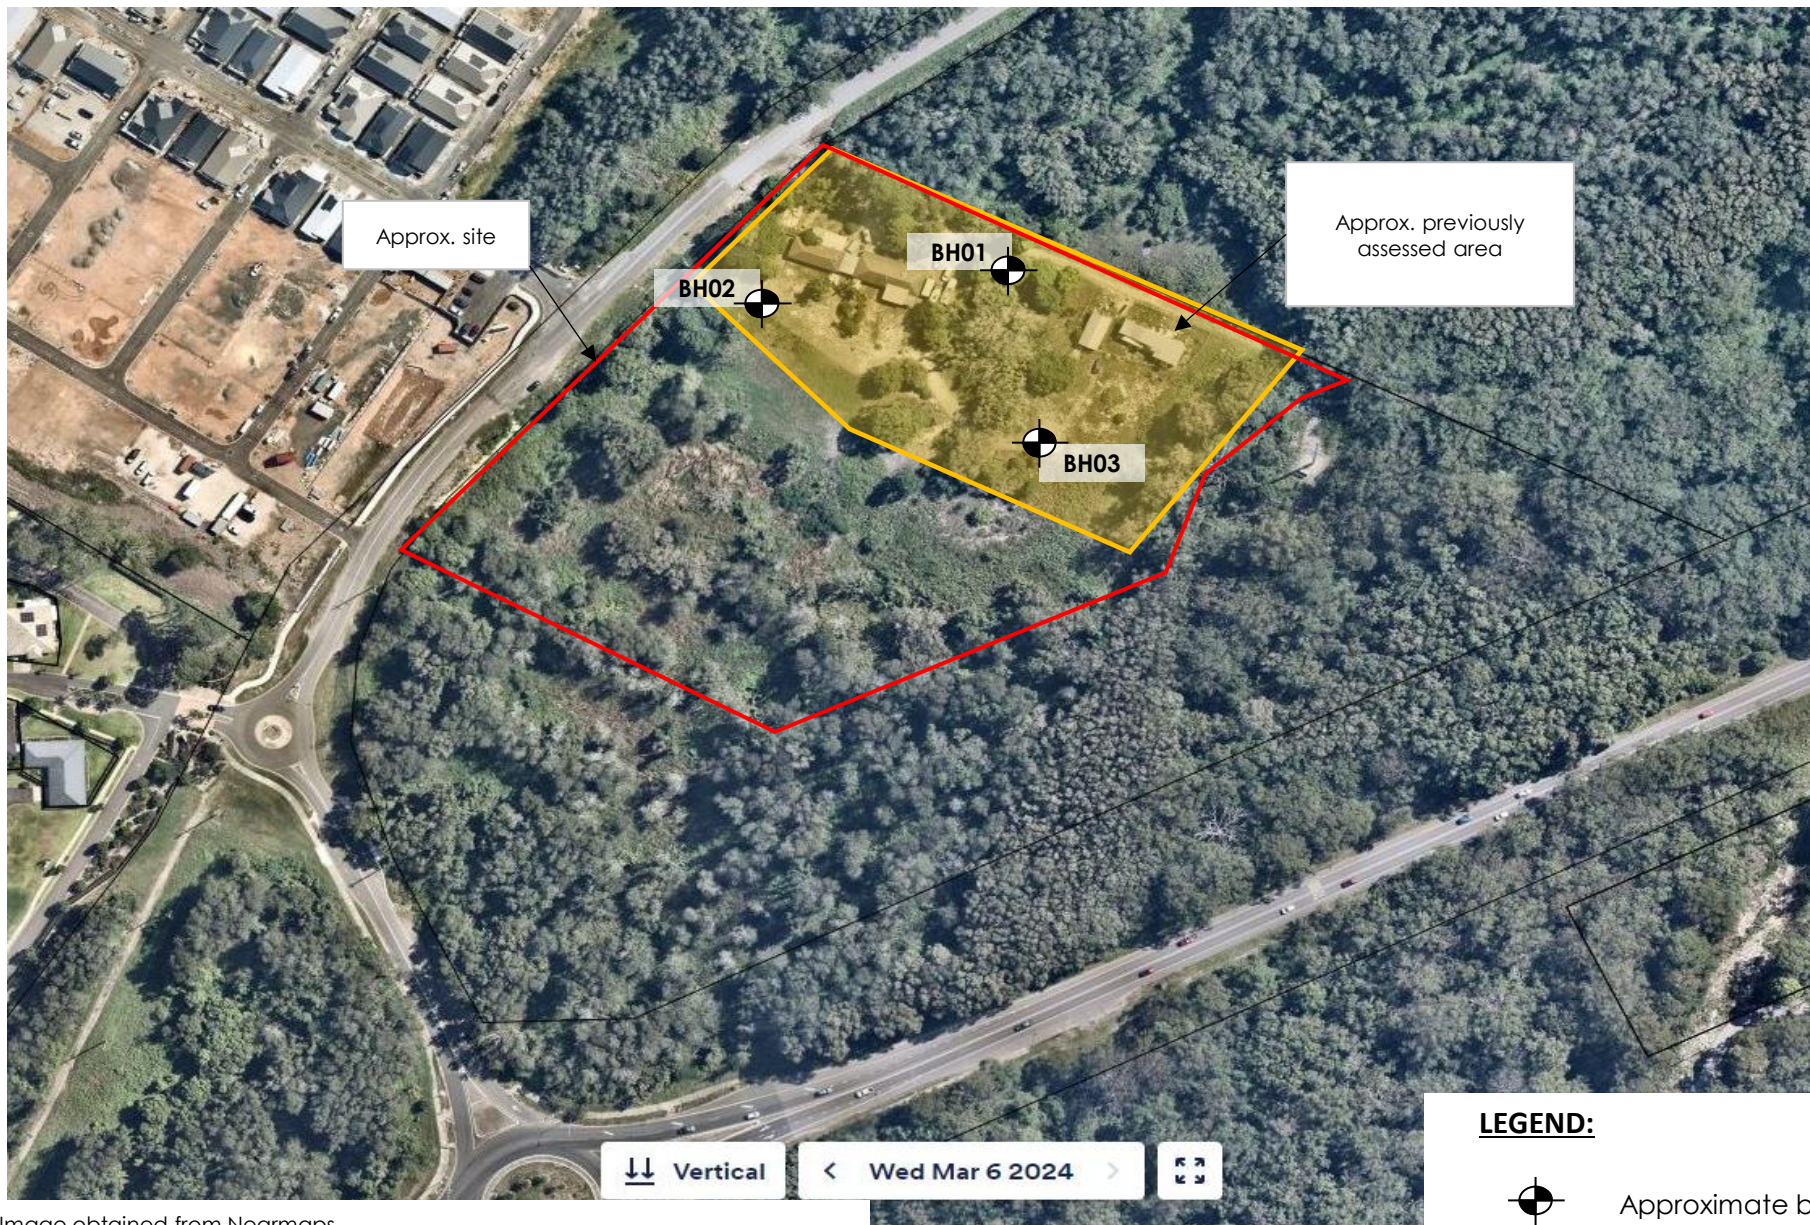
Client:	CANAAN PD 2 PTY LTD C/- MONTEATH & POWYS PTY LTD	Drawing No:	FIGURE 2
Project:	ACID SULFATE SOIL MANAGEMENT PLAN	Project No:	NEW20P-0178-AD
Location:	42 FULLERTON COVE ROAD, FULLERTON COVE NSW	Scale:	N.T.S.
Title:	PREVIOUSLY ASSESSED AREA AND BOREHOLE LOCATIONS	Date:	31/05/2024

As part of the previous ASS assessment (Qualtest, 2021), field work was carried out by an Environmental Scientist from Qualtest on 8 February 2021. Three boreholes (BH01 to BH03) were drilled on the northern portion of the development footprint. The borehole locations are shown on Figure 1, attached.

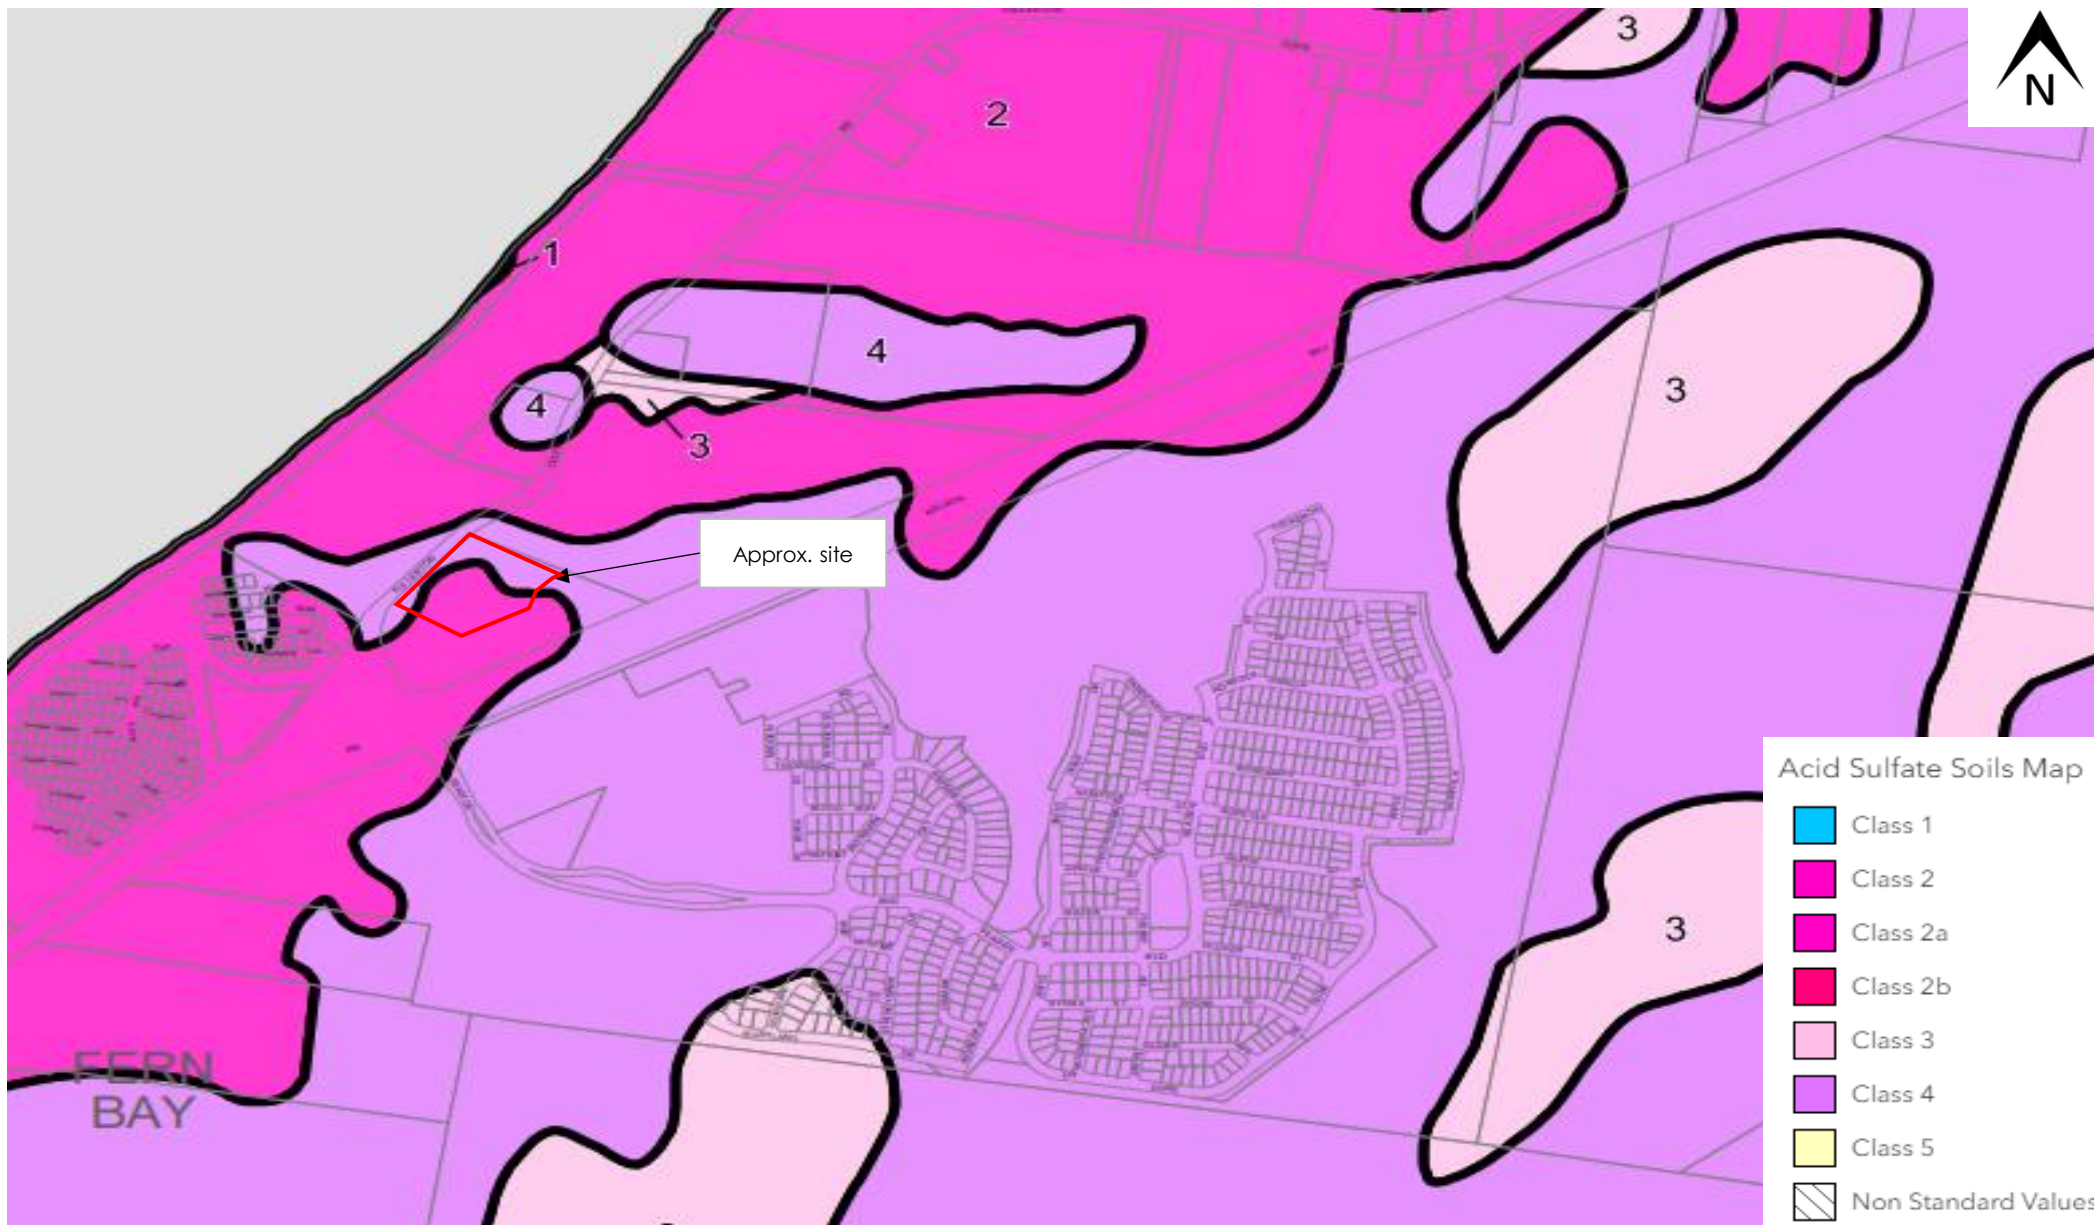
Client:	CANAAN PD 2 PTY LTD C/- MONTEATH & POWYS PTY LTD	Drawing No:	FIGURE 5
Project:	ACID SULFATE SOIL MANAGEMENT PLAN	Project No:	NEW20P-0178-AD
Location:	42 FULLERTON COVE ROAD, FULLERTON COVE NSW	Scale:	N.T.S.
Title:	ASS CLASS MAP - PORT STEPHENS LEP	Date:	31/05/2024

The Port Stephens Local Environmental Plan (LEP) 2013 maps:

- The northern portion of the site as Class 4 ASS, which requires development consent and an ASS Management Plan (ASSMP) for *“Works more than 2m below the natural ground surface. Works by which the watertable is likely to be lowered more than 2m below the natural ground surface.”*
- The remainder of the site as Class 2 ASS, which requires development consent and an ASS Management Plan (ASSMP) for *“Works below the natural ground surface. Works by which the watertable is likely to be lowered.”*

The site overlain on the LEP ASS Map is presented as Figure 5, Appendix A.
