# Remediation Action Plan

Lots 200-212 Astra  
Aerolab, Williamtown  
NSW

NEW24P-0090-AG  
21 May 2024

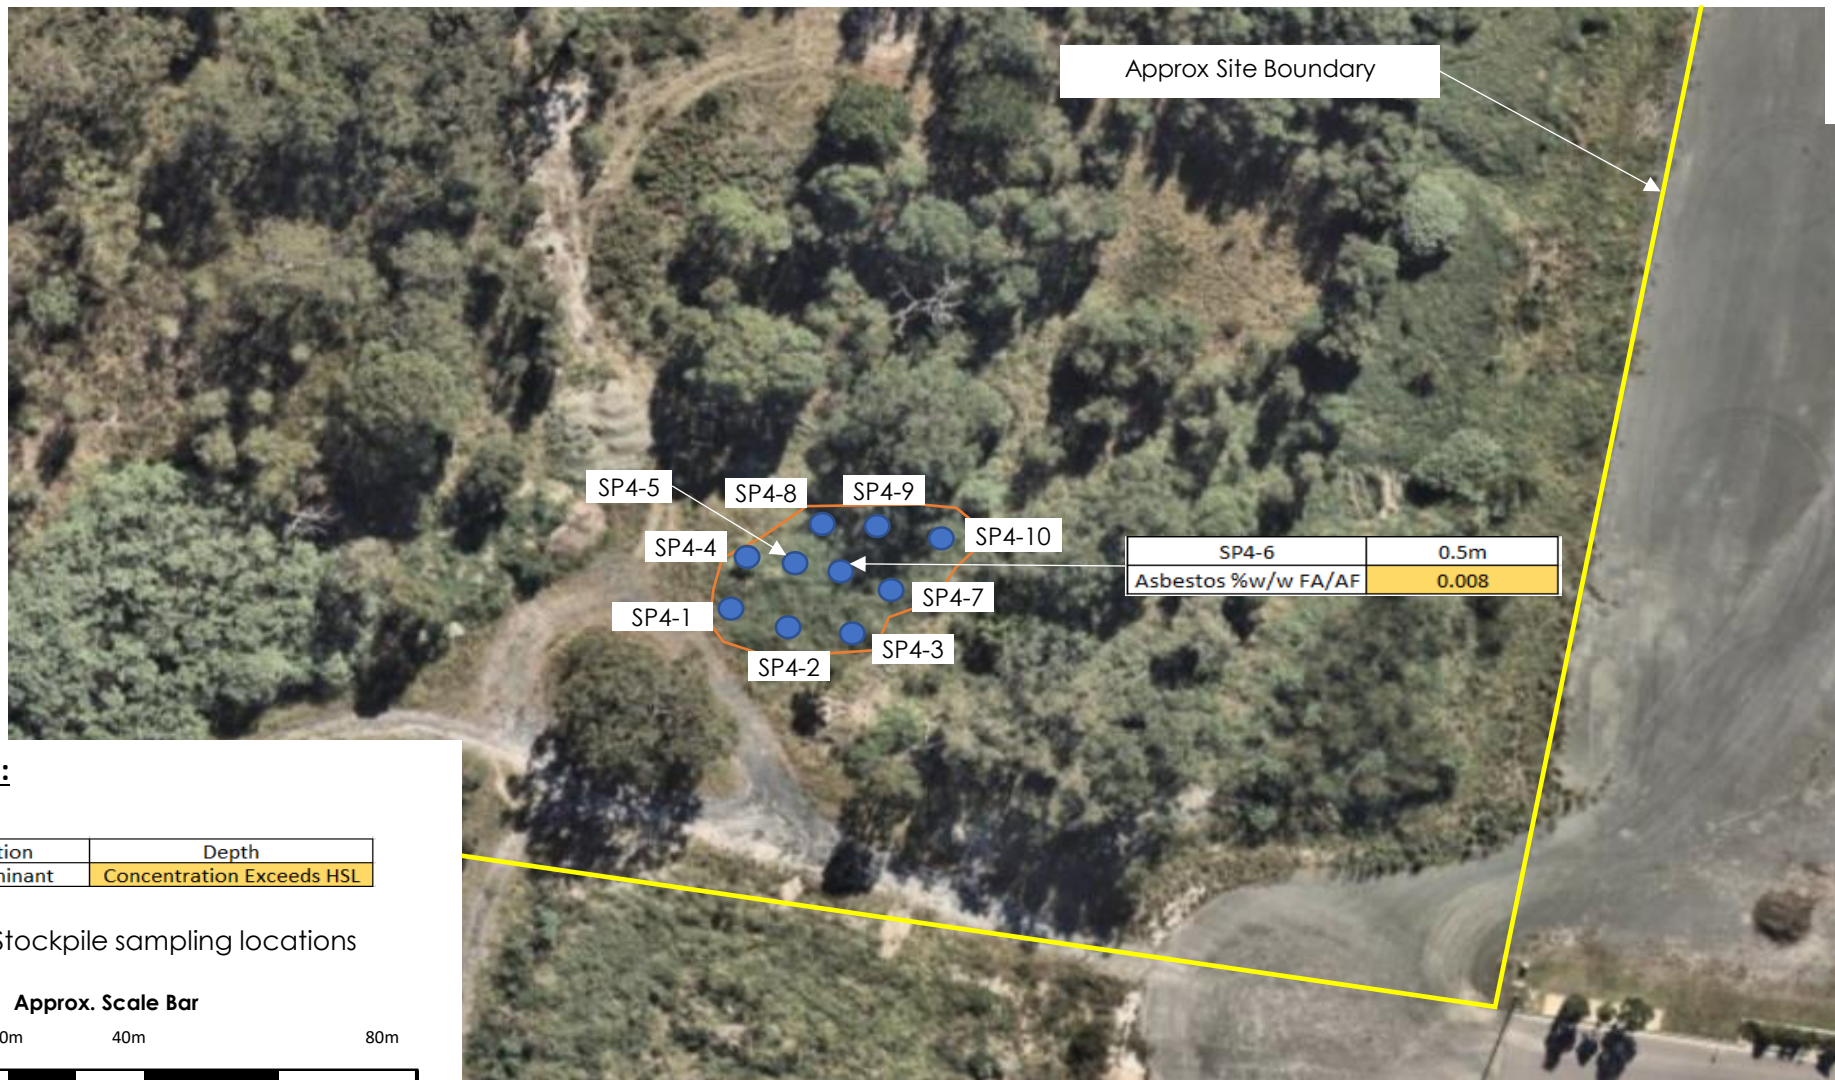
Client:	GREATER NEWCASTLE AEROTROPOLIS PTY LTD	Drawing No:	FIGURE 6
Project:	REMEDIATION ACTION PLAN	Project No:	NEW24P-0090-AG
Location:	PROPOSED LOT 200-212, ASTRA AEROLAB, WILLIAMTOWN NSW	Scale:	N.T.S.
Title:	IDENTIFIED CONTAMINATION	Date:	17/05/2024

Location	Depth
Contaminant	Concentration Exceeds HSL

The proposed remediation method is removal/excavation of contaminated soils in SP4 and disposal to an appropriately licensed waste facility, followed by validation of the resulting footprint of SP4.
