## **Remediation Action Plan**

### **Proposed Residential Development**

**139 Teralba and 190 Brunker Roads,  
Adamstown NSW**

**Project 225230.00**

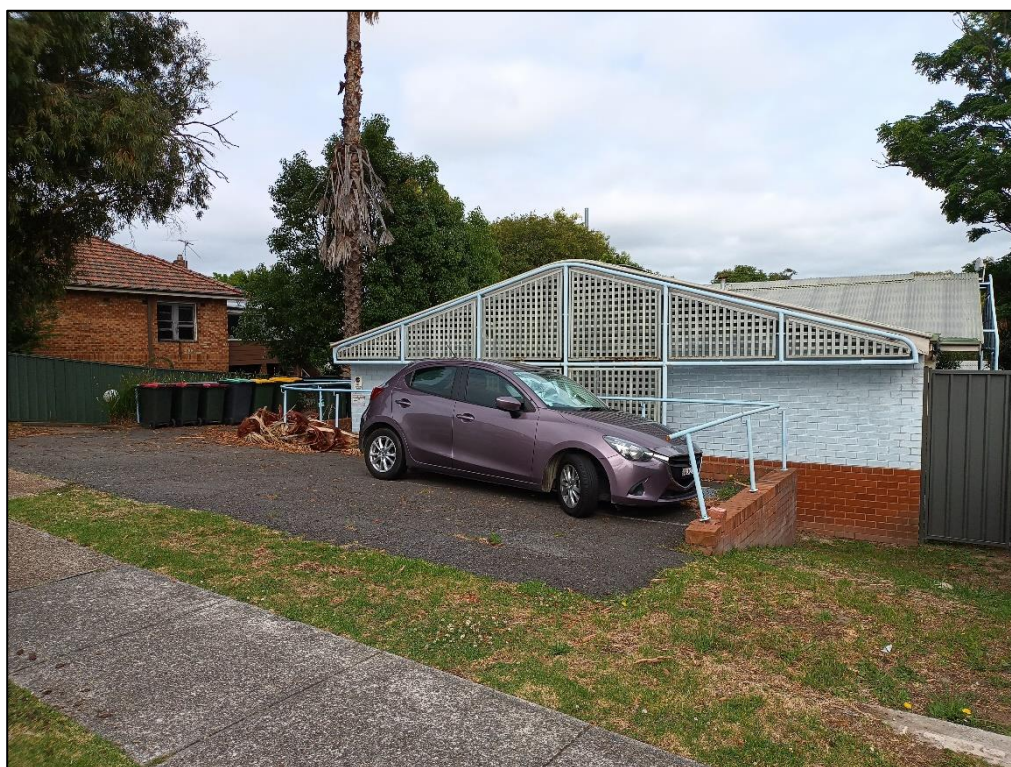
**Figure 3: Site condition, southern boundary of the site (Brunker Road), looking north-west.**

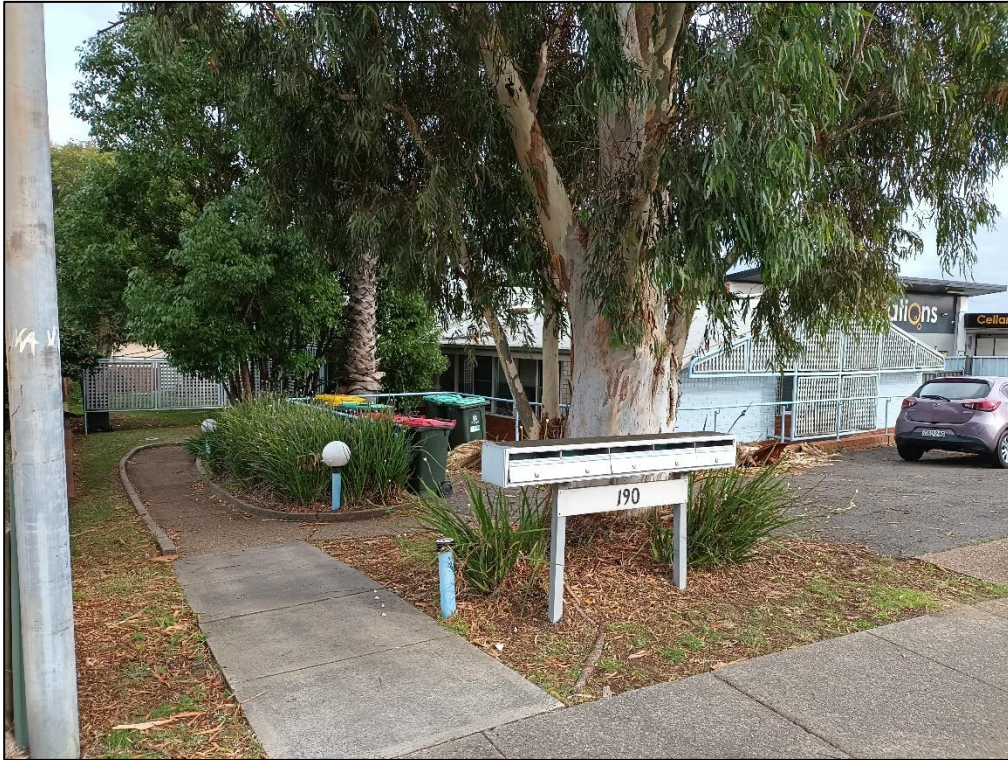
**Figure 4: Site condition, southern boundary of the site (Brunker Road), looking north-west.**

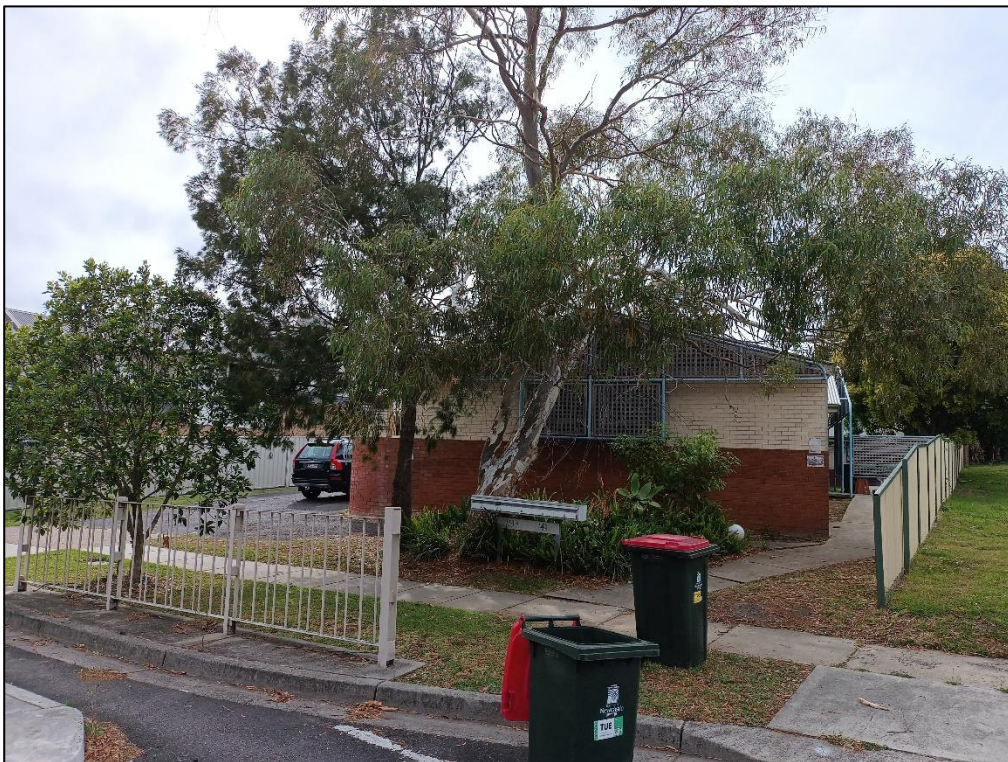
**Figure 5: Site condition, northern boundary of the site (Teralba Road), looking south-east.**

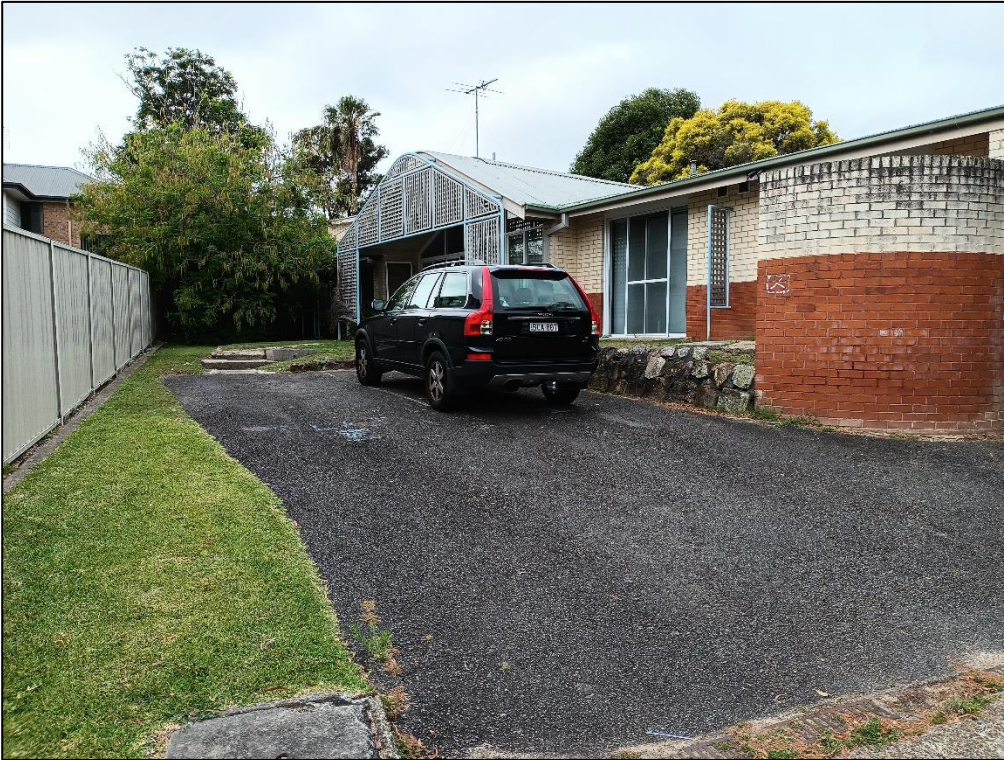
**Figure 6: Site condition, northern boundary of the site (Teralba Road), looking south-east.**
