# Remediation Action Plan

2-4 Brownlee Street,  
Ourimbah NSW

NEW23P-0208-AE  
5 November 2024

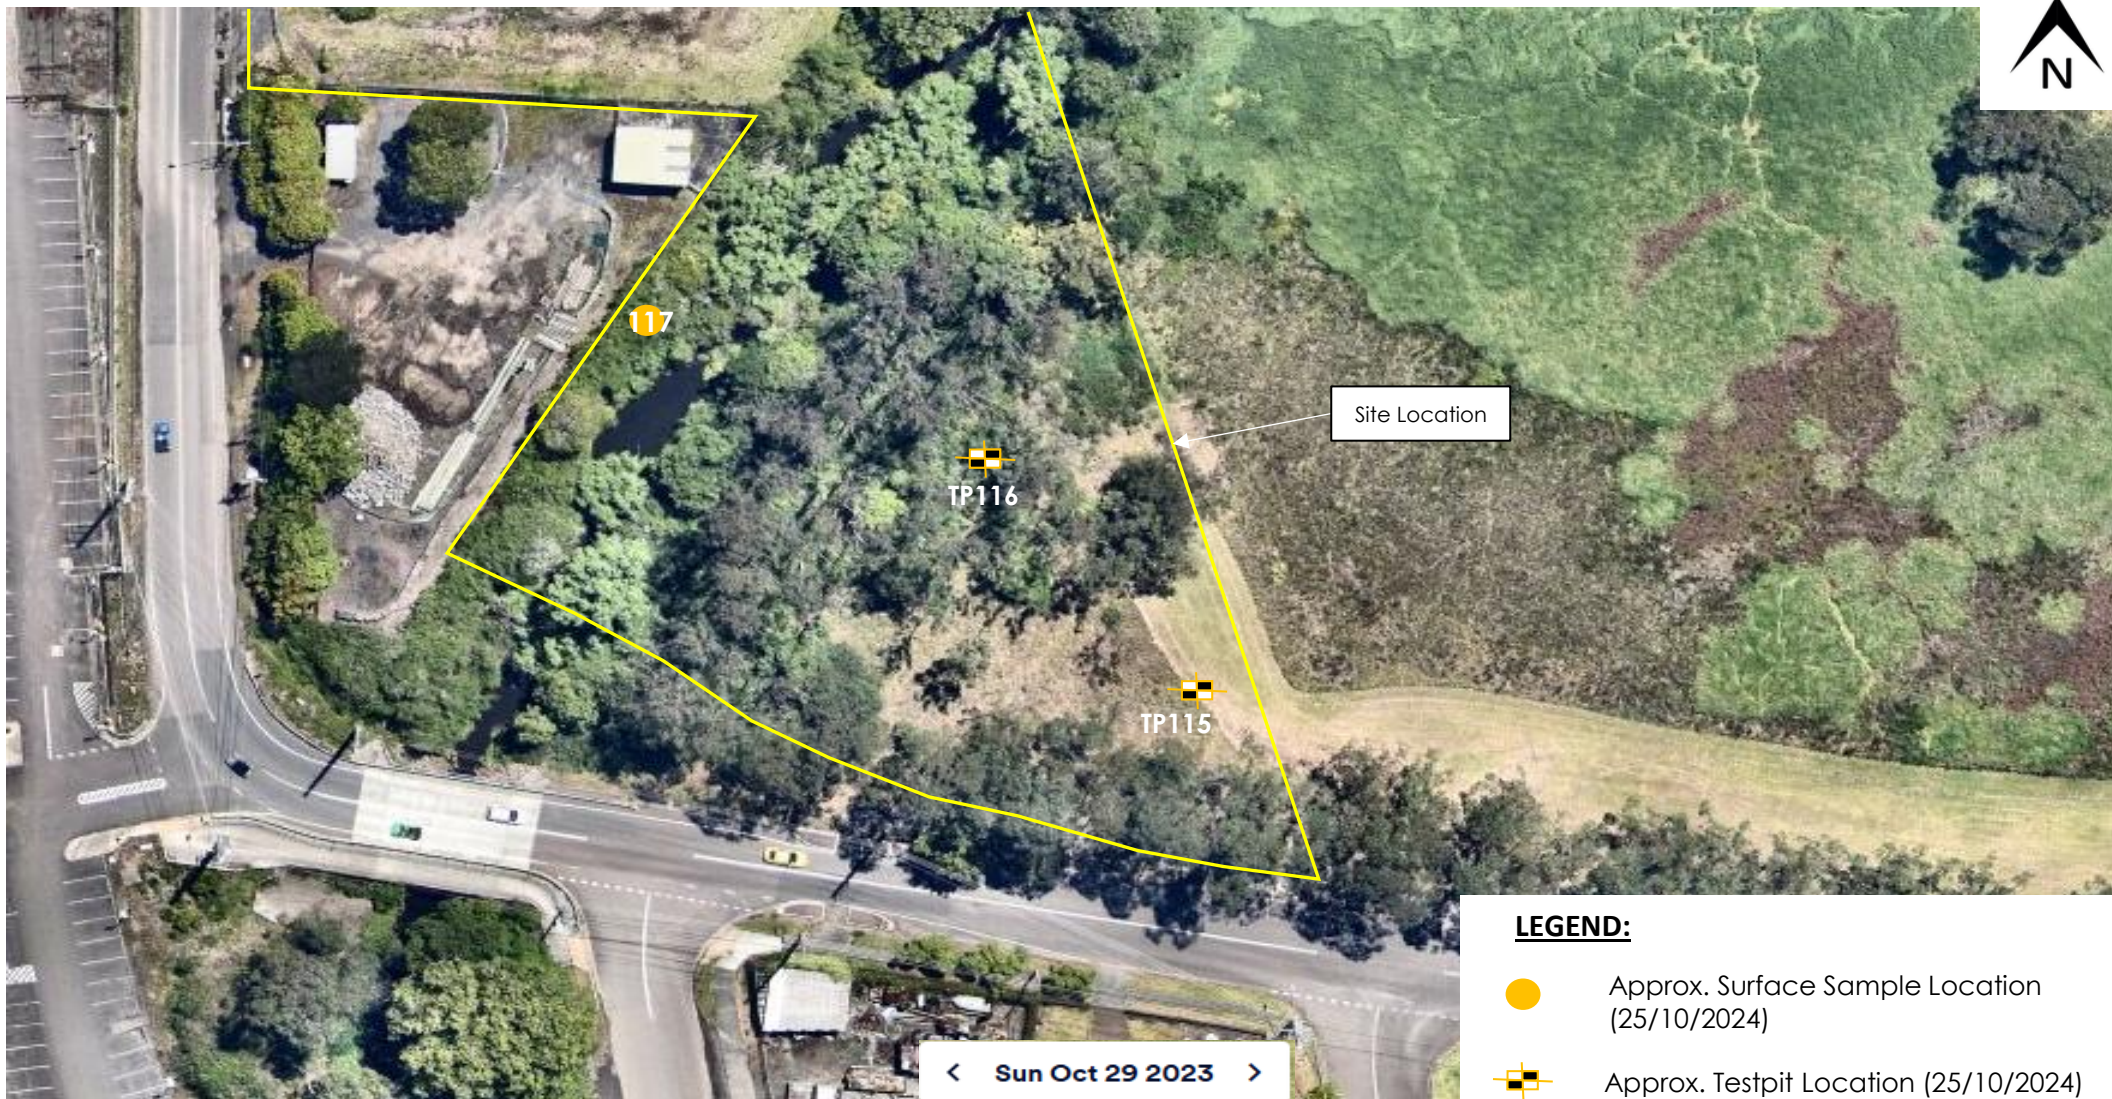
| Title: | Sample Plan - Southern Portion | Date: | 29/10/2024 |

- Approx. Surface Sample Location (25/10/2024)
- Approx. Testpit Location (25/10/2024)
- Approximate Site Boundary

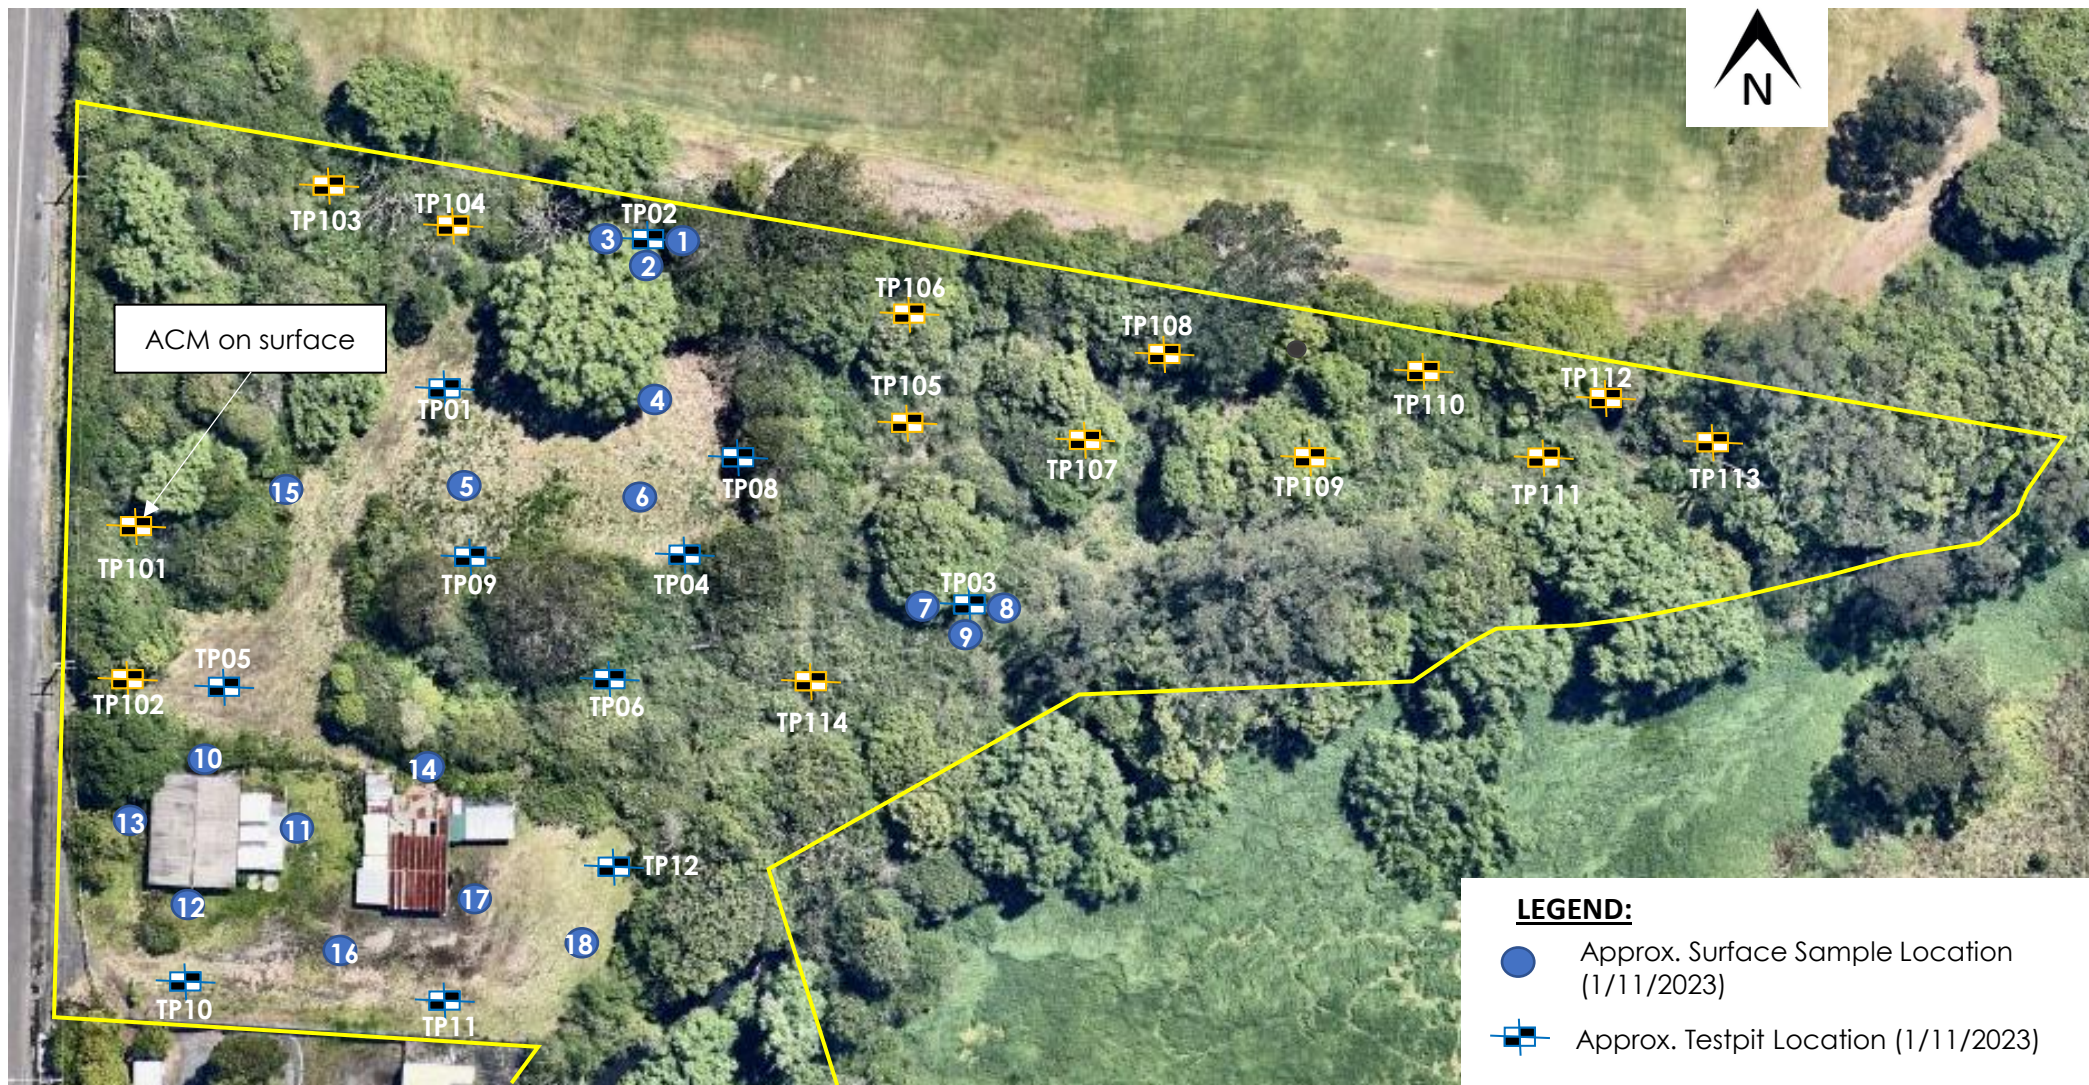
| Title: | Identified Contamination | Date: | 1/11/2024 |

- Approx. Surface Sample Location (1/11/2023)
- ⊠ Approx. Testpit Location (1/11/2023)
- ⊠ Approx. Testpit Location (25/10/2024)
- ▮ Approximate Site Boundary

The DSI identified contamination in the form of bonded Asbestos Containing Materials (ACM) on the site surface in sample location TP101 0.0-0.1, located in the former office area (central western portion) of the site.

- Bonded fragments of Asbestos Containing materials (ACM) were identified below the adopted HSL, but on the site surface in test pit TP101\_0.0-0.1 in the central western portion of the site (former sawmill office). ASC NEPM (2013) states “no visible evidence for surface soil (top 10cm)” is permitted for all types of asbestos. It was considered that the contamination was likely caused by weathering/demolition of the former sawmill office building and localised to this area of the site.
