Geotechnical and Acid Sulfate Soil Investigation Report

31-37 Phillips Street, Raymond Terrace, NSW

Report No: NR163_GI & ASSA

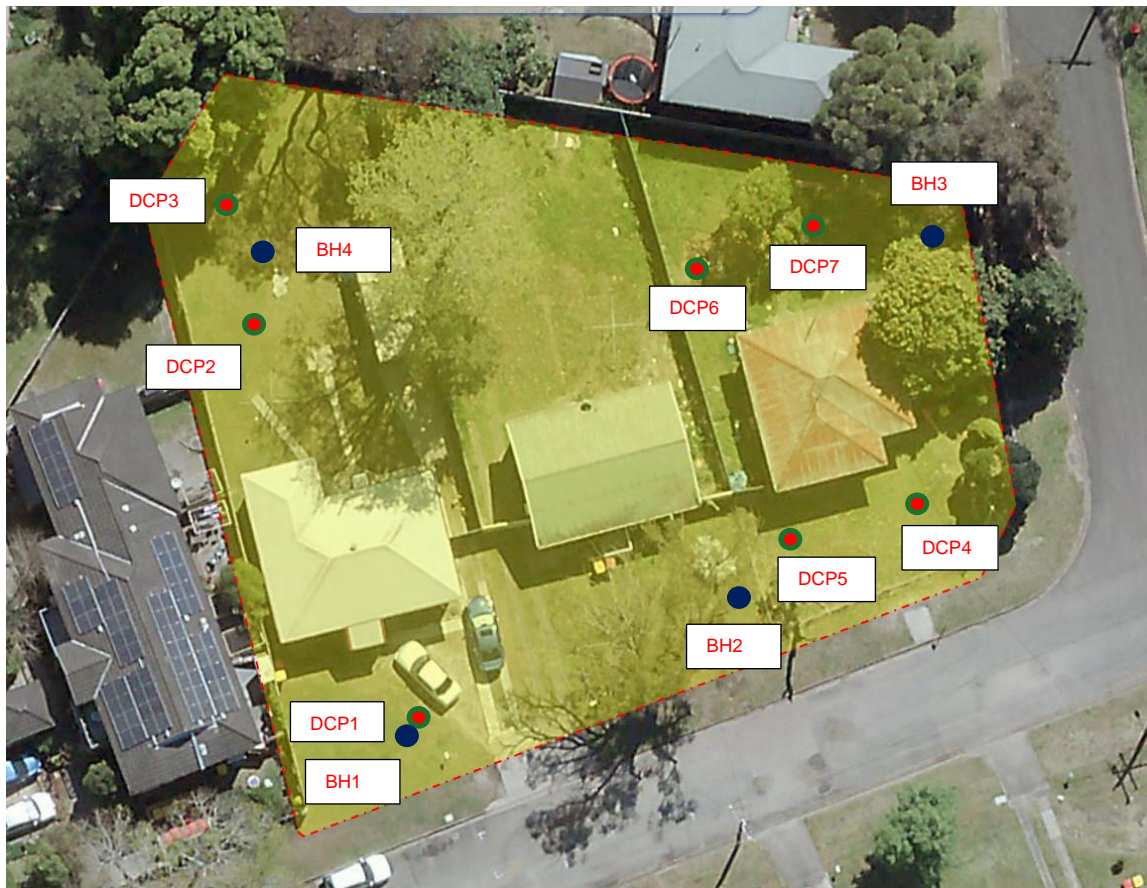
Plate 1: BH/DCP Test Location Plan

- Site walkover inspection by a geotechnical engineer to assess topographical features and site the conditions,
- Four boreholes with auger drilling fitted on UTE as shown in **Plate 1**,
- Seven Dynamic Cone Penetrometer (DCP) tests (as shown in **Plate 1**) were carried out from ground surface in accordance with AS1289.6.3.2 – 1997, “Determination of the penetration resistance of a soil – 9kg Dynamic Cone Penetrometer” to estimate near surface soil conditions and confirm depths to bedrock. The termination depths encountered at DCP test locations are tabulated below in **Table 1-1**:

Building	Test No.	Location	Termination Depth (m, BEGL)	Comments
Hume A	DCP1	As shown in Plate 1	4.90	Terminated on Loose Sand
	BH1	As shown in Plate 1	6.00	Terminated in Sand
Hume B	DCP2	As shown in Plate 1	5.10	Terminated on medium dense Sand
	DCP3	As shown in Plate 1	5.90	Terminated on very dense Sand
	BH4	As shown in Plate 1	4.00	Terminated in Sand
LAHC A	DCP4	As shown in Plate 1	3.40	Terminated on dense Sand
	DCP5	As shown in Plate 1	3.30	Terminated on dense Sand
	BH2	As shown in Plate 1	4.00	Terminated in Sand
LAHC B	DCP6	As shown in Plate 1	2.00	Refusal on Extremely Weathered Material (hard clay)
	DCP7	As shown in Plate 1	1.83	Refusal on Extremely Weathered Material (hard clay)
	BH3	As shown in Plate 1	4.20	Refused on Low Strength Bedrock

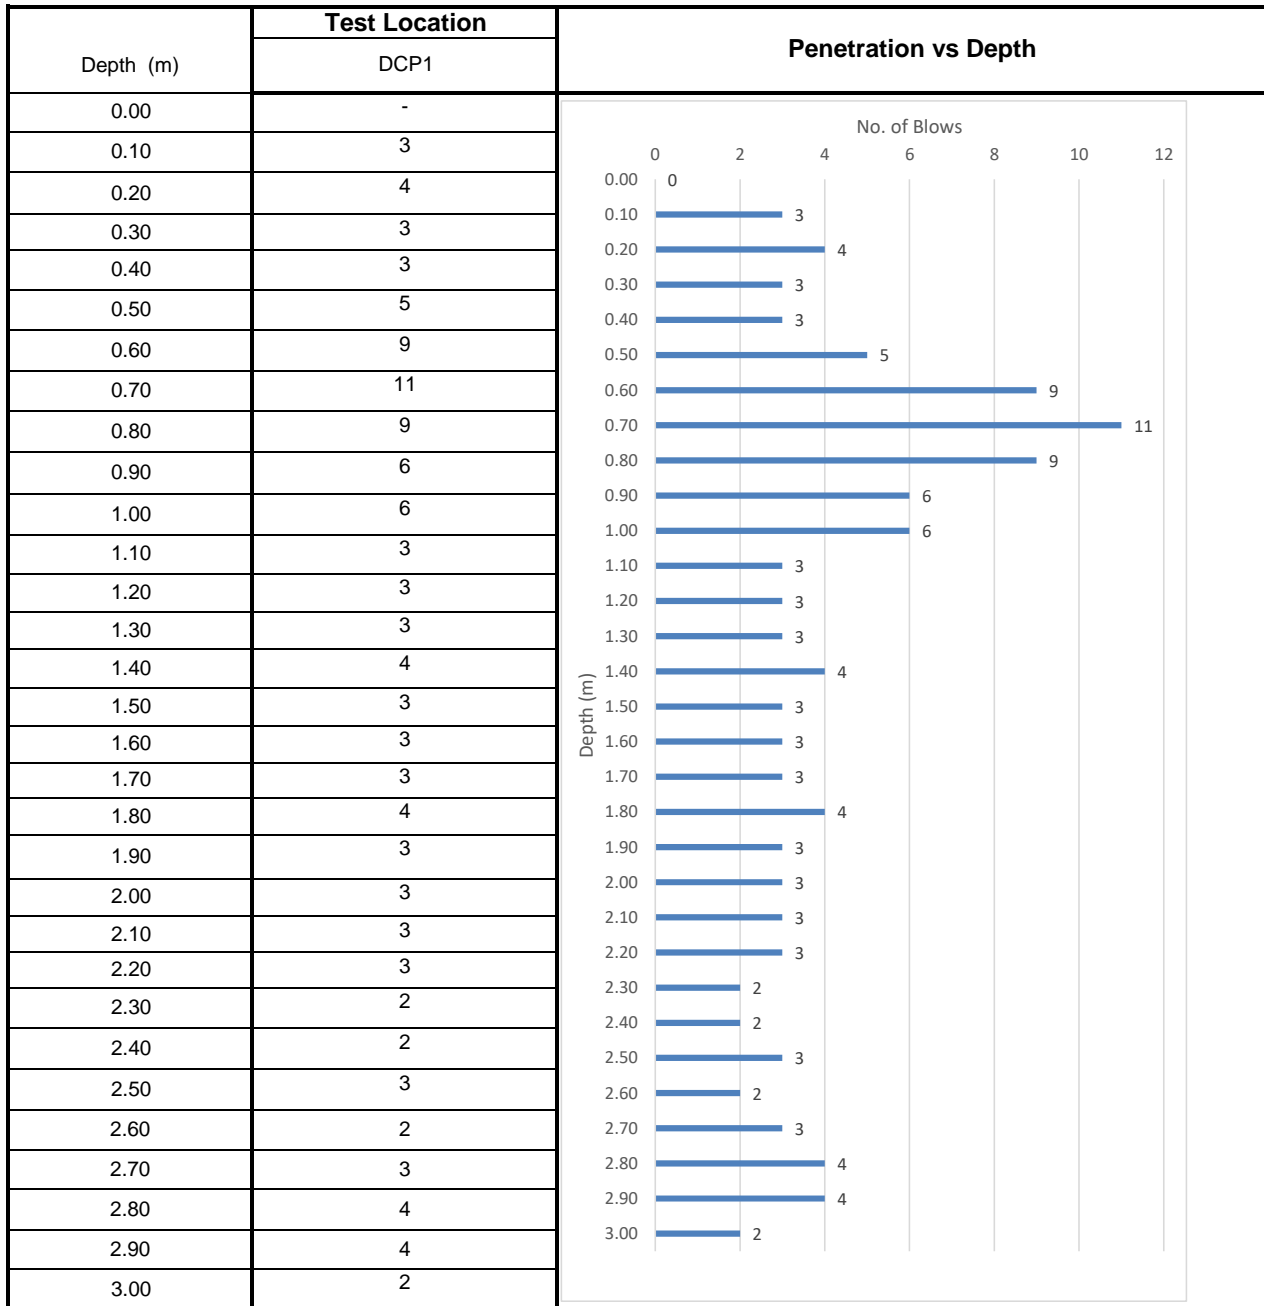
DYNAMIC PENETROMETER TEST SHEET

TEST METHOD: AS 1289. F3.2, CONE PENETROMETER PENETROMETER

Depth (m)	Test Location	Penetration vs Depth
	DCP1	
3.00	-	
3.10	2	
3.20	2	
3.30	2	
3.40	2	
3.50	1	
3.60	1	
3.70	1	
3.80	1	
3.90	1	
4.00	1	
4.10	1	
4.20	1	
4.30	1	
4.40	1	
4.50	1	
4.60	1	
4.70	1	
4.80	1	
4.90	Terminated @ 4.9m	
5.00	on very loose sand	
5.10		
5.20		
5.30		
5.40		
5.50		
5.60		
5.70		
5.80		
5.90		
6.00

REMARKS: (HB) Test hammer bouncing upon refusal on solid object
 -- No test undertaken at this level due to prior excavation of soils
 DCP cone was moist on retrieval indicates water seepage water.
