# Preliminary Site Investigation

Stanton Dahl Architects on behalf of  
Catholic Schools Broken Bay

Mackillop Catholic College  
91 Sparks Road, Woongarah  
NSW, 2259

July 2024

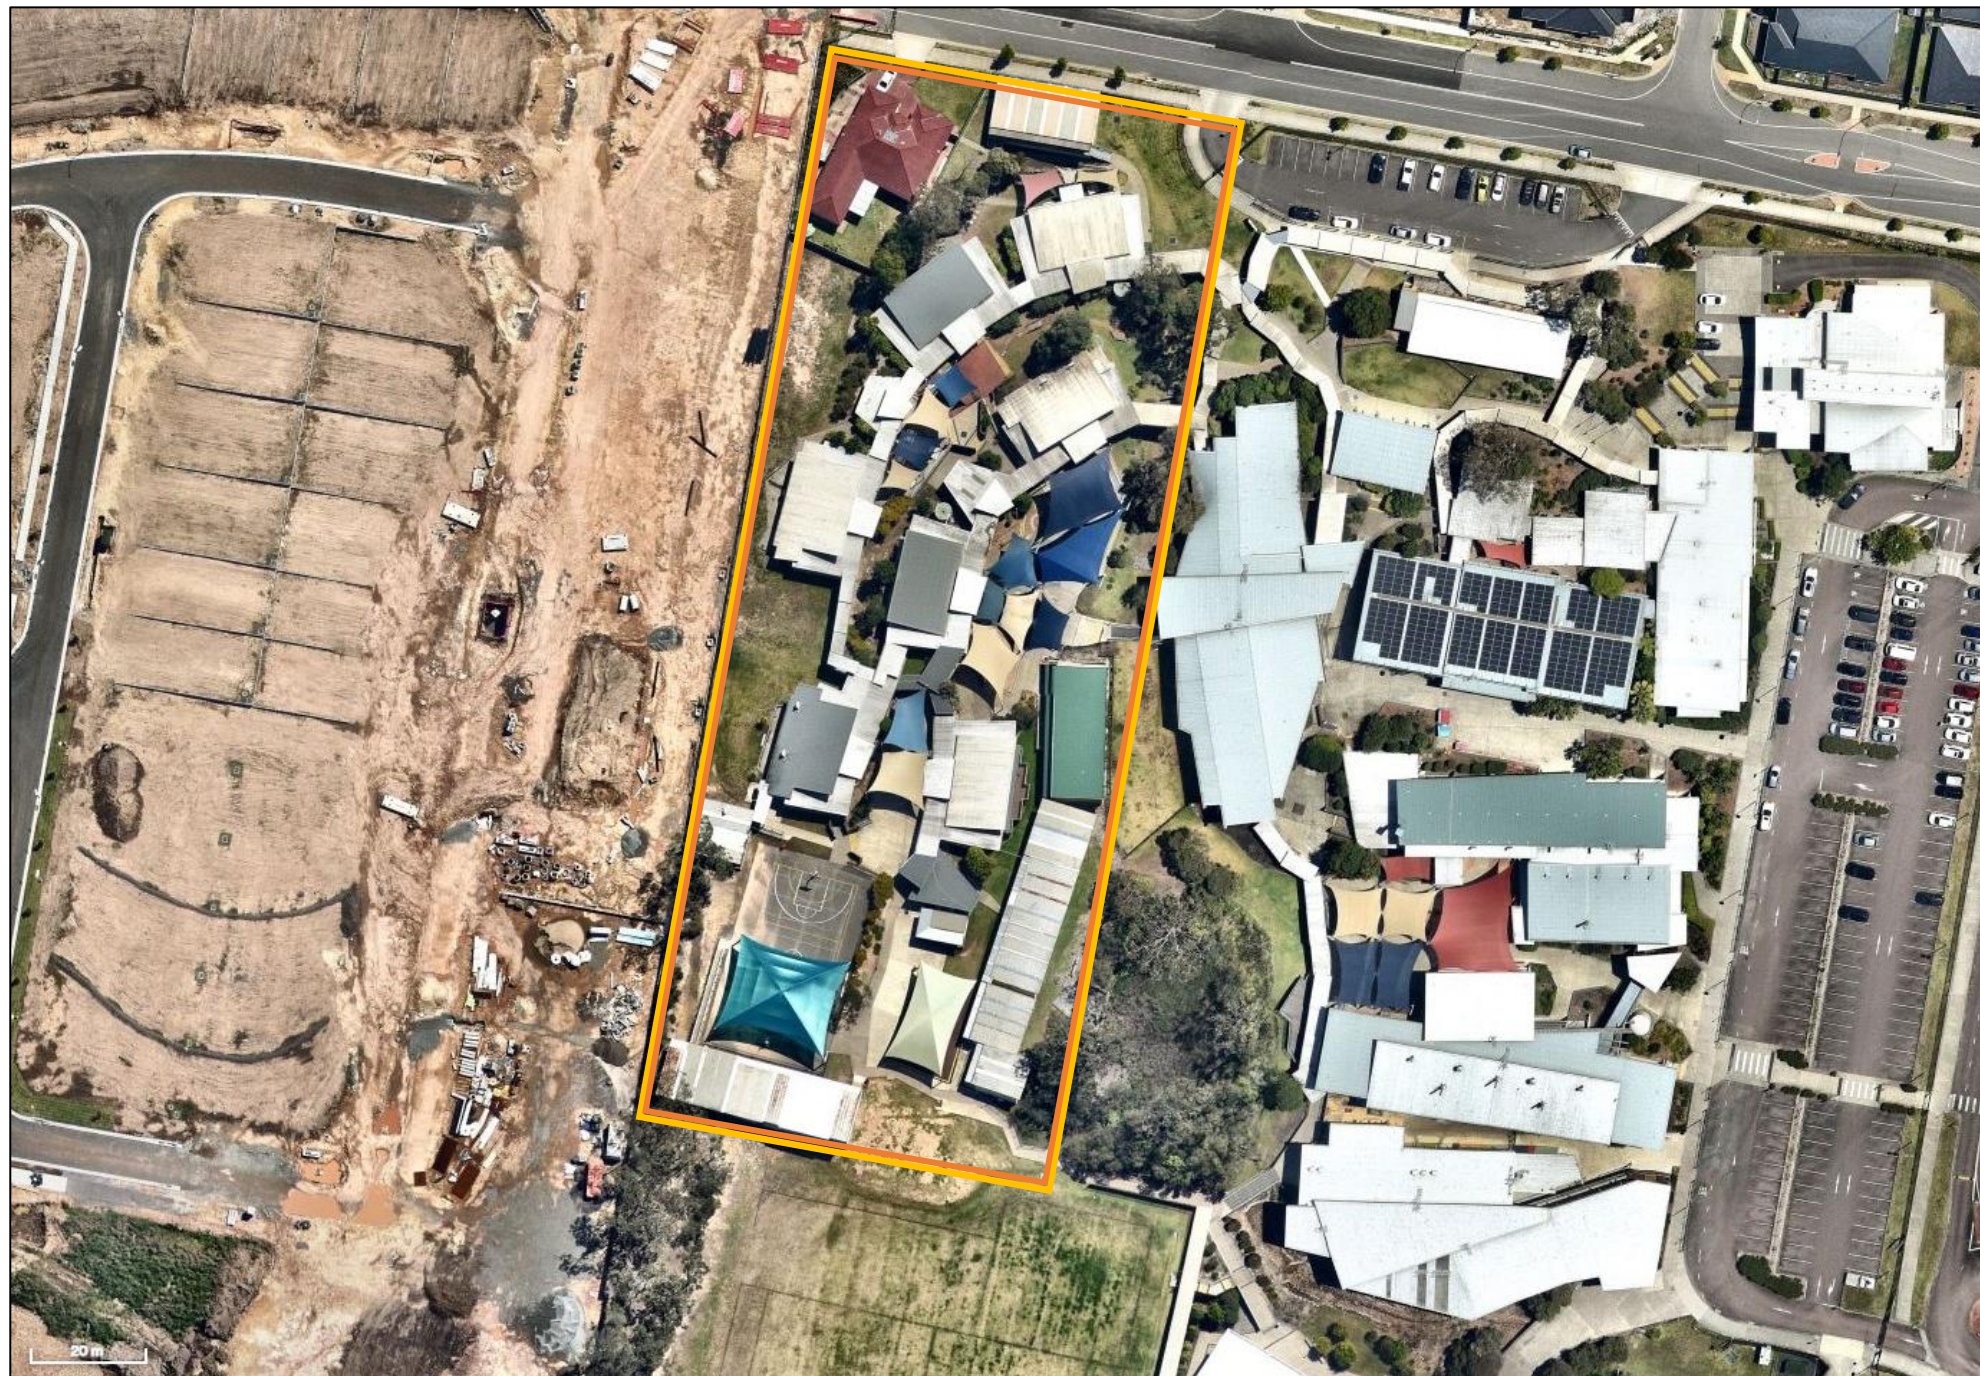
**Figure 3:**  
Areas of Environmental  
Concern Plan

- AEC1 – Potential uncontrolled fill material situated across site beneath the buildings.

Based on the preliminary CSM, the potential exposure of CoPC at the site is considered **low-moderate** given the presence of one (1) AECs identified across the site, as shown in Figure 3, **Appendix A**.

- Based on the site inspection, desktop review and the proposed development involving in situ soil disturbance excavations, intrusive soil sampling in the form of a detailed site investigation is recommended to assess the contamination status of in situ soils identified in Areas of Environmental Concern: AEC1, of which are known to be disturbed during future site-based works. This will confirm the source, pathway, and receptor linkages to the CSM, assessing the risk of exposed soils to future site users and construction workers to ensure suitability for the proposed development;

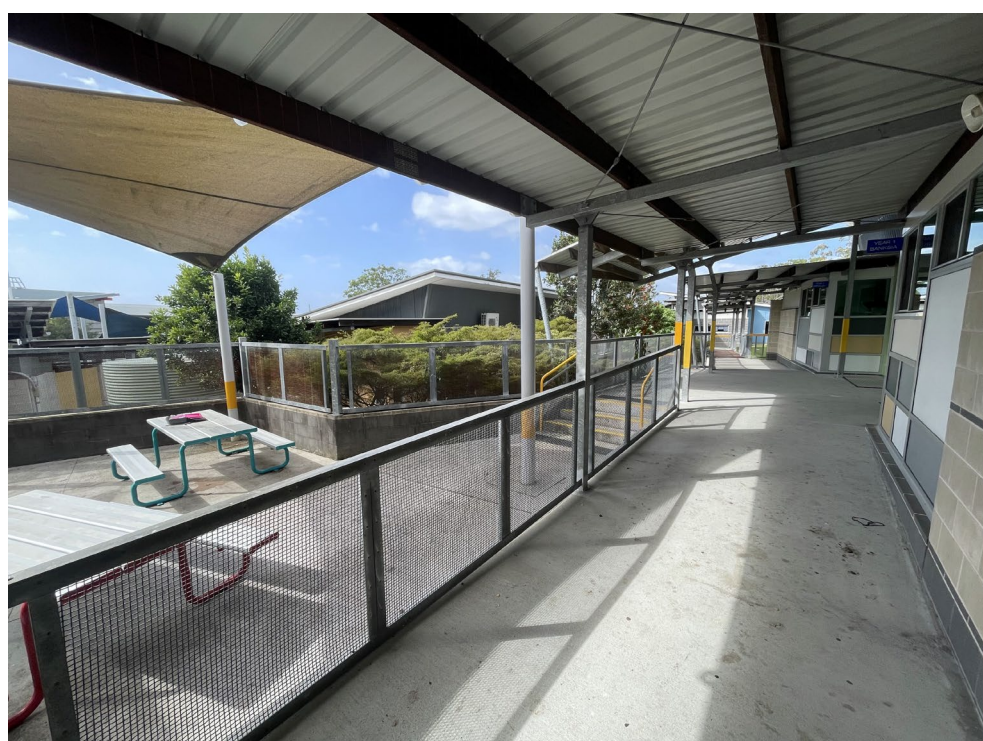
Photo 3: Overview of the Central portion of the investigation area, amongst the current primary school buildings present and in use. Looking south.

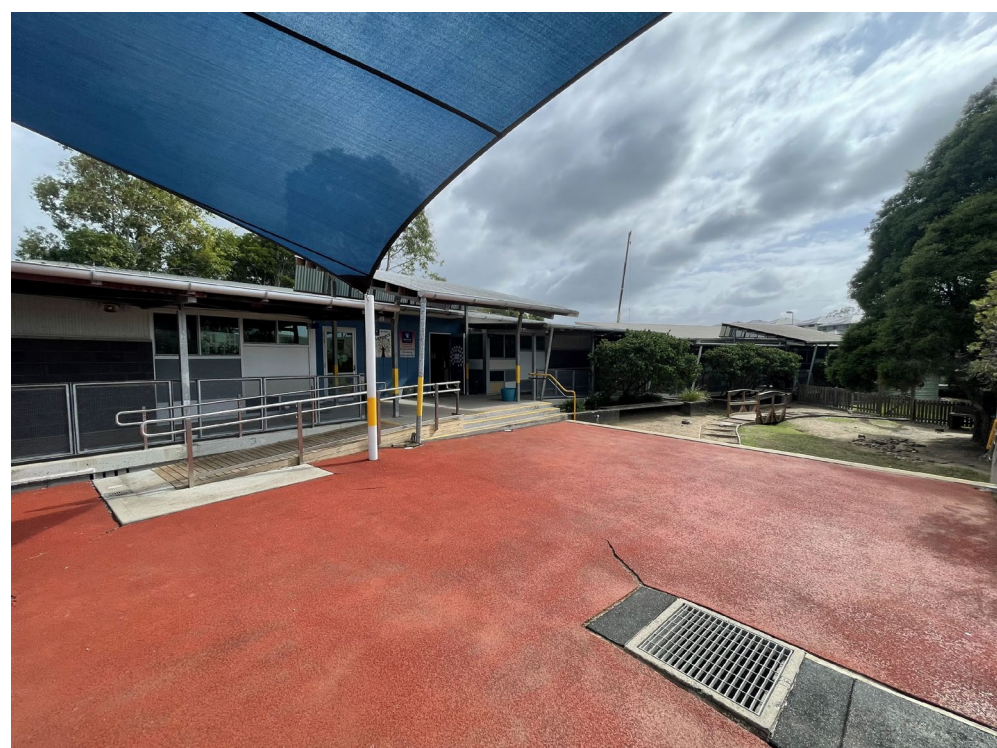
Photo 4: Overview of the central portion of the investigation area, amongst the current primary school buildings still in use. Looking north.

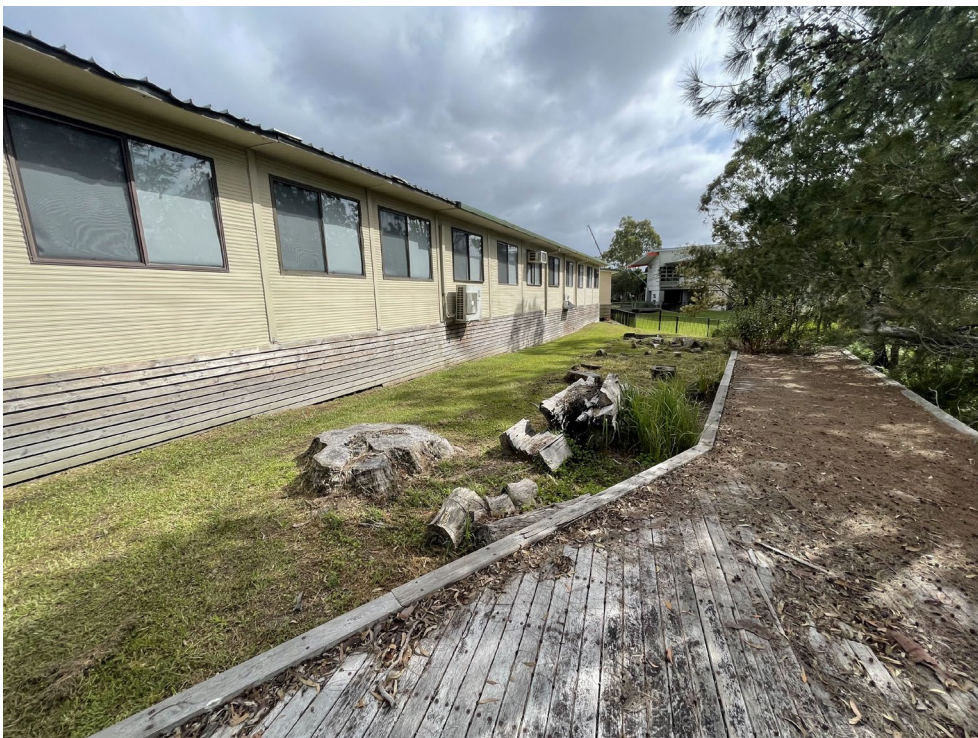
Photo 9: Overview of the southeastern portion of the investigation area showing the old weathered wooden boardwalk present and the rear portion of the primary school buildings present here.

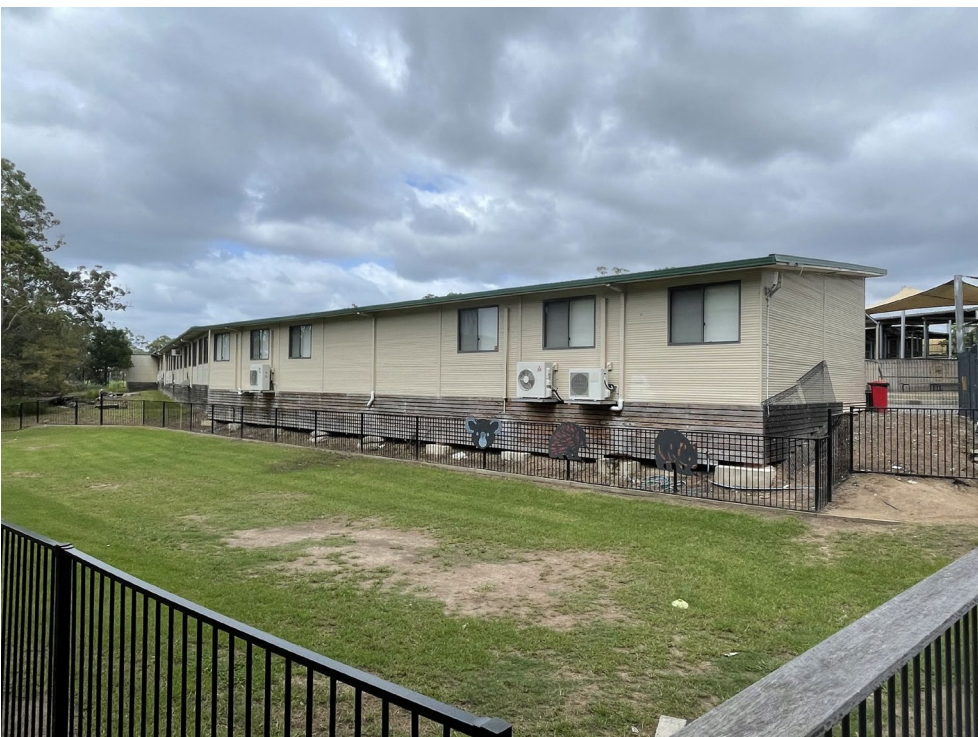
Photo 11: Overview of the eastern portion of the site and the primary school buildings present. The damaged boardwalk structure is present in the distance. Looking southwest.
