**Geotechnical Assessment**

**Manning Rise Development**

**Marie Avenue, Kolodong**

Report No. RGS02310.1-AB\_Rev1

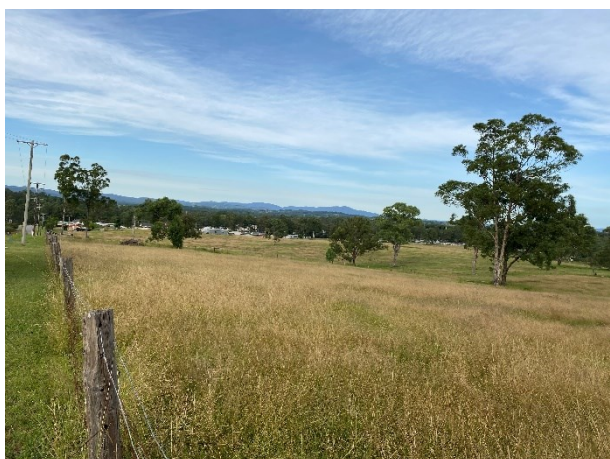
*Looking south west from north east corner of the site on Marie Avenue. This area of the site slopes at 5° to 6° towards the south west*

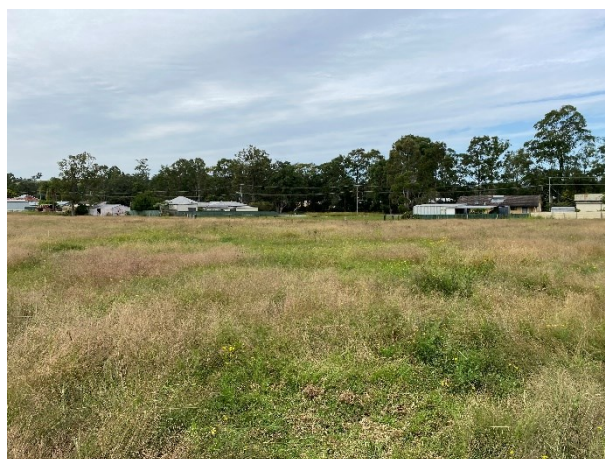
*Looking west from TP107 showing the higher central part of site slopes at 2° to 3°*

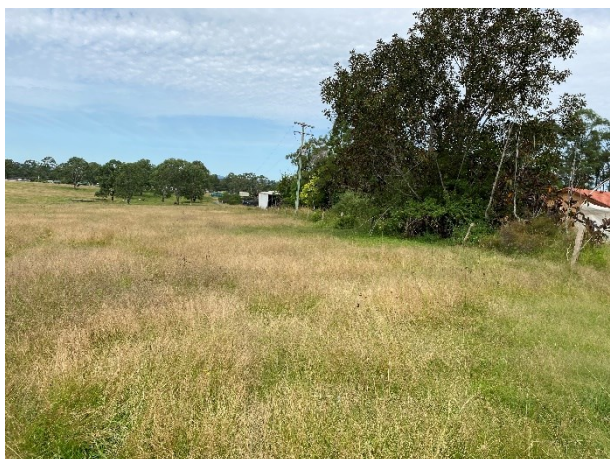
*Looking south from TP111 showing the western boundary of the site. This area slopes at 3° to 5°*

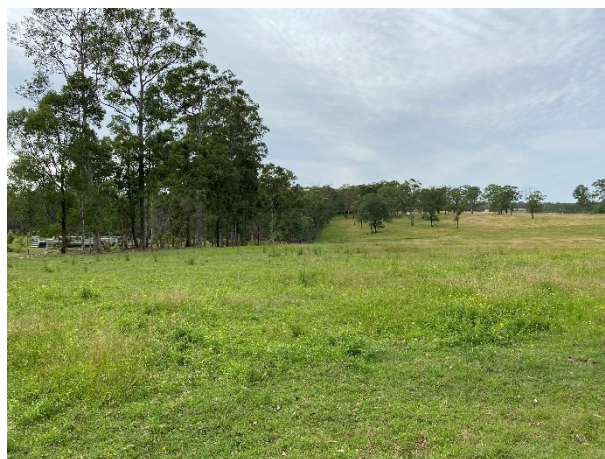
*Looking east from the north west corner of the site. This area slopes at 3° to 5° towards the south east*

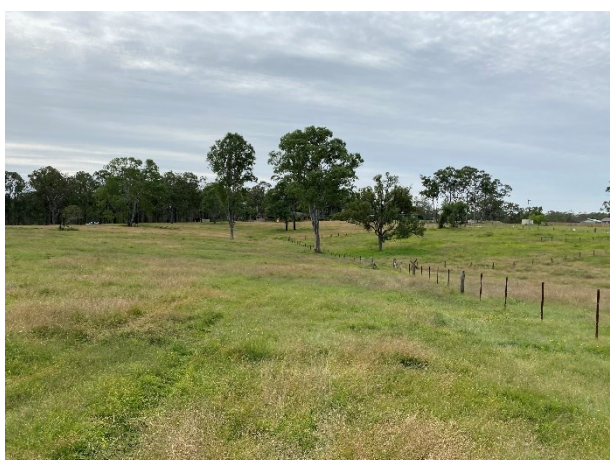
*Looking towards north east from TP103. This area slopes at 3° to 4° towards east and south east*
