# Proposed Residential Development for 38 Stockton and 8A Tomaree Steet, Nelson Bay

## Unexpected Finds Protocol

**Report reference number: 754-NTLGE368007-AD**

**COHO Property**  
49 Stockton Street  
Nelson Bay  
NSW 2315

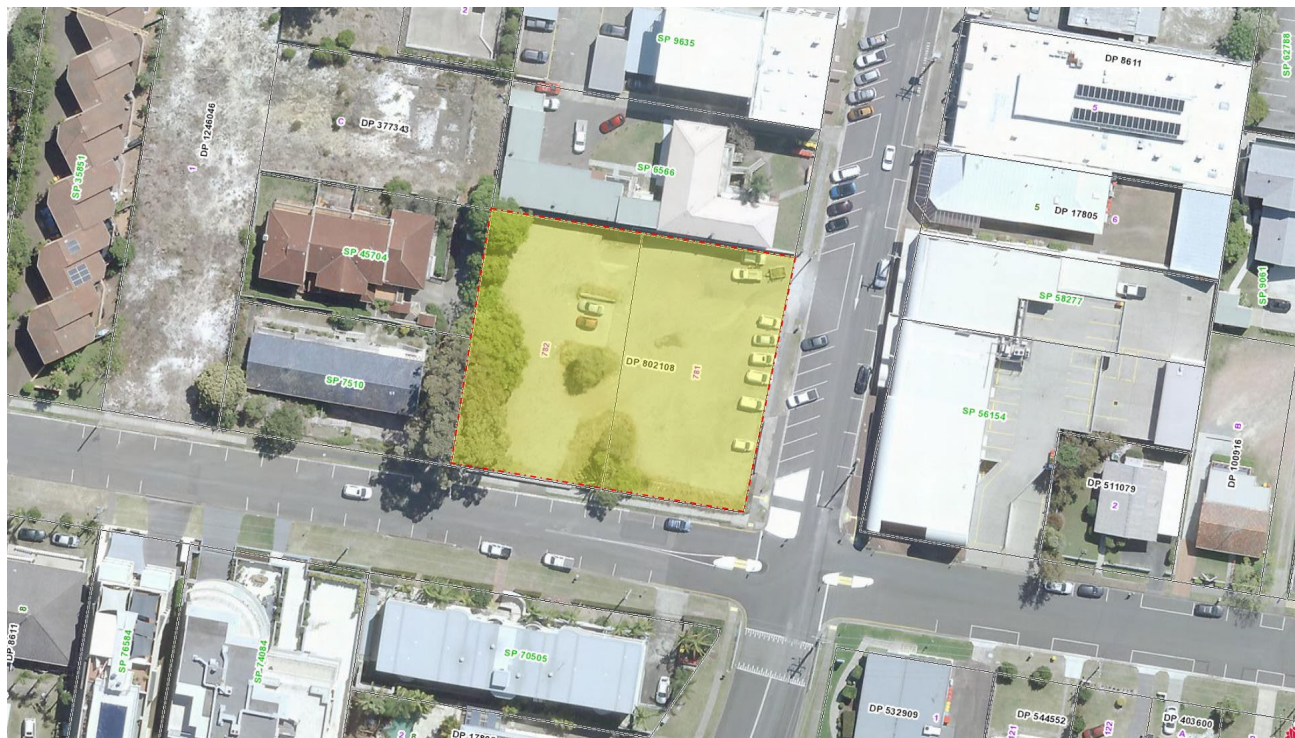
**Figure 1-1: Location and Current Layout of the Site (bound in red and shaded yellow) (Six Maps Imagery, September 2024)**

Tetra Tech Coffey Pty Ltd. (Tetra Tech) was engaged by COHO Property Pty Ltd. (COHO) to undertake a contamination assessment review and prepare a Environmental Site Assessment (ESA) report which considers the suitability of land, with respect to contamination, located at 38 Stockton Street and 8A Tomaree Street, Nelson Bay NSW 2315 (Lot 781 and Lot 782 DP 802108) (the Site) for a proposed residential development. The location and current layout of the Site are shown in Figure 1-1.

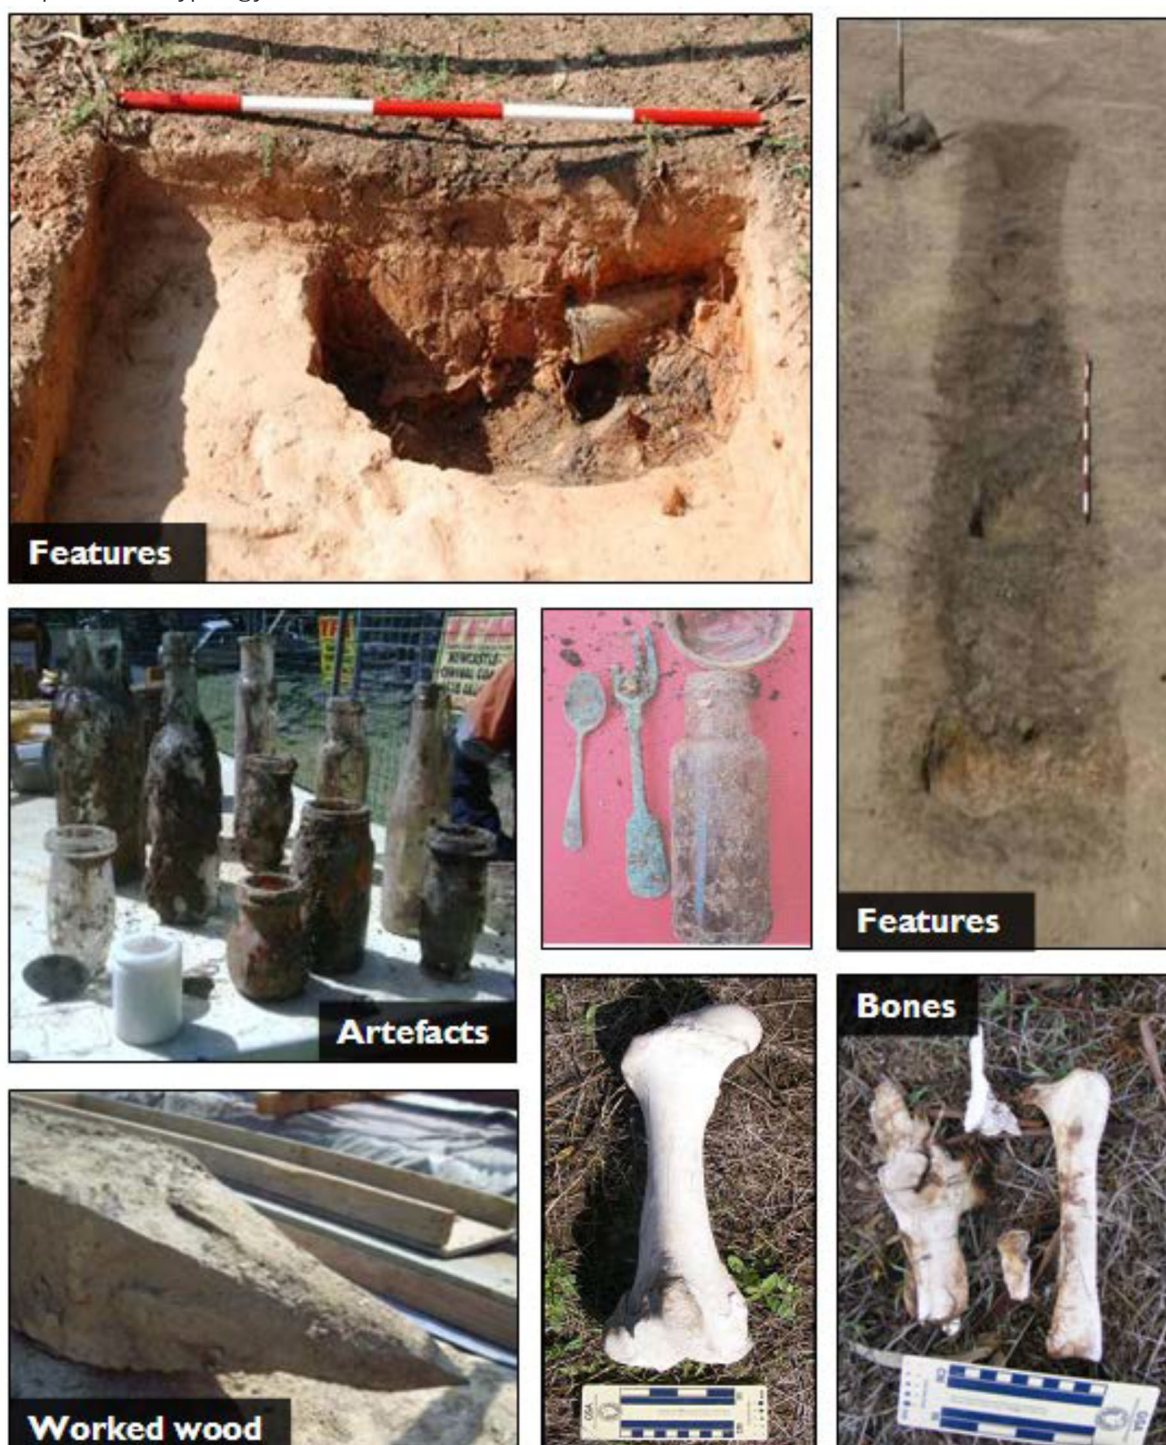
**Figures:** Top left hand picture continuing clockwise: stock camp remnants (Hume Highway Bypass at Tarcutta); linear archaeological feature with post holes (Hume Highway Duplication), animal bones (Hume Highway Bypass at Woomargama); cut wooden stake; glass jars, bottles, spoon and fork recovered from refuse pit associated with a Newcastle Hotel (Pacific Highway, Adamstown Heights, Newcastle area).

The following images can be used to assist in the preliminary identification of potential unexpected items (both Aboriginal and non-Aboriginal) during construction and maintenance works. Please note this is not a comprehensive typology.

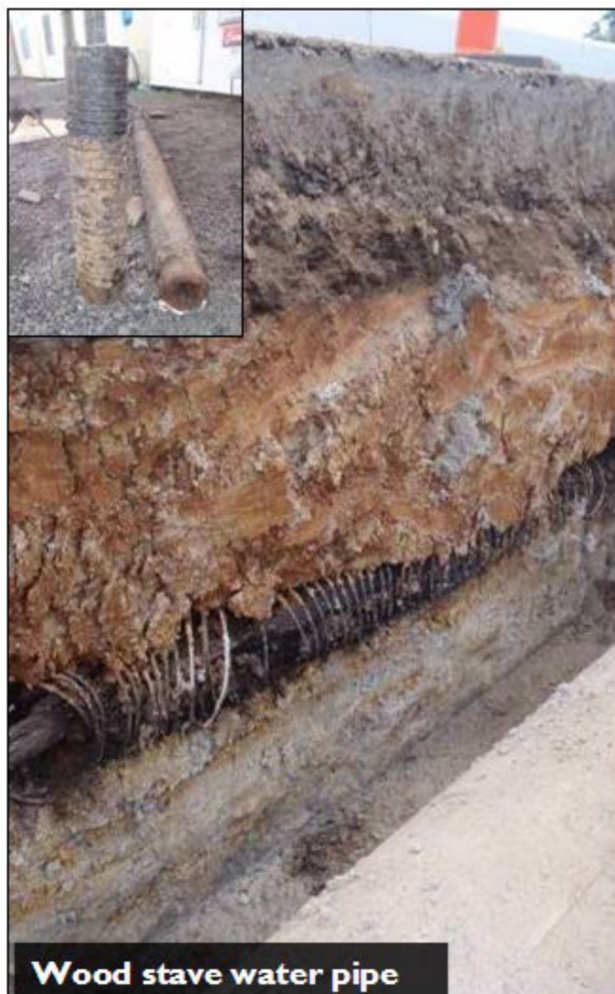
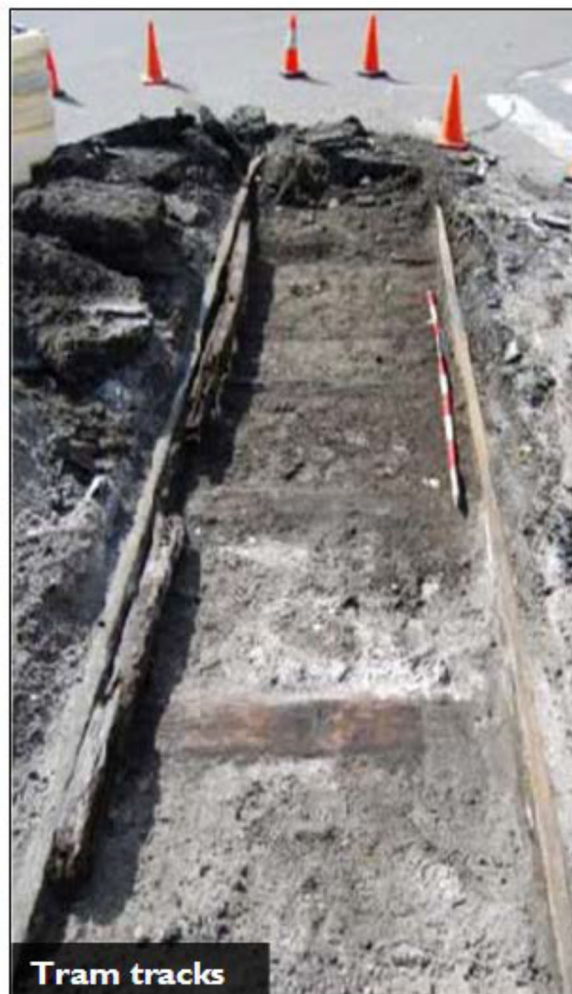
**Figures:** Top left hand picture continuing clockwise: woodstave water pipe with tar and wire sealing (Horsley drive); tram tracks (Sydney); brick lined cistern (Clyde); retaining wall (Great Western Highway, Leura).

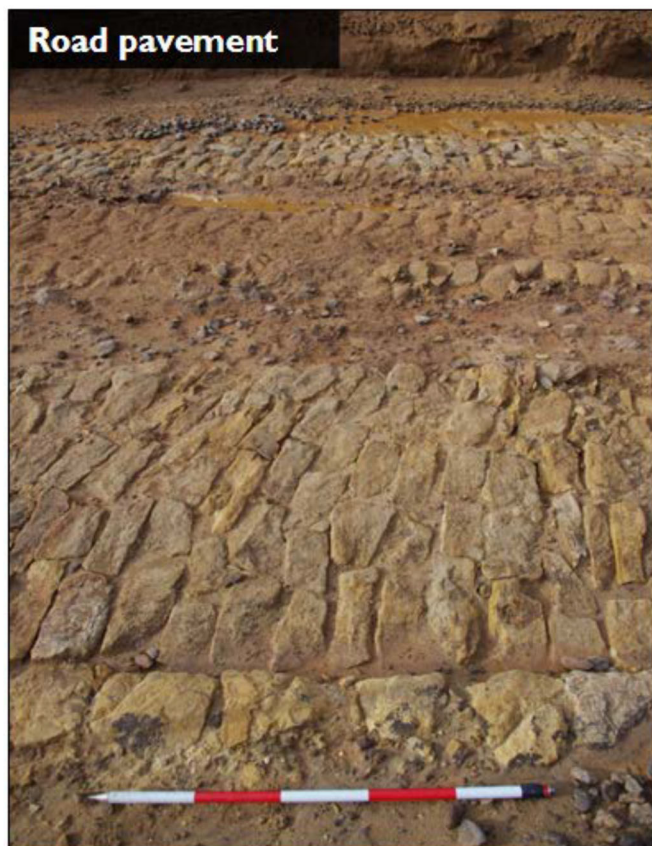
**Figures:** Top left-hand picture continuing clockwise: road pavement (Great Western Highway, Lawson); sandstone kerbing (Parramatta Road, Mays Hill); Telford sandstone road base (Great Western Highway, Leura); ceramic conduit and sandstone culvert headwall (Blue Mountains, NSW); corduroy timber road base (Entrance Road, Wamberal).

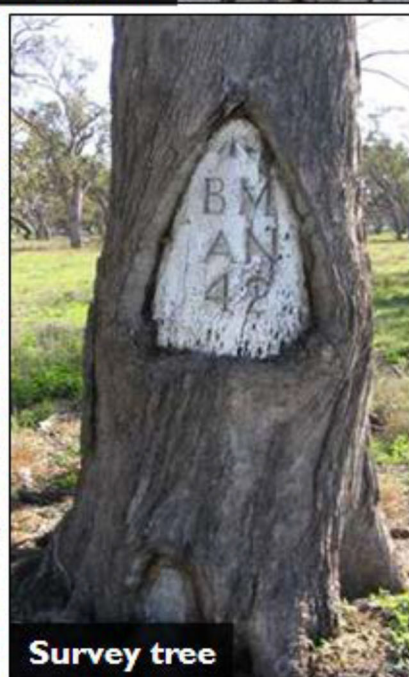
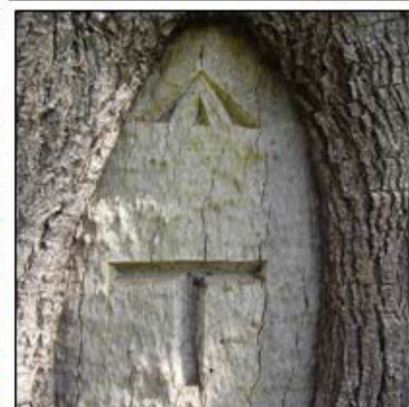
**Figures:** Top left-hand corner continuing clockwise: alignment pin (Great Western Highway, Wentworth Falls); survey tree (MR7, Albury); survey tree (Kidman Way, Darlington Point, Murrumbidgee); survey tree (Cobb Highway, Deniliquin); milestone (Great Western Highway, Kingswood, Penrith); alignment stone (near Guntawong Road, Riverstone). Please note survey marks may have additional statutory protection under the *Surveying and Spatial Information Act 2002*.

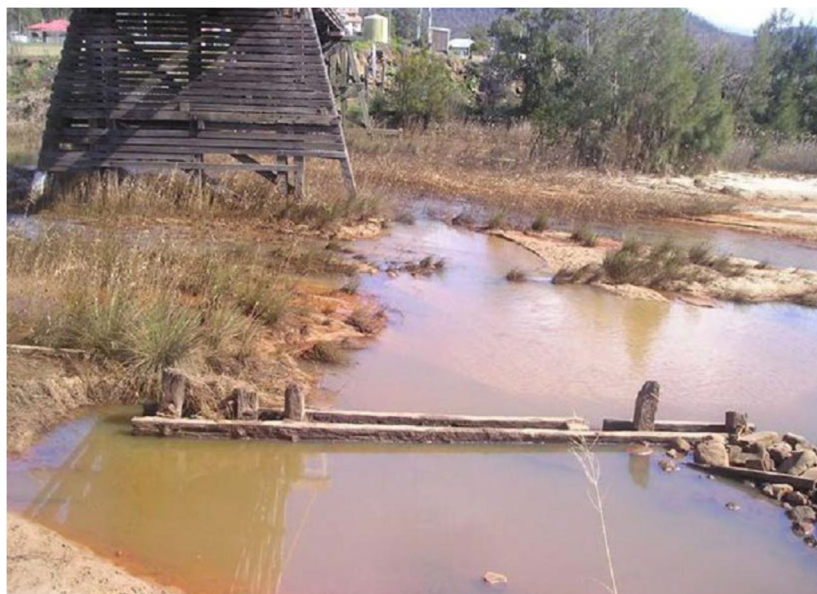
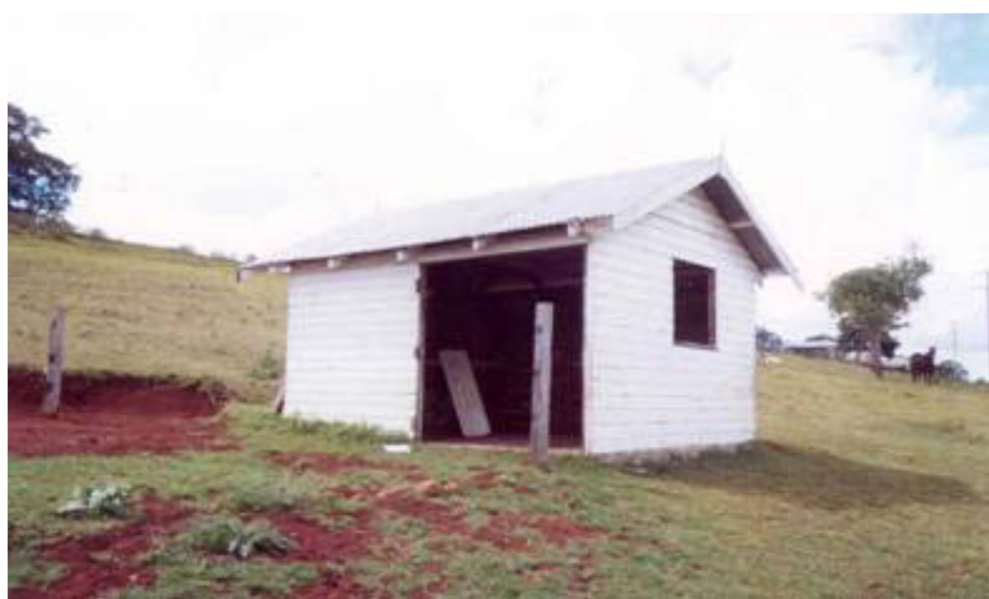
**Figures:** Top left-hand corner continuing clockwise: remnant bridge piers (Putty Road, Bulga); wooden boundary fence (Campbelltown Road, Denham Court); dairy shed (Ballina); *Golden Arrow Mine Shaft Act 2002*.

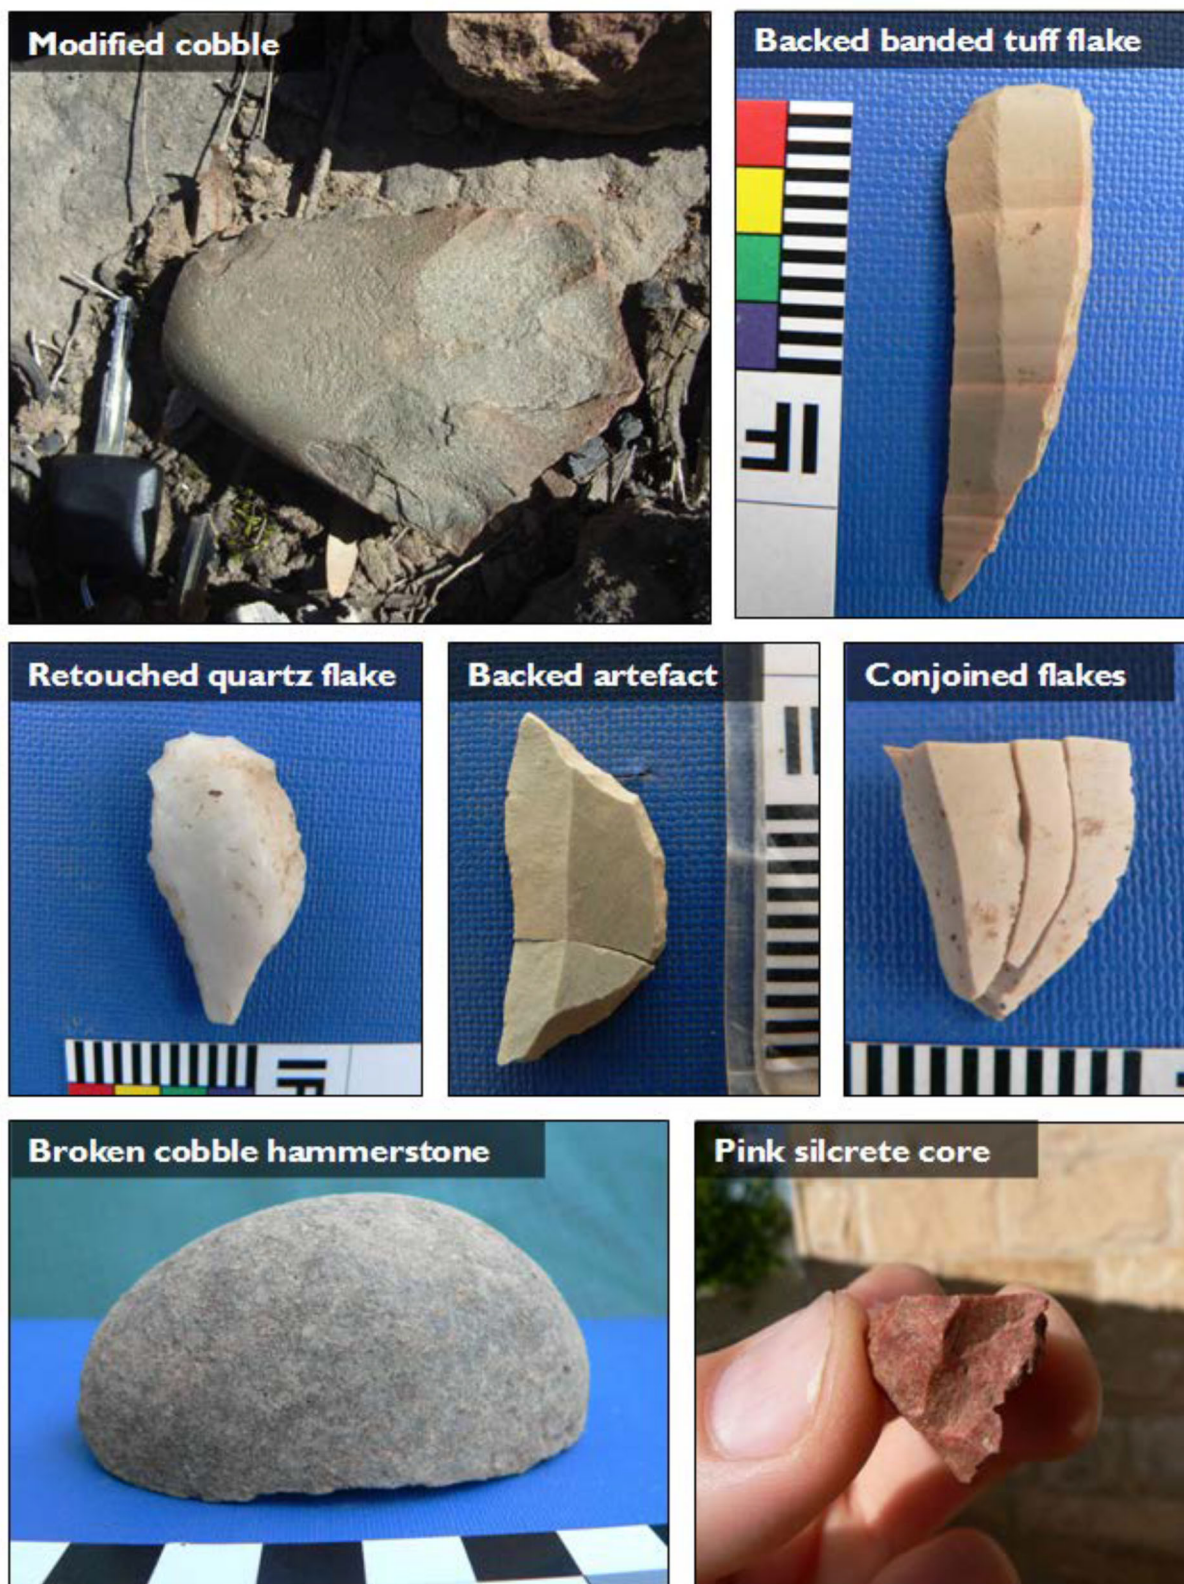
**Figures:** Top left-hand corner: culturally-modified stone discovered on Main Road 92, about two kilometres west of Sassafras. The remaining images show a selection of stone artefacts retrieved from test and salvage archaeological excavations during the Hume Highway Duplication and Bypass projects from 2006-2010

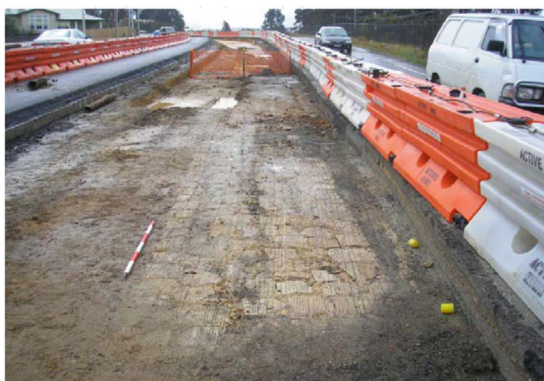
**Figure 1:** Telford road uncovered on the Great Western Highway (Leura) in 2008.

It is important to take a general photograph (Figure 1) to convey the location and setting of the item. This will add much value to the subsequent detailed photographs also required (Figure 2).

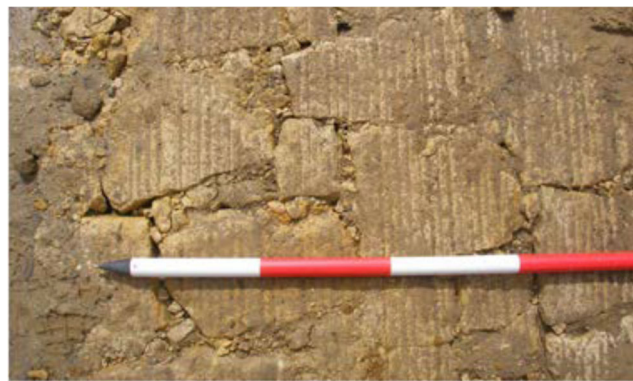
**Figure 4:** Close up detail of the sandstone surface showing material type, formation and construction detail. This is essential for establishing date of the feature.

Where unexpected items have a distinguishing feature, close-up detailed photographs must be taken of this, where practicable. In the case of a building or bridge, this may include diagnostic details architectural or technical features. See Figures 3 and 4 as examples.

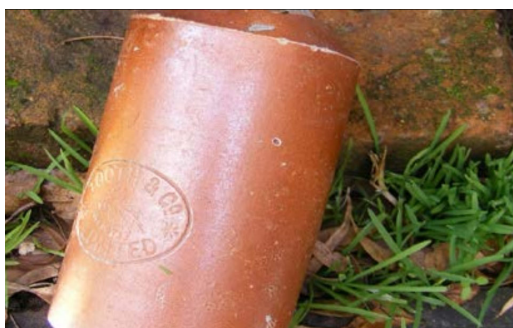
**Figure 3:** Ceramic bottle artefact with stamp.

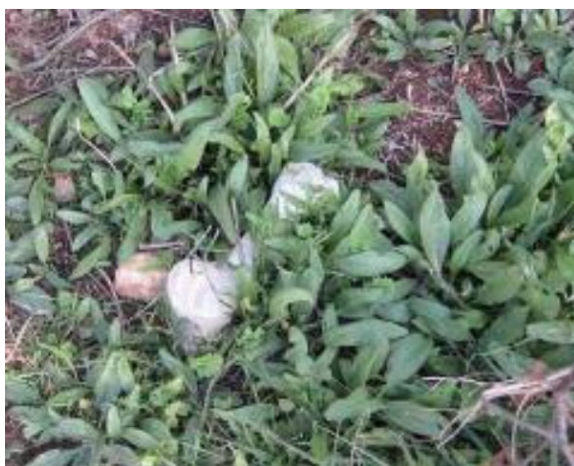
**Figure 5:** Bone concealed by foliage.

Ensure that photographs of bones are not concealed by foliage (Figure 5) as this makes it difficult to identify. Minor hand removal of foliage can be undertaken as long as disturbance of the bone does not occur. Excavation of the ground to remove bone(s) should not occur, nor should they be pulled out of the ground if partially exposed. Where sediment (adhering to a bone found on the ground surface) conceals portions of a bone (Figure 6) ensure the photograph is taken of the bone (if any) that is not concealed by sediment.

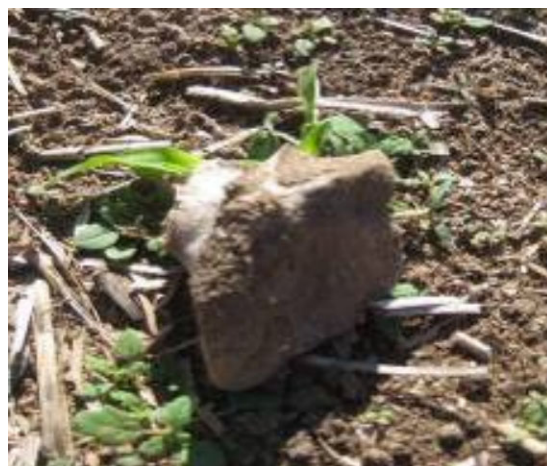
**Figure 6:** Bone covered in sediment.

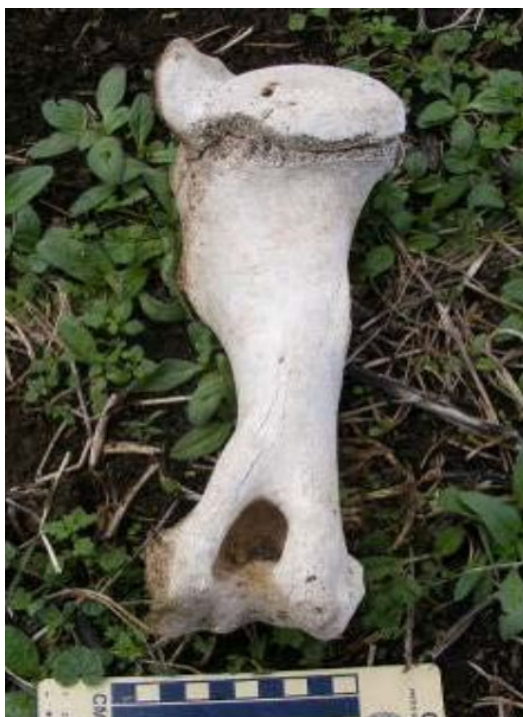
**Figure 7:** Photograph showing complete bone.

Ensure that all close-up photographs include the whole bone and then specific details of the bone (especially the ends of long bones, the epiphysis, which is critical for species identification). Figures 7 and 8 are examples of good photographs of bones that can easily be identified from the photograph alone. They show sufficient detail of the complete bone and the epiphysis.

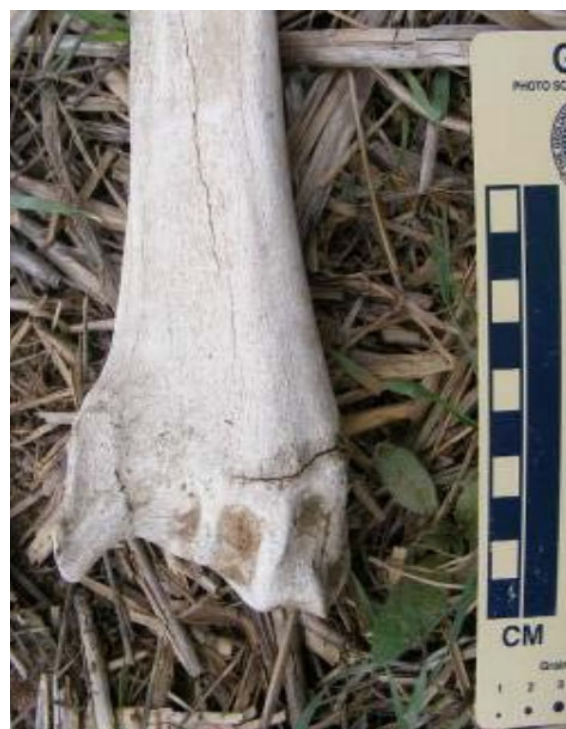
**Figure 8:** Close up of a long bone's epiphysis.

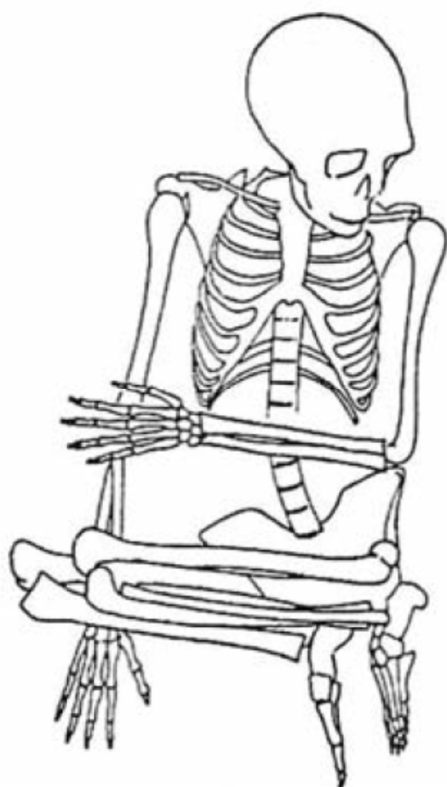
Figure 1: Schematic of complete skeleton that is obviously human<sup>11</sup>.

On the very rare occasion where it is instantly obvious from the remains that they are human, the Project Manager (or a delegate) should **inform the police by telephone** prior to seeking specialist advice. It will be obvious that it is human skeletal remains where there is no doubt, as demonstrated by the example in Figure 1. Often skeletal elements in isolation (such as a skull) can also clearly be identified as human. Note it may also be obvious that human remains have been uncovered when soft tissue and clothing are present.

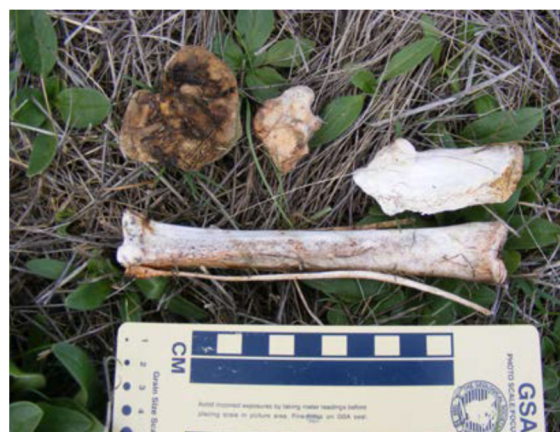
Figure 2: Disarticulated bones that require assessment to determine species.

Where it is not 'obvious' that the bones are human (in the majority of cases, illustrated by Figure 2), specialist assessment is required to establish the species of the bones. Photographs of the bones can assist this assessment if they are clear and taken in accordance with guidance provided in Appendix C. Good photographs often result in the bones being identified by a specialist without requiring a site visit; noting they are nearly
