UPGRADES TO EXISTING RISING SEWER MAINS

*29 ST JOHNS ROAD, JILLIBY, NSW*

*ABORIGINAL ARCHAEOLOGICAL*

*DUE DILIGENCE ASSESSMENT*

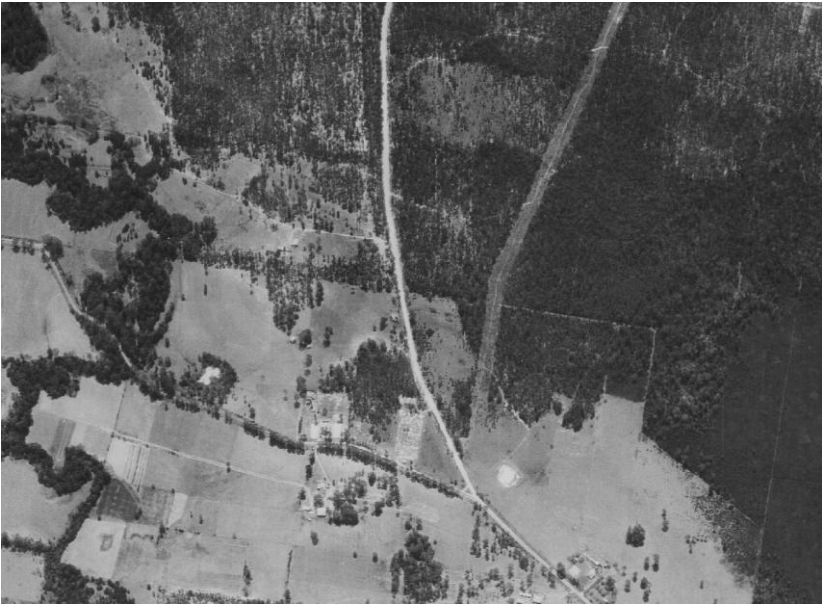
| Date and image | Notes |
|---|---|
| <p><i>Plate 1: Northern section of the project area, 1966</i></p> | <ul style="list-style-type: none"> <li>• There is much remnant bushland in the east, intersected by roads and easements</li> <li>• Hue Hue Road is already established</li> <li>• The cemetery is visible between the intersection of Hue Hue Road and Watagan Forest Road</li> <li>• Some built structures are present</li> </ul> |

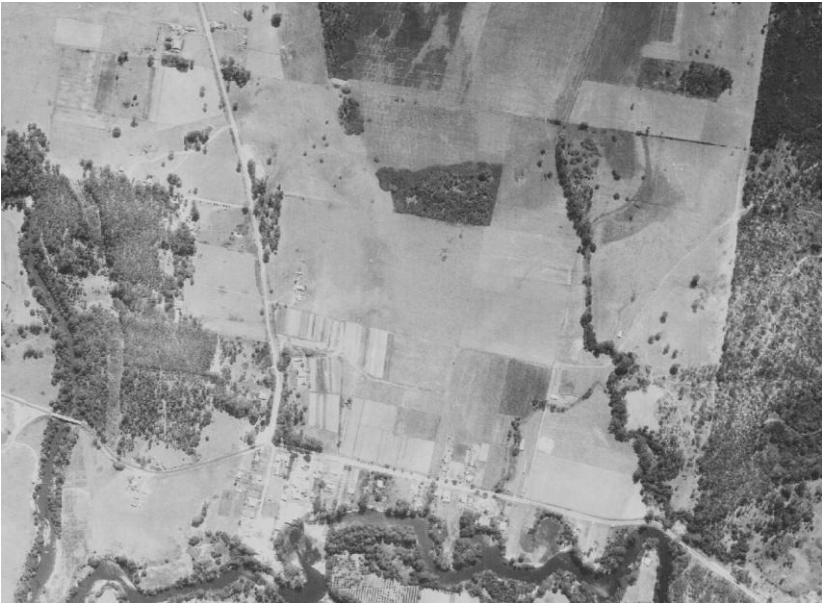
| Date and image | Notes |
|---|---|
| <p><i>Plate 2: Southern section of the project area, 1966</i></p> | <ul style="list-style-type: none"> <li>• Most of this southern area has been used for agriculture, in close proximity to the Wyong River</li> <li>• Hue Hue Road is established</li> <li>• Alison Road is established</li> <li>• Remnant bush is predominately concentrated along waterways</li> <li>• Some built structures are present</li> </ul> |

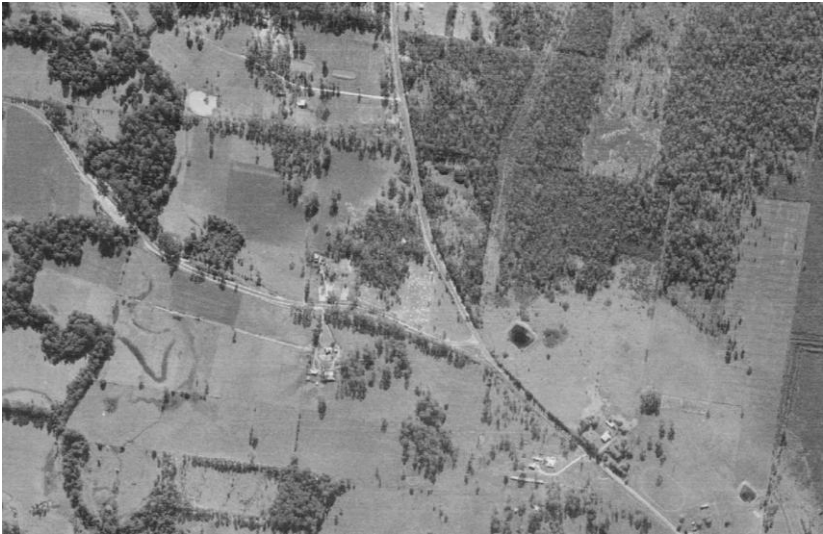
| Date and image | Notes |
|---|---|
| <div> <p>Plate 3: Northern section of the project area, 1976</p> </div> | <ul style="list-style-type: none"> <li>• Minor changes in the bushland in the east, intersected by roads and easements</li> <li>• The cemetery is visible between the intersection of Hue Hue Road and Watagan Forest Road</li> <li>• Some additional built structures are present in the north-west</li> </ul> |

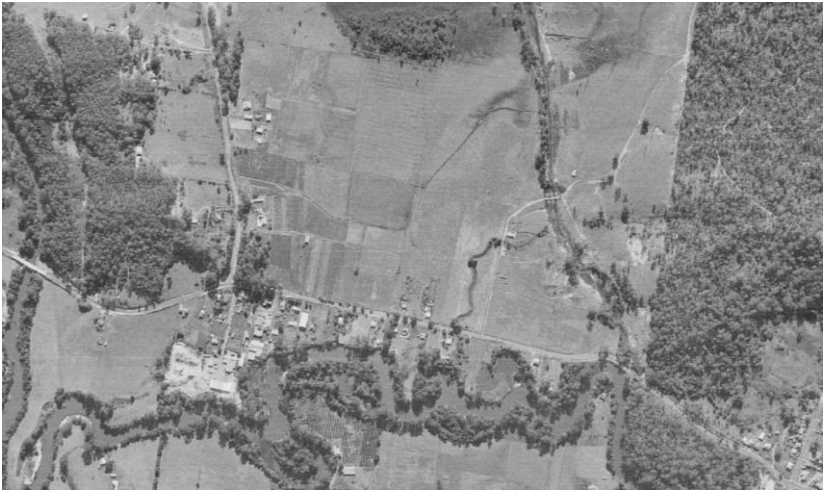
| Date and image | Notes |
|---|---|
| <div> <p>Plate 4: Southern section of the project area, 1976</p> </div> | <ul style="list-style-type: none"> <li>• Minimal changes are evident between 1966 and 1976</li> <li>• Some additional built structures are present in the south-east</li> </ul> |

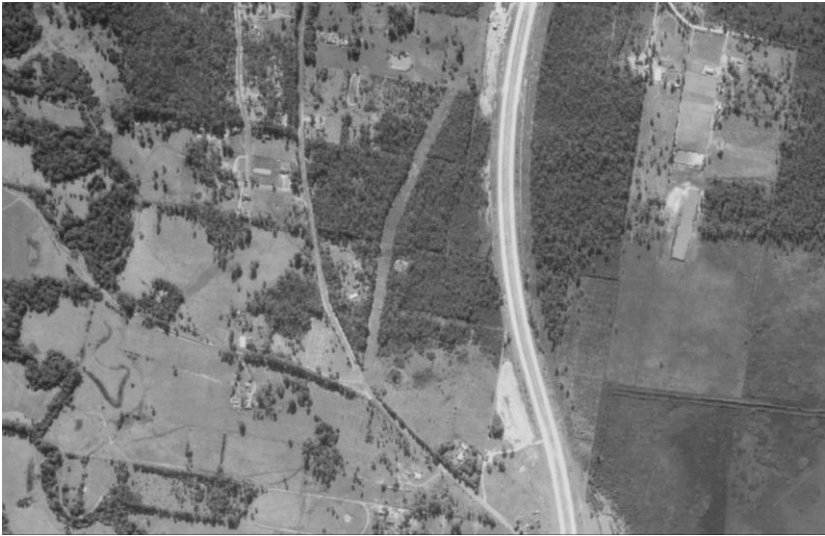
| Date and image | Notes |
|---|---|
| <p><i>Plate 5: Northern section of the project area, 1984</i></p> | <ul style="list-style-type: none"> <li>• The most noticeable change is the construction of the Pacific Motorway (M1)</li> <li>• Changes in the bushland in the east are also evident with modified bodies of water</li> </ul> |

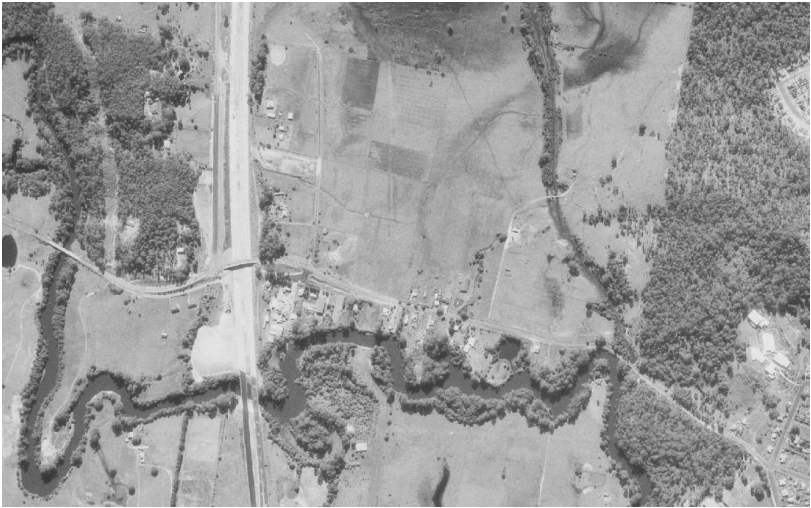
| Date and image | Notes |
|---|---|
| <p><i>Plate 6: Southern section of the project area, 1984</i></p> | <ul style="list-style-type: none"> <li>• The most noticeable change is the construction of the Pacific Motorway (M1) and the bridge over the Wyong River</li> <li>• Changes in the bushland in the east are also evident with modified bodies of water</li> <li>• Additional built structures are present in the south-east</li> </ul> |

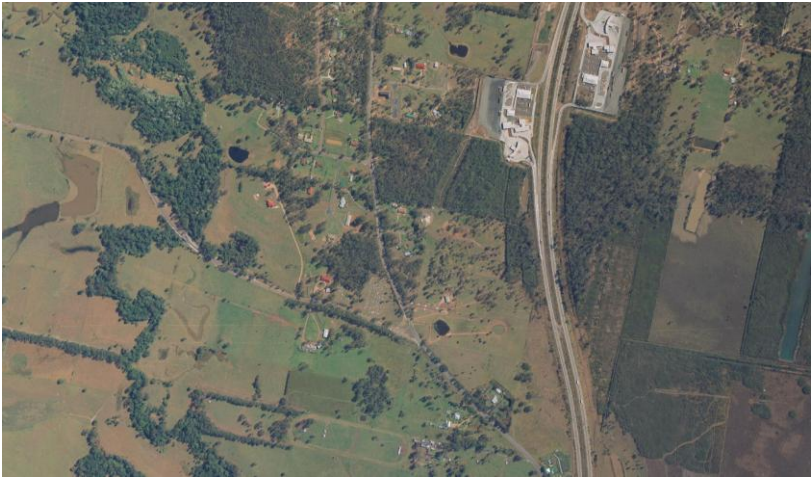
| Date and image | Notes |
|---|---|
| <div> <p>Plate 7: Northern section of the project area, 1994</p> </div> | <ul style="list-style-type: none"> <li>• The most noticeable change is the construction of the Twin Servo (Ampol Wyong Northbound and Southbound service stations)</li> <li>• A reduction in the bushland in the west is also evident</li> <li>• Additional built structures are associated with the vegetation clearance in the west</li> </ul> |

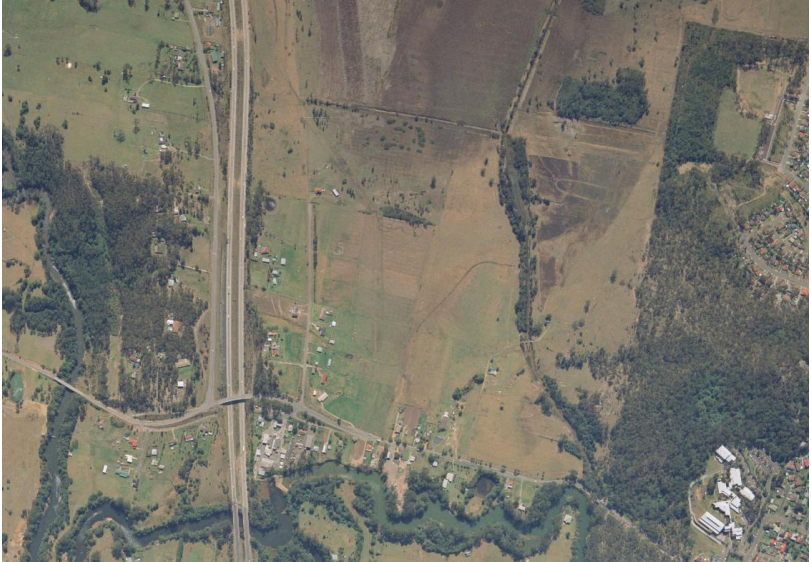
| Date and image | Notes |
|---|---|
| <div> <p>Plate 8: Southern section of the project area, 1994</p> </div> | <ul style="list-style-type: none"> <li>• Changes in the bushland in the west are evident with additional built structures</li> </ul> |

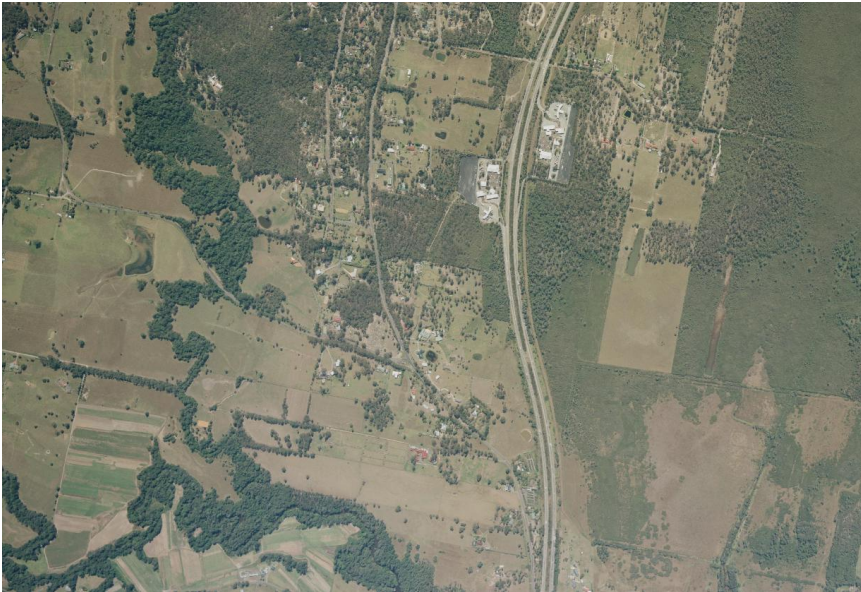
| Date and image | Notes |
|---|---|
| <p><i>Plate 9: Northern section of the project area, 2006</i></p> | <ul style="list-style-type: none"> <li>Minimal changes are evident between 1994 and 2006</li> </ul> |

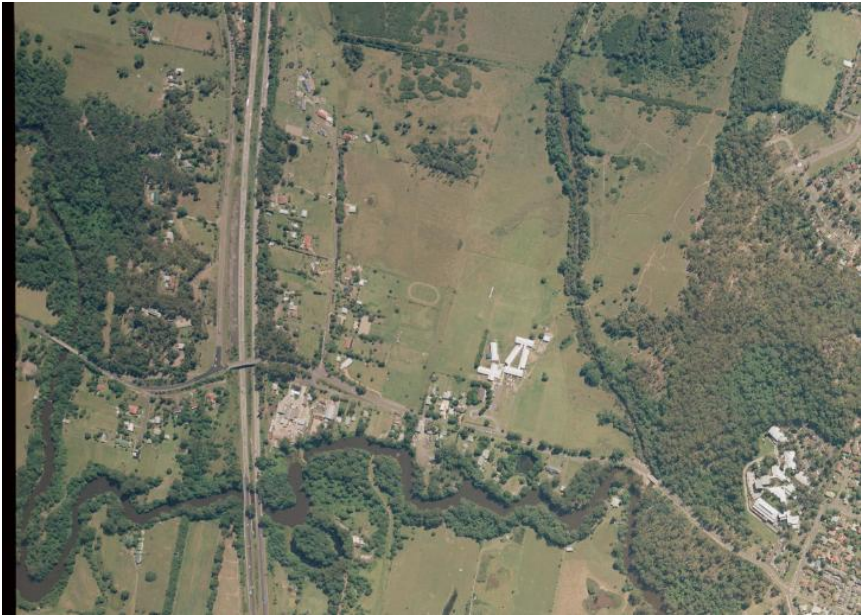
| Date and image | Notes |
|---|---|
| <p><i>Plate 10: Southern section of the project area, 2006</i></p> | <ul style="list-style-type: none"> <li>Some minor revegetation has occurred in the south-west</li> <li>Additional built structures are evident north of Alison Road and east of the Pacific Motorway</li> </ul> |

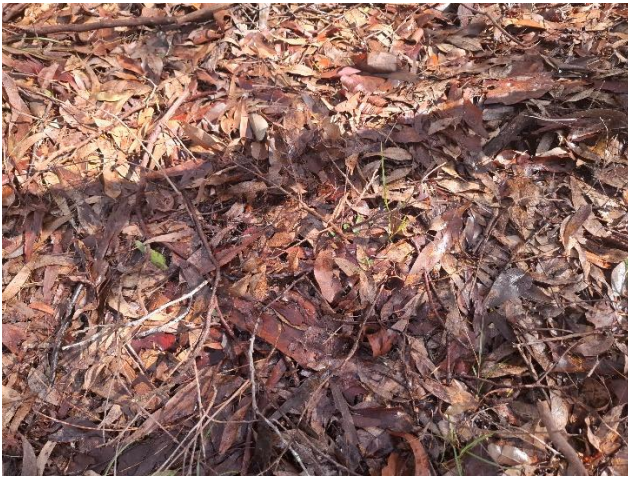
*Plate 11: Low GSV, leaf litter in the northern section*

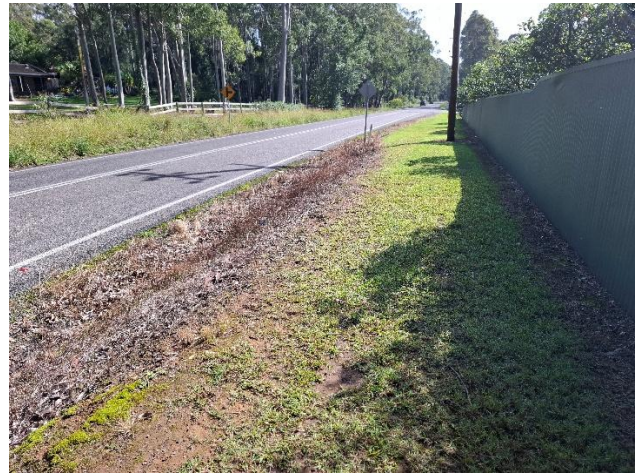
*Plate 12: GSE in the Hue Hue Road easement, view north*

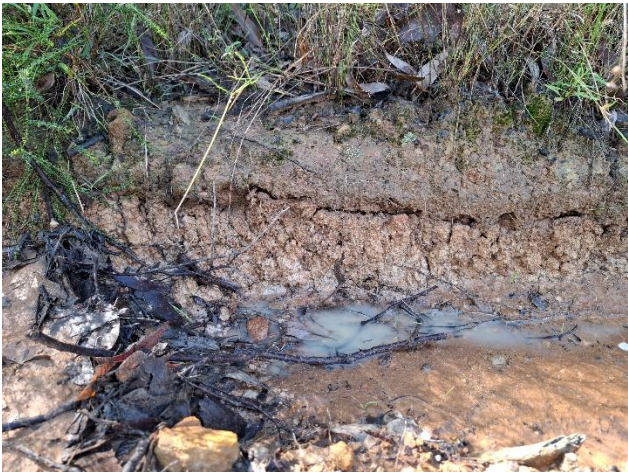
*Plate 13: GSE in northern section revealing clays*

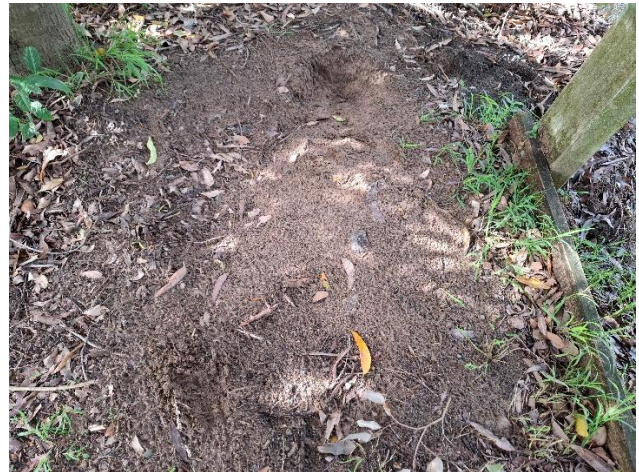
*Plate 14: GSE in southern section revealing sand*

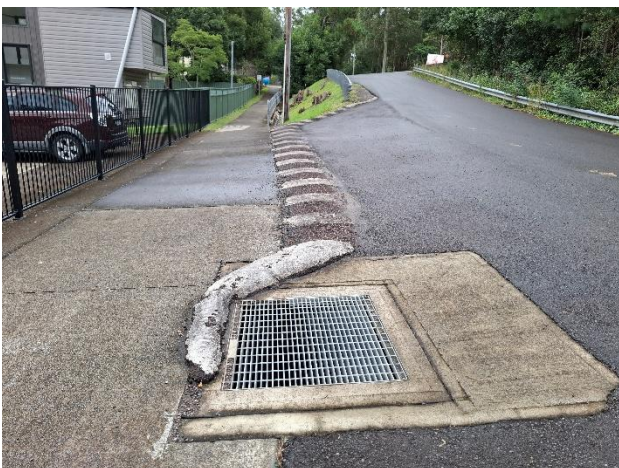
*Plate 15: Example of disturbances and low GSV at Alison Road, view west*

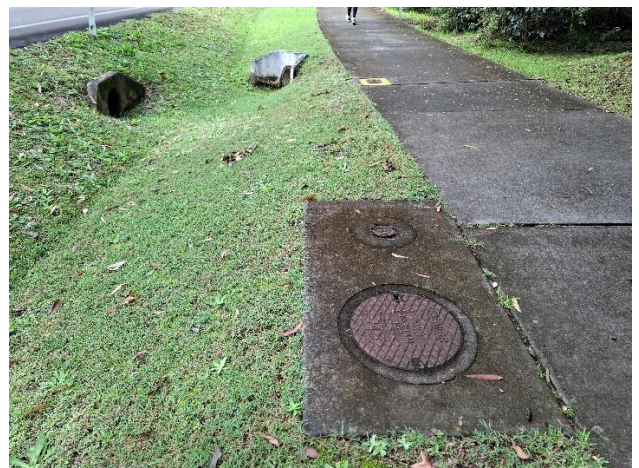
*Plate 16: Sewer access and culverts*

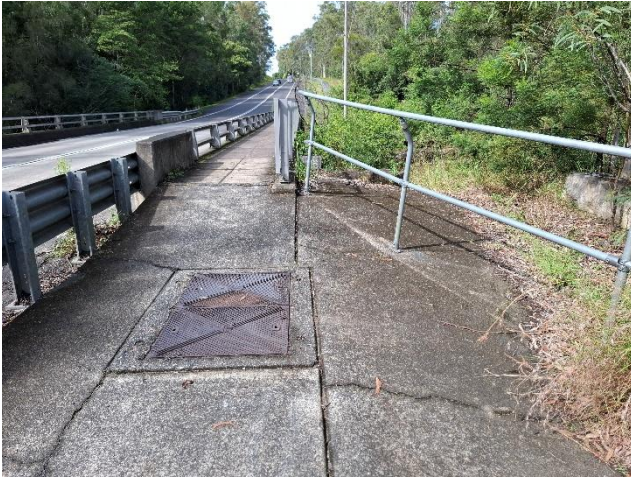
*Plate 17: Porters Creek crossing, low GSV, view east*

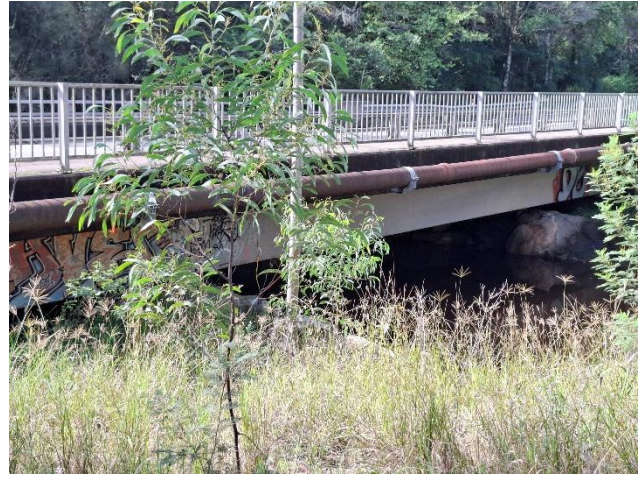
*Plate 18: Porters Creek crossing, disturbances, view northeast*

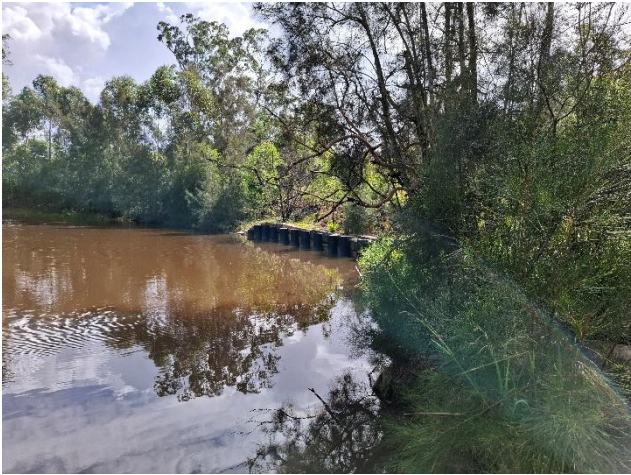
*Plate 19: Trees on the northern bank of the Wyong, view northwest*

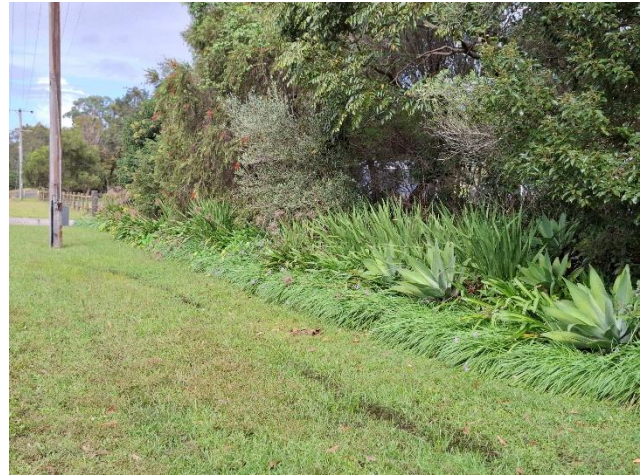
*Plate 20: Endemic garlic chives and nasturtiums*

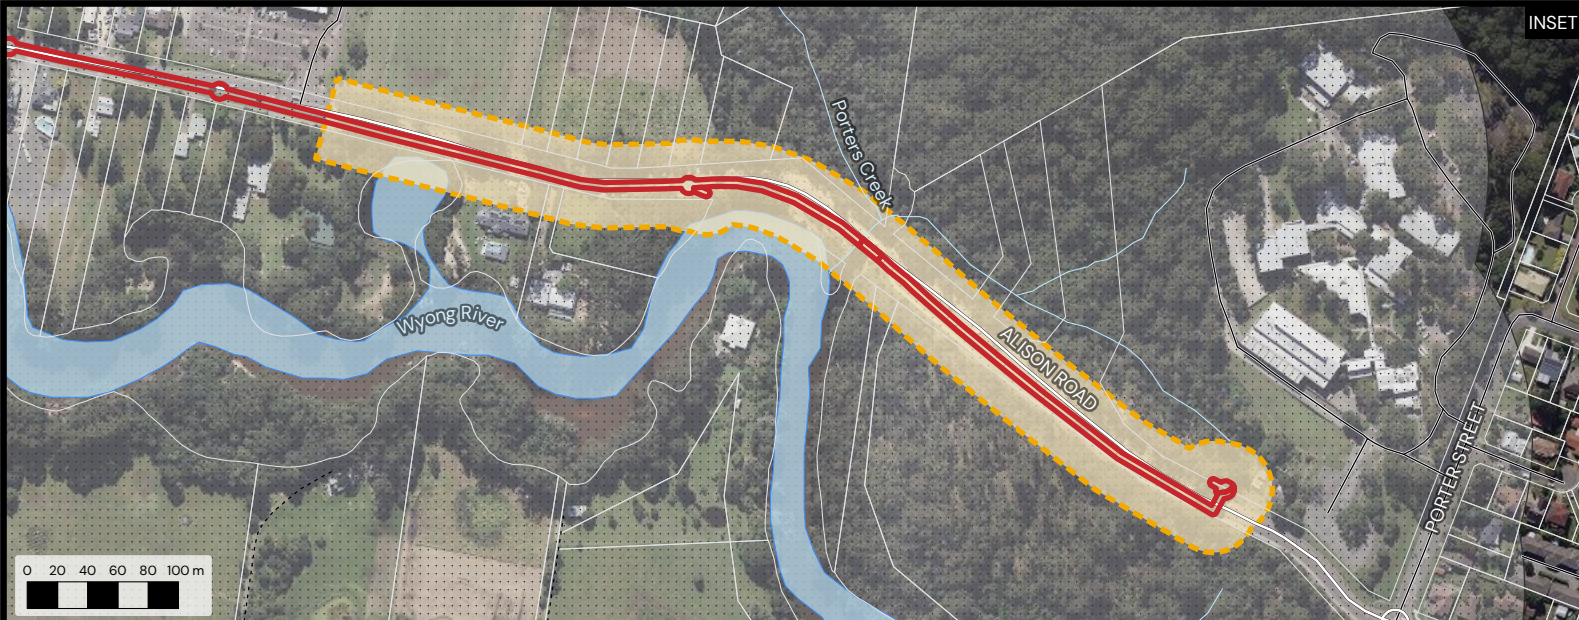
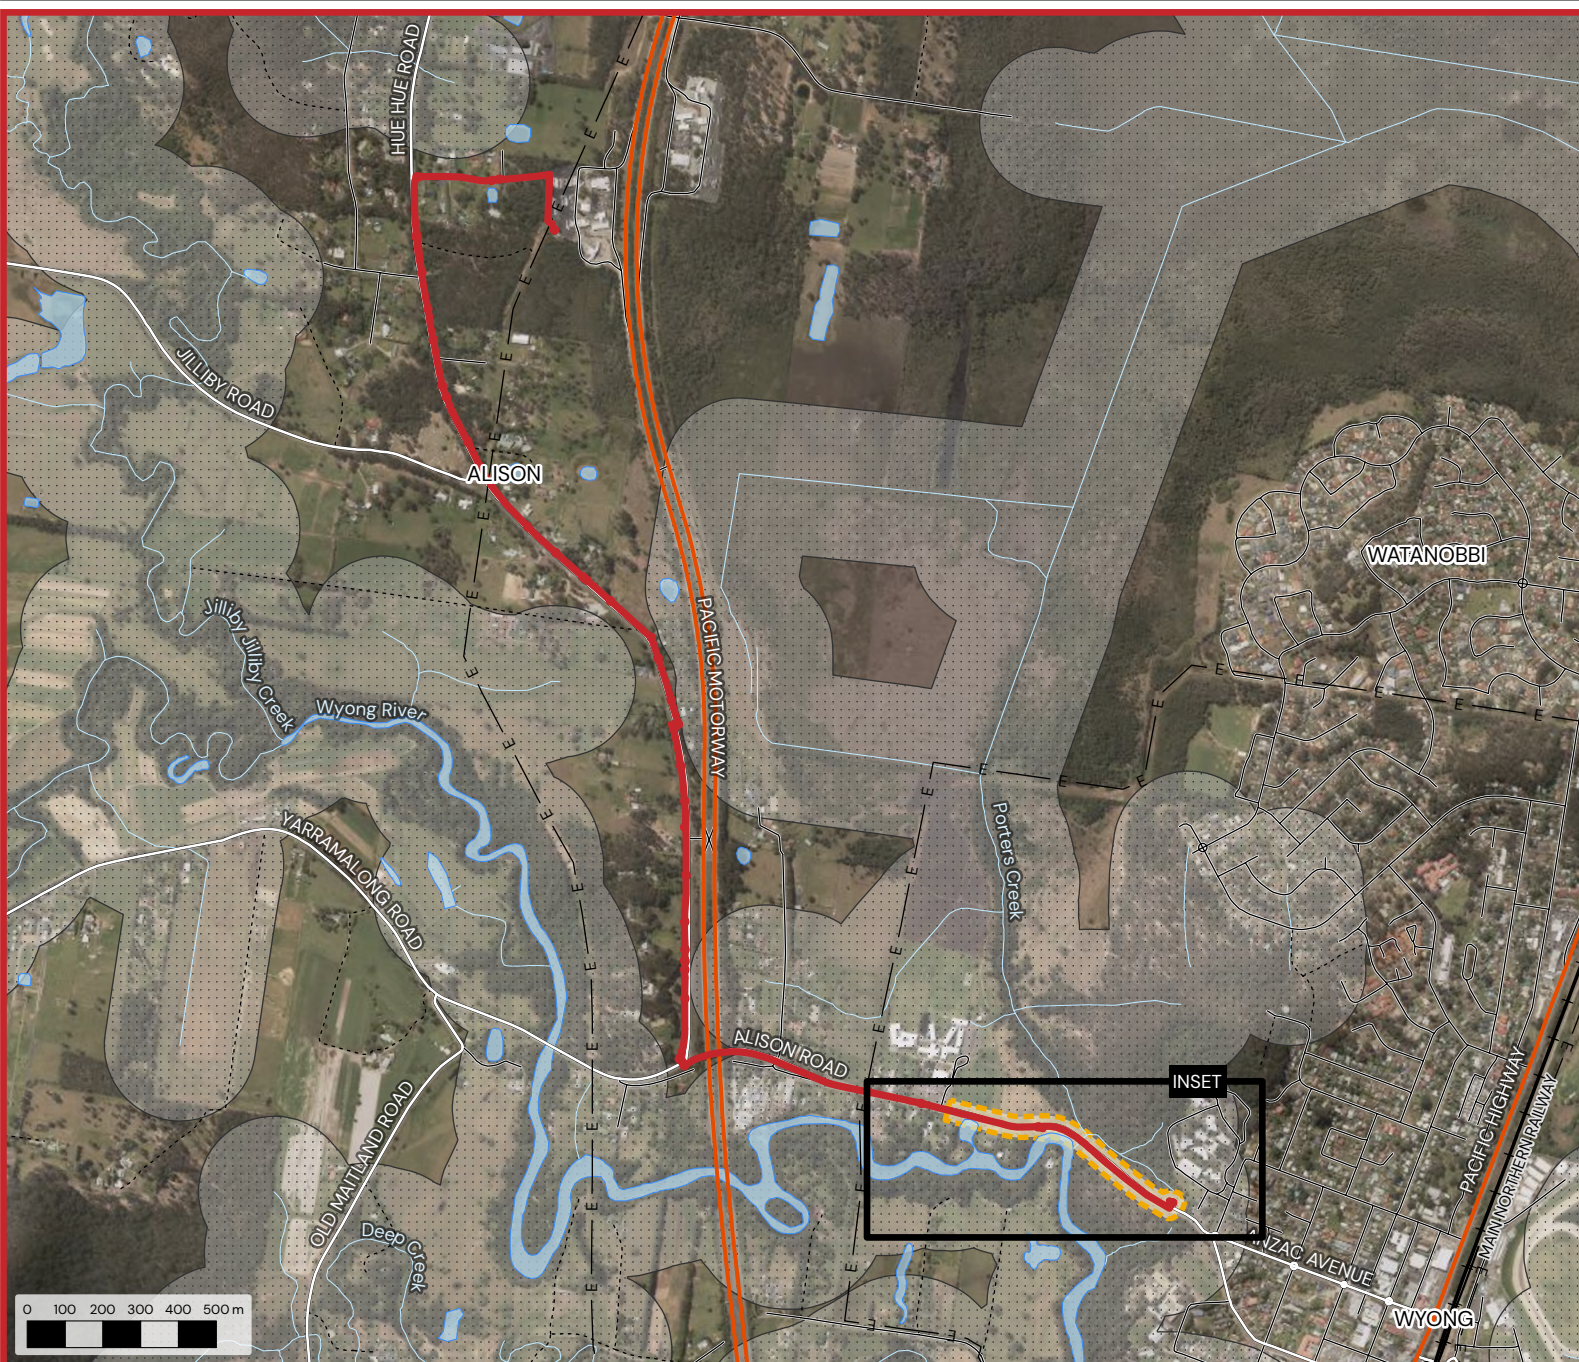
Figure 3 - Survey results

Due to the results of the previous assessments, environmental context and site inspection results, potential for subsurface artefacts is assessed as low in the northern section along Hue Hue Road and still low in the southern section along Alison Road. However, we note that the southern section along Alison Road it is located in a sensitive area for Aboriginal occupation evidence dependent on the extent of previous land use history (Figure 3).

If the proposed works impact footprint was wider than the existing pipeline, further assessment may be needed along Alison Road prior to ground surface disturbance activities (Figure 3).

unknown Aboriginal objects through the majority of the inspected areas. **However, the section of project area located on the bank of the Wyong River is in a sensitive landform is the exception (refer to Figure 3).** If the proposed impact footprint is wider than the existing services, further assessment will be triggered under the Due Diligence Code may be required.

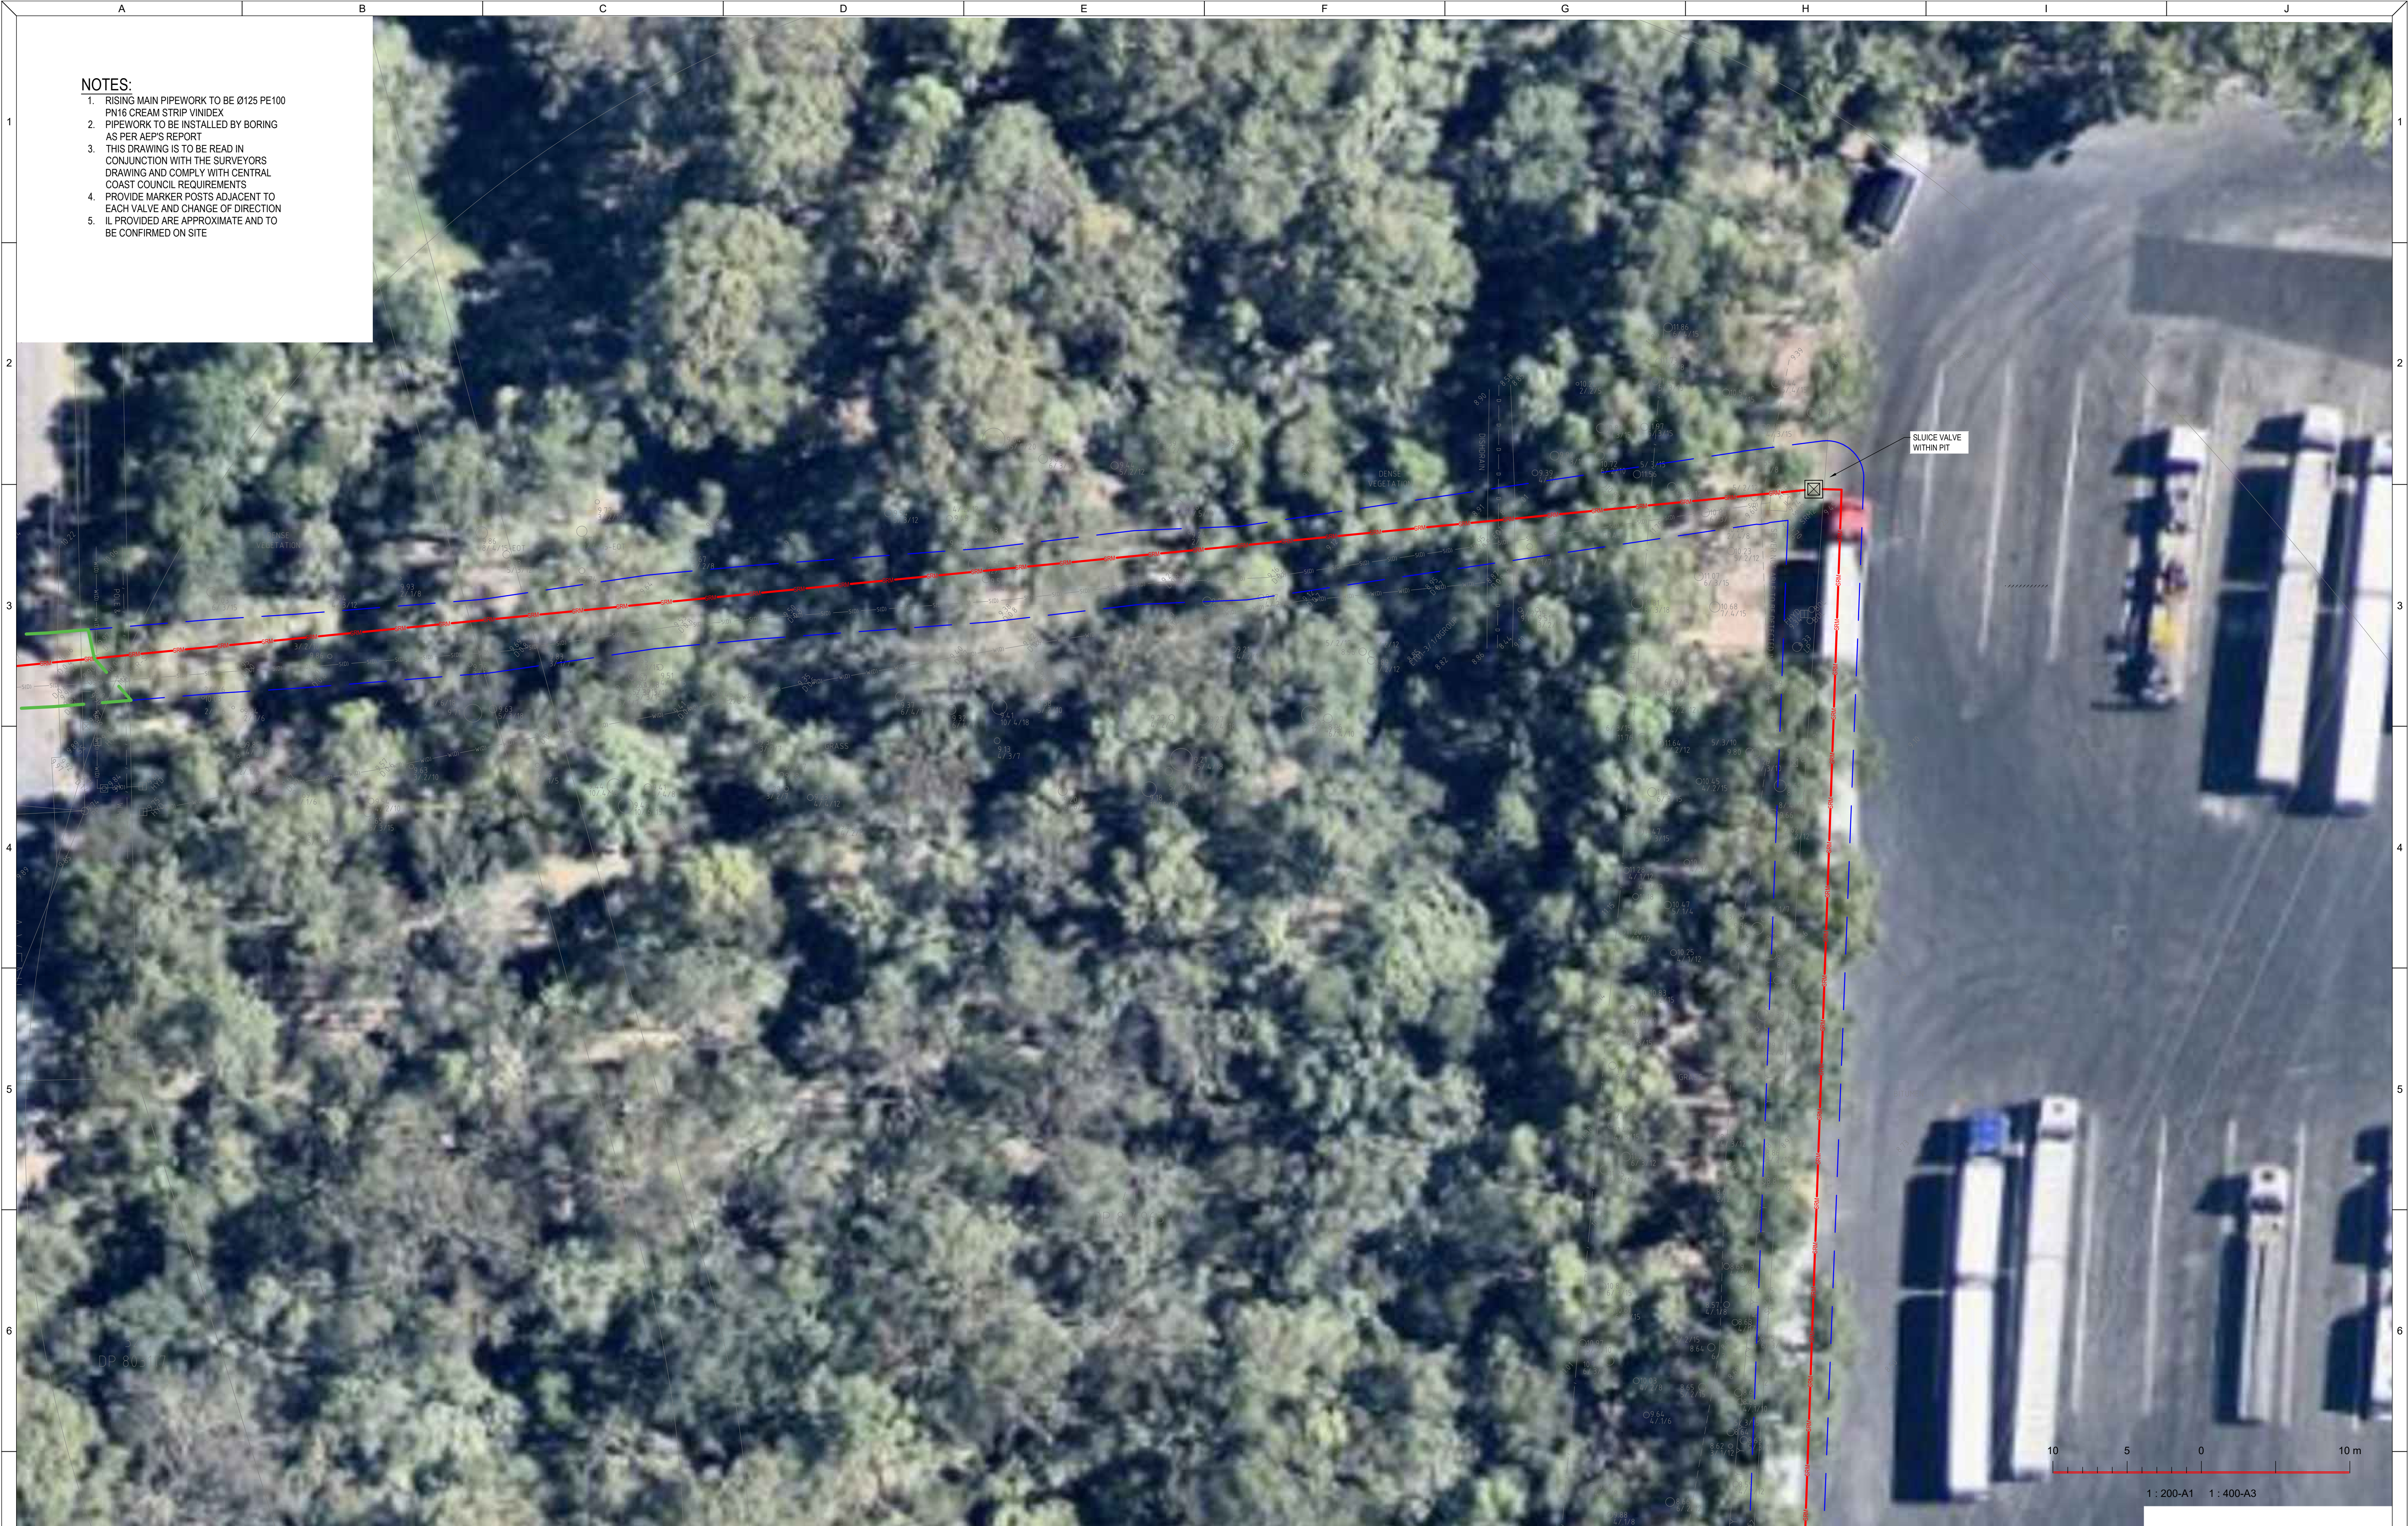
- NOTES:**
1. RISING MAIN PIPEWORK TO BE Ø125 PE100 PN16 CREAM STRIP VINDEX
  2. PIPEWORK TO BE INSTALLED BY BORING AS PER AEP'S REPORT
  3. THIS DRAWING IS TO BE READ IN CONJUNCTION WITH THE SURVEYORS DRAWING AND COMPLY WITH CENTRAL COAST COUNCIL REQUIREMENTS
  4. PROVIDE MARKER POSTS ADJACENT TO EACH VALVE AND CHANGE OF DIRECTION
  5. IL PROVIDED ARE APPROXIMATE AND TO BE CONFIRMED ON SITE

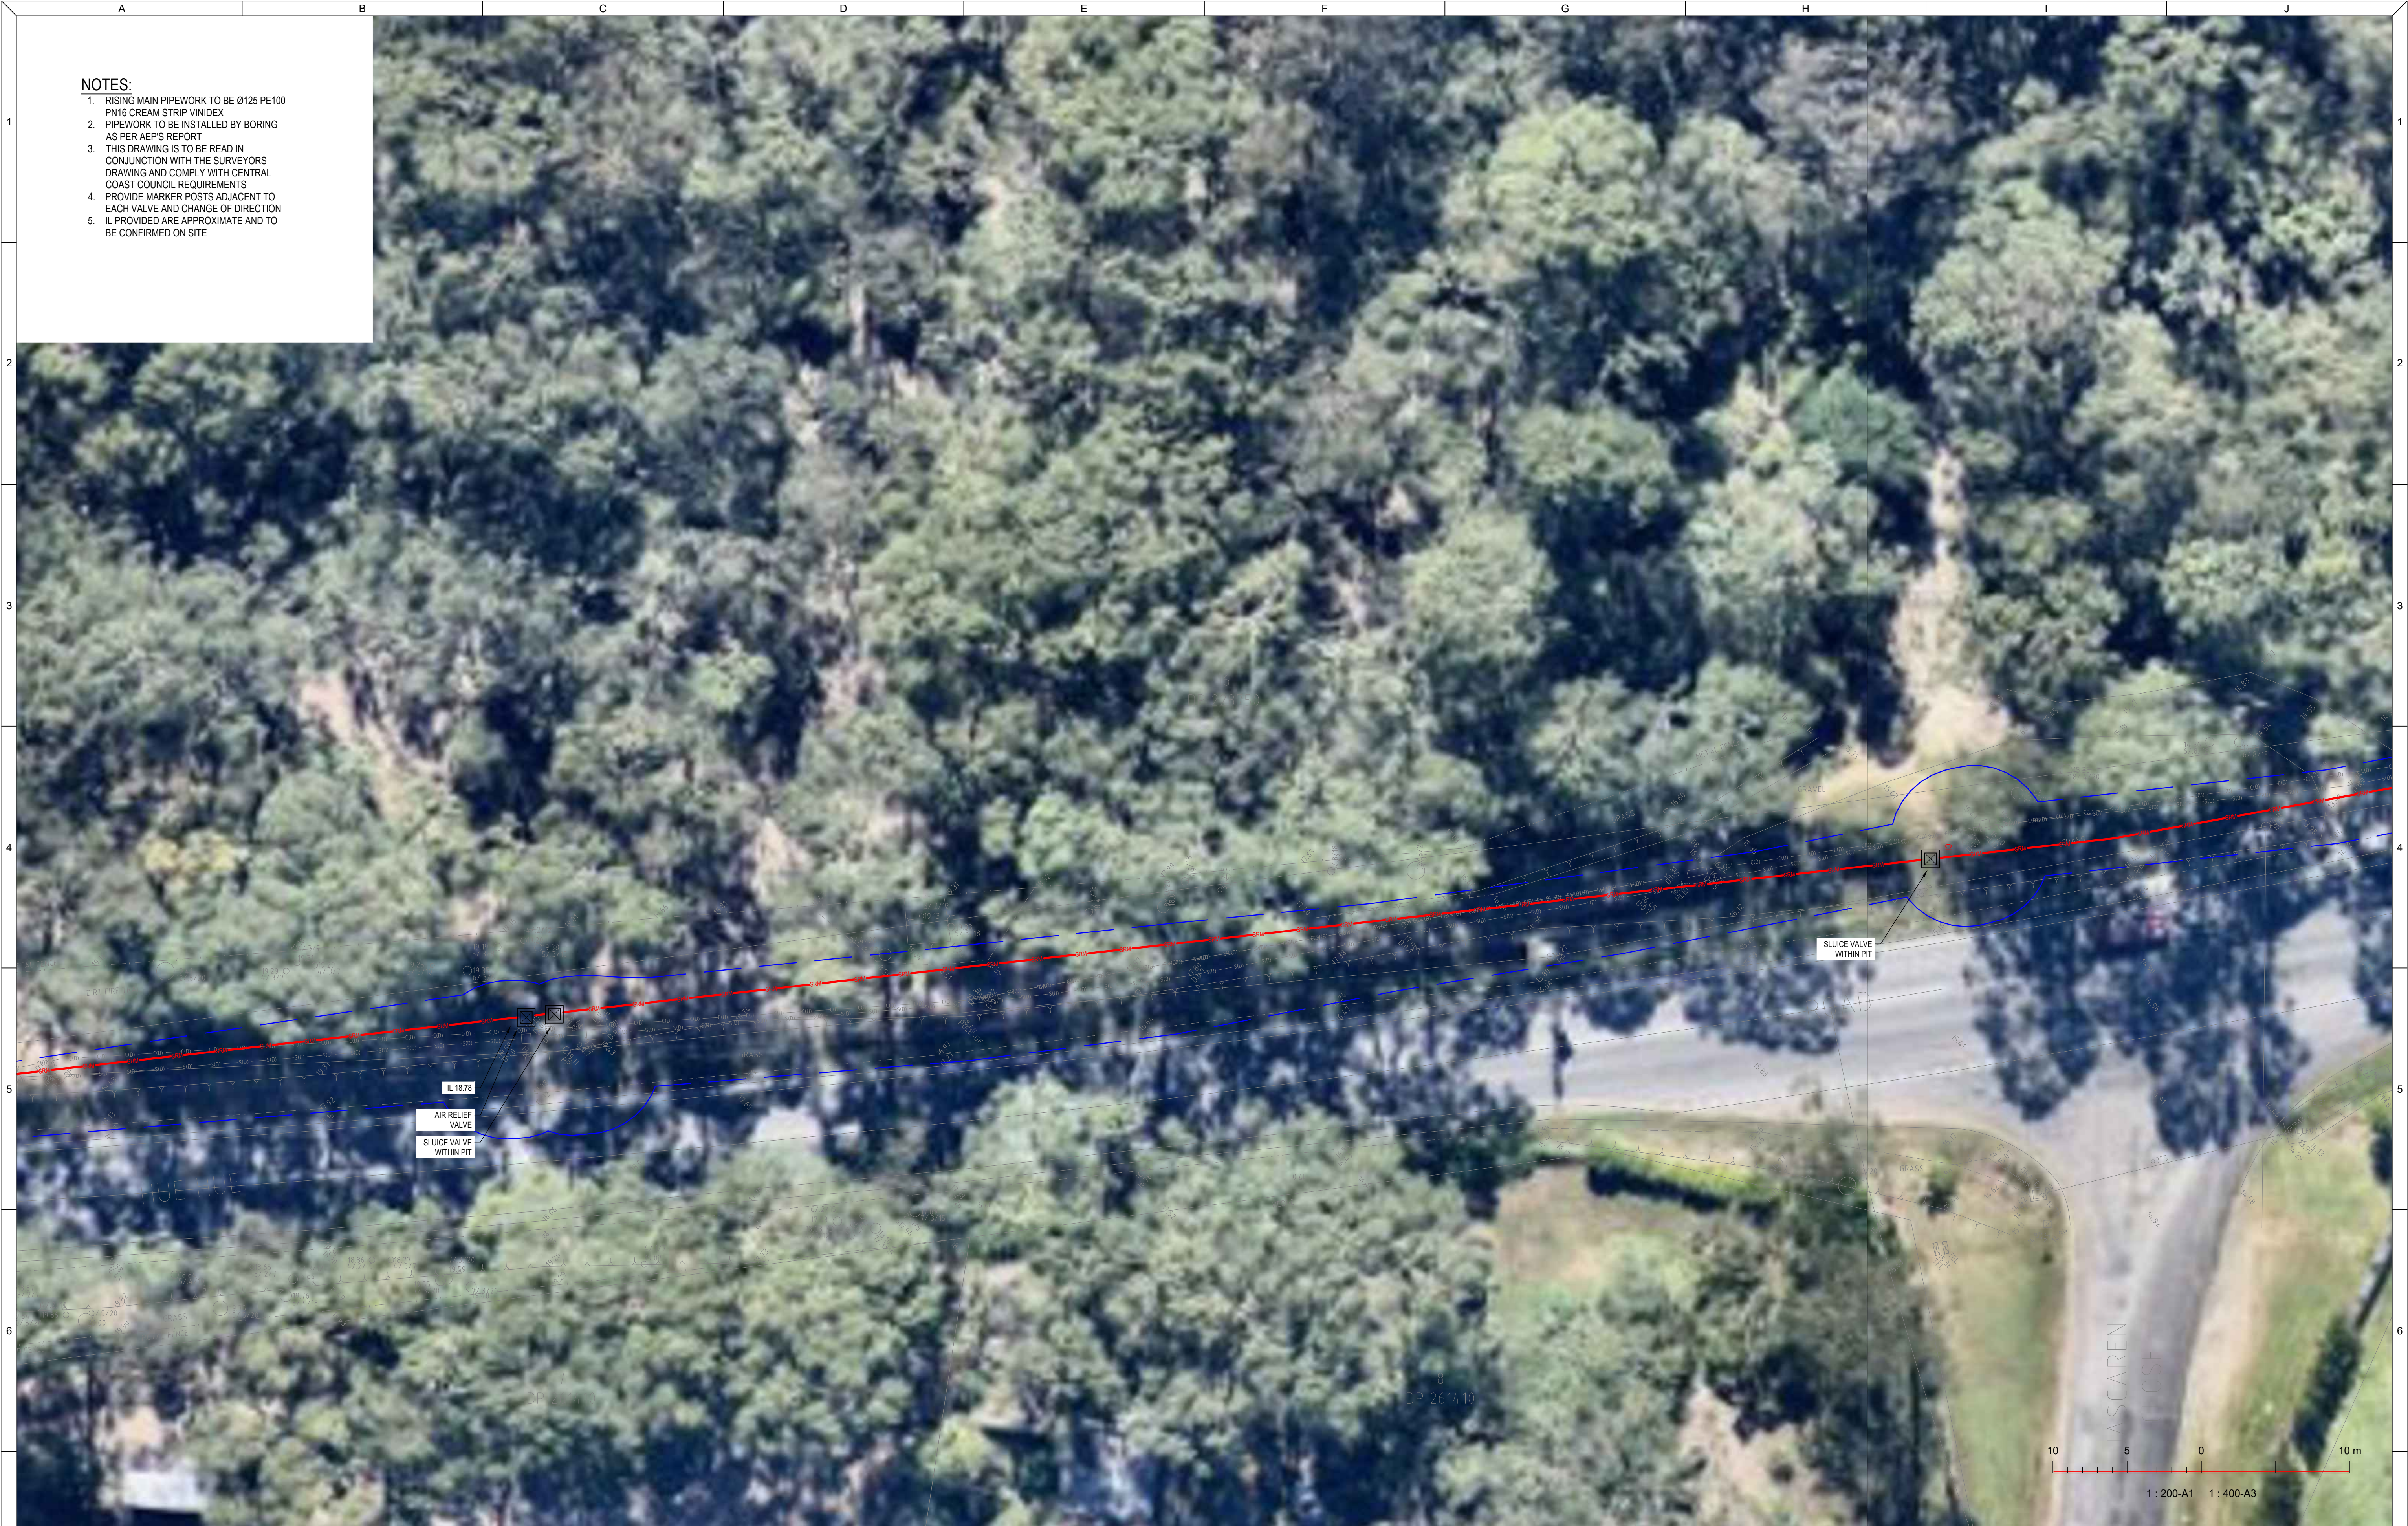
- NOTES:**
1. RISING MAIN PIPEWORK TO BE Ø125 PE100 PN16 CREAM STRIP VINDEX
  2. PIPEWORK TO BE INSTALLED BY BORING AS PER AEP'S REPORT
  3. THIS DRAWING IS TO BE READ IN CONJUNCTION WITH THE SURVEYORS DRAWING AND COMPLY WITH CENTRAL COAST COUNCIL REQUIREMENTS
  4. PROVIDE MARKER POSTS ADJACENT TO EACH VALVE AND CHANGE OF DIRECTION
  5. IL PROVIDED ARE APPROXIMATE AND TO BE CONFIRMED ON SITE
