UPGRADES TO EXISTING RISING SEWER MAINS

*29 ST JOHNS ROAD, JILLIBY, NSW*

*ABORIGINAL ARCHAEOLOGICAL*

*DUE DILIGENCE ASSESSMENT*

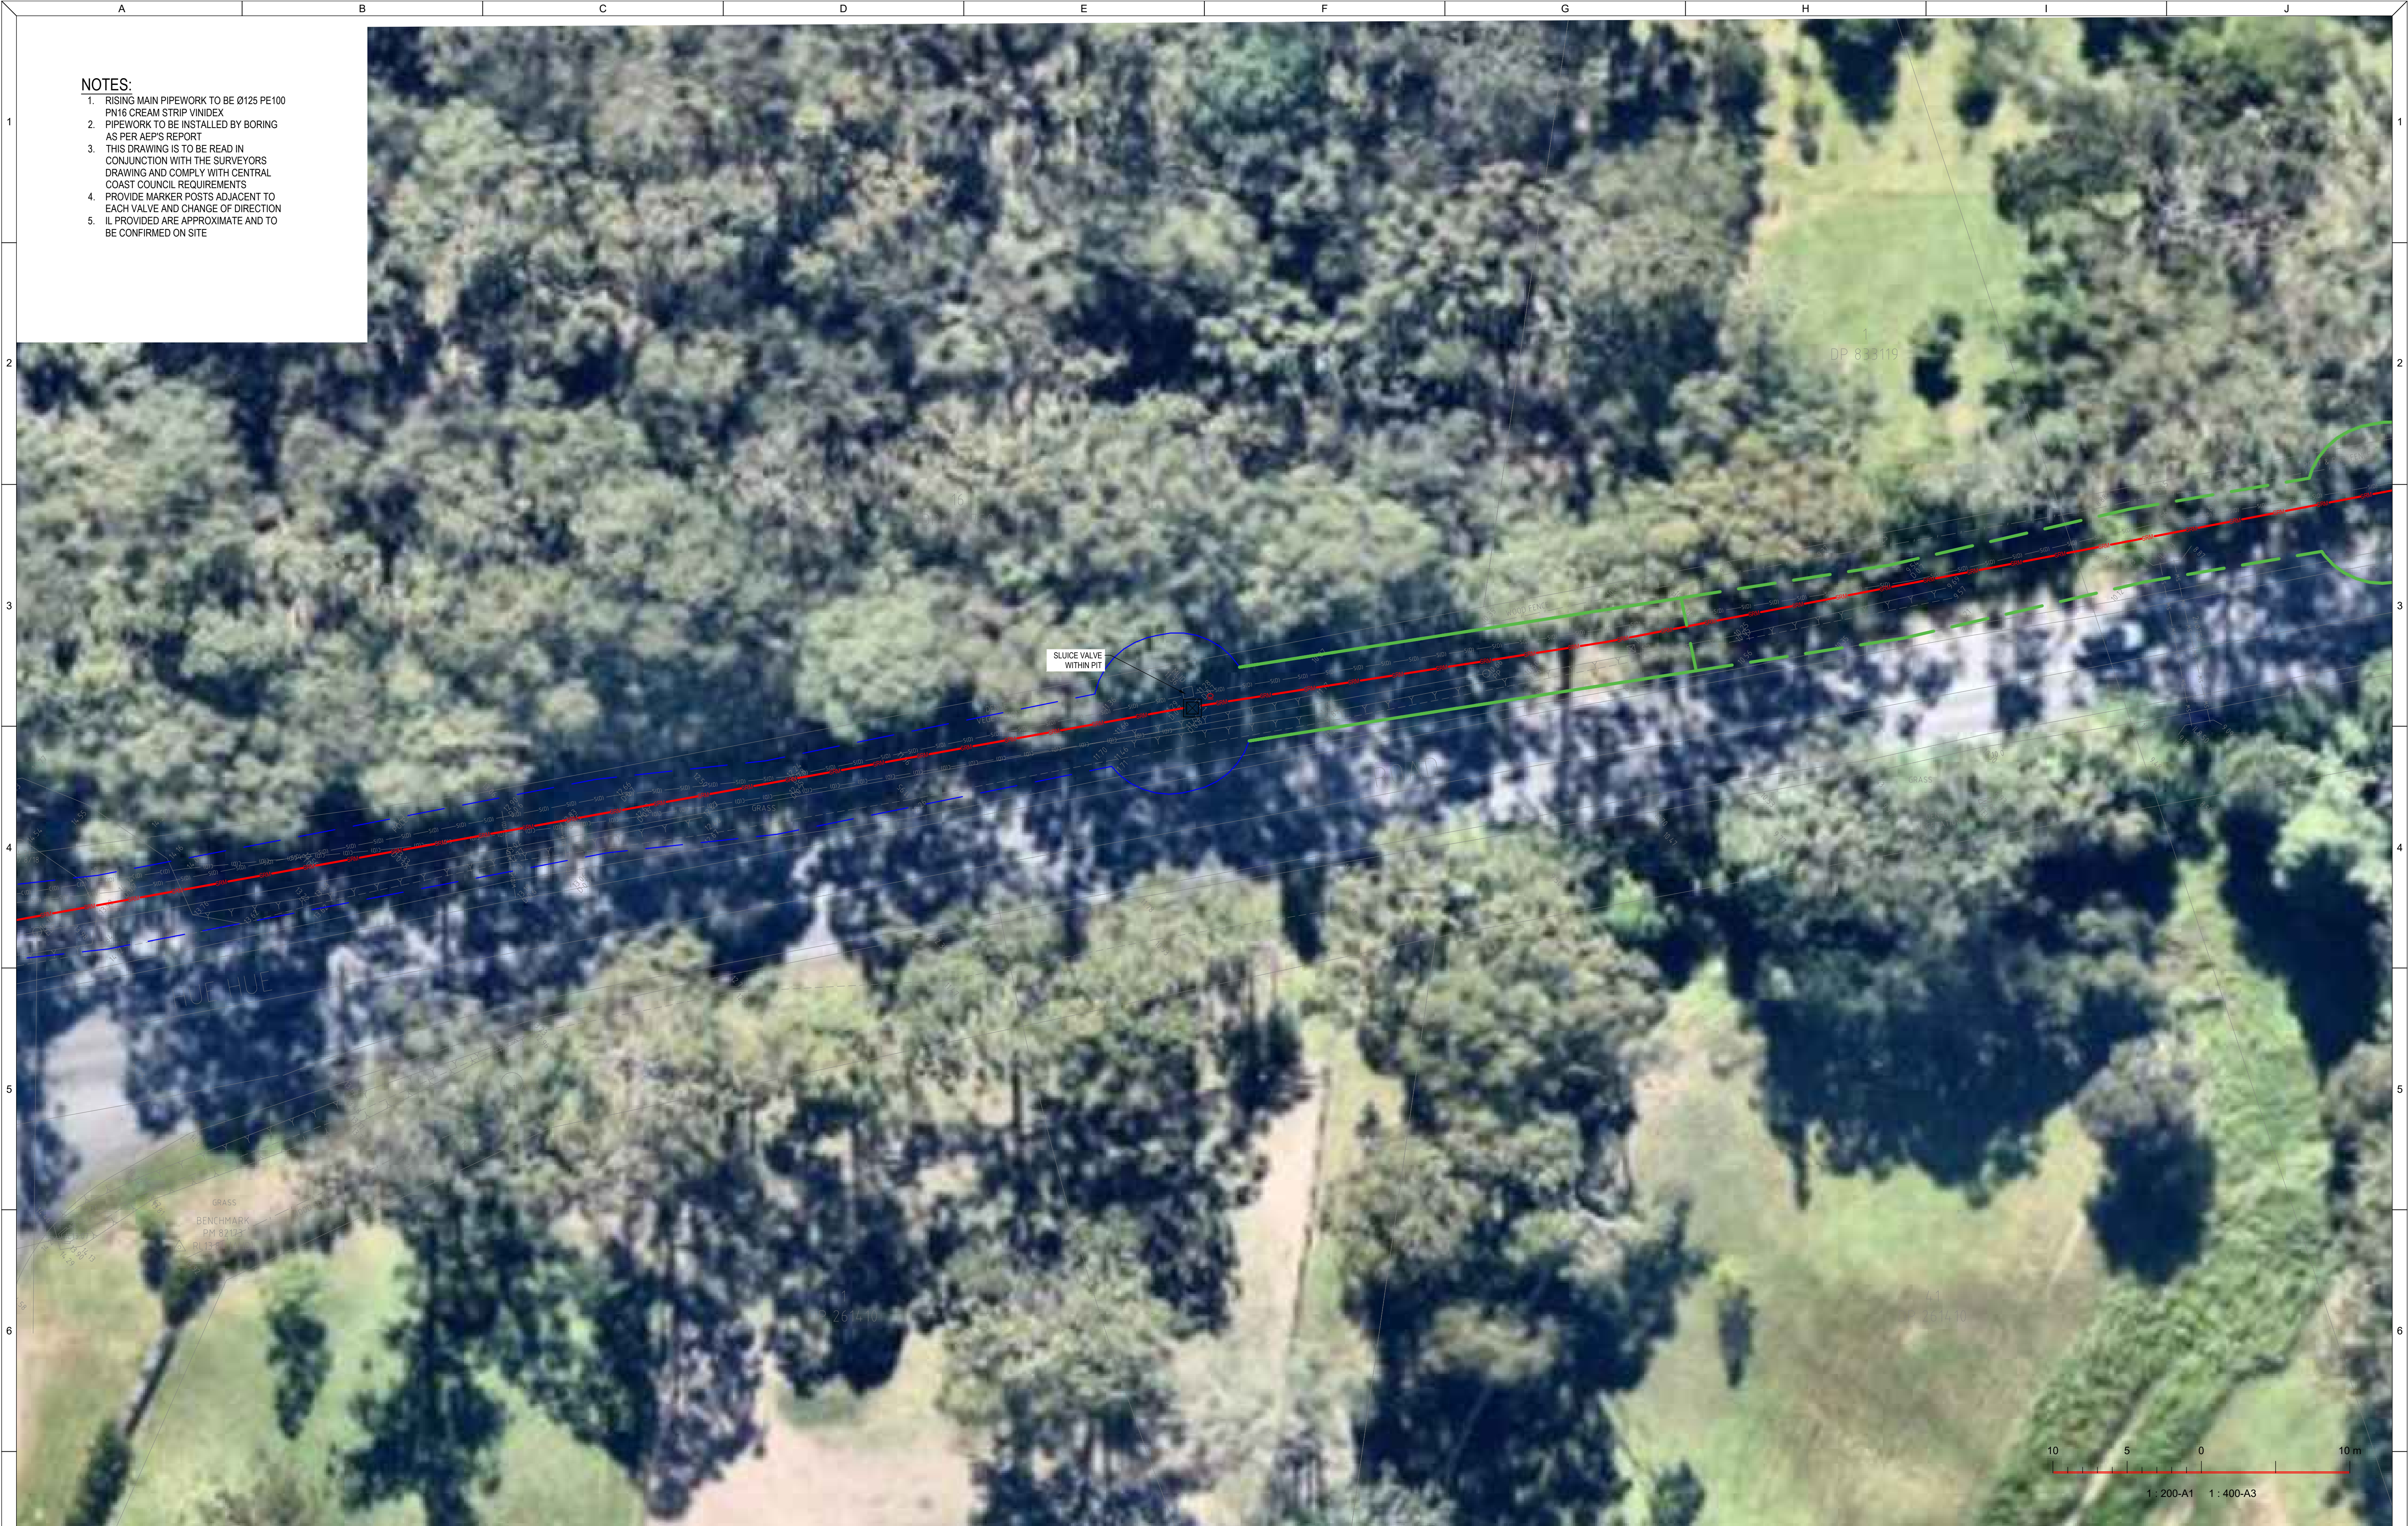
- NOTES:**
- 1. RISING MAIN PIPEWORK TO BE Ø125 PE100
  - 2. PIPEWORK TO BE INSTALLED BY BORING
  - 3. THIS DRAWING IS TO BE READ IN CONJUNCTION WITH THE SURVEYORS DRAWING AND COMPLY WITH CENTRAL COAST COUNCIL REQUIREMENTS
  - 4. PROVIDE MARKER POSTS ADJACENT TO EACH VALVE AND CHANGE OF DIRECTION
  - 5. IL PROVIDED ARE APPROXIMATE AND TO BE CONFIRMED ON SITE

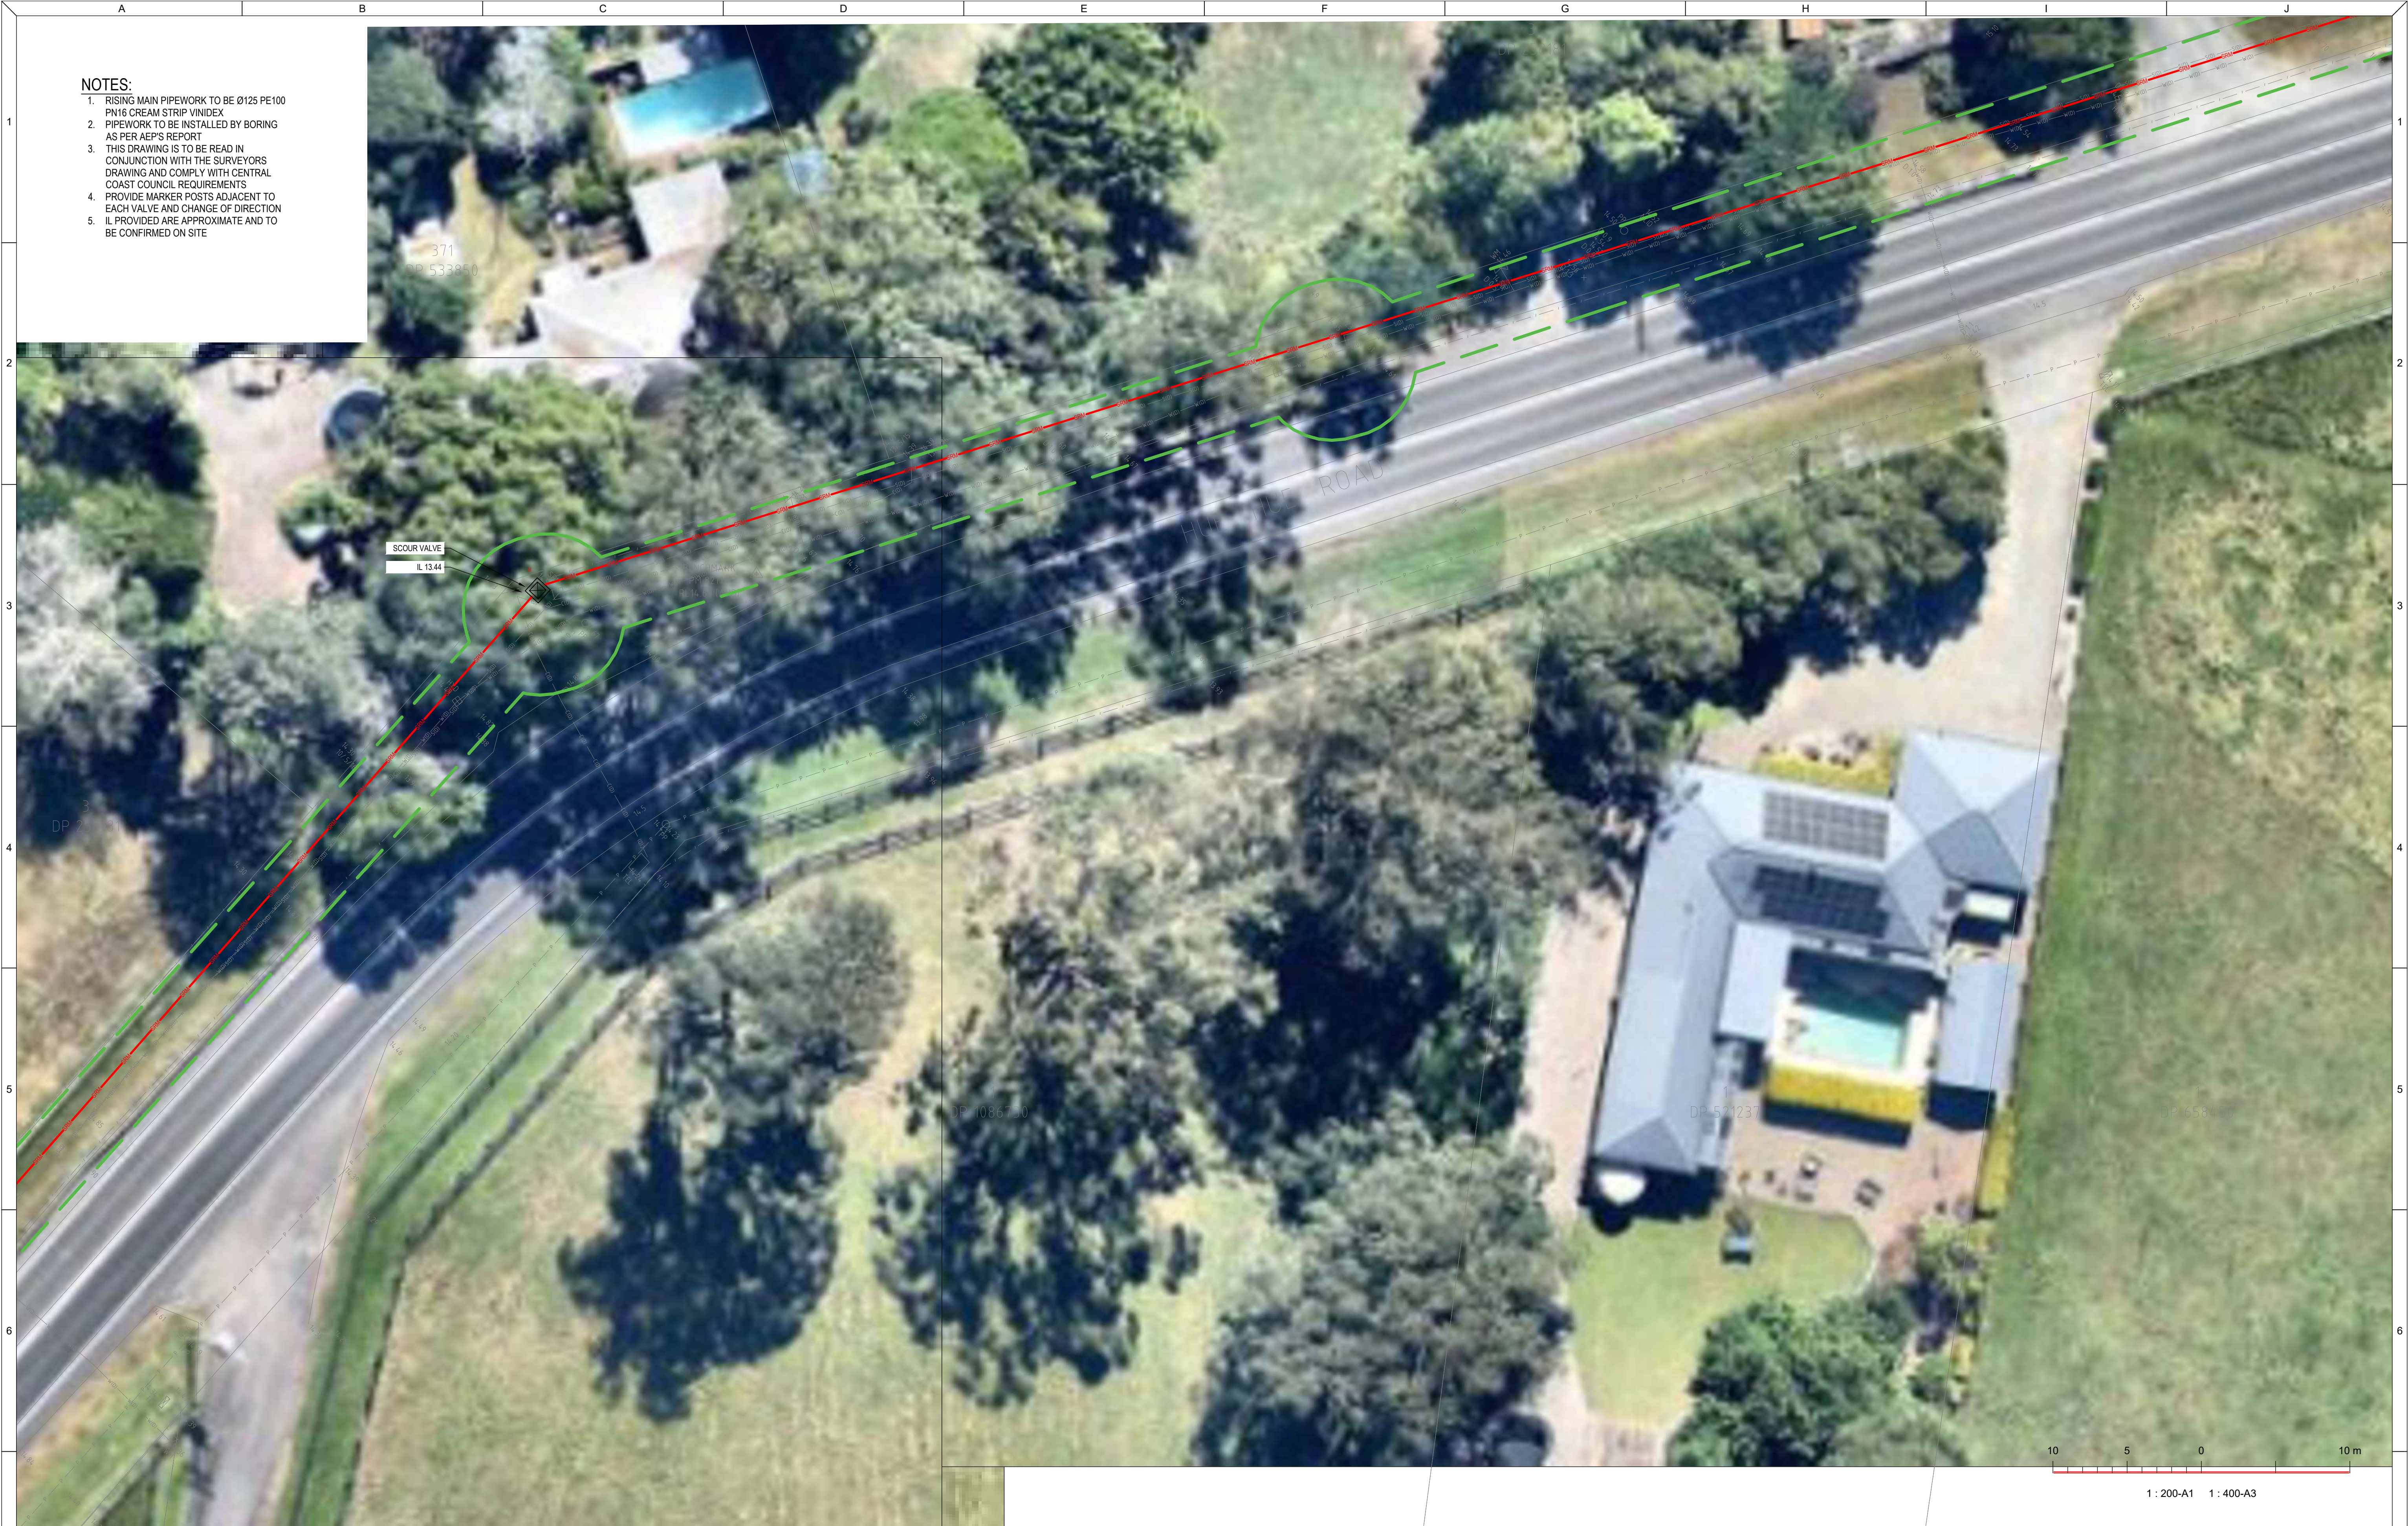
- NOTES:**
1. RISING MAIN PIPEWORK TO BE Ø125 PE100
  2. PNV6 CREAM STRIP VINDEX
  3. PIPEWORK TO BE INSTALLED BY BORING
  4. AS PER AEP'S REPORT
  5. THIS DRAWING IS TO BE READ IN CONJUNCTION WITH THE SURVEYORS DRAWING AND COMPLY WITH CENTRAL COAST COUNCIL REQUIREMENTS
  6. PROVIDE MARKER POSTS ADJACENT TO EACH VALVE AND CHANGE OF DIRECTION
  7. IL PROVIDED ARE APPROXIMATE AND TO BE CONFIRMED ON SITE

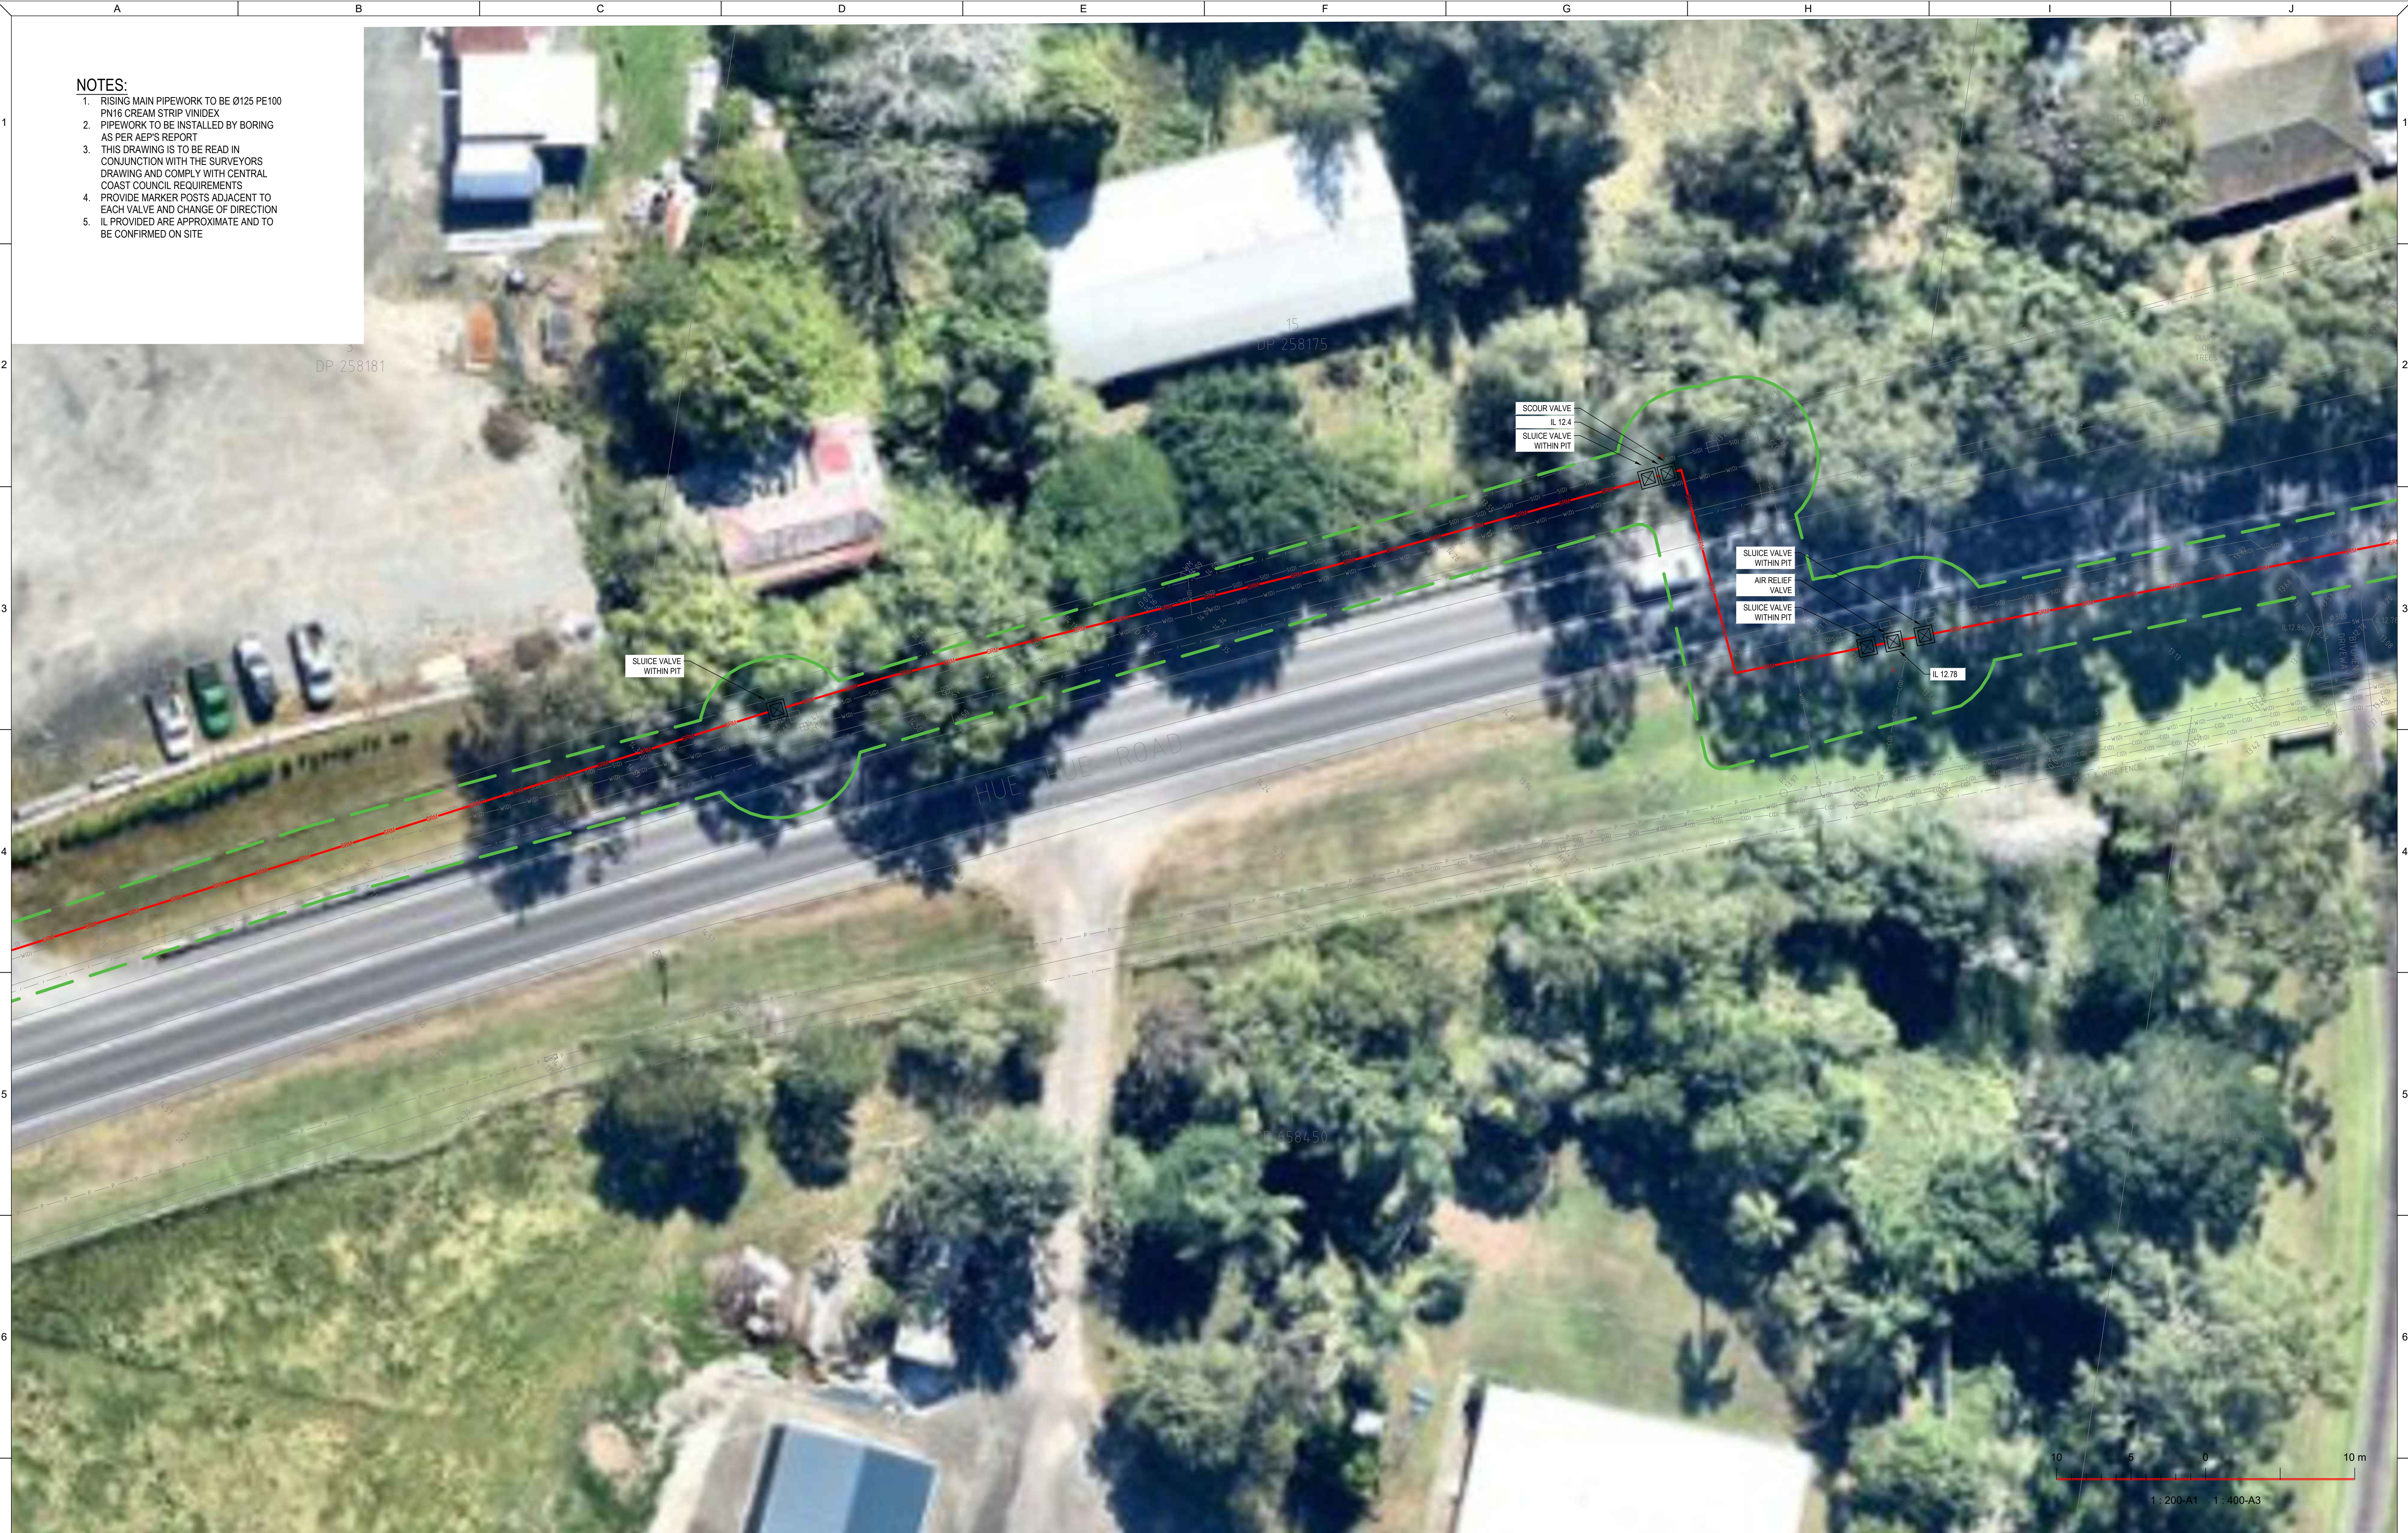
- NOTES:**
1. RISING MAIN PIPEWORK TO BE Ø125 PE100 PN16 CREAM STRIP VINIDEX
  2. PIPEWORK TO BE INSTALLED BY BORING AS PER AEP'S REPORT
  3. THIS DRAWING IS TO BE READ IN CONJUNCTION WITH THE SURVEYORS DRAWING AND COMPLY WITH CENTRAL COAST COUNCIL REQUIREMENTS
  4. PROVIDE MARKER POSTS ADJACENT TO EACH VALVE AND CHANGE OF DIRECTION
  5. IL PROVIDED ARE APPROXIMATE AND TO BE CONFIRMED ON SITE

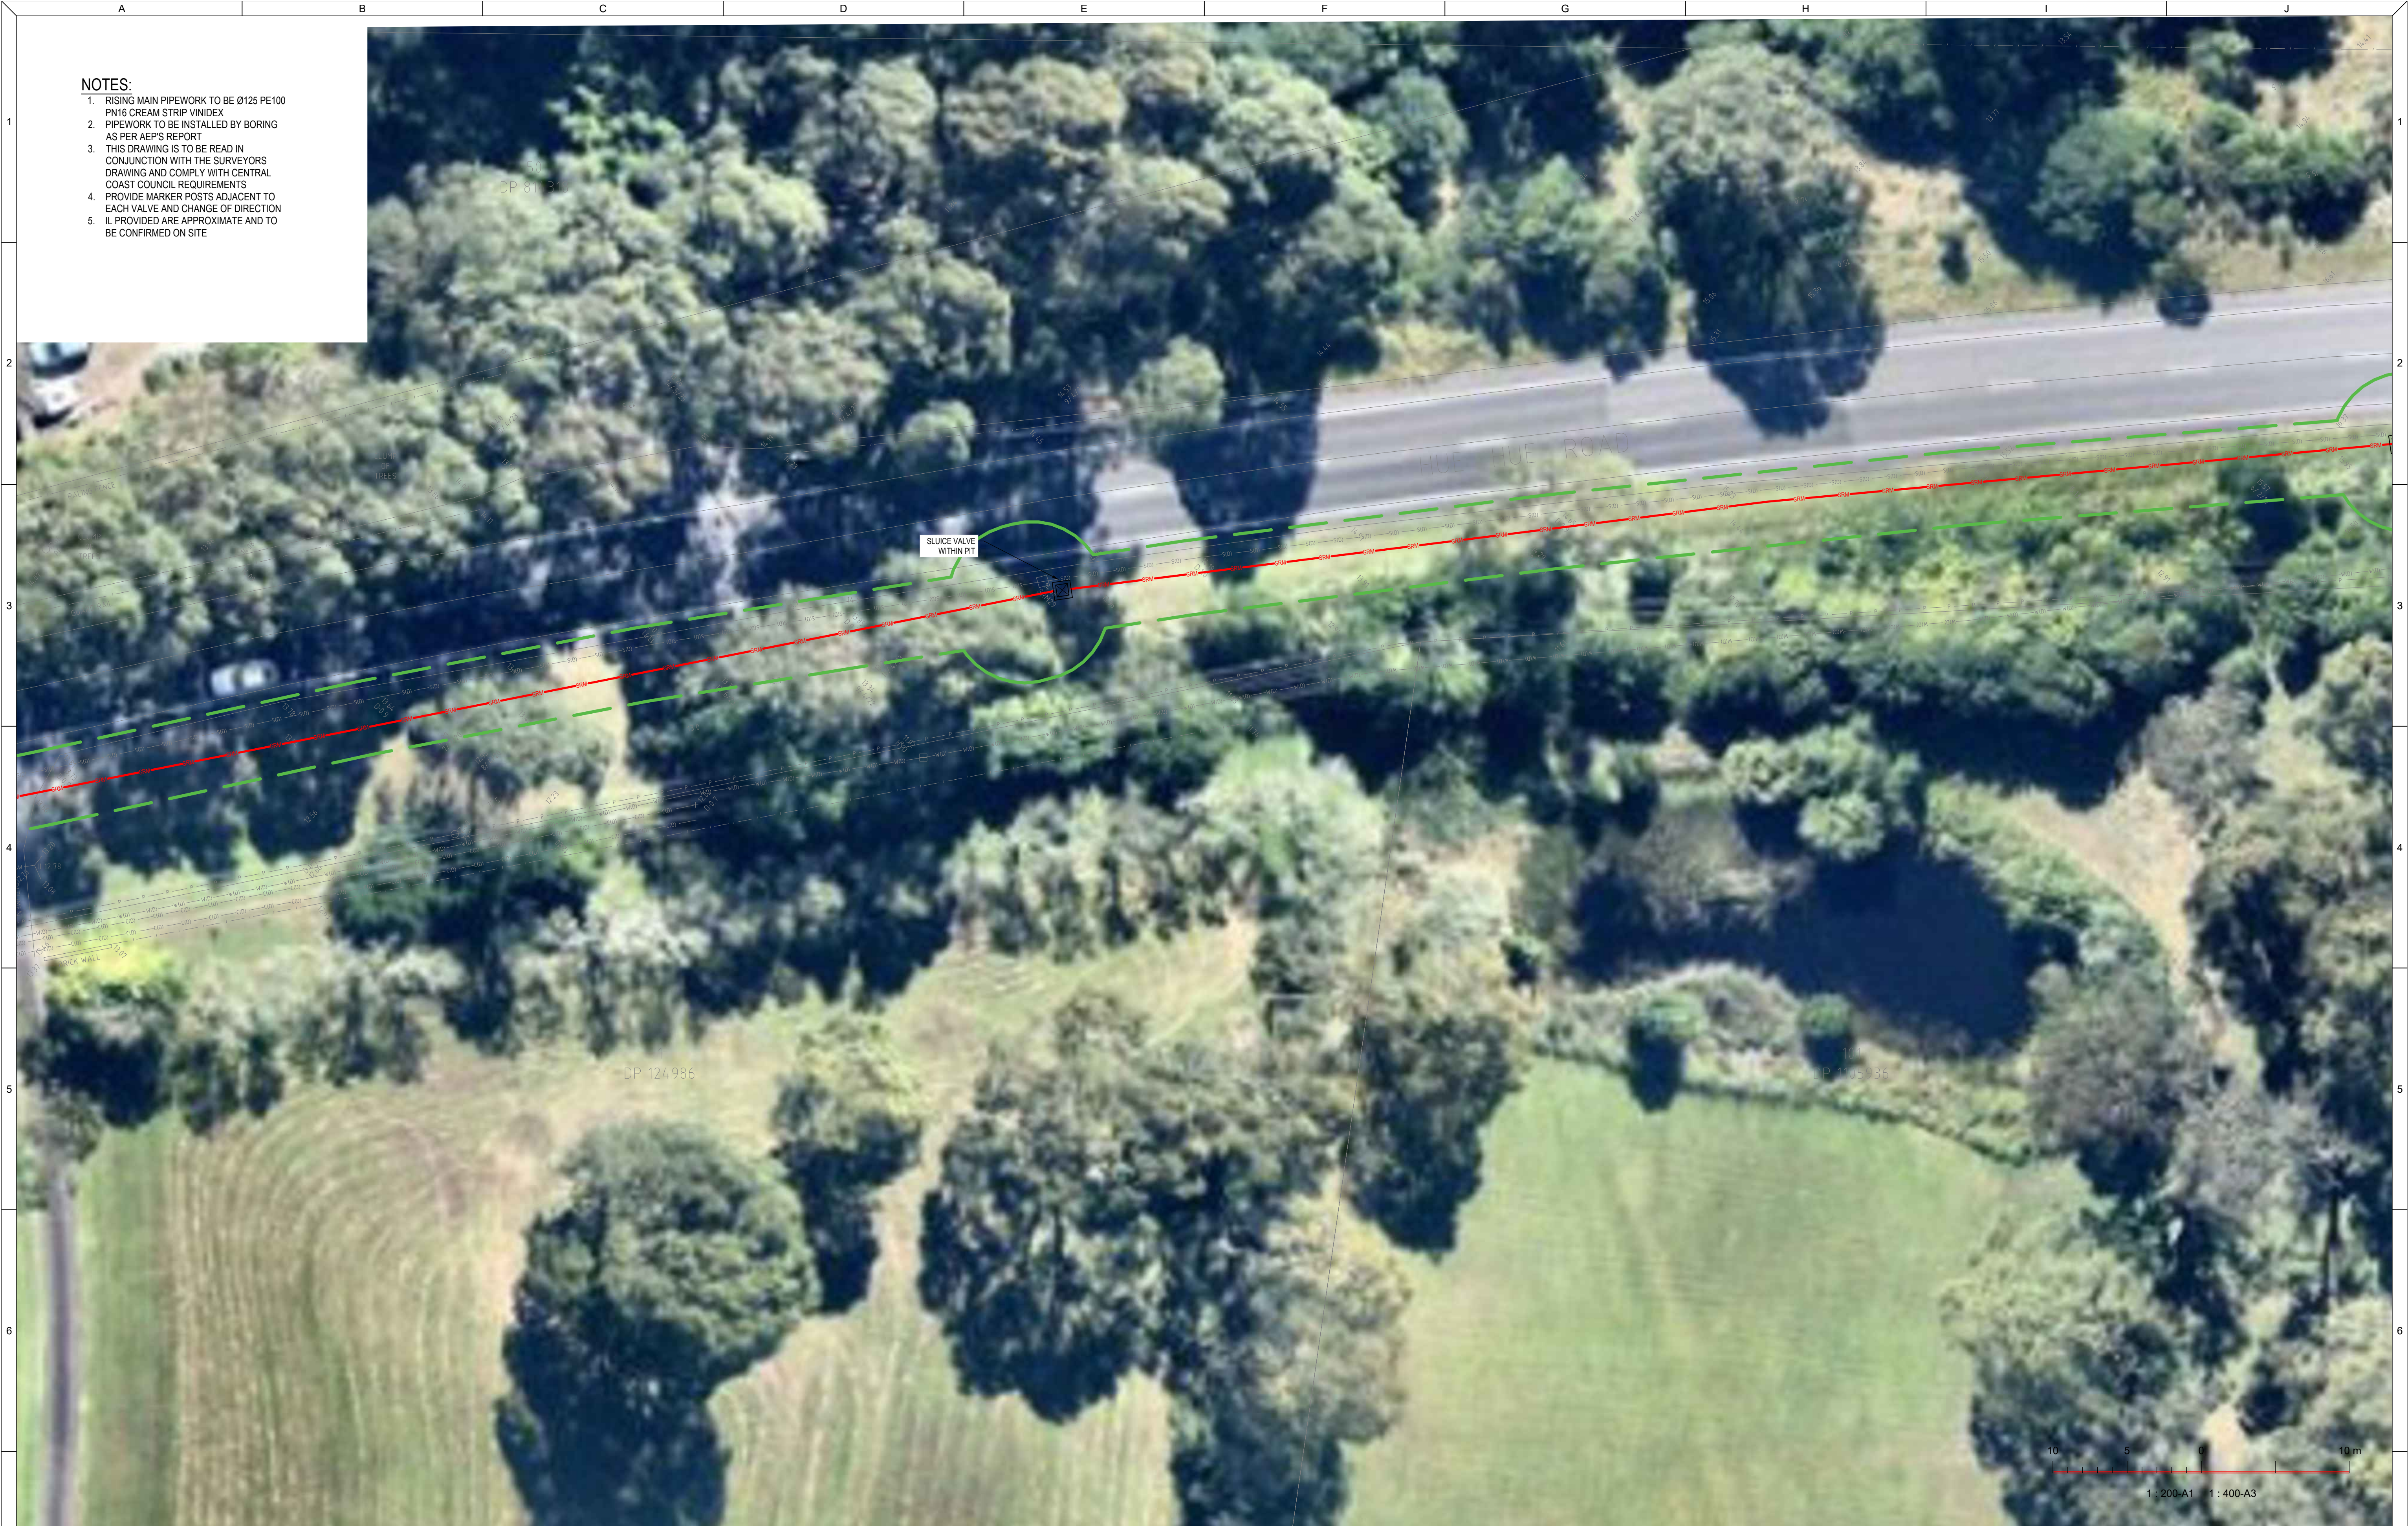
- NOTES:
1. RISING MAIN PIPEWORK TO BE Ø125 PE100 PN16 CREAM STRIP VINDEX
  2. PIPEWORK TO BE INSTALLED BY BORING AS PER AEP'S REPORT
  3. THIS DRAWING IS TO BE READ IN CONJUNCTION WITH THE SURVEYORS DRAWING AND COMPLY WITH CENTRAL COAST COUNCIL REQUIREMENTS
  4. PROVIDE MARKER POSTS ADJACENT TO EACH VALVE AND CHANGE OF DIRECTION
  5. IL PROVIDED ARE APPROXIMATE AND TO BE CONFIRMED ON SITE

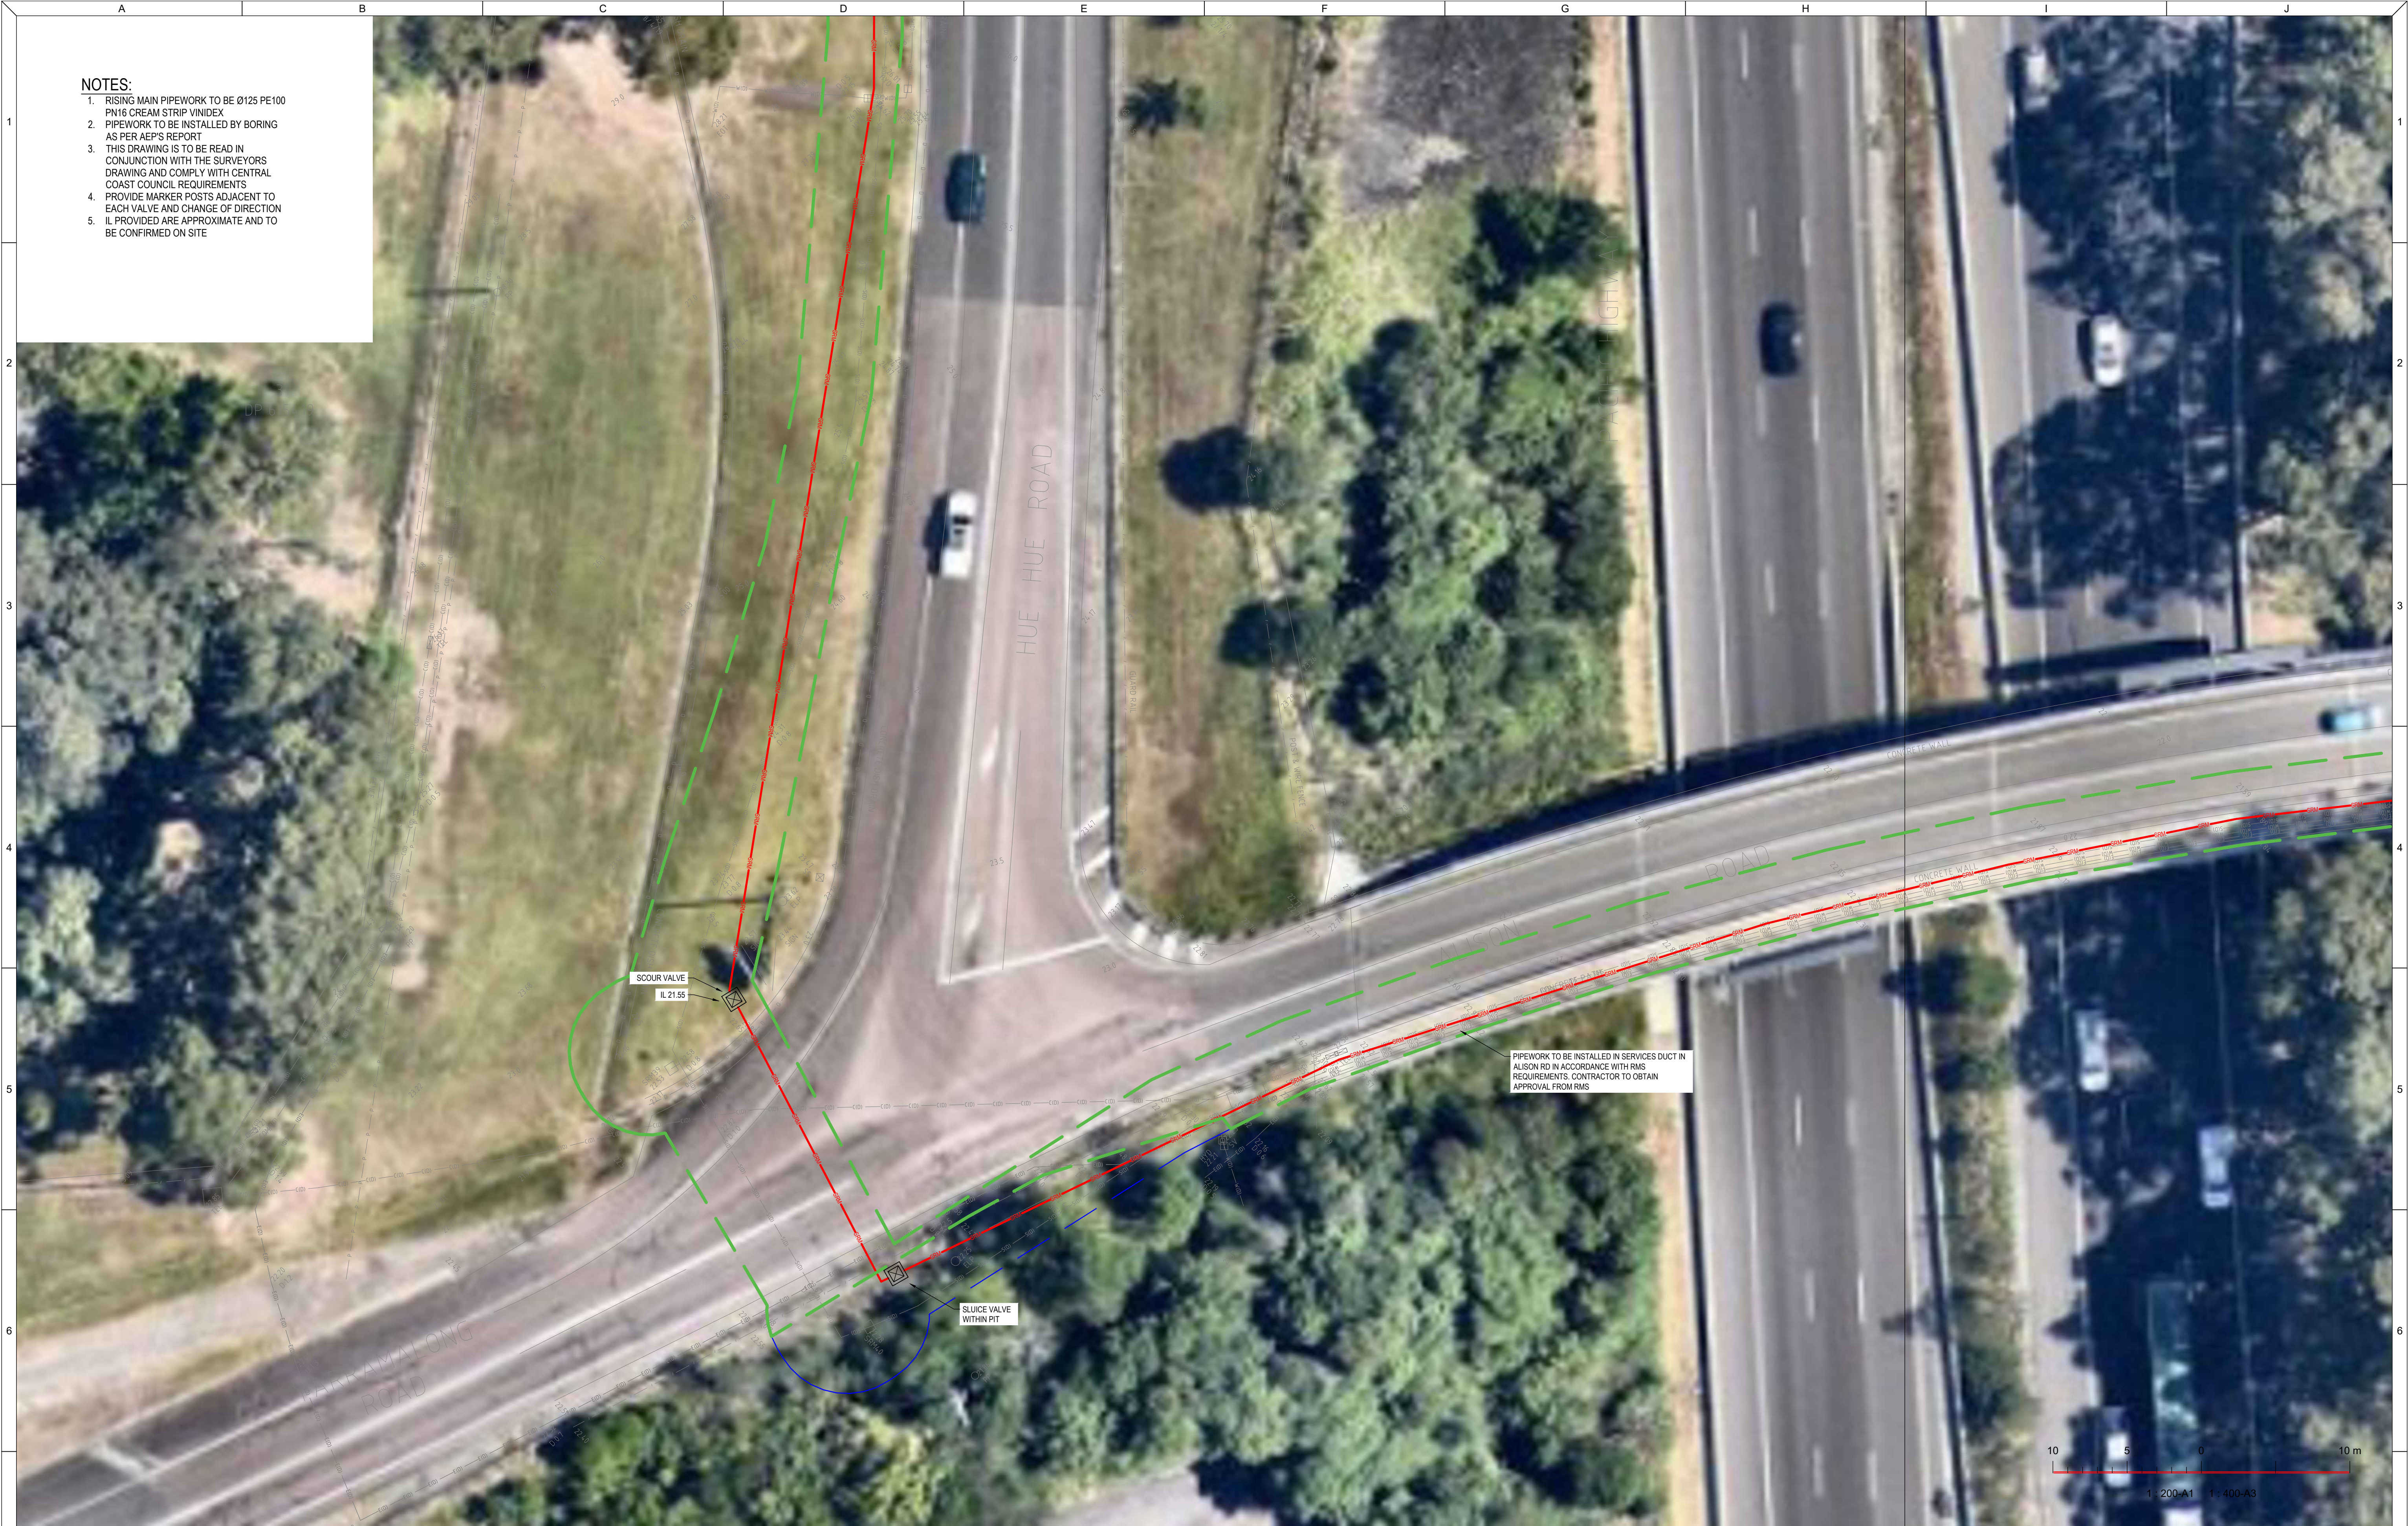
- NOTES:
1. RISING MAIN PIPEWORK TO BE Ø125 PE100 PN16 CREAM STRIP VINDEX
  2. PIPEWORK TO BE INSTALLED BY BORING AS PER AEP'S REPORT
  3. THIS DRAWING IS TO BE READ IN CONJUNCTION WITH THE SURVEYORS DRAWING AND COMPLY WITH CENTRAL COAST COUNCIL REQUIREMENTS
  4. PROVIDE MARKER POSTS ADJACENT TO EACH VALVE AND CHANGE OF DIRECTION
  5. IL PROVIDED ARE APPROXIMATE AND TO BE CONFIRMED ON SITE

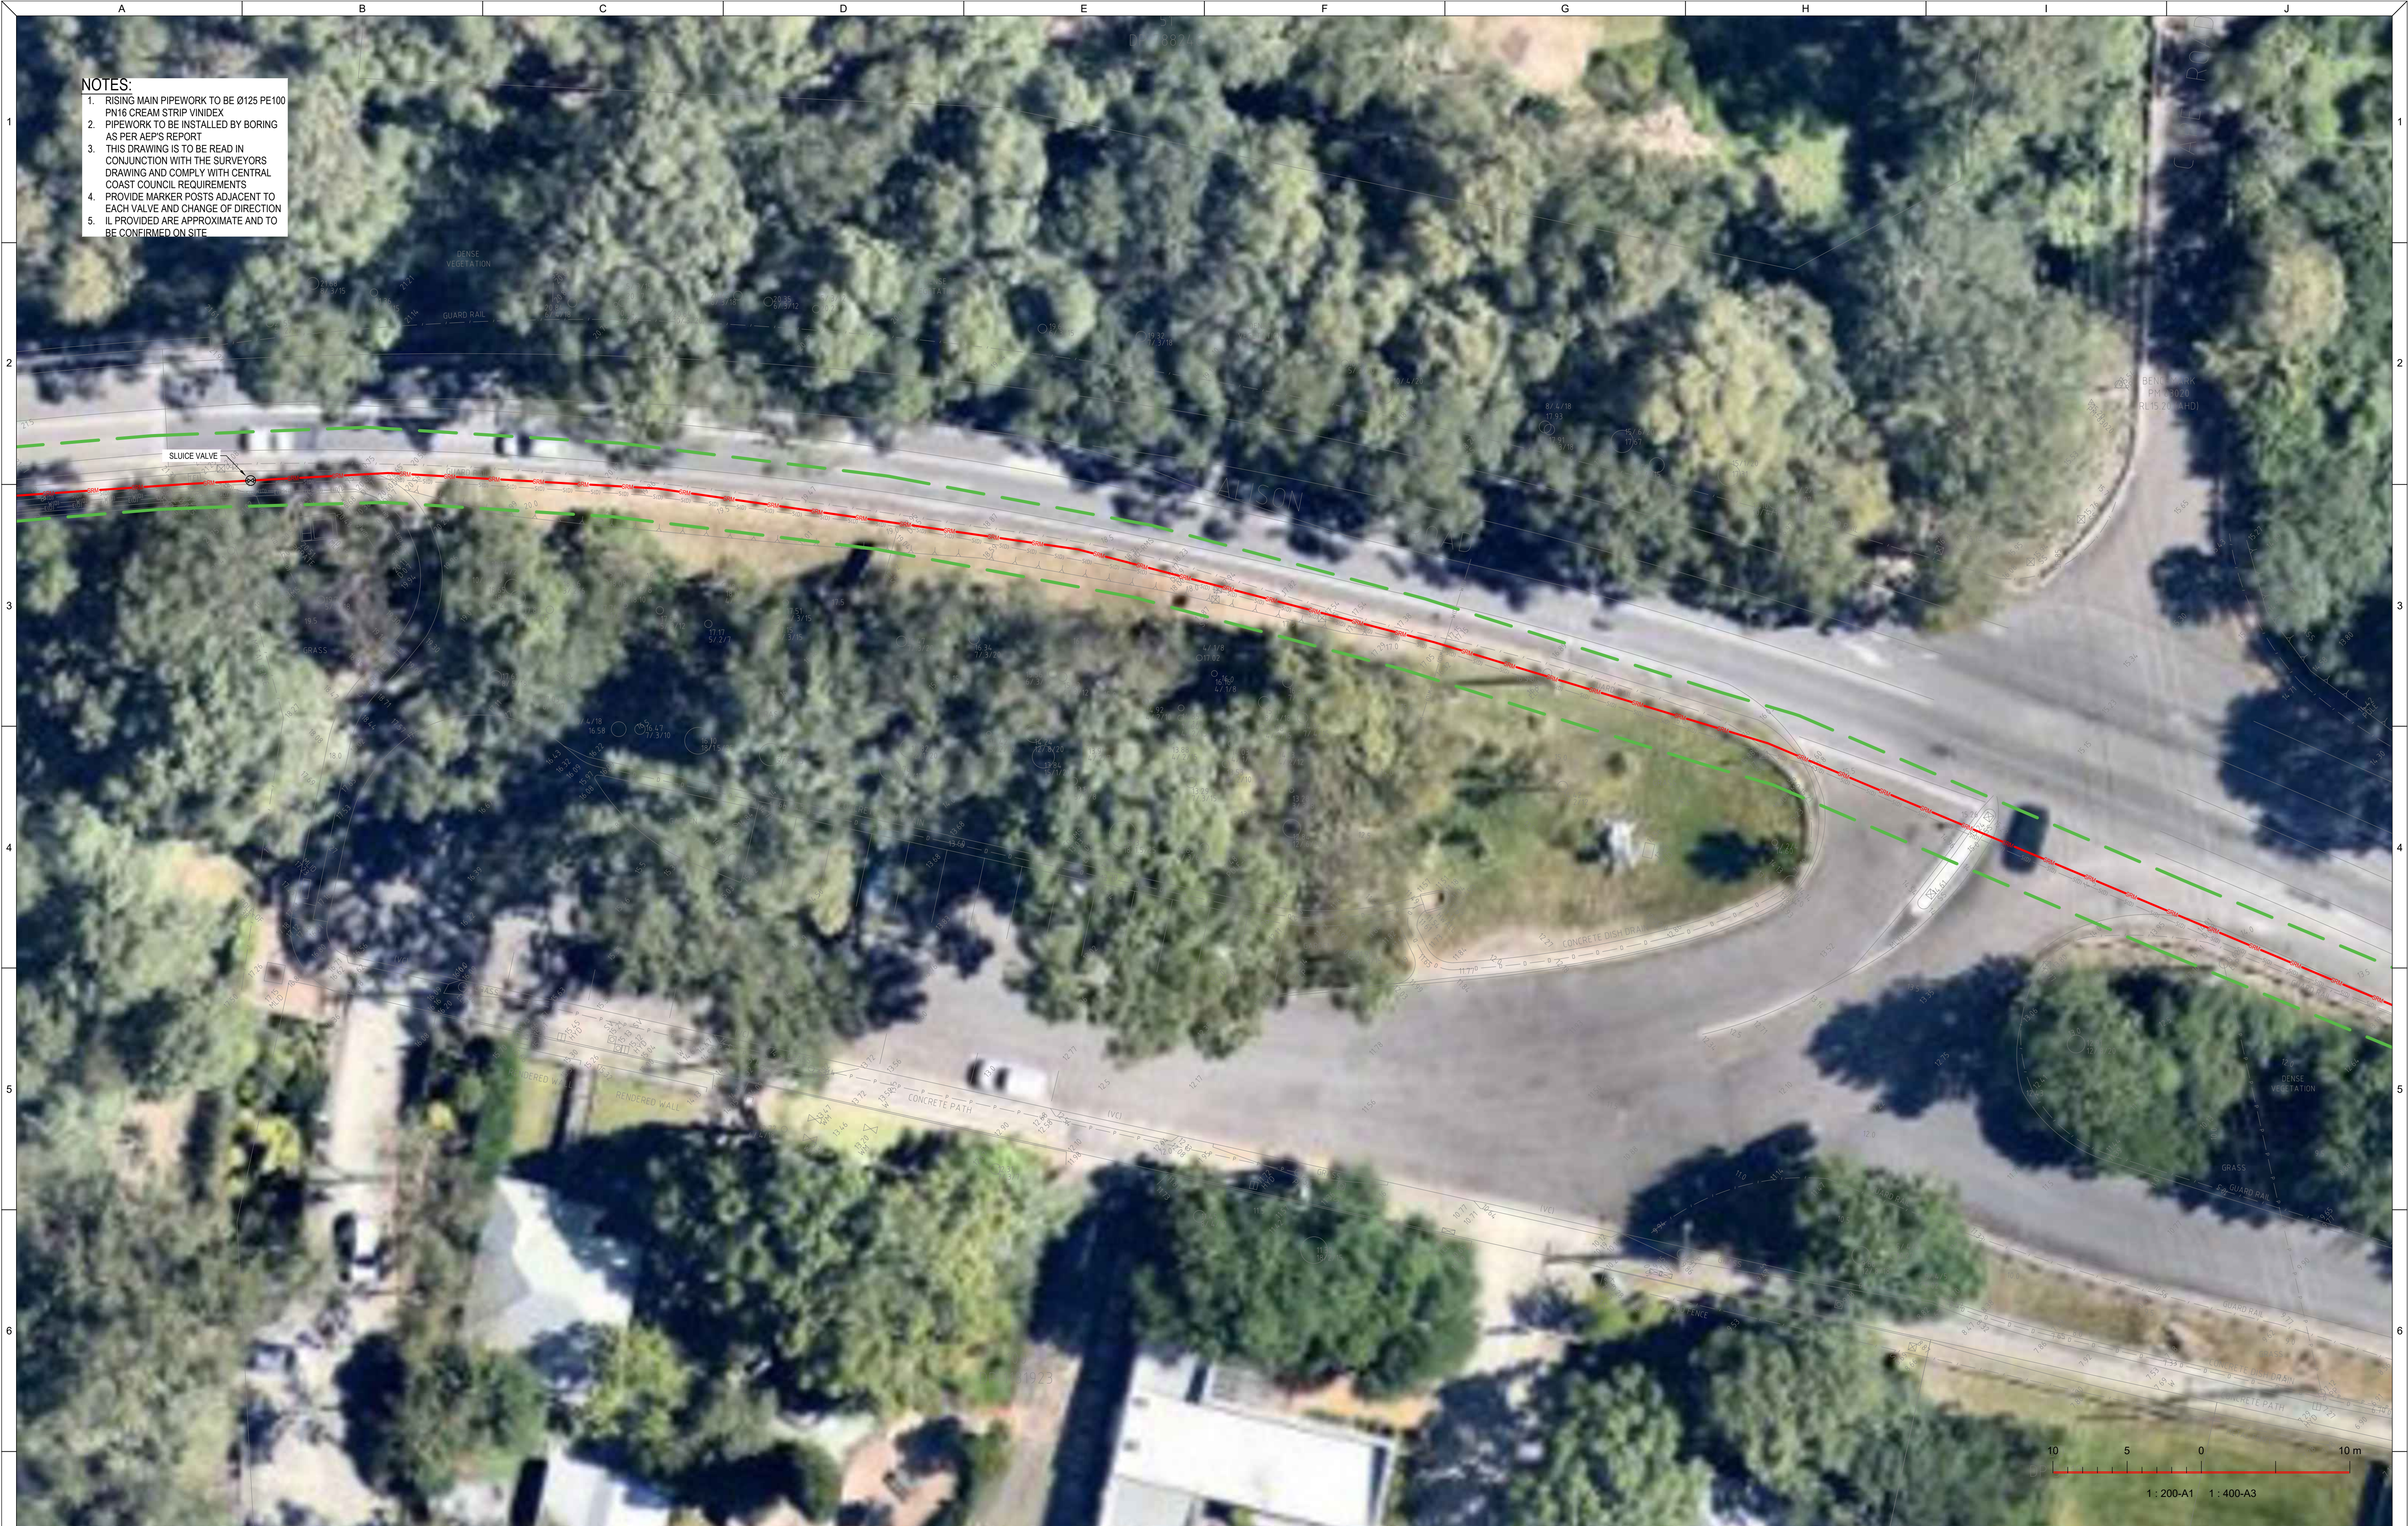
- NOTES:**
1. RISING MAIN PIPEWORK TO BE Ø125 PE100 PN16 CREAM STRIP VINDEX
  2. PIPEWORK TO BE INSTALLED BY BORING AS PER AEP'S REPORT
  3. THIS DRAWING IS TO BE READ IN CONJUNCTION WITH THE SURVEYORS DRAWING AND COMPLY WITH CENTRAL COAST COUNCIL REQUIREMENTS
  4. PROVIDE MARKER POSTS ADJACENT TO EACH VALVE AND CHANGE OF DIRECTION
  5. IL PROVIDED ARE APPROXIMATE AND TO BE CONFIRMED ON SITE
