UPGRADES TO EXISTING RISING SEWER MAINS

*29 ST JOHNS ROAD, JILLIBY, NSW*

*ABORIGINAL ARCHAEOLOGICAL*

*DUE DILIGENCE ASSESSMENT*

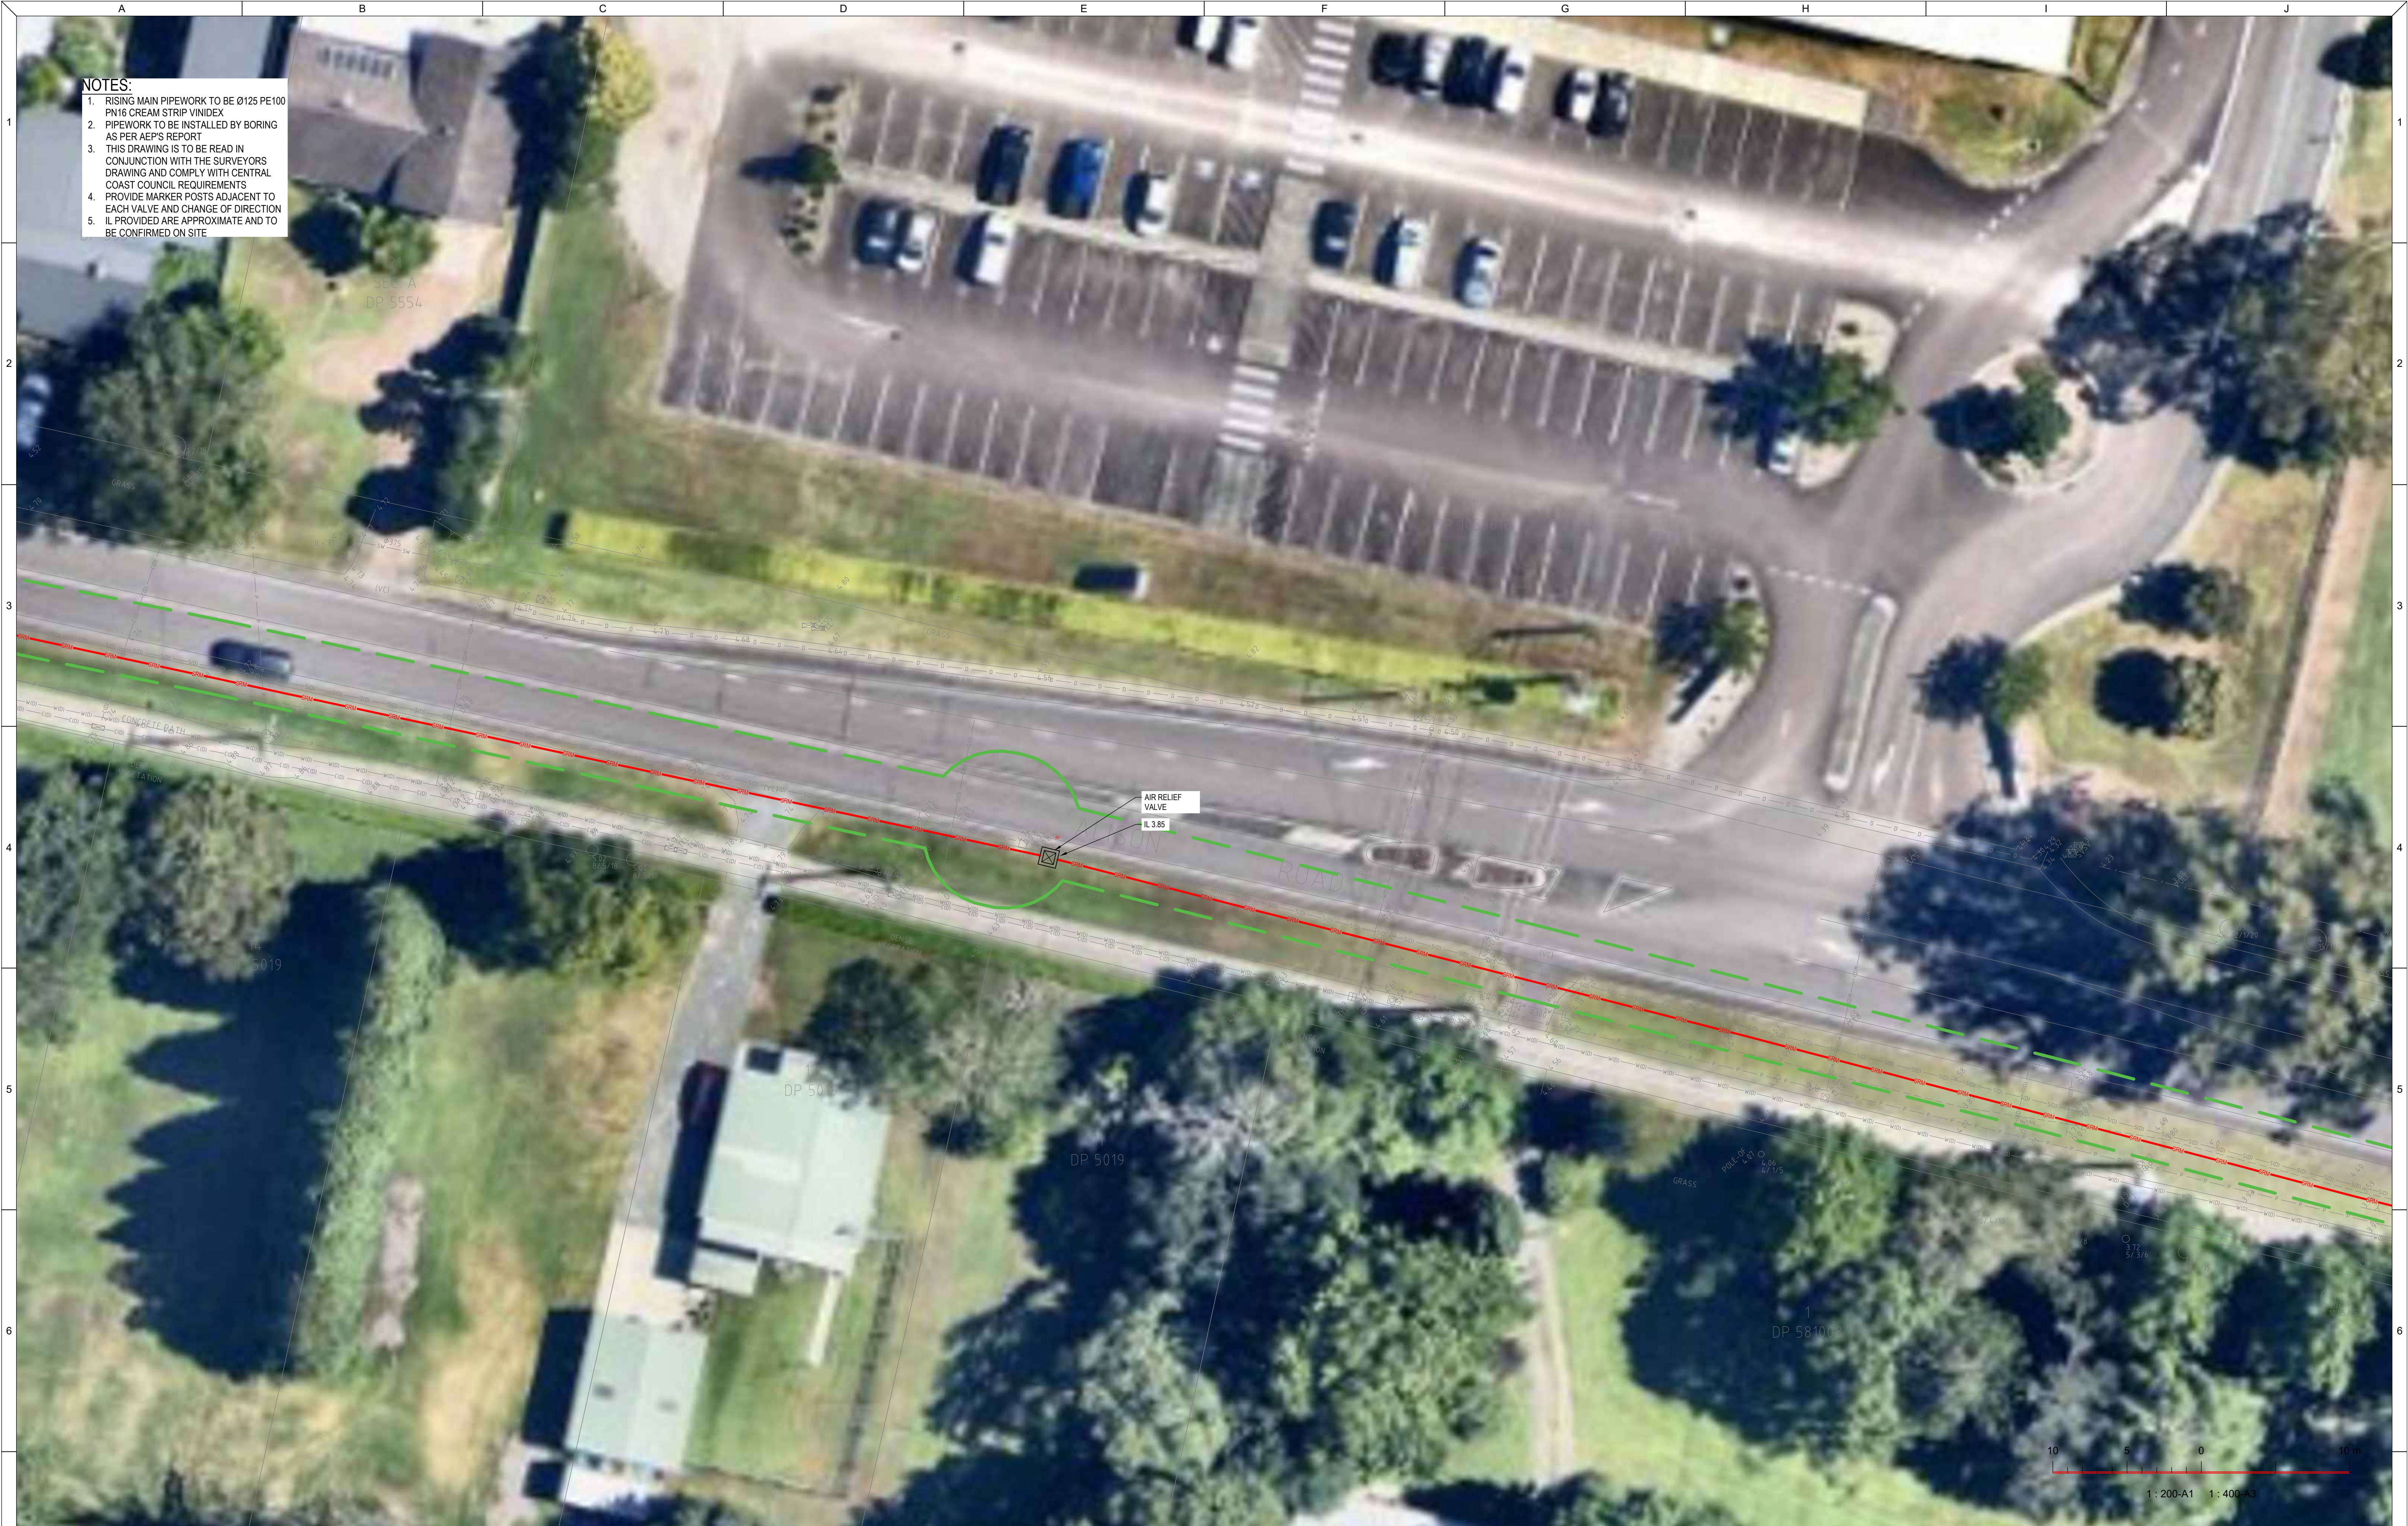
- NOTES:
1. RISING MAIN PIPEWORK TO BE Ø125 PE100 PN16 CREAM STRIP VINIDEX
  2. PIPEWORK TO BE INSTALLED BY BORING AS PER AEP'S REPORT
  3. THIS DRAWING IS TO BE READ IN CONJUNCTION WITH THE SURVEYORS DRAWING AND COMPLY WITH CENTRAL COAST COUNCIL REQUIREMENTS
  4. PROVIDE MARKER POSTS ADJACENT TO EACH VALVE AND CHANGE OF DIRECTION
  5. IL PROVIDED ARE APPROXIMATE AND TO BE CONFIRMED ON SITE
