Road Safety Audit

Anambah Road, Gosford – Existing Conditions

Thirdi Communities

25.224r01v01

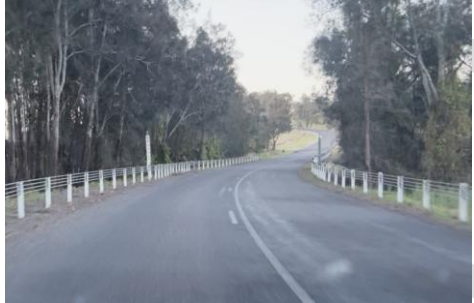
AUDIT FINDING REFERENCE	ROAD SAFETY AUDIT FINDING	LIKELIHOOD	SEVERITY	LEVEL OF RISK	PROJECT MANAGER RESPONSES
1- Overtaking at Chainage 1800 to 2000	<p>The centreline lane markings between approximate Chainage 1800 to 2000 permits overtaking in the northbound direction.</p> <p>The commencement of overtaking is partially within a horizontal curve with flexible wire barrier on either side of the carriageway. Sight lines through the curve are limited for northbound vehicles on approach to the overtaking area and within the 100 km/h speed zone area. There are no shoulders present and no run-off road area due to the presence of wire rope flexible safety barrier.</p> <p>There is a risk of head-on crashes with opposing vehicles within this Chainage.</p>

<p><i>Northbound view of overtaking centreline marking</i></p>	Rare	Serious	Medium (FSI)

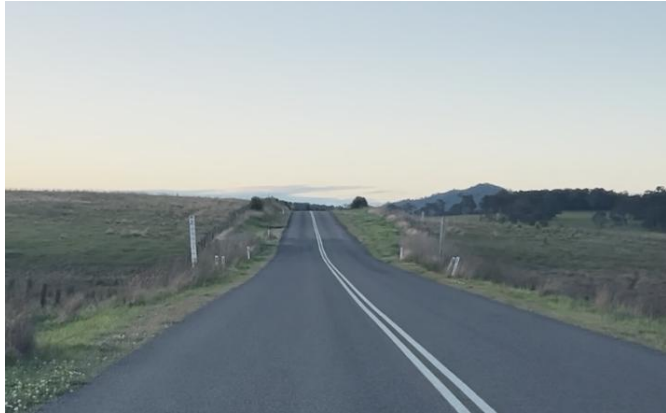
AUDIT FINDING REFERENCE	ROAD SAFETY AUDIT FINDING	LIKELIHOOD	SEVERITY	LEVEL OF RISK	PROJECT MANAGER RESPONSES
2 – Culvert Location on Straight Alignment	<p>There are unprotected culverts / headwalls located within the straight road alignment of Anambah Road. These headwalls present non-frangible hazards in close proximity to the travel lane.</p> <p>There is a risk that errant vehicles in these locations may impact with the headwall, resulting in increased severity of the crash. The likelihood of these locations are considered to be rare given they are on the straight road alignment.</p> <p>These are located at Chainage 1500, 2800, 4400,</p>

<p><i>Example of culvert in close proximity to travel lanes</i></p>	Rare	Serious	Medium (FSI)

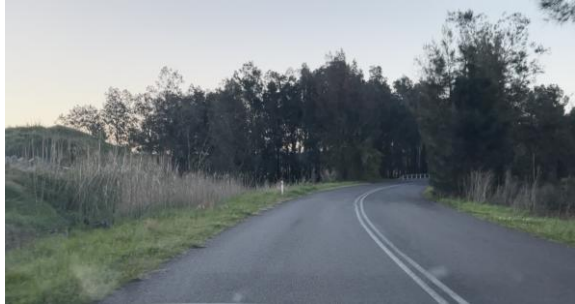
AUDIT FINDING REFERENCE	ROAD SAFETY AUDIT FINDING	LIKELIHOOD	SEVERITY	LEVEL OF RISK	PROJECT MANAGER RESPONSES
3 – Wire Rope Barrie Point of Need	<p>The position of the flexible wire-rope barrier located at approximate Chainage 1800 to 2000 may not adequately contain errant vehicles and their point of need.</p> <p>The location of the wire-rope barrier is within the horizontal curve with steep embankment and vegetation. The wire-rope does not extend the full length of the horizontal curve such that errant vehicles in this location may still encroach into the embankment or other rigid hazards, increasing the severity of a crash.</p>

<p><i>Northbound view of right-hand curve and wire-rope barrier in foreground. No barrier treatment within the curve.</i></p>	Unlikely	Serious	High (FSI)

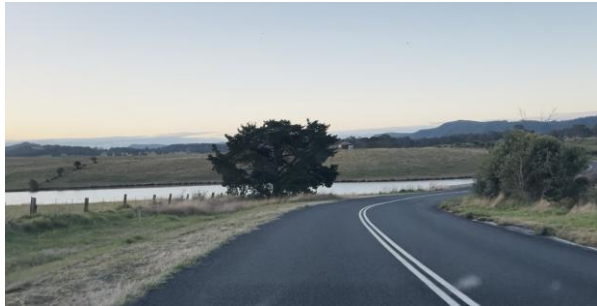
AUDIT FINDING REFERENCE	ROAD SAFETY AUDIT FINDING	LIKELIHOOD	SEVERITY	LEVEL OF RISK	PROJECT MANAGER RESPONSES
4 – Guardrail point of need	<p>There is horizontal curve located between Chainage 3000 to 3200 within a flood prone location. The horizontal curve is provided with guardrail however may not adequately contain errant vehicles are their point of need.</p> <p>An errant vehicle through the curve may not be contained by the barrier and encroach into the embankment area, or impact with the leading terminal of the barrier increasing the severity of a crash in this location. The severity of crash may be increased should their be presence of water nearby.</p>

<p><i>Northbound view of right hand curve with guardrail in foreground. No guardrail in advance of the floodway area.</i></p>	Unlikely	Serious	High (FSI)	
5 – Curve Advisory	<p>Between Chainage 2800 to 3400, there are a series of horizontal curve alignment changes. A motorist proceeding in either the northbound or southbound direction may be unaware of the road alignment and travel through these curves at excess speed. There is a risk that inadequate information may result in increased likelihood of a crash between these Chainages.</p>	Rare	Serious	Medium (FSI)

ITEM 4:
 GUARD RAIL AT POINT OF NEED FROM CH3000 - CH3200
 REMOVE EXISTING TERMINAL END AND TIE INTO EXISTING VEHICULAR BARRIER.
 EXTEND VEHICULAR BARRIER THROUGH HORIZONTAL CURVE.
 PROVIDE TERMINAL END.

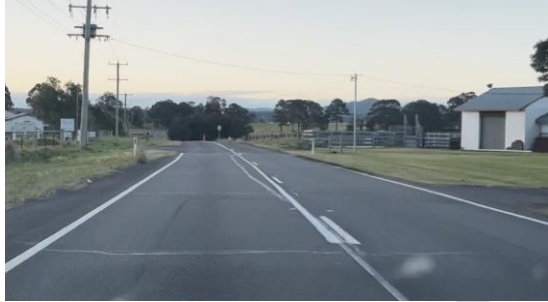
AUDIT FINDING REFERENCE	ROAD SAFETY AUDIT FINDING	LIKELIHOOD	SEVERITY	LEVEL OF RISK	PROJECT MANAGER RESPONSES
12 – Overtaking Near Intersections	<p>There is a short segment of linemarking which permits overtaking in the southbound direction on Anambah Road, north of Niven Parade. The location of overtaking is considered to be relatively close to the intersection and may impact decision making for vehicles entering or exiting Niven Parade.</p> <p>A vehicle entering or exiting Niven Parade may not identify a vehicle undertaking an overtake manoeuvring in the southbound direction of Anambah Road, increasing the likelihood of a near or far-side crash.</p>

<p><i>Northbound view of centreline marking</i></p>	Rare	Moderate	Low	
13 – Stockpile Driveway Sight Lines	<p>There appears to be a Stockpile site and driveway located at approximate Chainage 2000. The driveway is located slightly south of the horizontal curve on Anambah Road. Sight lines for vehicles exiting the Stockpile driveway may be inadequate due to the impacts of the horizontal curve and road side vegetation.</p> <p>There is a risk of far-side crashes between vehicles exiting the Stockpile driveway and southbound vehicles on Anambah Road.</p>	Rare	Serious	Medium (FSI)

ITEM 12:
OVERTAKING NEAR INTERSECTIONS
PROVIDE UNBROKEN CENTRELINE MARKINGS TO RESTRICT OVERTAKING MOVEMENTS 100m NORTH OF ANAMBDAH ROAD / NIVEN PARADE INTERSECTION.

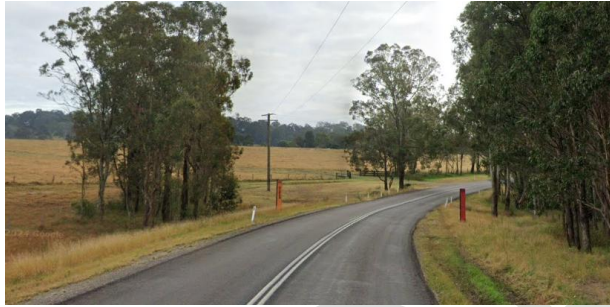
AUDIT FINDING REFERENCE	ROAD SAFETY AUDIT FINDING	LIKELIHOOD	SEVERITY	LEVEL OF RISK	PROJECT MANAGER RESPONSES
14 – Unprotected embankments	<p>There is an unprotected embankment and culvert / headwall located at Chainage 0 to 100. The location of this horizontal curve is downgrade for northbound vehicles. There is a curve advisory sign with 75 km/h advisory speed on approach for northbound vehicle.</p> <p>The location of the curve on a downgrade may result in a run-off road crash, particularly during inclement weather conditions or high travel speed. The presence of vertical drop and headwall near the culvert may increase the severity of a crash in this location.</p>

<p>Northbound view of right-hand curve with embankment on passenger (left-hand) side.</p>	Rare	Serious	Medium (FSI)

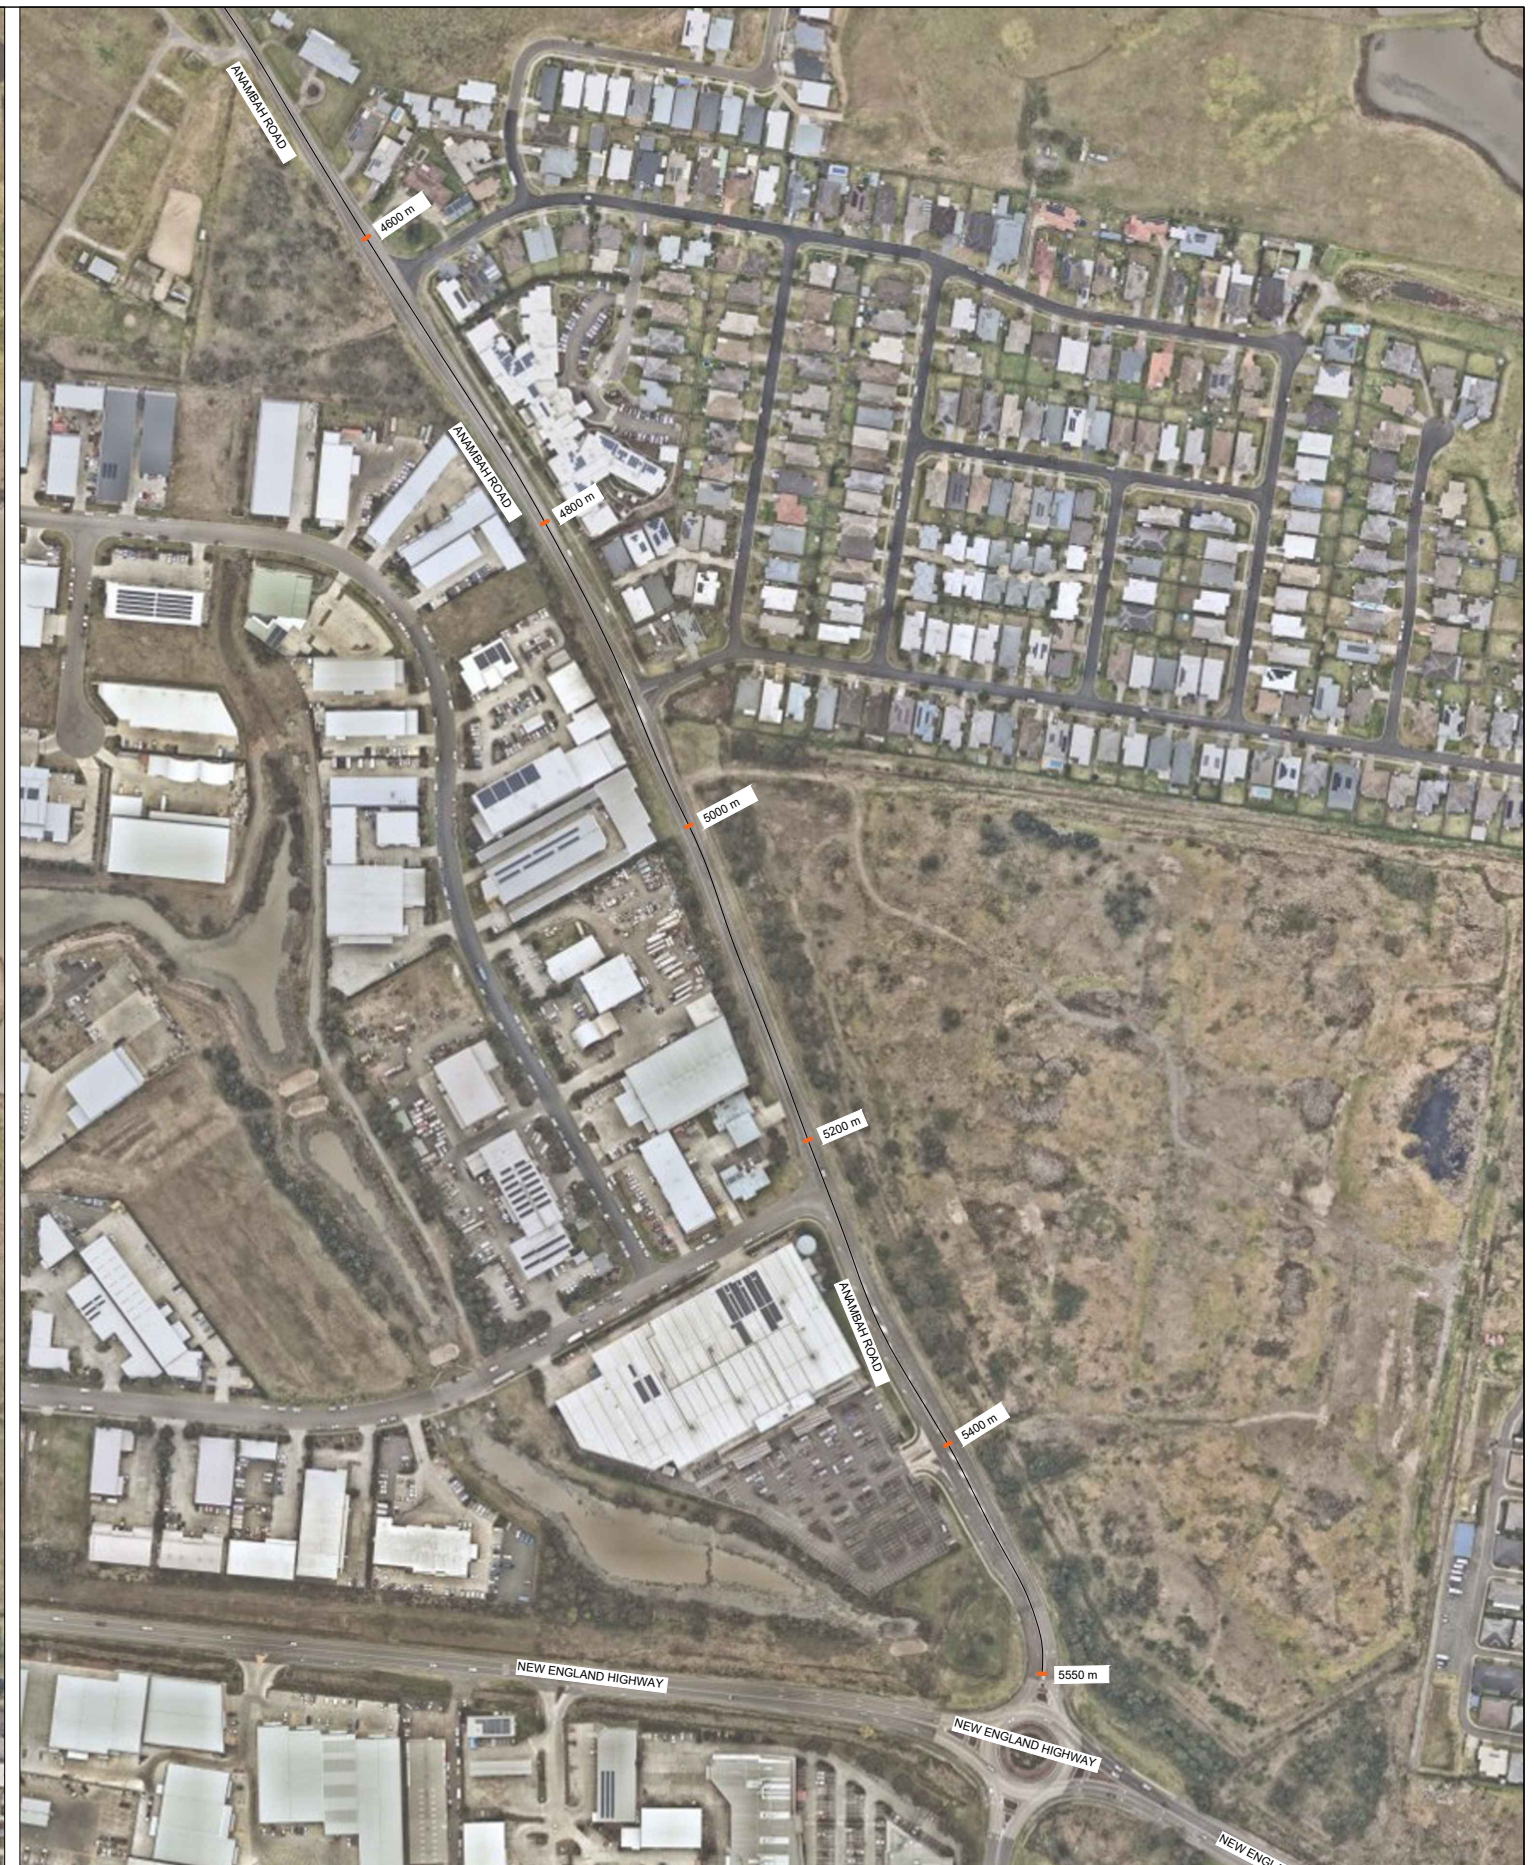
<table><tr> <td style="width: 50%;">Drawing No. 002</td> <td style="width: 50%;">Revision No.</td> </tr></table>

<p>Drawing Prepared By</p>  	<p>North</p>  	<p>Swept Path Key</p> <ul style="list-style-type: none"> ----- Vehicle Wheel Path ----- Vehicle Body Envelope ----- 300mm Vehicle Clearance 	<p>Project Anambah Road, Gosforth</p> <p>Project No 24.224</p>	<p>Drawing Title Anambah Road / New England Highway Chainage Plan Section 3 & 4</p> <p>Sheet Status NOT FOR CONSTRUCTION</p>

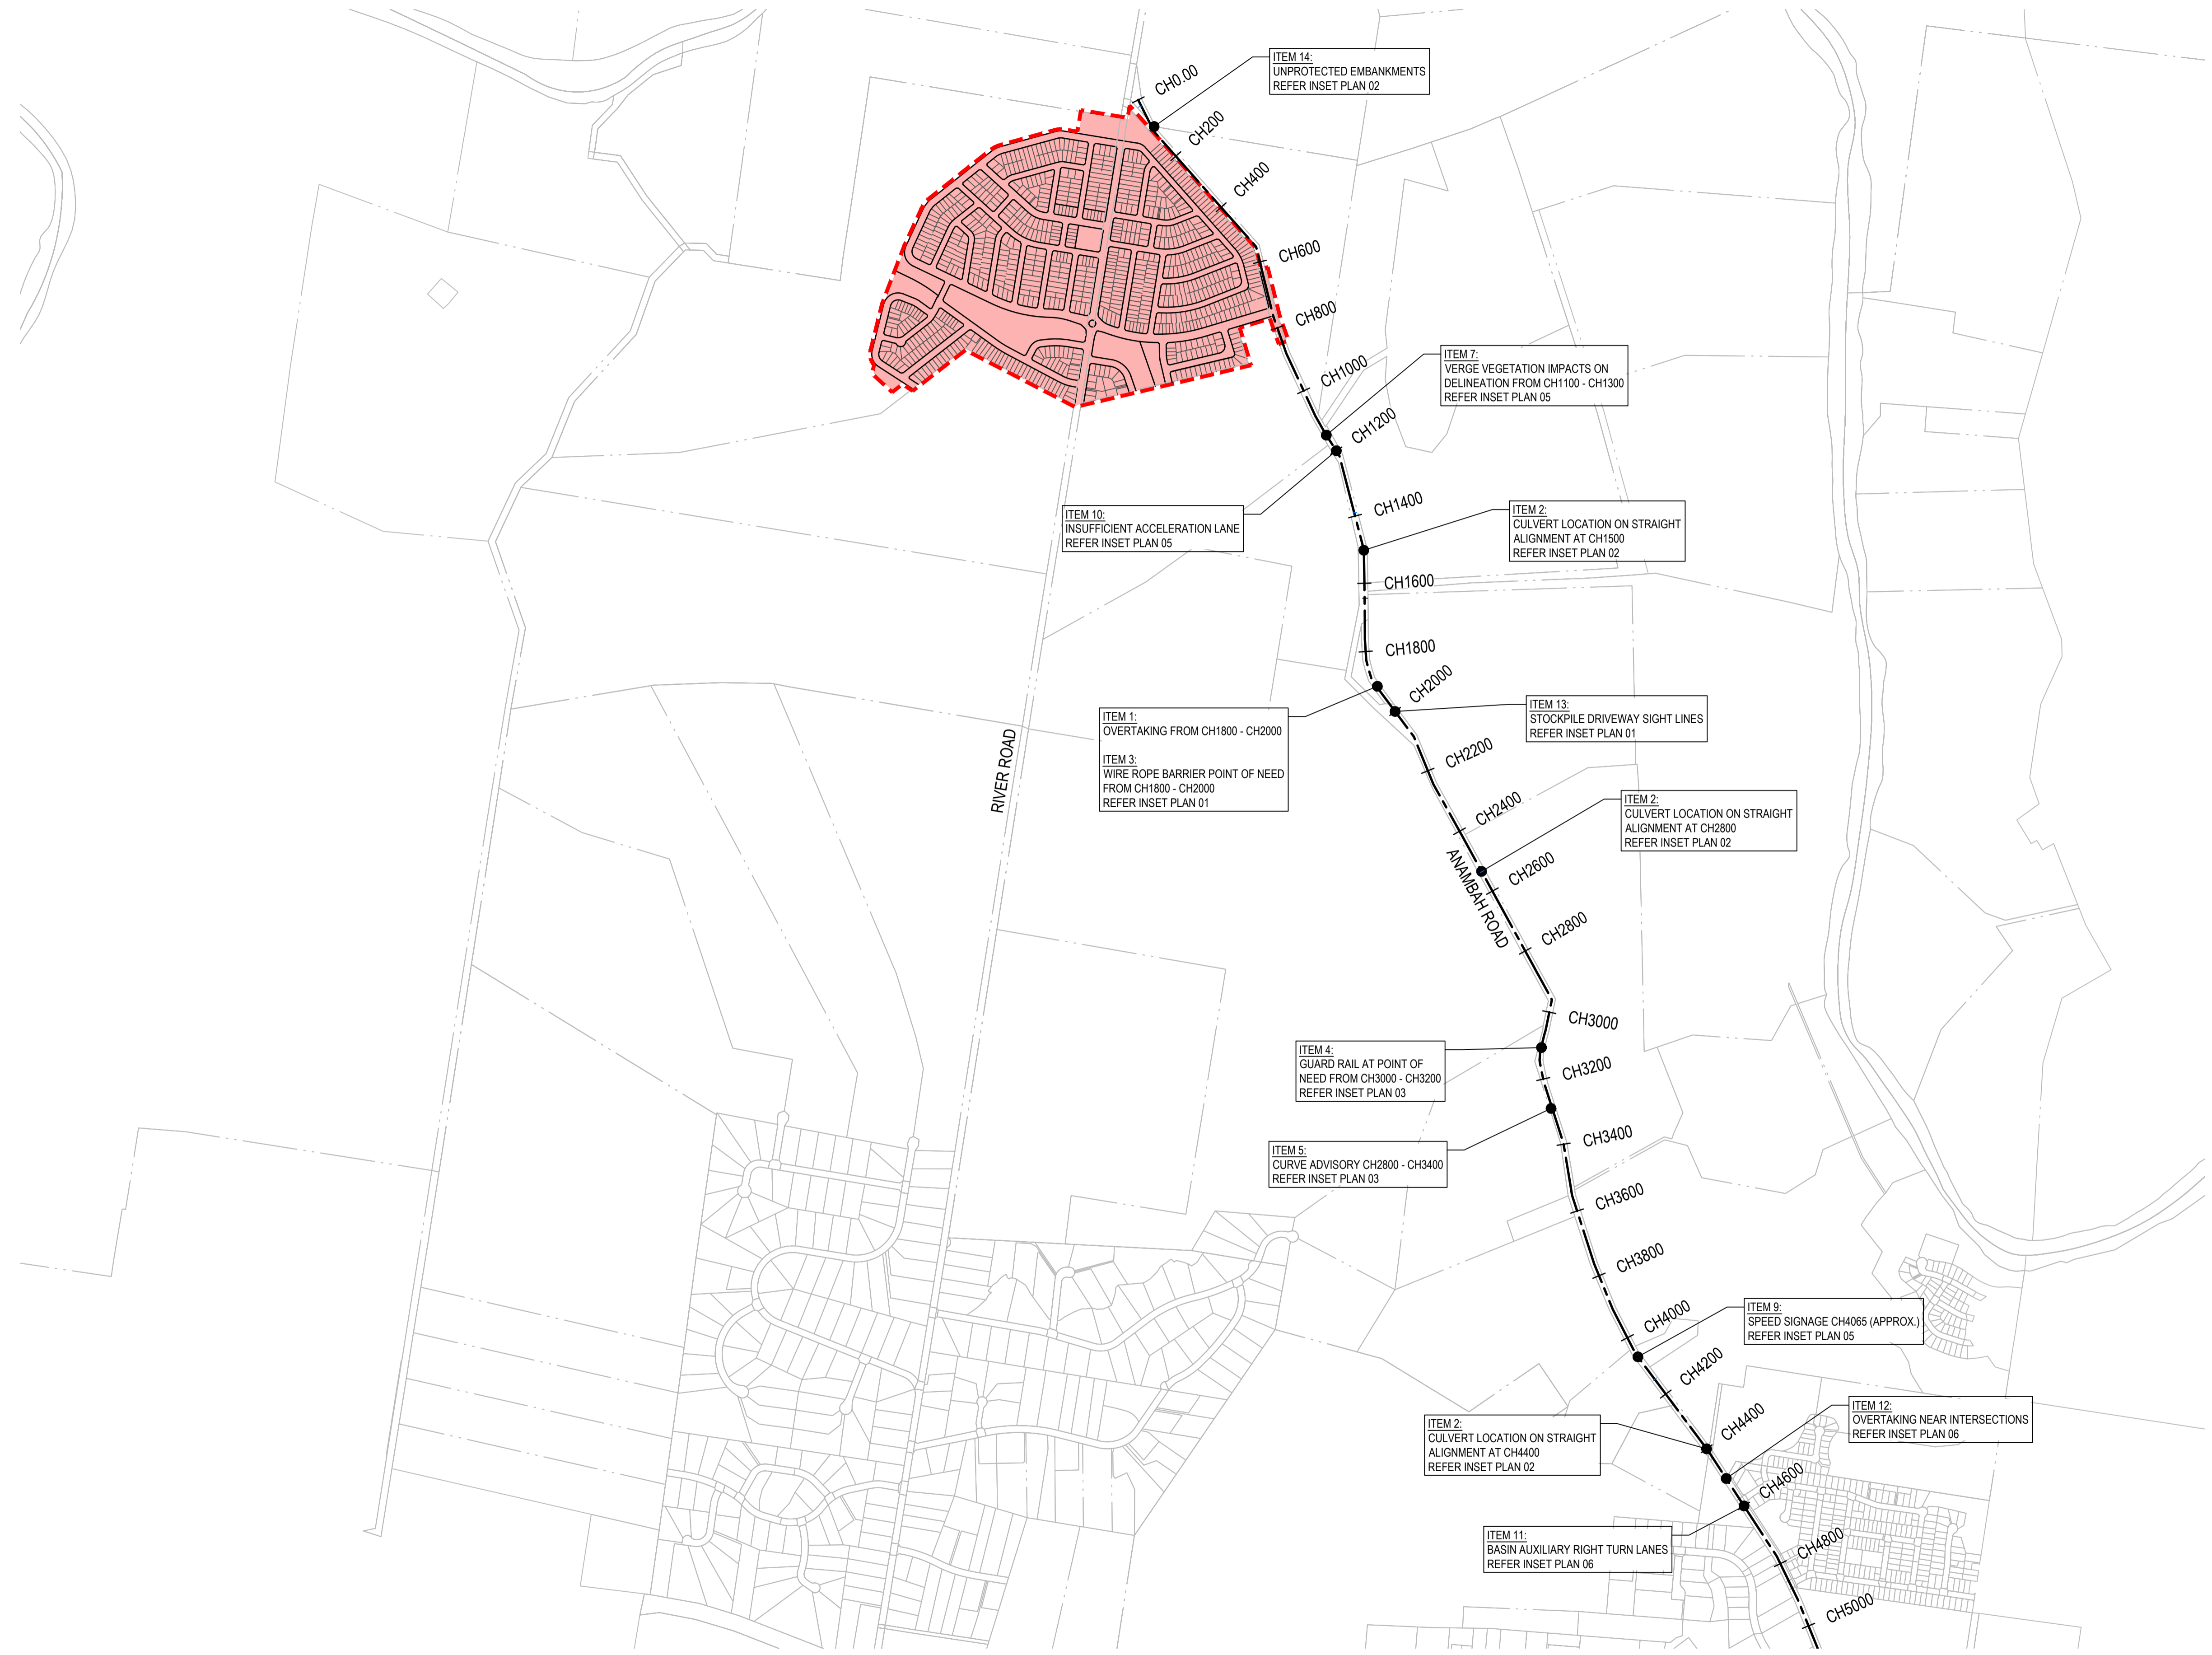
DRAWING TITLE
ANAMBAH ROAD - ROAD SAFETY AUDIT FINDINGS OVERVIEW PLAN

ITEM 6 - VERGE VEGETATION IMPACTS ON PAVEMENT

ITEM 8 - GUIDE POST REFLECTIVITY

THERE ARE SEGMENTS OF ROAD WHERE THE EDGE OF BITUMEN HAS EVIDENCE OF GRASS / WEED GROWTH AND OVER TIME THIS GROWTH MAY IMPACT THE STRUCTURAL INTEGRITY OF THE PAVEMENT THROUGH DEGRADATION OF THE EDGE OF BITUMEN. DETAILED SURVEILLANCE OF THE EAST AND WESTERN SIDES OF ANAMBAH ROAD SHOULD BE UNDERTAKEN AND WHERE VEGETATION IS OBSERVED GROWING IN TO THE EDGE OF THE PAVEMENT THEN IT SHALL BE REMOVED (PHYSICAL REMOVAL, SPRAYING, ETC) TO REDUCE THE POTENTIAL EROSION DEGRADATION PROCESS.

MISSING OR DAMAGED GUIDE POSTS WERE OBSERVED. DETAILED SURVEILLANCE OF THE EAST AND WESTERN SIDES OF ANAMBAH ROAD SHOULD BE UNDERTAKEN AND WHERE DAMAGE TO EXISTING GUIDE POSTS IS OBSERVED THEY SHALL BE RECTIFIED OR REPLACED, AND WHERE MISSING GUIDE POSTS ARE OBSERVED THEY SHALL BE REPLACED WITH NEW.

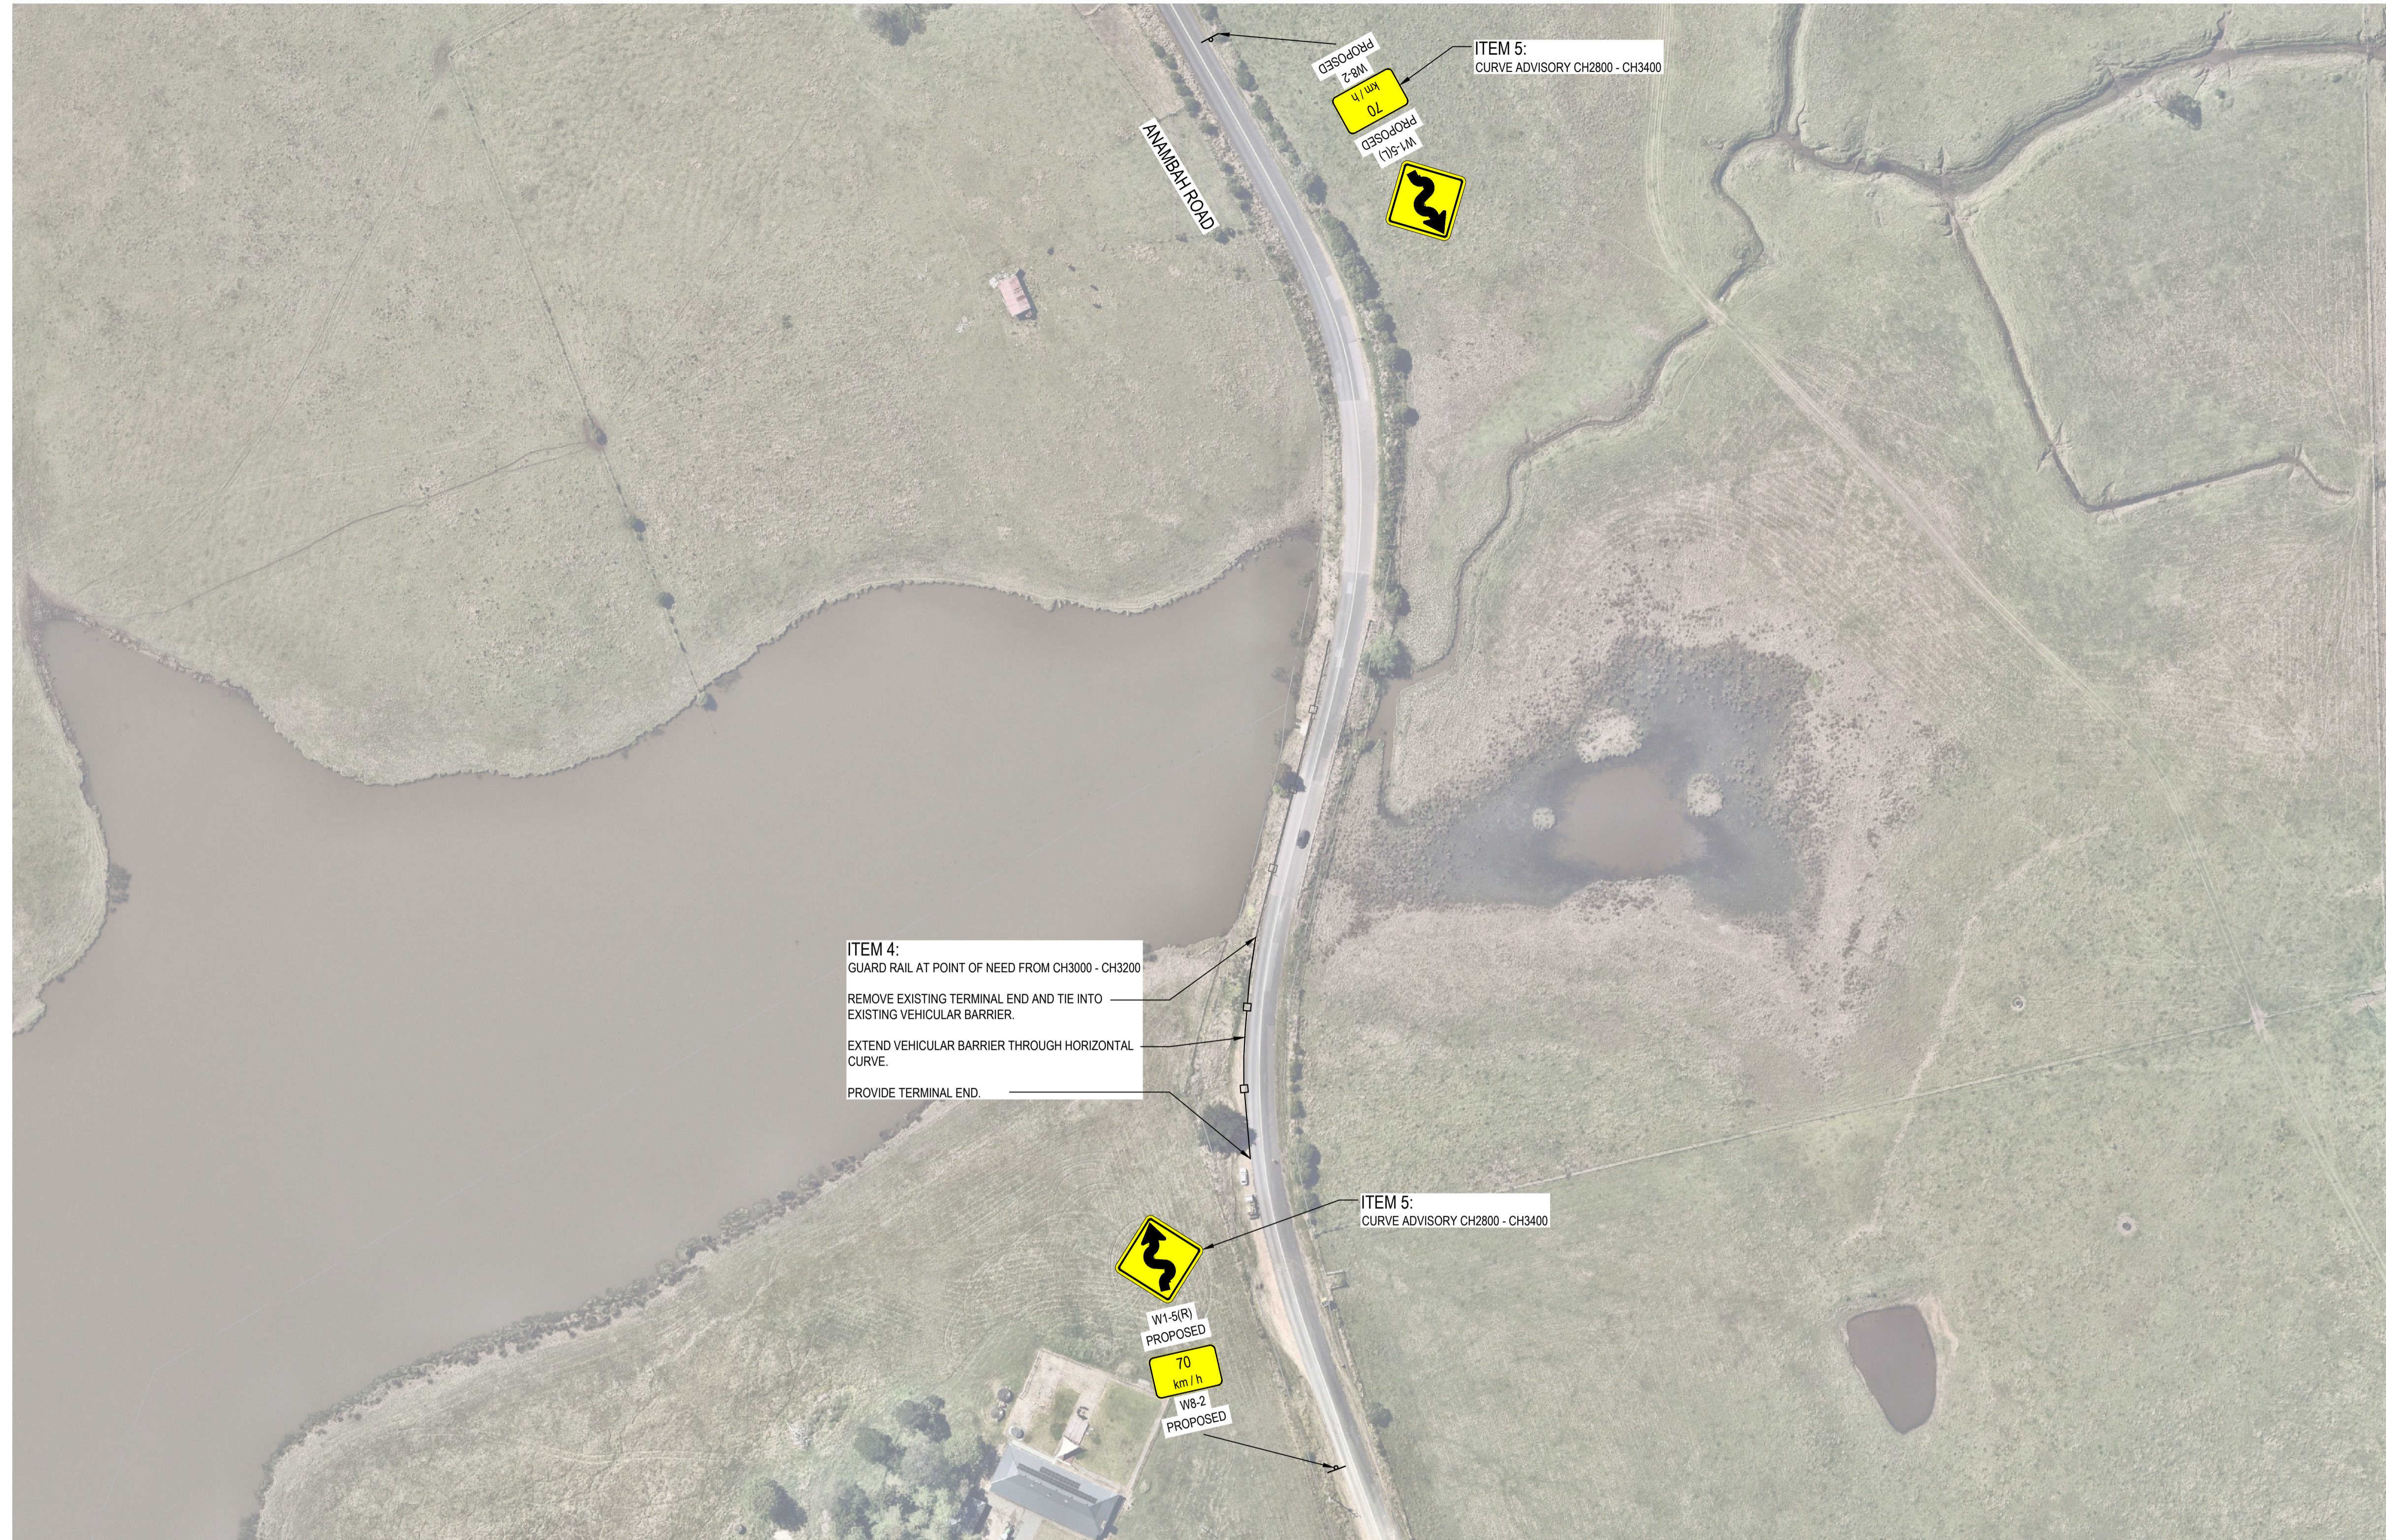
ITEM 5:
 CURVE ADVISORY CH2800 - CH3400

AUDIT FINDING REFERENCE	ROAD SAFETY AUDIT FINDING (SEE RSA REPORT PREPARED BY PDC CONSULTANTS FOR FULL DESCRIPTION)	INITIAL RISK (AS IDENTIFIED IN RSA REPORT BY OTHERS)			DESIGN ACTION / REMEDIATION	RESIDUAL RISK			PERSON RESPONSIBLE FOR CONTROLS
		LIKELIHOOD	SEVERITY	LEVEL OF RISK		LIKELIHOOD	SEVERITY	LEVEL OF RISK	
4	GUARDRAIL POINT OF NEED	UNLIKELY	SERIOUS	HIGH (FSI)	EXTEND GUARDRAIL TO FULL EXTENT OF HORIZONTAL CURVE	RARE	MODERATE	LOW	DEVELOPER
5	CURVE ADVISORY	RARE	SERIOUS	MEDIUM (FSI)	PROVIDE WARNING SIGNAGE AHEAD OF HORIZONTAL CURVES IN BOTH DIRECTIONS OF TRAVEL	RARE	SERIOUS	MEDIUM (FSI)	DEVELOPER

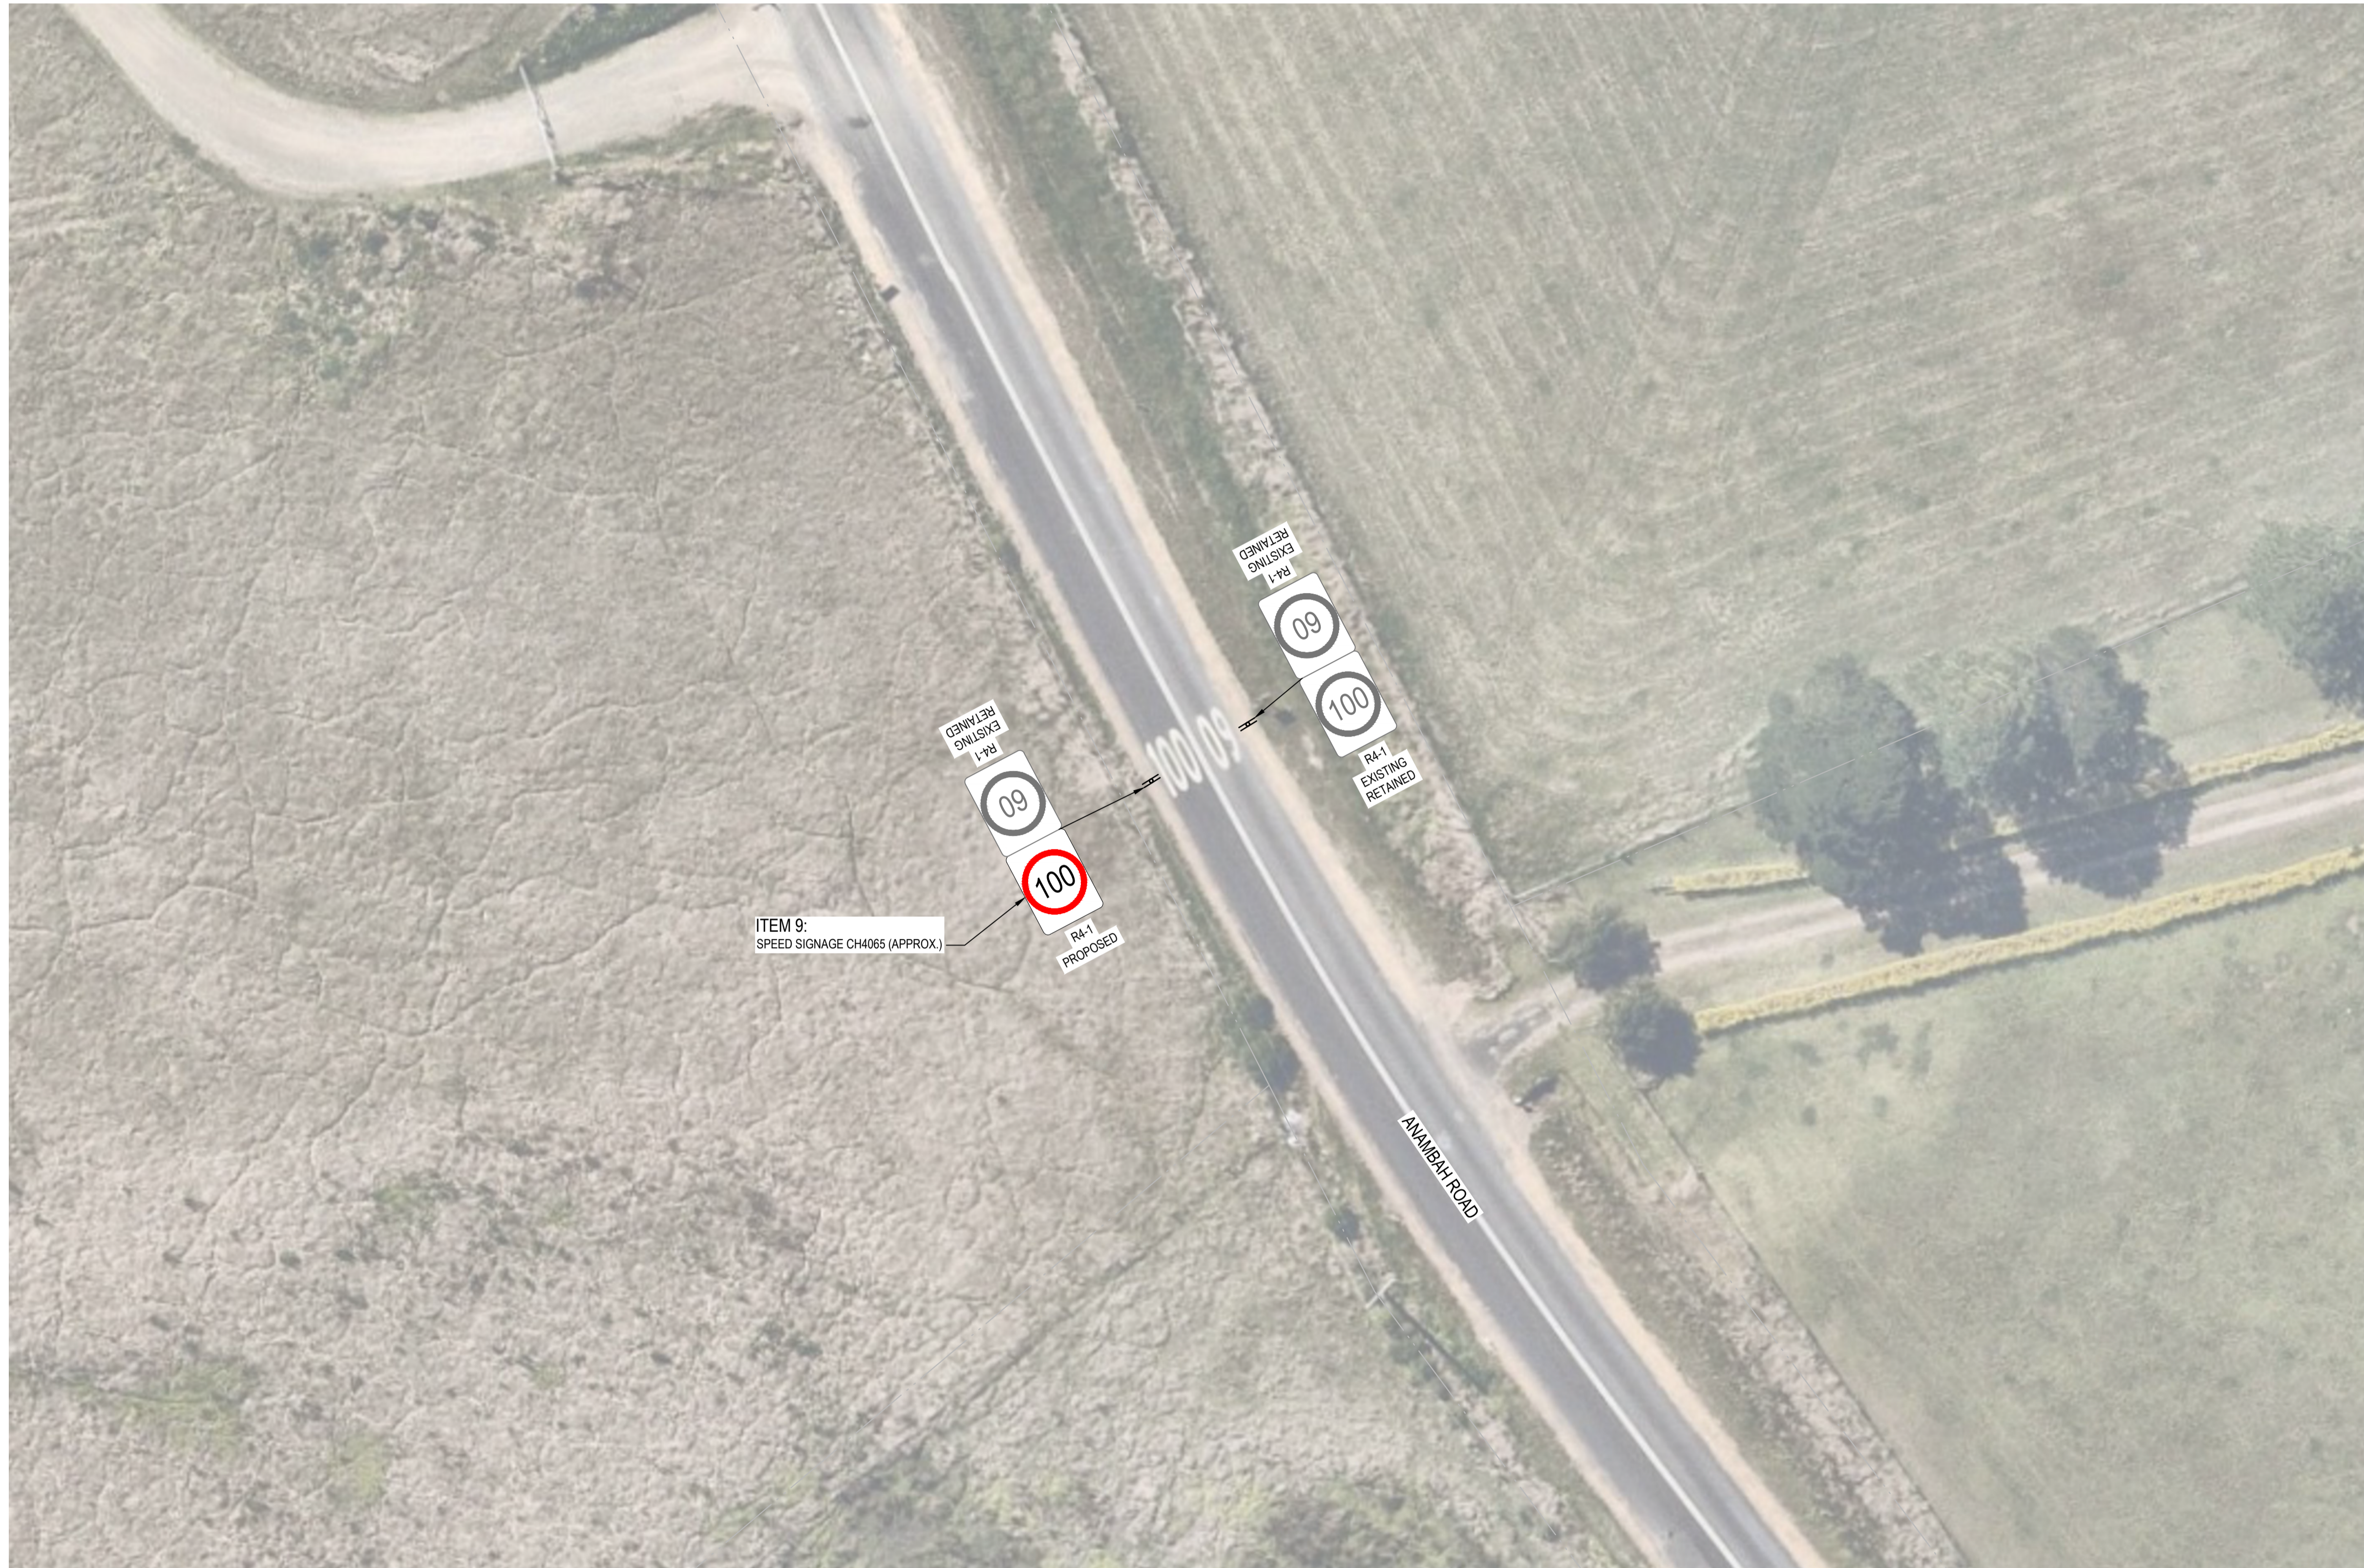
PROJECT - SET - DRAWING - SHEET	REVISION
250055-SK-009-04	A

9 – Speed Signage	<p>There appears to be speed zone signage missing at the speed zone change approximately 520m north of Niven Parade.</p> <p>The missing or lack of speed signage may result in drivers adopting a higher speed, which may increase the severity of a crash should one occur.</p> <p>It is notes that a single sign and pavement markings are provided to identify the speed zone signage, such that the likelihood is considered to be rare.</p>   <p><i>View of speed zone signage and missing sign on passenger (left hand) side</i></p>	Rare	Moderate	Low

AUDIT FINDING REFERENCE	ROAD SAFETY AUDIT FINDING (SEE RSA REPORT PREPARED BY PDC CONSULTANTS FOR FULL DESCRIPTION)	INITIAL RISK (AS IDENTIFIED IN RSA REPORT BY OTHERS)			DESIGN ACTION / REMEDIATION	RESIDUAL RISK			PERSON RESPONSIBLE FOR CONTROLS
		LIKELIHOOD	SEVERITY	LEVEL OF RISK		LIKELIHOOD	SEVERITY	LEVEL OF RISK	
9	SPEED SIGNAGE	RARE	MODERATE	LOW	PROVIDE SPEED SIGNAGE ON LEFT HAND SIDE OF NORTHBOUND LANE AT SPEED LIMIT CHANGE	RARE	MODERATE	LOW	DEVELOPER
