PRELIMINARY ARBORIST REPORT

HILLSBOROUGH INDOOR STADIUM

9 October 2020
Rev: 2
AEP Ref: 2078.02

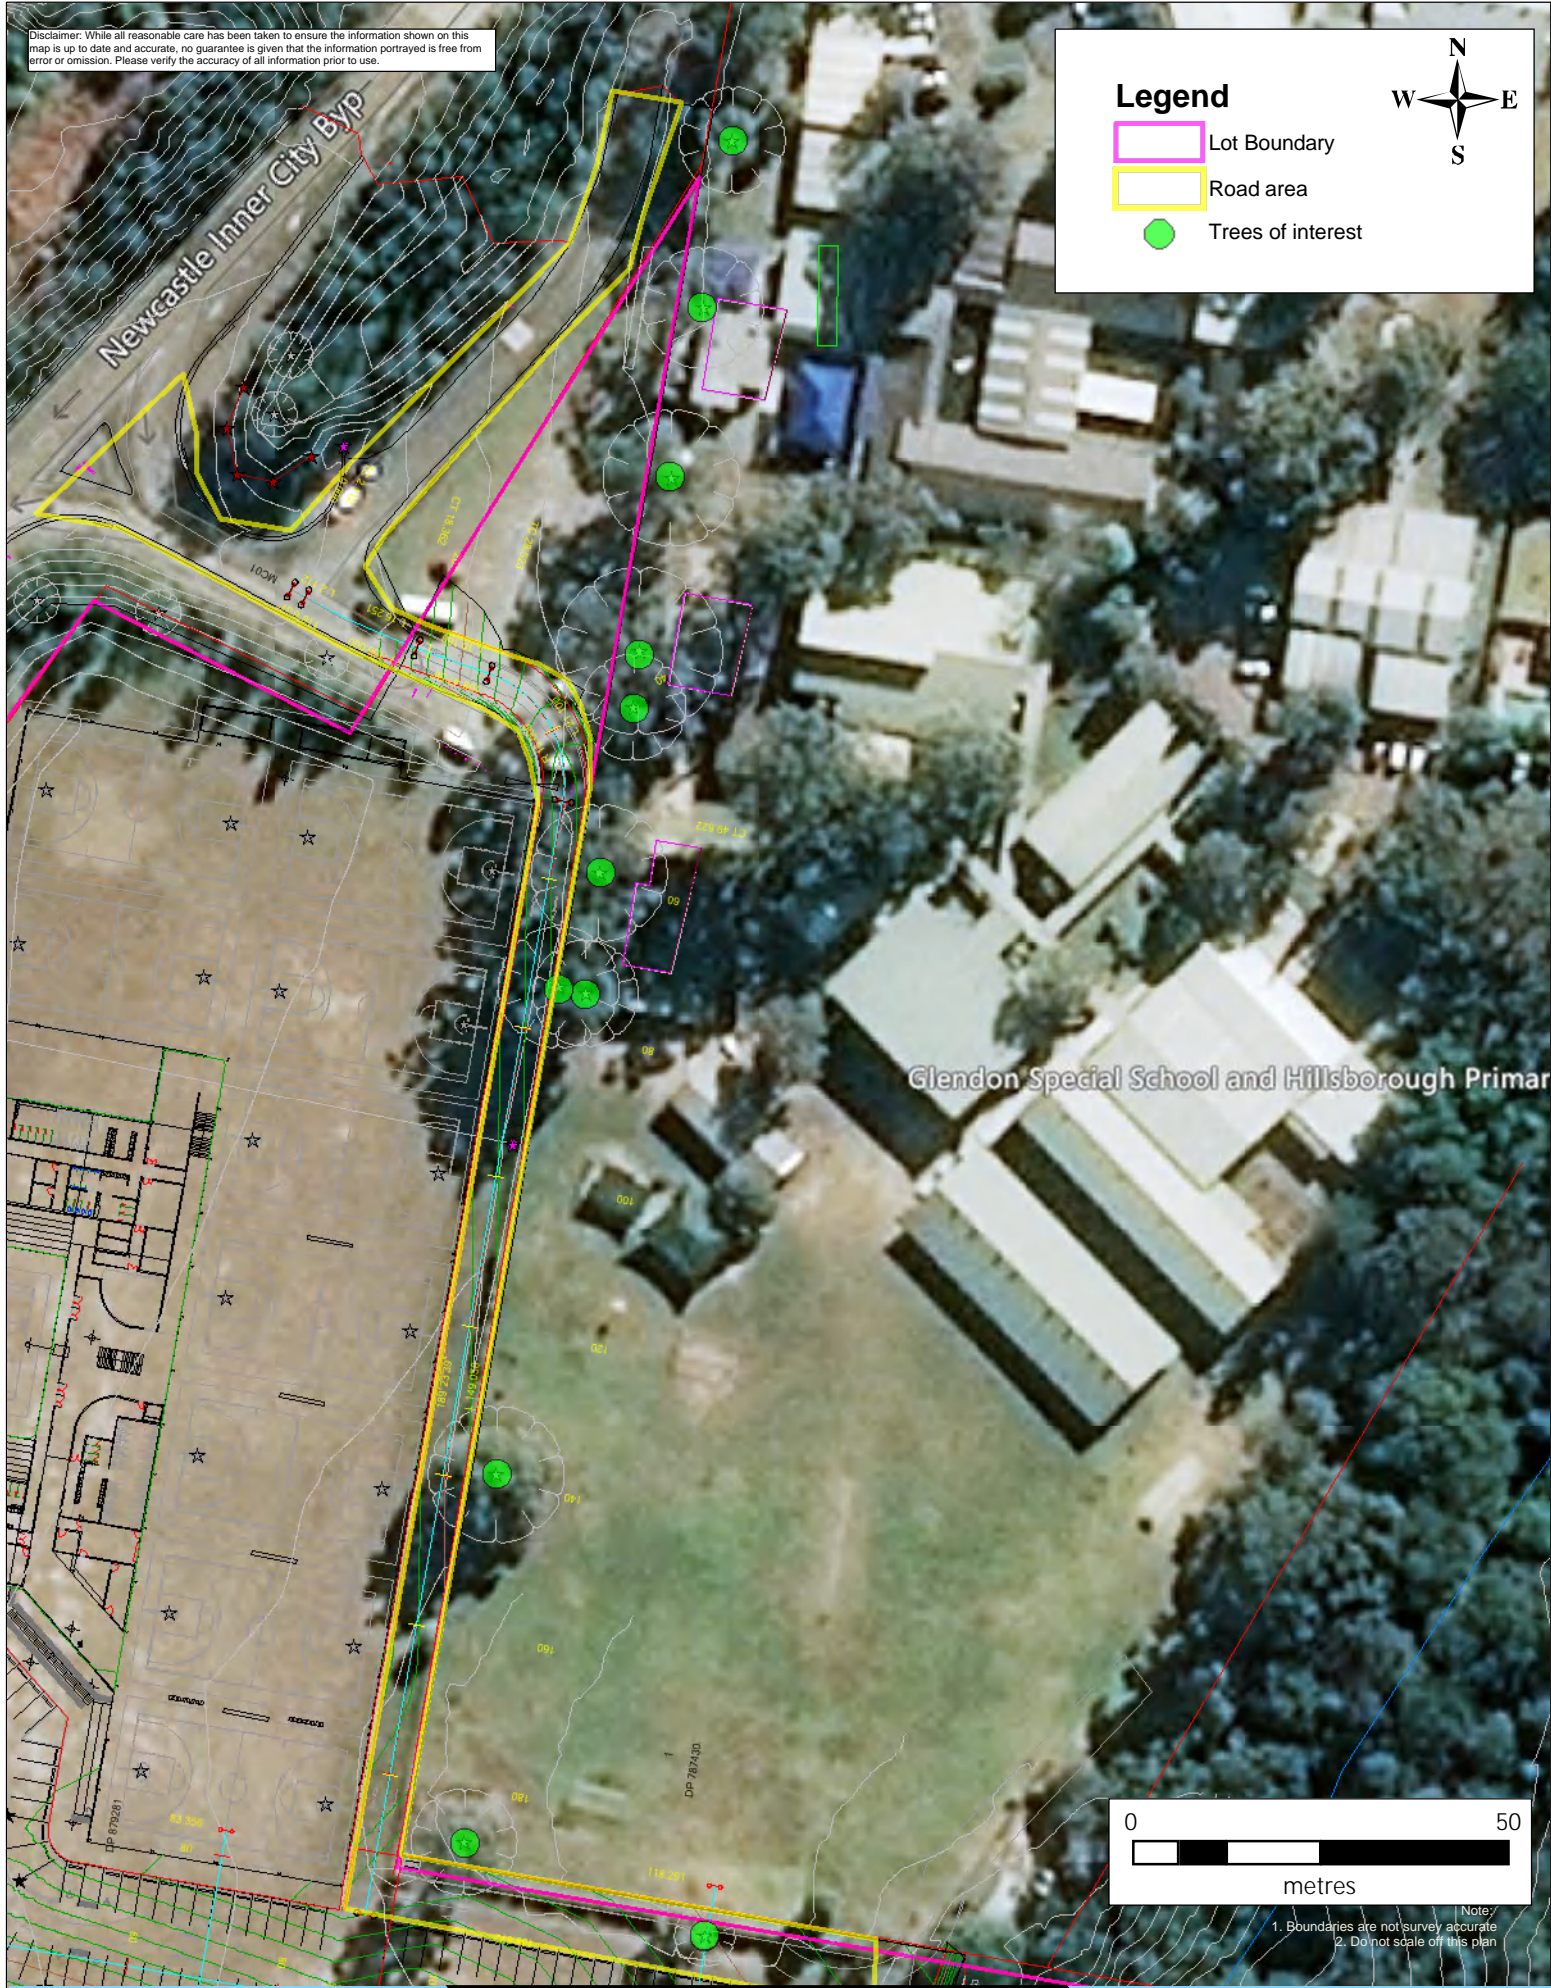
Tilte: Figure 2 - Proposed Development

Figure 1 depicts the land subject to the development assessment and **Figure 2** depicts the proposed development.

The site survey was undertaken on the Subject Site by David Cummings (AQF 5 Arborist). Trees surveyed included all trees provided on the survey plan shown in **(Figure 2)**. Each tree was distinguished by the reference number provided on the survey plans. Trees were identified to species based on guidance from regional identification guides (Fairley and Moore 1989, Robinson 2003), and descriptions and records provided by the Royal Botanic Gardens (Plantnet 2016).

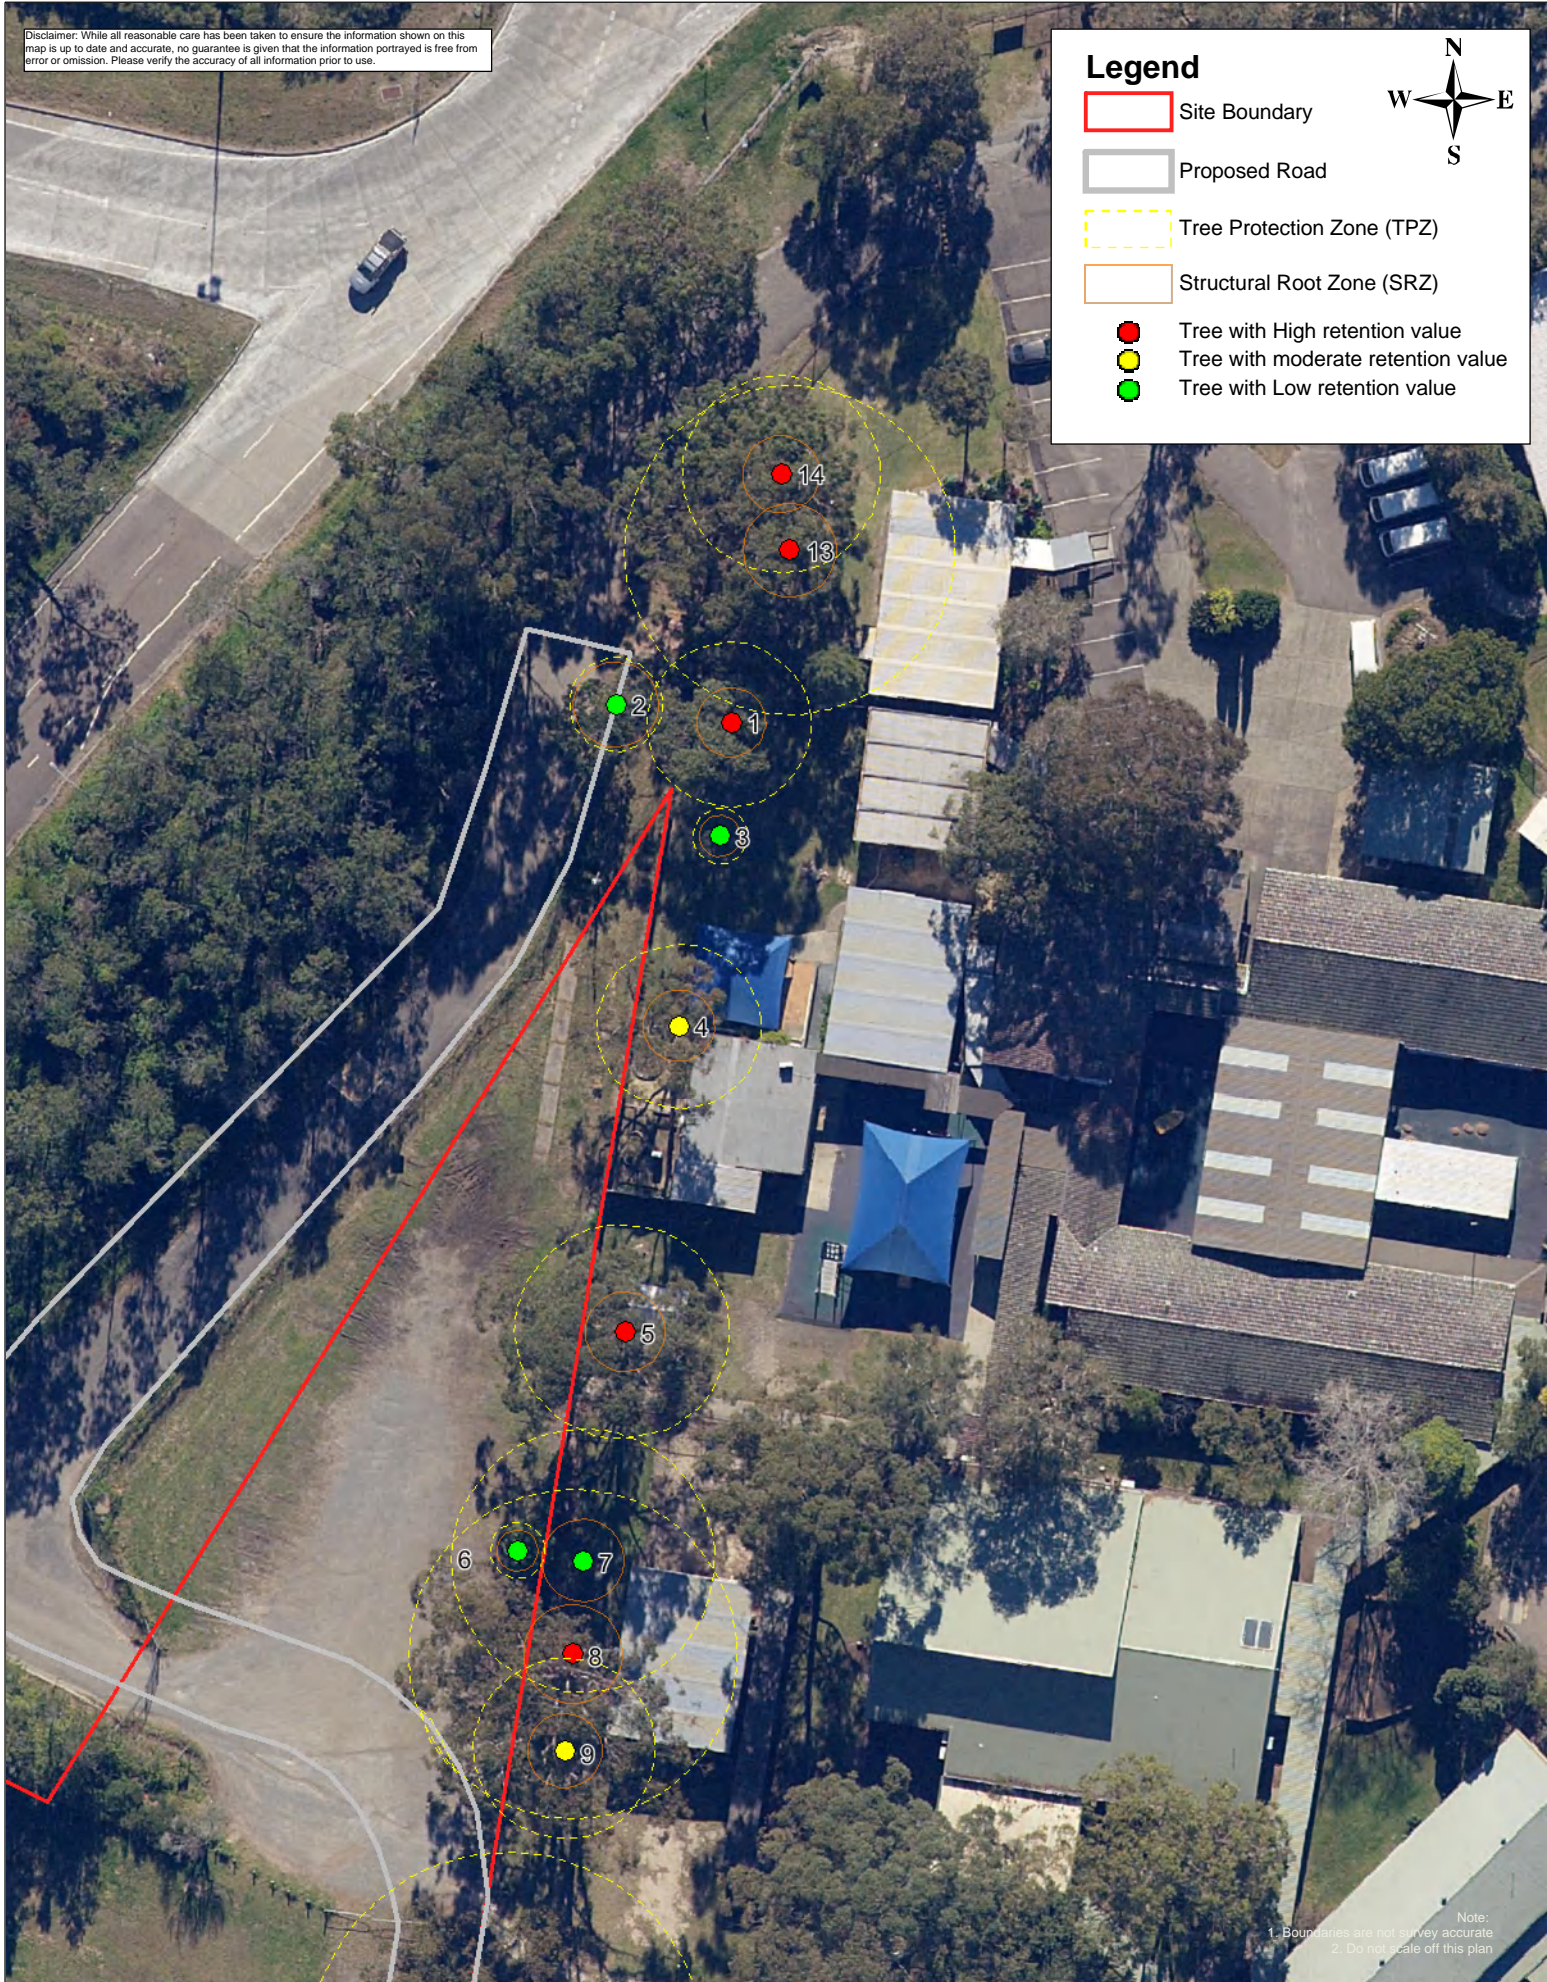
Title: Figure 3a - Tree Protection zones (North)

All assessed trees have been assigned a unique number and identified in **Figures 3 to 6**. Of the 23 trees assessed only six were located within the Subject Site, and the remainder (17) were located within the school grounds. Trees were in general native or locally indigenous and mature plantings.

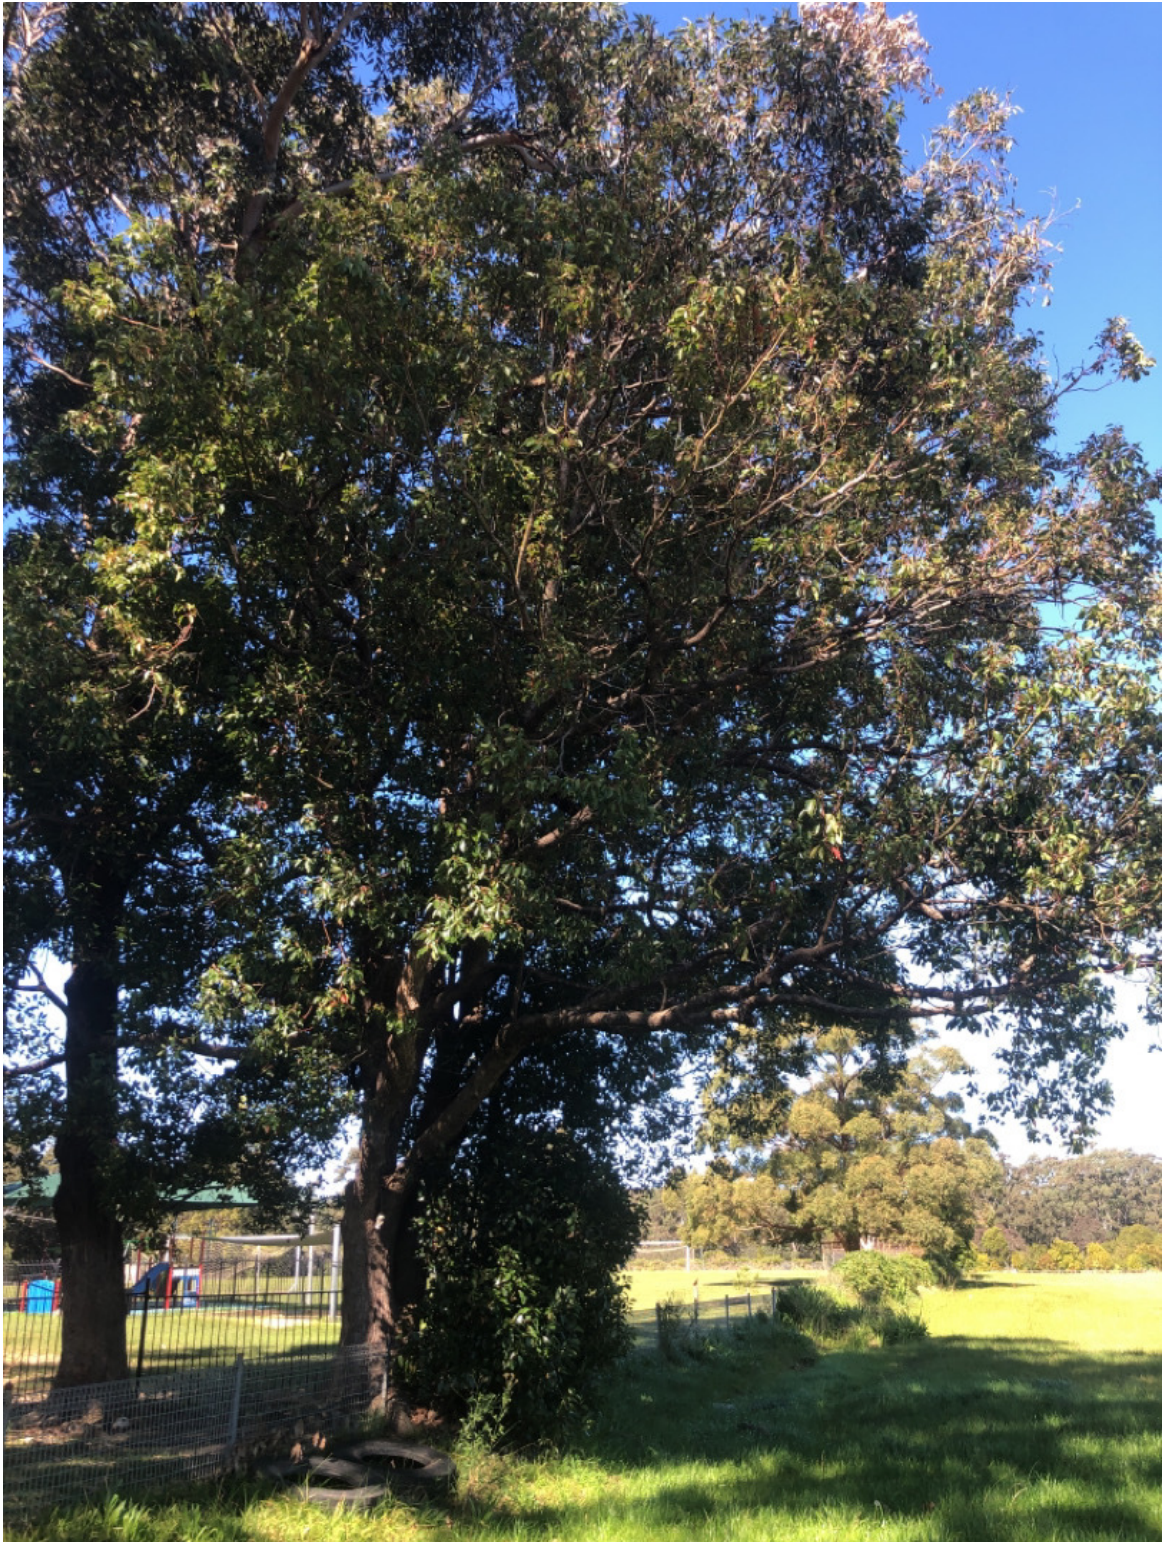
Plate 1 – View along western of boundary fence of the school facing south.

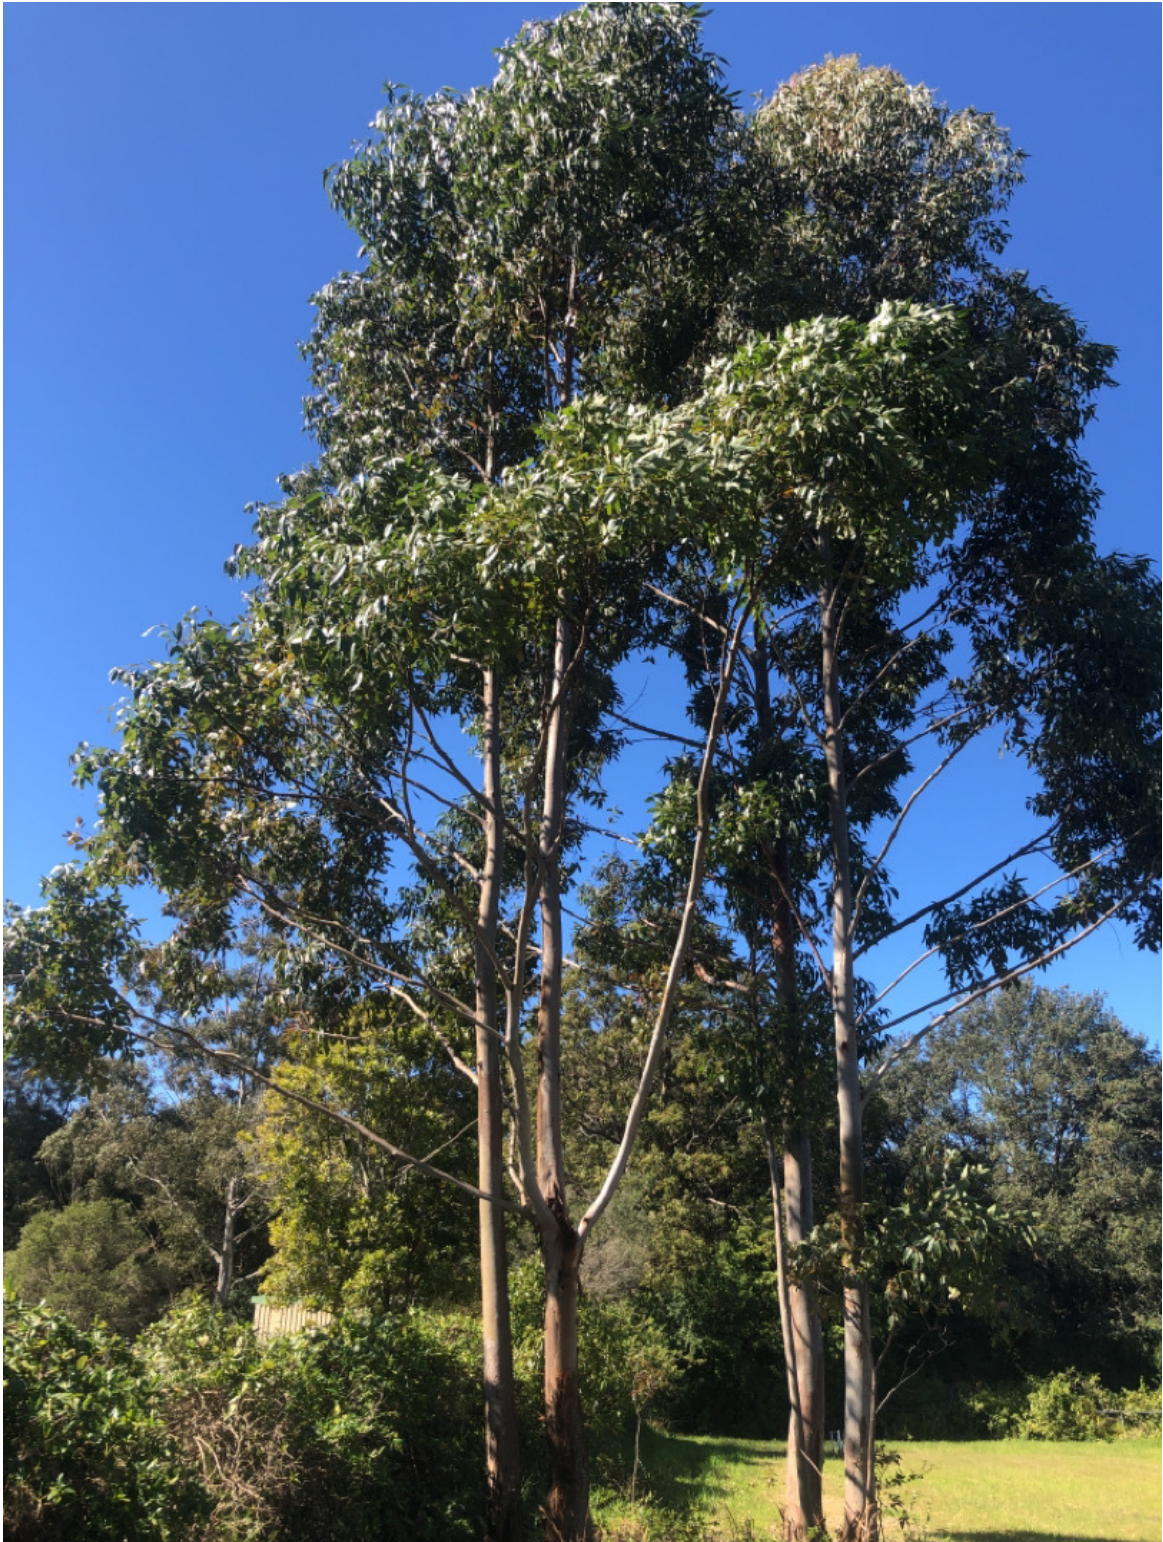
Plate 2 – View of trees along the southern boundary of the school facing east.
