Report on
Grouting and Verification Plan for 'Yard' / Dudley
Seam Workings

Newcastle City Art Gallery Expansion
1 Laman Street, Newcastle

Project 49737.03
September 2021

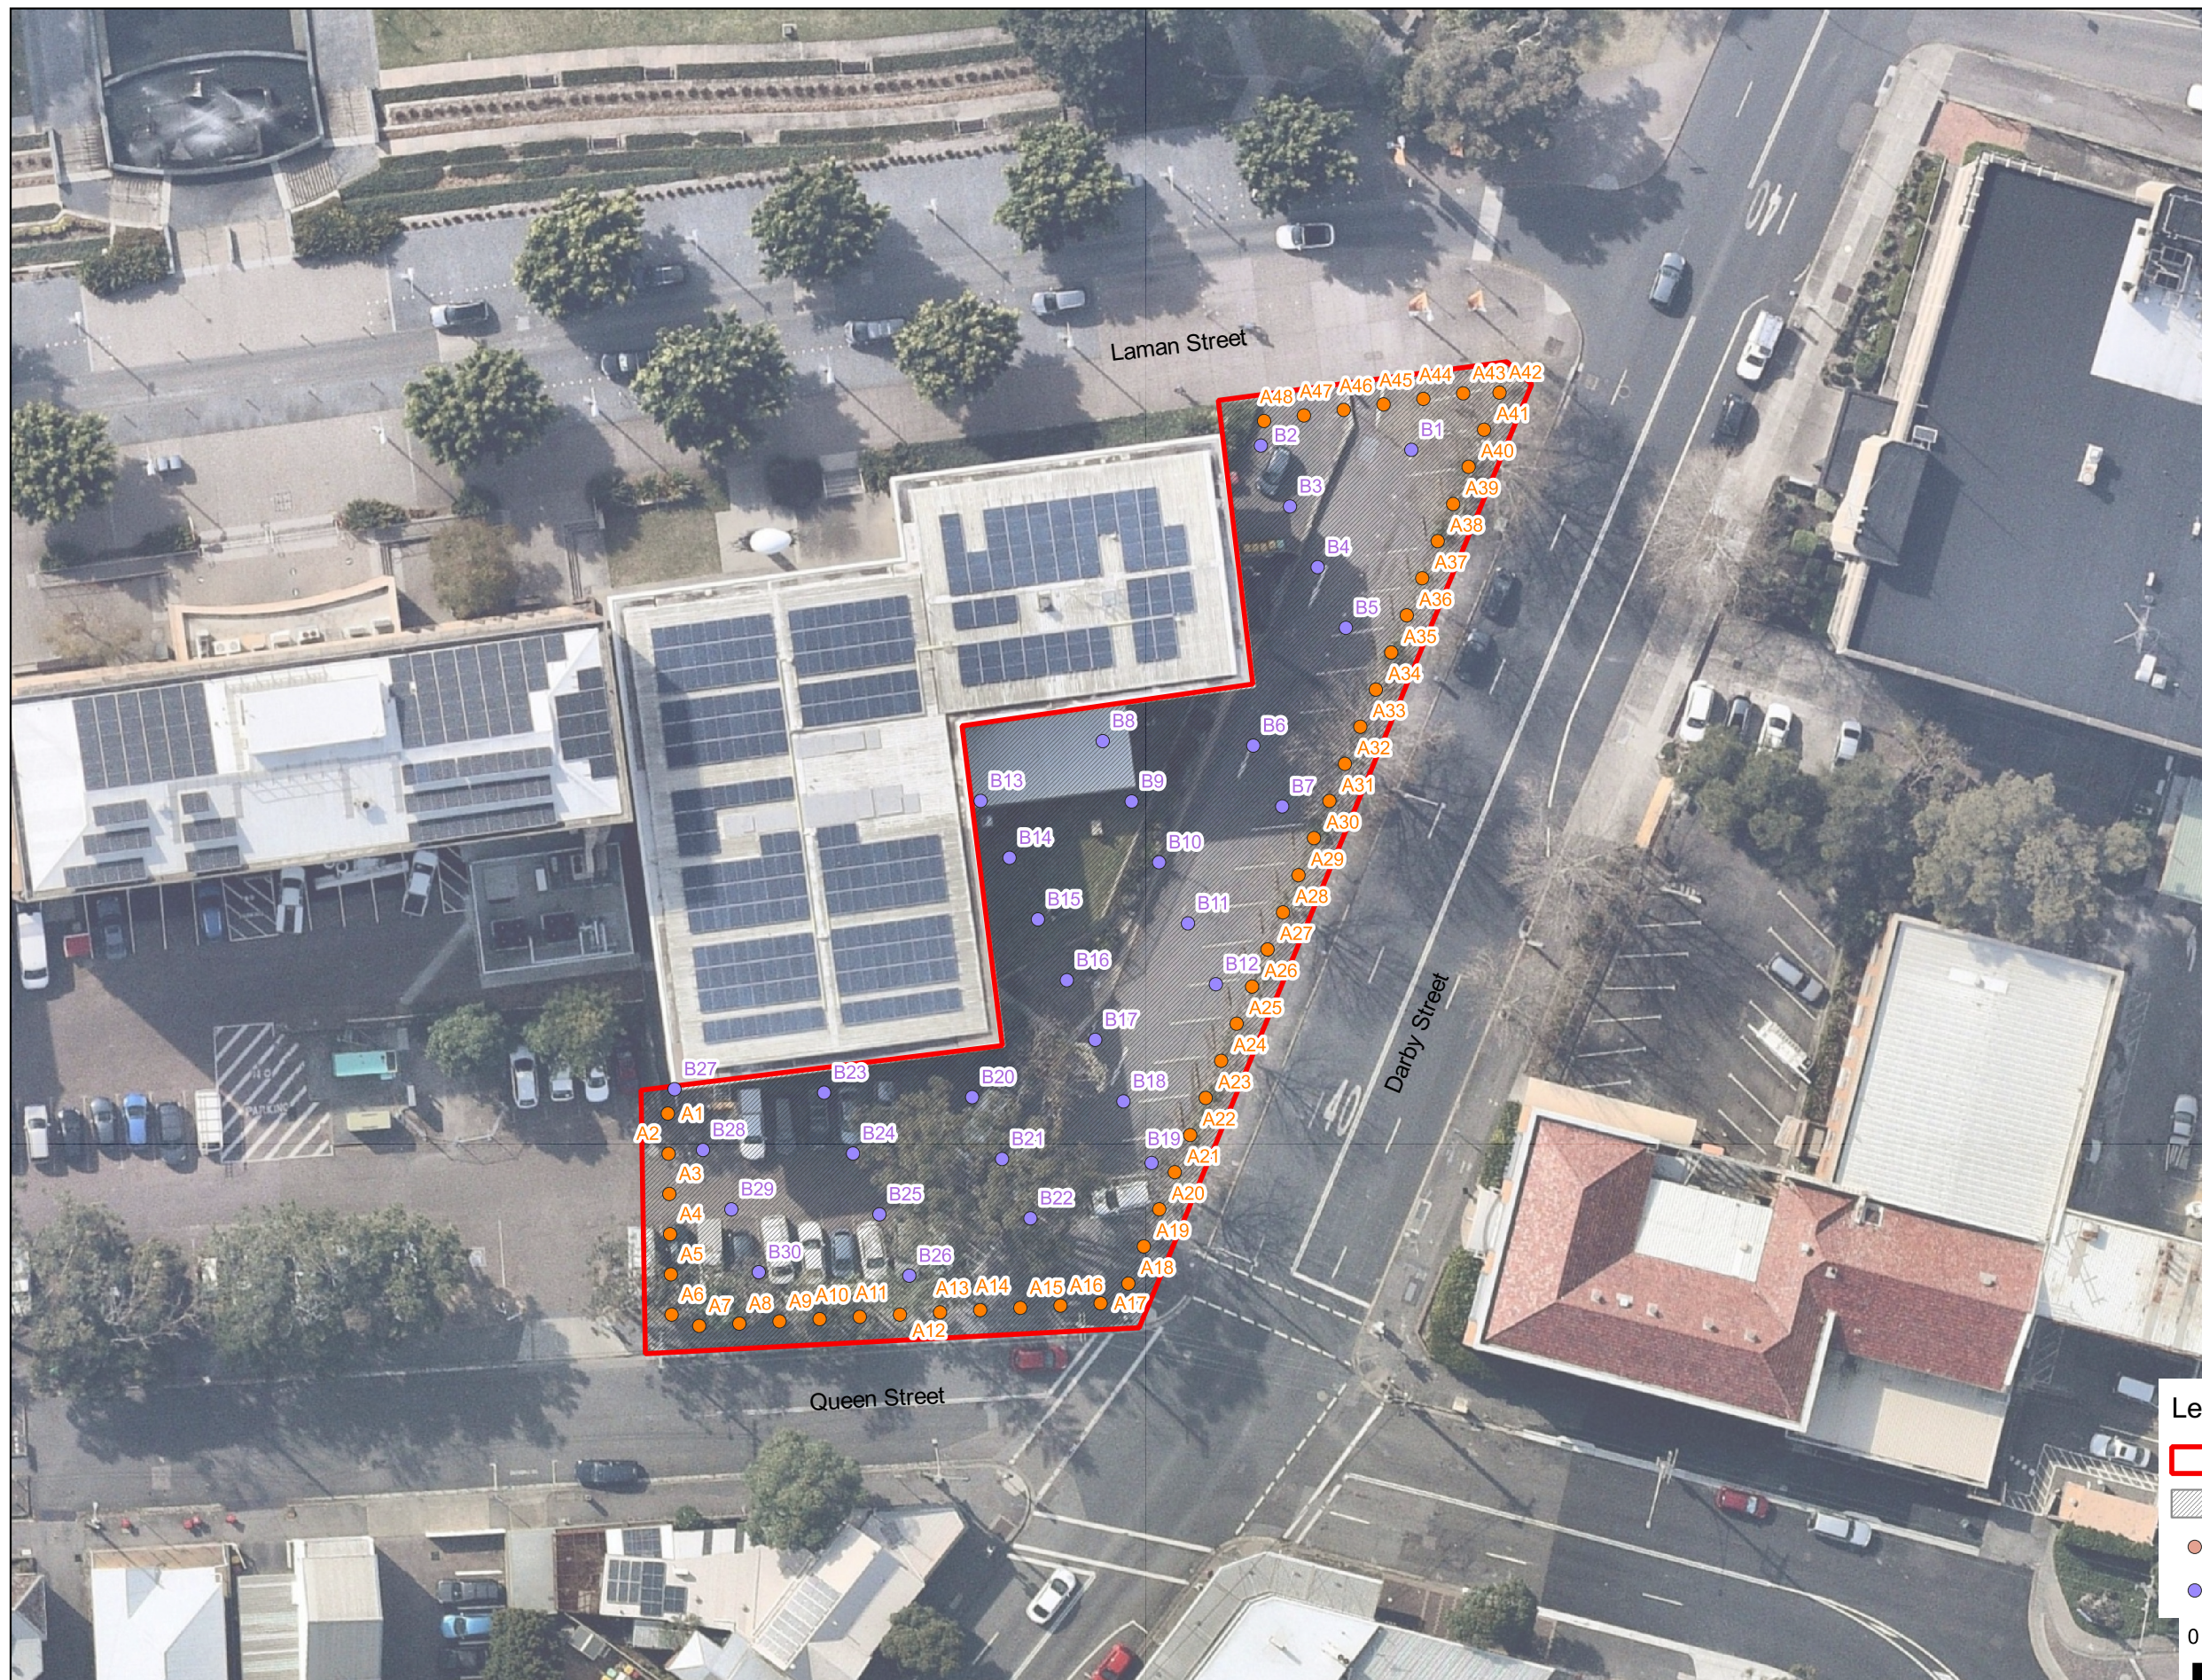
Drawing adapted from Nearmap image dated 02 September 2020

The bores required for the assessment of the workings, grouting and verification of grouting shall be drilled by the Grouting Contractor to achieve grouting of the target areas as presented in the attached drawing. The aim of the grouting is to grout areas at the site which are not occupied by the existing building. The 'area to be grouted' is shown on the drawing attached.

The approximate location of the proposed grout target bores are presented in the drawing attached. These bore locations are indicative and should be confirmed by the Grouting Contractor following assessment of in-ground services, drilling accessibility, layout of the workings and any necessary permits from authorities or the Principal. Alternate drilling locations shall be submitted to DP for approval.

- The perimeter bores should be drilled at 3 m spacing's around the site northern, eastern, and southern boundary as per the attached Drawing 1, and Table A attached. Where the stage boundary is located adjacent to an existing neighbouring development or existing site development, the bores shall be drilled by the Grouting Contractor at a distance of 1.0 m from the neighbouring development. Any voids identified during such drilling shall be grouted in accordance with this specification;

- Once the perimeter have been grouted and accepted by DP, internal primary bores located internal to the site should be drilled and grouted;
- The primary bores should be drilled at 10 m spacings, along bords (ie roadways) alignments , and bores drilled along 'lines' which are aligned in the north-east and south-west direction. The lines of bores should be a typical offset of 5 m from each other, and should be based on targeting boards from sonar readings. The primary bore locations need to be flexible and should be based on the results of 'mapping' from the bores as they progress. Refer to the attached Drawing 1 and Table A attached for a general guide;

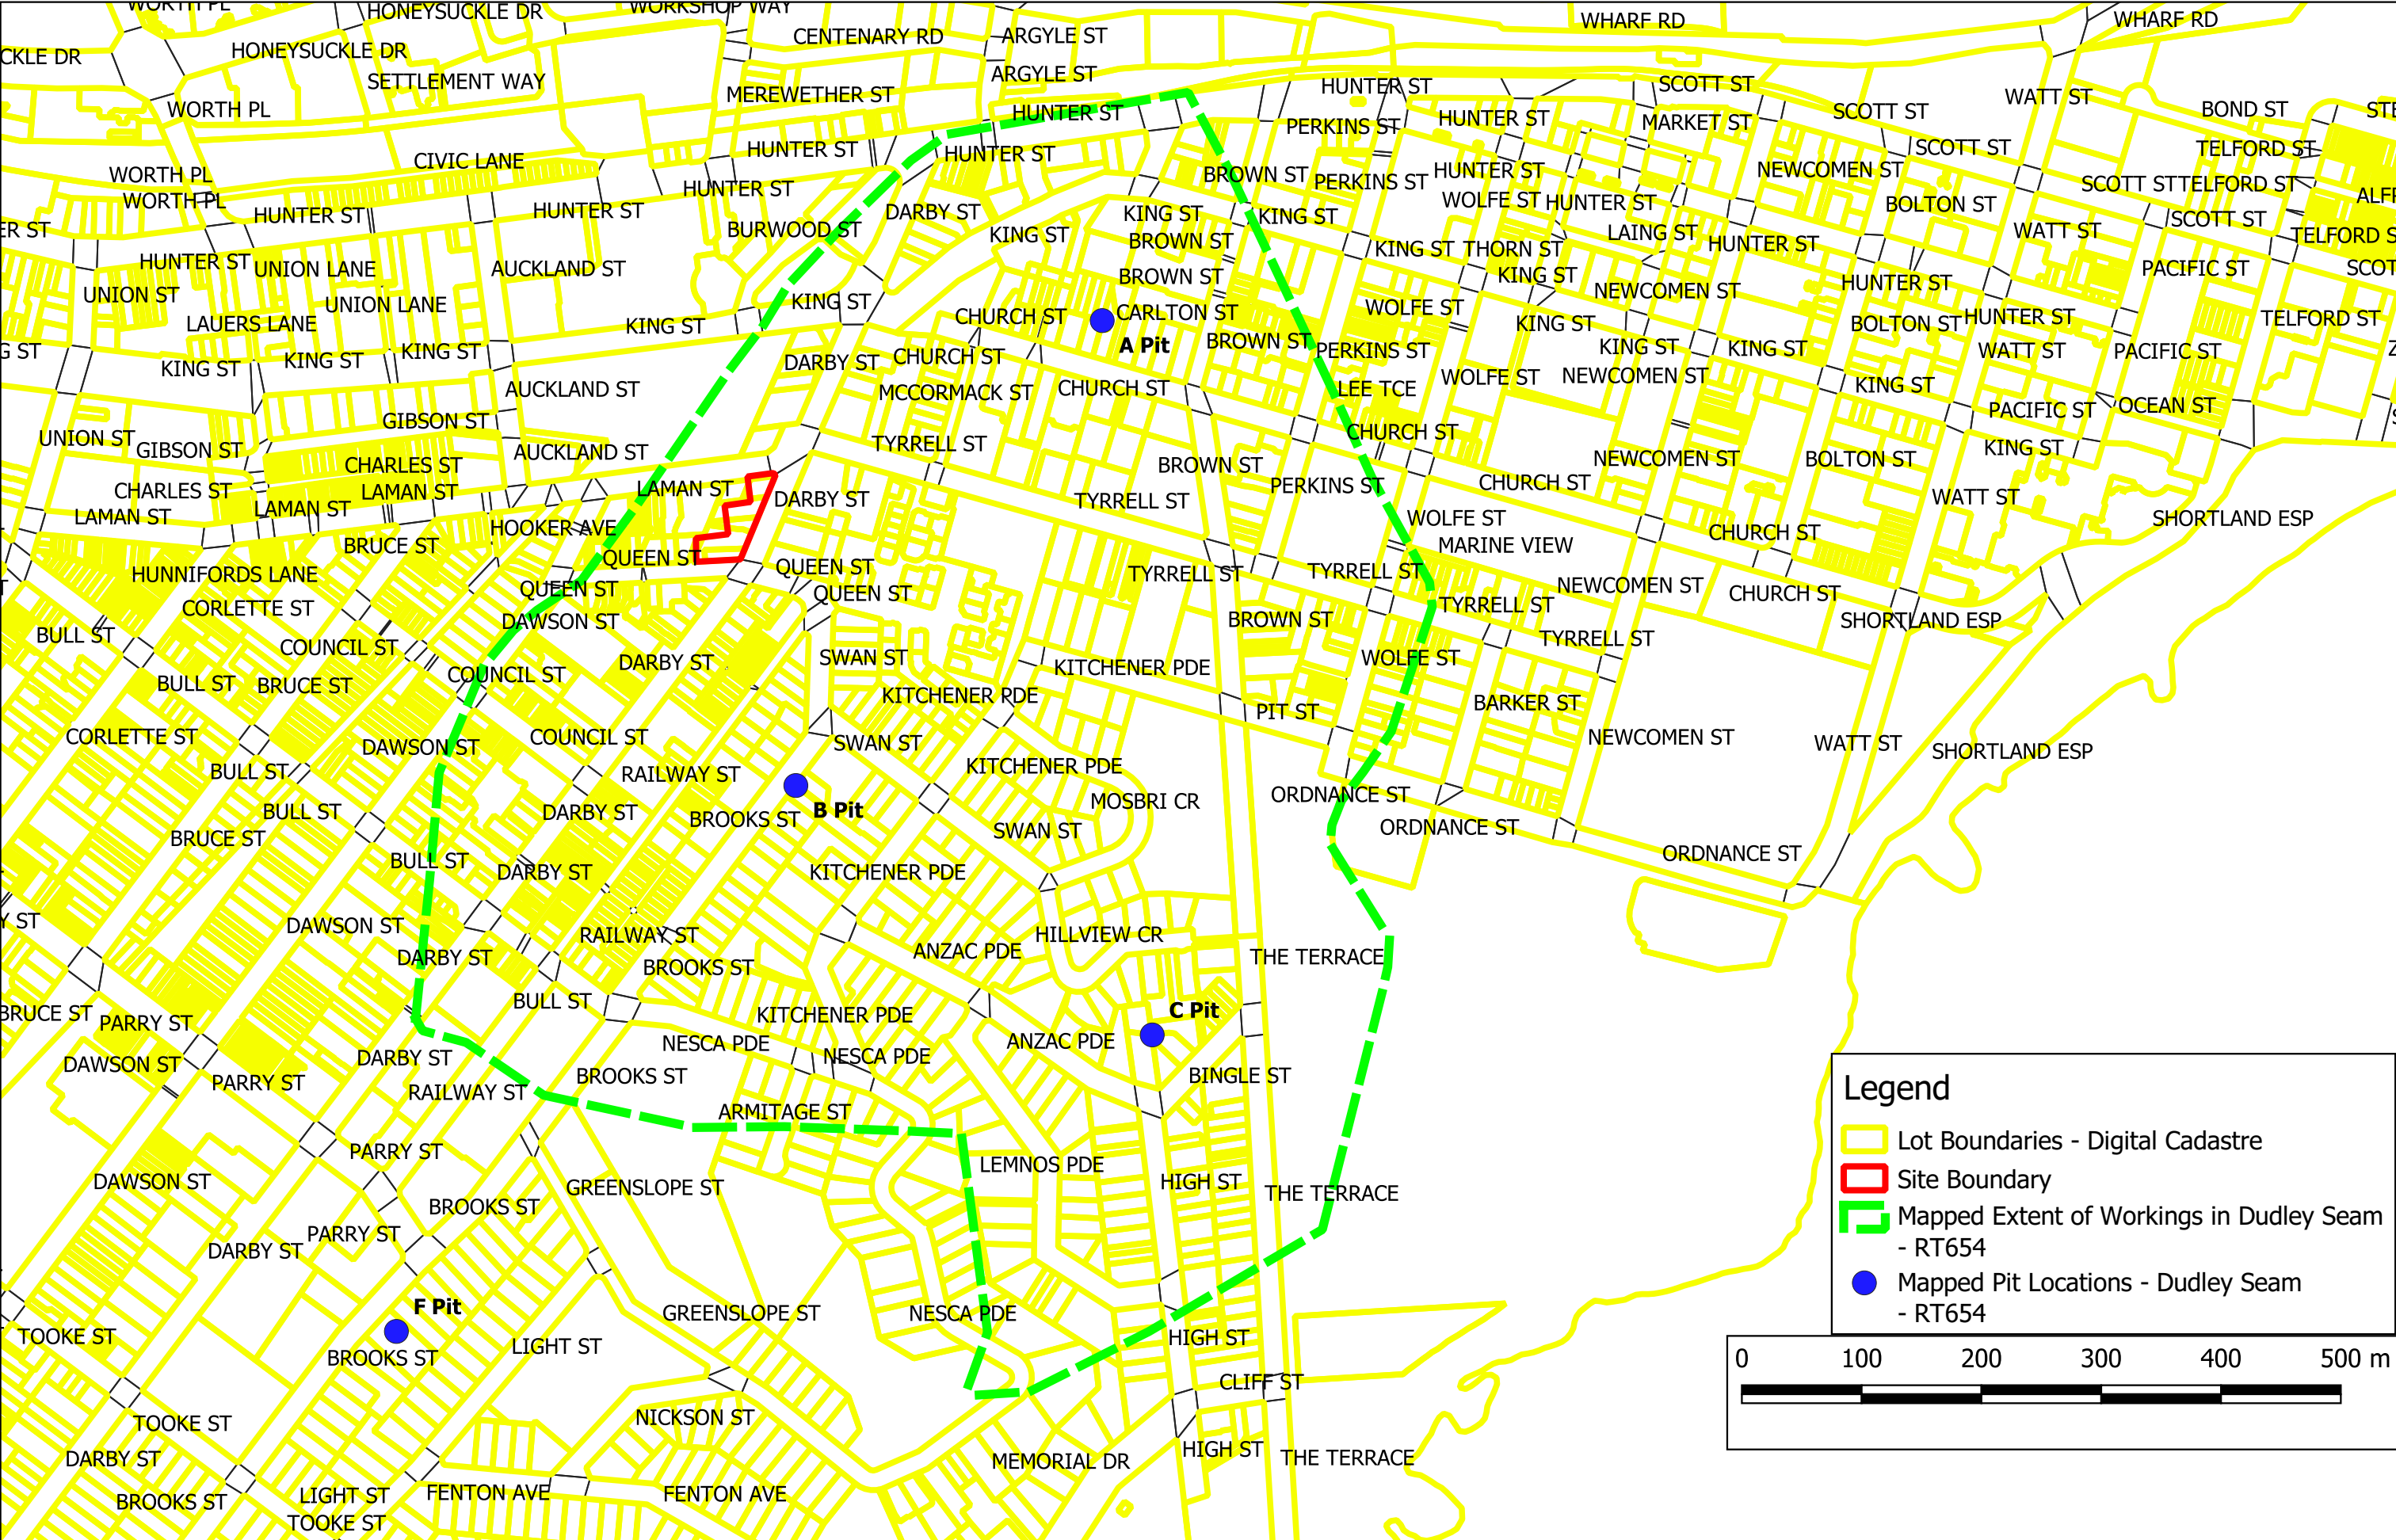
- No detailed record of the mine layout is available, except for RT566 which shows the approximate probable extent of the 'Yard Seam' workings. RT566 is a copy of Exhibit 'Y' – Royal Commission on Earth Subsidence at Newcastle dated 1906, and is a Plan of the Workings of A, B and C Pits, of the A A Company's Colliery. Drawing 2 attached shows the inferred extent of the workings from the RT;
- The historic name of the workings is the 'Yard Seam', however, collation of deeper drilling records from the last decade indicate these workings most likely belong to the strata of the Dudley Seam. For the purpose of this report DP will refer to these workings as the Dudley Seam.
