Muswellbrook Waste Transfer Station

Road Safety Review

Prepared for: Muswellbrook Shire Council 23 June 2022

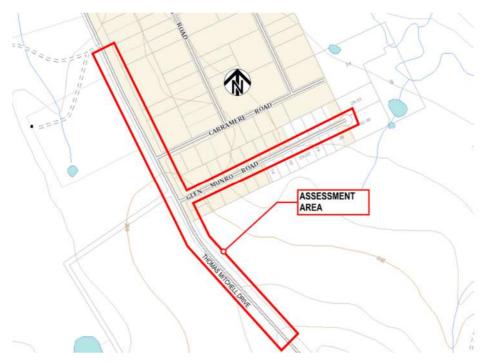
Figure 2: Assessment Area

The Thomas Mitchell Drive and Glen Munro Road intersection is situated in the Muswellbrook LGA, around 5km south of Muswellbrook. The assessment location can be accessed via Thomas Mitchell Drive and either New England Highway (to the south) and Denman Road (to the north). Refer to Figure 1 and Figure 2

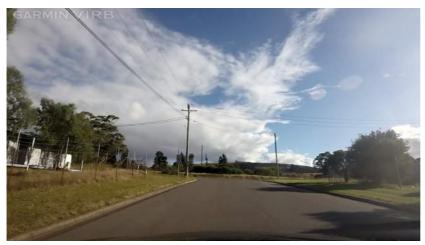
Figure 3: Glen Munro Road approaching the intersection with Thomas Mitchell Drive

Glen Munro Road is around 11 m wide and over 600 m long and is a 'no through' road, with access to several industrial businesses. It has an average vertical grade of around 4.5% grading away from Thomas Mitchel Drive. It has a barrier kerb and gutter installed along both sides and has no linemarking, either along its centre line or hold line at the intersection.

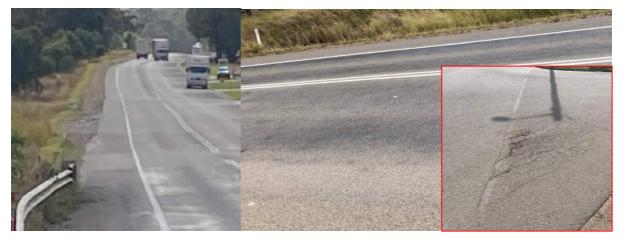
Figure 6: Pavement Condition in the Vicinity of the Intersection

A visual inspection was performed on the existing pavement and similar to what was highlighted in the EMM report, alligator cracking was noted at the intersection. Some other issues were noted in relation to the pavement. The western edge of the pavement showed signs of deterioration, which may be caused by vehicles travelling over this edge as they either overtook a turning vehicle or parked in the verge. The verge also looked slightly eroded but still in relatively good condition. The final issue noted during the site visit was some bleeding of the road surface. This was noted mainly in the wheel paths and could affect the available longitudinal pavement friction and increase the required stopping distance. It is recommended that the road surface is tested to determine the available pavement friction to determine if pavement rehabilitation is required.

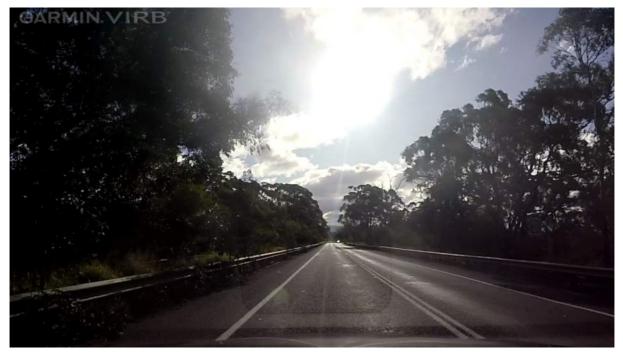
Figure 7: Thomas Mitchell Drive Northbound Speed Zone Change (100km/h to 80 km/h)

Glen Munro Road has a 50km/h speed limit. The 80km/h speed zone on Thomas Mitchell Drive starts around 400m south of the intersection and extends to Denman Road. The speed change from 100km/h to 80km/h (400m south of the intersection) is delineated with signage only, with one sign obscured by vegetation. It is noted that during the site drive

through the glare from the sun limited the ability to see these signs effectively. It is recommended that the vegetation is cleared within the sightlines to these signs and that pavement numerals are marked on the pavement to better delineate the change in speed limit.

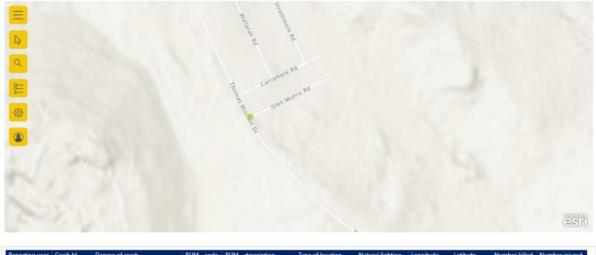
Figure 9: Crash Map (Source: https://roadsafety.transport.nsw.gov.au/statistics/interactivecrashstats)

There has been one crash within the assessment area in the 5-year period between 2016 and 2020. This was a serious injury crash involving a light vehicle that departed the carriageway to the right and hit an object or parked vehicle. This occurred at the intersection of Thomas Mitchell Drive and Glen Munro Road. Based on this information there isn't any crash trends or crash hotspots within the assessment area.

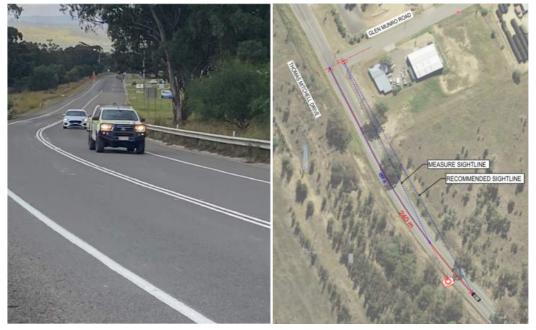
Figure 10: Photo looking north along Thomas Mitchell Drive at the SISD target

SISD was measured on site by setting up a target which was in line with the 5m setback from the lip of the channel along Thomas Mitchell Drive and set at a height of 1.25m. The assessors then positioned themselves at the maximum distance along Thomas Mitchell Drive where they could still see the SISD target while lowering their eye height to 1.1m. At this location a distance was measured to the target and to the centre of the northbound lane, refer to Figure 10.

Using this method, a SISD of 180m was measured, which is higher than what was documented in the EMM Road Safety Assessment (140m), but less than what is recommended.

The calculated SISD is 226m with a grade correction of 13m, which brings the total recommended SISD to 239m. So 180m would only provide SISD for a design speed of around 74km/h or reduce the observation time/reaction time by around 2 seconds.

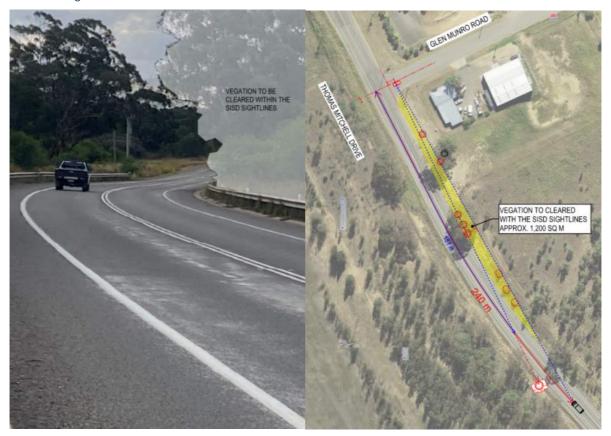
Figure 11: Vegetation Clearing

SISD is measured from a driver's eye height (1.1m) to the top of the vehicle approaching the intersection (1.25m). Unlike the other types of sight distance, SISD can be achieved over the top of some types of road safety barriers, if the vertical road geometry allows (no crest). At this location there is a standard W-Beam gaudrail road safety barrier with a height of 0.78m and the vertical road geometry does not obscure the sightlines. To achieve SISD to the intersection only vegetation needs to be cleared. Regular maintenance will be required to provide a clear viewing area at all times. There is a TfNSW sign also in this area.

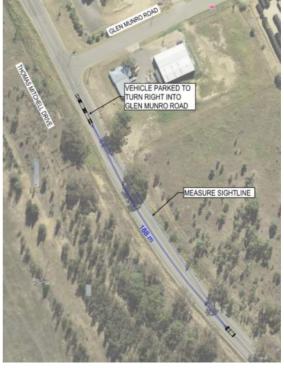
Figure 12: Stopping Sight Distance to Vehicle Turning Right into Glen Munro Rd

The eastern road safety barrier along Thomas Mitchell Drive restricts the SSD to a vehicle waiting to turn right into Glen Munro Road to 188m. There is therefore a risk a rear-end crash could occur at this location.

To improve SSD the road safety barrier would need to be modified (set-back from the edge of the road). Modifying the location of a road safety barrier can have affect the barriers performance (higher impact angles) and any changes would need to be carefully considered. Note providing adequate SSD does not eliminate the risk of rear-end crashes. Another solution, which would be the preferred, would be to provide space for a vehicle to overtake a waiting vehicle. This mitigation measure would significantly reduce the likelihood of rear-end crashes as it would provide space to a vehicle to manoeuvre around the waiting vehicle if it was late seeing the waiting vehicle. This is in essence a BAR which is discussed in the next section.

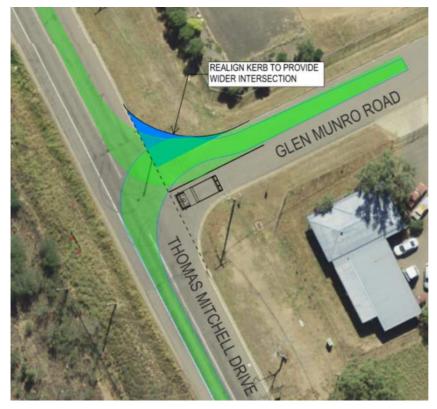
Figure 14: Realign Kerb Return

Provide kerb returns that would allow a vehicle to hold closer to the intersection while allowing a truck to turn
right or left into Glen Munro Road, see Figure 4. Note that while increasing kerb return radii will improve the
heavy vehicles entering Glen Munro Road clear of vehicles waiting to depart the intersection, there is a risk that
smaller vehicles will enter a low speed environment from Thomas Mitchell Drive at a higher speed. Careful
consideration of the intersection layout will be required in subsequent design stages to maintain safety for all
aspects and users of the intersection.
