# **Acid Sulfate Soil Assessment**

No 182 Salamander Way, Salamander Bay

# **St Philip's Christian Education Foundation**

# Re: Acid Sulfate Soil Assessment Proposed School Buildings No 182 Salamander Way, Salamander Bay

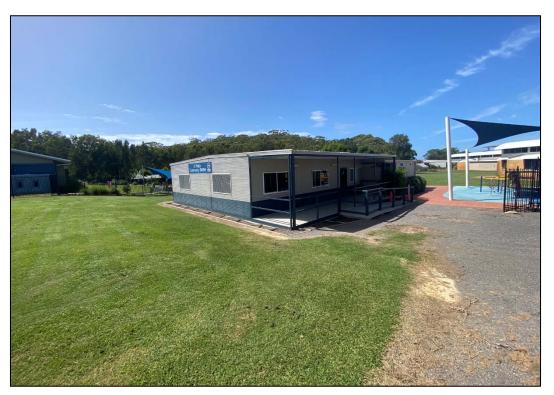
Photograph P1A – View towards south-east

At the time of the investigation the site was partially occupied by brickwork school buildings and metal-clad demountable school buildings. Slopes on the site are near level with an embankment to the south of the proposed development sloping towards the south at approximately 9 % (5° slope angle).

Vegetation on the site comprised established grass cover, garden shrubs and a single mature tree.
