To:	Terry Woods	From:	Troy Lowien
Address:	Via email	Date:	26/08/2019
		File Ref.:	2289_200_001
Re:	Meppem Quarry – Suitability of Resource for Supply to Inland Rail Project.

Inland Rail Project: Preliminary Resource Investigation – Meppem Property

Title: Petrographic Inspection Report: Olivine Basalt Spall

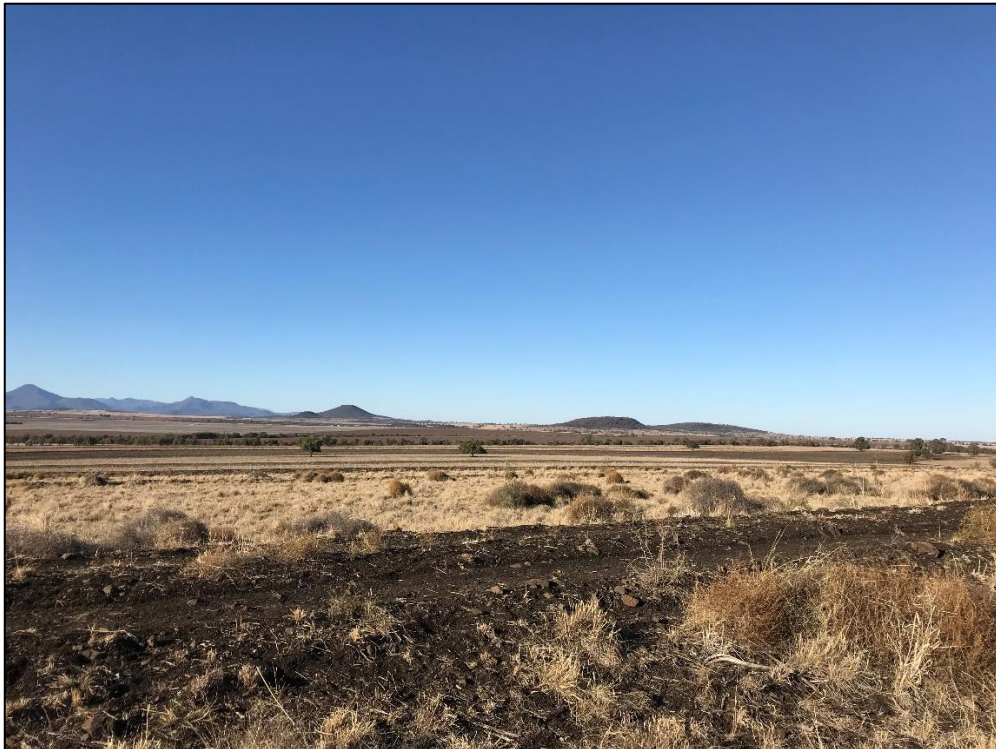
Plate 1 – View looking south from base of Black Hill. Residual basaltic soil in foreground, remnant basaltic flows forming hills in background.

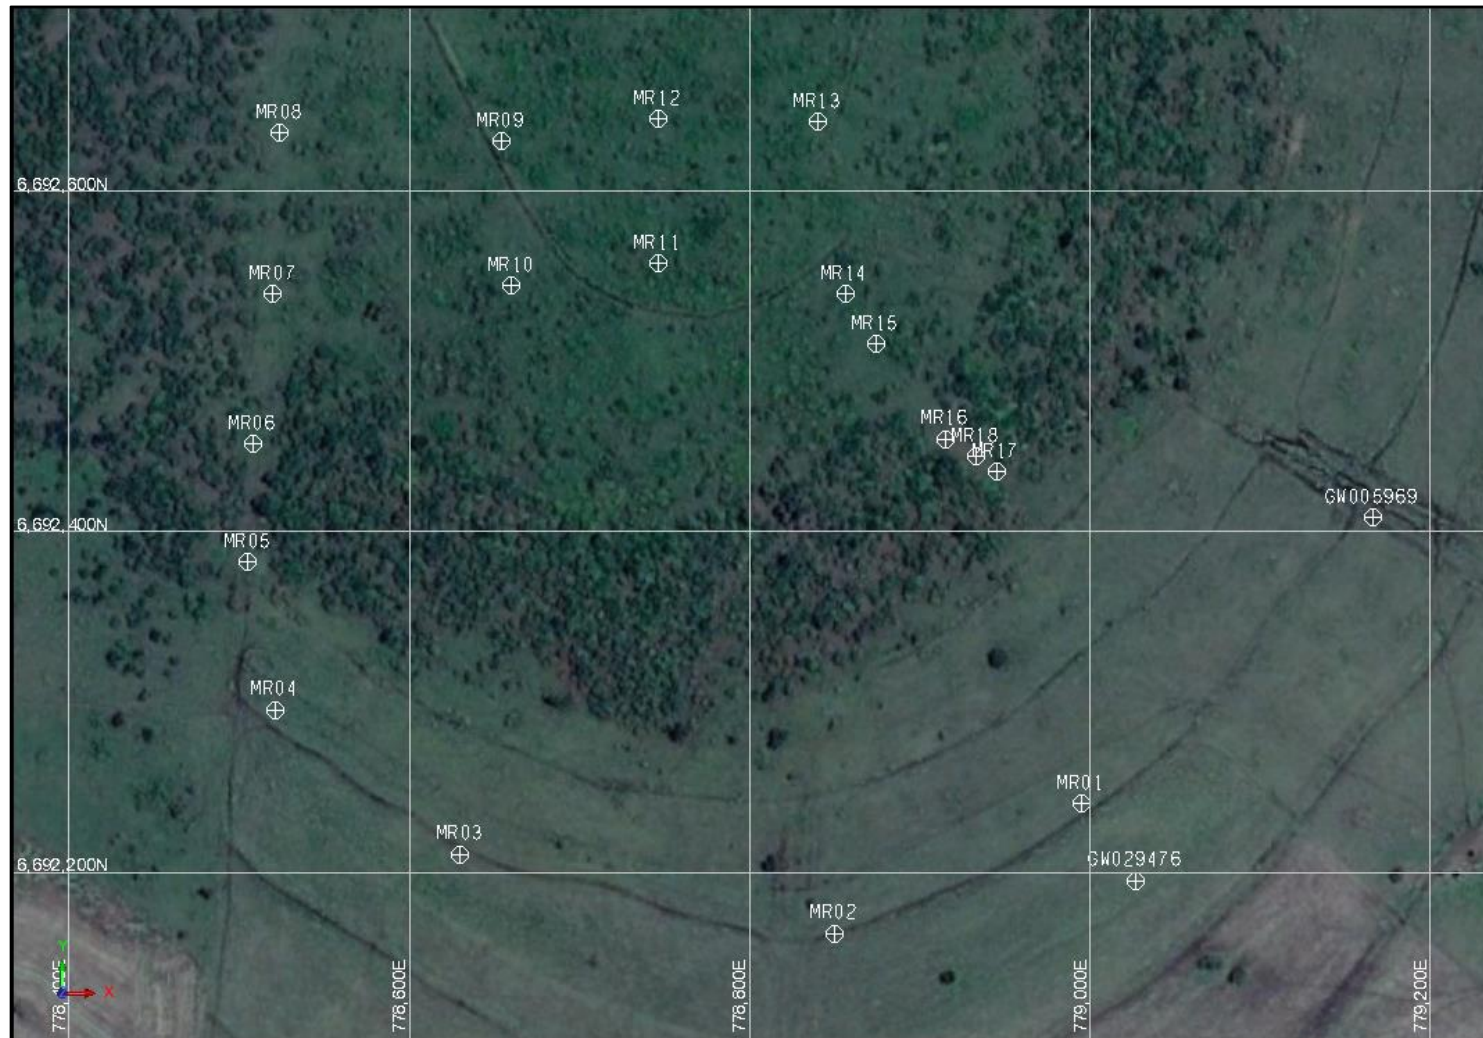
Figure 1 – Drillhole Location Plan

Recent investigative drilling consisted of eighteen (18) percussion holes with material retrieved at one (1) metre intervals to be stored in chip trays for later logging. All drill collars were surveyed using a hand-held GPS unit, refer **Figure 1 - DRILLHOLE LOCATION**.

Contractor: Ron Sothern Drilling
Holes Drilled: 1 Percussion Holes (MR01 to MR18)
Total Meters Drilled: 200m
Drill Hole Inclination: Linear holes drilled at -90°
Drilling Date: July 2018
Hole Size: 89mm
Drilling Style: Top hole hammer

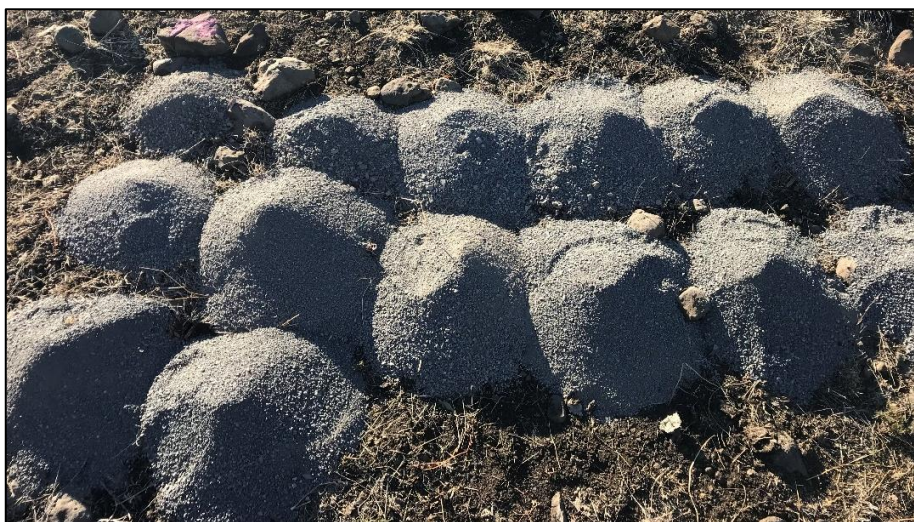
Plate 2 – High Quality Basalt intersected in hole MR014

Along the top of the hill, holes MR07 to MR14 were drilled in an approximate 100m by 100m grid to test the basalt to a depth of 15- 20m in the footprint of the proposed quarry site. All these holes intersected high quality basalt to end of hole (refer **Plate 2**).

The basalt is a black, fine grained, sparsely vesicular basic igneous rock, displaying a basaltic mineral assembly consisting of abundant plagioclase laths and ubiquitous ferromagnesian phases including pyroxene, olivine and magnetite. Olivine crystals form 0.2 to rare 0.5mm green or weathered brown phenocrysts. The rock displays slight weathering as ferruginous staining and occasional argillic infill of sparse vesicles. The basalt displays otherwise competent, granular broken faces and is likely to produce well-shaped aggregate with crushing. The rock is regarded as hard, and is of predicted high strength and durability, well suited to a broad range of engineering products. The basalt is highly magnetic. Trace sulfides as pyrite is observed.

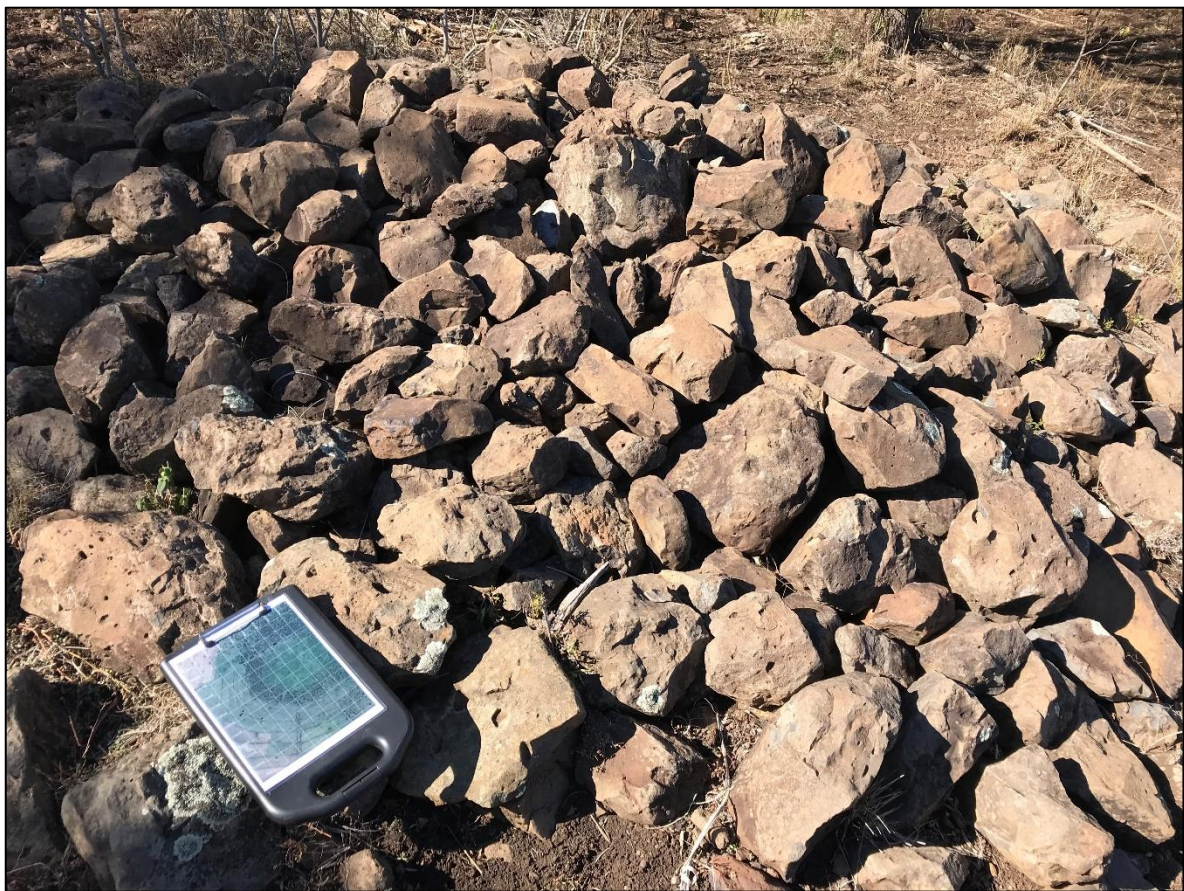
Plate 3 – Basaltic rubble on side of main hill.

Overburden on the hill consists of a very thin veneer of residual basaltic soil (<500mm) and cobbles.

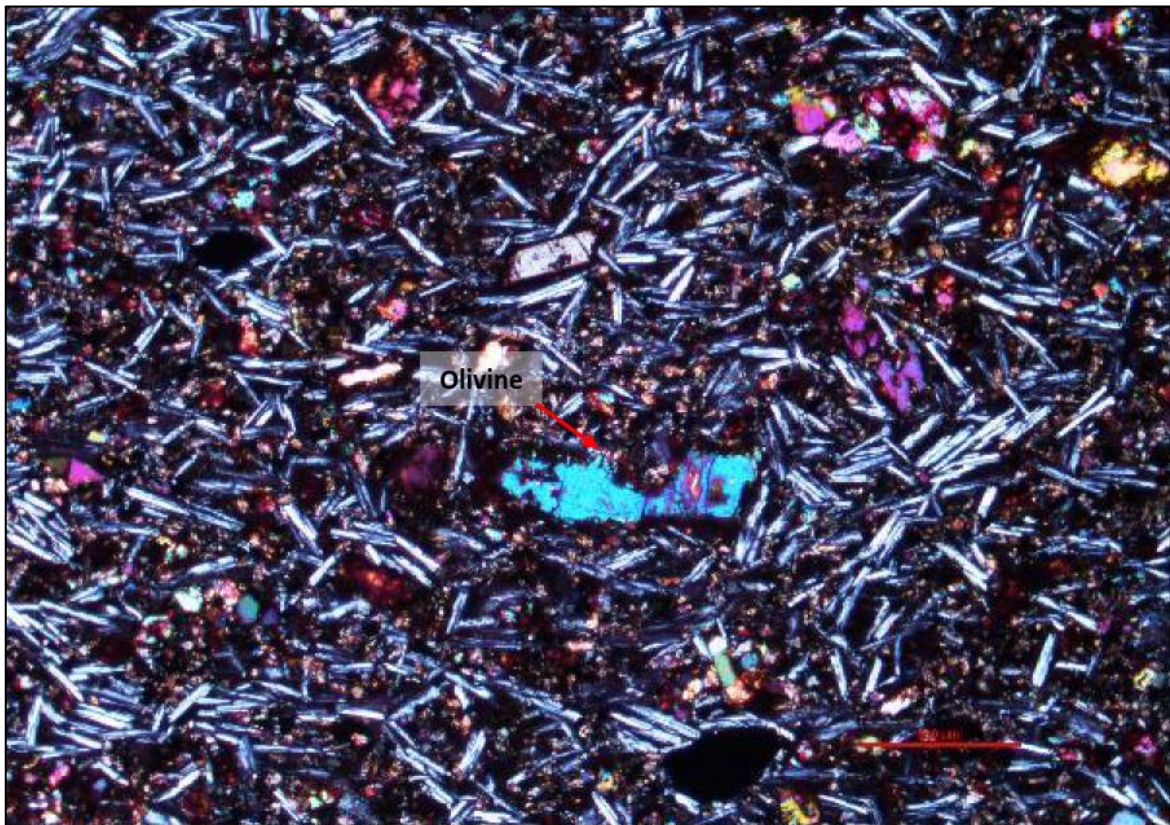
Plate 4 – Microphotograph displaying representative mineral assembly of the basalt including abundant plagioclase, fine tabular pyroxene and plagioclase with finely disseminated magnetite. Image shown in cross polarised light.

A sample of basalt was collected from the largest available boulder on the hill as representative of the site's geology and used for petrographic analysis to determine salient mineralogical and textural features as well as determine if deleterious secondary minerals are present which may constrain the utility of the rock. The Petrographic Inspection Report can be found in **APPENDIX 2 – PETROGRAPHIC REPORT**. An excerpt with associated microphotograph is provided below.

For engineering purposes, the rock may be summarised as:

- Olivine Basalt, a Basic Igneous Rock.
- Essentially unweathered to slightly weathered with generally texturally isolated weak-secondary phases (9%) and minor vesicular smectite.
- Hard, of high strength and regarded as durable.
- Non-porous with minor residual vesicular voids and no heir-line fractures.
- Containing 2% free silica as remnant ferromagnesian volcanic glass. On this basis the basalt is considered innocuous in relation to ASR in concrete provided significantly more glassy material is not encountered.

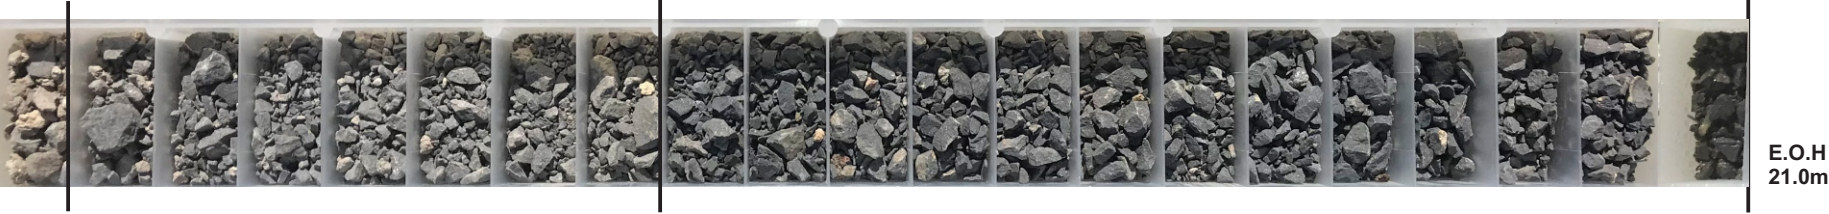
MR07

E.O.H
21.0m

0.0 - 1.0m
Distinctly weathered basalt. Ferruginous staining. Lower strength.

1.0 - 8.0m
Slightly weathered basalt. Ferruginous staining. Higher strength.

8.0 - 21.0m
Fresh basalt. High strength.

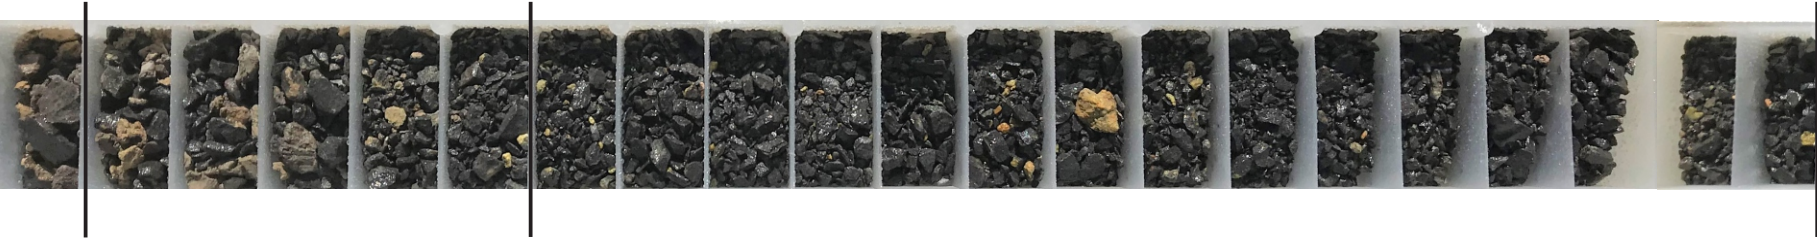
MR08

E.O.H
21.0m

0.0 - 1.0m
Slightly to distinctly weathered basalt. Ferruginous staining. Lower strength.

1.0 - 6.0m
Slightly weathered basalt. Ferruginous staining.

6.0 - 21.0m
Fresh basalt. High strength.

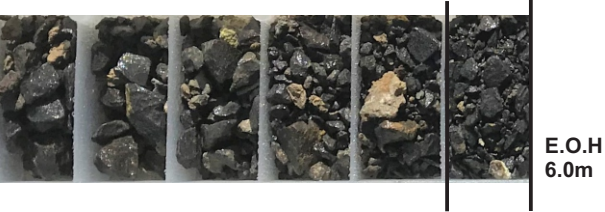
MR10

0.0 - 5.0m

Slightly weathered basalt. Ferruginous staining.

Fresh basalt with ferruginous staining on joint surfaces. High strength.

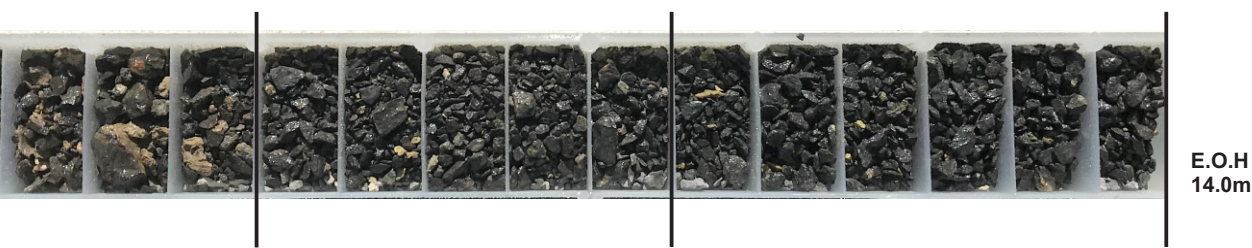
MR12

0.0 - 3.0m

Slightly weathered basalt. Ferruginous staining.

Fresh basalt with ferruginous staining on joint surfaces. High strength.

Fresh basalt. High strength.

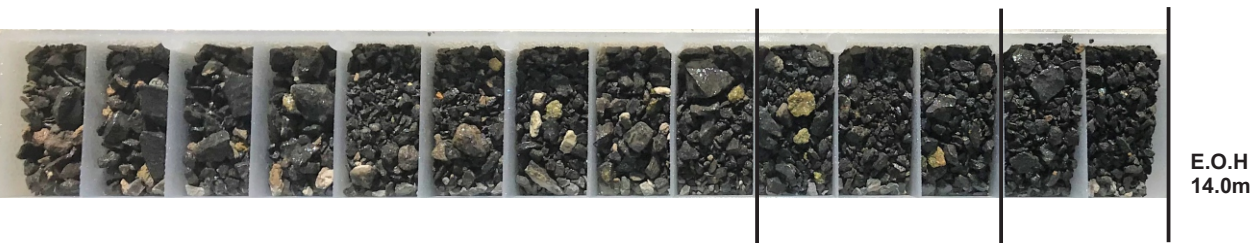
MR14

0.0 - 9.0m

Slightly weathered basalt. Ferruginous staining.

Fresh basalt with ferruginous staining on joint surfaces. High strength.

Fresh basalt. High strength.

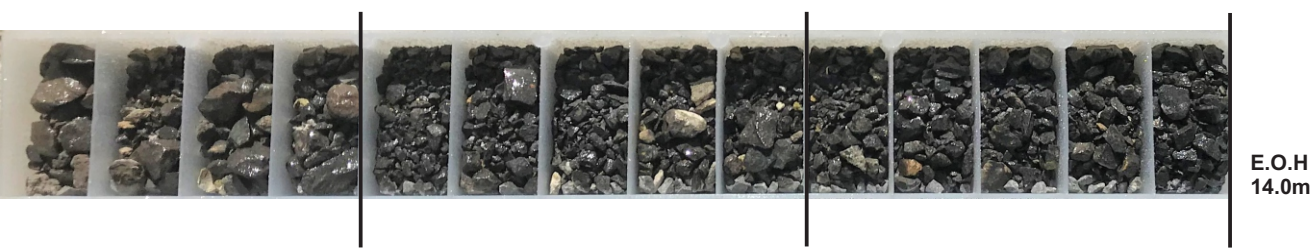
MR13

0.0 - 4.0m

Slightly weathered basalt. Ferruginous staining.

Fresh basalt with ferruginous staining on joint surfaces. High strength.

Fresh basalt. High strength.

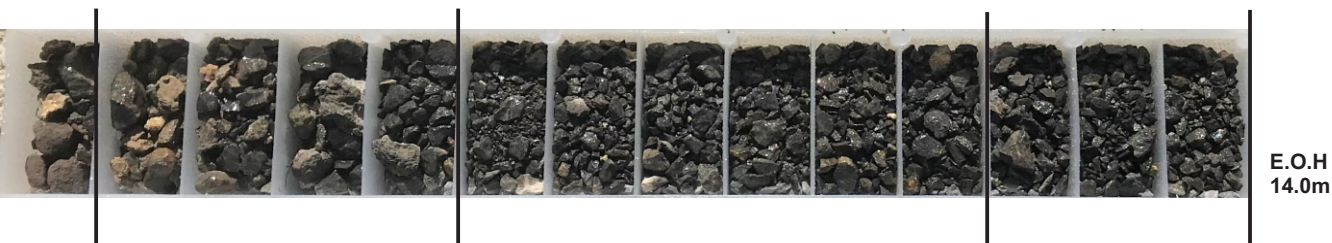
MR15

0.0 - 1.0m

Distinctly weathered basalt. Ferruginous staining. Lower strength.

Slightly weathered basalt. Ferruginous staining.

Fresh basalt with ferruginous staining on joint surfaces. High strength.

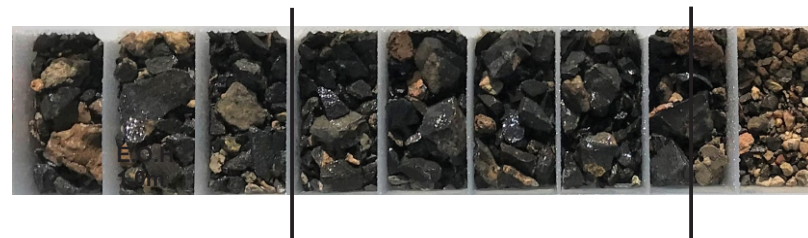
MR18

0.0 - 3.0m

Slightly weathered basalt. Ferruginous staining.

Distinctly weathered basalt. Ferruginous staining. Lower strength.

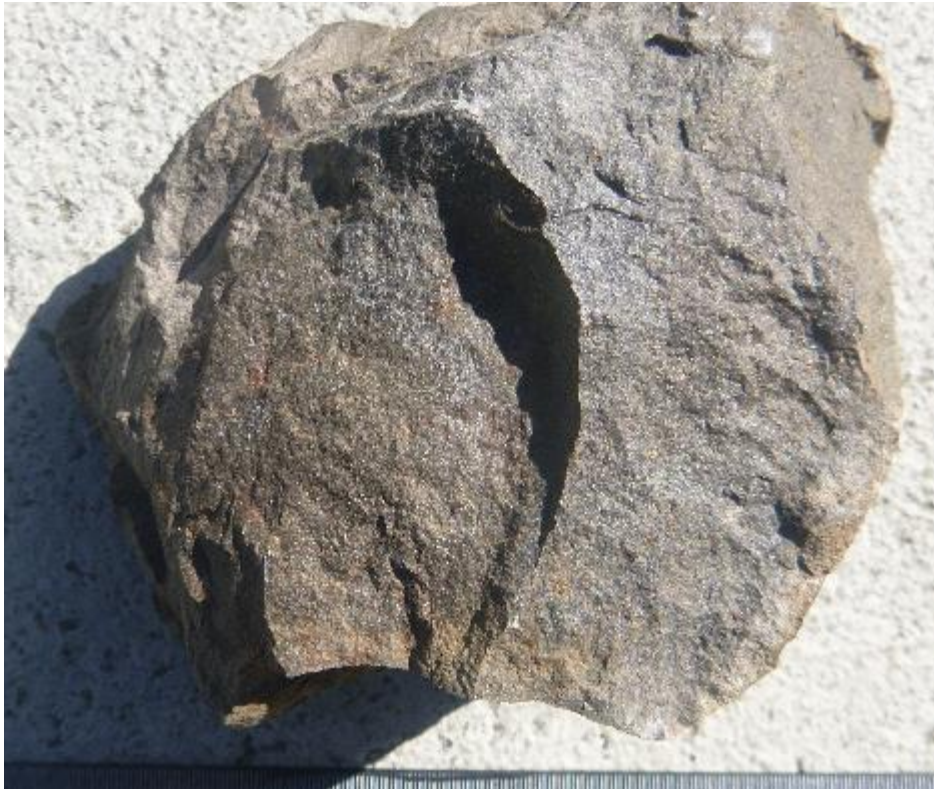
Plate 1: Photograph displaying weathered rind common among surficial spalls on-site. Vesicles in the basalt resulting from entrained gas bubbles remain as partially filled voids in the rock measuring to 0.5mm in diameter and hosting secondary quartz and ferruginous/argillic material.
