**Wallum Estate  
Torakina Road, Brunswick Heads  
Lot 13 DP 1251383**

**Acid Sulfate Soil Management Plan**

Client	: Clarence Properties
Prepared by	: Australian Wetlands Consulting Pty Ltd
Project #	: 1-211400_04c
Date	: September 2022

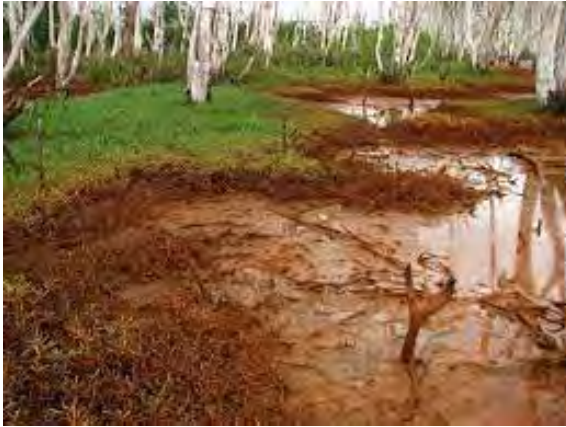
*Photo 1 Example iron floc staining*

Surface Water Quality – Field/visual indicators	Refer Table 2-2 and Photo 1 and Photo 2	<ol style="list-style-type: none"> <li>1. Confirm data is correct (ie instrument calibration, review other relevant data) <ol style="list-style-type: none"> <li>a. If trigger values are exceeded, undertake additional surface water laboratory analysis and investigation as below</li> </ol> </li> <li>2. Notify Environmental Manager and/or Site Superintendent</li> </ol>

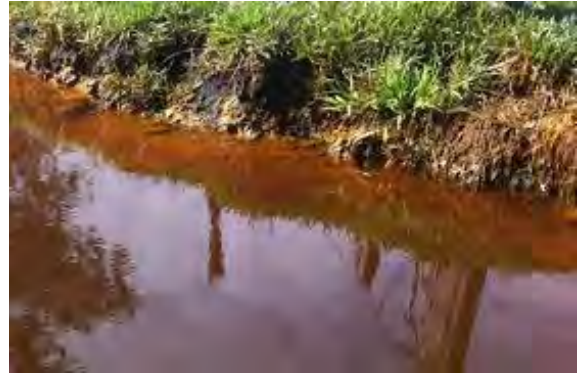
*Photo 2 Example iron floc staining (2)*
