**Our Reference: J6963**

**Response to Request for Further Information- 10.2021.698.1**  
**Reflections Holiday Park Coastal Protection Works, Clarkes Beach, Byron Bay**

WRL Ref: WRL2020065 JTC LR20220304

## **Geobag works fronting Clarkes Beach Café and Reflections Holiday Park, Byron Bay**

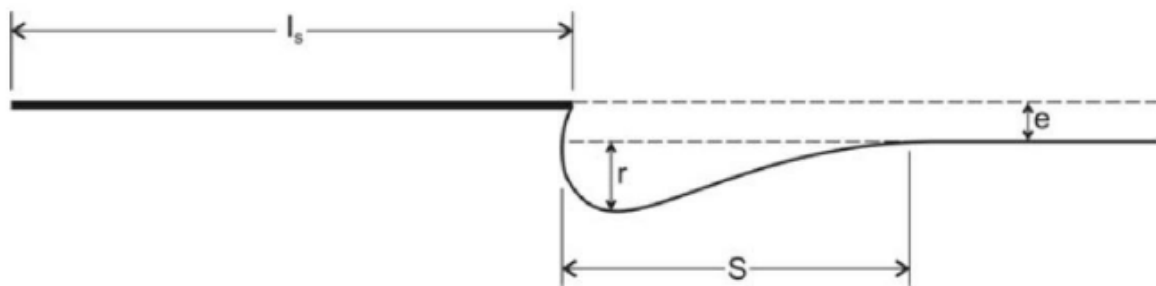
End effects estimates were detailed in Table 7.2 of WRL (2021) using two techniques. The form of end effects is shown in Figure 1.

**Figure 1: Seawall end effect variables (Figure 7.3 in WRL, 2021)**

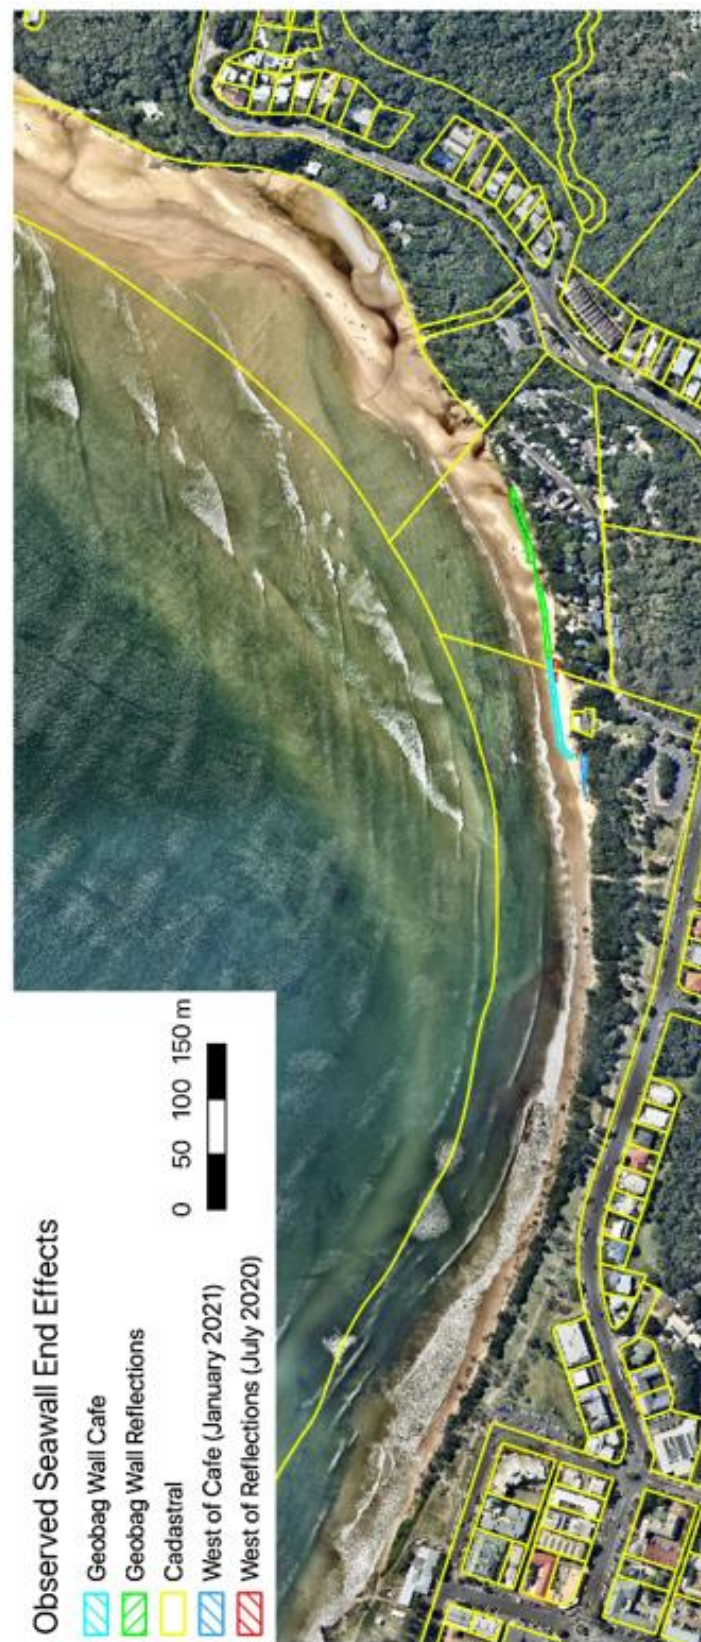
Observed end effects are shown in Figure 2 and Figure 3. At embayment-wide scale (Figure 2), this is virtually imperceptible

- Reflections only,  $l_s = 160$  m (prior to October 2020)
  - $r = 4$  m
  - $S = 20$  m
- Reflections plus Cafe,  $l_s = 250$  m
  - $r = 5$  m
  - $S = 35$  m

**Figure 2: Observed end effect – embayment view (Figure 7.5 in WRL, 2021)**

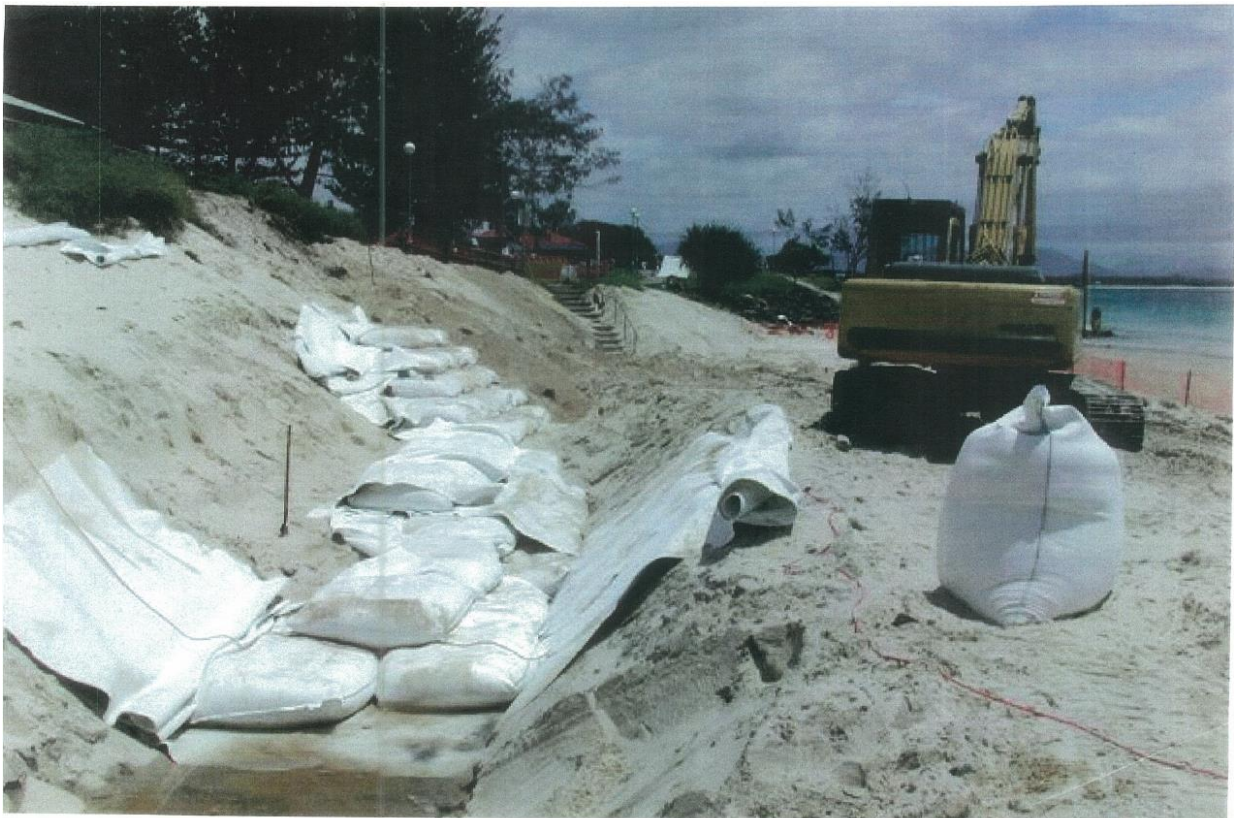
Historic erosion has occurred at Main Beach in the past. This led to the construction of geobag walls fronting Byron Bay SLSC in c2001 (Figure 5) following serious erosion from 1999. This was well before any geobag works were constructed at Clarkes Beach. A historical photo of the beach fronting First Sun Caravan Park from c1999 is shown in Figure 6.

**Figure 5: Construction of geobags fronting Byron Bay SLSC c2001 (Source: Byron Shire Council)**

Erosion at Main Beach has occurred in the past, prior to the construction of the Clarkes Beach geobags. This necessitated the construction of geobag works protecting Byron Bay SLSC in c2001. Such erosion appears to be a large scale, embayment wide process.

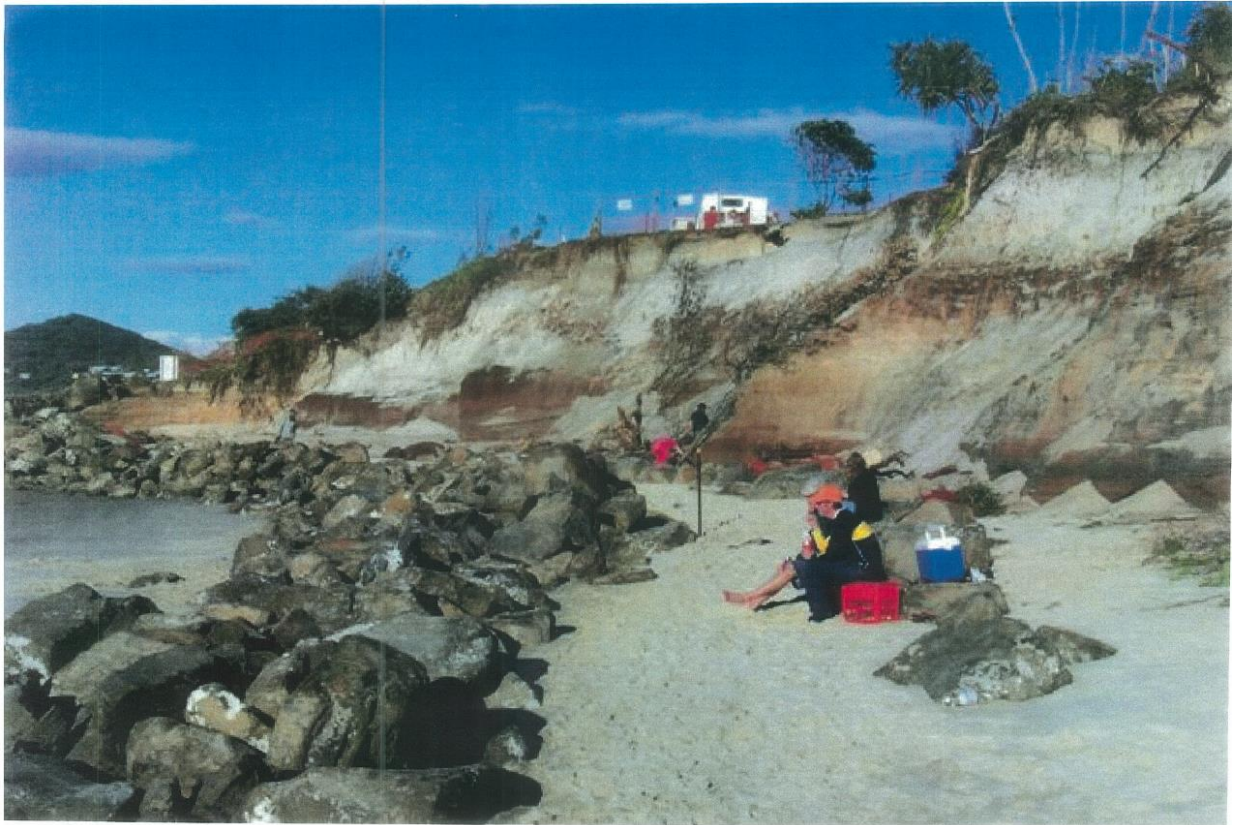
**Figure 6: Erosion to the west of Jonson Street protection works, First Sun Caravan Park c1999  
(Source: Byron Shire Council)**
