# Clarkes Beach Addendum Coastal Assessment

Reference: R.A10466.001.01 Clarkes Beach Addendum Coastal Assessment\_Master.docx

Date: May 2021

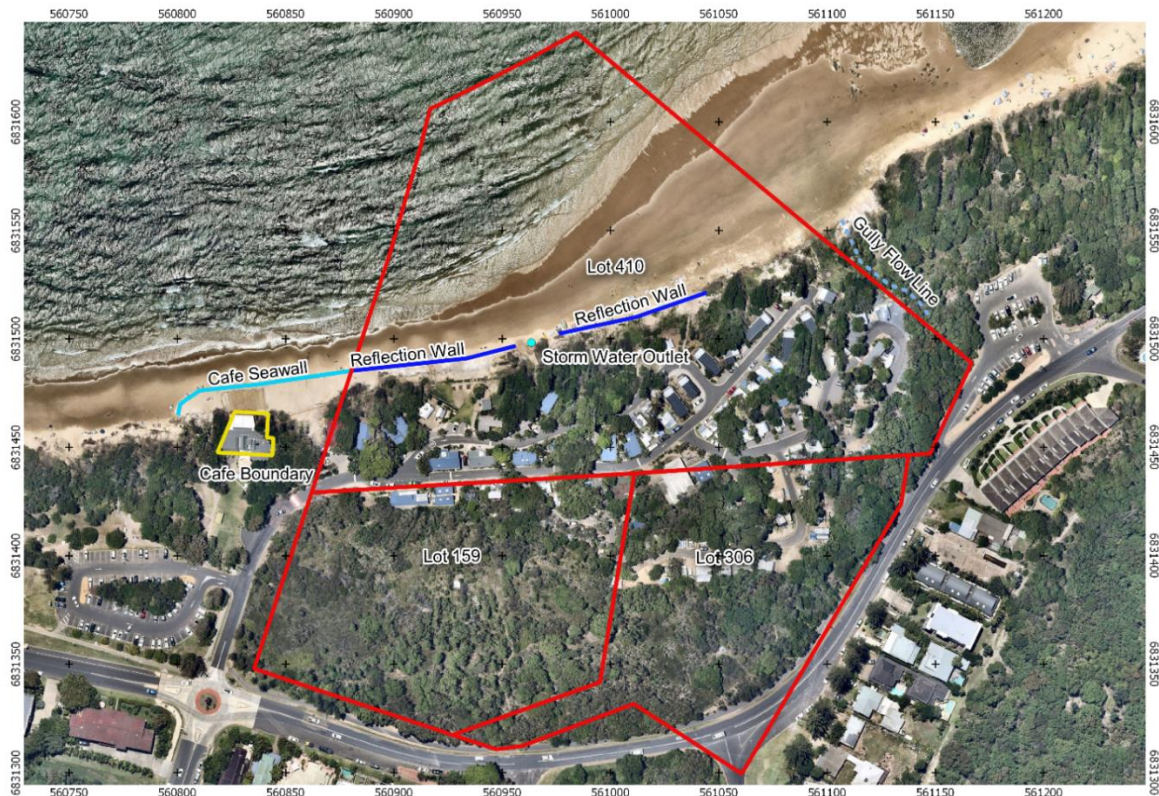
**Figure 1 Project area: Red bounded Reflections Clarkes Beach Holiday Park (15 Jan 2021)**

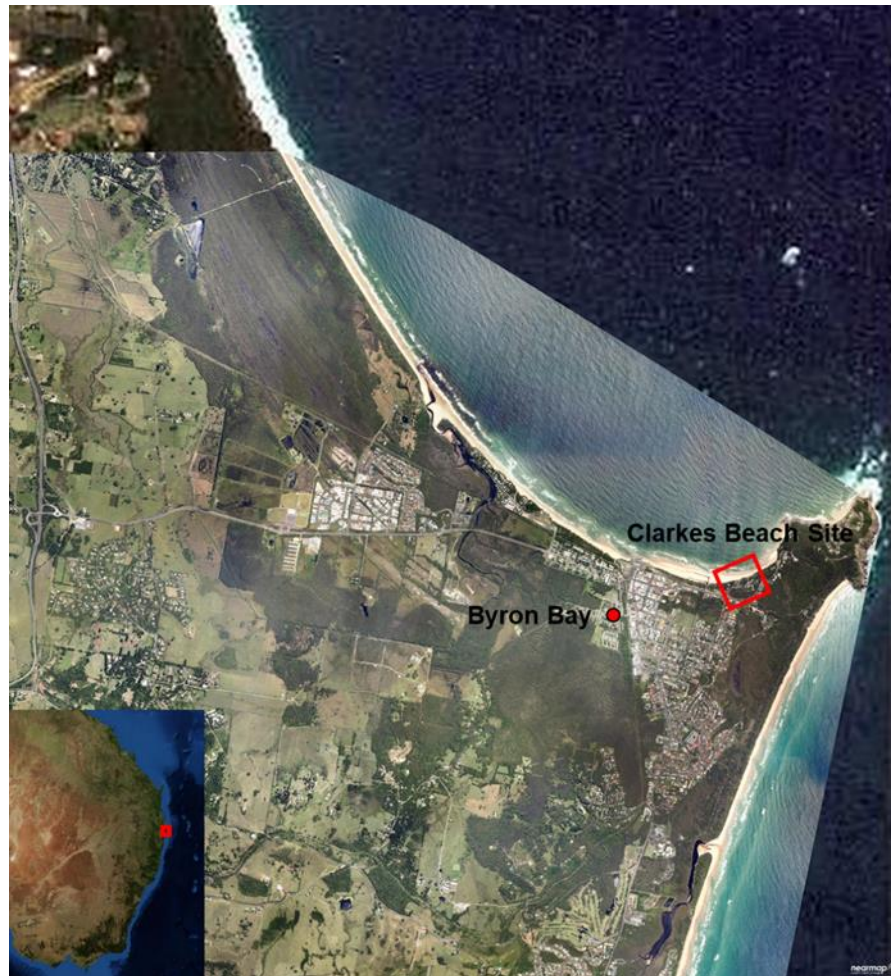
**Figure 2-1 Clarks Beach area of concern**

Reflections Clarks Beach Holiday Park (RBCHP) is situated adjacent to Clarks Beach, a north facing beach on the eastern edge of Byron Bay, NSW (Figure 2-1).

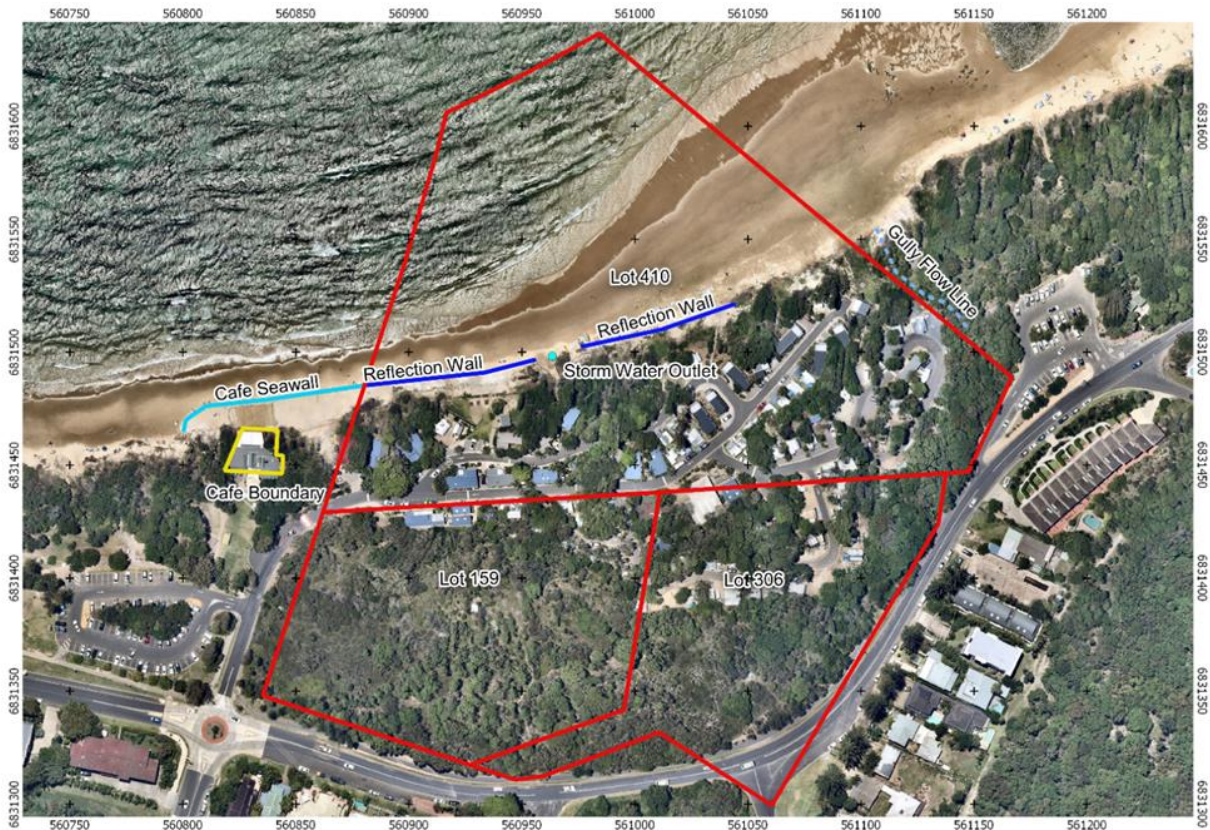
Figure 2-3 Red bounded Reflections Clarkes Beach Holiday Park and yellow bounded Beach Byron Bay Cafe with temporary seawalls in front. (15 Jan 2021)

Since approximately 2010, and more significantly in the last few years, the Clarks Beach back dune has been eroding towards the RCBHP. After an erosion event in mid-2019 where beach access stairs from RCBHP were lost, the park constructed two temporary geotextile sand container (sandbag) walls at the base of the erosion scarp attempting to halt the erosion (referred to as the Reflections seawall as per Figure 2-2). In the following year, the Beach Byron Bay Café adjacent and to the west of the RCBHP constructed a continuation of the temporary geotextile sand container revetments along their beach frontage (referred to as the Café wall – see Figure 2-3).

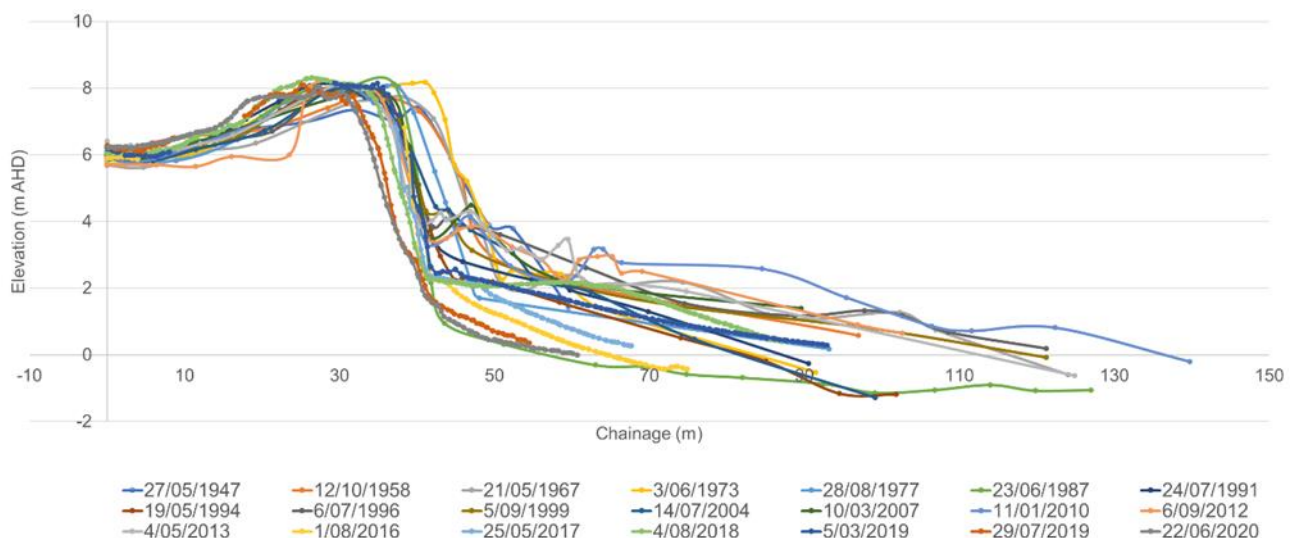
**Figure 2-4 All recorded beach profiles for Clarks Beach from 1947-Present (UNSW, 2020)**

Beach profile data from the last 70 years (UNSW, 2020) shows a cycle of erosion and sand deposition, with the dune scarp migrating backwards and forwards multiple times. Figure 2-4 shows the beach profile history directly in front of Reflections Clarks Beach Holiday Park, at the current location of the western seawall from 1947 until 2020.

In this context, the current (June 2020) erosion is similar to that seen in the 1980's with similar dune scarp placement, beach height and beach width.

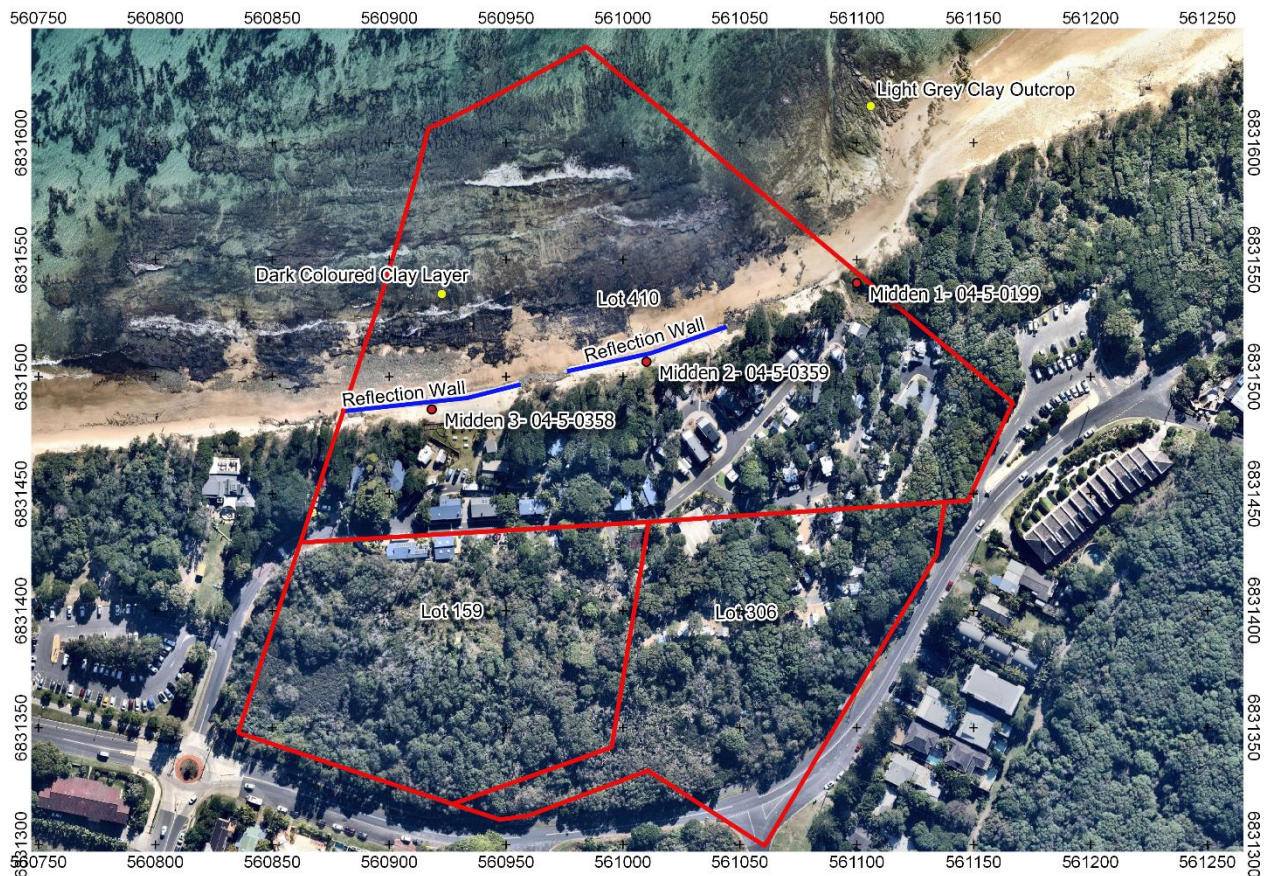
Additional to this and as shown in Figure 2-5, there is also a lighter-coloured clay outcrop (possibly 'coffee rock') sitting just offshore to the east of the Reflections holiday park boundary. This clay outcrop likely causes local attenuation of wave energy which is likely responsible for the seaward land bulge immediately east of the gully.

An extensive search of the Aboriginal Heritage Information Management system (AHIMS) by Hill, T *et al.* (2019) identified three significant indigenous middens sites in or near the Reflections Clarks Beach Holiday Park site, each of which are marked for reference in Figure 2-5 below. The potential impacts to these middens under current and potential future conditions are discussed in subsequent sections.

**Figure 2-5** Locations of the three Indigenous middens close to the Reflections Clarks Beach Holiday Park site. Noting the significant exposure of both the dark-coloured clay layer and the light grey clay outcrop in the surf zone (4 July 2020).

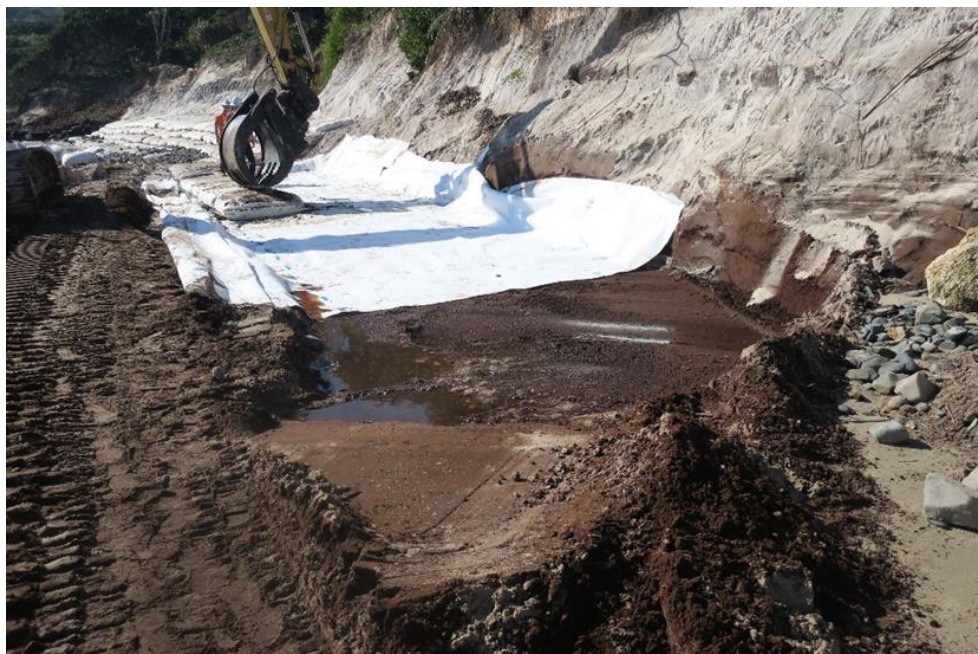
Figure 2-7 Construction of Reflections seawall (east) with geotextile filter directly overlying the clay layer. July 2019.

During construction, there were some known variations to the design and some differences between Reflections east and west seawalls. It is understood that prior to the placement of sandbags the slope was trimmed, a toe trench excavated, and a geotextile installed on foundation material for both walls. The eastern wall foundation material was observed during construction to be the clay-layer (believed to be approximately -1.0 m AHD elevation), however, it is reported that the western seawall foundation material is unconsolidated sand. Figure 2-8 shows western wall shortly after completion.

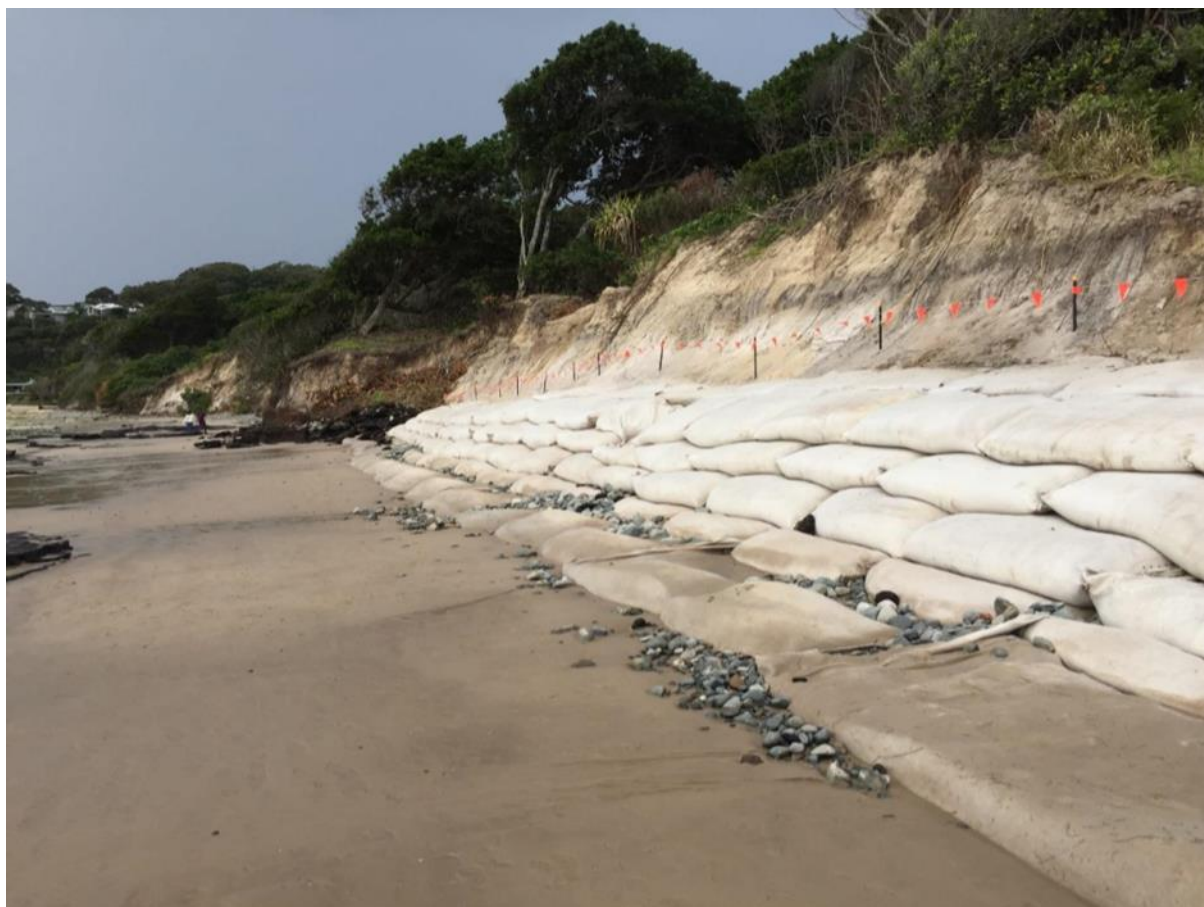
**Figure 2-9 Reflections seawall (east) immediately post-construction (2 August 2019).**

Immediately after the Reflections seawall was constructed, limited effort was made to shape or revegetate the back-dune scarp. It was rather, allowed to slump naturally to its angle of repose (more stable position) before revegetation of the area began. Figure 2-8 and Figure 2-9 show the wall sections immediately post construction.

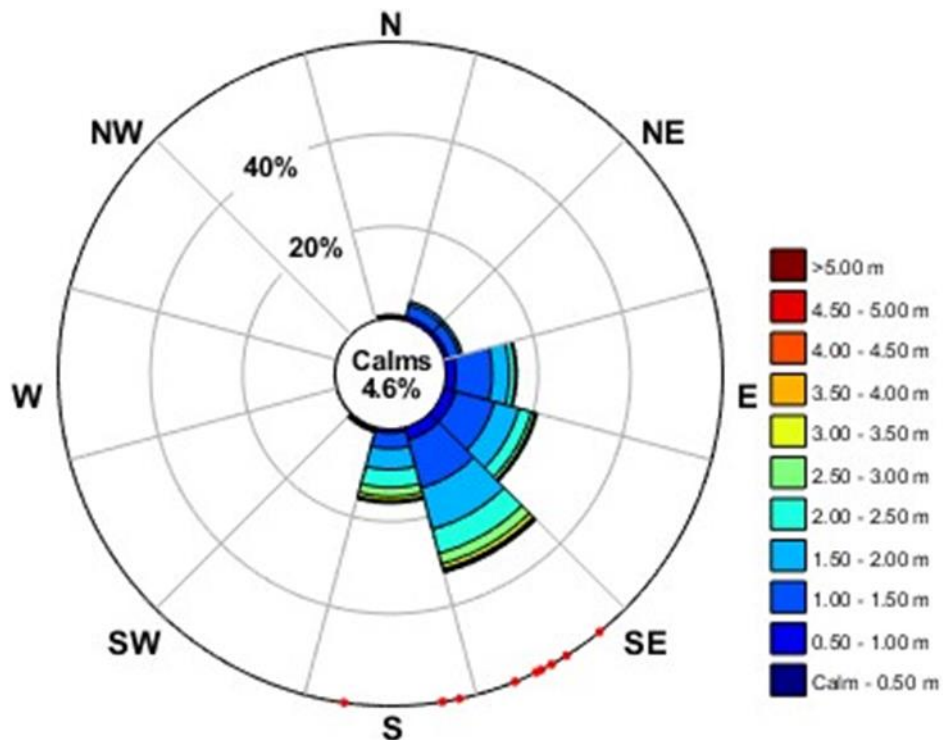
**Figure 3-1 Wave height rose for Byron Bay Wave Buoy Data (2017-2020)**  
(Data Source: Manly Hydraulics Laboratory 2020)

The deep-water wave climate of the northern NSW coast comprises a highly variable wind wave climate superimposed on a persistent long period moderate to high energy swell arriving predominantly from the southeast to east direction sectors (Figure 3-1, Manly Hydraulics Laboratory 2020). Two types of storm wave generation, east coast lows and tropical cyclones, are dominant in determining the prevailing extreme wave climate. BMT WBM's (2013) analysis found a distinct seasonal pattern with more southerly directions in winter and more easterly directions in summer. The plan shape of the shoreline along the region reflects the dominant southeast swell conditions and northward net movement of beach sand. This manifests as a series of crenulate shaped embayments, more hooked at their southern ends and aligned more uniformly and relatively consistently at north-northeast (approx. 20°) at their northern ends.

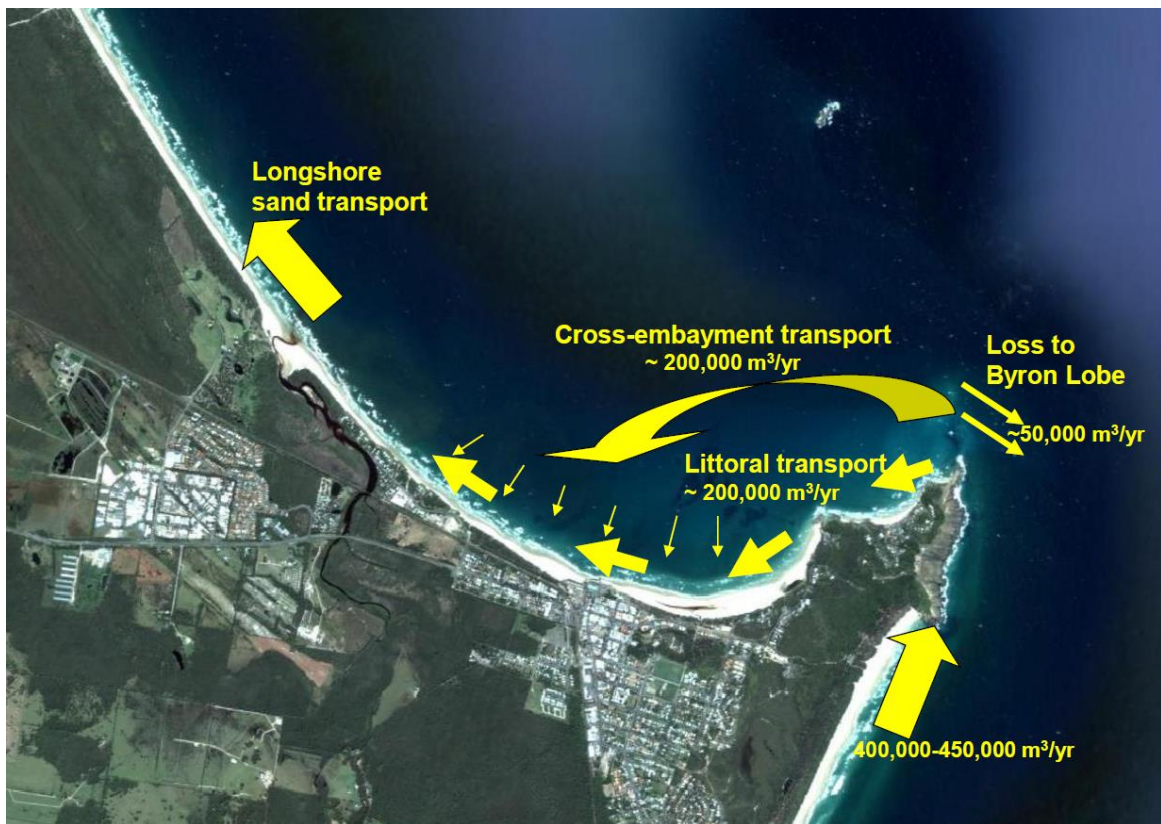
**Figure 3-2 Conceptual model of sediment transport processes at Cape Byron (BMT WBM, 2013)**

- BMT WBM (2013) suggest approximately 50,000 m<sup>3</sup>/year of the littoral drift transport is intercepted by the southwards directed East Australian Current (EAC) and lost to a deep-water sediment sink. This unique element of the Byron Bay coastline is the interaction of a net northerly littoral drift with the EAC which runs from north to south along the east coast of Australia, at typical speeds of 1-2m/s and in water depths greater than 40-50m. at these depths, the EAC does not typically influence sediment transport in the surf-zone of east coast beaches, but offshore of Cape Byron, the shoreface dips sharply and steeply to water depths of 40-50m, at slopes of 1:18 to 1:30 (PWD, 1978). This places the northerly littoral drift currents immediately next to the southerly directed EAC, resulting in some of the northerly littoral sand being sheared off by the EAC where it is then effectively lost from the coastal system at water depths of 40m+.

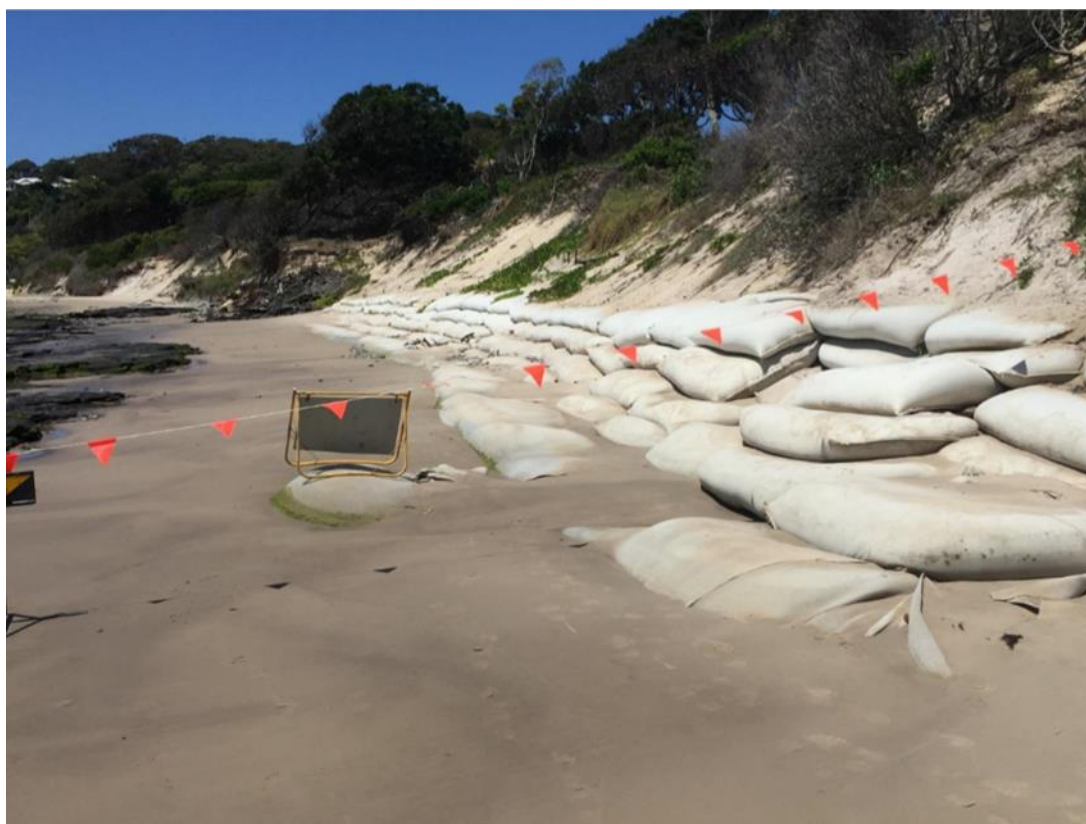
The main defects observed in the walls are sandbag displacement and bag puncture and deflation (Figure 4-1 and Figure 4-2). Photographic records show that one to two sandbags have been displaced from western ends of both the eastern and western wall. Sandbag displacement is due to hydrodynamic stability issues where sandbags are essentially knocked from the seawall structure by waves breaking on the seawall. Sandbag deflation is reported to have occurred during the first few months from wall construction where sandbags were inadvertently punctured during construction and thus, apparently has little to do with hydrodynamic energy impacting the seawall.

In summary, there is seemingly no difference between the damage observed in the Reflections seawall east or west sections with both having approximately 0 to 5% damage sustained since construction. Although these defects have not yet greatly affected the function of the wall, it does demonstrate that waves in storm events have already directly impacted the seawall with sufficient energy to move sandbags.

**Figure 4-1 Displacement and deflation of sandbags from Reflections seawall (east)  
(5 November 2020)**

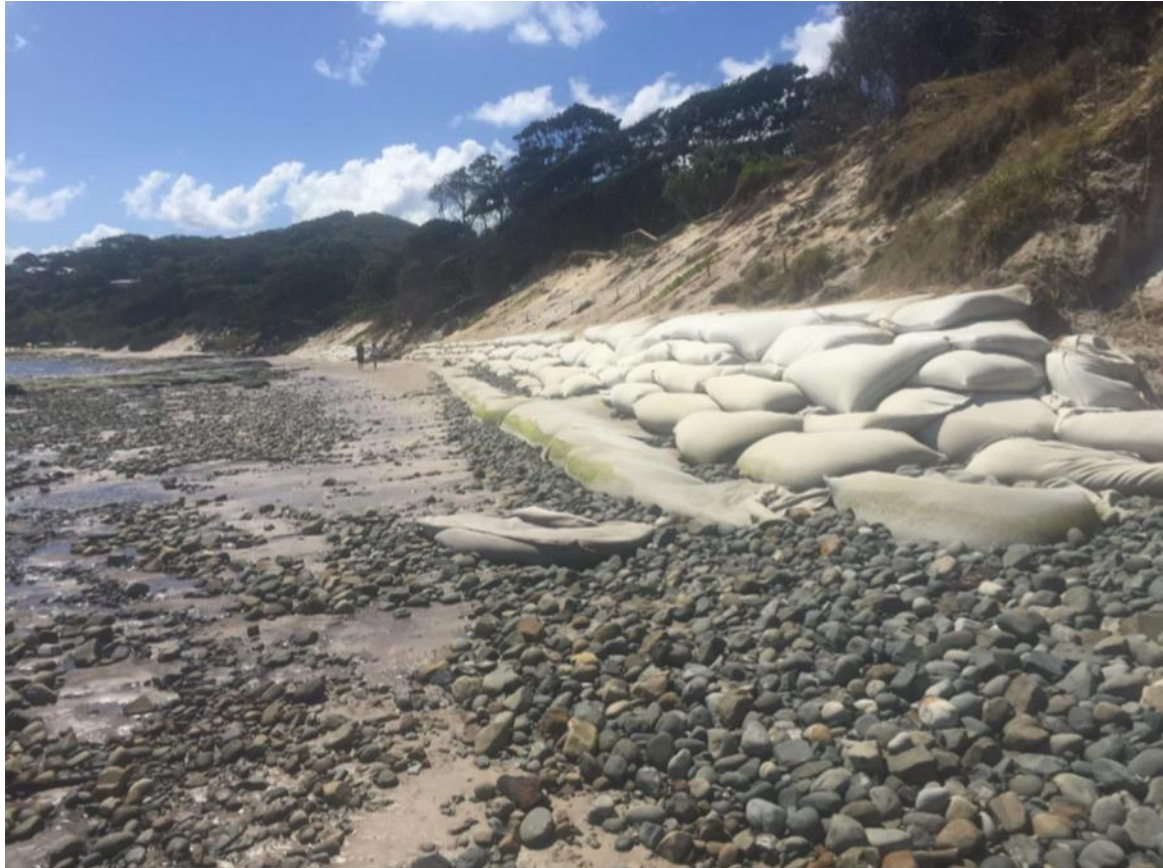
**Figure 4-2 Displacement of sandbags from Reflections seawall (west)**  
**(15 October 2020)**

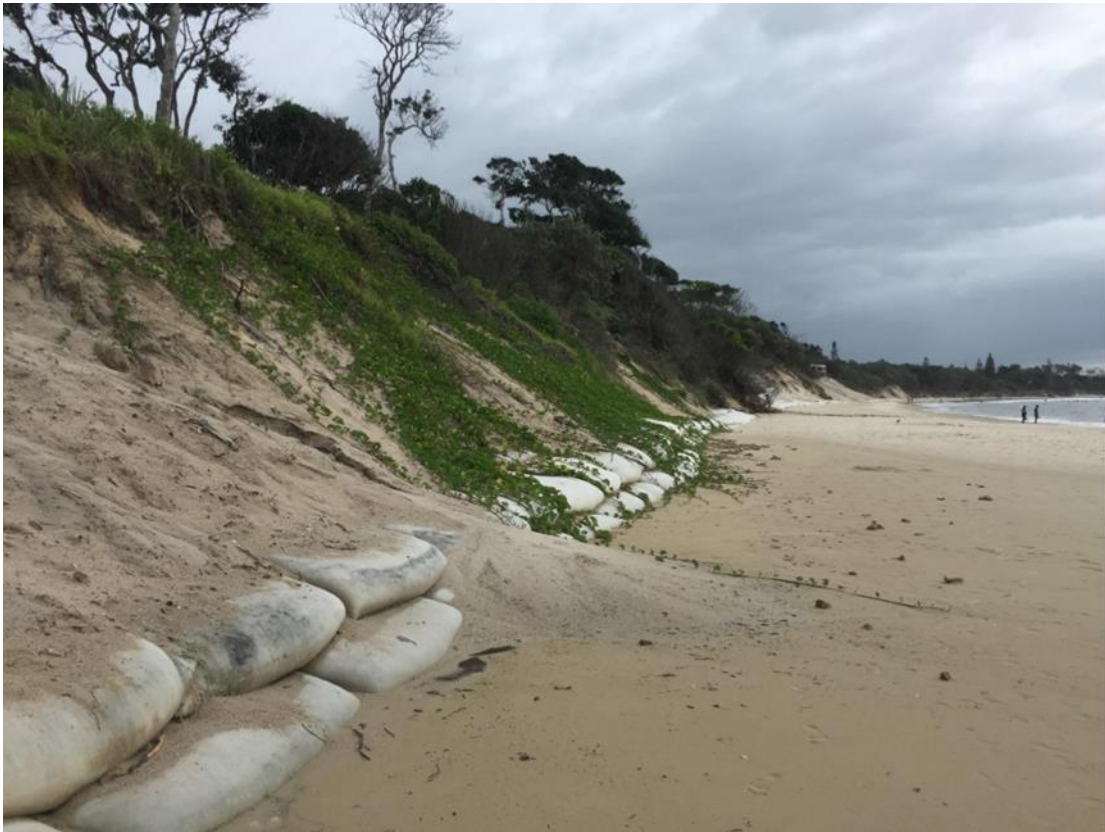
Figure 4-3 Reflections seawall (east) - 21 February 2021.

Currently, approximately 20 months since construction, the Reflections seawall is generally in good condition (as defects have been amended), still largely functioning as intended and stable. Especially pertinent to mention is that since December 2020 when erosion was severe (Figure 4-2), there has been an influx of sand from the pass (since January 2021) filling in Clarks Beach significantly with only the two top layers of sandbags now visible above beach level (Figure 4-3). There has also been some vegetation growth on the now-slumped erosion scarp behind the sandbag wall, stabilising the dune face.

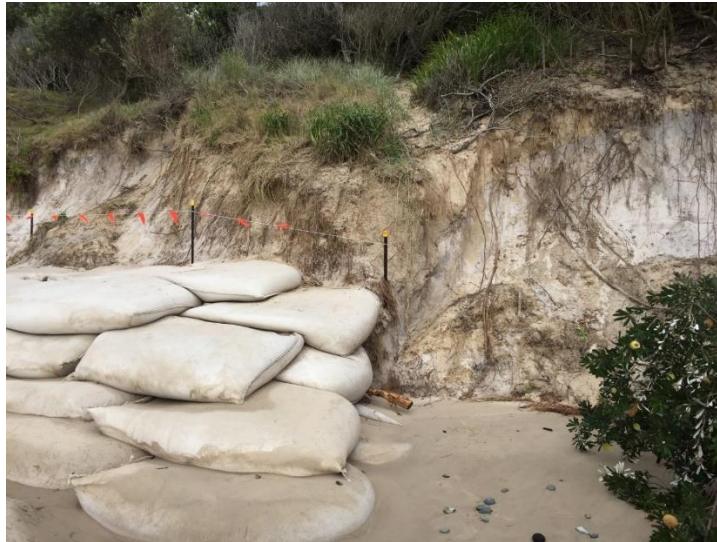
after construction and the associated erosion scarp at that time. In this image the erosion scarp in the dune immediately to the west of wall is approximately 1m landward of the wall crest.

**Figure 4-8 Western end of Reflections seawall (west) 2 August 2019 (within days of construction being completed)**

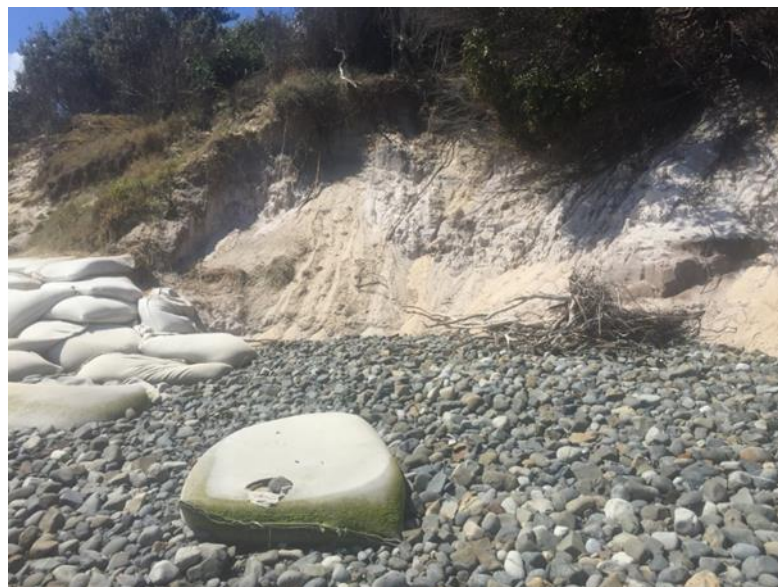
**Figure 4-9 Western end of western wall, 14 October 2020**

The image in Figure 4-9 is approximately 15 months post construction and shows the extent of erosion downdrift of the Reflections seawall. In this image, the erosion scarp is approximately 2-3m landward of the wall crest. Figure 4-10 from the same day shows the consistent evidence of ongoing beach-wide erosion (dune escarpment, undermined vegetation, exposed rock on beach) visible for hundreds of metres.

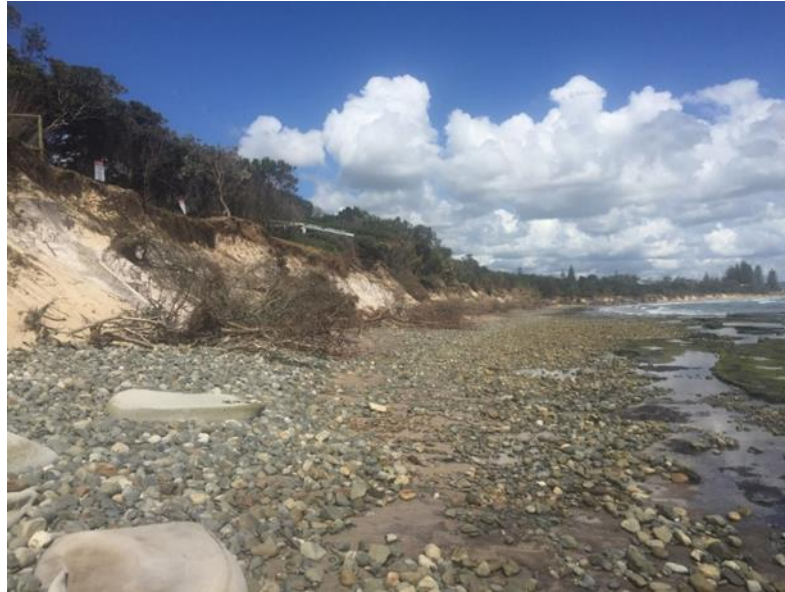
**Figure 4-10 Looking west from the western end of Reflections Wall, 14 October 2020**

- Erosion immediately to the west of Reflections seawall (west) is no more than 2-3m over this period (Figure 4-8 and Figure 4-9); and
- By October 2020 there is major erosion to the west of the Reflections seawall extending several hundreds of metres down the beach (Figure 4-10).

Visual site inspections over the last 18-months have validated this assessment by UNSW showing that end effects caused by the Reflections seawall are smaller than predicted and in fact not distinguishable from the underlying dune recession seen west of the seawall to Main Beach (see Section 4.4.1 and Figure 4-10).

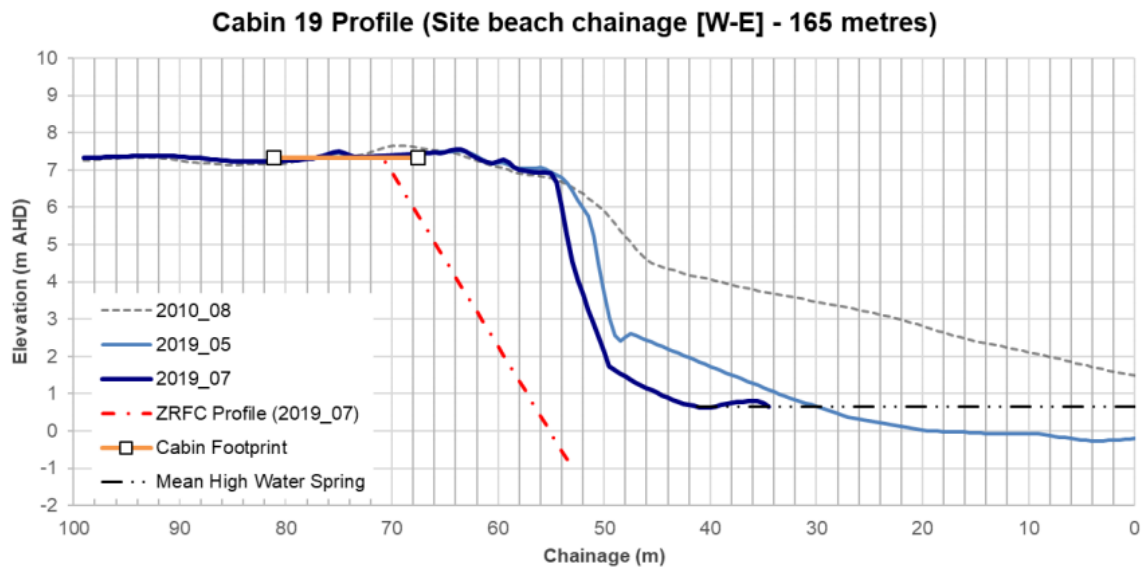
ZRFC. Cabin 19 exemplifies other cabins in similar situations in the park (Cabins 1, 2, 3, 8, 9 and the cottage) which may also become vulnerable to damage/collapse if the wall was removed.

**Figure 5-1 Example profile showing the Zone of Reduced Foundation Capacity (ZRFC) for the dune prior to wall construction. (Rollason, Downes 2019).**

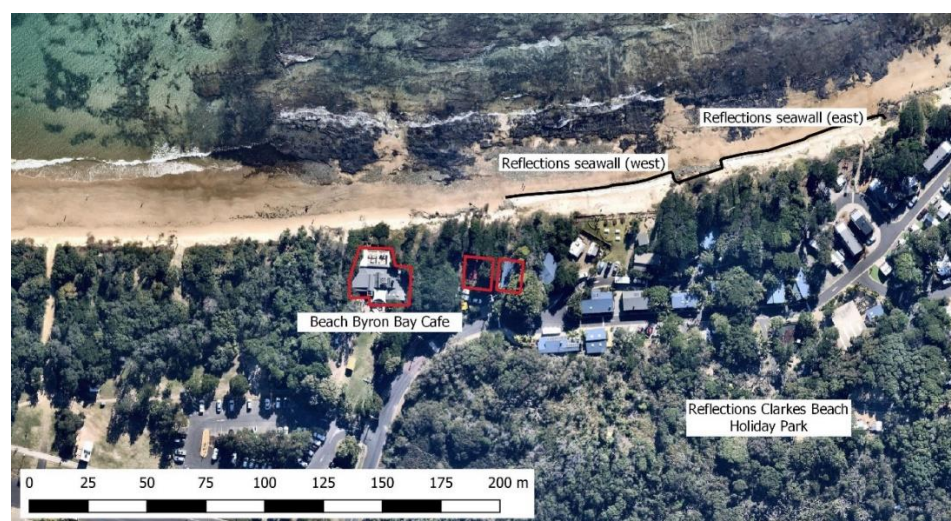
While this analysis assumes the removal of the Café seawall has already occurred, in actual fact the Café seawall is in place currently. While it is in place, the risk to the café and other buildings is low. If the Café seawall were to be removed, the buildings in the vicinity would be at higher risk from the background coastal erosion hazard than the from the end scour effects.

**Figure 5-3 Reflections Clarkes Beach Holiday Park site, seawall, and adjacent area to the west.** (Image dated 04/07/2020, Nearmap)

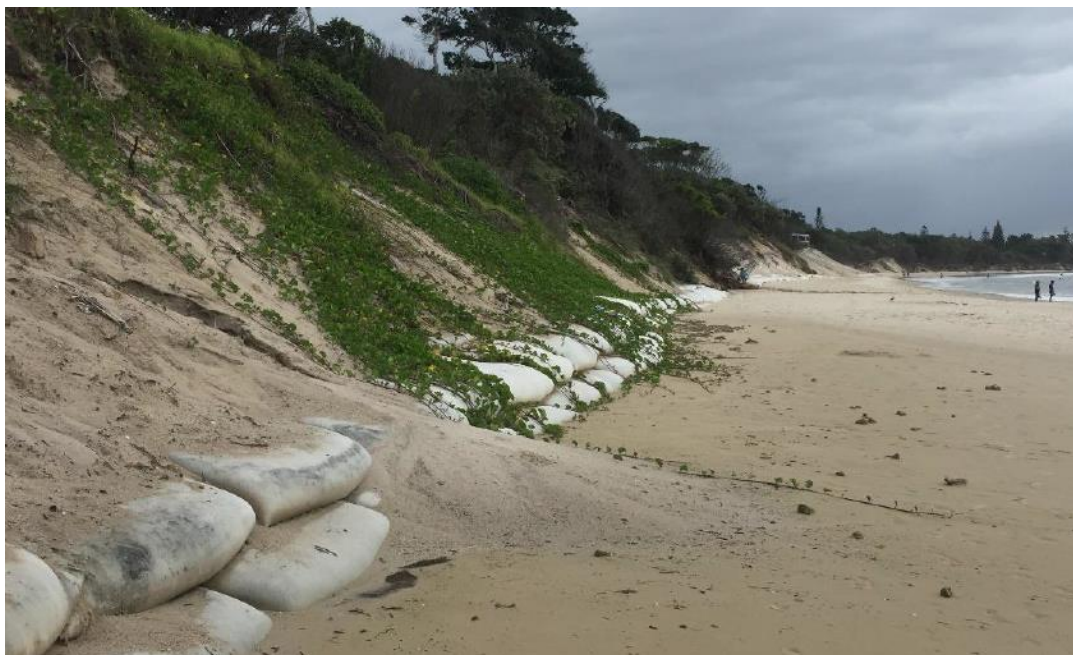
**Figure 5-5 Regeneration of dune vegetation above the Reflections seawall (east)**

Dune vegetation (undescribed) is currently colonising the dune scape above the seawall, as shown in Figure 5-5.
