**Acid Sulfate Soil Assessment**

**Proposed Residential Development**

**52-54 Miles Street, Yamba**

Report No. RGS31546.1-AM

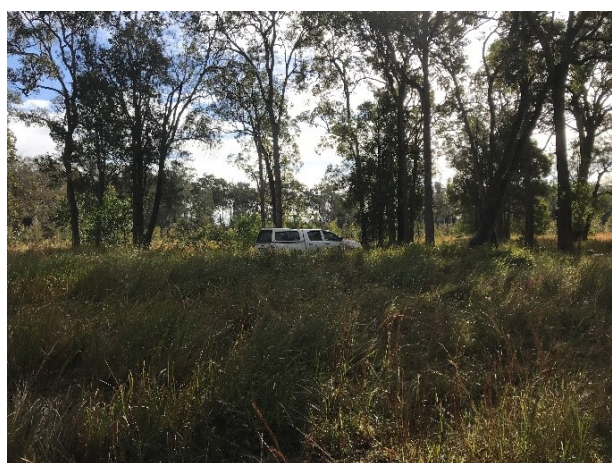
Looking west from the southeast corner of the site.  
Groups of trees are scattered across this area.

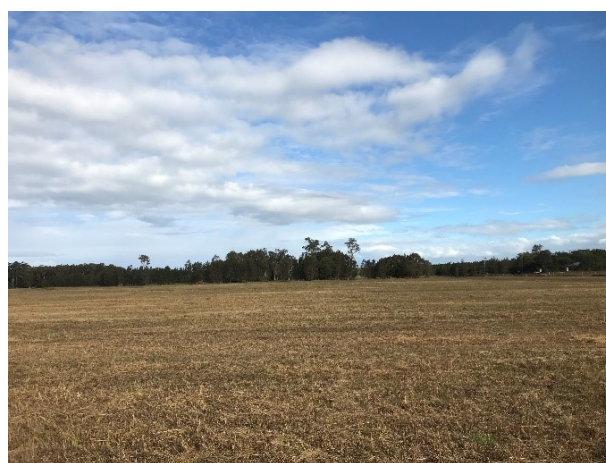
Looking south across the northwest portion of the site  
that was being used for grazing purposes in 2018

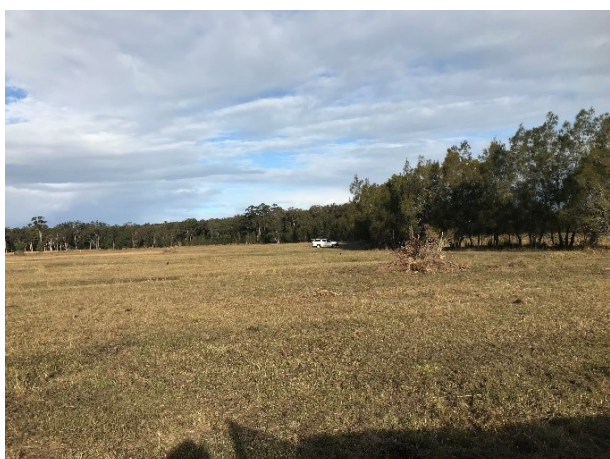
*A row of trees can be seen which are located on the edge of a drainage line in the southwest of the site that drains into Oyster Channel*

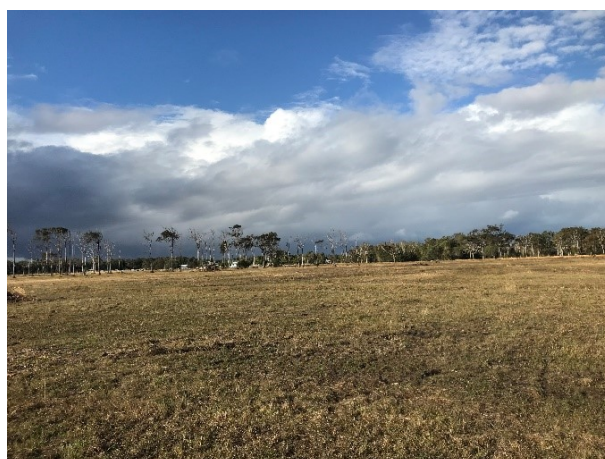
*Looking north from the central portion of the site at open farmland in June 2018*
