Vegetation Management Plan

Lot 46 DP751395 Miles Street Yamba

Prepared for: Garrard Building Pty Ltd
© GeoLINK, 2023

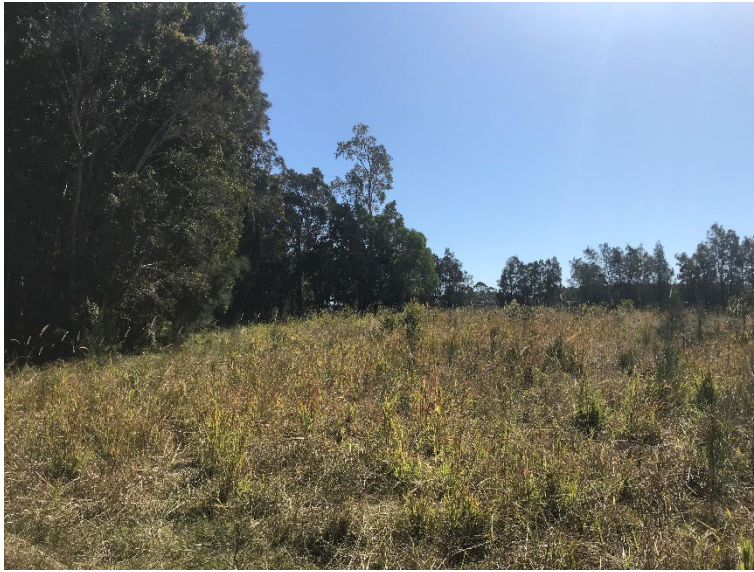
Plate 4.1 Photo point 1 looking north to pasture and Swamp Oak flanking the first order stream

Photographs have been taken within each Management Zone (refer to **Illustration 4.1** for photo points and **Plate 4.1** to **Plate 4.8**).

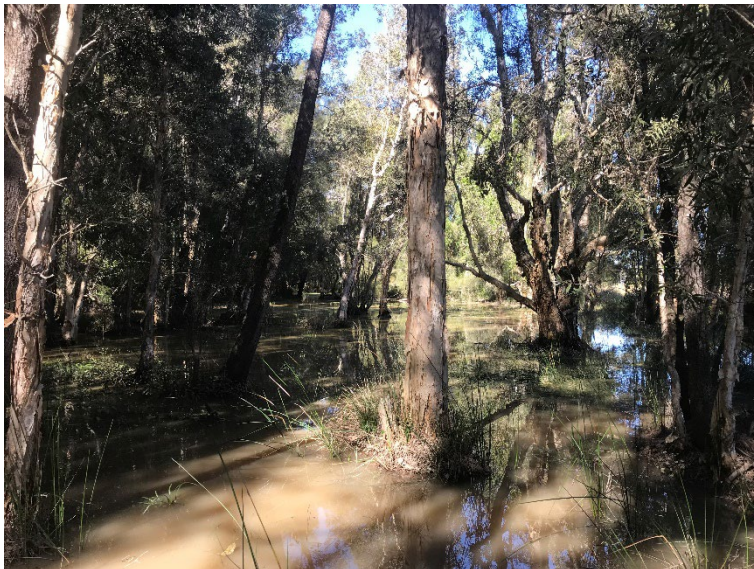
Plate 4.2 Photo point 2 looking south to wetland basin within swamp paperbark forest (PCT 1064)

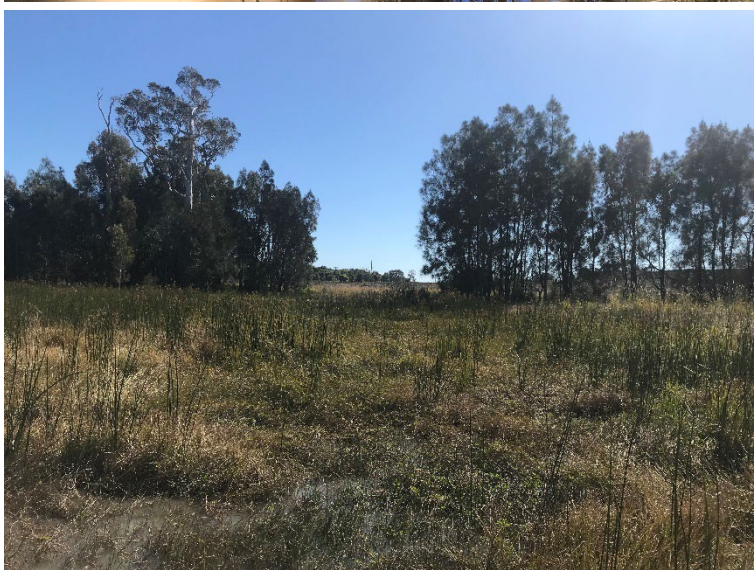
Plate 4.3 Photo point 3 looking north to regenerating sedgeland (PCT 780) within vegetation gap

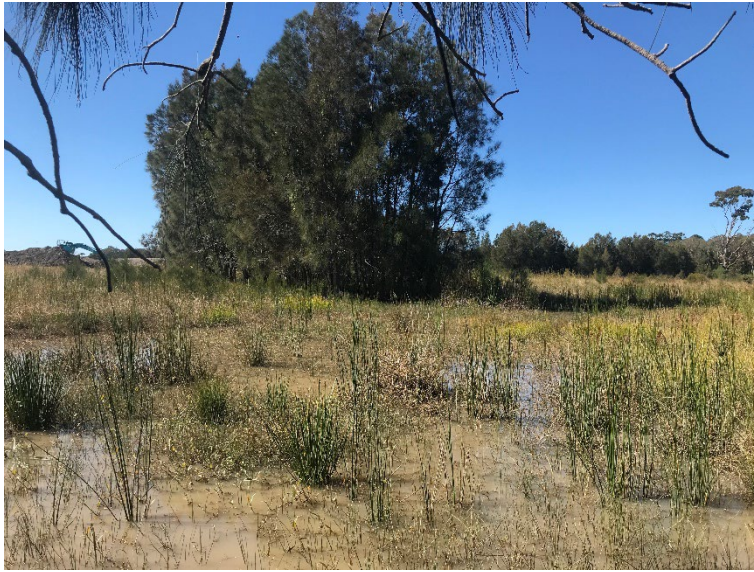
Plate 4.4 *Photo point 4 looking east across regenerating sedgeland (PCT 780) to Swamp Oak (PCT 1235) on first order stream*

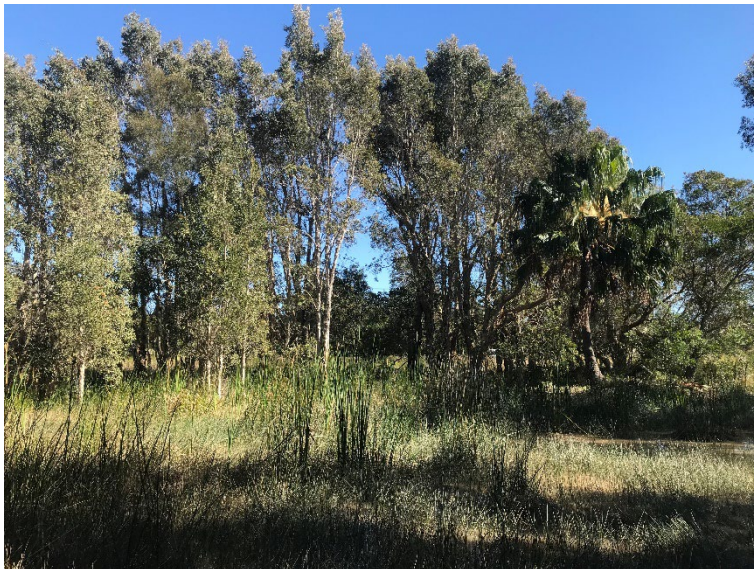
Plate 4.5 *Photo point 5 looking west across regenerating sedgeland (PCT 780) to patch of swamp paperbark forest (PCT 1064)*

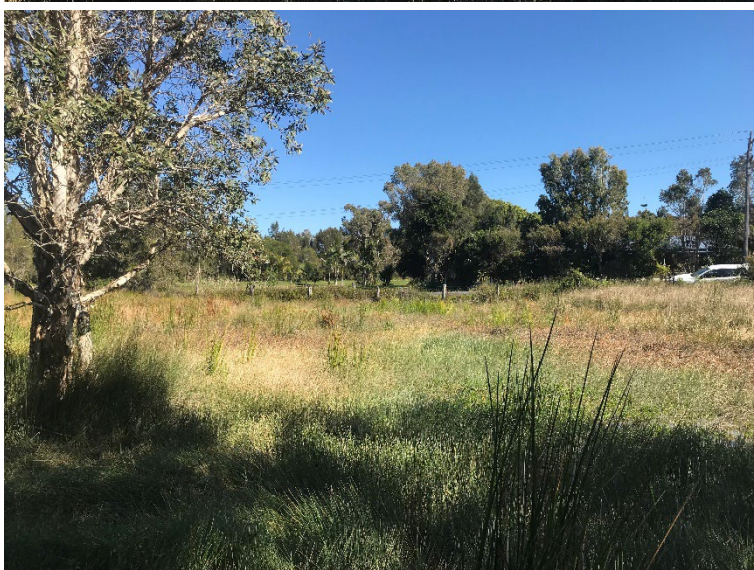
Plate 4.6 *Photo point 6 looking west across regenerating sedgeland (PCT 780) to Carrs Drive*

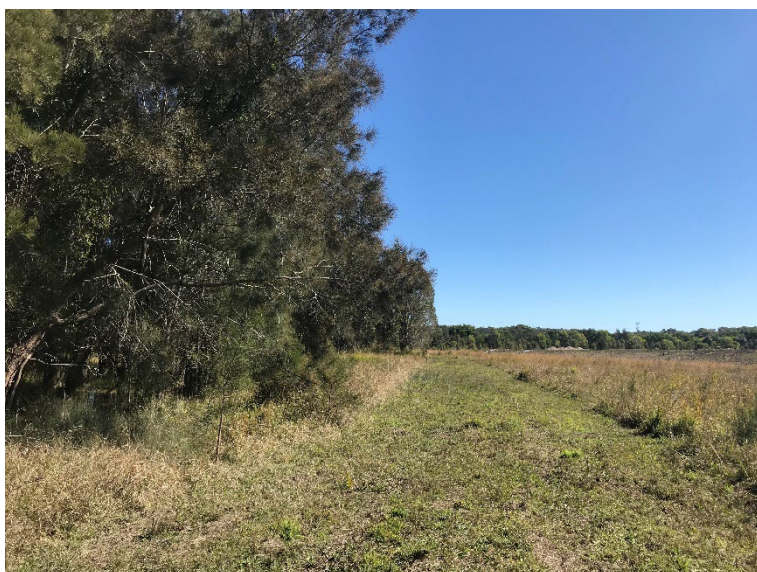
Plate 4.7 Photo point 7
looking west across edge of
PCT 1235 on north side of
watercourse; this area will be
planted out over a width of 10
metres

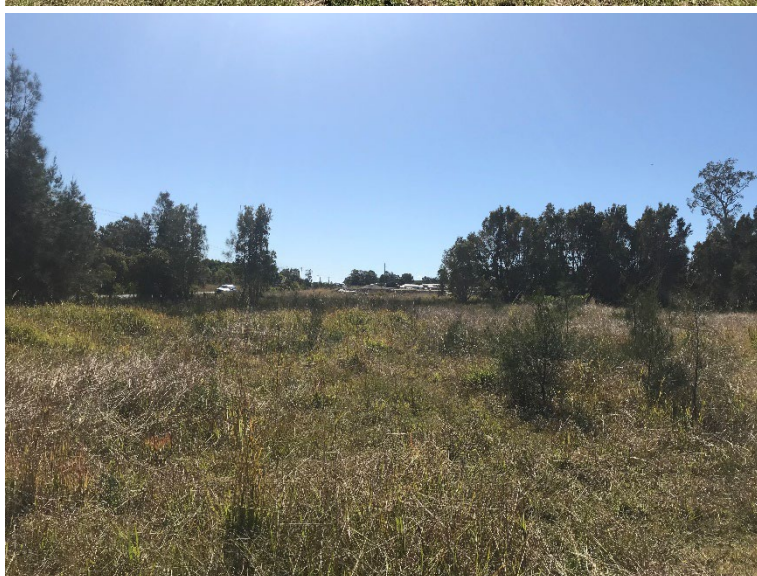
Plate 4.8 Photo point 8
looking north across pasture
to regenerating sedgeland
(PCT 780); areas of pasture will
be planted out over a width of
30 metres in this location

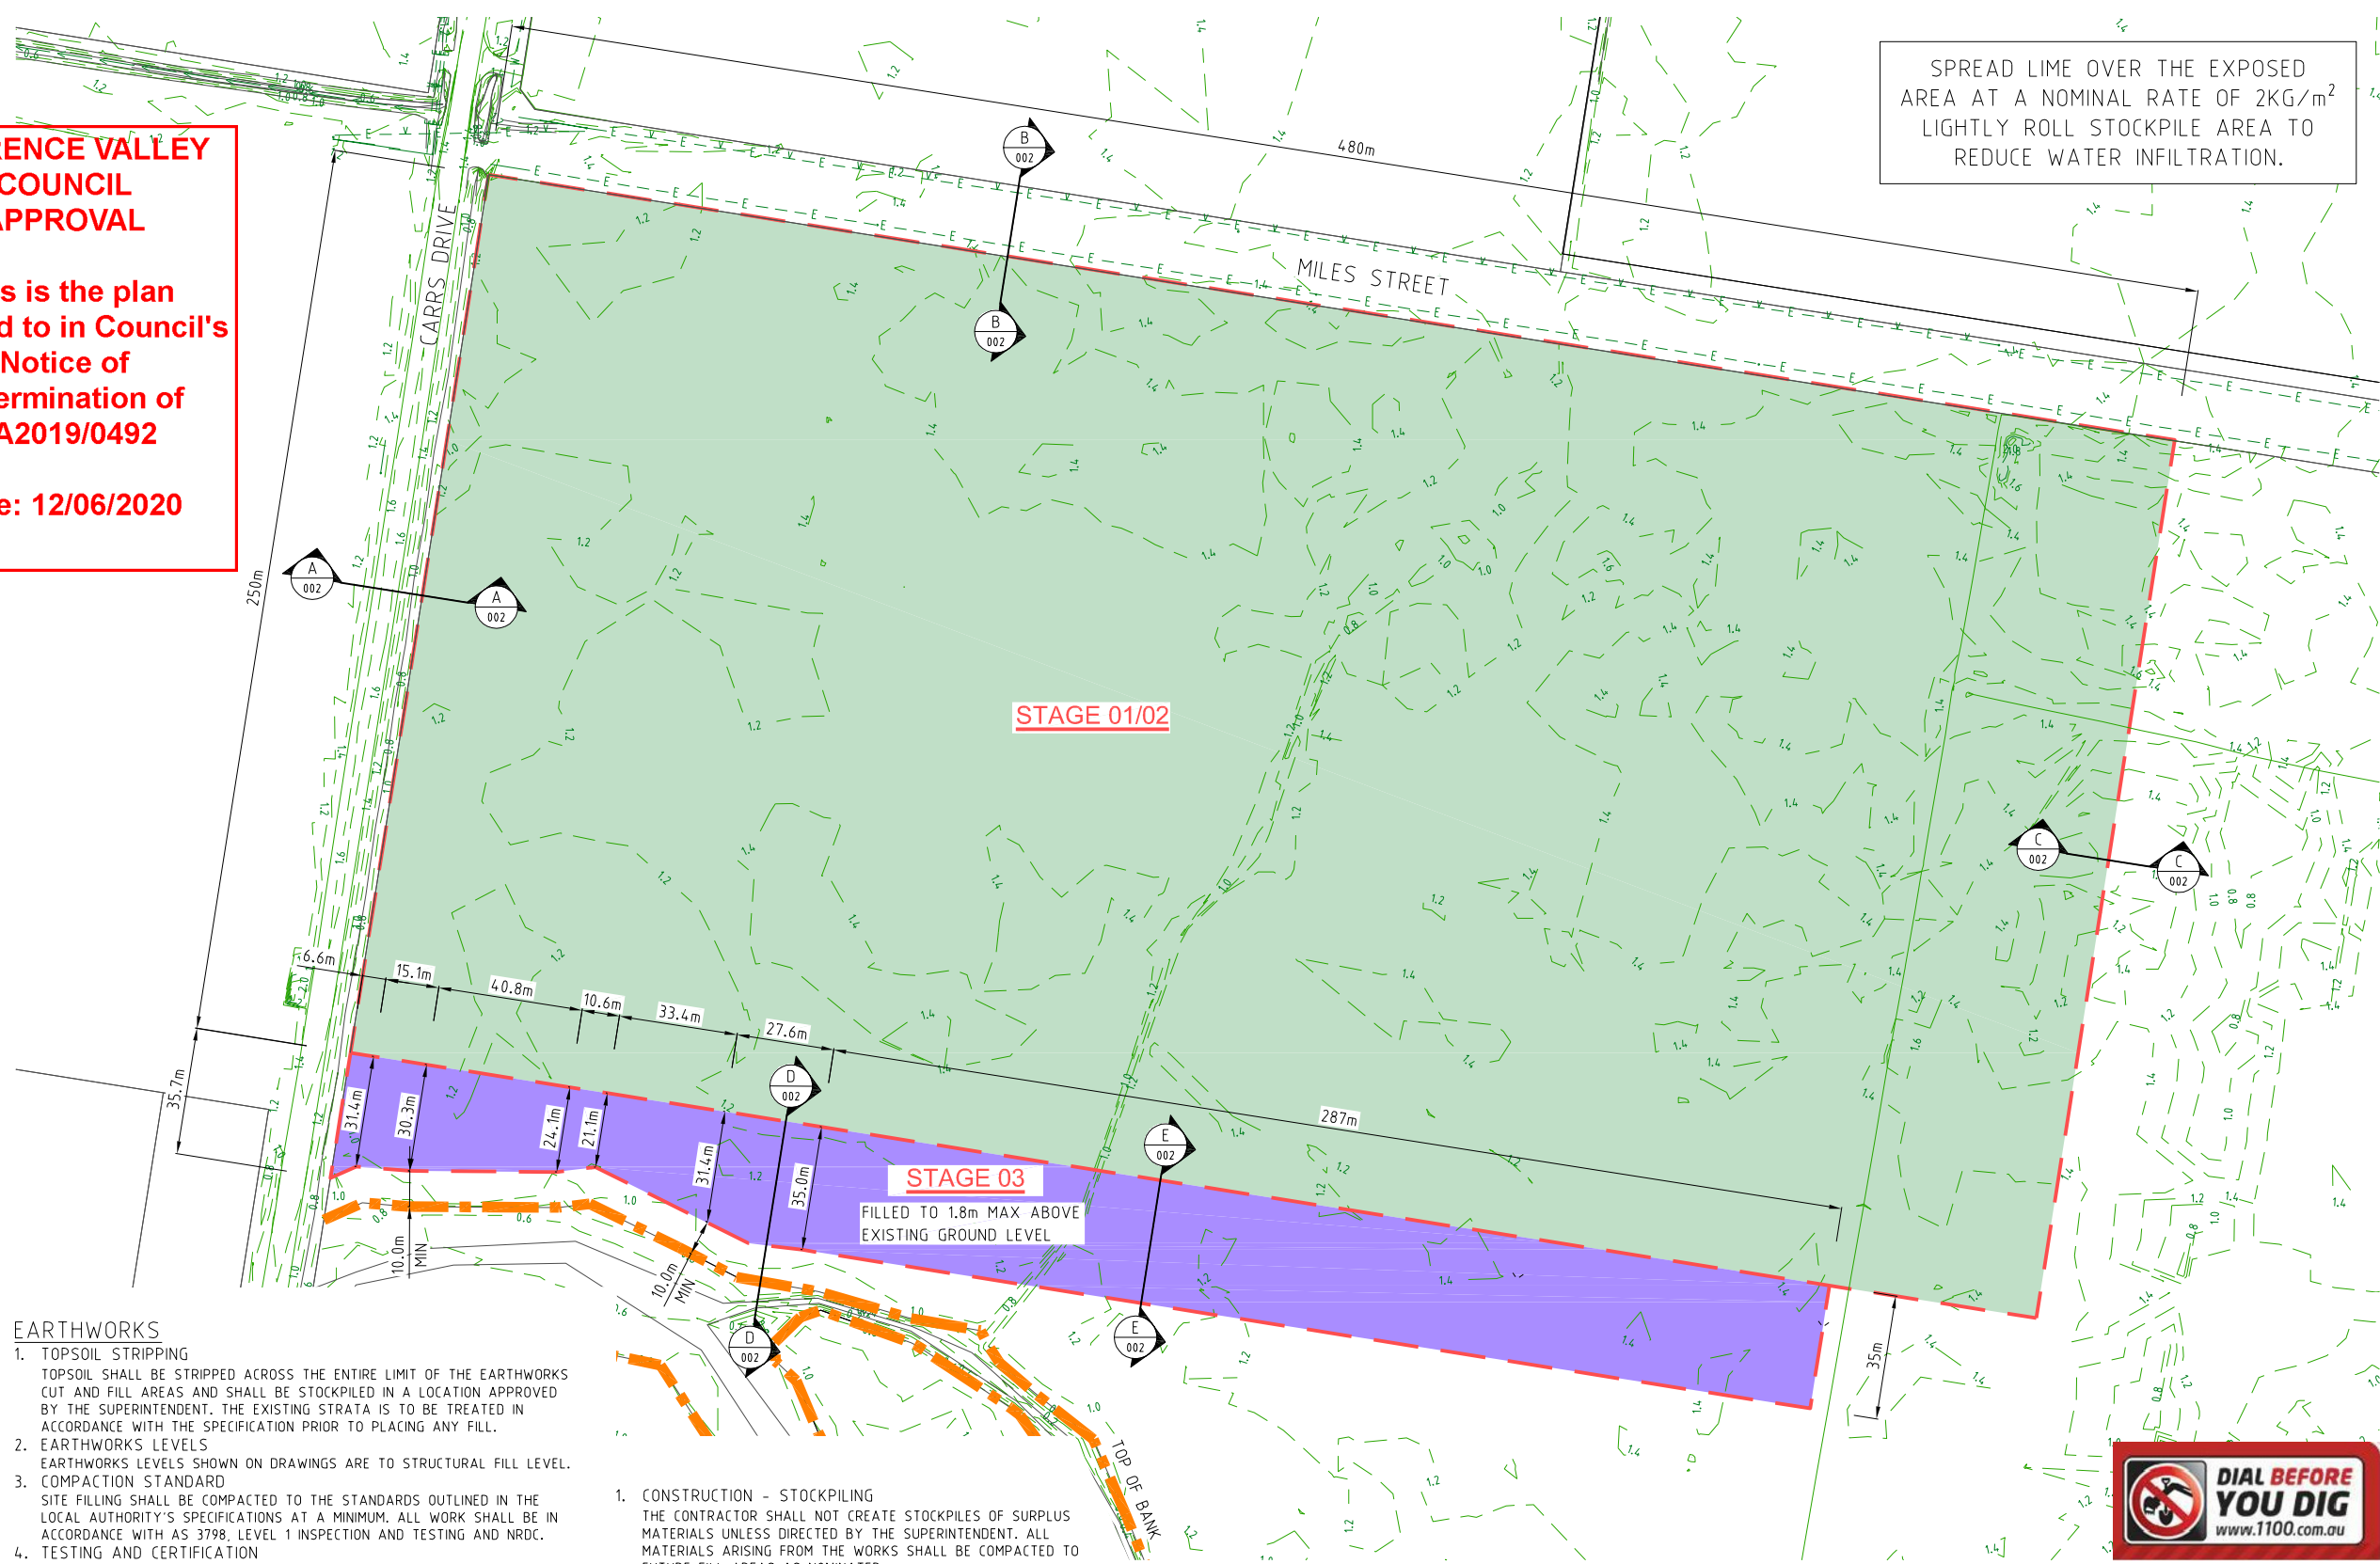
- LEGEND
- EXISTING PROPERTY LINE
 - - - 1.0 EXISTING CONTOURS MAJOR
 - - - 1.5 EXISTING CONTOURS MINOR
 - - - SURVEYED TOP OF BANK LINE
 - - - STAGE BOUNDARY
 - STAGE 02 (FILLED TO 1.8m MAX)
 - STAGE 03

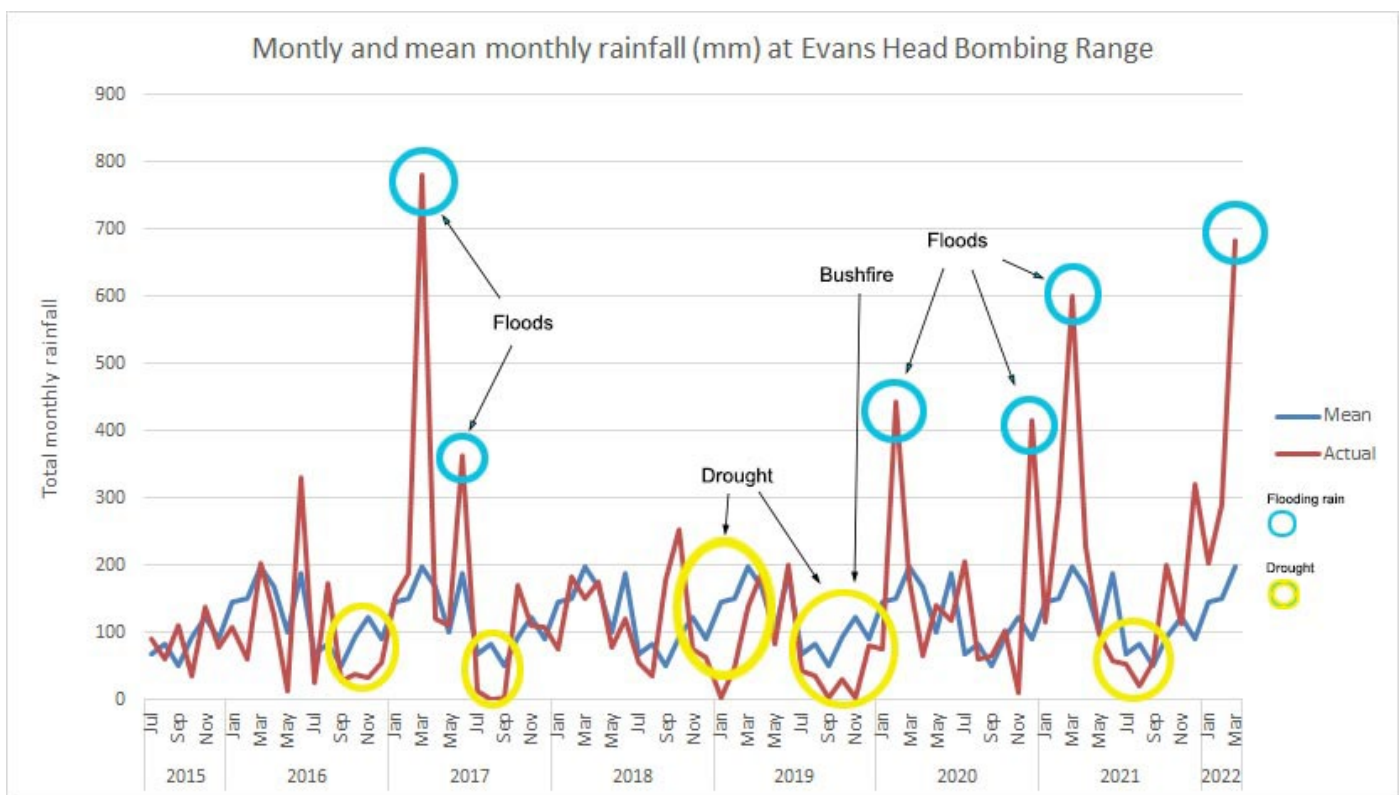
Figure 2: Monthly and mean monthly rainfall for Evans Head Bombing Range approximately 30 km north of Yamba, 2015 to 2022. The weather pattern was characterised by high rainfall variability with frequent droughts (defined as three or more months of below average rainfall) and floods (the bushfire shown in 2019 did not affect the Subject Site). Source: Ecos Environmental (2022).

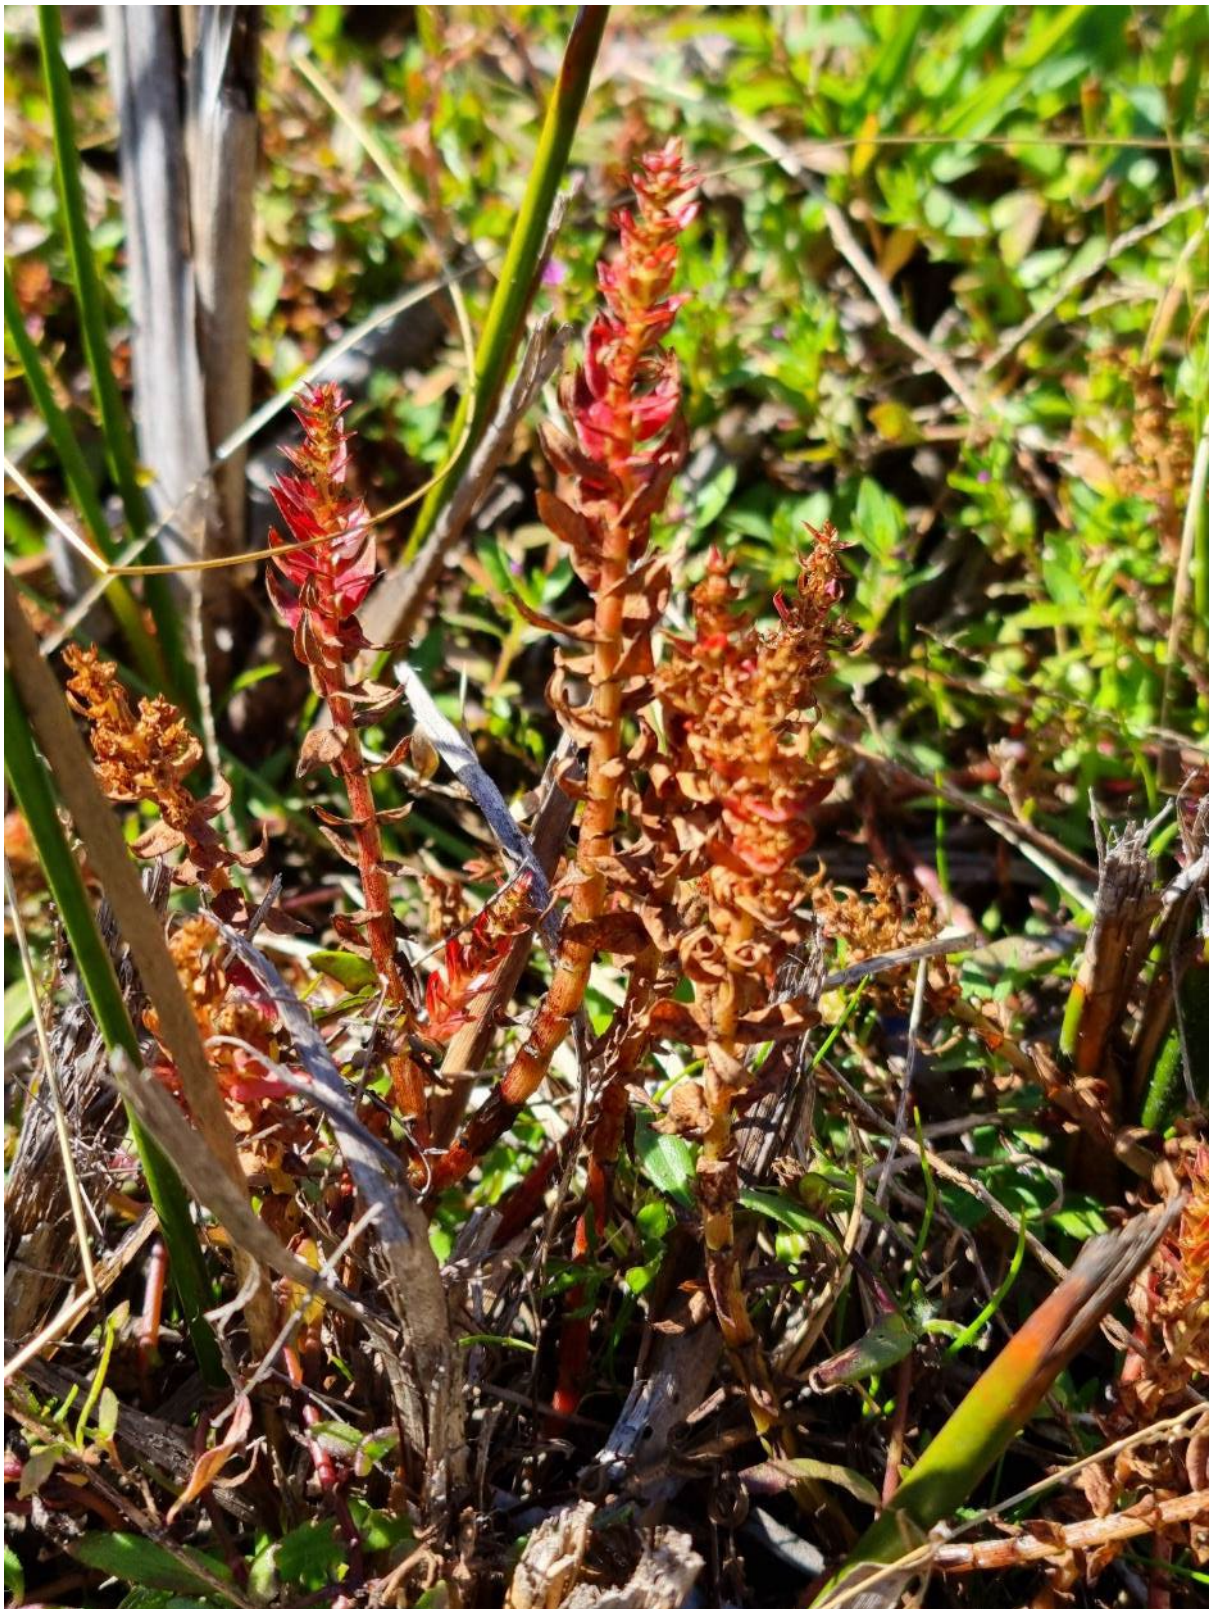
Plate 1: About 10 *Rotala* were recorded on Lot 47 in June 2023 in the same location plants were recorded in 2018. This plant has turned red and is starting to die back due to cold conditions.

The *Rotala* plants recorded on Lots 46 and 47 in June 2023 by Ecos Environmental and Geolink (approx. 10) appeared to be older plants rather than recent seedlings (see Plates 1 and 2). They could have germinated in hoof depressions or tractor ruts in 2022 and gone undetected until June 2023, which would make them about 12 months old.

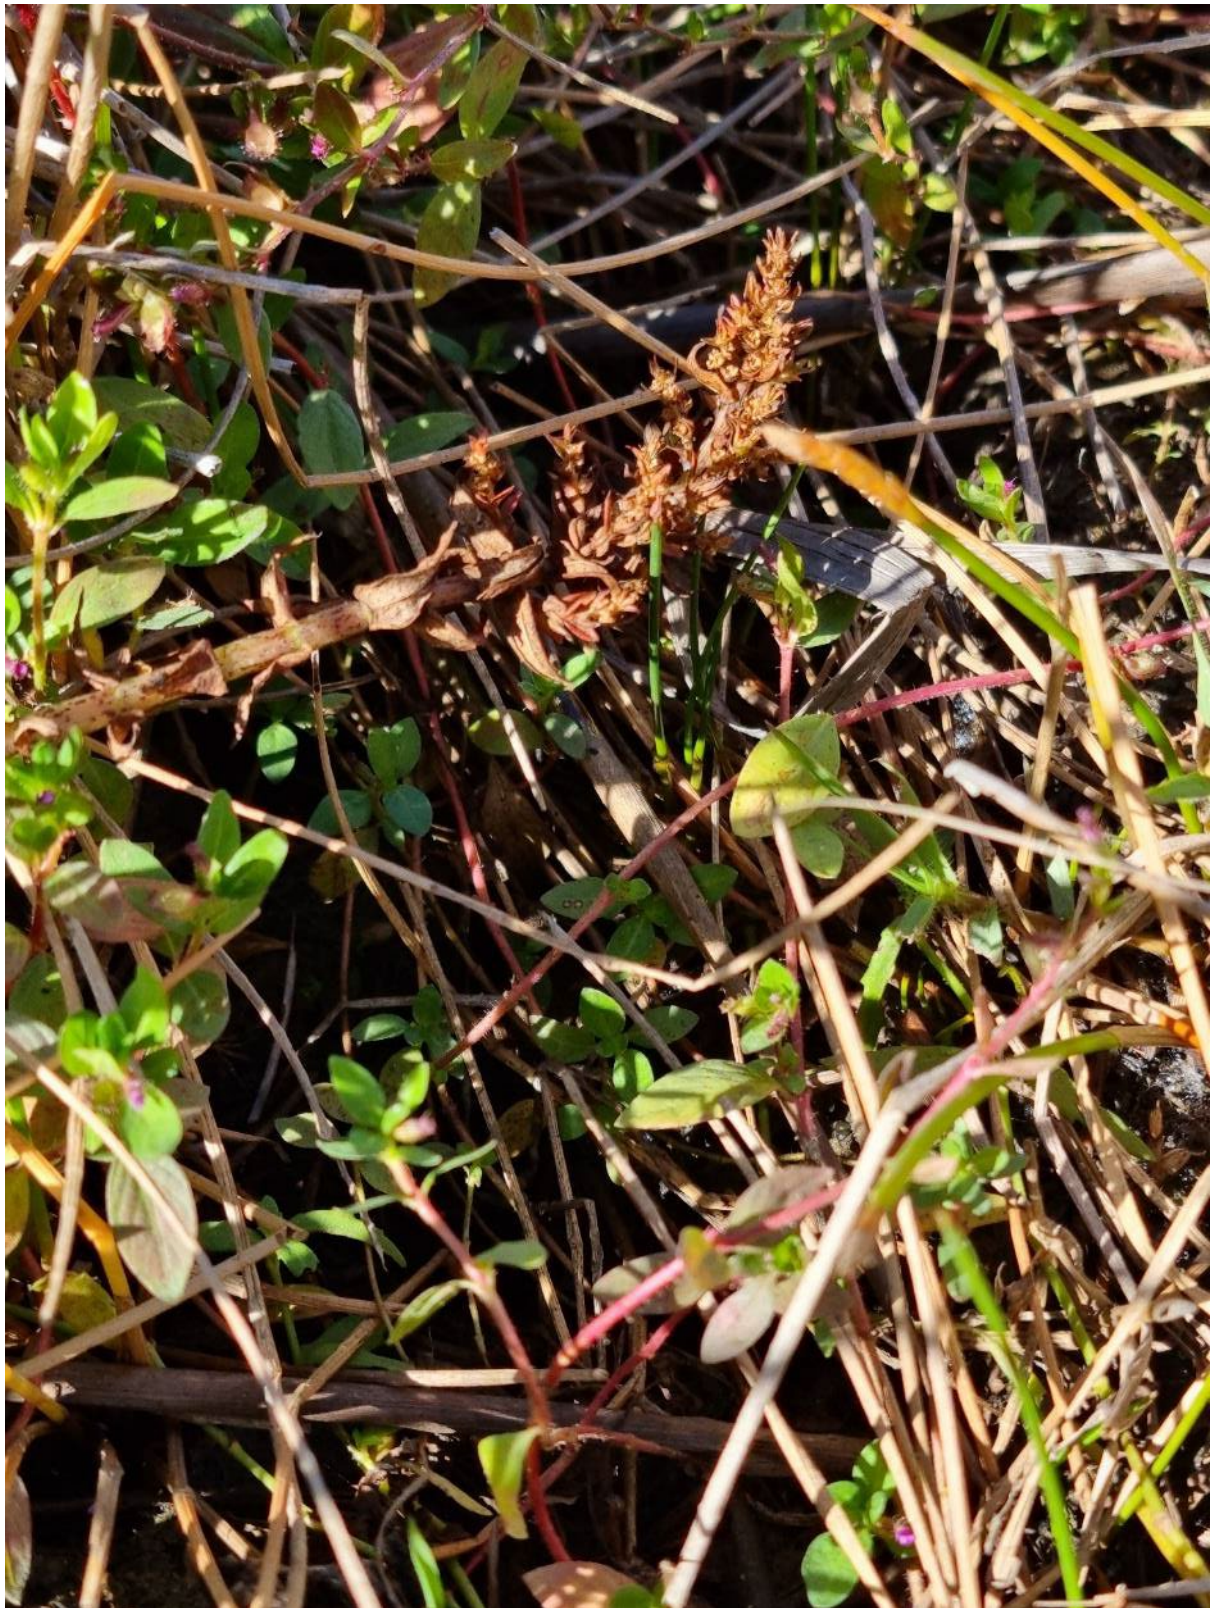
Plate 2: A *Rotala* recorded on Lot 46 in June 2023 at the same location plants were recorded in 2021. This plant is turning brown and dying back due to cold conditions.

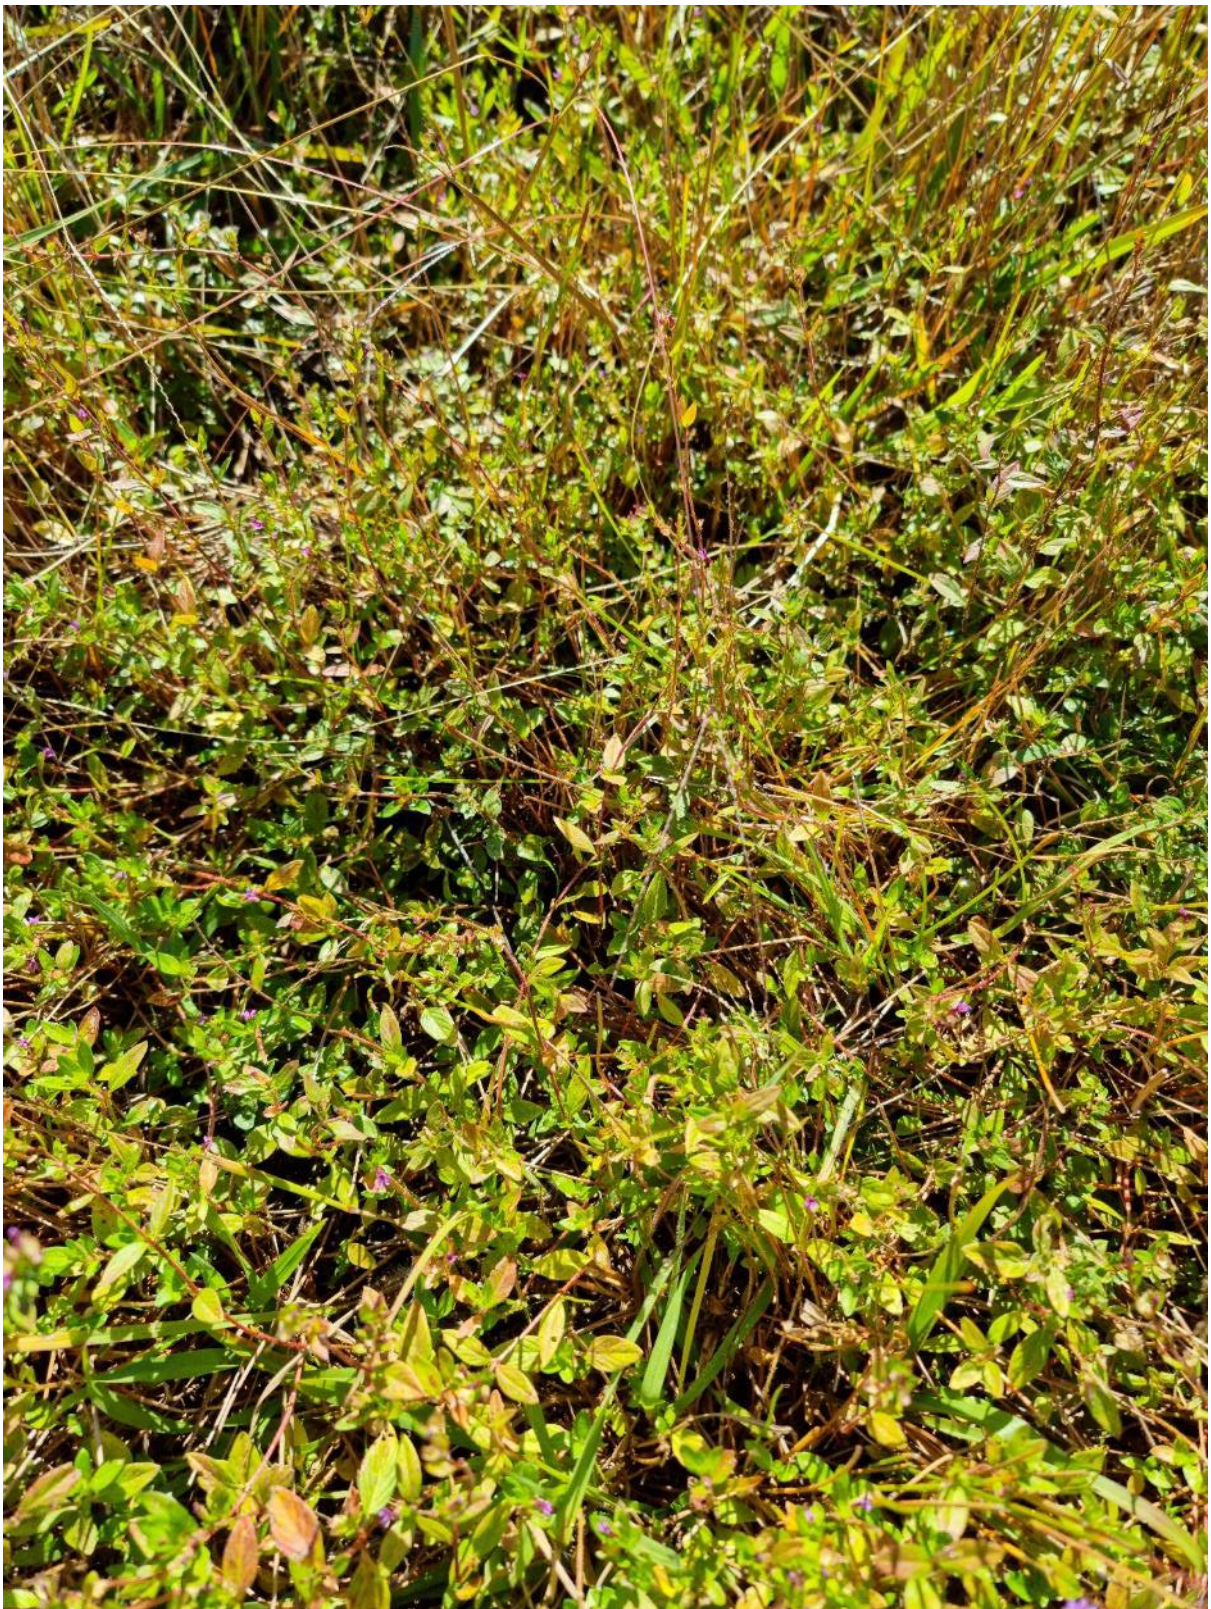
Plate 3: Wetland community PCT720 on Lot 47 in June 2023 dominated by the exotic herb *Cuphea carthagenicus*.

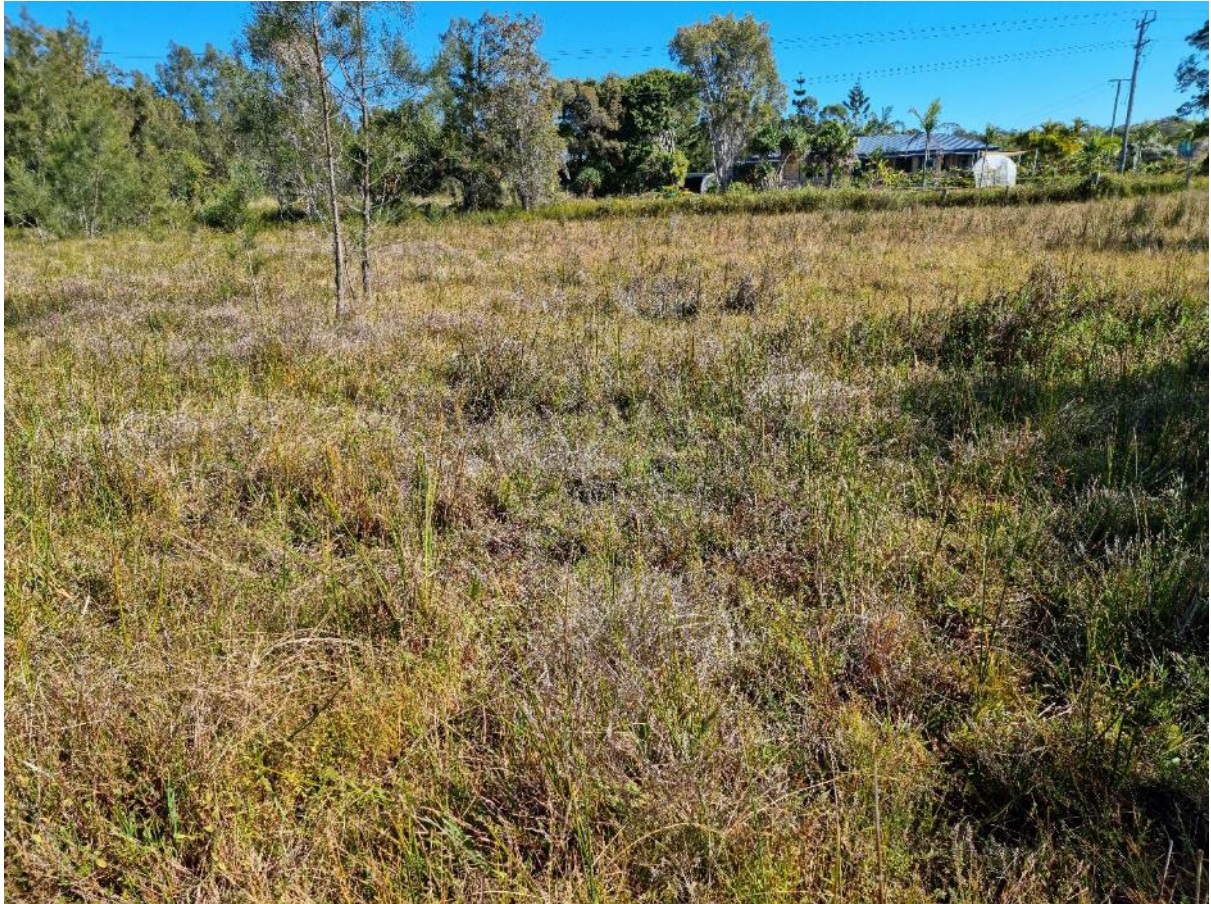
Plate 4: Wetland community PCT 720 on Lot 46 in June 2023, browning off due to cold temperatures.

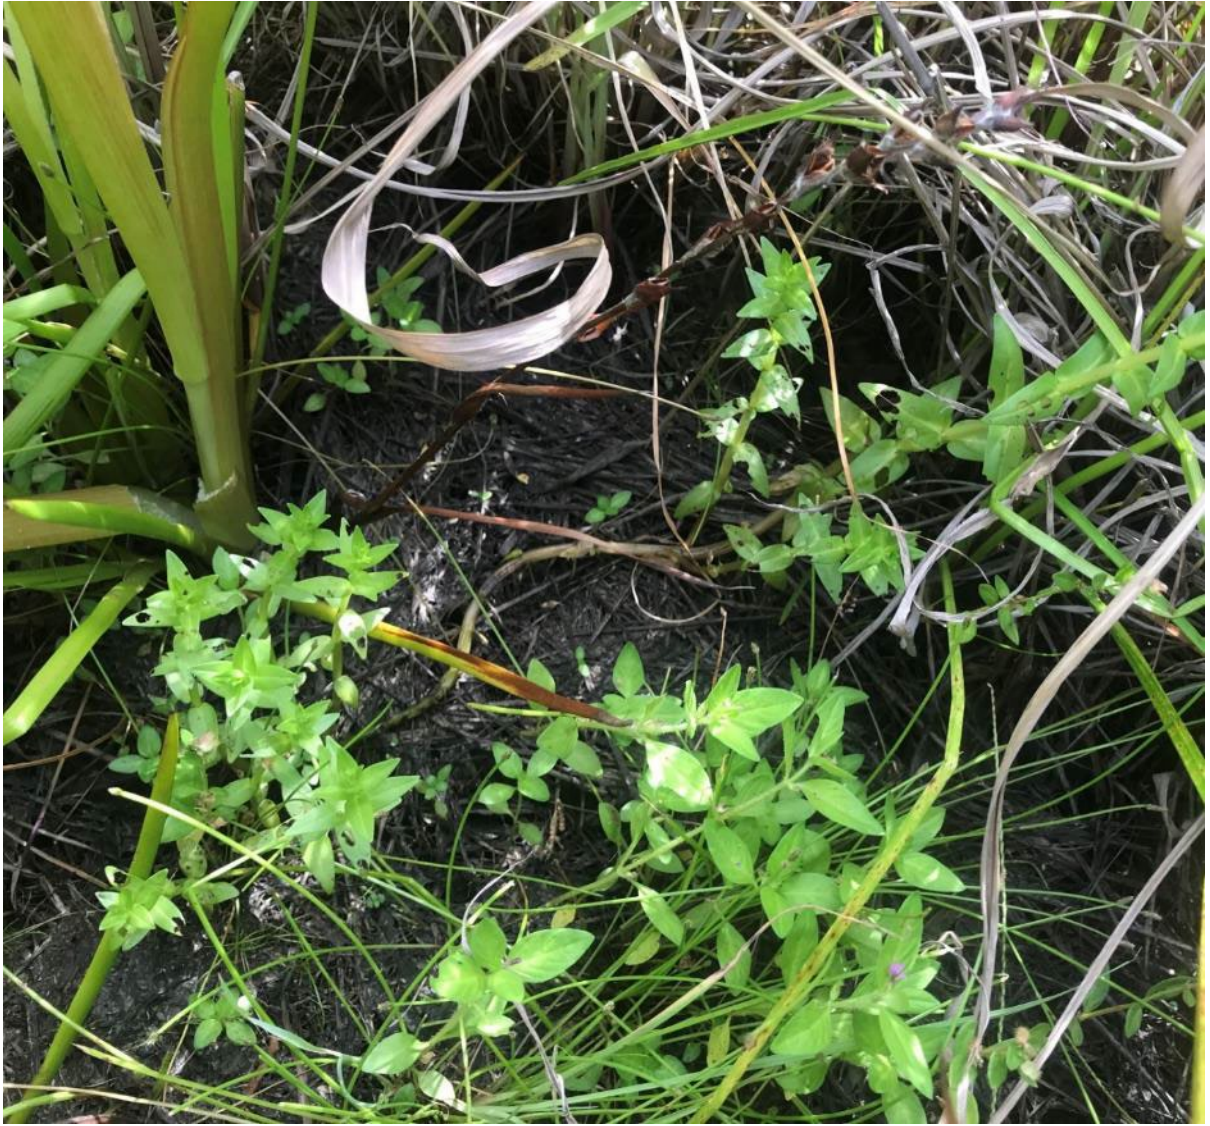
Plate 5: *Rotala* seedlings on Lot 47 in November 2018. Photo supplied by D. Havilah.

The photograph of *Rotala* on the Subject Site in 2018 supplied by Geolink (Plate 5) appears to show evidence of fire, similar to the photos from Mongogarrie (Plates 6 and 7), which suggests plants recorded in 2018 on the Subject Site could have germinated after an earlier low intensity fire. *Rotala* plants in Plate 5 appear to be seedlings a few months old and may have germinated after heavy rain in Aug-Sept 2018 (Figure 2). This rainfall event was preceded by a drier than average period of about three months (conditions suitable for a pasture burn) and then another, more intense dry period extending into summer (Figure 2) when the population is reported to have died out. However, there is no mention of evidence of fire in the BDAR and David Havilah considered it unlikely (pers. comm.).

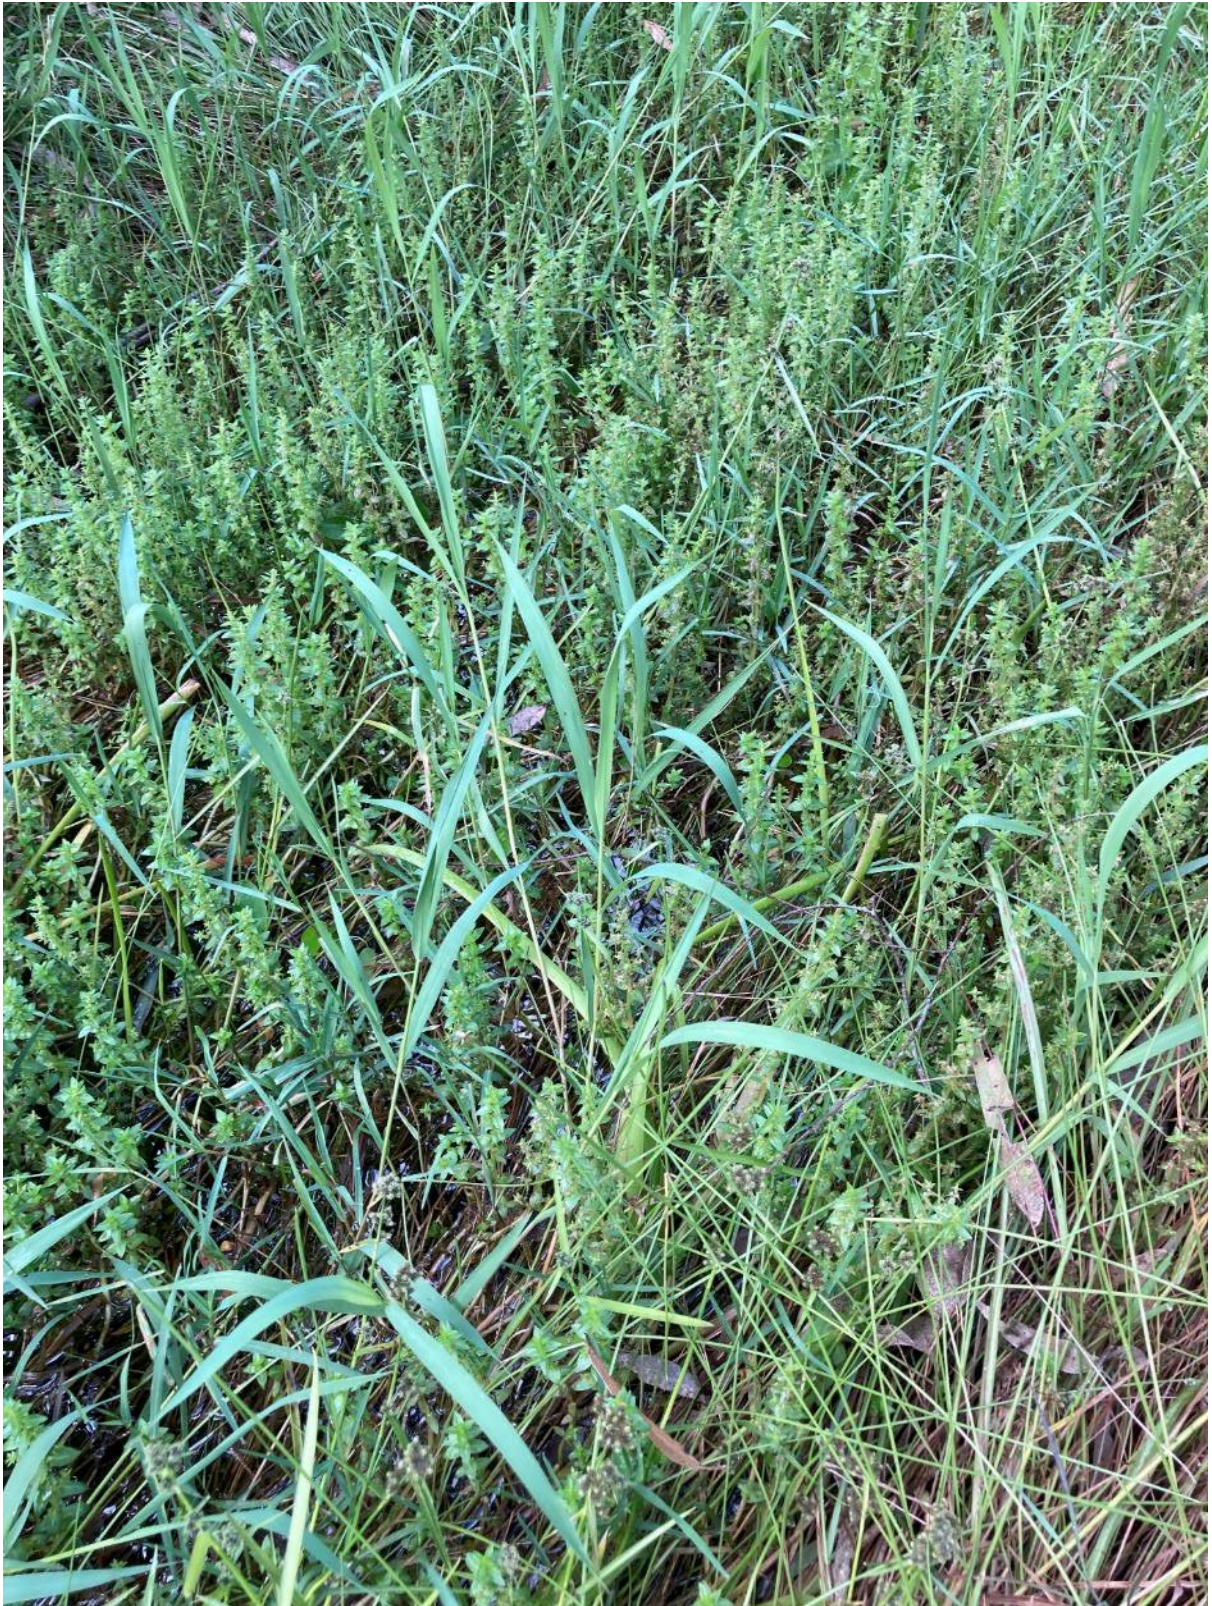
Plate 6: Dense *Rotala* seedlings germinated after fire on a property at Mongogarrie, south of Casino. Photo supplied by D. Havilah.

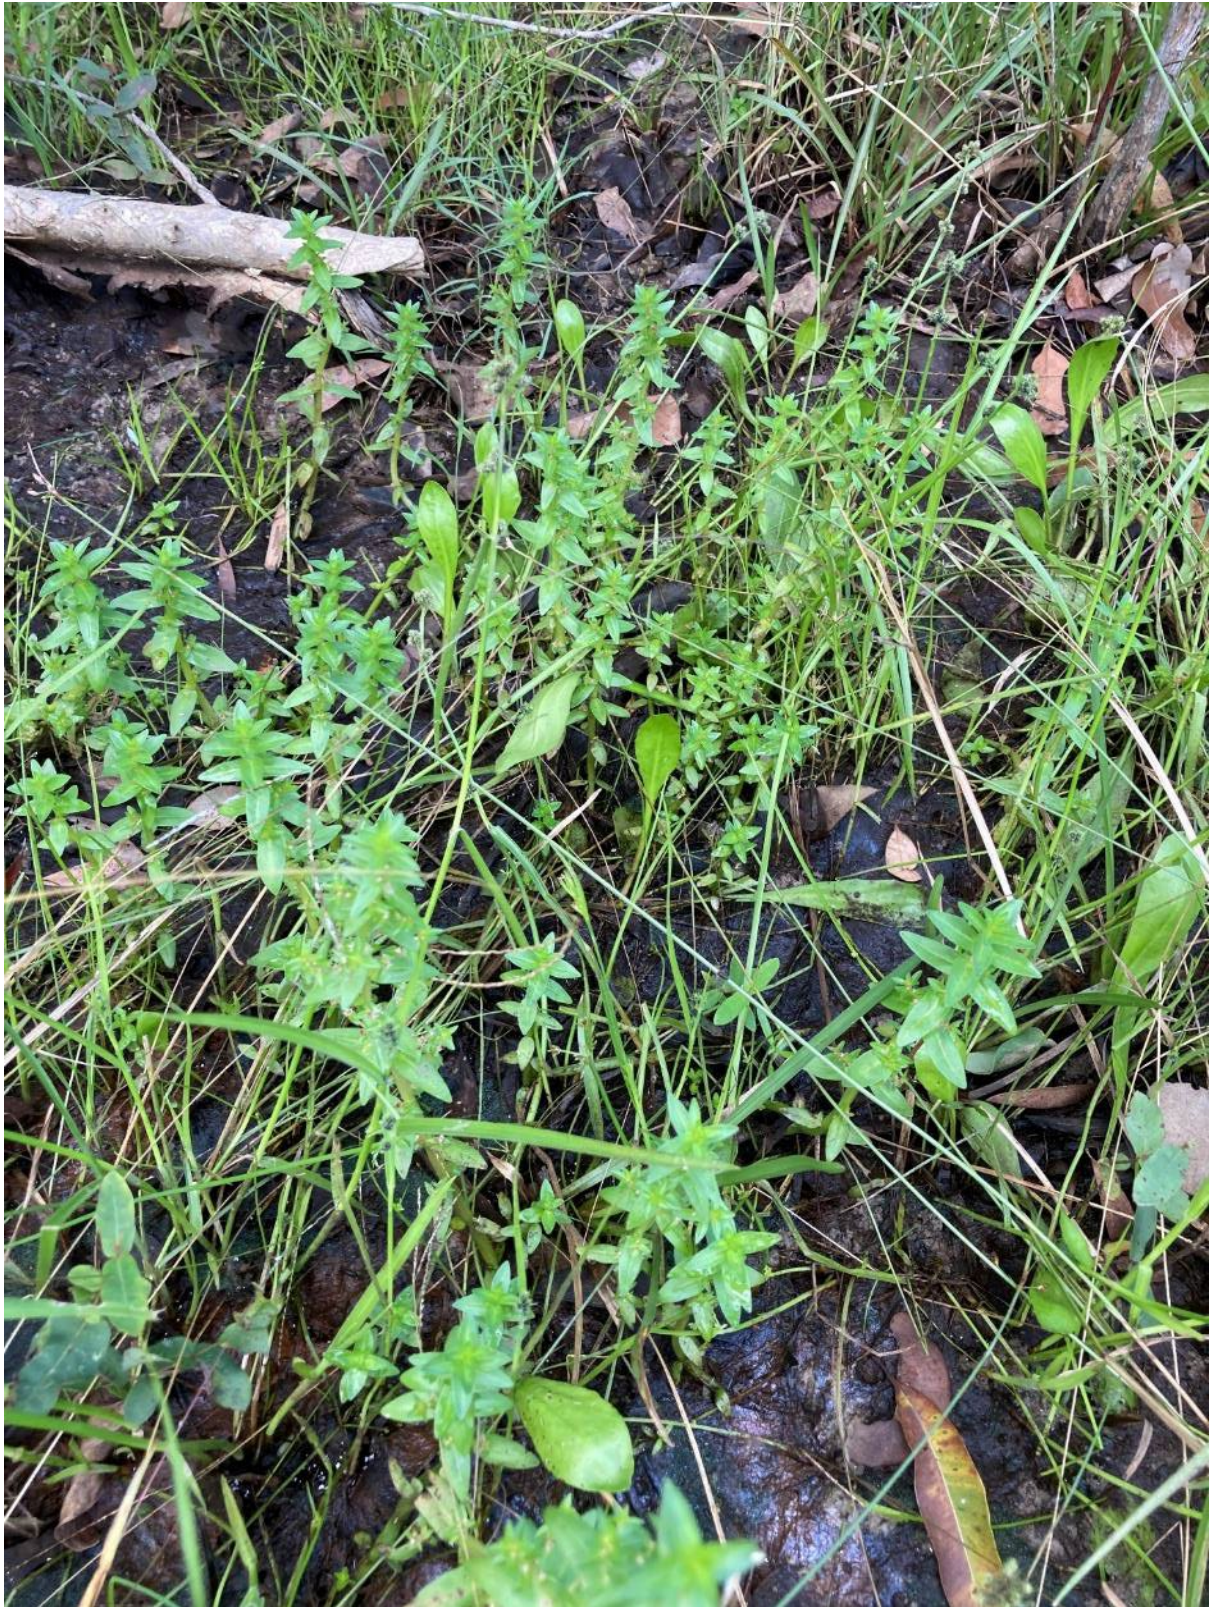
Plate 7: *Rotala* seedlings germinated after fire on a property at Mongogarrie, south of Casino. Photo supplied by D. Havilah.
