Vegetation Management Plan

Lot 46 DP751395 Miles Street Yamba

Prepared for: Garrard Building Pty Ltd
© GeoLINK, 2023

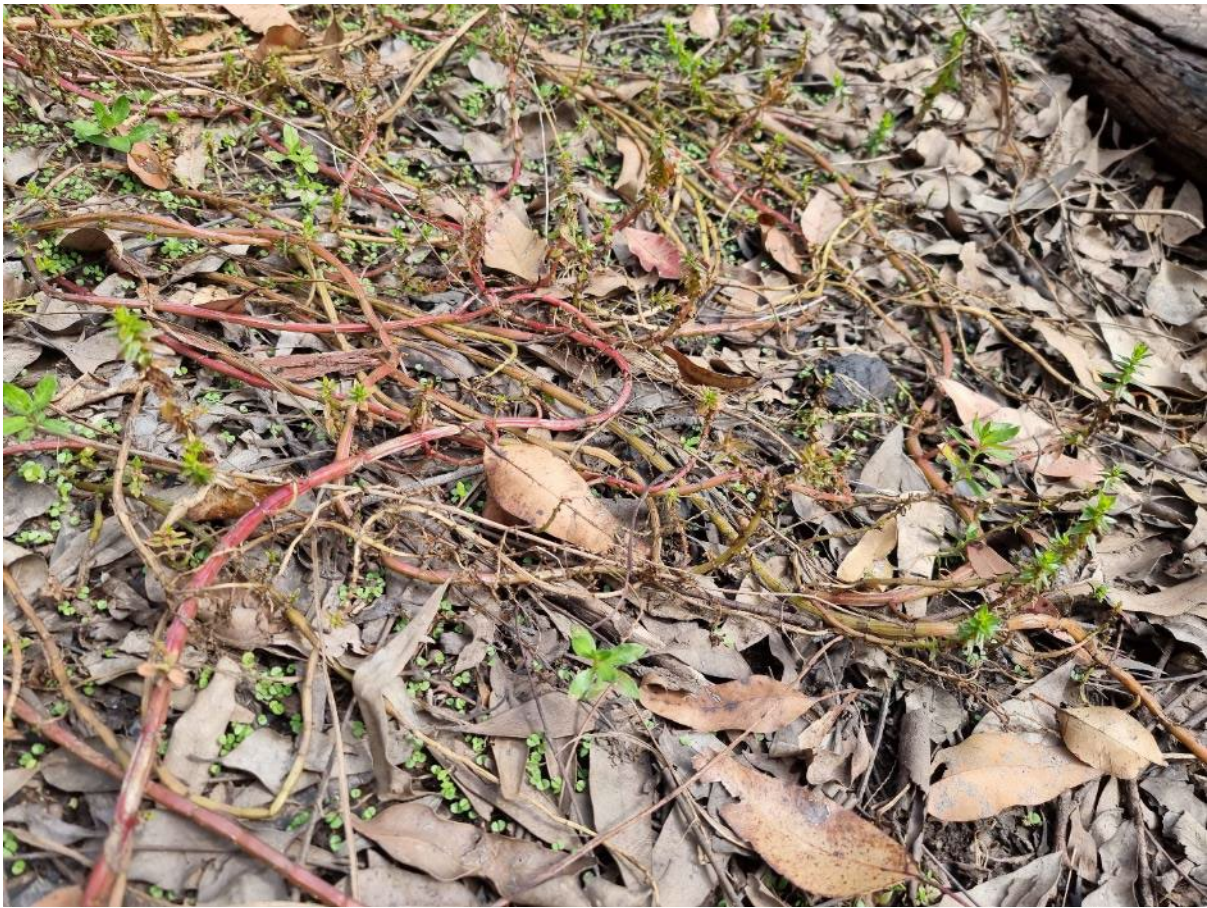
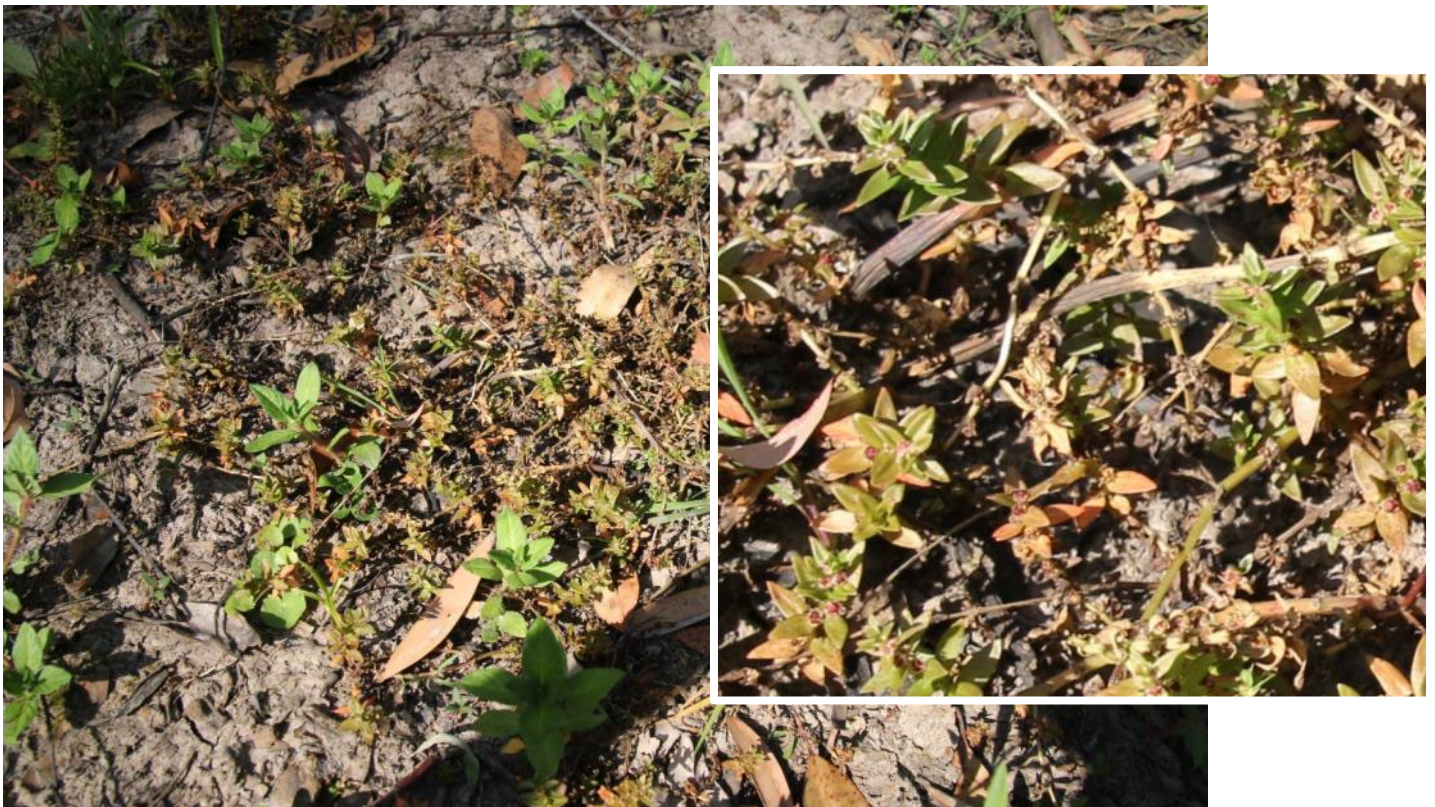
Plates 8-10: *Rotala* plants translocated from near the intersection of Jacky Bulbin Rd and the Pacific Highway to a recipient site 1 km south, for the Woolgoolga to Ballina project. Some plants survived for five years after being transplanted. **Plate 8** (top) – reddish stolons (prostrate, perennating stems) with small shoots. **Plates 9-10.** - clump of *Rotala* 3-5 cm high spreading by stolons and close up. Sept 2020

By contrast, the author found that *Rotala* plants monitored on the W2B project at Jacky Bulbin Rd and the Pacific Highway were perennial, as they persisted in situ for 2 years in a cleared paddock, then for another 5 years after being translocated (Ecos Environmental 2021). More than half the translocated plants died, but some survived for five years. Many flowers were produced but no seedling recruitment was observed in five years. Plants spread 10-30 cm by prostrate stolons that took root at nodes. They died back during the year in dry or cold conditions and appeared to persist by means of leafless stolons (see Plate 8). Additional watering was carried out that may have prolonged their life span.

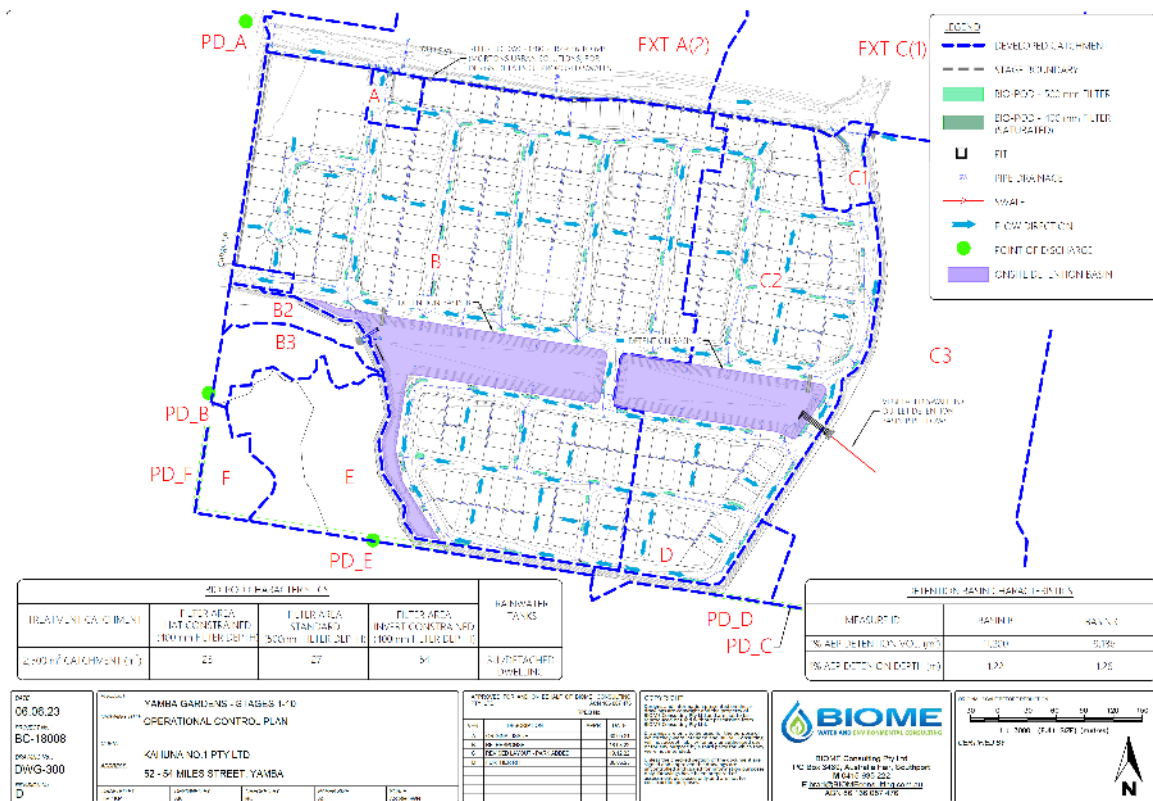
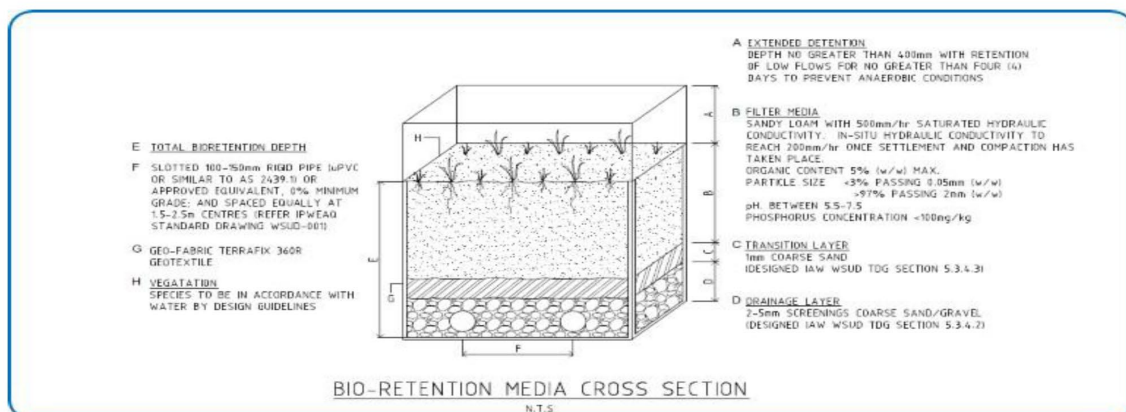
Figure 7.1 Bioretention specifications (Typical)

Appendix 2: Location of two bio-retention basins and how they will be linked with housing. This design is repeated across the site. Below is the design the bioretention media which is a soil/particulate medium (source: Biome Pty Ltd 2023)
