Geotechnical Assessment

Yamba Gardens Residential Estate

52-54 Miles Street, Yamba

Report No. RGS31546.1-AP

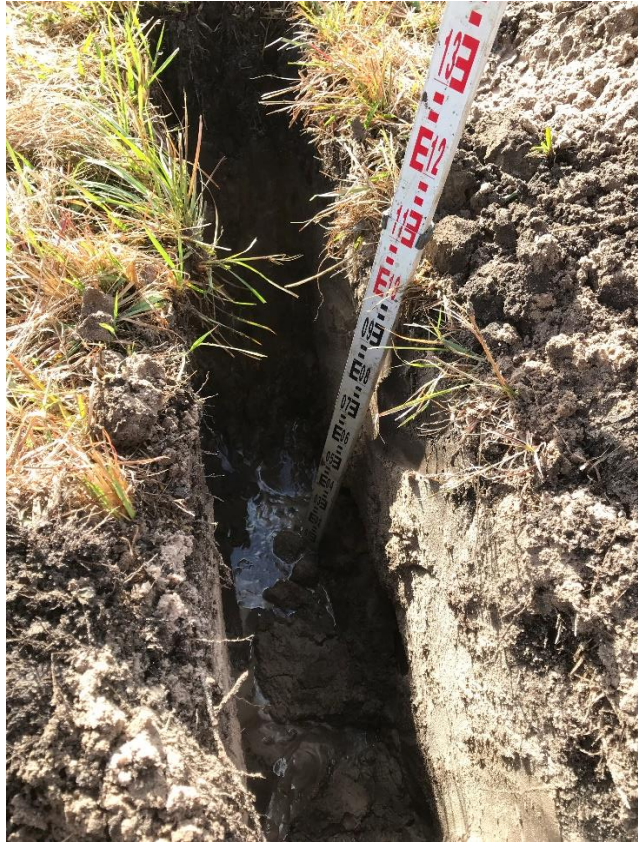
TP1 encountered 0.2m of topsoil overlying sand. Groundwater was encountered at 0.7m.

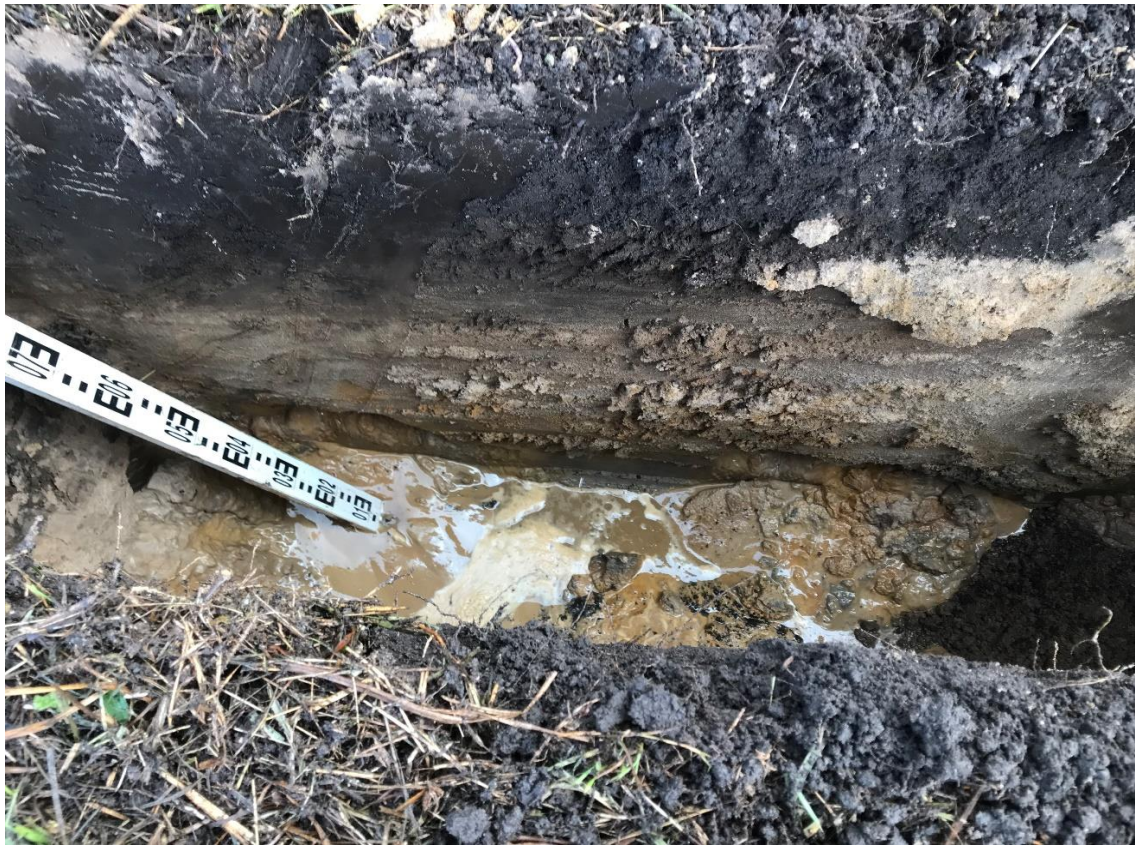
TP10 encountered 0.25m of topsoil overlying sand. Groundwater was encountered at 0.8m.

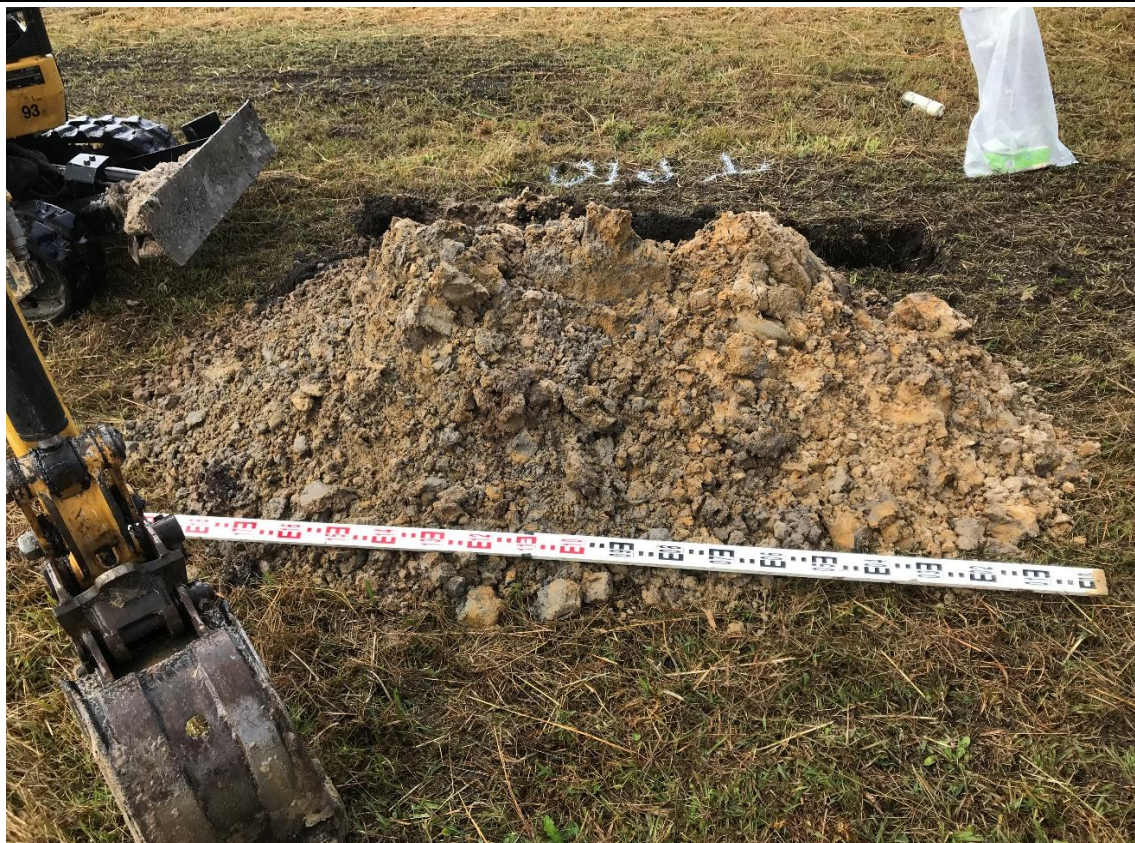
Excavated material from TP10

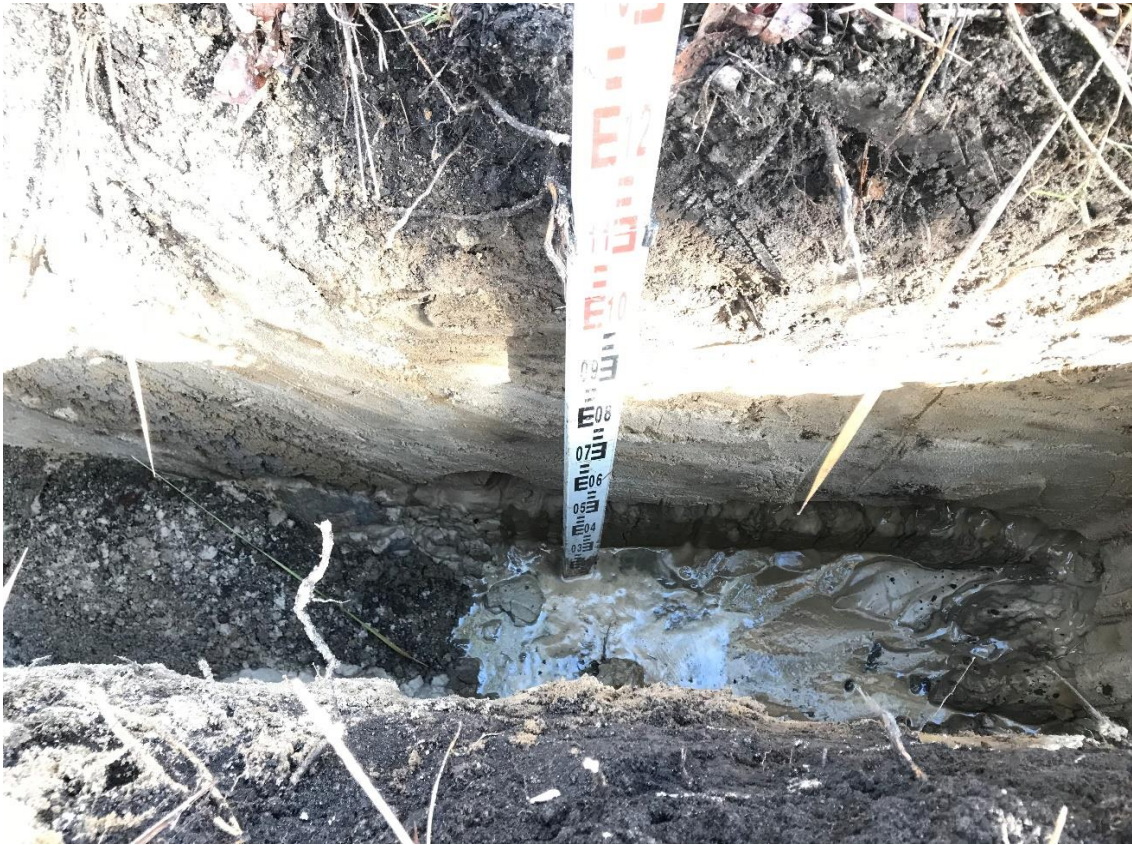
TP11 encountered 0.2m of topsoil overlying sand. Groundwater was encountered at 0.8m.

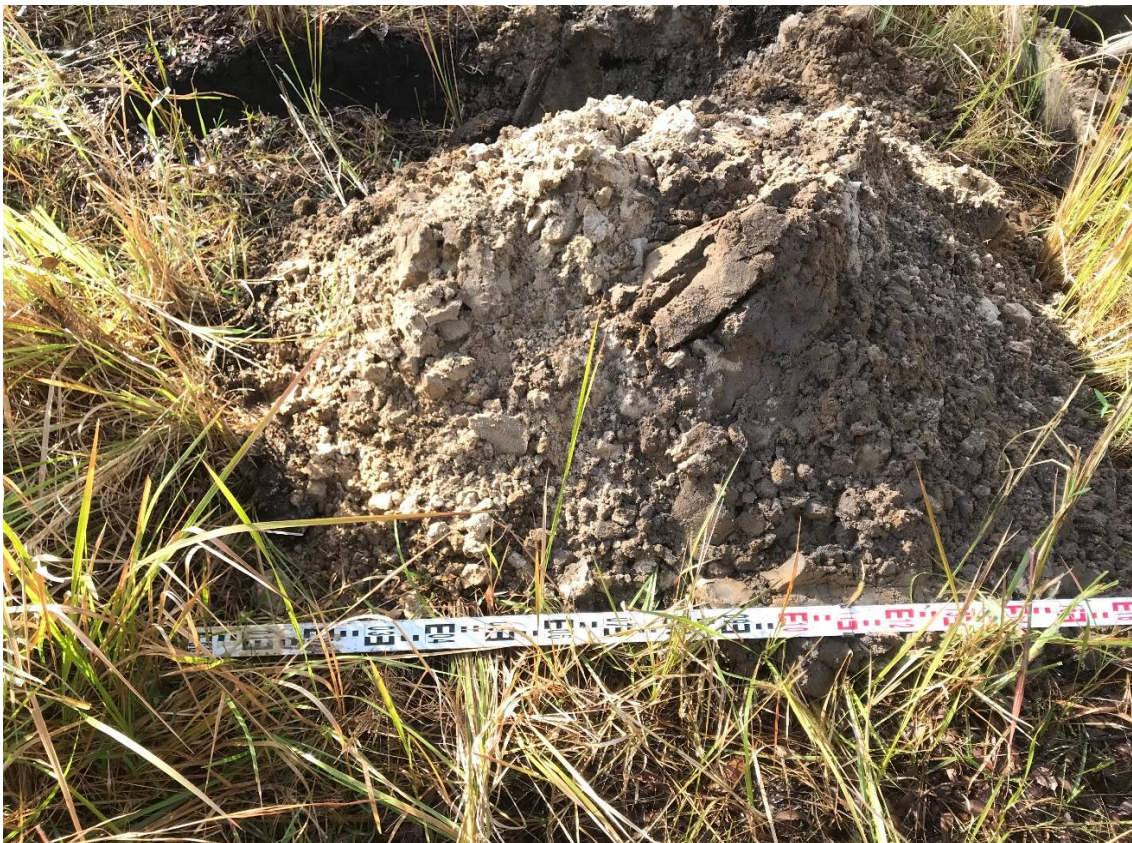
Excavated material from TP11

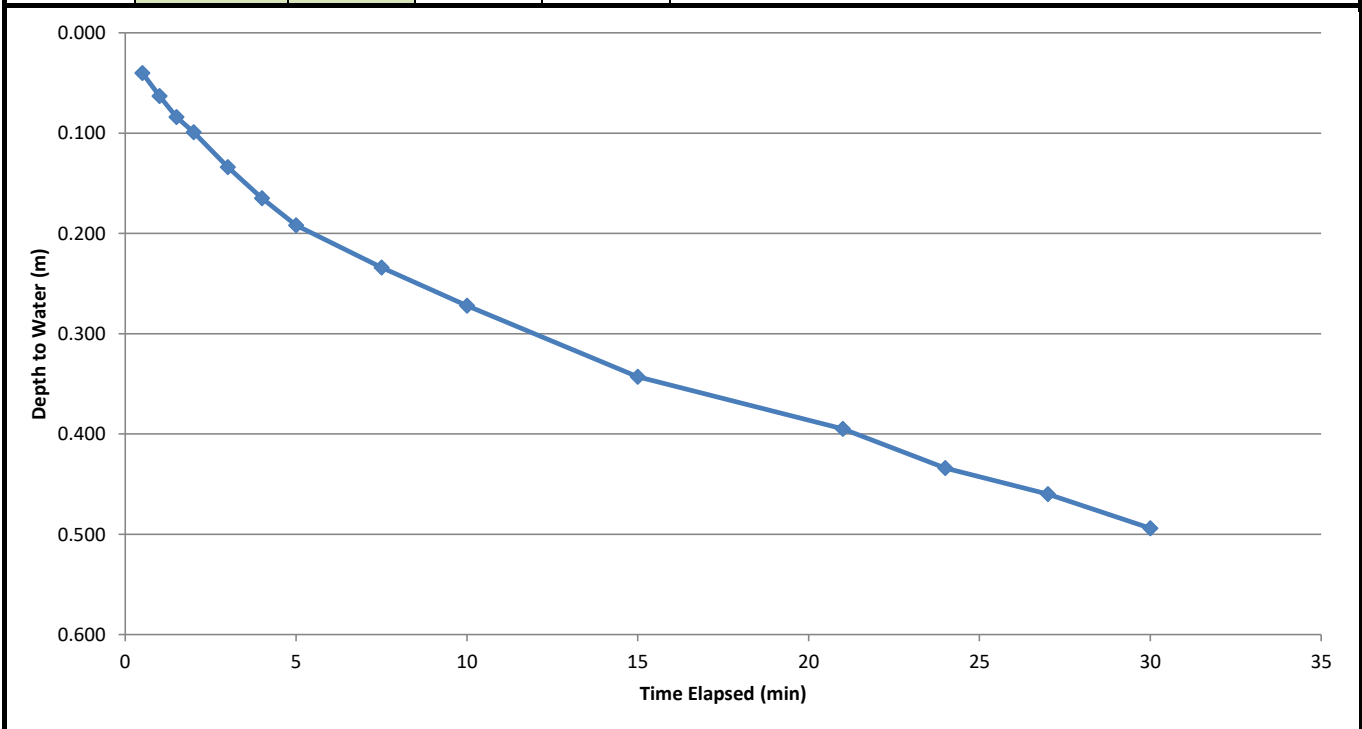
Reading	Time elapsed (min)	Depth to water (m)	Height of water (m)		Calculations
1	0.5	0.040	0.50		Constant loss time period:
2	1	0.063	0.48		Reading 1: 7 Time 1: 5 Height 1: 0.348
3	1.5	0.084	0.46		Reading 2: 14 Time 2: 30 Height 2: 0.046
4	2	0.099	0.44		Total time (min): 25.00
5	3	0.134	0.41		Total head loss (m): -0.302
6	4	0.165	0.38		<p>In situ Permeability:</p> $K = \frac{(Height\ 2 - Height\ 1)}{(Time\ 2 - Time1)}$ <p>K= 2.01E-04 m/sec (x 10m/sec)</p>
7	5	0.192	0.35		
8	7.5	0.234	0.31		
9	10	0.272	0.27		
10	15	0.343	0.20		
11	21	0.395	0.15		
12	24	0.434	0.11		
13	27	0.460	0.08		
14	30	0.494	0.05		
15
