Preliminary Site Investigation

110 – 120 Carrs Drive

Yamba NSW

August 2022, Ref. 21029.2

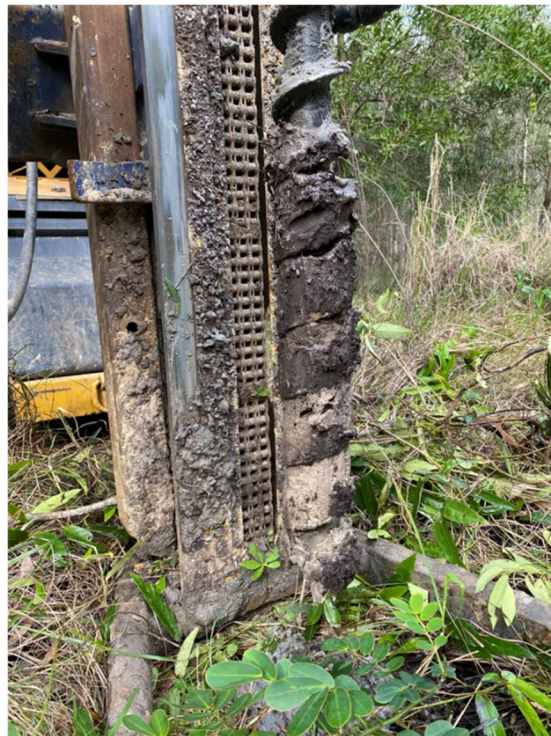
Plate 8.1: Borehole, ASSBH07

In general, the profile across the site was relatively consistent, consisting of a black, silty, sandy clay overlying saturated white sands from approximately 0.3 m depth. A photograph showing the general profile is provided as Plate 8.1. A summary of fill and aesthetic observations is provided in Table 8.1

General profile encountered, black clays overlying saturated white sand

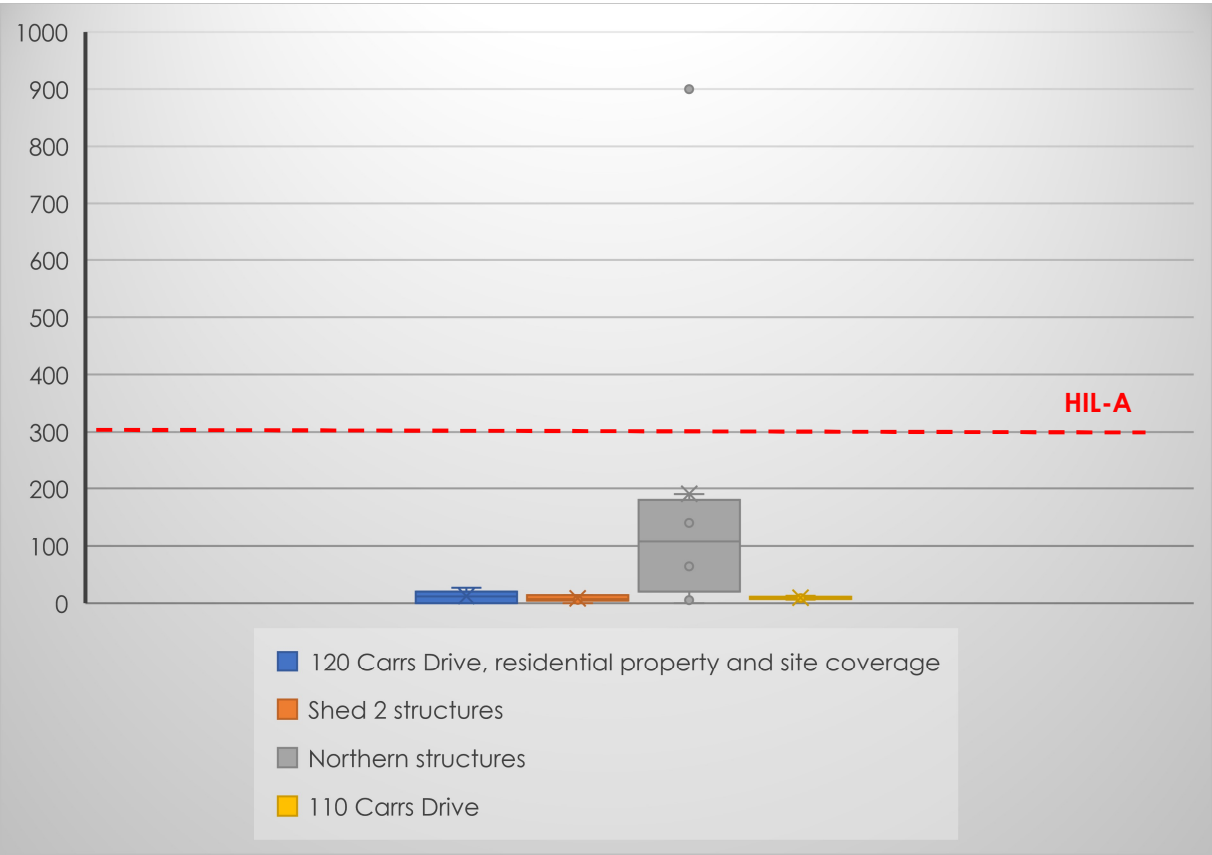
Figure 9.1: Lead concentrations (mg/kg), grouped by area

Elevated concentrations of lead were detected in surface soils at BH07, located adjacent to the concrete slab of the former residential dwelling. Figure 9.1 shows the lead data set for the samples collected from the area of the Northern Structures against the site data for all other areas. While the majority of samples exhibited concentrations below the HIL-A criteria, it is clear that samples from the area of the northern structures exhibit elevated concentrations above background.

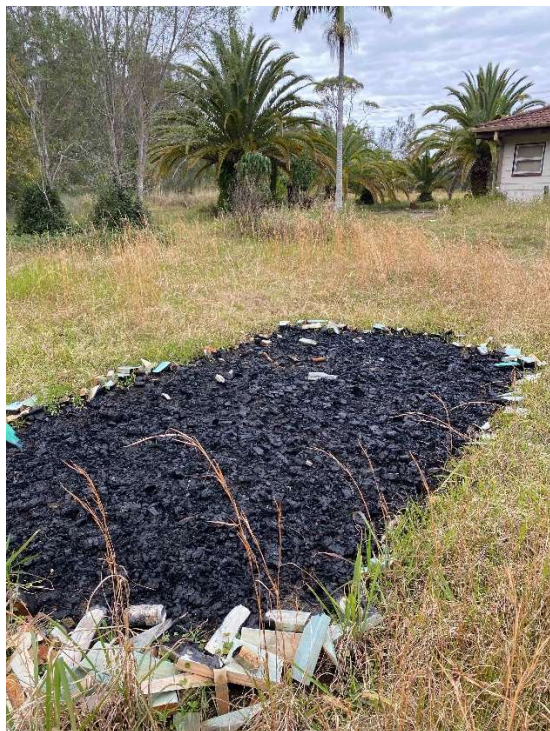
Photograph 3: 120 Carrs Drive. Fire pit behind residential house which can be seen in the background.

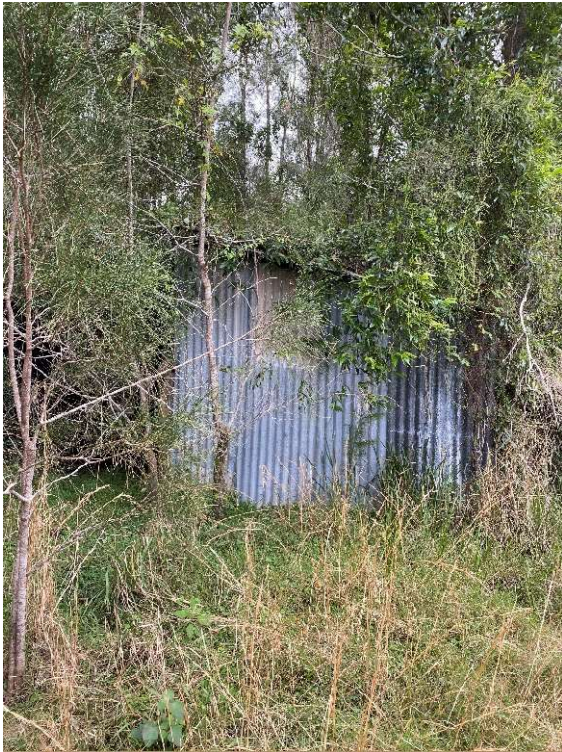
- A large open shed near the residential house of 120 Carrs Drive (denoted 'Shed 1') was observed to contain various items and rubbish, including batteries, old tools, golf clubs, general house-hold 'hard-rubbish', etc. scattered across the area.

Photograph 5: 120 Carrs Drive. Shed 1 under trees.

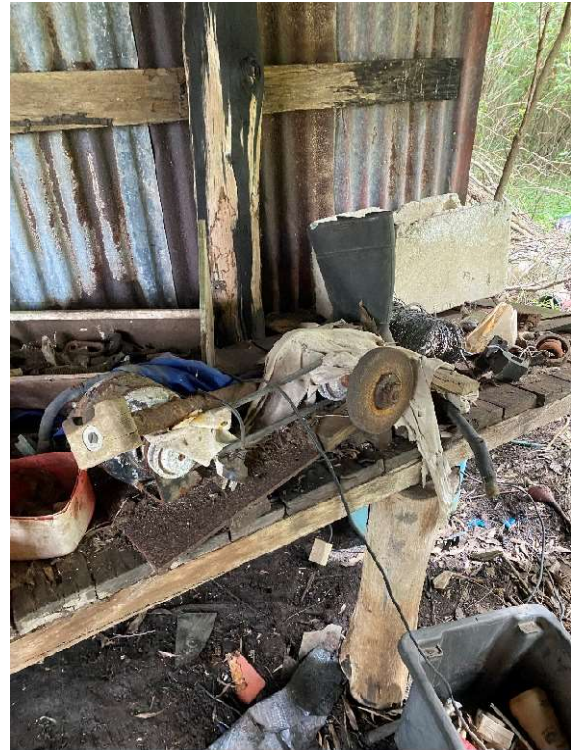
Photograph 6: 120 Carrs Drive, within shed.

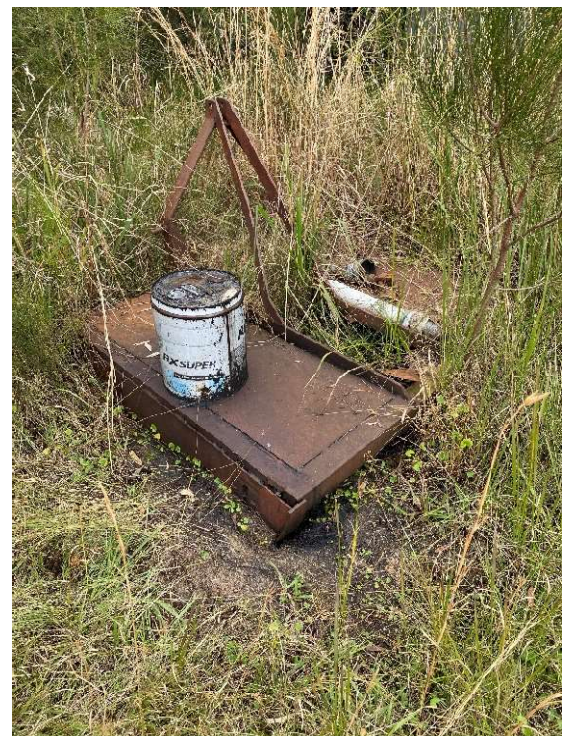
- An oil drum was observed to be located on top of a what appeared to be a metal tractor attachment, near the old shed with visible oil staining across the metal structure and ground below.

Photograph 8: Oil drum on metal structure. Oil staining and dead grass can be seen surrounding the drum.

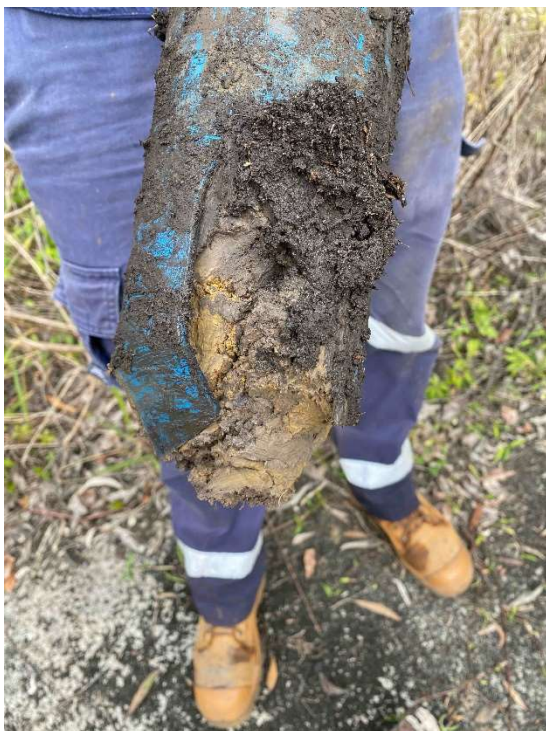
Photograph 11: Area of northern structures. BH07, located adjacent to concrete slab. Burnt timber can be seen in the black clay.

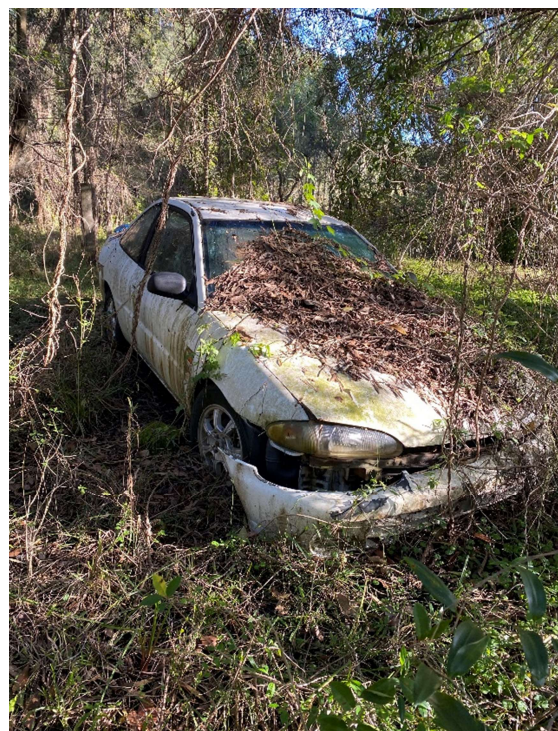
- A large amount of waste was observed in the area of the residential dwelling in the northern portion of 120 Carrs Drive, mixed amongst the various sheds and structures. Waste included an abandoned car, plastic and metal petrol and oil drums, house-hold 'hard-rubbish', timber, corrugated iron, a hot-water service, crab pot, plastic sheeting, etc.

Photograph 12: Area of northern structures. Abandoned car.

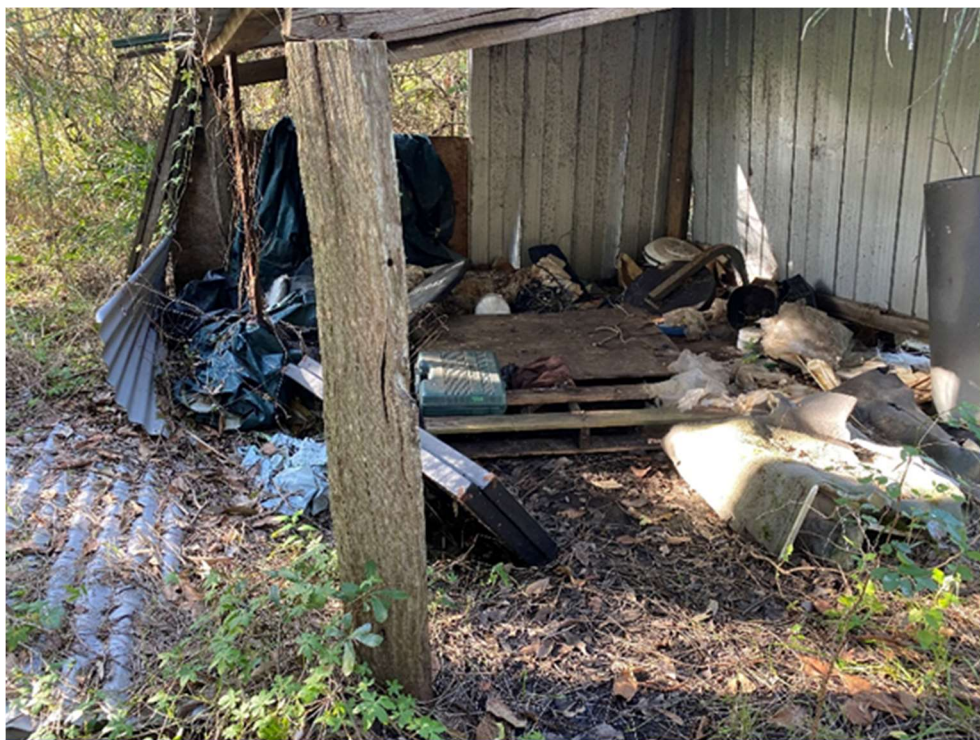
Photograph 17: Area of northern structures. Open shed with various waste.

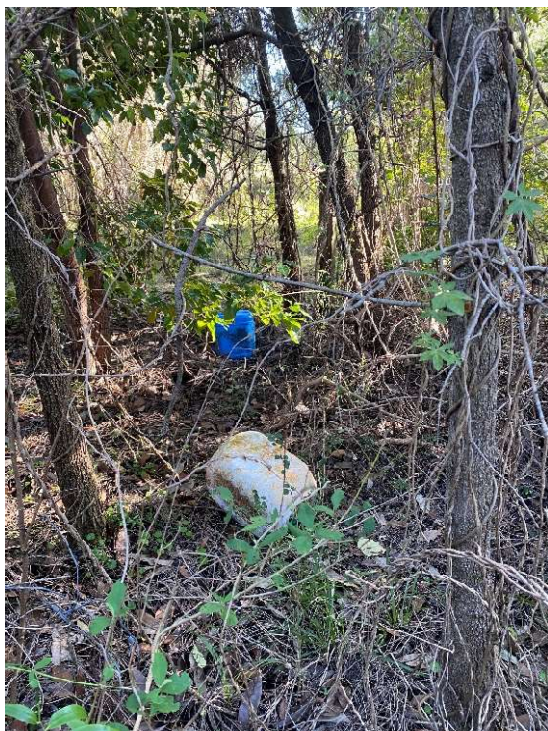
Photograph 18: Area of northern structures. Example of waste scattered around the area, including dangerous goods storage container

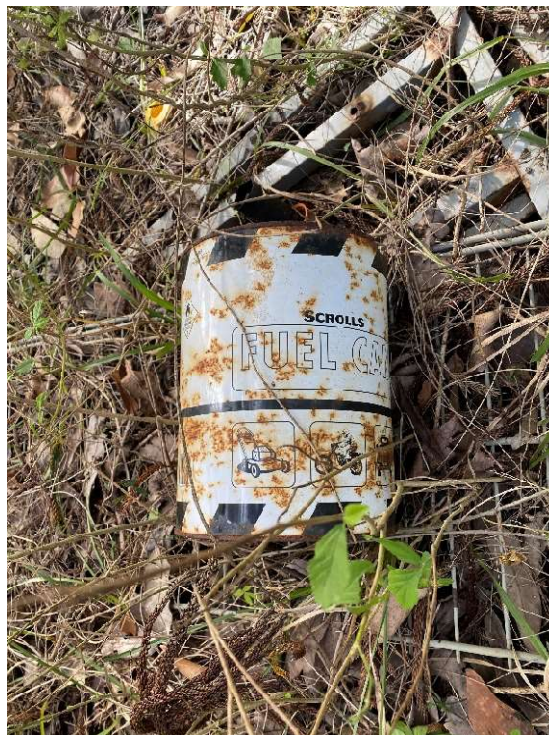
Photograph 19: Area of northern structures. Example of waste scattered around the area, including rusty fuel drum.

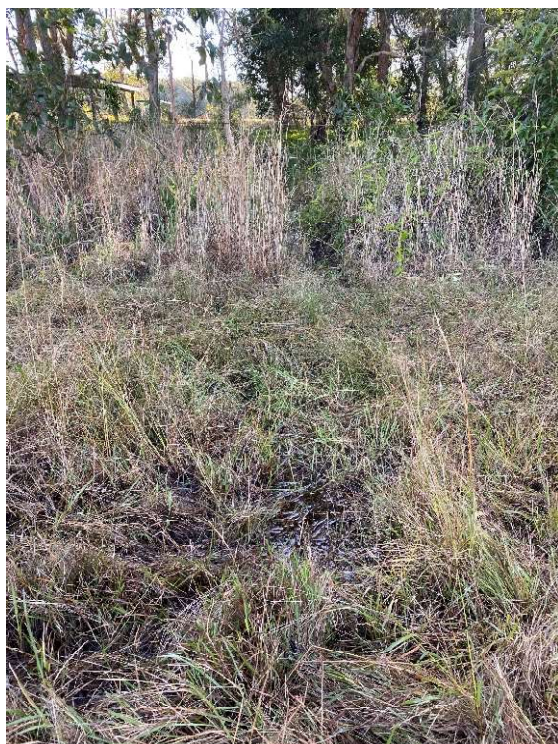
Photograph 20: 110 Carrs Drive. Water can be seen pooled on the surface.

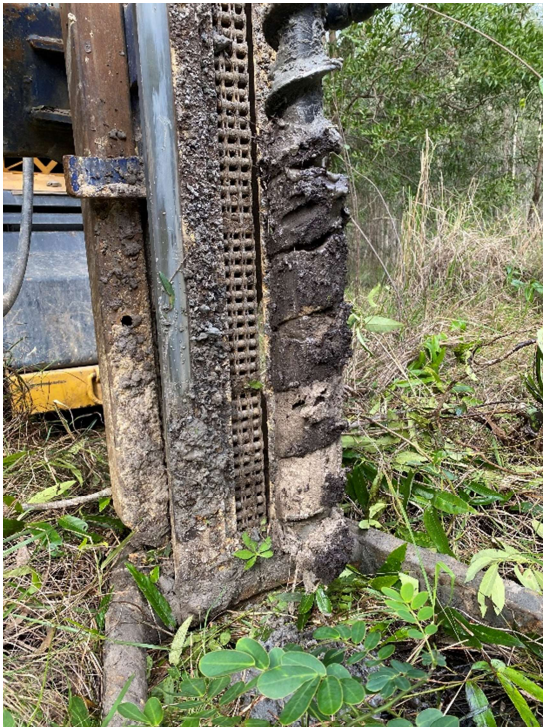
Photograph 22: ASSBH07. Typical profile encountered, being black clays overlying saturated white sand.

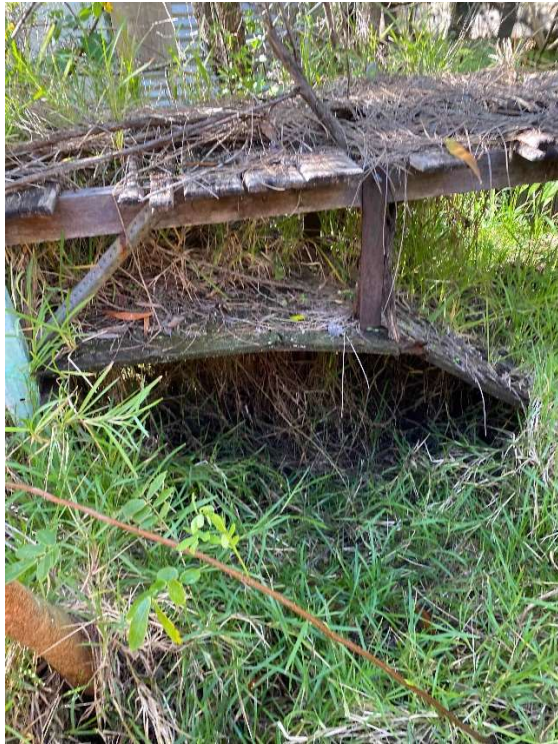
Photograph 25: Area of "Shed 2". Timber workbench, location of BH02.

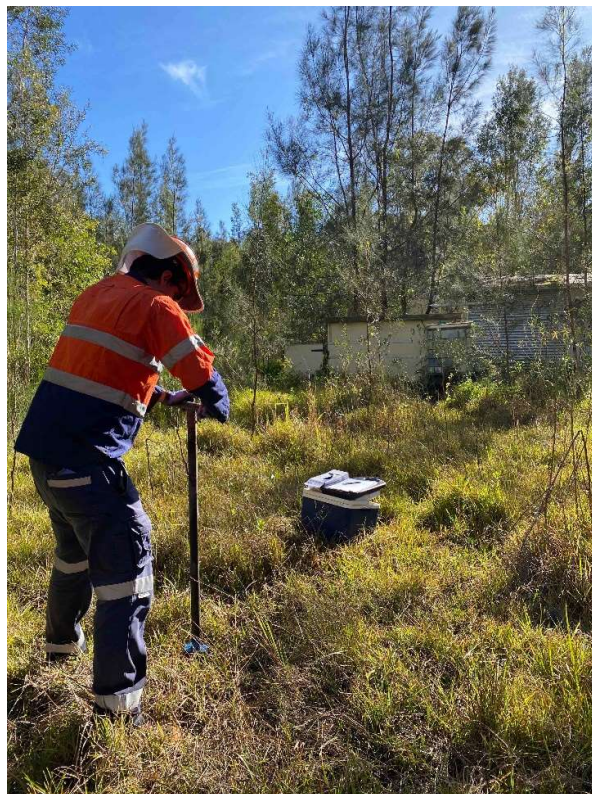
Photograph 27: BH03. Shed 2 and associated features can be seen in background, including Shed 2 and IBC.
