Preliminary Site Investigation

Faheys Pit –
9720 Armidale Road,
Tyringham NSW 2453

Report prepared for – Sheridans Hard Rock Quarry
17 June 2022
BPE22035-R01

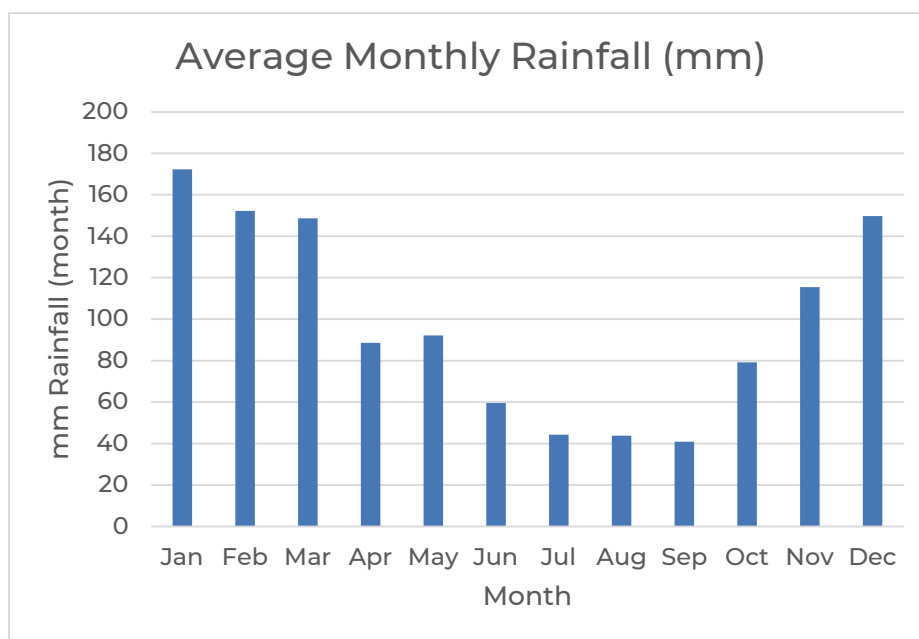
The local daily rainfall data records for the site were based on the nearby (~6km) BoM station at Tyringham (Station 59118), with the long-term average rainfall data tabulating shown below in Plot 1. Tyringham has an annual average rainfall of 1,141mm.

Plot 1. Summary of the long-term average rainfall at Tyringham (BOM Station #59118)

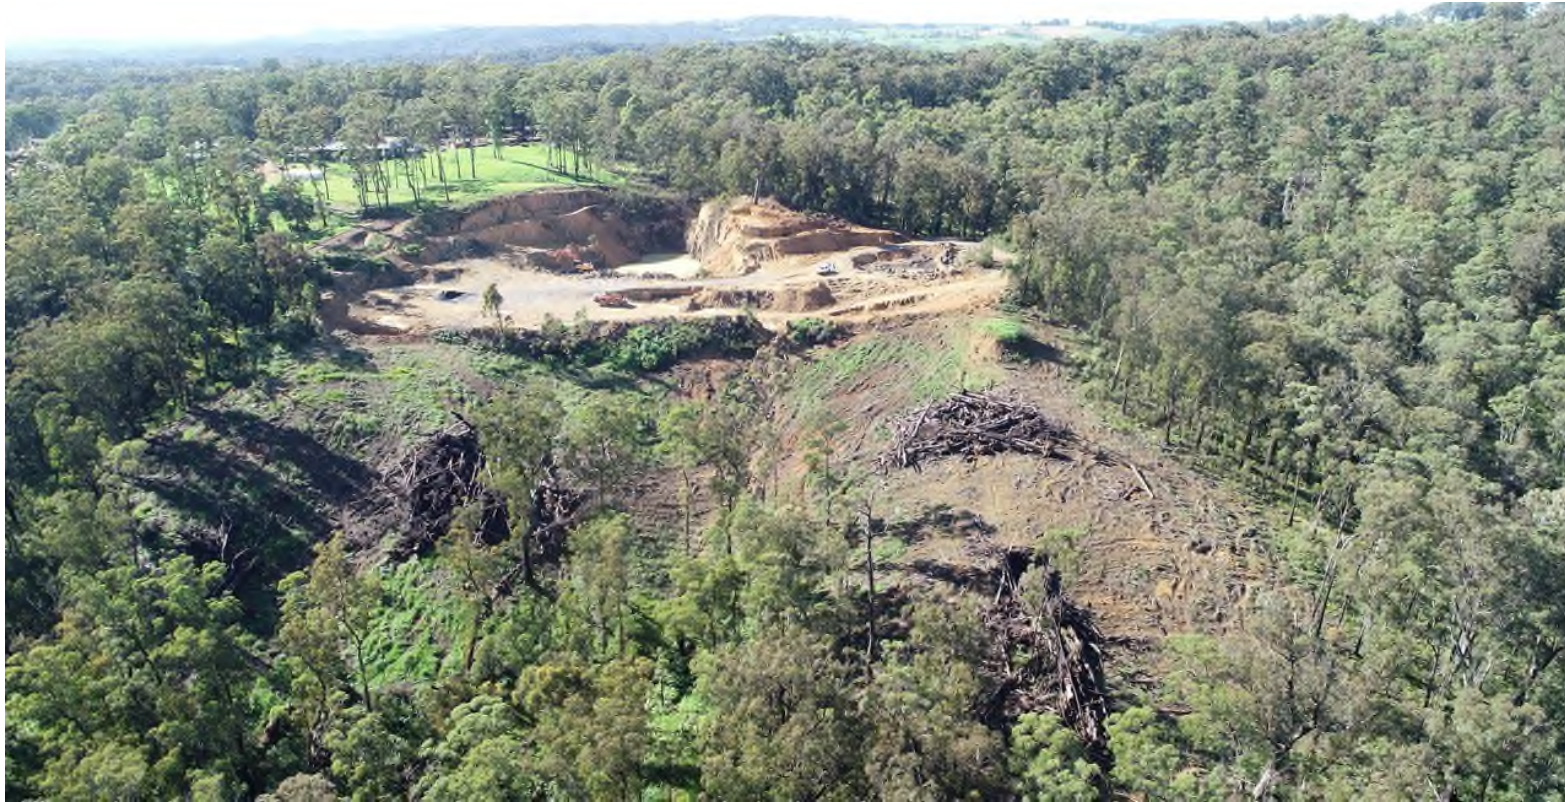
Photograph 1, shows aerial photograph of the existing Faheys Pit and the areas of clearing to the north of the pit. The sawmill operation is visible in the background of the photograph.

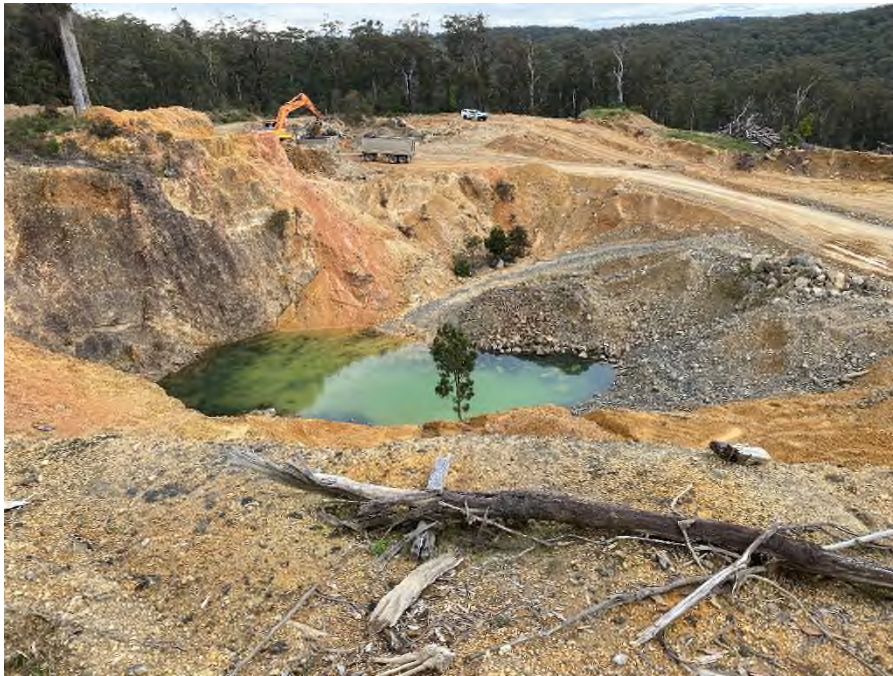
- No visible signs or indicators of contamination, such as oil staining, were observed during the walkover.
- The southern extent of the existing pit has been extended to the southern boundary of the property. The lowest point in the southern portion of the pit was acting as a water storage area with standing water pooling in this area, see photograph 2.

Photograph 2, shows the existing quarry pit, viewed towards the northwest. The water in the base of the pit is visible. The area where material is currently being excavated from can be seen where the excavator is working in the background.

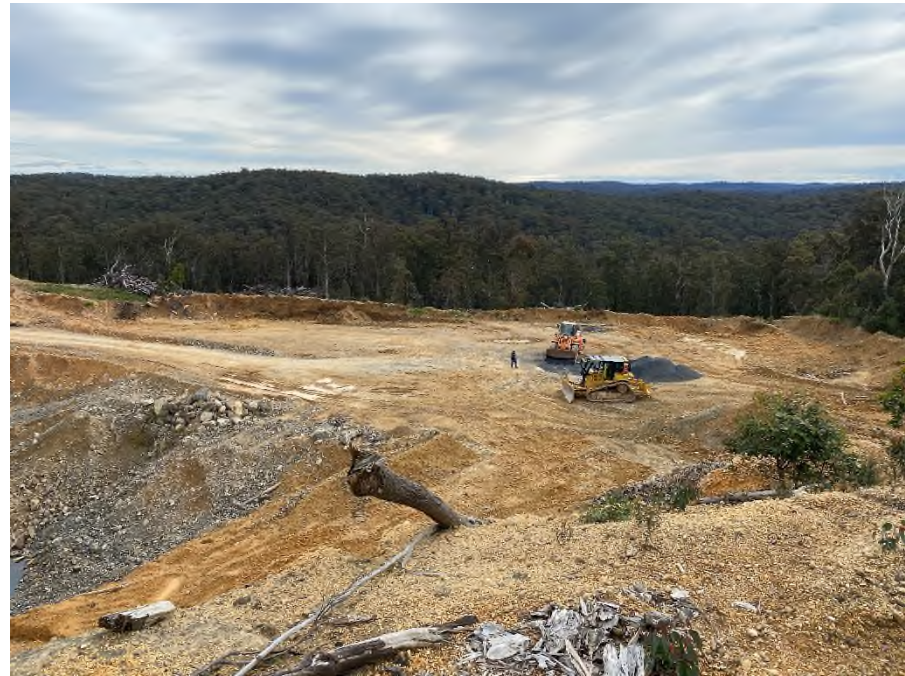
Photograph 3, shows the existing quarry pit, viewed towards the north. The earthen bund constructed along the northern extent of the pit can be seen in the background.

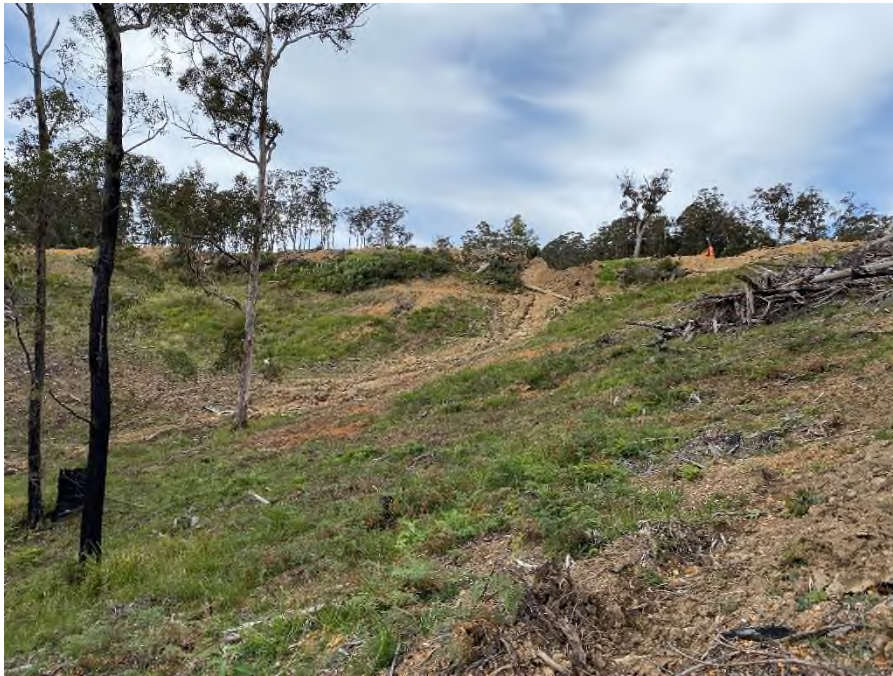
Photograph 4, shows the cleared northern extent of the proposed quarry expansion area viewed towards the southeast. The existing earthen bund on the northern extent of the quarry pit can be seen in the background.

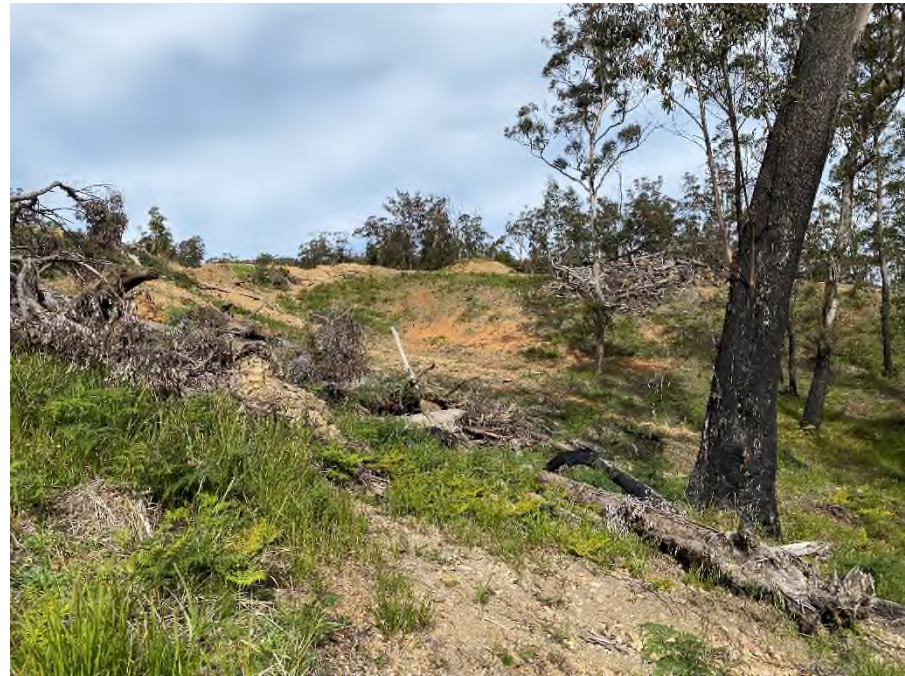
Photograph 5, shows northern extent of the proposed quarry expansion area viewed towards the southwest.

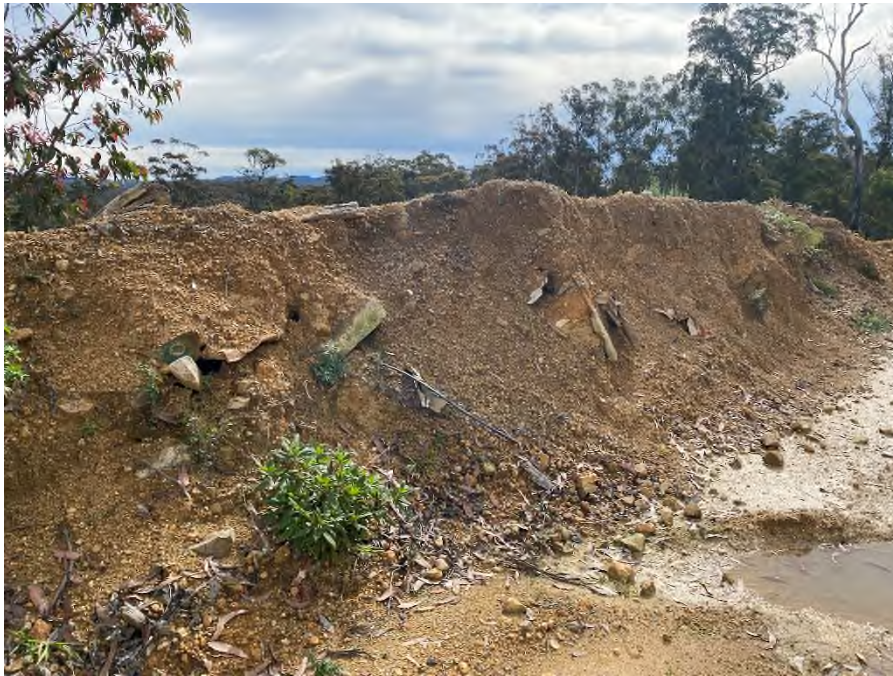
- An existing earth bund is constructed along the northern side of the quarry pit. This appeared to have been constructed using materials excavated from within the site. Inert waste was visible on the surface and partially buried on the southern and north faces of this earth bund wall. Waste material observed included: tyres, broken concrete, empty 200l steel drums (crushed), concrete filled drums, metal including reinforcing mesh sheets and tin, see photographs 6 to 9.

Photograph 6, shows earth bund constructed along northern extent of the quarry pit. Visible inert waste can be seen within this bund including; concrete, and metal items.

These excavations will require the removal of the current northern earthen bund wall. The removal of this bund wall will also expose buried inert waste materials observed during the site walkover including tyres, empty 200l metal drums, concrete, scrap metal and equipment. It is recommended that these inert waste materials are collected and removed from this site for recycling (e.g., scrap metal) or to an appropriate NSW EPA licensed waste facility which can accept this waste.

- AEC 2 – Buried inert waste from historical poor waste disposal practices, including in the northern bund wall. Development of the quarry will require the excavation and removal of the northern bund wall and any buried waste materials. It is recommended that these inert waste materials are collected and removed from this site for recycling (e.g., scrap metal) or to an appropriate NSW EPA licensed waste facility which can accept this waste.

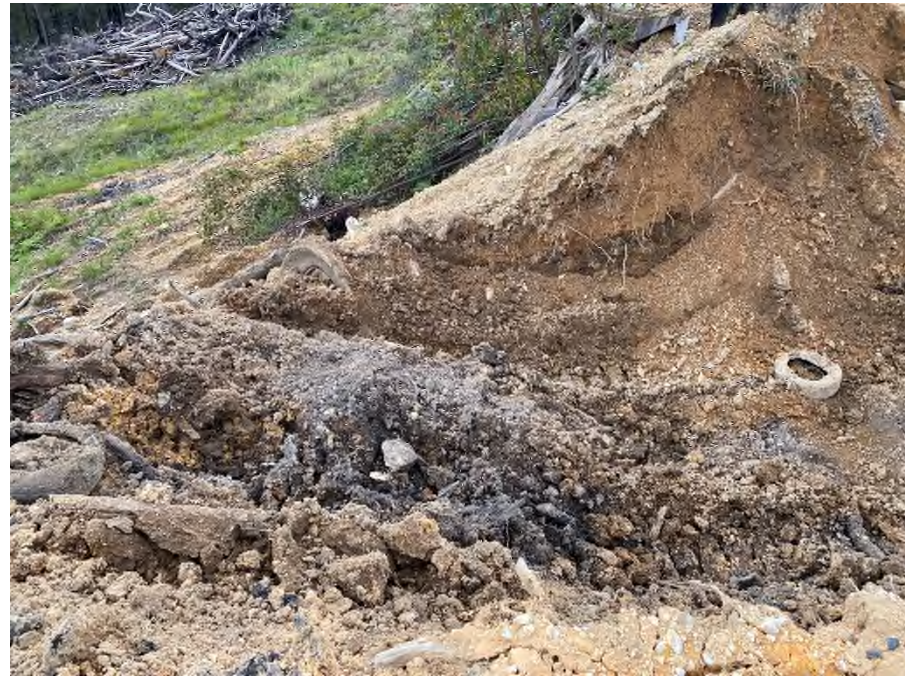
Photograph 7, shows area in central portion of the northern earth bund which has been previously excavated. Several previously buried tyres can be seen in the photograph.

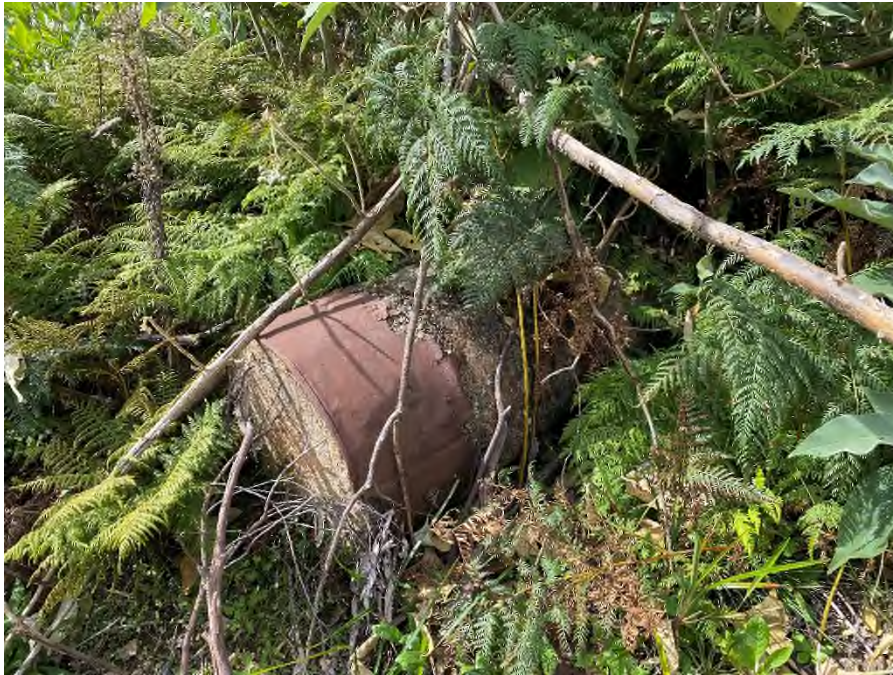
Photograph 8, shows inert waste (concrete filled drum) observed in shrub material on the northern side of earth bund.

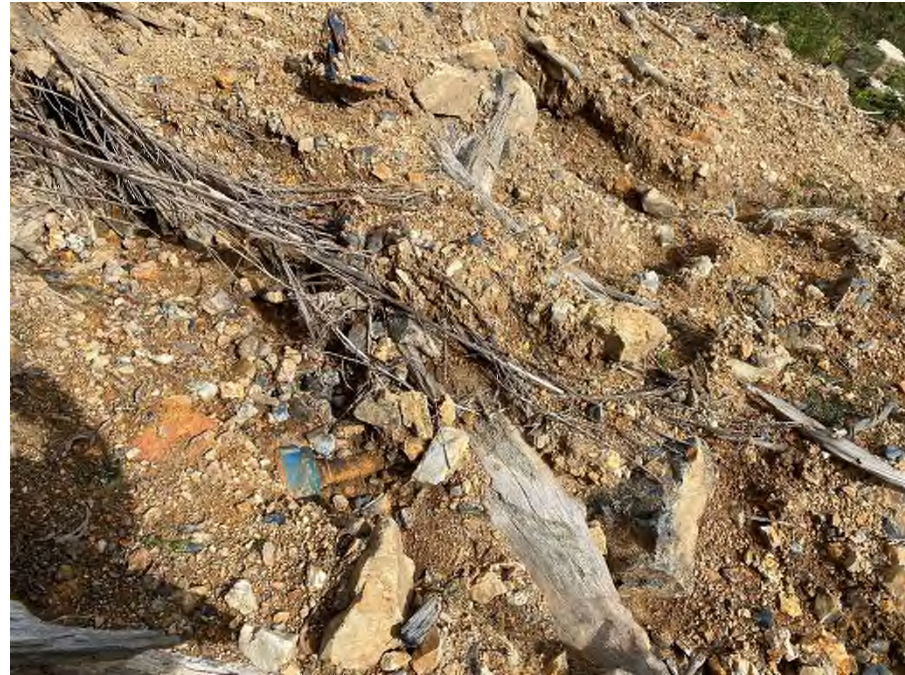
Photograph 9, shows inert waste in fill material on northern earth bund wall. Remnants of an empty metal drum and vehicle axle are partly buried in the bund material.
