GENERAL ARRANGEMENT PLAN

| NO. | STAGE | DSN | DWN | CHKD | APPR | DATE | NOTES | <div><div></div><div>RENEWABLES</div><div><div>info@itpau.com.au<br/>itpau.com.au<br/>+61 2 6257 3511</div><div>PO Box 6217<br/>O'Connor, ACT 2602<br/>AUSTRALIA</div></div></div> | <div>DSNISC</div> | <div>DWNMJB</div> | DRG TITLE | | | | |
|---|---|---|---|---|---|---|---|---|---|---|---|--|---|---|---|
| | | | | | | | ALL MEASUREMENTS IN mm<br>UNLESS OTHERWISE STATED. | | PROJECTBOGGABRI SOLAR FARM | | | | | SCALE | AS NOTED |

# State Environmental Planning Policy (Resilience and Hazards) – Screening Assessment

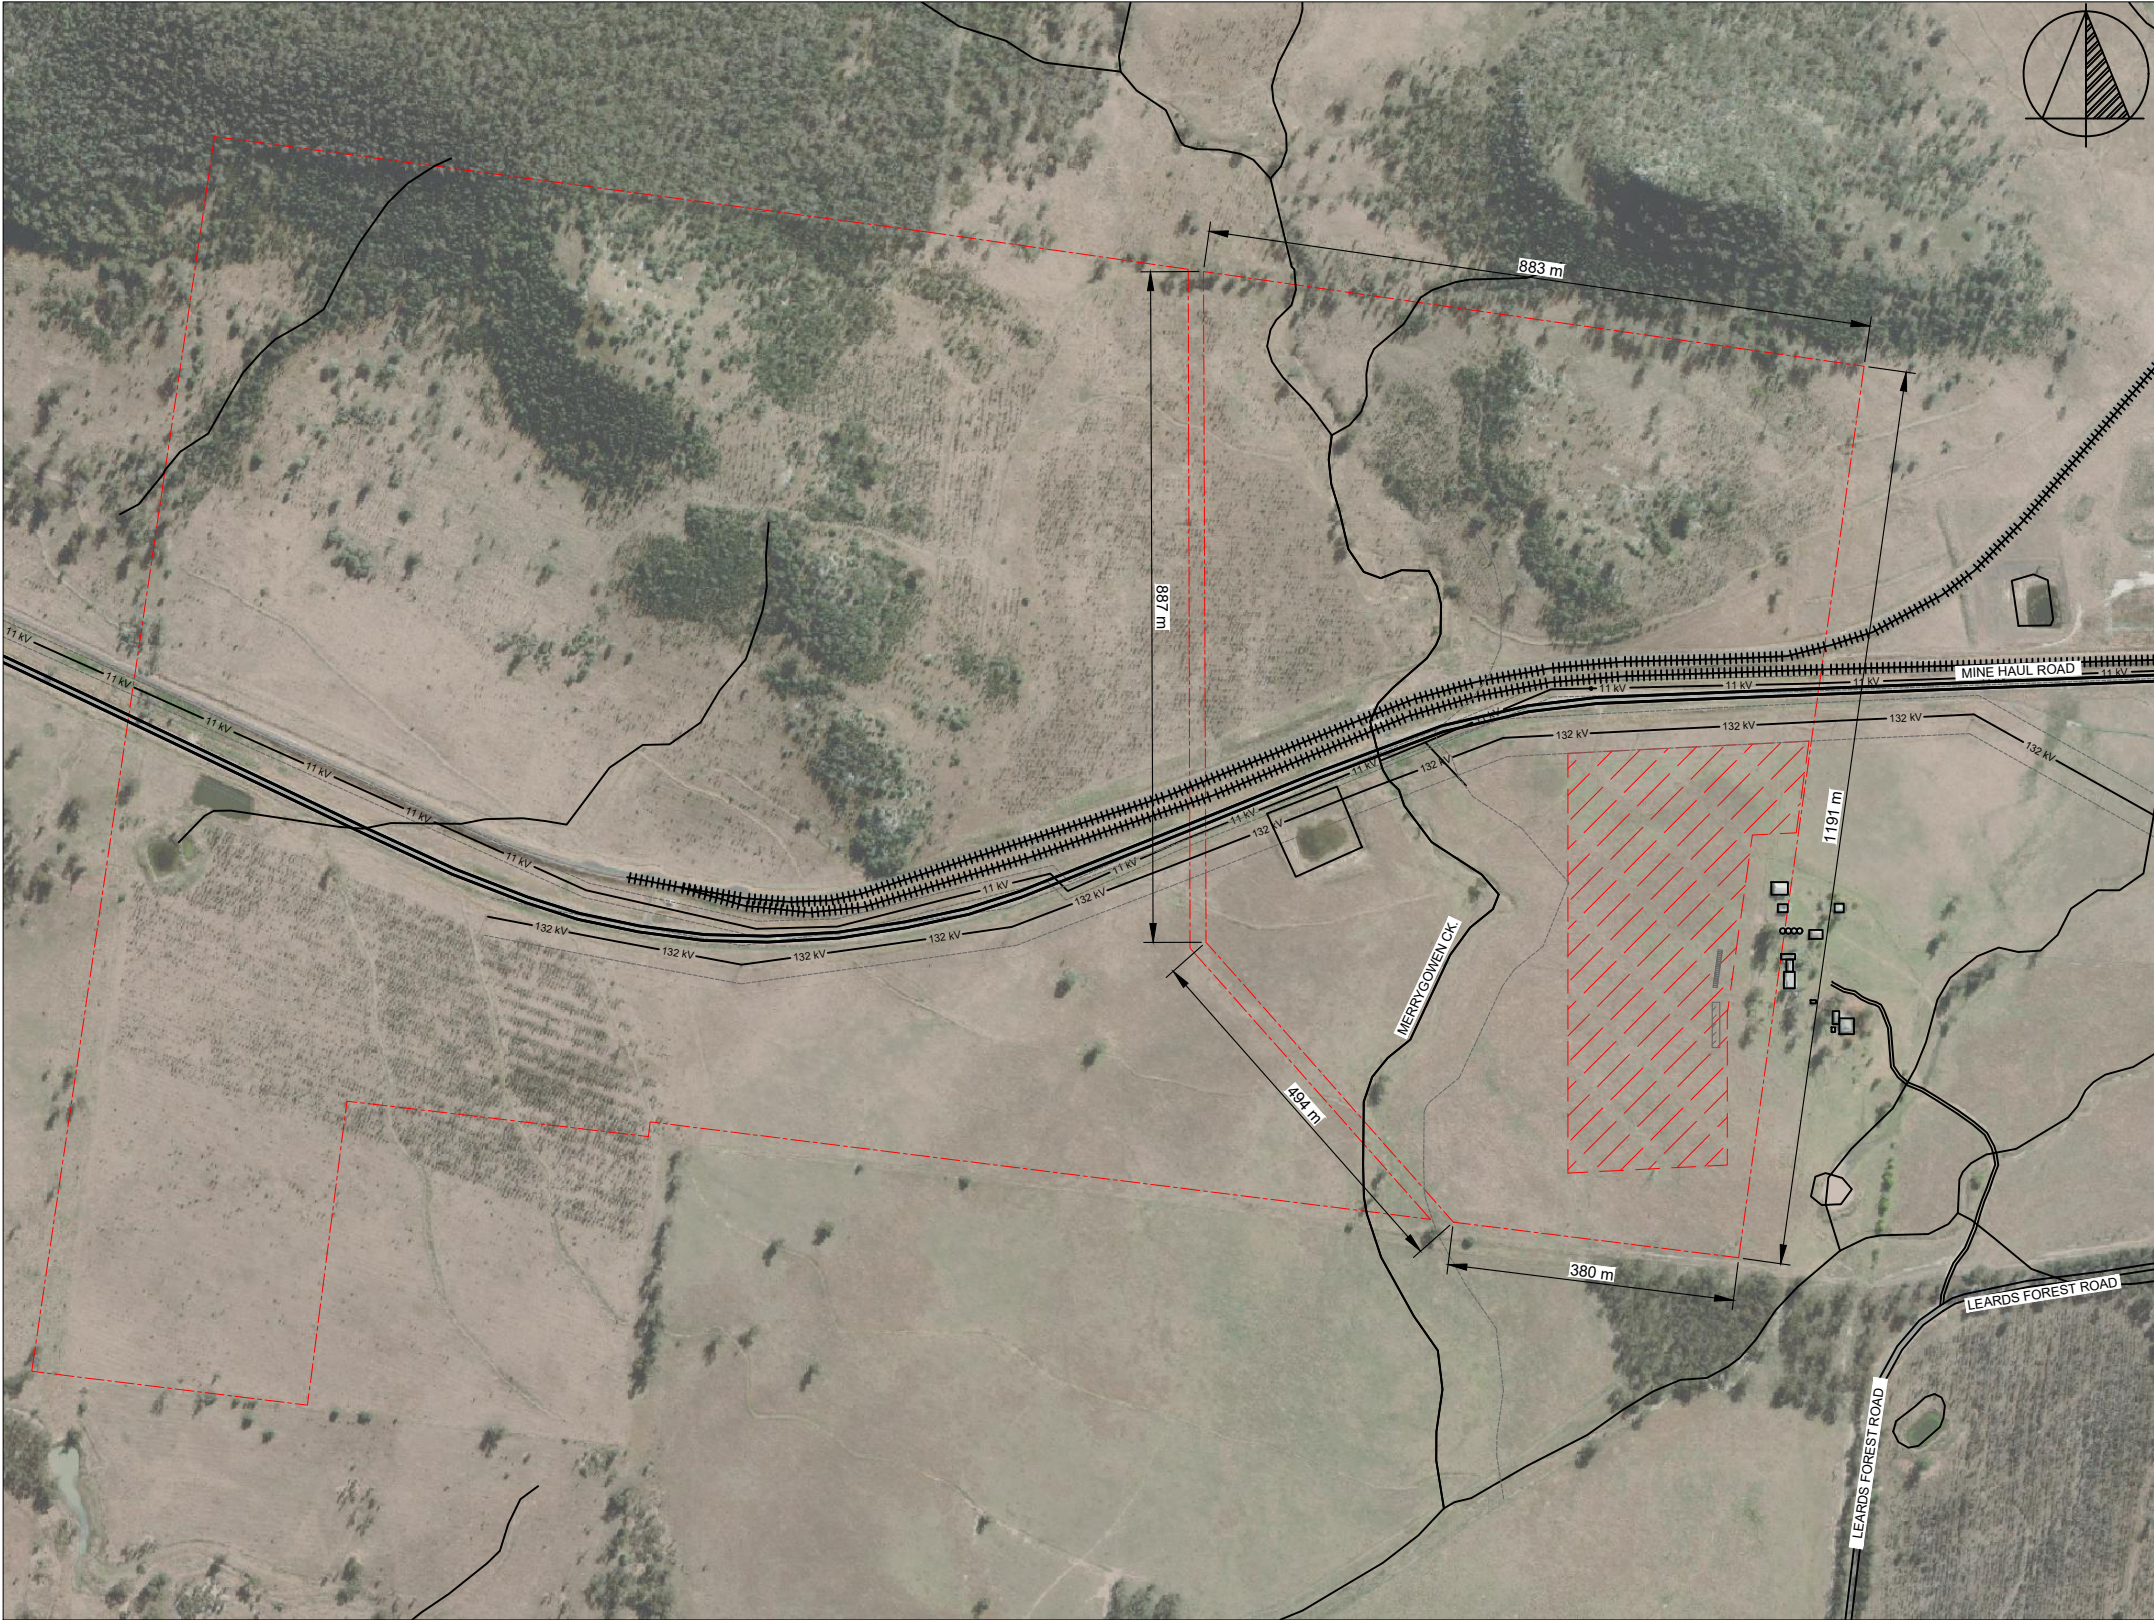
3 SITE PLAN  
SCALE: 1:10000

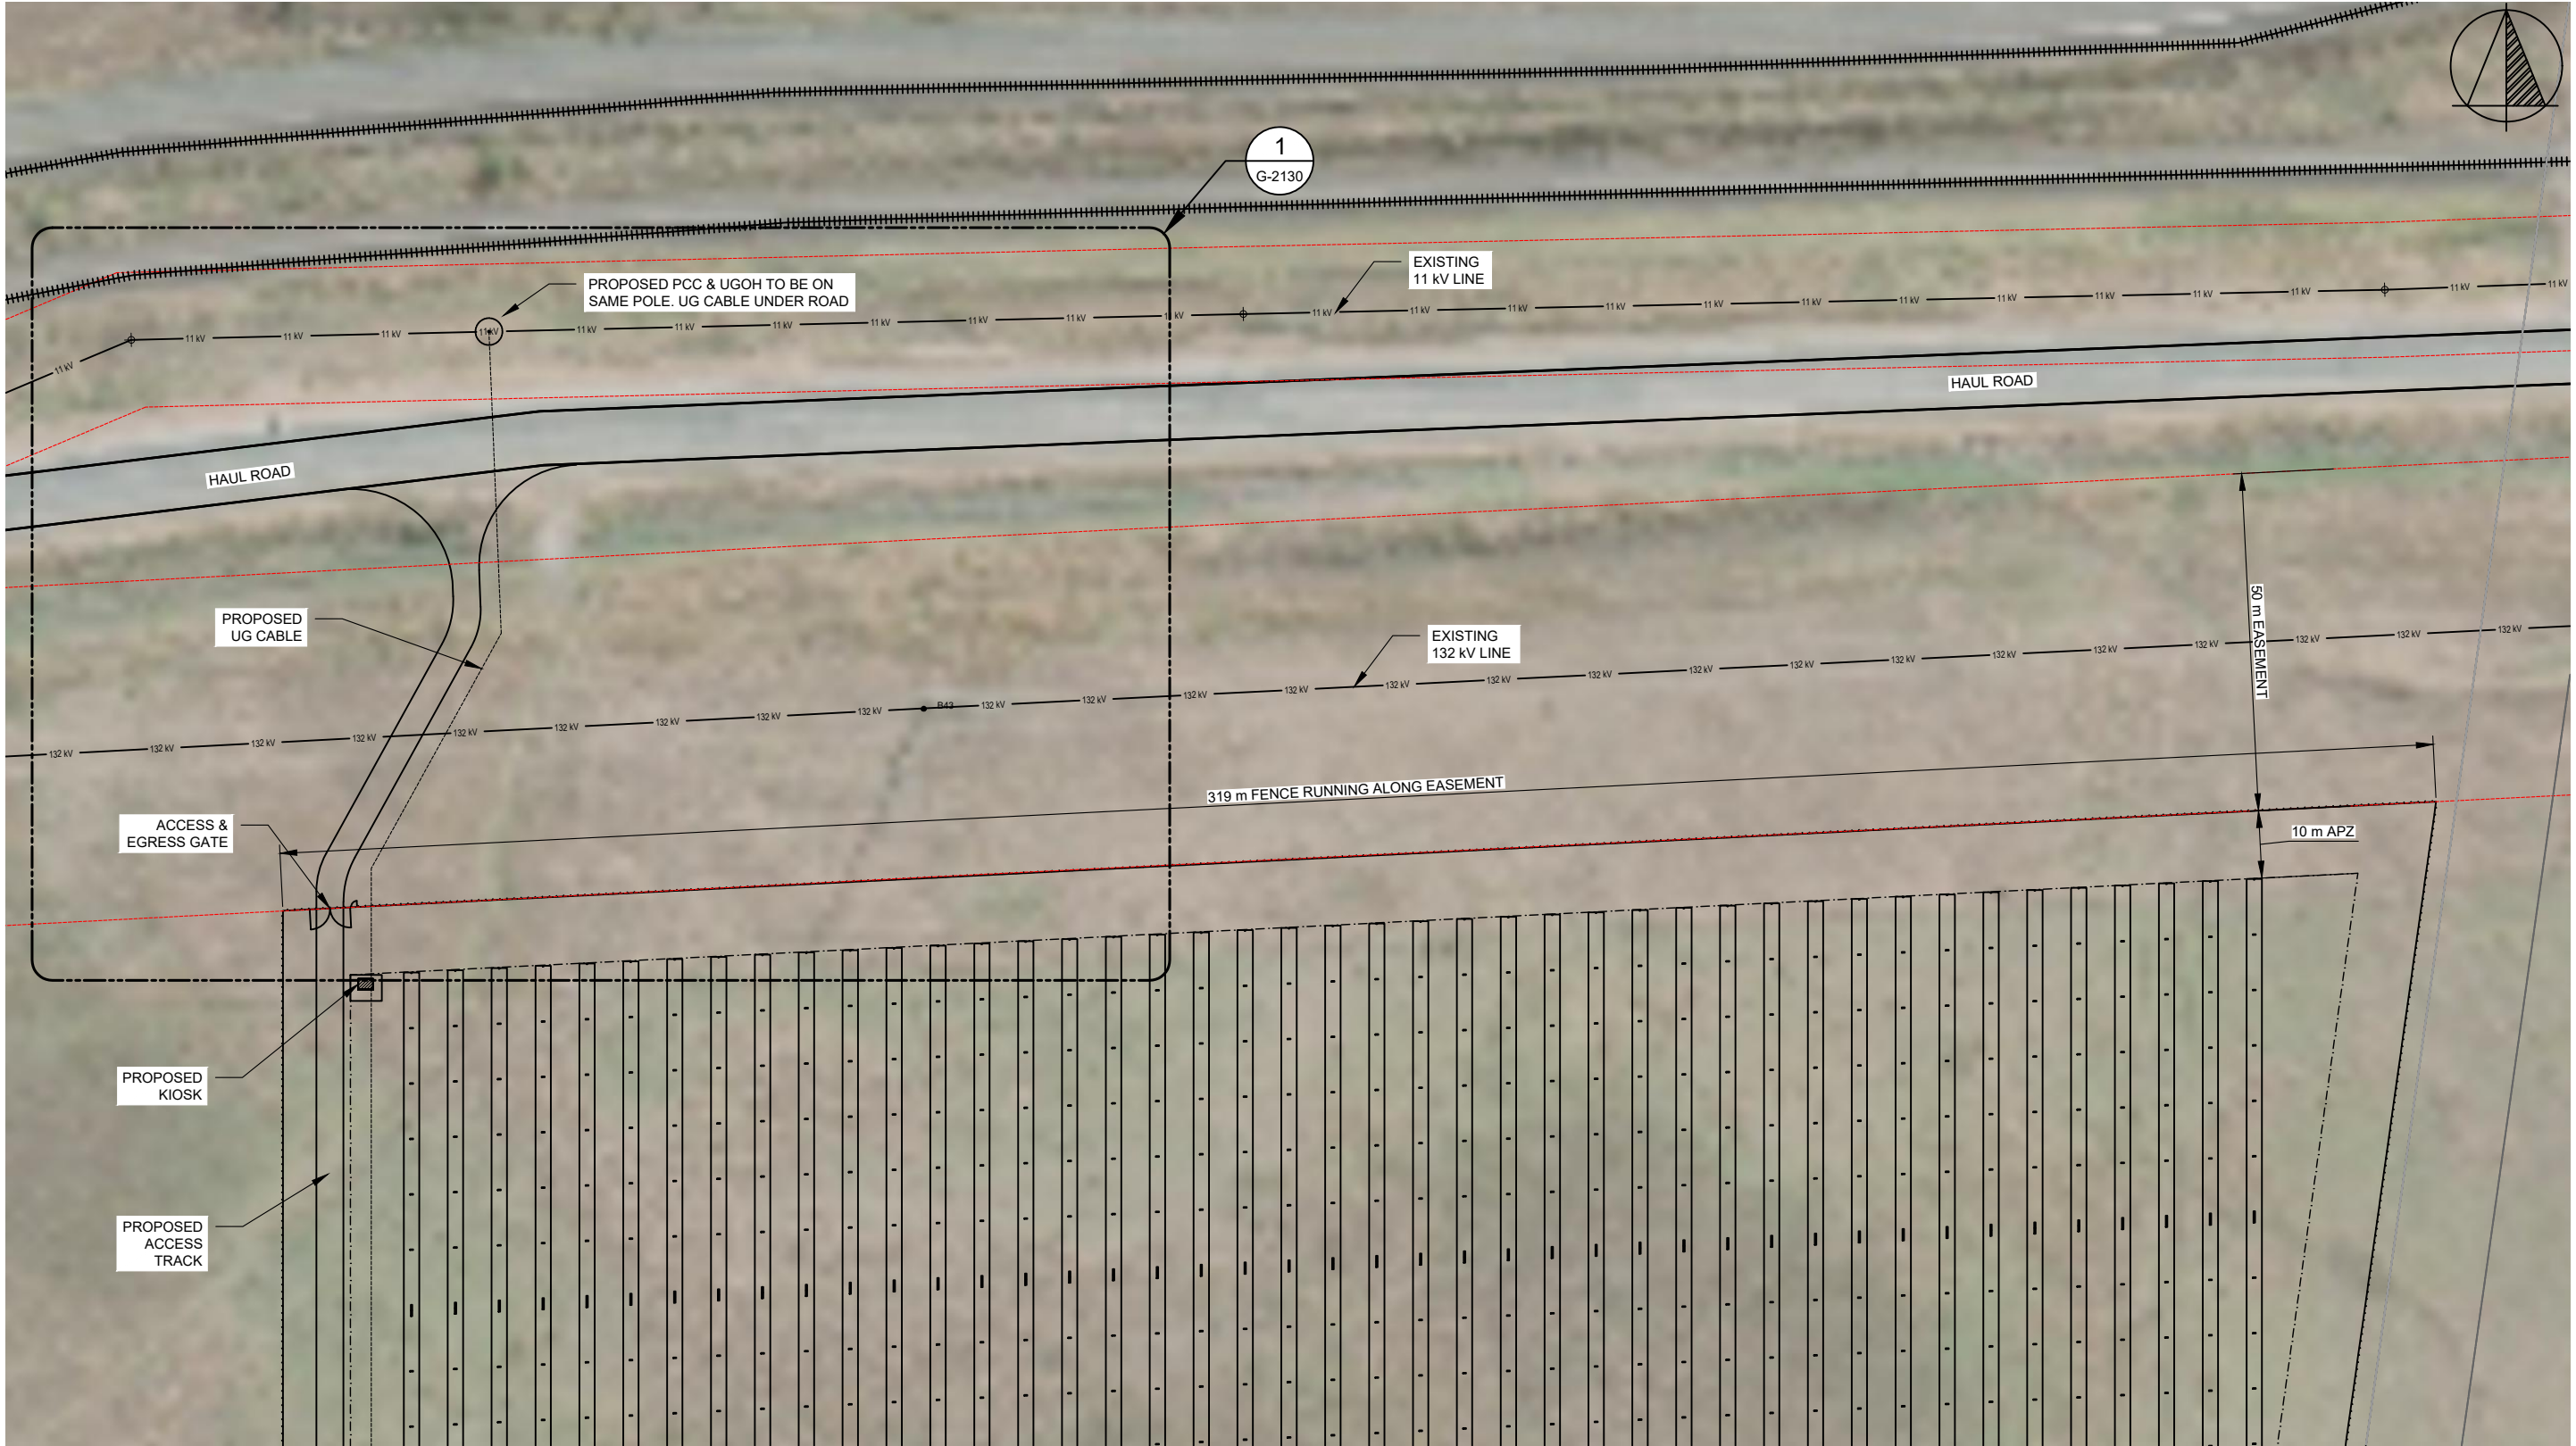
**1 EASEMENT DETAIL PLAN**  
SCALE: 1:1000

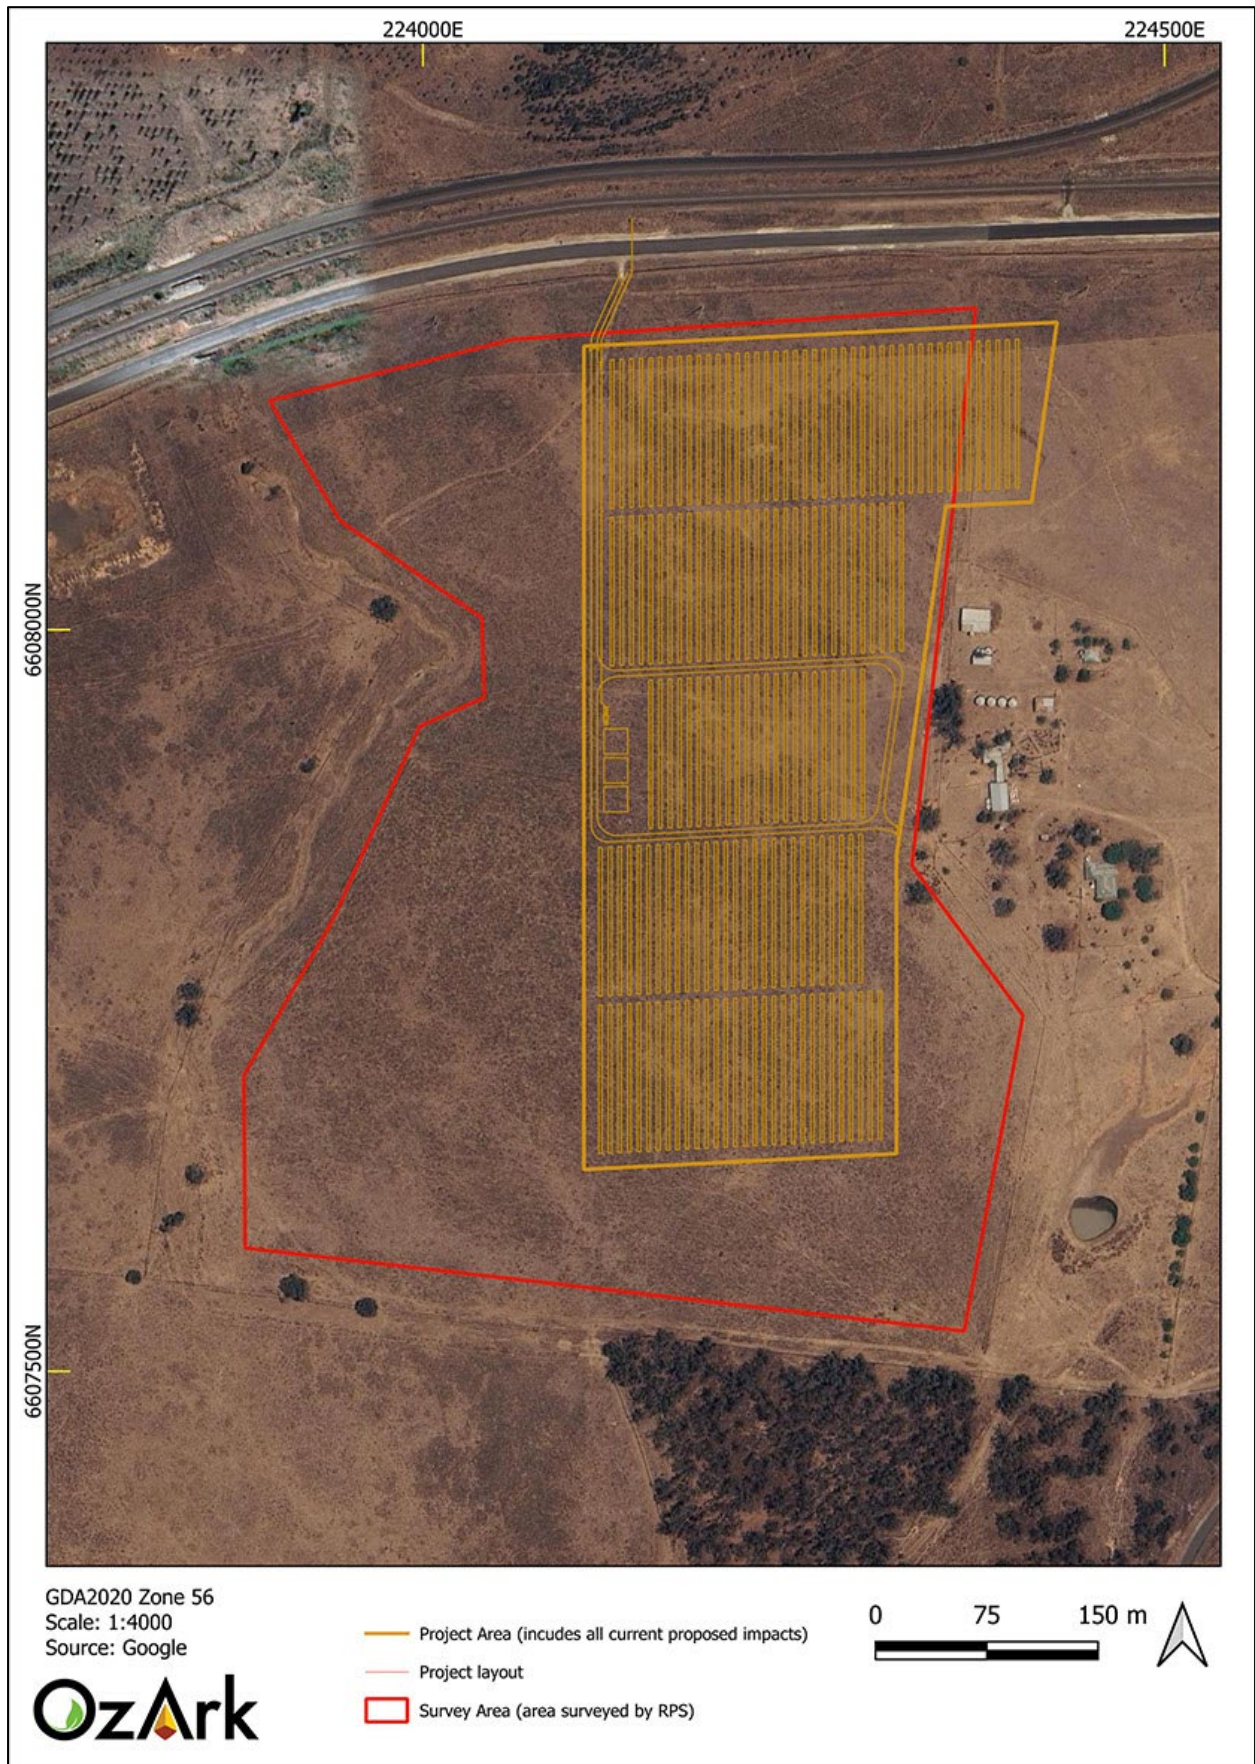
Figure 1-3: Survey and Project Areas.

The area to the north of the Project Area where site access is required is part of the Boggabri Mine Project Approval Area and 50 m either side of the haul road has already been surveyed and is included in the Boggabri Mine Cultural Heritage Management Plan curtilage. Because of this, the area did not require further assessment for the Project.

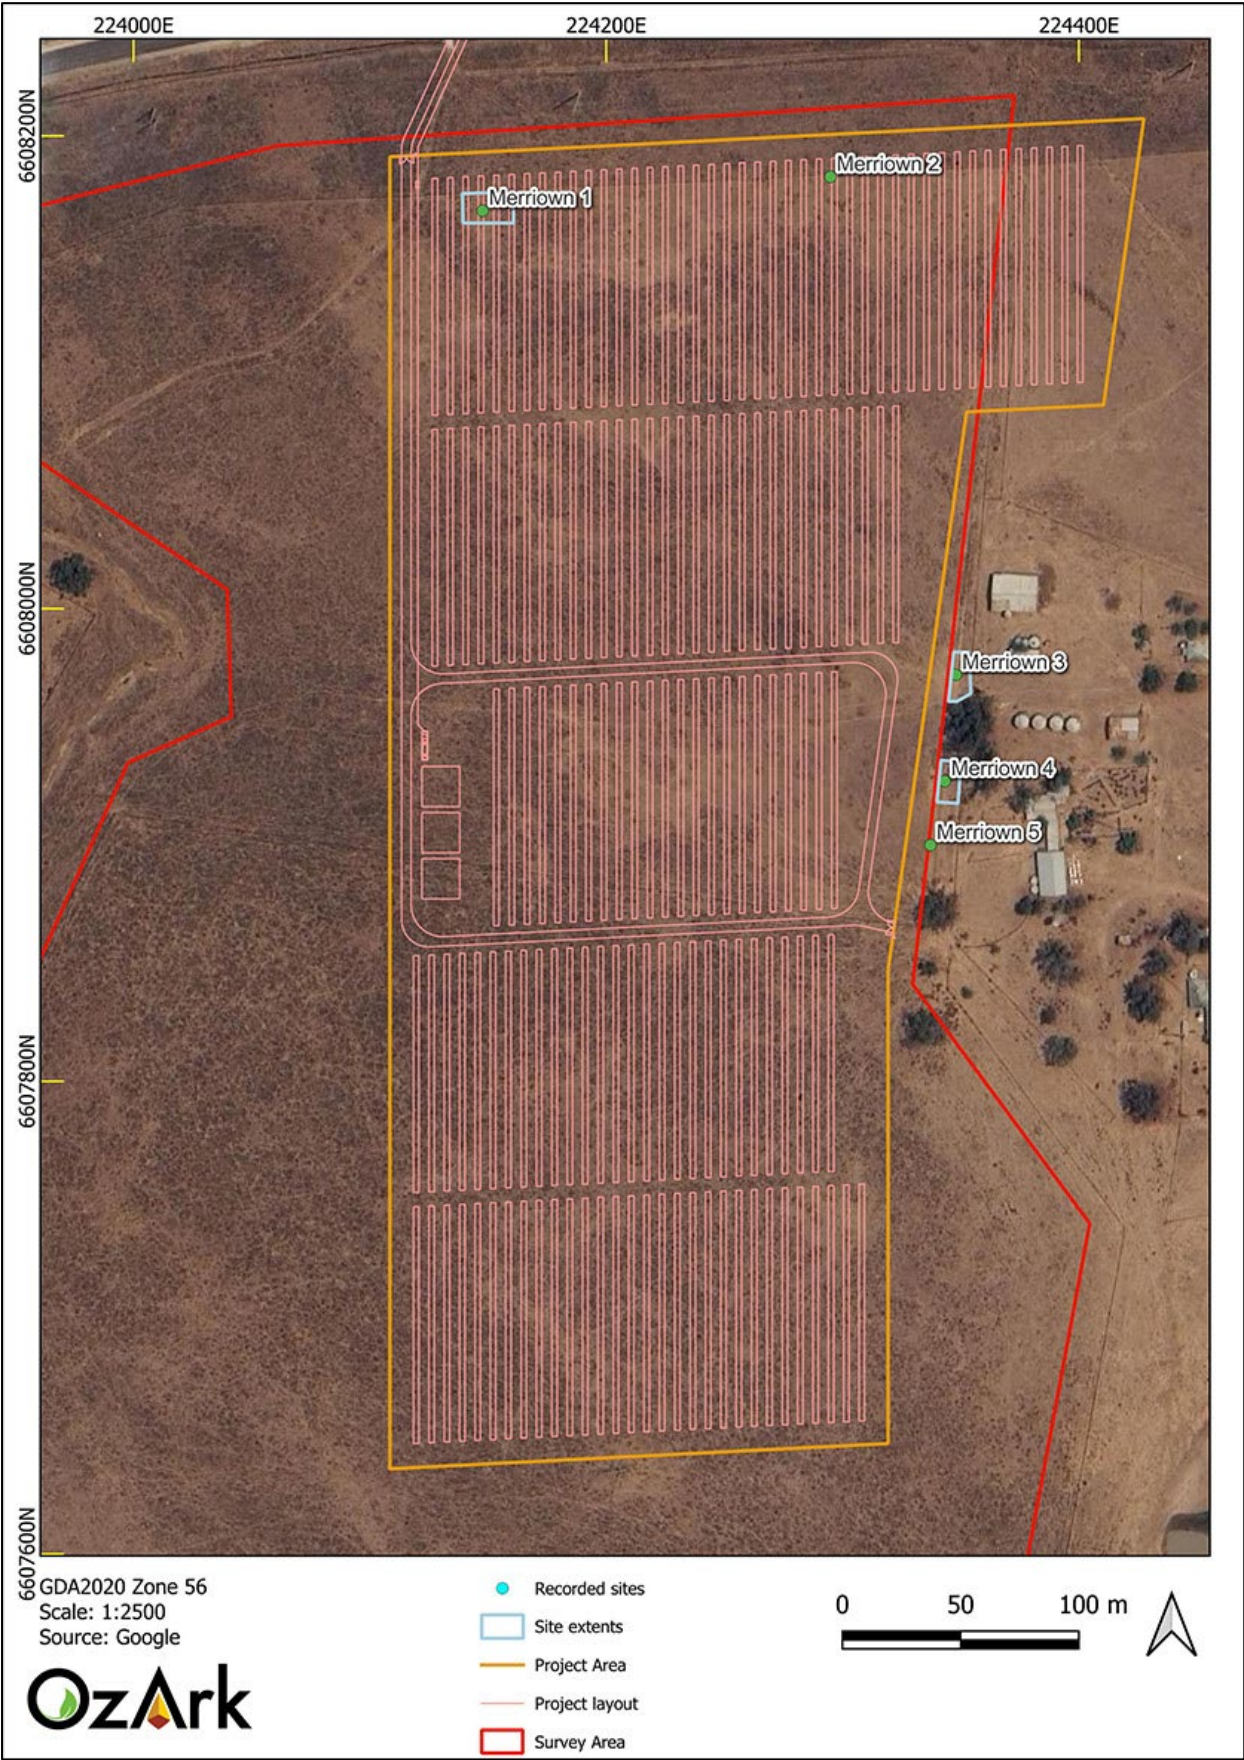
Figure 6-3: Sites recorded during the survey.

**Table 6-3** summarises the Aboriginal cultural heritage sites recorded during the survey of the Survey Area. Further details on each site follows (**Table 6-3**) and their location is shown on **Figure 6-3**.

**20-4-1120 (Merriown 1)****Site type:** Artefact scatter**GPS coordinates:** 224147E 6608168N, GDA 94, Zone 56**Location of site:** 27 m south of the northern boundary, 254 m east of the western boundary (Figure 6-3).**Description of site:** The site comprises two surface artefacts manufactured from chalcedony identified in an area of low ground surface visibility near the northern property boundary (Table 6-4 and Figure 6-4). The site extent is 22 x 12 m.**Table 6-4: Merriown 1. Artefact attributes.**

**Location of site:** The site is located 31 m south of the northern boundary and 403 m east of the western boundary (**Figure 6-3**).

**20-4-1117 (Merriown 3)****Site type:** Artefact scatter**GPS coordinates:** 224348E 6607972N, GDA 94, Zone 56**Location of site:** The site is located along the eastern boundary, 246 m south of the northern boundary (**Figure 6-3**).**Description of site:** Artefact scatter comprising five artefacts identified along an approximate 19 m length of a recent levee bank along with eastern fence line. Artefacts comprise mudstone and chalcedony flakes (**Table 6-6** and **Figure 6-6**). The site extent is 20 x 8 m.**Table 6-6: Merriown 3. Artefact attributes.**

**20-4-1116 (Merriown 4)****Site type:** Artefact scatter**GPS coordinates:** 224343E 6607927N, GDA 94, Zone 56**Location of site:** The site is located along the eastern boundary, 293 m south of the northern boundary (Figure 6-3).**Description of site:** Artefact scatter comprising two artefacts manufactured on mudstone and silcrete and one possible glass artefact identified on the upcast soil of the eastern levee bank (Table 6-7 and Figure 6-7). The site extent is 18 x 9 m.**Table 6-7: Merriown 4. Artefact attributes.**

**20-4-1118 (Merriown 5)****Site type:** Isolated artefact**GPS coordinates:** 224337E 6607900N, GDA 94, Zone 56**Location of site:** The site is located along the eastern boundary, 317 m south of the northern boundary (Figure 6-3).**Description of site:** Isolated artefact comprising a silcrete medial flake identified in area of exposure on western levee bank (Table 6-8 and Figure 6-8). The site extent is 5 x 5 m.**Table 6-8: Merriown 5. Artefact attributes.**

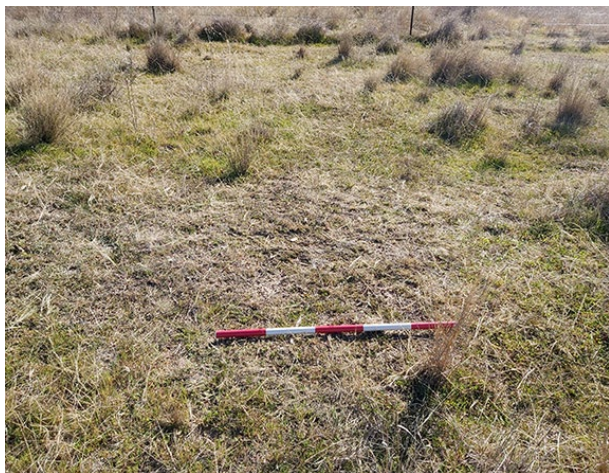
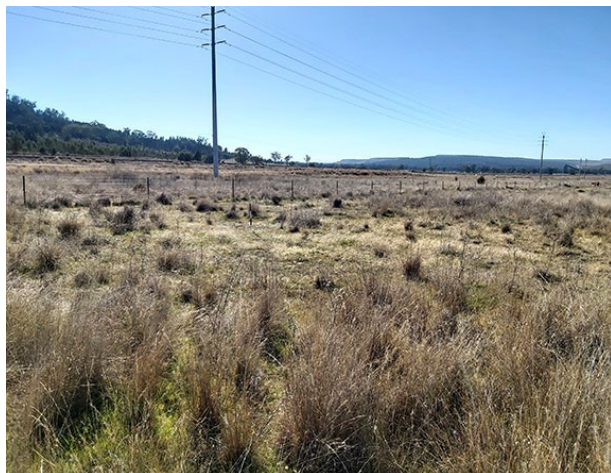
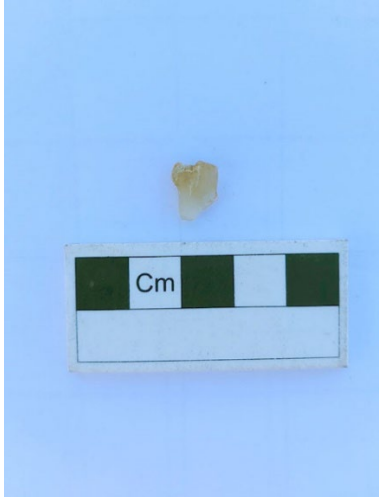
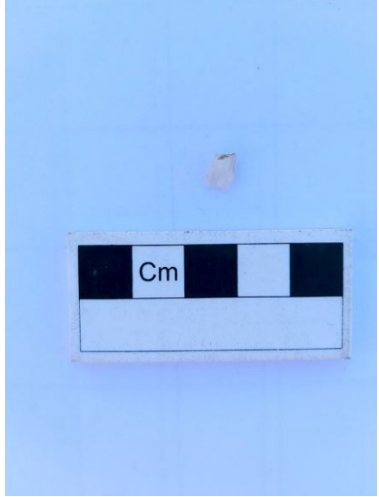
**Figure 6-4: Merriown 1. View of site and recorded artefacts.**

| 1. Merriown 1 location. | 2. View northeast, Merriown 1. |
| 3. Artefact #1, Merriown 1. | 4. Artefact #2, Merriown 1. |

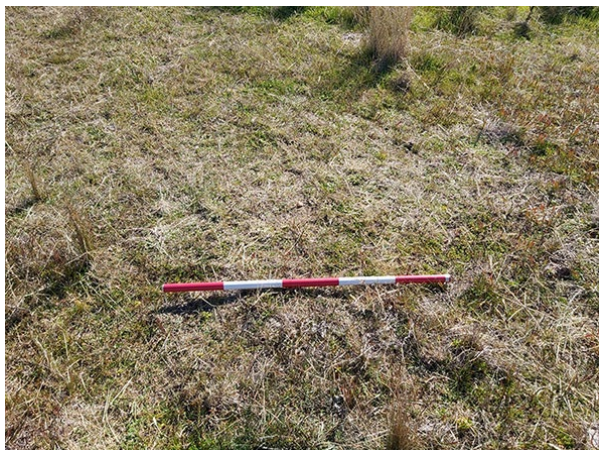
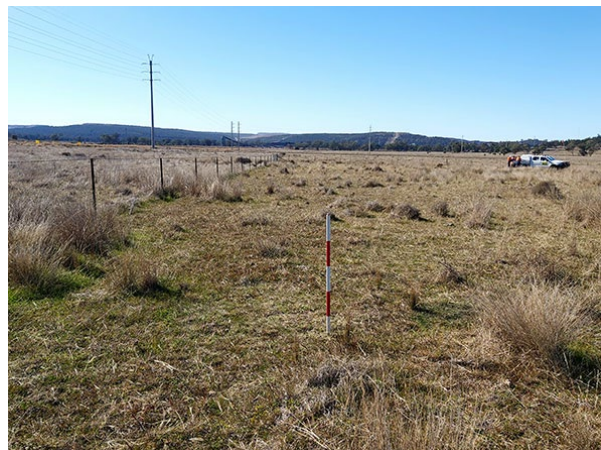
**Figure 6-5: Merriown 2. View of site and recorded artefact.**

**Description of site:** Single isolated artefact comprising a core fragment manufactured from chalcedony identified within an area of exposure on the plain (**Table 6-5** and **Figure 6-5**). The site extent is 5 x 5 m.

| <p>1. Merriown 2 location.</p> | <p>2. View east, Merriown 2.</p> |

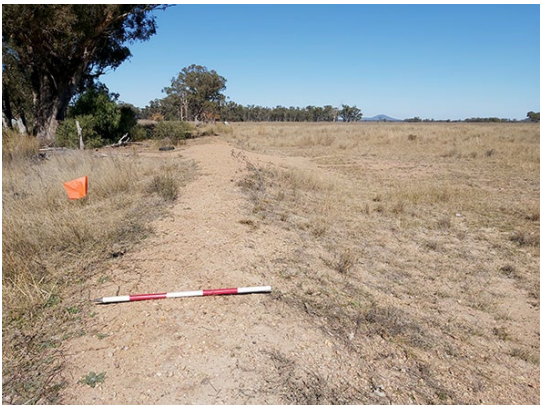
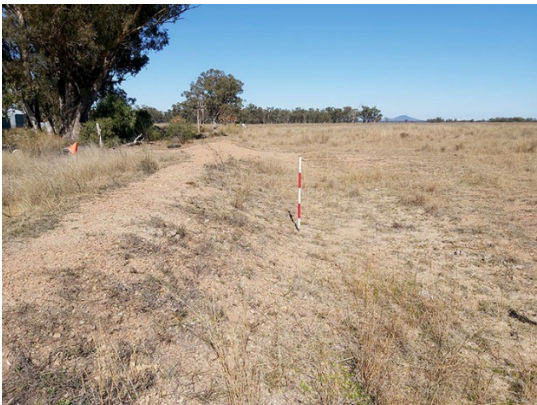
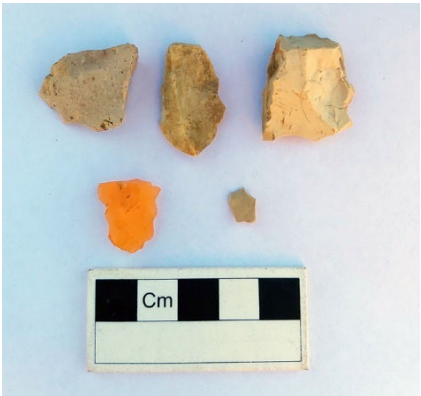
**Figure 6-6: Merriown 3. View of site and recorded artefacts.**

| 1. View south along levee bank showing location of Merriown 3. | 2. View south across Merriown 3 showing height of levee bank. |
| 3. Artefacts #4-9, Merriown 3. | |

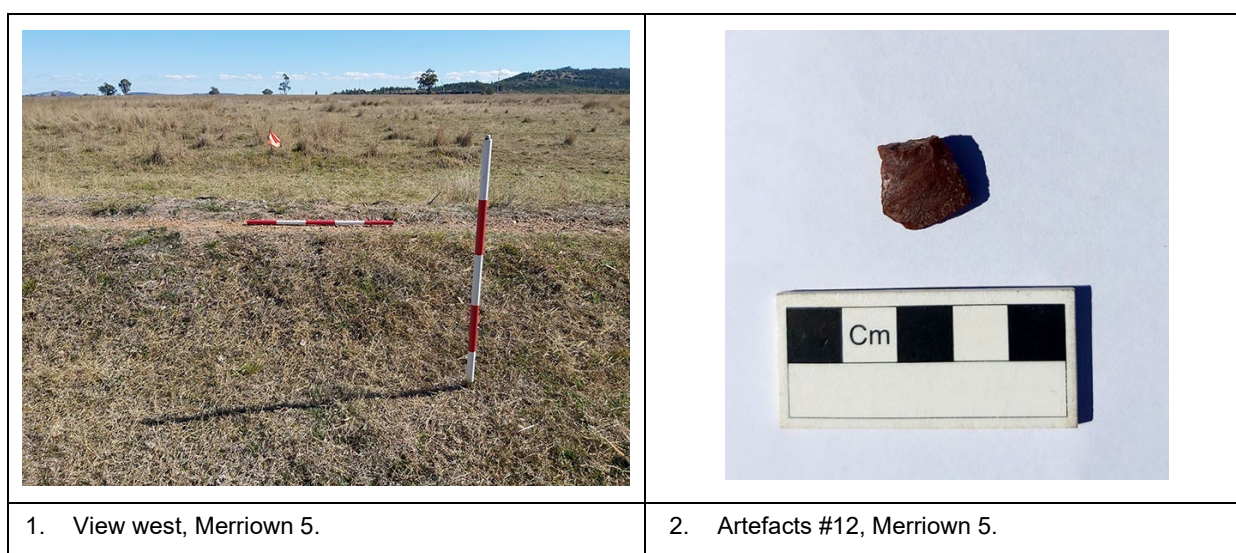
**Figure 6-8: Merriown 5. View of site and recorded artefacts.**

1. View west, Merriown 5.

2. Artefacts #12, Merriown 5.

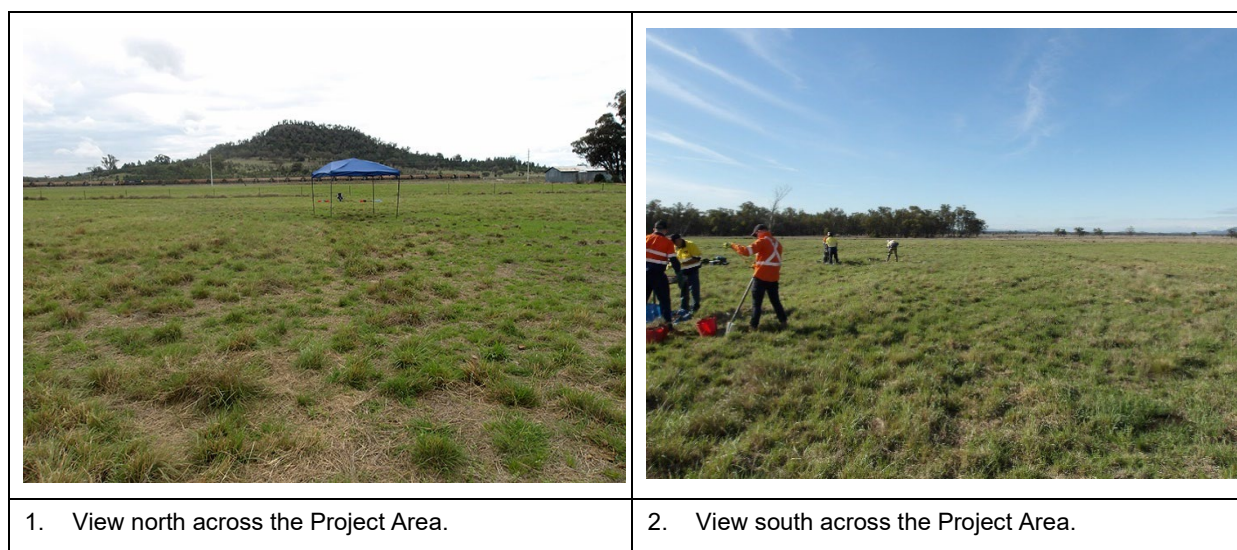
**Figure 7-2: Views of the test excavation area.**

The entirety of the Project Area is located within a flat plain landform with a very slight slope down to the east and south. The landscape of the excavation area is shown on **Figure 7-2**.

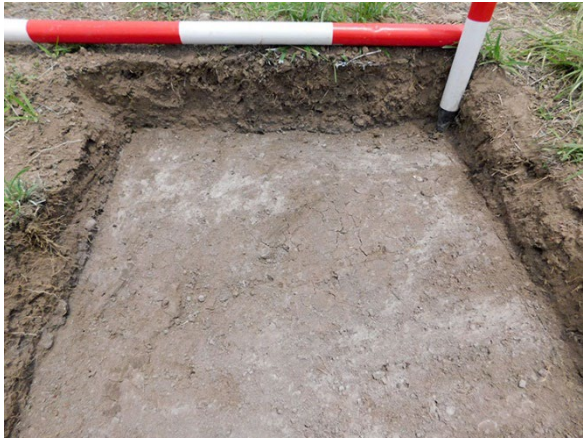
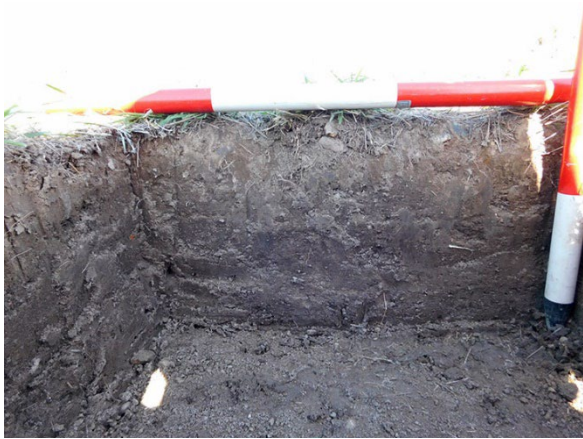
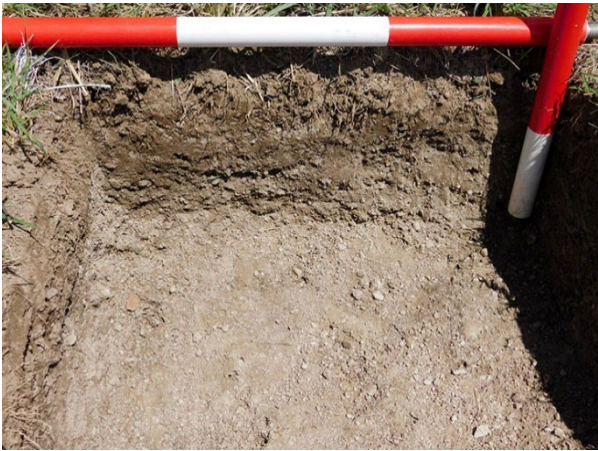
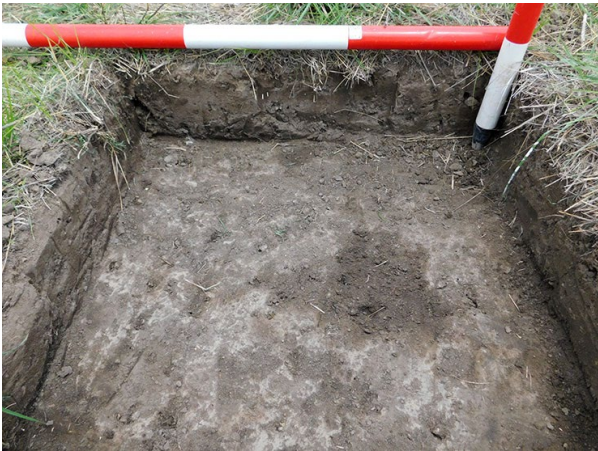
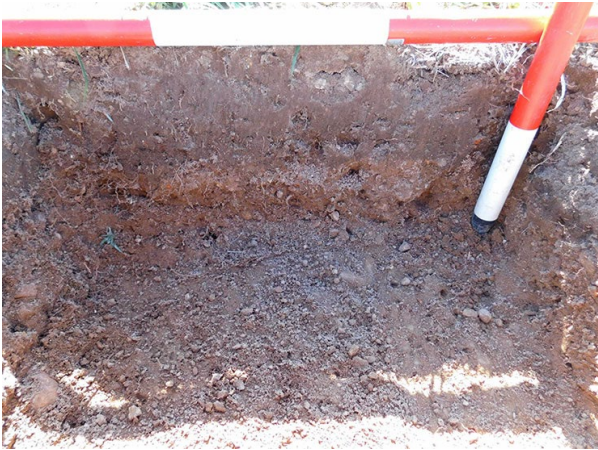
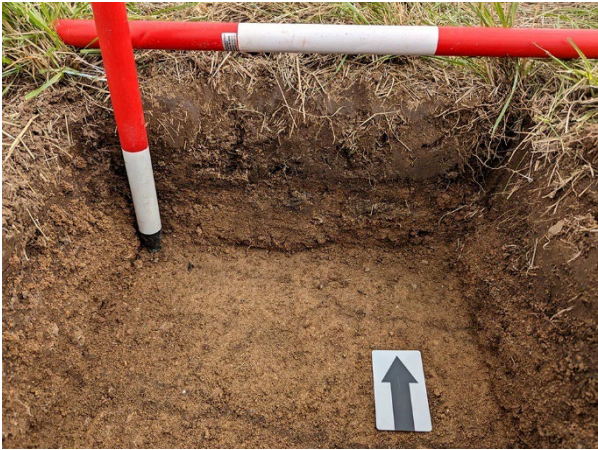
Figure 7-3: Example images of TU stratigraphy.

| 1. Transect 3 TU3: view of north section. | 2. Transect 4 TU5: view of north section. |
| 3. Transect 5 TU3: view of north section | 4. Transect 6 TU: view of north section |
| 5. Transect 7 TU5: view of north section | 6. Transect 9 TU1: view of north section |

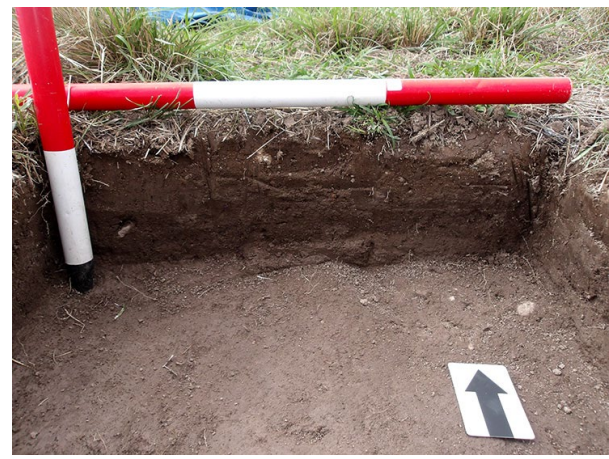
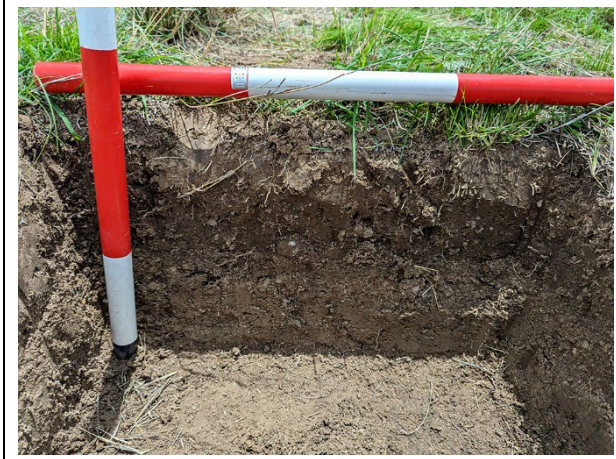
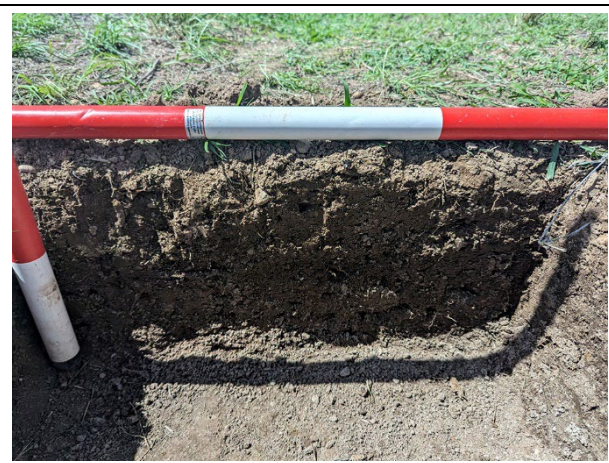
| 7. Transect 10 TU4: view of north section | 8. Transect 12 TU5: view of north section |
| | 9. Transect 13 TU4: view of north section |

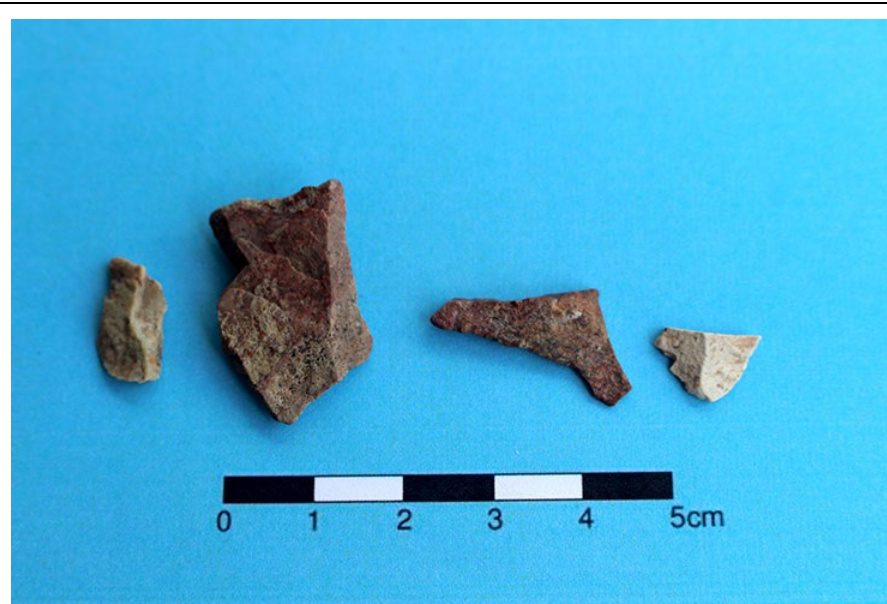
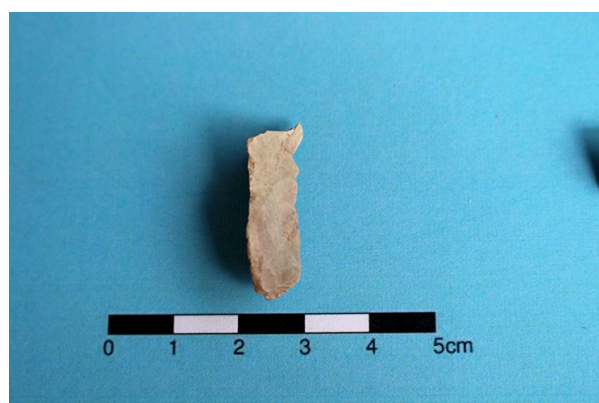
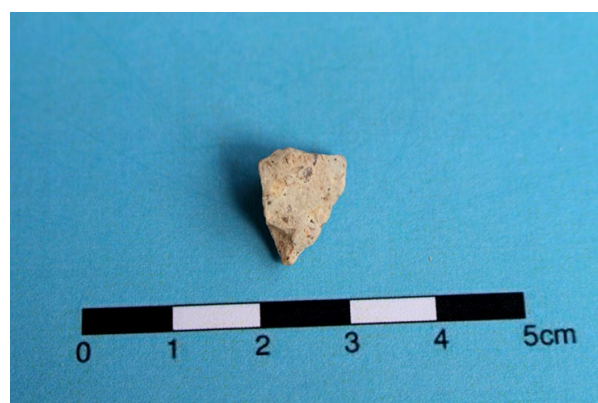
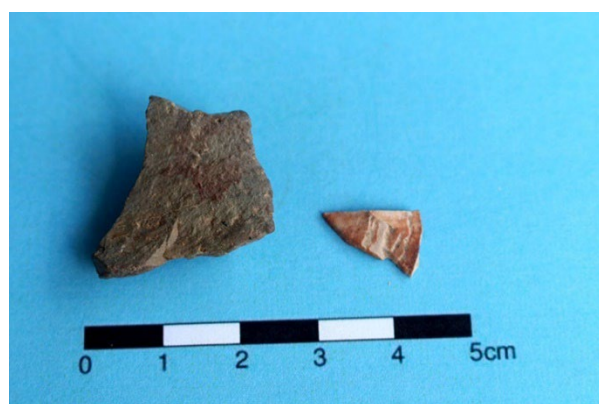
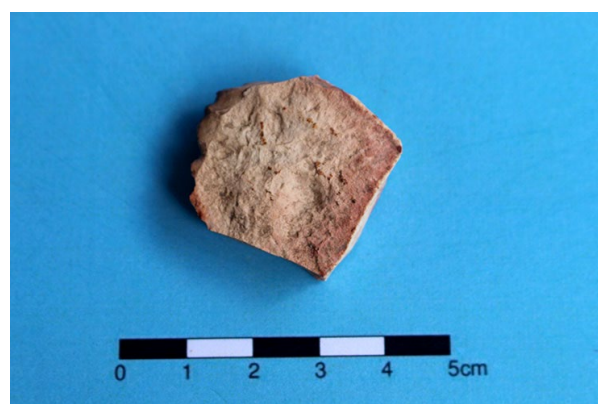
**Figure 7-5: Sample images of artefact assemblage.**

1. From left to right: Two silcrete flakes, silcrete shatter, and distal mudstone flake fragment, Transect 13 TU4 Spit 2.

2. Mudstone blade, Transect 9 TU2 Spit 1

3. Distal mudstone flake fragment, Transect 9 TU2 Spit 1.

4. Volcanic flake (left) and mudstone shatter (right), Transect 9 TU3 Spit 2.

5. Mudstone flake, Transect 13 TU2 Spit 2.

**Figure 7-5** provides sample images of the assemblage.

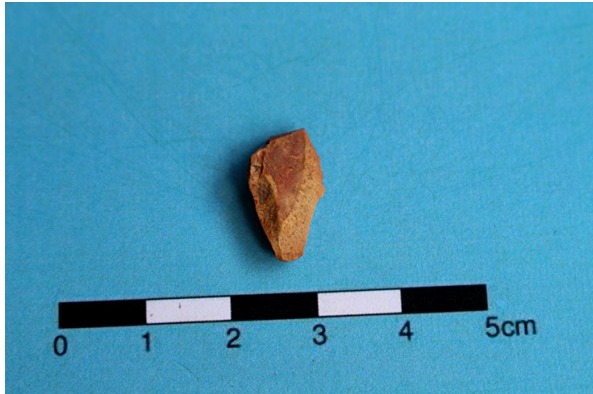
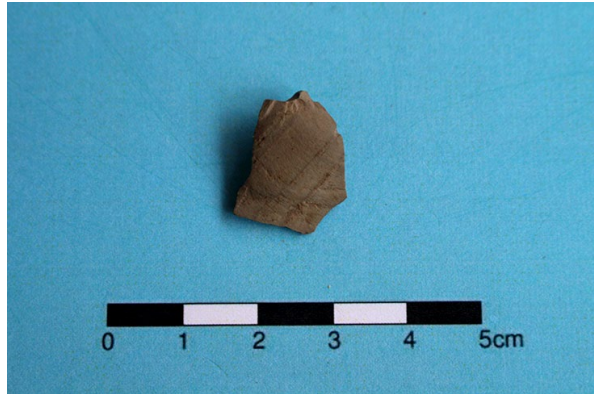
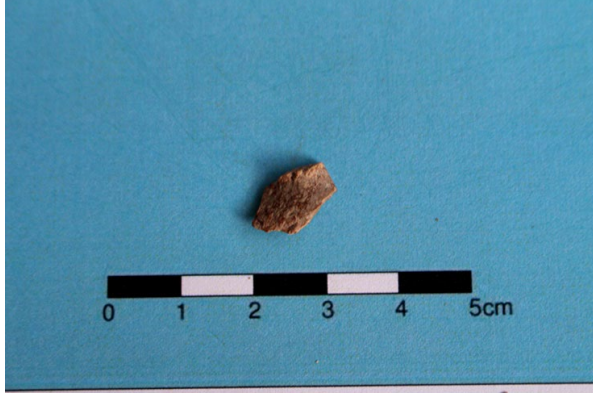
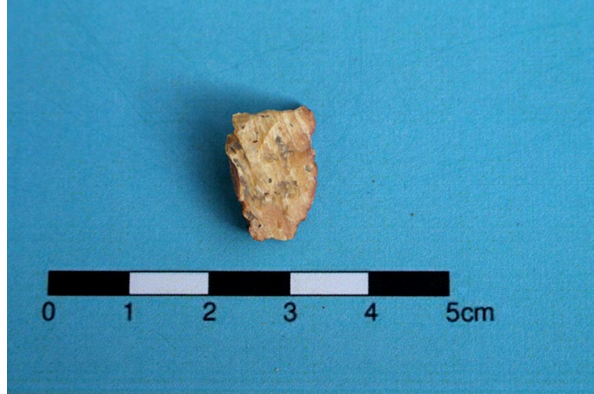
| 6. Mudstone flake, Transect 9 TU6 Spit 1. | 7. Volcanic flake, Transect 13 TU5 Spit 2. |
| 8. Silcrete flake, Transect 4 TU 5 Spit 1 | 9. Petrified wood proximal flake fragment, Transect 3 TU1 Spit 2. |
