GENERAL ARRANGEMENT PLAN

| NO. | STAGE | DSN | DWN | CHKD | APPR | DATE | NOTES | <div><div></div><div>RENEWABLES</div><div><div>info@itpau.com.au<br/>itpau.com.au<br/>+61 2 6257 3511</div><div>PO Box 6217<br/>O'Connor, ACT 2602<br/>AUSTRALIA</div></div></div> | <div>DSNISC</div> | <div>DWNMJB</div> | DRG TITLE | | | | |
|---|---|---|---|---|---|---|---|---|---|---|---|--|---|---|---|
| | | | | | | | ALL MEASUREMENTS IN mm<br>UNLESS OTHERWISE STATED. | | PROJECTBOGGABRI SOLAR FARM | | | | | SCALE | AS NOTED |

# State Environmental Planning Policy (Resilience and Hazards) – Screening Assessment

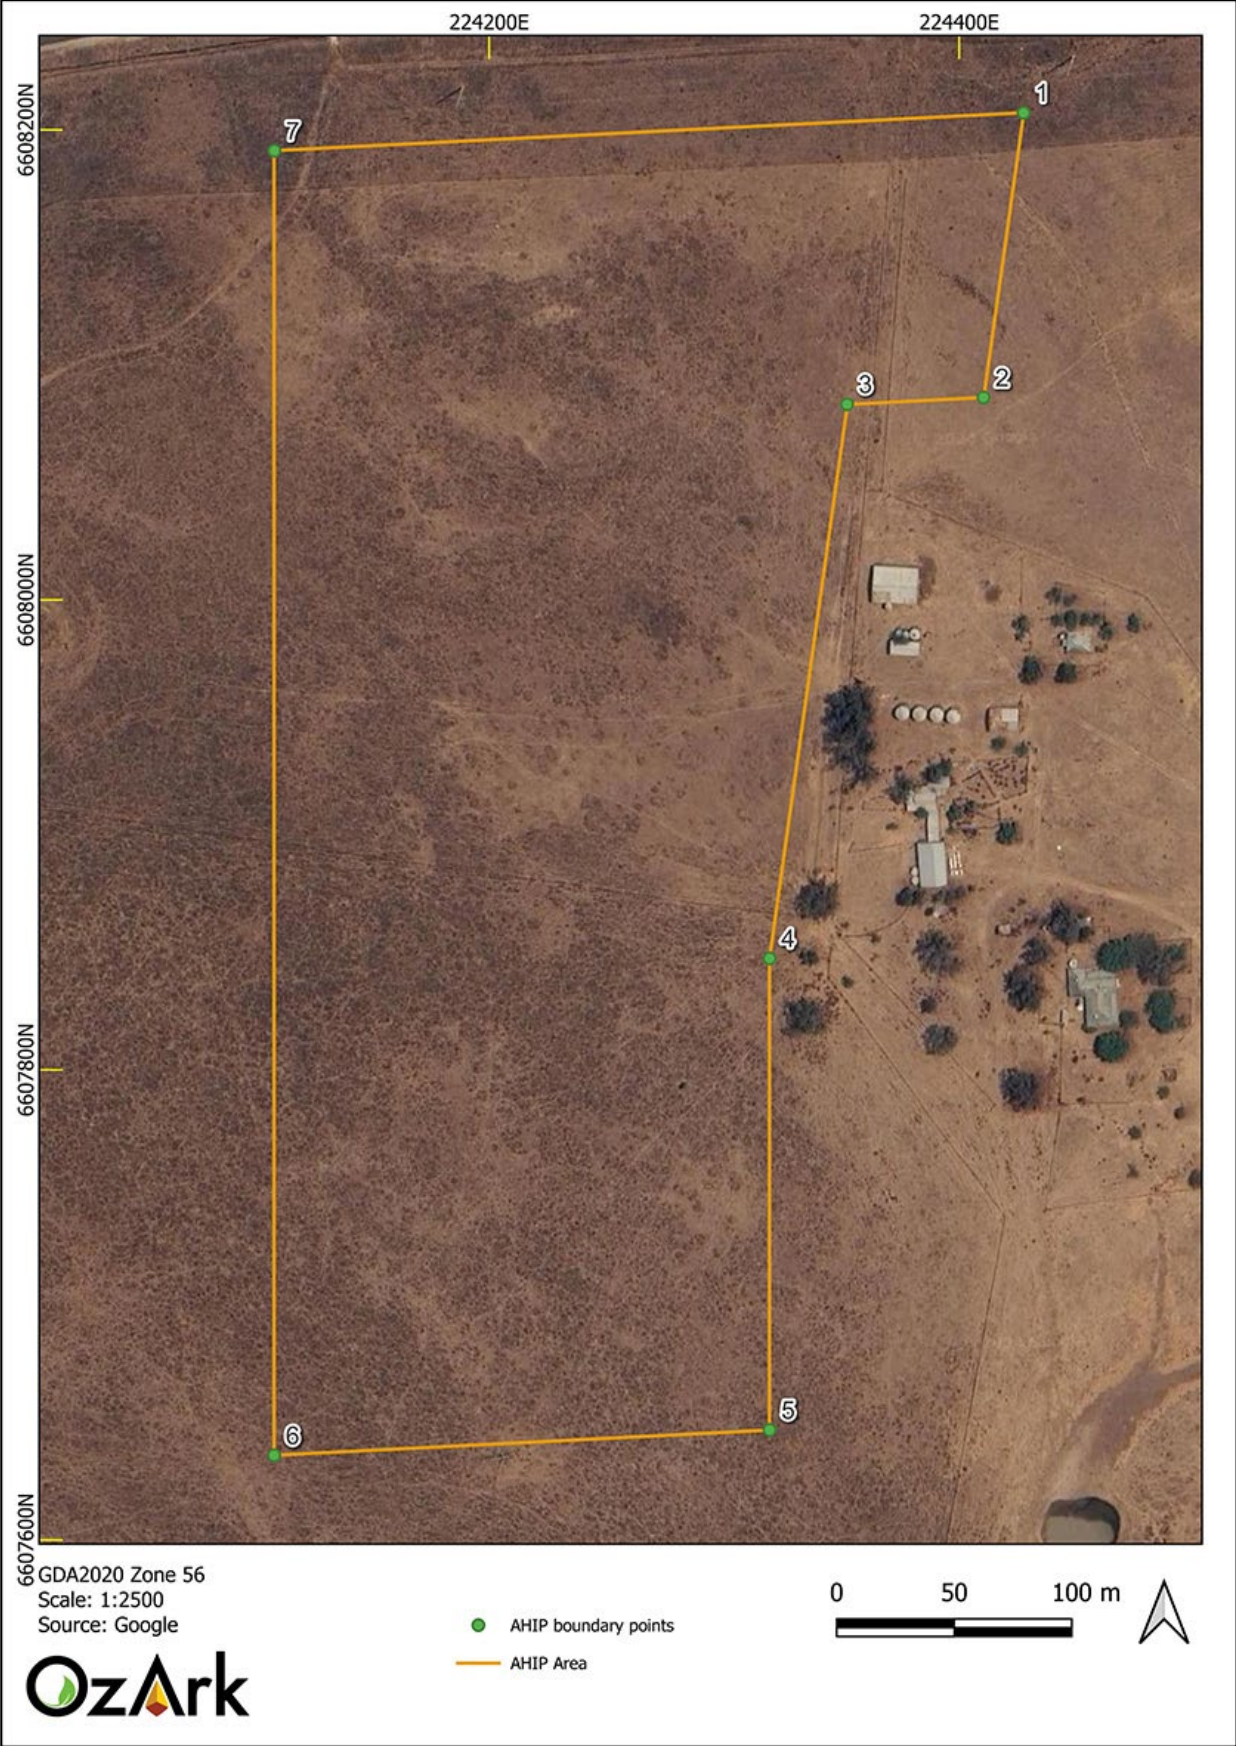
Figure 11-1: The AHIP Area and boundary points.

**Figure 11-1** shows the AHIP area and coordinates demarcating the AHIP Area are detailed in **Table 11-1**.

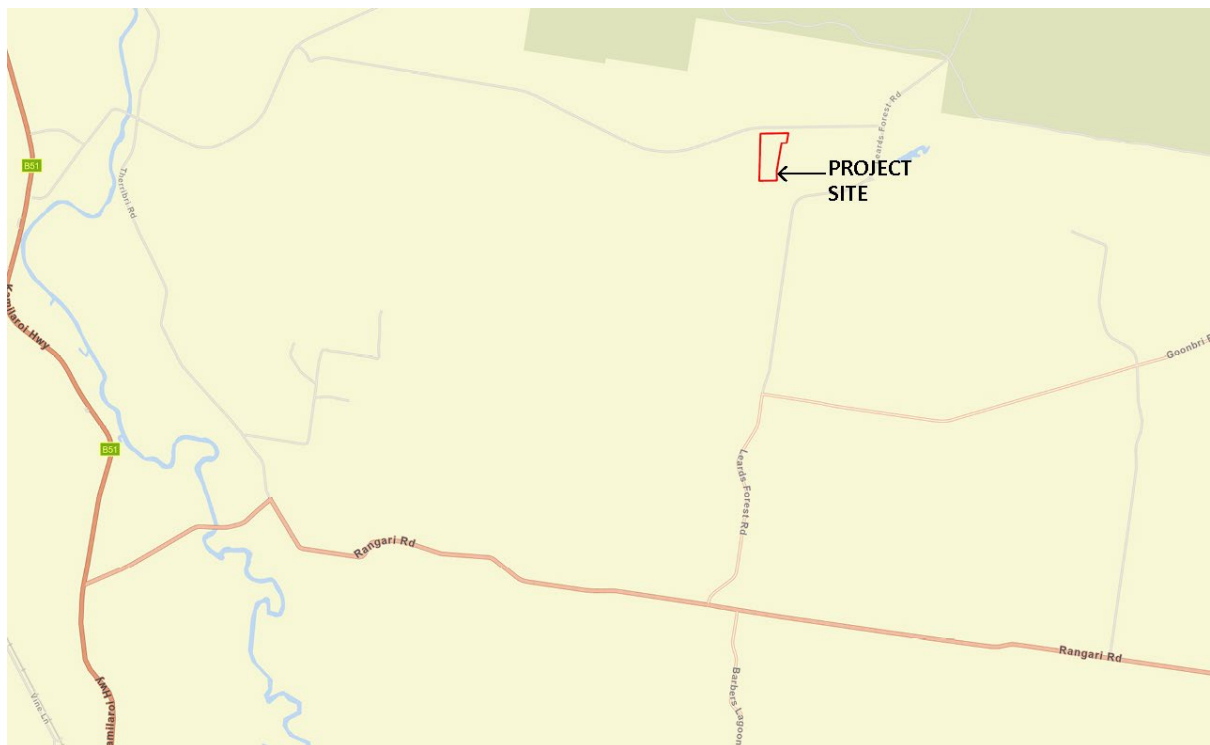
*Figure 1. Location Plan*

The Project site is located approximately 10 kilometres (km) north east of Boggabri, within the Narrabri Local Government Area, *refer Figure 1*. Boggabri Coal Mine is located approximately 1.5km to the east of the site.

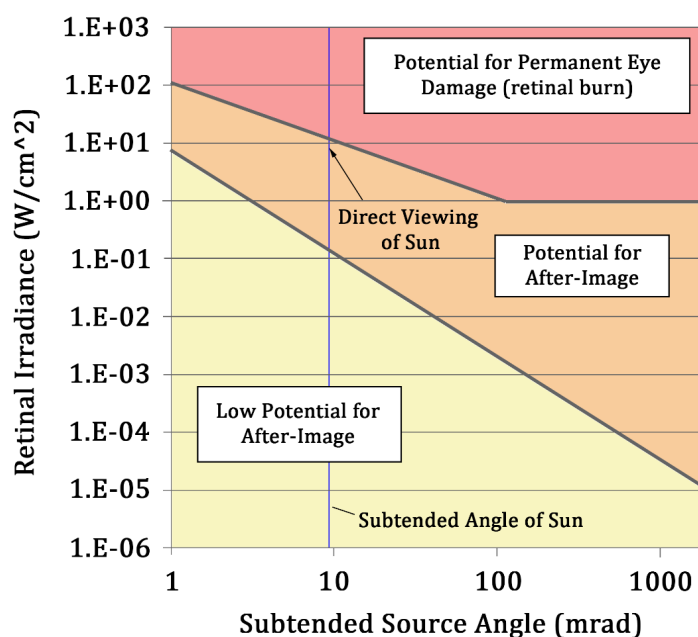
*Figure 2. Ocular impacts and Hazard Ranges<sup>3</sup>*

Glare can be broadly classified into three categories: low potential for after-image (referred to as "Green Glare" in SGHAT), potential for after-image (referred to as "Yellow Glare" in SGHAT), and potential for permanent eye damage (referred to as "Red Glare" in SGHAT), *Figure 2* illustrates the glare intensity categories used in this study.

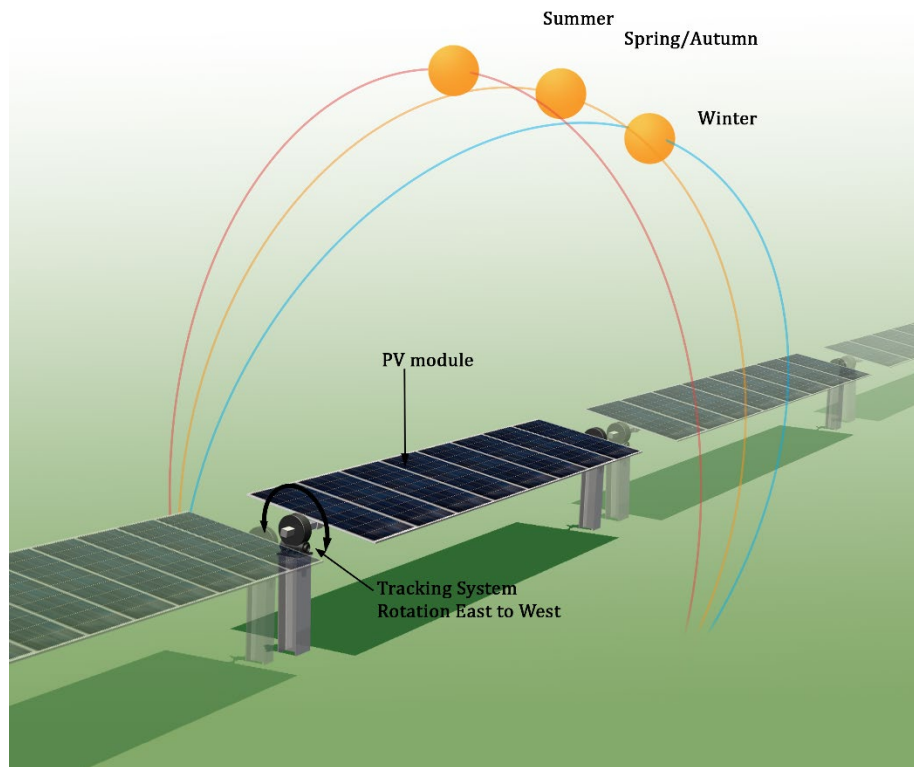
Figure 5. Diagrammatic illustration of sun position relative to PV module mounted on a horizontal single axis tracking system.

Tracking systems operate from a set resting angle, resting angles define the final angle at the beginning and end of the backtracking cycle. Generally resting angles range between 0 and 30 degrees, depending on the type of system used and the site requirements. A slight angle (5 degrees) is commonly used to allow rain and dew to sheet off the panels, some systems use higher angles in more extreme climatic conditions. Shallow resting angles increase the angle of incidence between the sun and PV model, therefore the shallower the angle the more likely glare may occur.

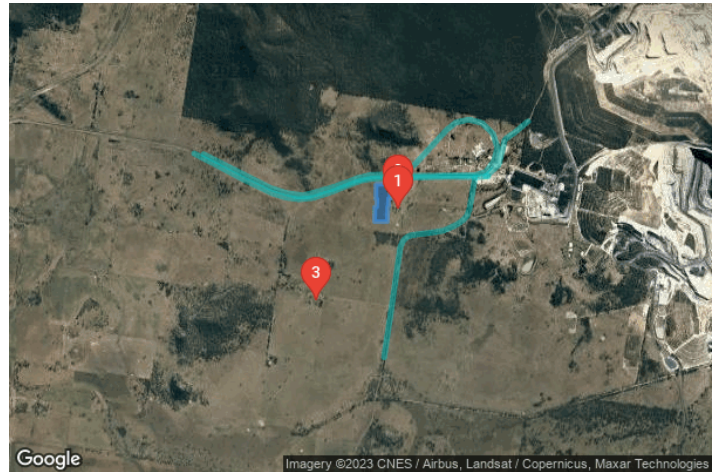
## Summary of Results No glare predicted

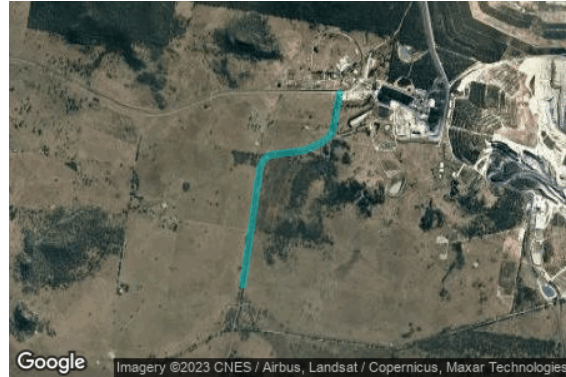
**Name:** Mine Access Road 1  
**Path type:** Two-way  
**Observer view angle:** 90.0°

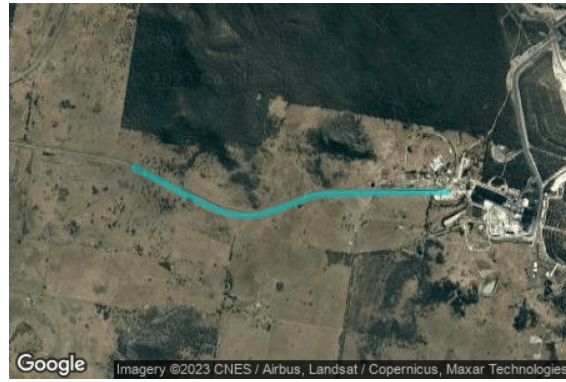
**Name:** Mine Access Road 2  
**Path type:** Two-way  
**Observer view angle:** 90.0°

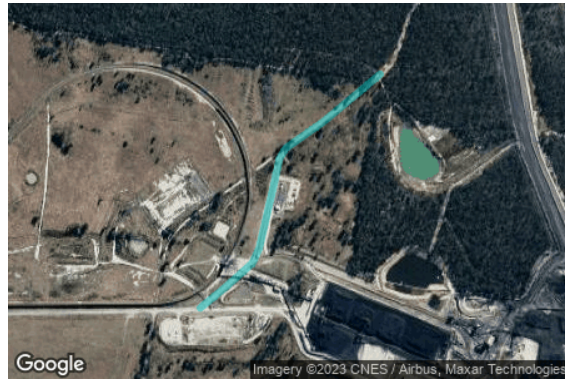
**Name:** Rail Line Spur  
**Path type:** Two-way  
**Observer view angle:** 50.0°

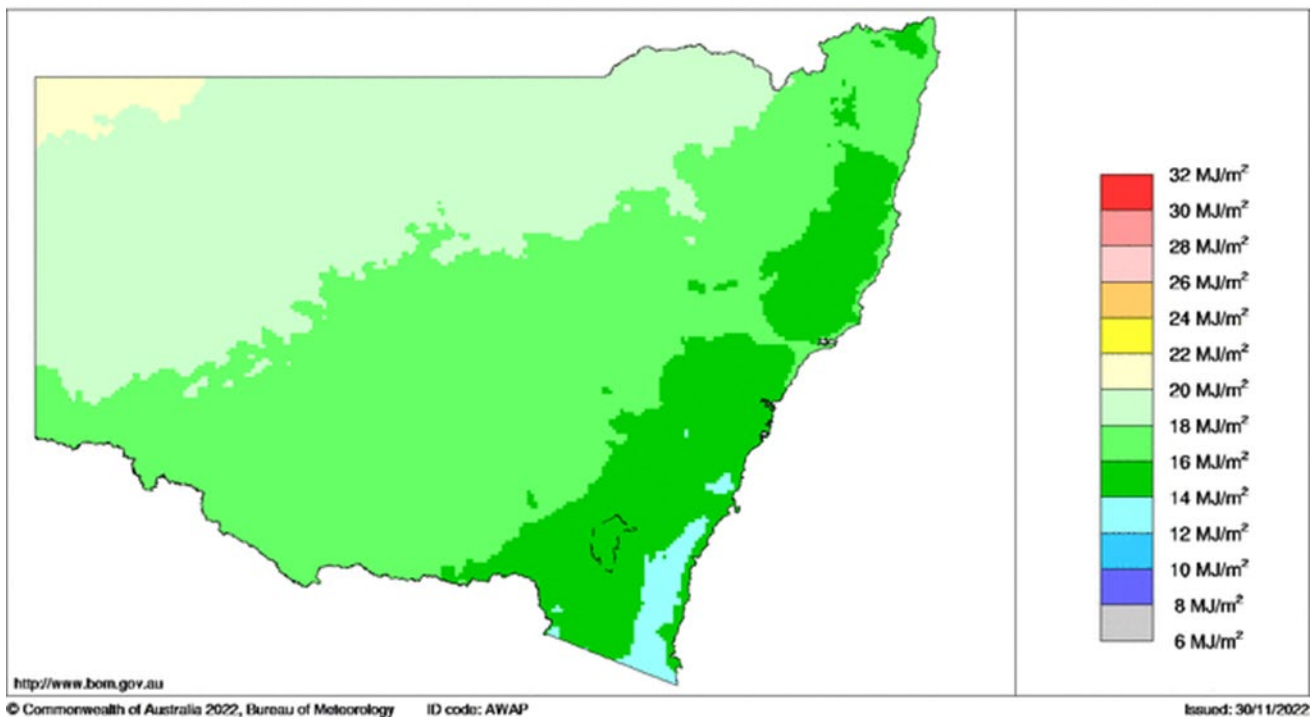
**Figure 2–3 Global Solar Exposure Daily Averages 01/12/2021 to 30/11/2022**

Based on BoM computer model estimates, the site would have received approximately 16-18MJ/m²/day in the observed 12-month period.

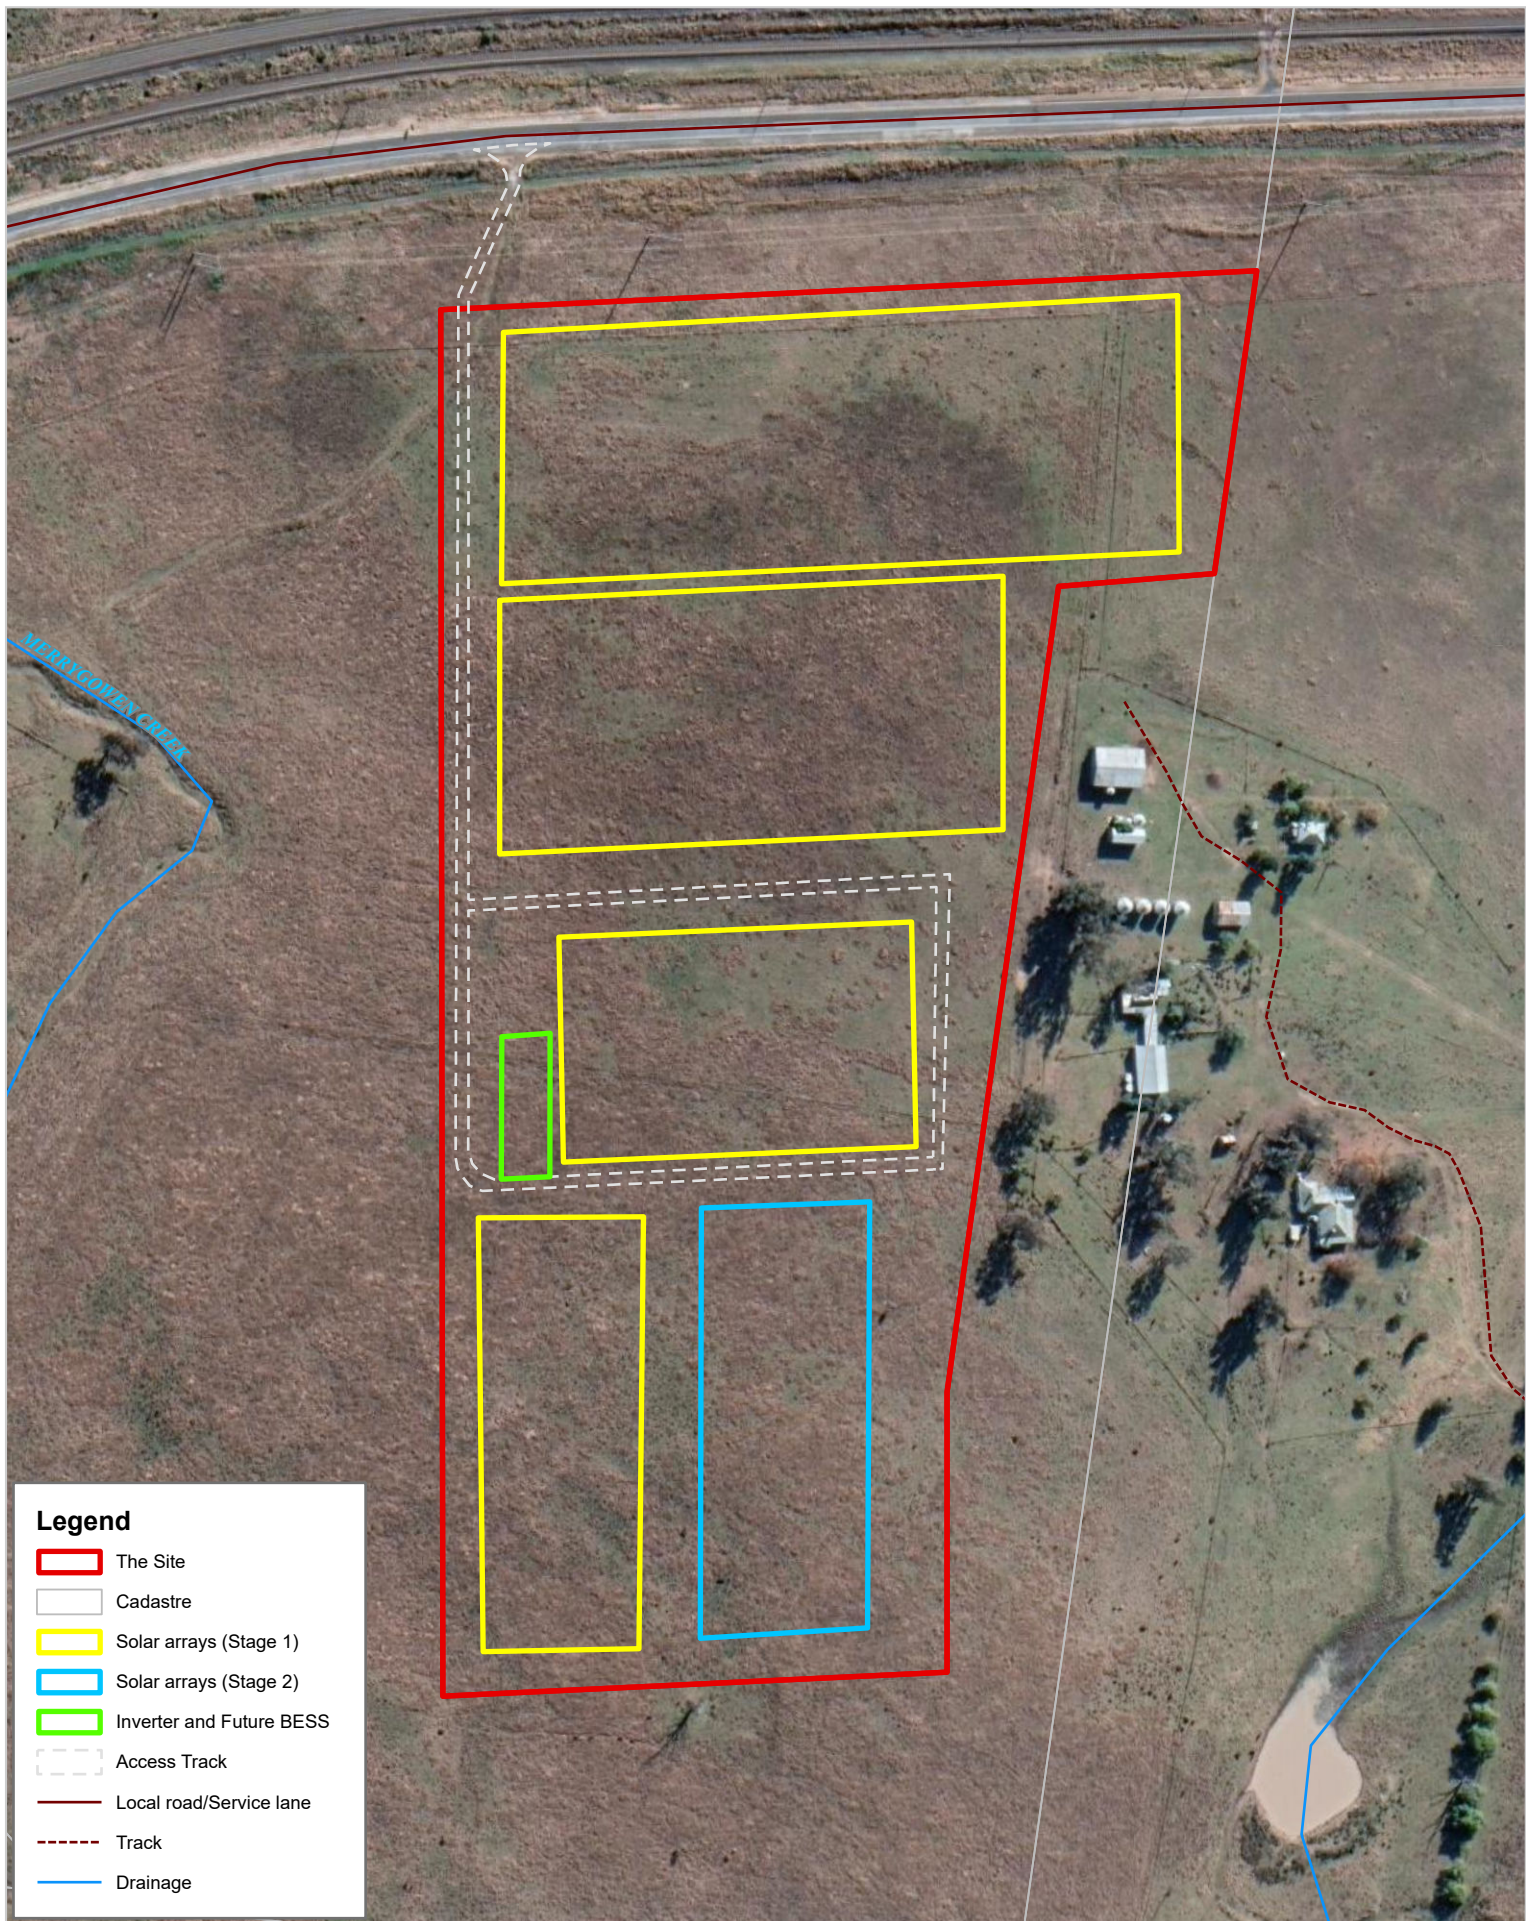
## FIGURE 3-1

A layout of the Detailed Site Plan is provided in Figure 3–1 below.

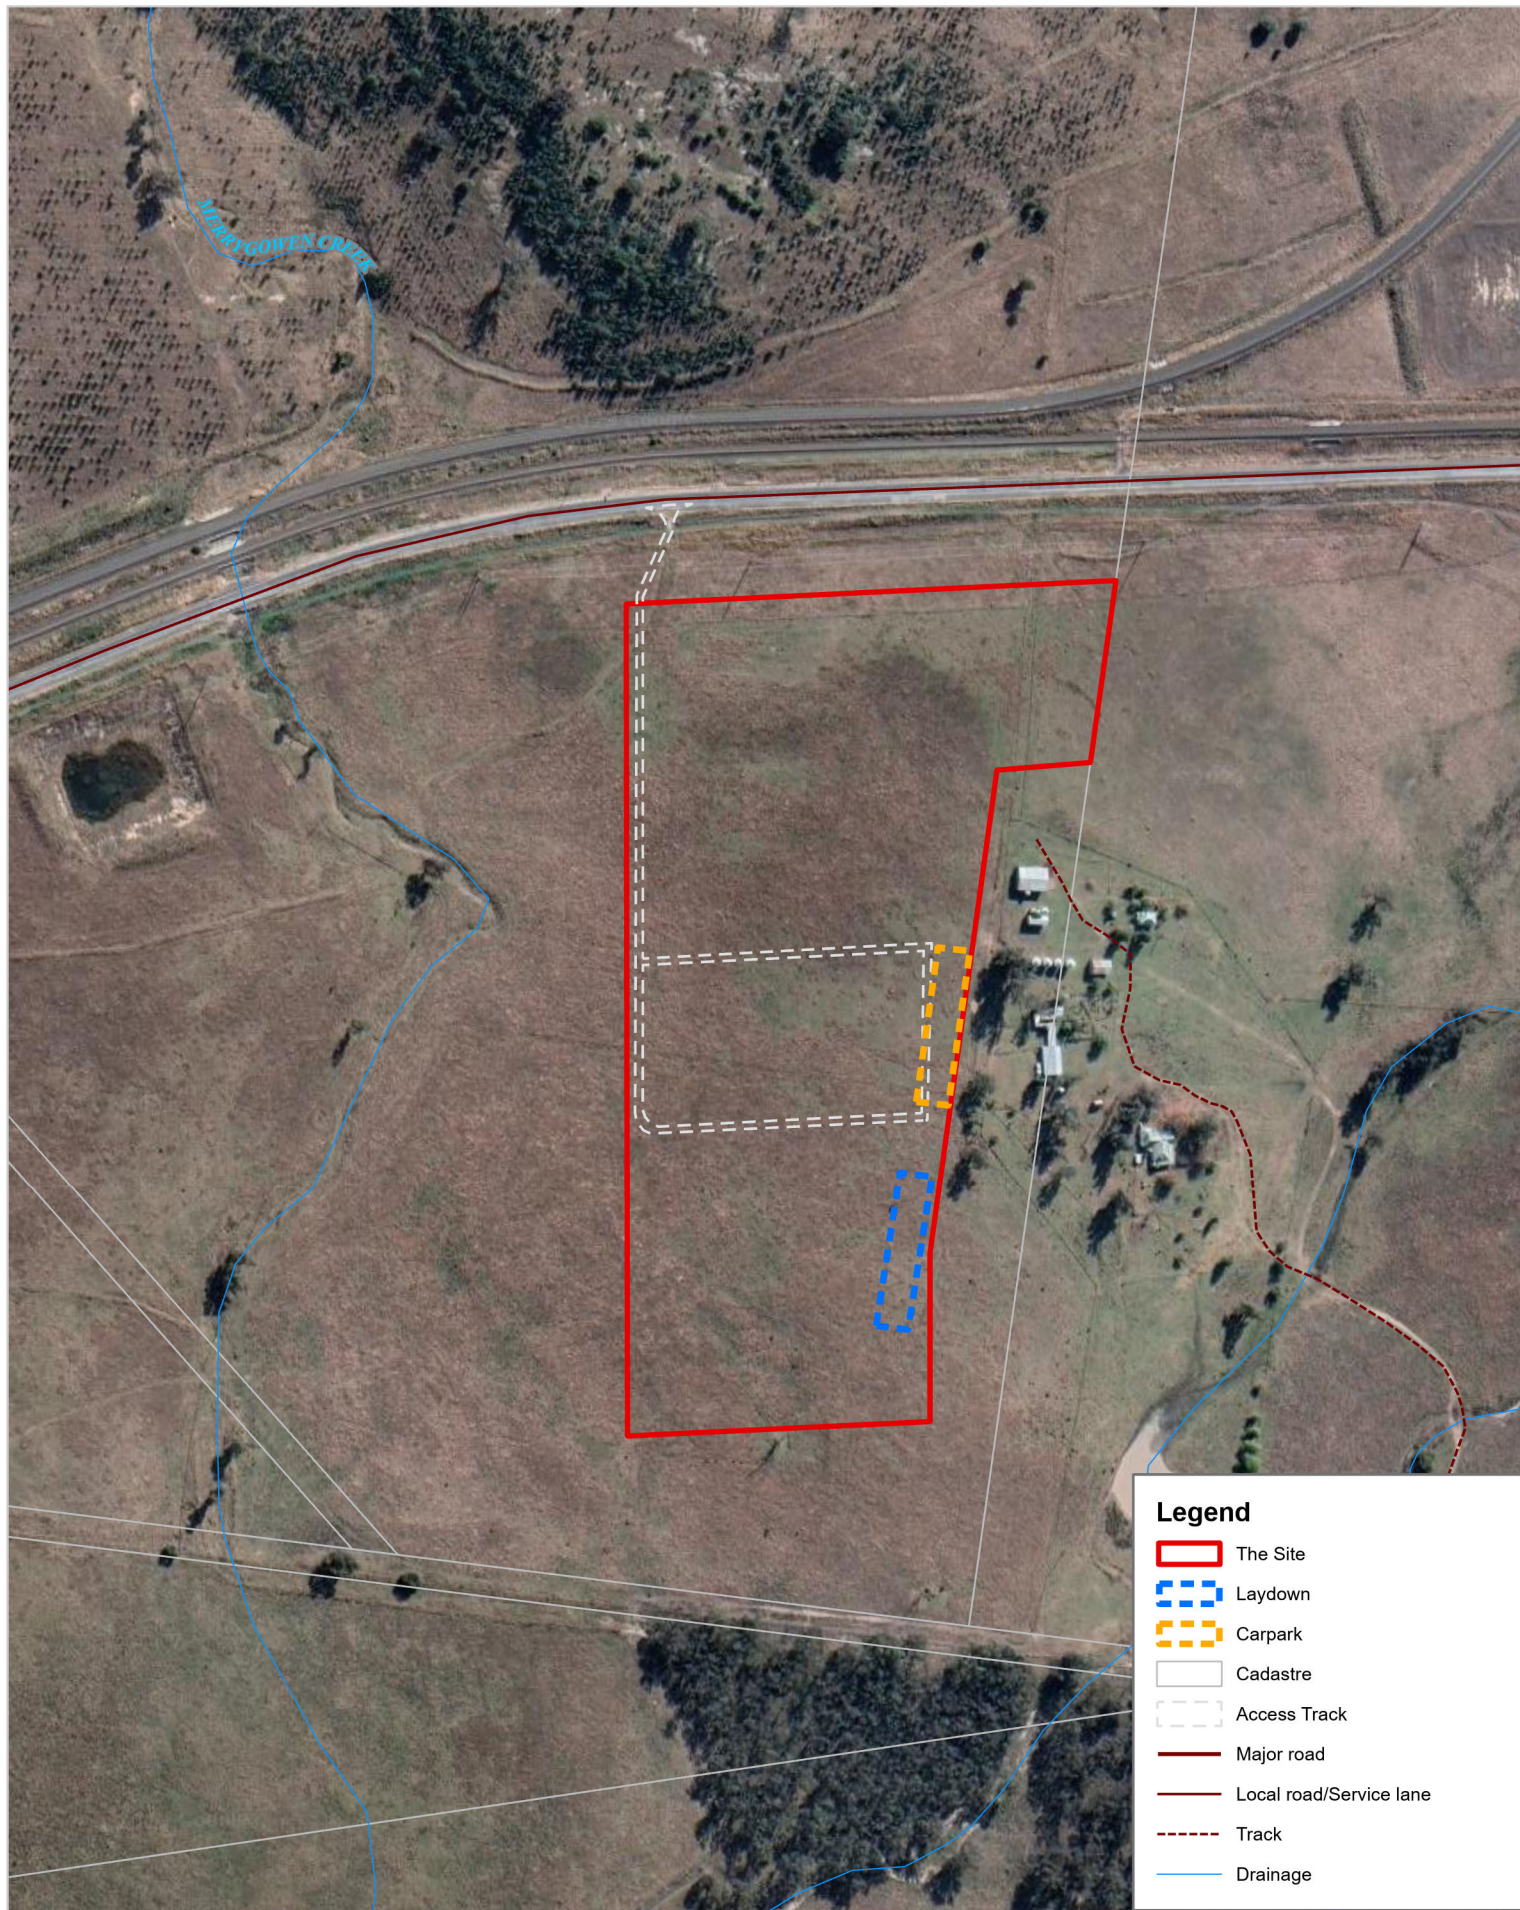
During Stage 1 there will be a stockpile and laydown area located in the northern portion of the site. This will enable ease of access for trucks and employees without unnecessarily interfering with the construction footprint.

During Stage 2, a new laydown area and carpark will be created further south, to facilitate the new proposed development area. The stockpile area in the north will still be utilised for Stage 2.

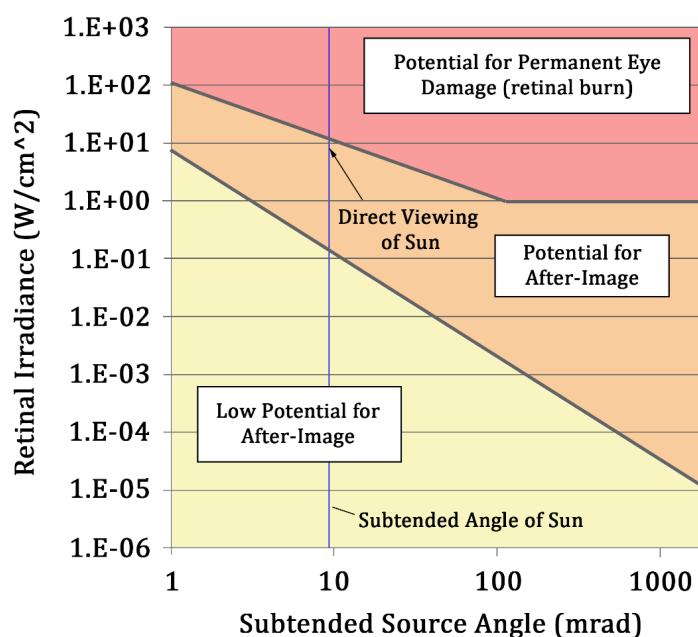
*Figure 2. Ocular impacts and Hazard Ranges<sup>3</sup>*

Glare can be broadly classified into three categories: low potential for after-image (referred to as "Green Glare" in SGHAT), potential for after-image (referred to as "Yellow Glare" in SGHAT), and potential for permanent eye damage (referred to as "Red Glare" in SGHAT), *Figure 2* illustrates the glare intensity categories used in this study.

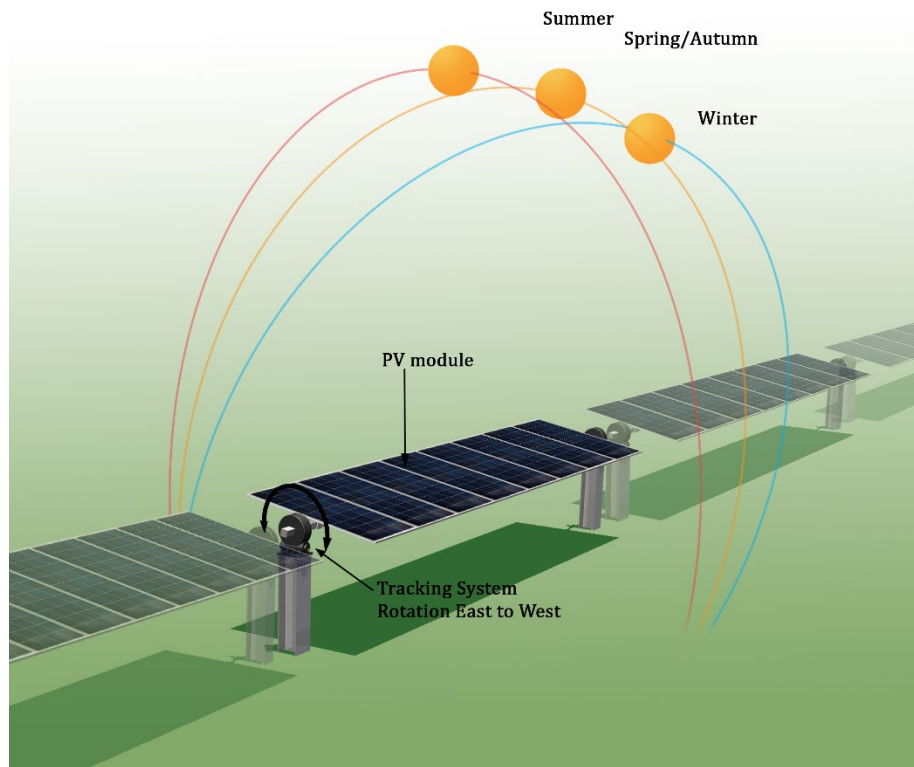
Figure 5. Diagrammatic illustration of sun position relative to PV module mounted on a horizontal single axis tracking system.

Tracking systems operate from a set resting angle, resting angles define the final angle at the beginning and end of the backtracking cycle. Generally resting angles range between 0 and 30 degrees, depending on the type of system used and the site requirements. A slight angle (5 degrees) is commonly used to allow rain and dew to sheet off the panels, some systems use higher angles in more extreme climatic conditions. Shallow resting angles increase the angle of incidence between the sun and PV model, therefore the shallower the angle the more likely glare may occur.

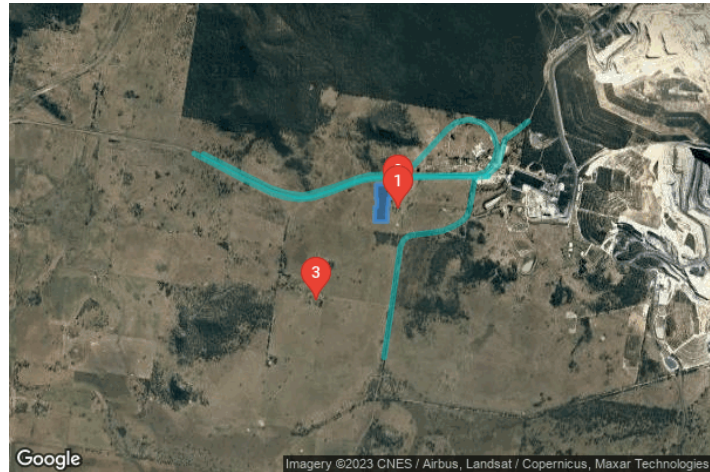
## Summary of Results No glare predicted
