# REVOLUTION TOWN PLANNING

**Attn:** Patsy Cox, Planning Officer  
**Address:** 33-35, 37 and 39 Maitland Street, Bingara NSW 2404  
**RPD:** Part of Lot 20 Section 38 on DP758111, Lot 1 on DP87721, Lots A, B and C on DP156383, Part of Lot A on DP152922 (BK1566 No 614 Right of Way) and Part of Lot 1 on DP209422 (BK1701 No 95 Right of Way)  
**Subject:** Response to Request for Additional Information  
**Council Ref:** PAN-388341:23/21822:pmc

This submission represents the Applicant's Response to a Request for Additional Information issued by Gwydir Shire Council (Council) dated 28 November 2023. (refer **Attachment 1**). It is considered the information addresses all of the issues raised by Council in the Request for Additional Information. Council is requested to continue assessment of the development application.

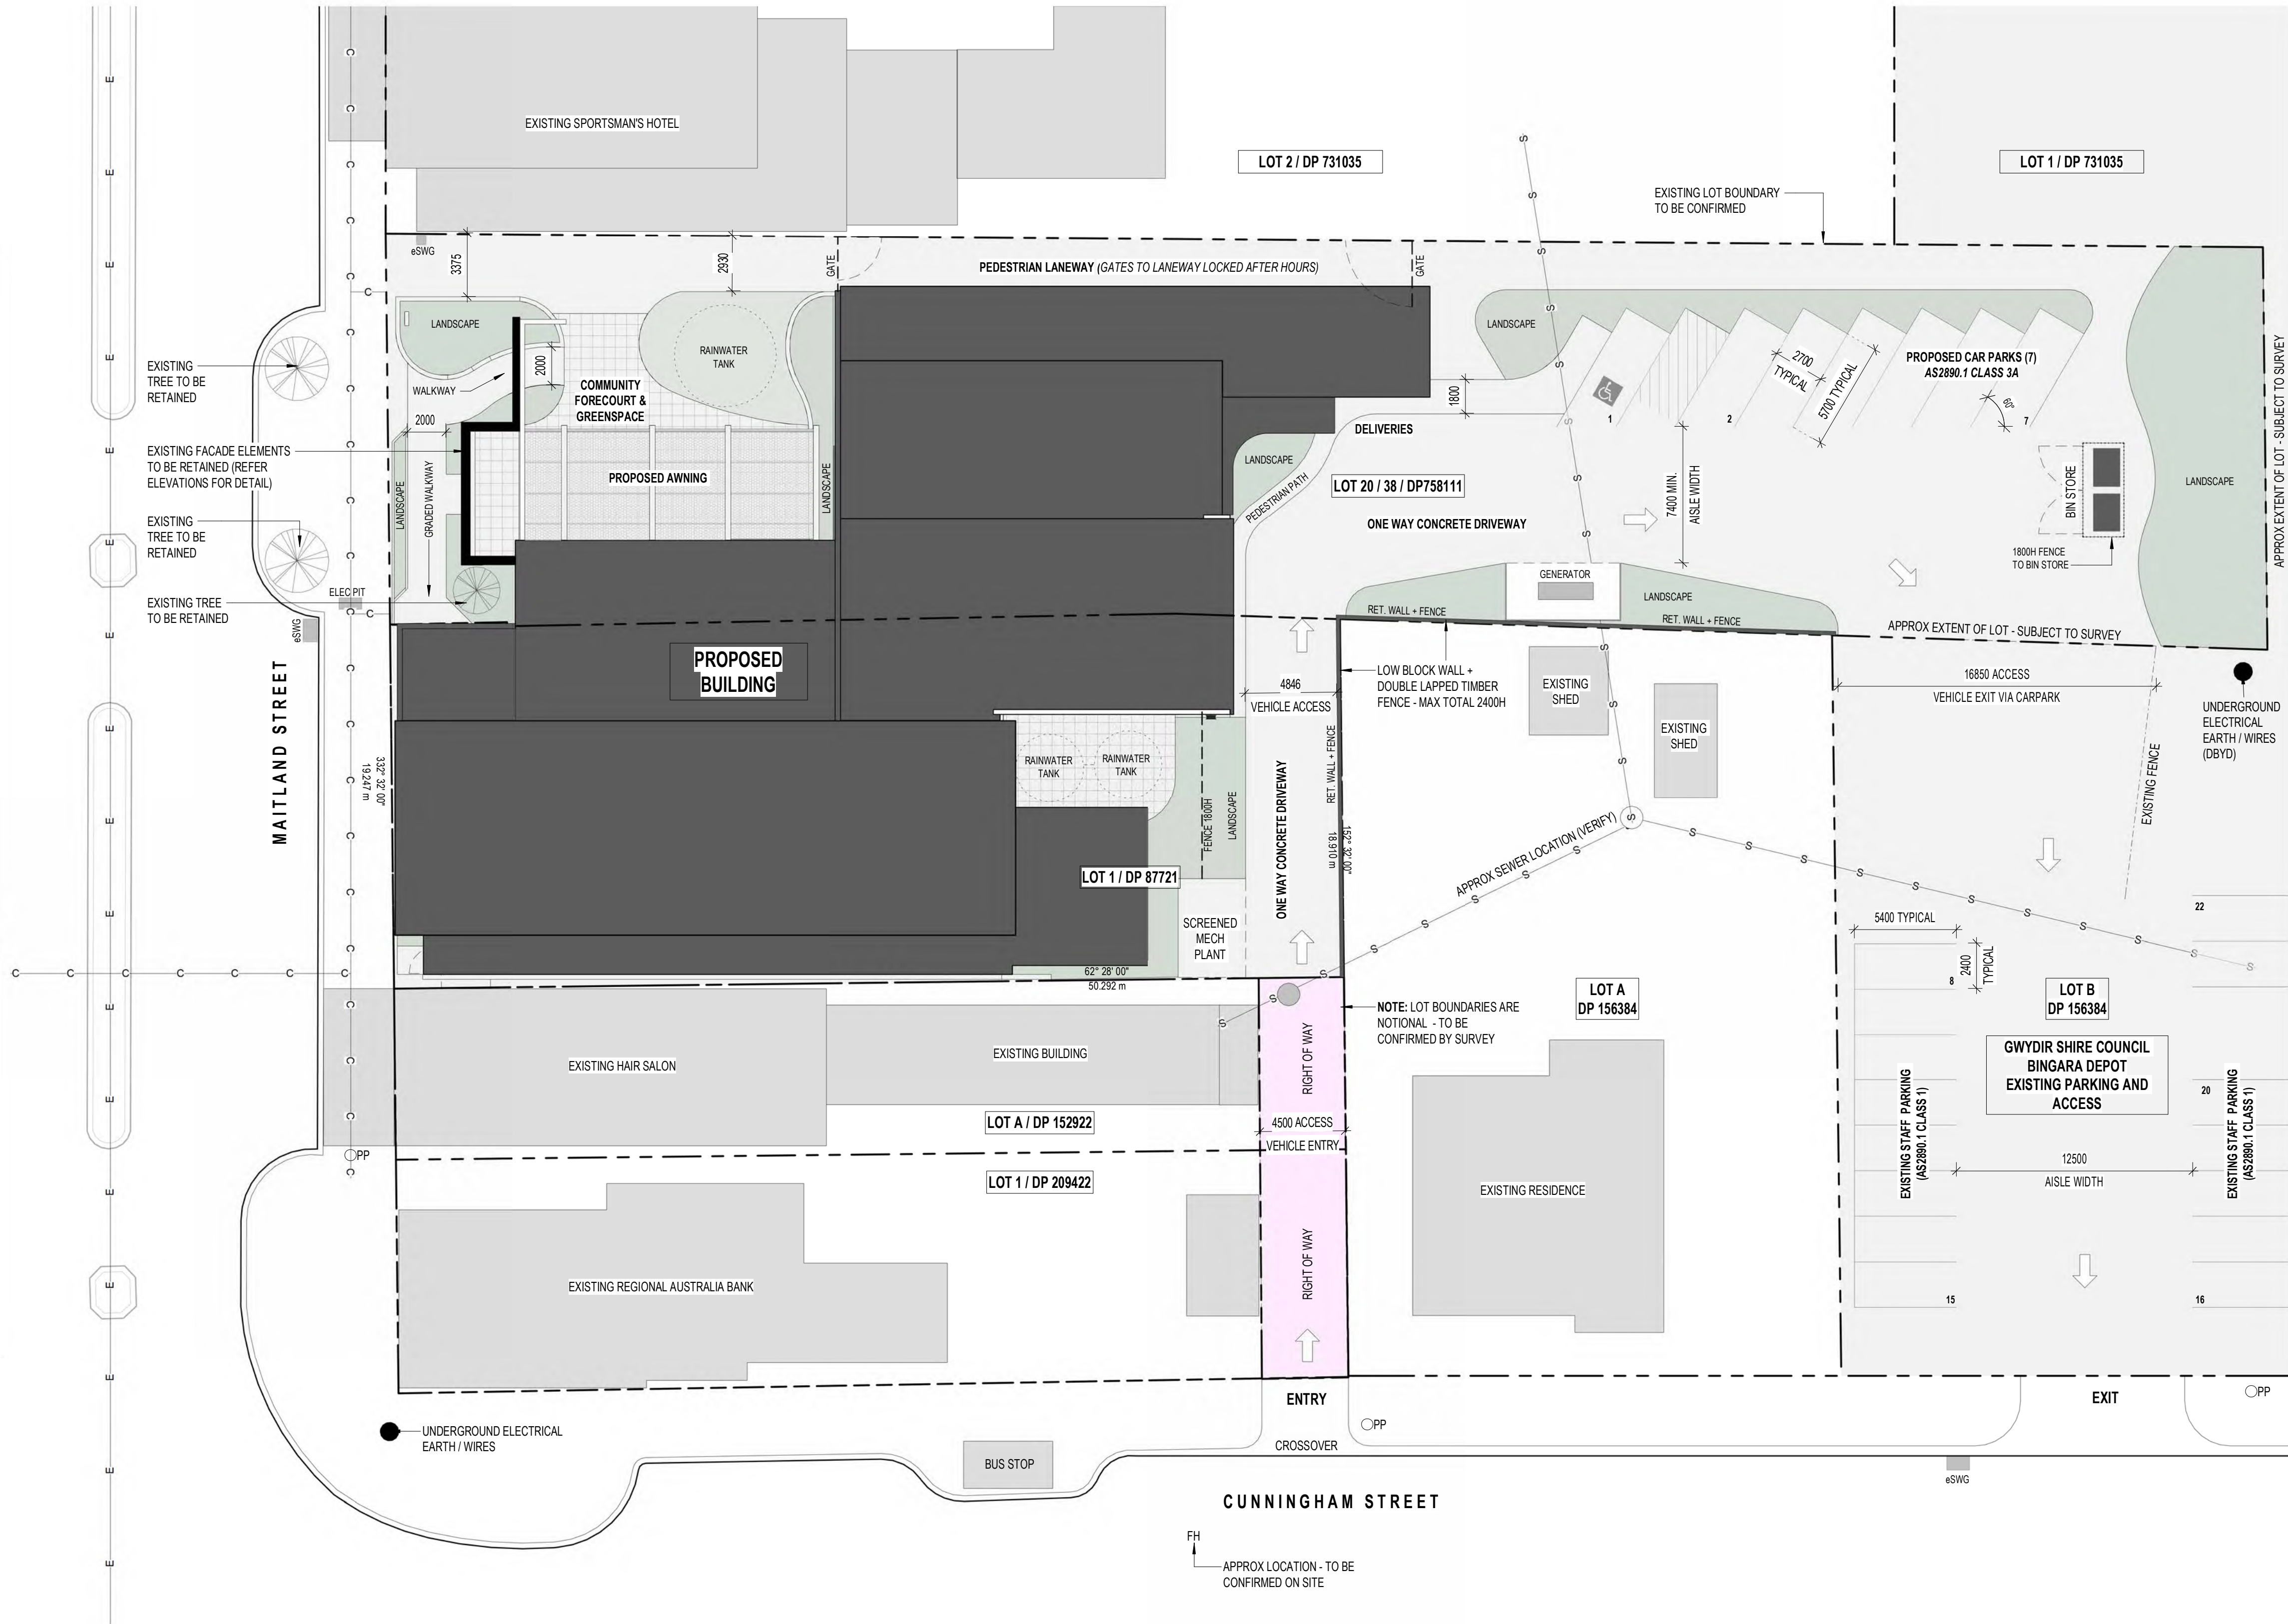
PROPOSED SITE PLAN

As shown in the Amended Plans, the proposed development improves the safety of the site through limiting access to the rear of the site after hours through lockable gates (may be locked at the same time as the public toilet facilities). CCTV and low-level security lighting will be installed on the building. It is recommended that 'No Public Access' signage is provided at the accesses to the carpark and Council Depot on Cunningham Street to discourage pedestrians cutting through the site as a more direct route to a northern destination on Maitland Street.

Please find attached amended plans with the dimensions of all accessways, carpark aisles and carparking spaces detailed. It is noted that sufficient site area exists for minor amendments to the concept to occur during detailed design.

**SOIL CONTAMINATION / REMEDIATION:**  
THE PRESENCE OF KNOWN CONTAMINANTS TO BE IDENTIFIED AND THE SITE MADE SAFE THROUGH CARRYING OUT DA/24/2023 PRIOR TO THE COMMENCEMENT OF WORKS FOR THE SUBJECT DEVELOPMENT

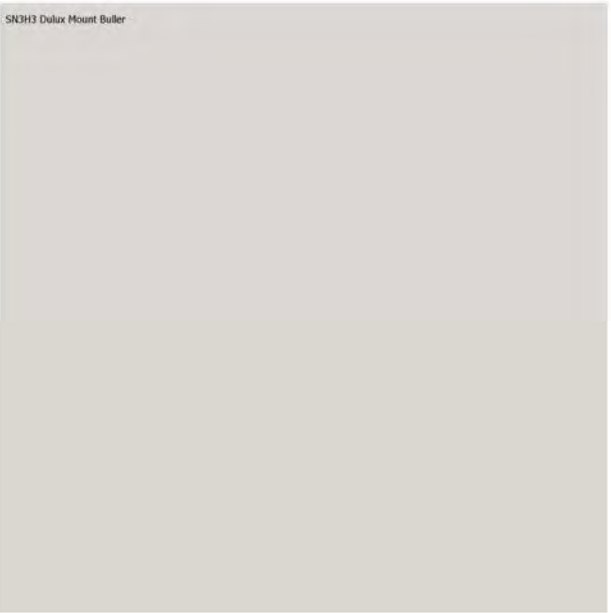
EXISTING PORTICO & FACADE - ARCHITECTURAL DETAILING  
COLOUR: DULUX MOUNT BULLER

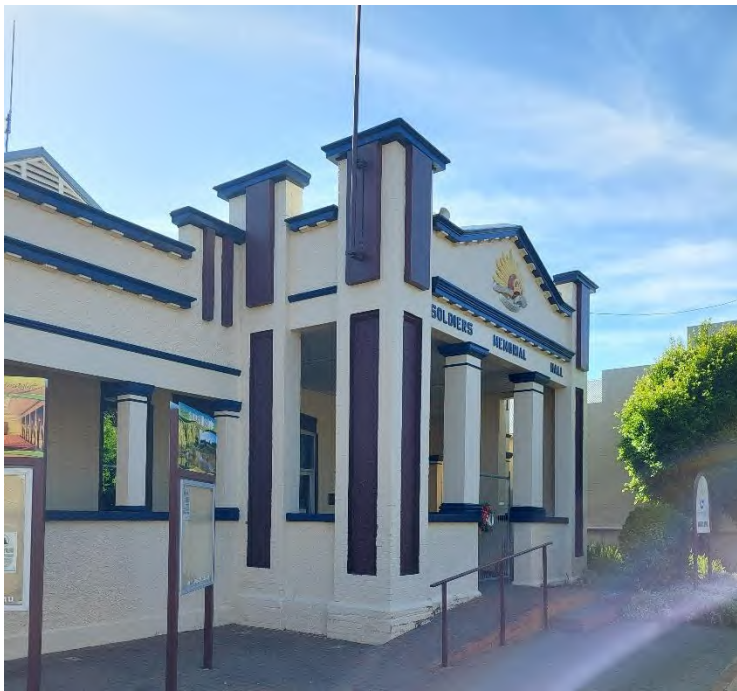
| Photograph | Description |
|---|---|
| <p>Lot 20 DP758111</p> <p>View to the south-east of the Soldiers Memorial</p> | <ul style="list-style-type: none"> <li>The Soldiers Memorial Hall occurred across the northern portion of the investigation area.</li> <li>The building comprised of a brick-and-mortar construction.</li> <li>Painted façades of the building fronting Maitland Street were in good condition and no flaking was observed.</li> <li>Painted surfaces toward the rear of the building (eastern portion) appeared weathered and some flaking was observed. Flaking was noticeable on painted timber doors.</li> <li>The interior of the building was unable to be accessed at the time of the inspection as the building was boarded up. This was expected to be related to the mould infestation noted by SMK (2023) (Section 3.3).</li> <li>No visual signs of contamination, including fragments of bonded asbestos fibre ("fibro") was observed during the inspection.</li> </ul> |

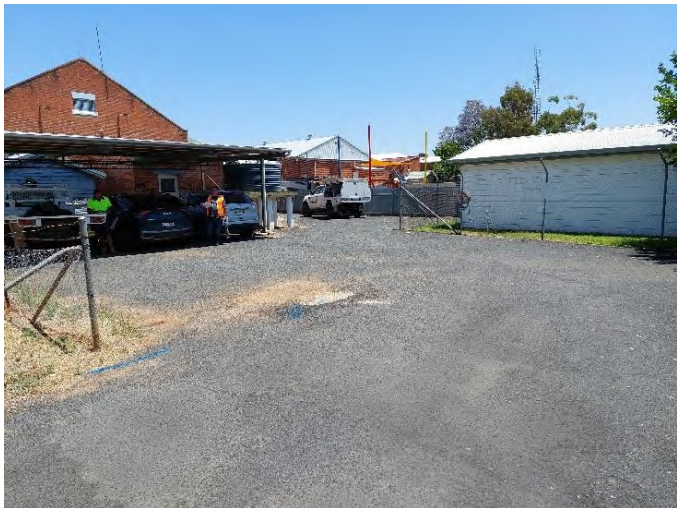
| Photograph | Description |
|---|---|
| <p>View to the north-west of the sealed hardstand area</p> | <ul style="list-style-type: none"> <li>The northern and eastern portions of the investigation area adjacent to the Soldiers Memorial Hall comprised of sealed asphalt hardstand.</li> <li>The area was used for covered car parking along the east of the Memorial Hall.</li> <li>The northern portion of the investigation area also served as a thoroughfare to Maitland Street and extended from Cunningham Street further south of the investigation area.</li> <li>A public toilet occurred within the northern portion of the investigation area adjacent to the Memorial Hall.</li> </ul> |

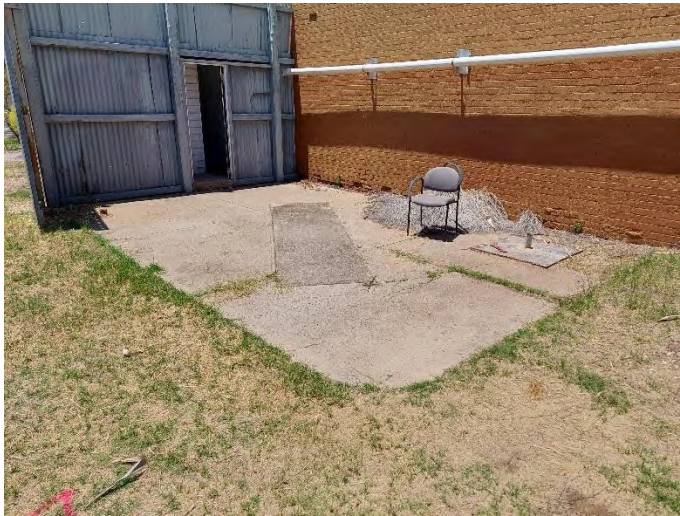
View to the south-east of a filled inspection pit

- The southern portion of the investigation area was historically used as a mechanical workshop and machine shop (refer to Section 3.4).
- Two (2) inground inspection pits occurred within the historic workshop area.
- Both inspection pits were filled with concrete at the time of the inspection. This was confirmed by Wayne Andrews of GSC at the time on the investigation.
- No further details, including depth of the pits were provided.

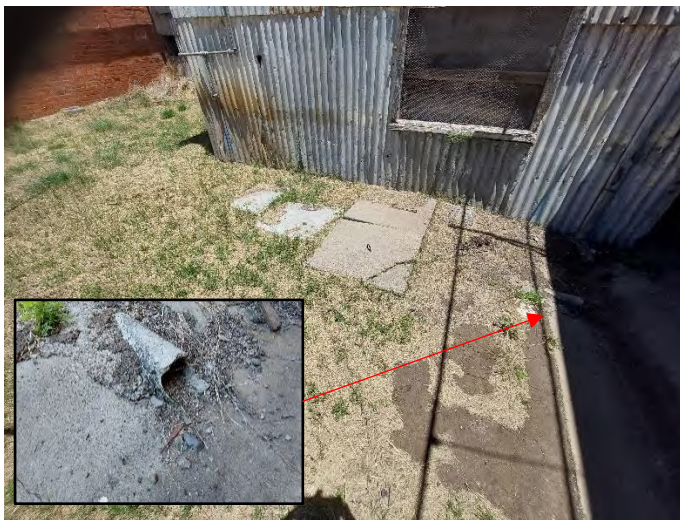
View of grease trap

- Two (2) grease traps occurred directly adjacent to the south of the warehouse (Figure 3).
- The grease trap was connected to a sealed stormwater gully by a fibre cement pipe. The exposed section of the pipe was suspected to be a bonded fibre asbestos pipe.

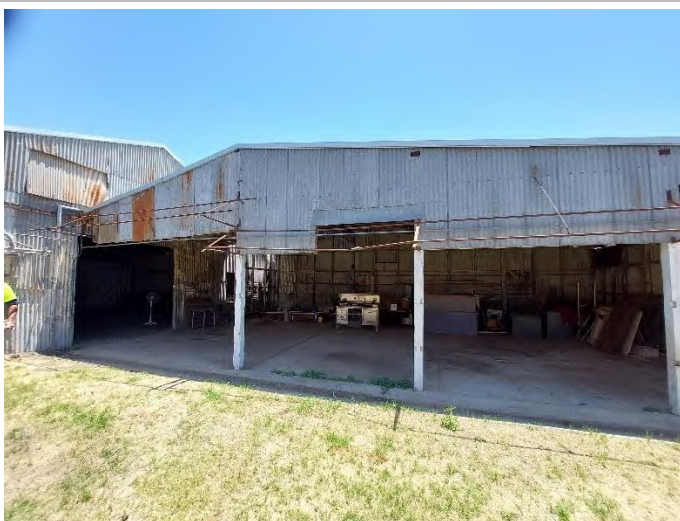
View to the north of the workshop area

- The workshop comprised of a sealed concrete hardstand floor.
- Minor staining was observed within the eastern portion of the workshop.
- Cracks were observed in the concrete floor.
- The area was used as storage for various miscellaneous items, including chairs, tables, and catering equipment.
- The eastern portion of the workshop comprised of grass cover. No staining was observed within the grassed area.

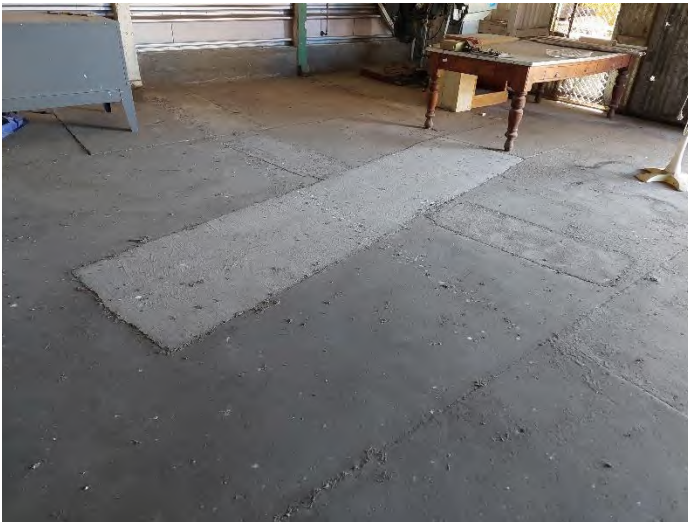
View of sealed inspection pit at the workshop area

- A second inspection pit occurred within the workshop area.
- The pit was filled with concrete at the time of the inspection. Wayne Andrews of GSC confirmed this at the time of the investigation.
- No further details, including depth of the inspection pit was provided.
- The remaining portion of the workshop comprised sealed concrete hardstand.
- A large crack was observed within the concrete hardstand area behind the Veterinary Clinic.

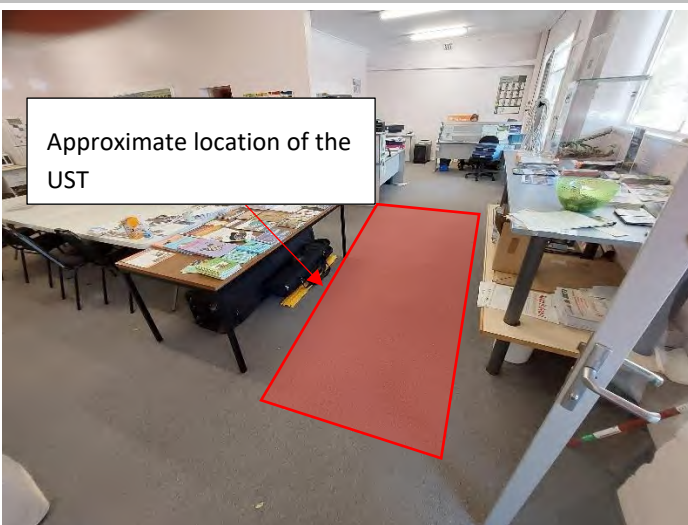
View of Landcare Office interior

- Mr Wayne Andrews of GSC advised that at least one (1) underground storage tank (UST) remained within the Landcare Office.
- The tank(s) were historically connected to a set of bowsers located within the footpath fronting Maitland Street.
- Further details of the tank are provided in Section 2.5.2

Mr Wayne Andrews of the GSC advised that one or more underground storage tanks (USTs) occurred within the western portion of the investigation area. The tanks were located within the existing Landcare Office. The tanks were historically connected to a set of bowzers located within the footpath along Maitland Street to the west of the investigation area. Mr Wayne Andrews provided the following information relating to UPSS that occurred within a portion of the investigation area (Figure 3).

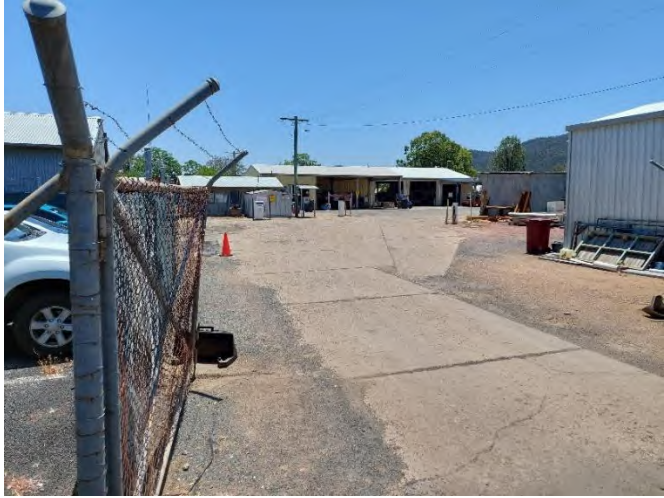
| Photos | Descriptions |
|---|---|
| <p>View to the north of the council depot</p> | <ul style="list-style-type: none"> <li>The depot included maintenance sheds and garages. Services and equipment observed at the depot included: <ul style="list-style-type: none"> <li>Car lifts</li> <li>Tyre repairs</li> <li>Refuelling</li> <li>Forklift storage.</li> <li>Construction material storage.</li> </ul> </li> <li>The site comprised of concrete hardstand and unsealed laydown areas.</li> <li>Three (3) bowzers occurred at the depot that included one (1) unleaded bowser and two (2) diesel bowzers.</li> </ul> |

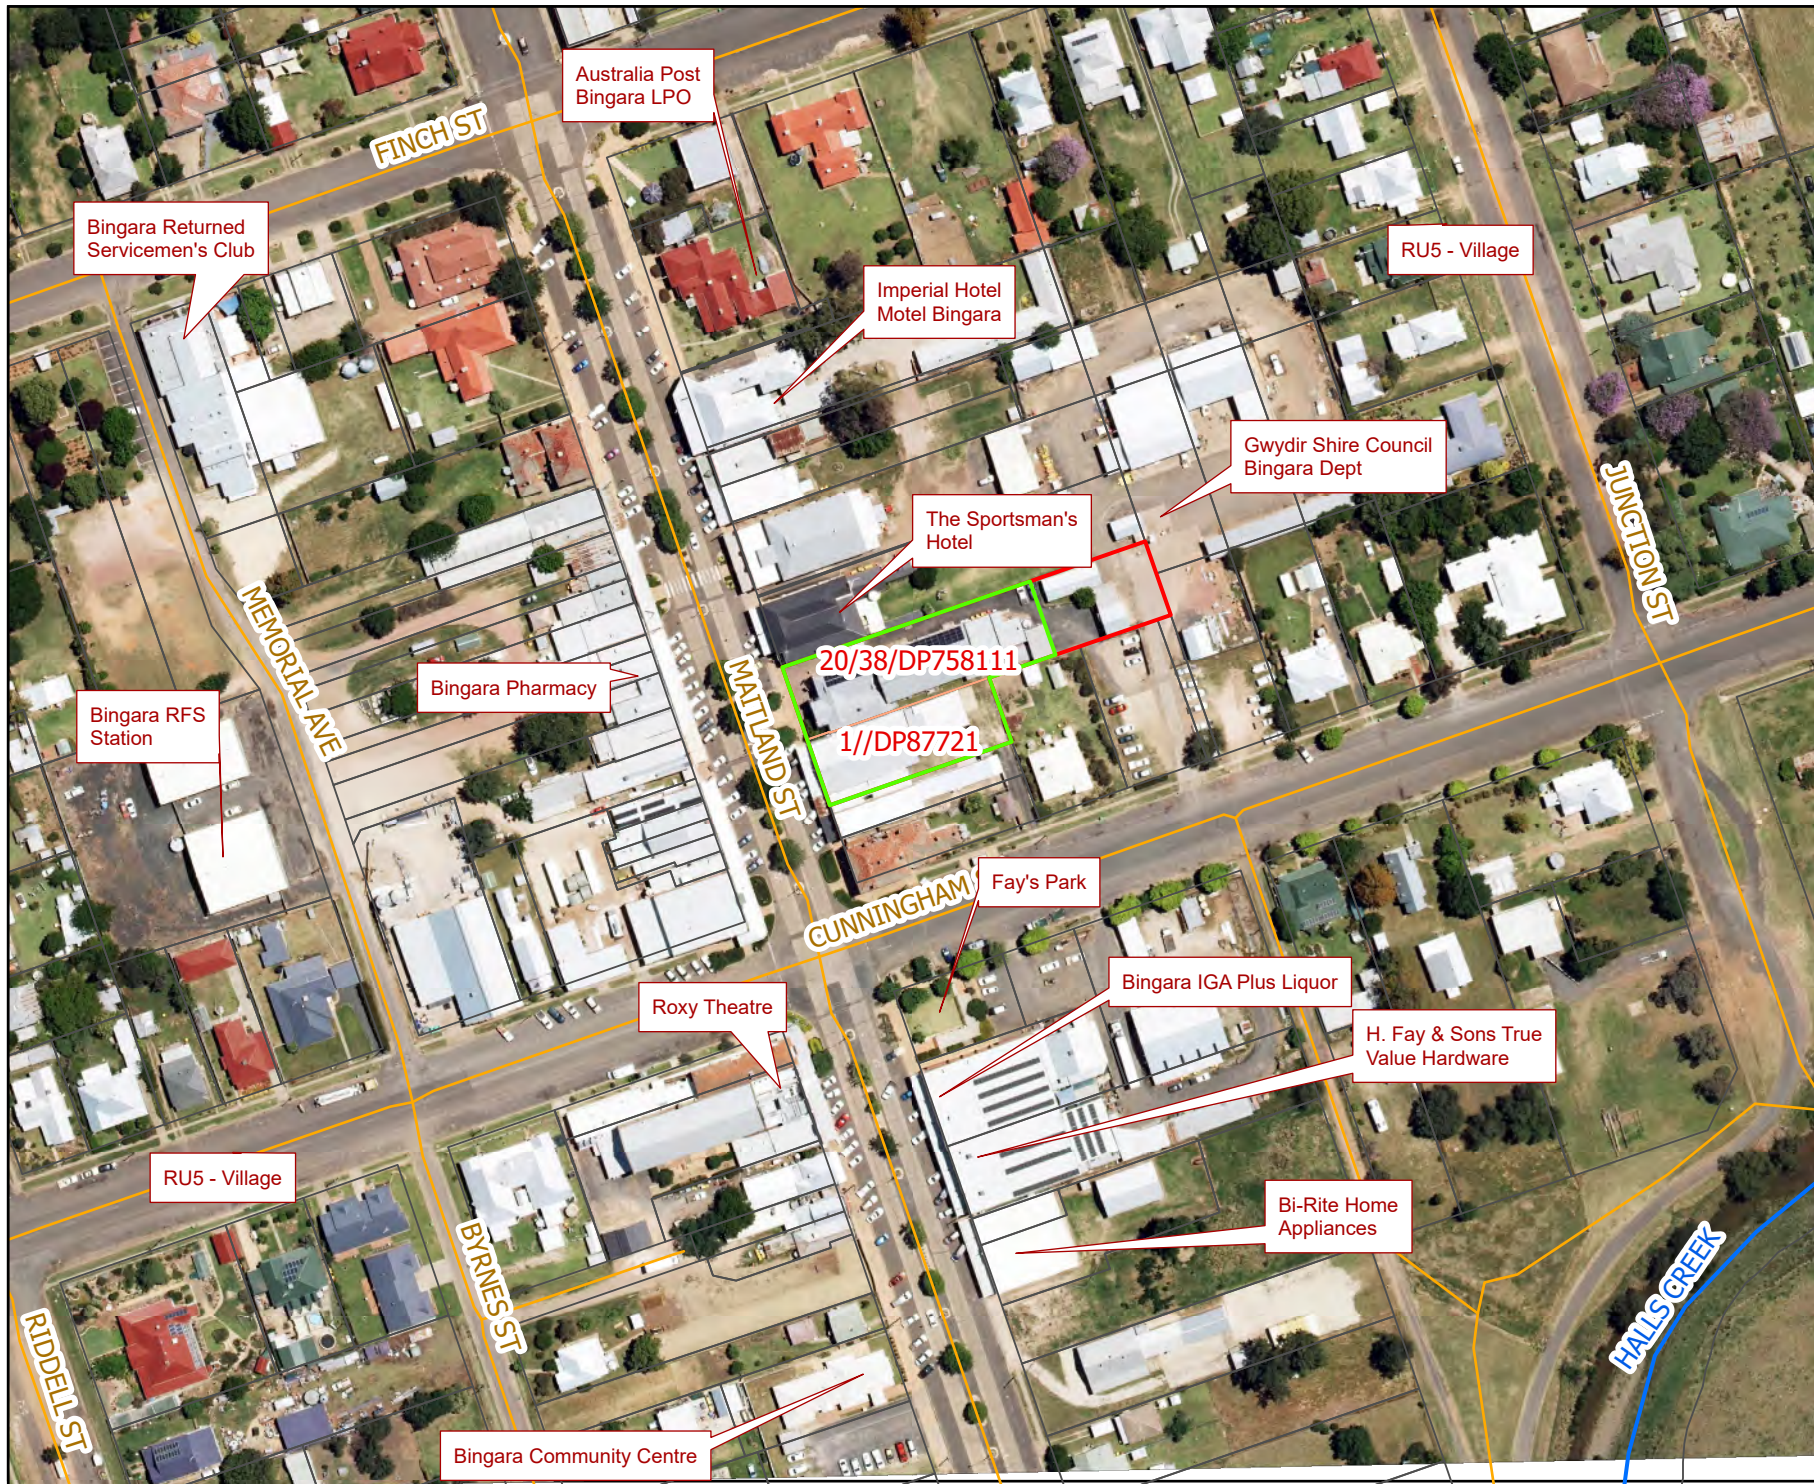
**Figure 4  
Current  
Surrounding  
Land Uses**

Past and present land uses and activities adjoining the investigation area were determined from the analysis of historical aerial imagery (Appendix D). Current surrounding land uses are shown in Figure 4.

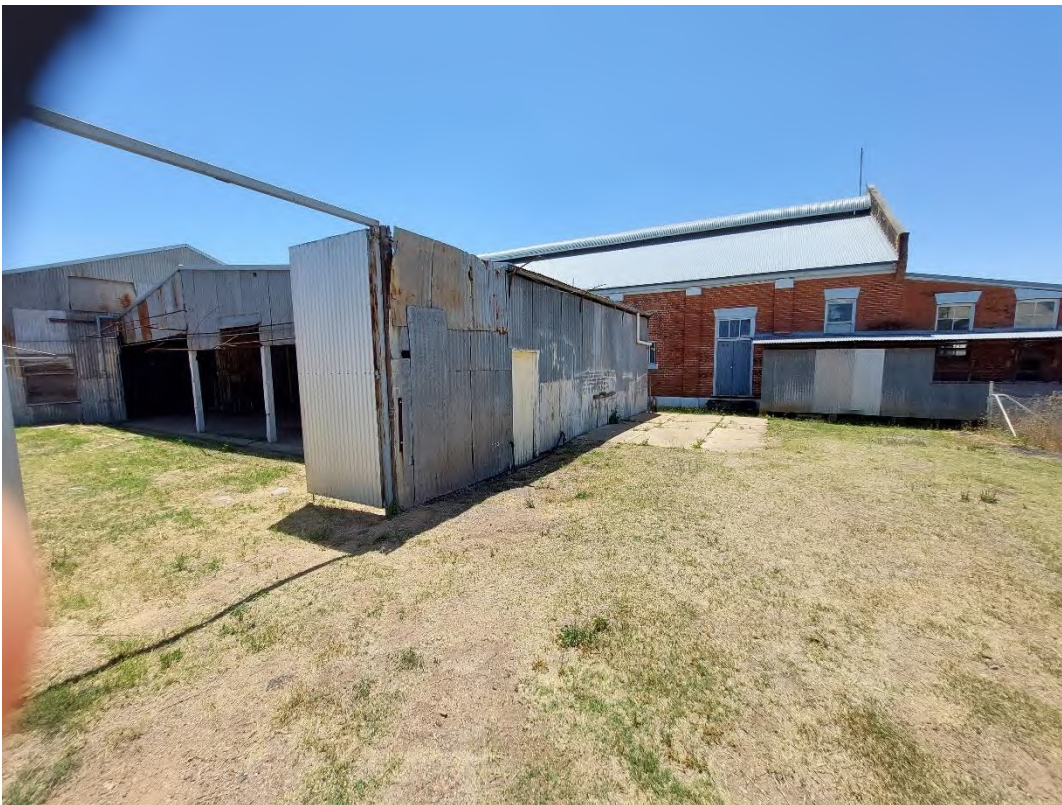
**Photograph 3 View of groundcover at the investigation area**

The investigation area occurred within a highly modified commercial/industrial area of low ecological value. Vegetation was limited to grass cover within the southern and eastern portion of the investigation area (Photograph 3). The remaining portion of the investigation area comprised of sealed concrete and asphalt hardstand. A small landscaped garden occurred at the western façade of the Soldiers Memorial Hall.

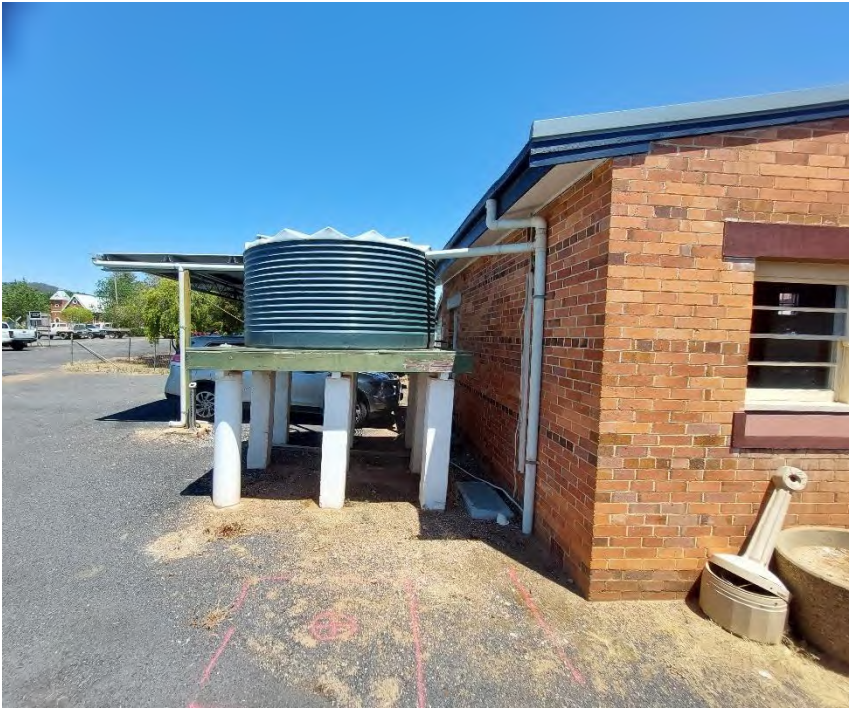
**Photograph 4 View to the south of the stormwater tank**

Stormwater on the roof of the Soldiers Memorial Building was directed into a stormwater holding tank (approximately capacity of 5,000L) (Photograph 4) located adjacent the building to the east. Overland flow from the sealed areas flowed to the west where it was directed to the council operated stormwater drains along Maitland Street.

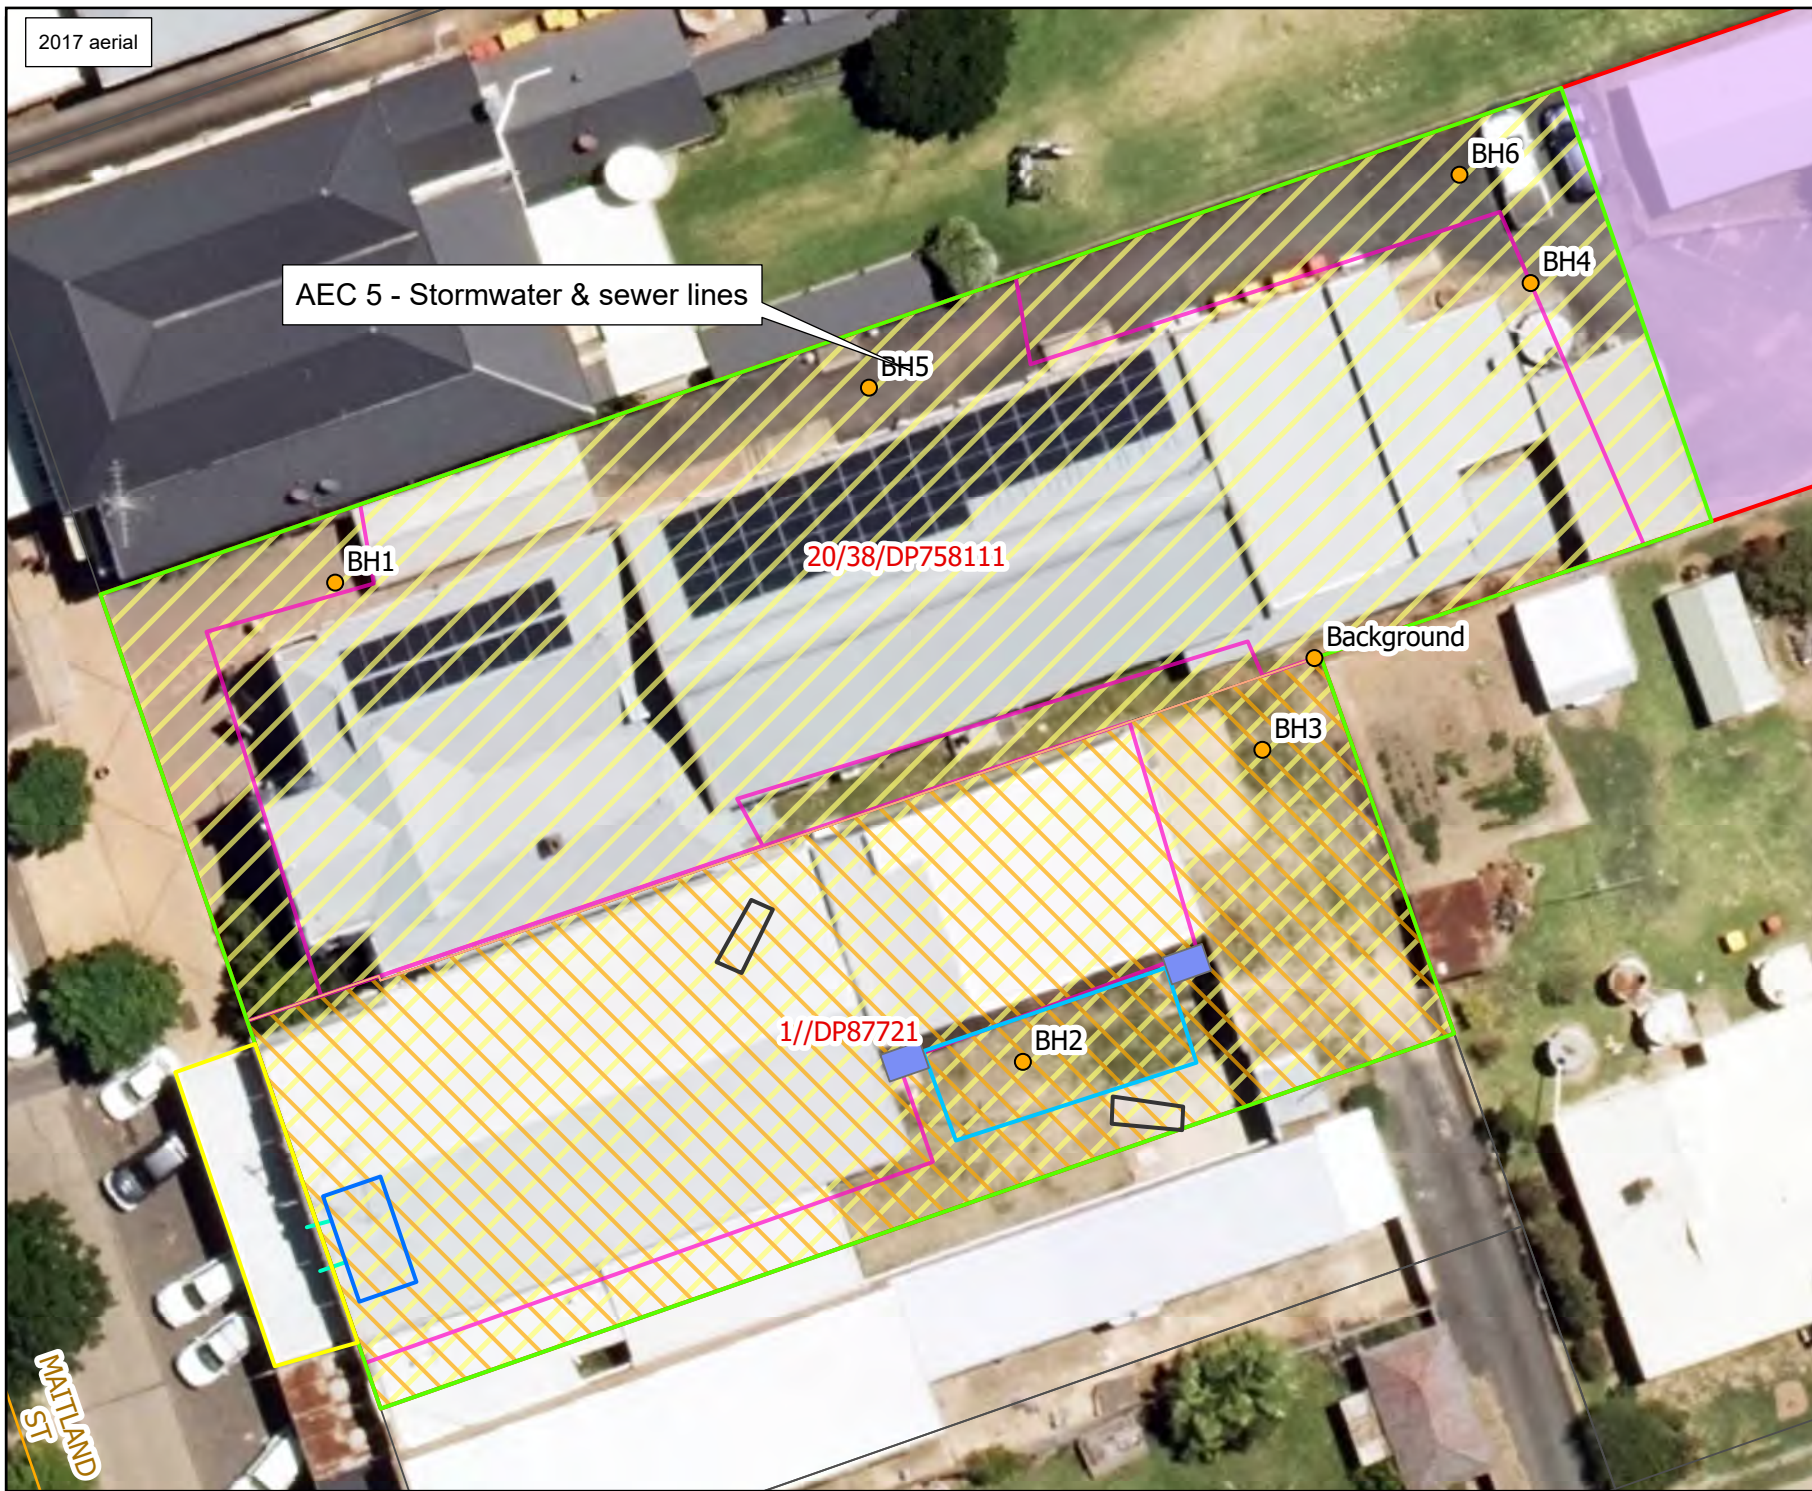
## Figure 7 Sample Locations

| General | <ul style="list-style-type: none"> <li>• One (1) background sample was collected from a 'clean' part of the investigation area to permit the calculation of concentration thresholds for metals, pH, and Cation Exchange Capacity (CEC).</li> <li>• Samples were field screened using a calibrated Photoionisation Detector (PID) (Appendix H).</li> <li>• A subset of samples was held by the laboratory without testing being undertaken. These samples would be considered for analysis if results indicate potential contamination risk at their sampled location.</li> </ul> |

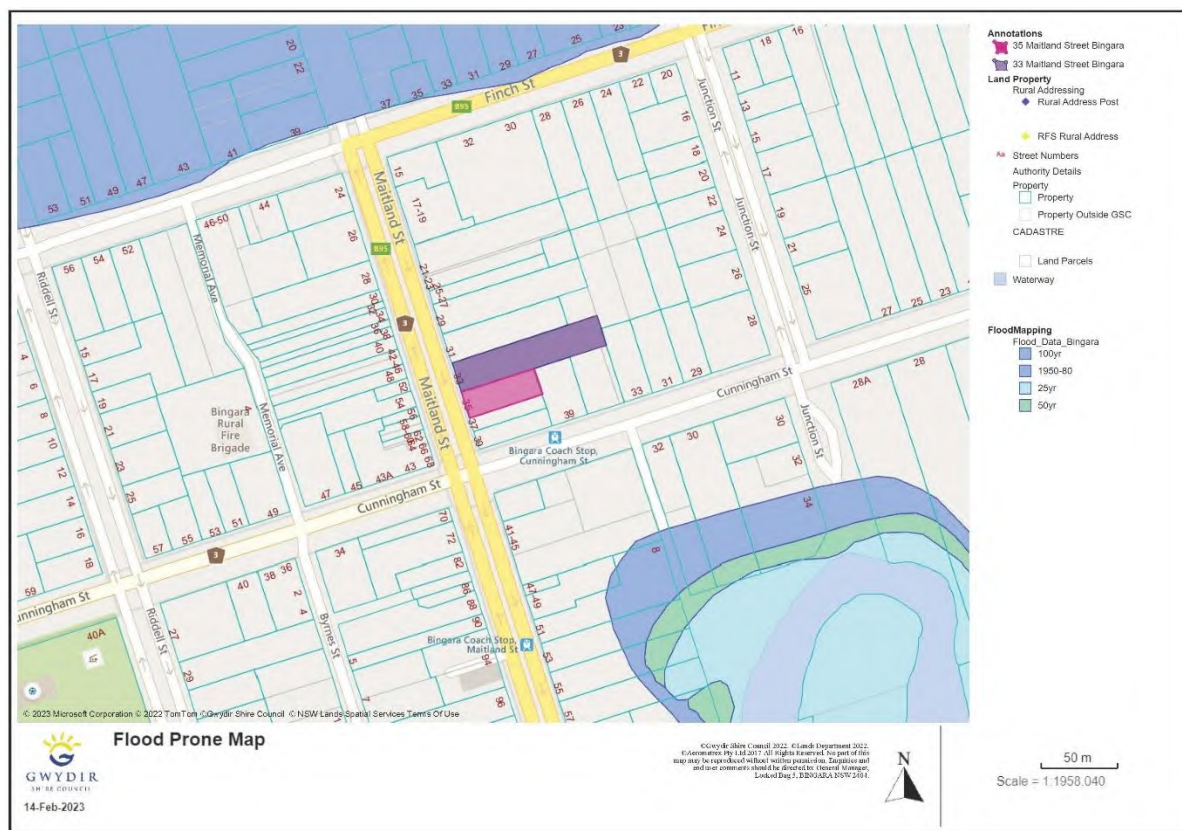
**Figure 1: Flood mapping for the proposed development site**

The site is considered flood free, per Council mapping show in in Figure 1 below. Bingara has historically not been flooded in storm or flood events associated with Bingara Creek to the north.

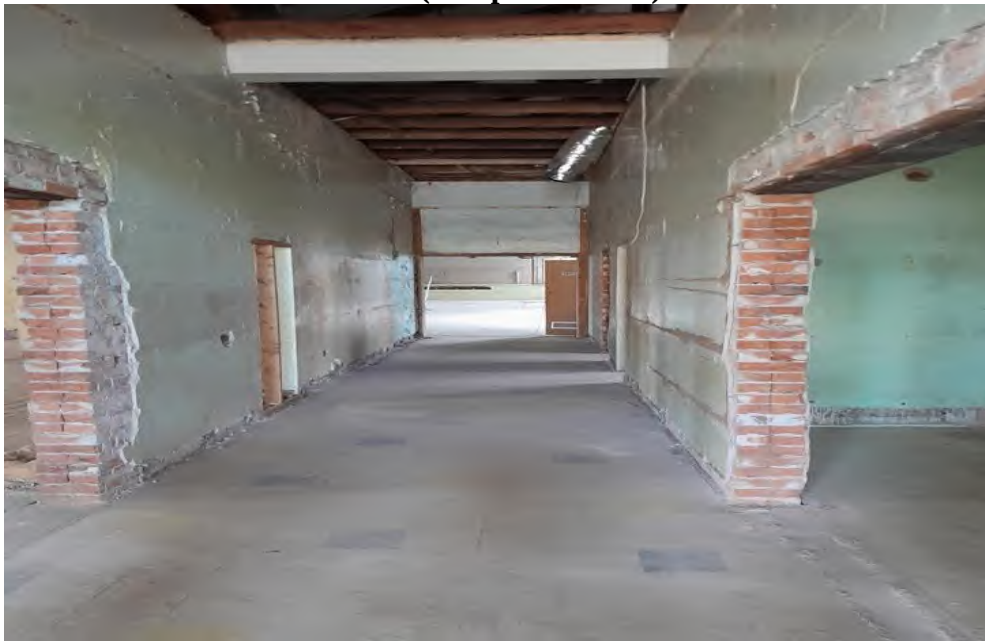
**Figure 7: Asbestos floor tiles within the Memorial Hall.  
(Sample: 23-33-3).**

- Potential bonded ACM panels and floor tiles were observed by SMK (2023) in the interior of the Soldiers Memorial Hall on Lot 20. The building could not be accessed during this investigation due to the presence of mould and was barricaded off.

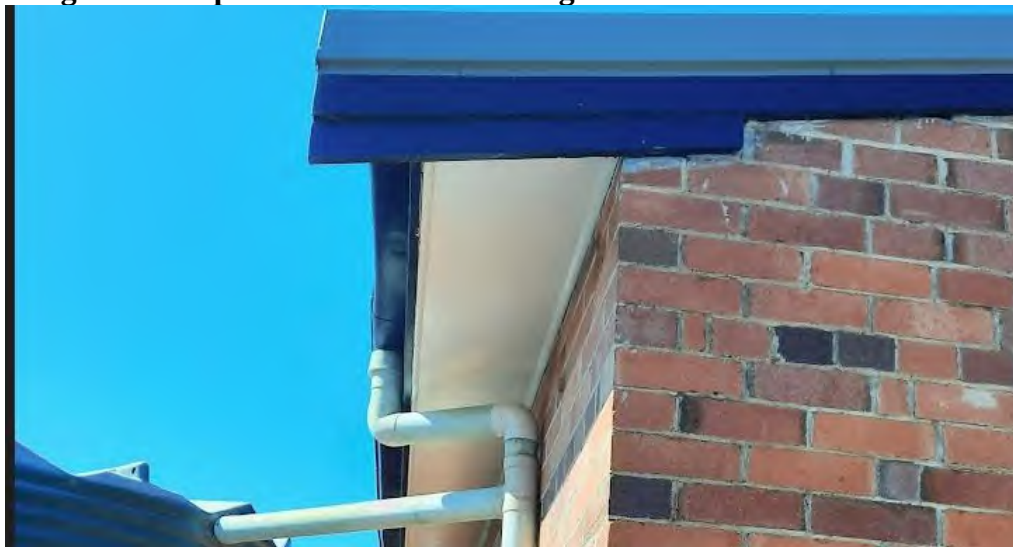
**Figure 8: Suspected asbestos containing material on the eaves of the building.**

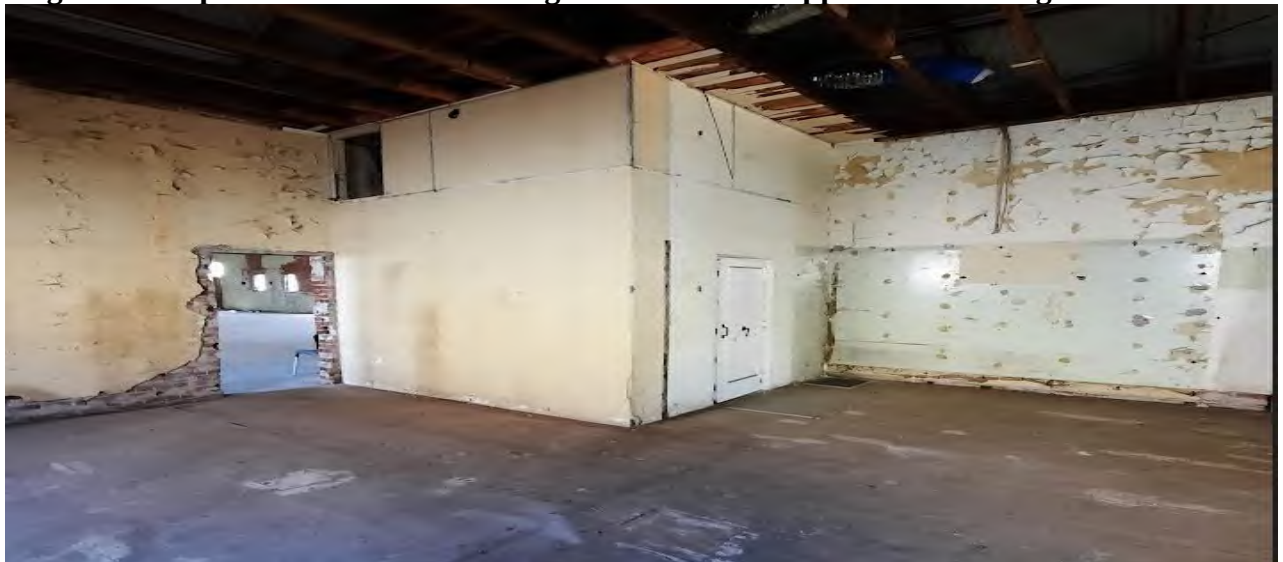
**Figure 9: Suspected asbestos containing material on the upper wall sheeting of the storeroom.**

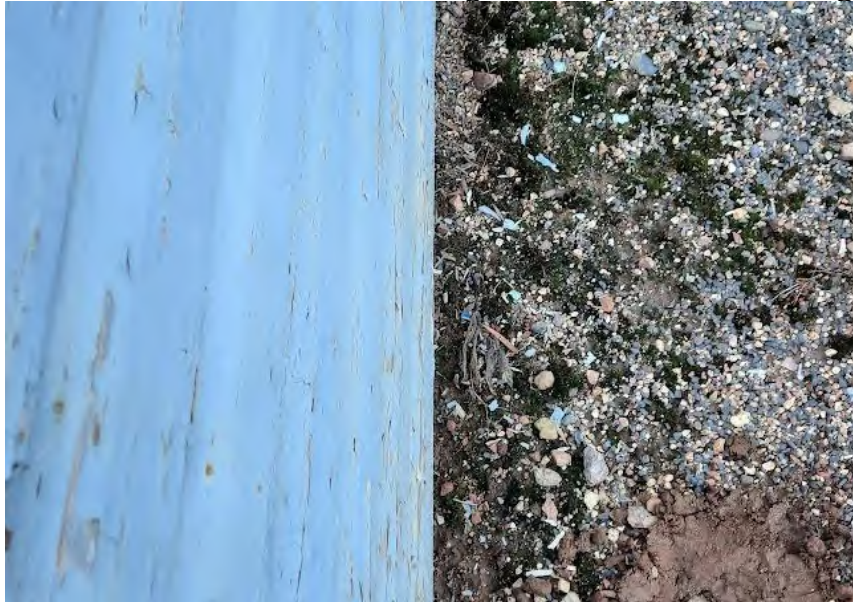
**Figure 11: Asbestos based pipe exposed.**

Below ground sewage or water pipes were exposed in one or more locations. The exposed sections of pipe were visually identified as asbestos containing material. This pipe will need to be included in the demolition and remediation process as it appears to be close to the surface and in poor condition.

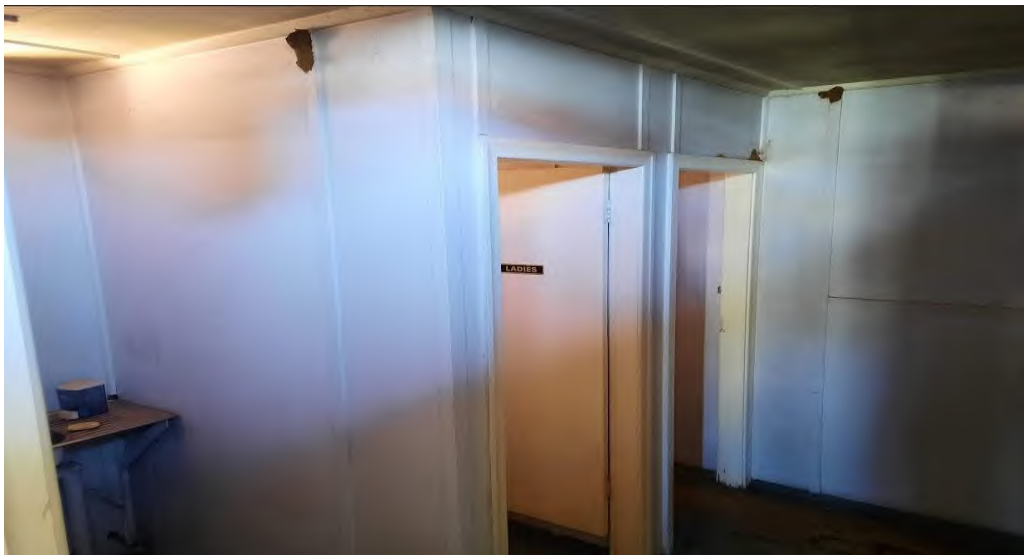
The toilet southeast of the building was also assessed for the presence of contaminants. The external walls of the toilet were made of timber with suspected lead based paint, while the internal walls and ceiling of the toilet were visually identified as asbestos sheeting.

**Figure 12: Internal walls of the toilet suspected to be asbestos contaminated material.**

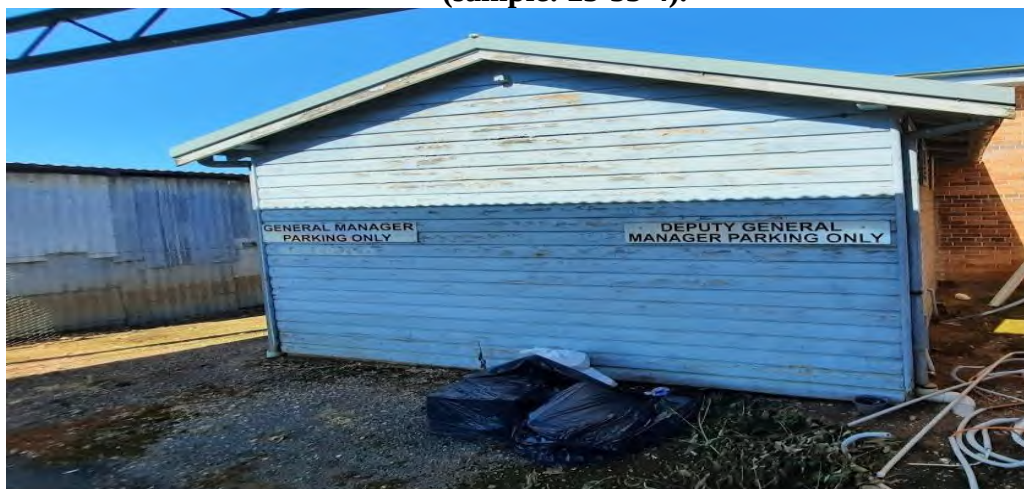
**Figure 13: Confirmed lead base paint on the walls and topsoil around the toilet building (sample: 23-33-4).**

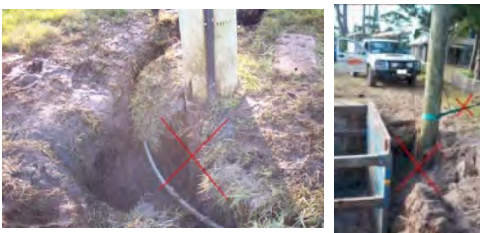
- > Underground cables should never be moved or relocated unless under the express authority of the organisation or person responsible for the powerlines
- > The excavator shall report all damage made to Essential Energy assets immediately. Damage includes: gouges, dents, holes and gas escapes
- > Never undermine poles, cables, earthing cable, pad-mount and kiosk substations.

Above: Poles with become unstable if undermined
