# REVOLUTION TOWN PLANNING

**Attn:** Patsy Cox, Planning Officer  
**Address:** 33-35, 37 and 39 Maitland Street, Bingara NSW 2404  
**RPD:** Part of Lot 20 Section 38 on DP758111, Lot 1 on DP87721, Lots A, B and C on DP156383, Part of Lot A on DP152922 (BK1566 No 614 Right of Way) and Part of Lot 1 on DP209422 (BK1701 No 95 Right of Way)  
**Subject:** Response to Request for Additional Information  
**Council Ref:** PAN-388341:23/21822:pmc

This submission represents the Applicant's Response to a Request for Additional Information issued by Gwydir Shire Council (Council) dated 28 November 2023. (refer **Attachment 1**). It is considered the information addresses all of the issues raised by Council in the Request for Additional Information. Council is requested to continue assessment of the development application.

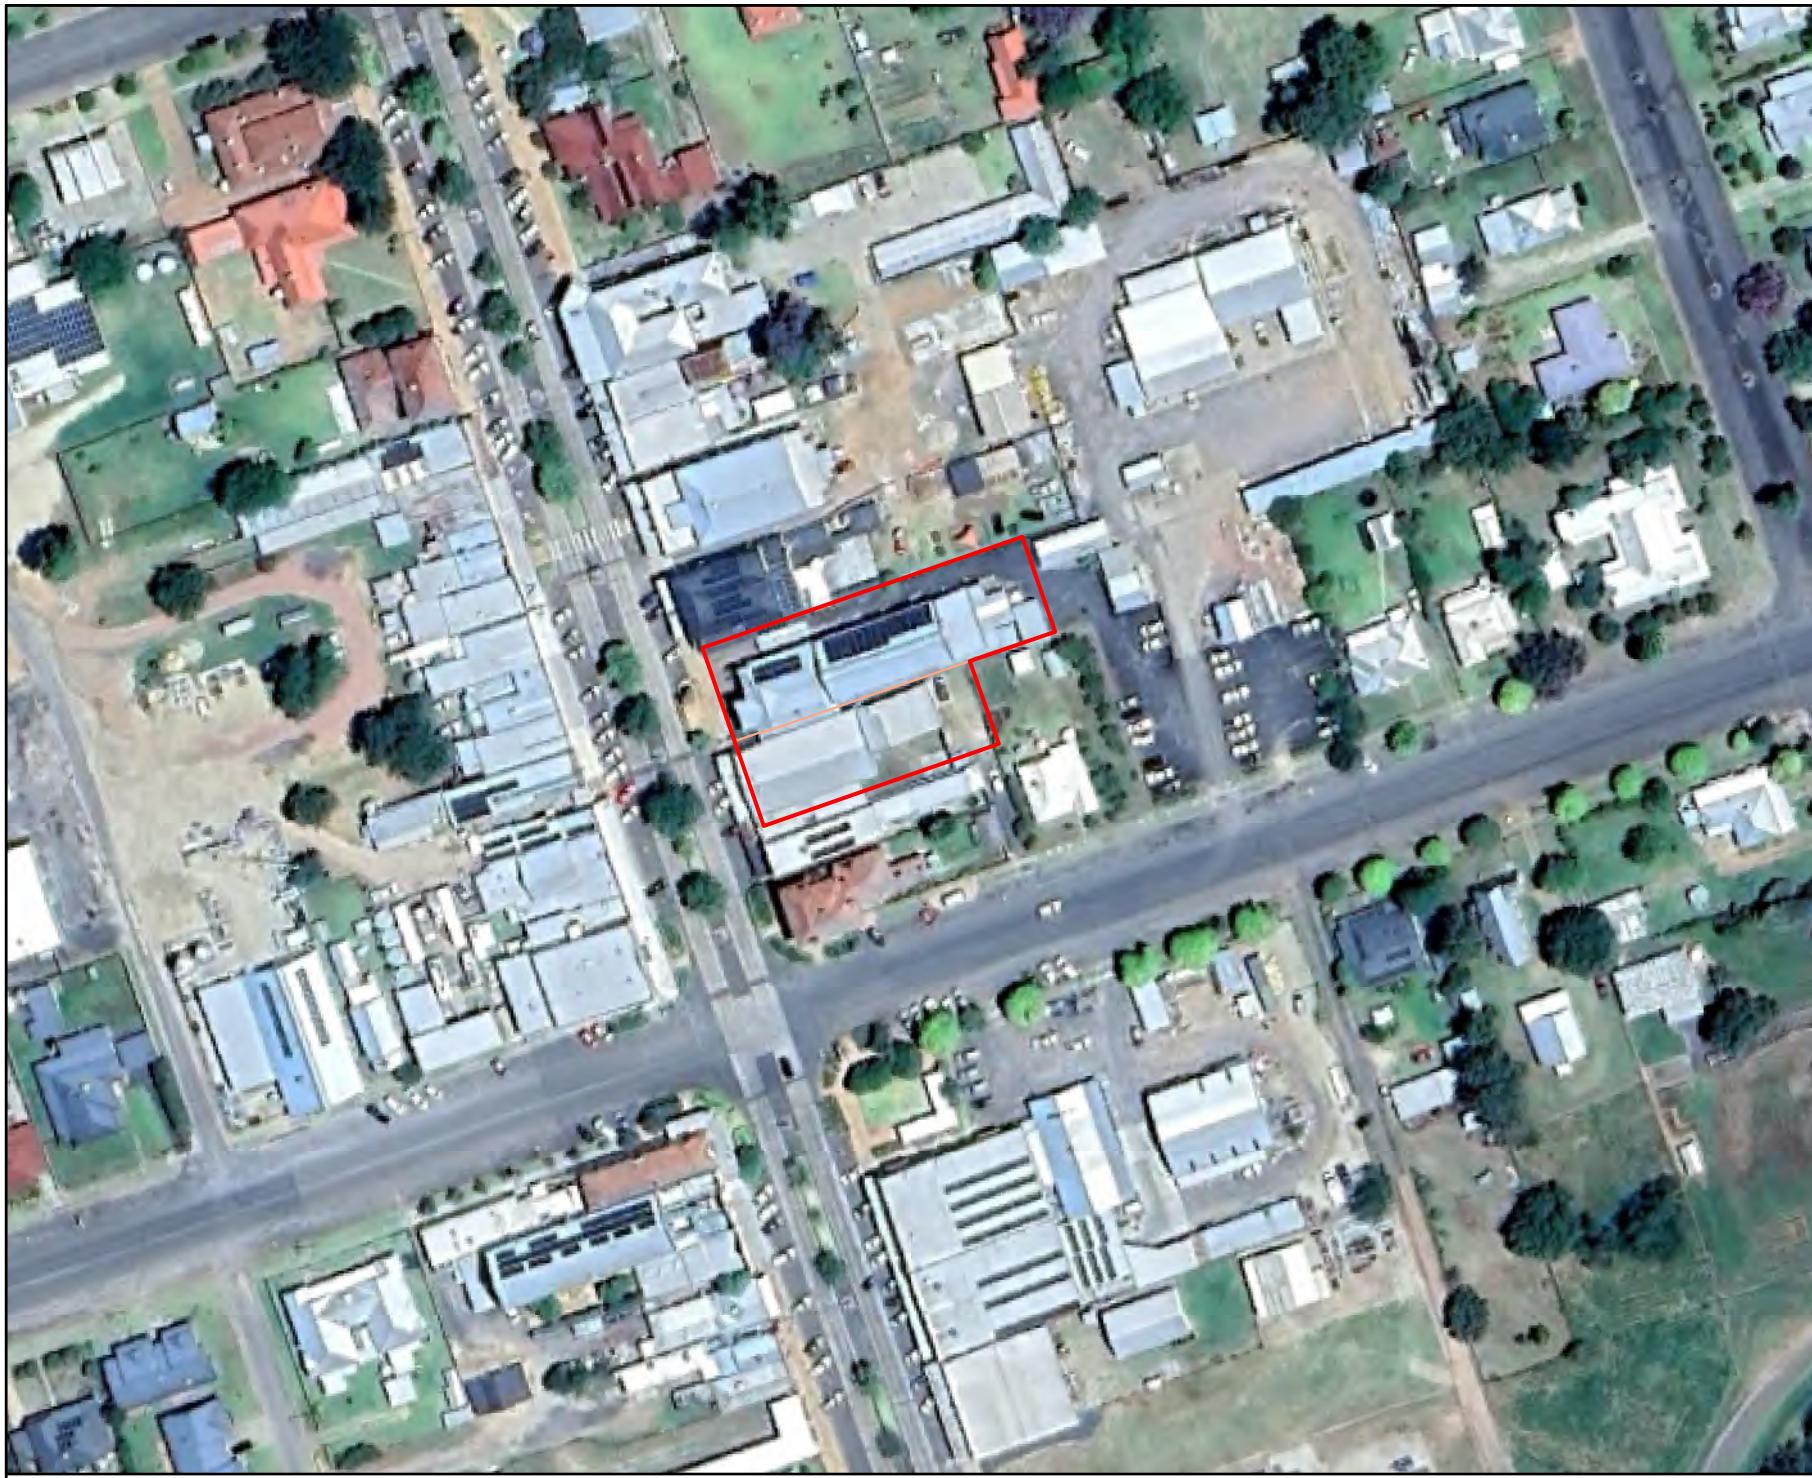
## 2023 Aerial Imagery

Source: Cadastral data sourced from DNRME (2022). Aerial imagery sourced from Metromap (2022).
