# Preliminary Site Investigation

Bolgers Pit –  
809 Oakey Creek Road,  
Piallaway NSW 2342

Report prepared for – Gunnedah Shire Council

1 December 2022  
BPE22110-R01

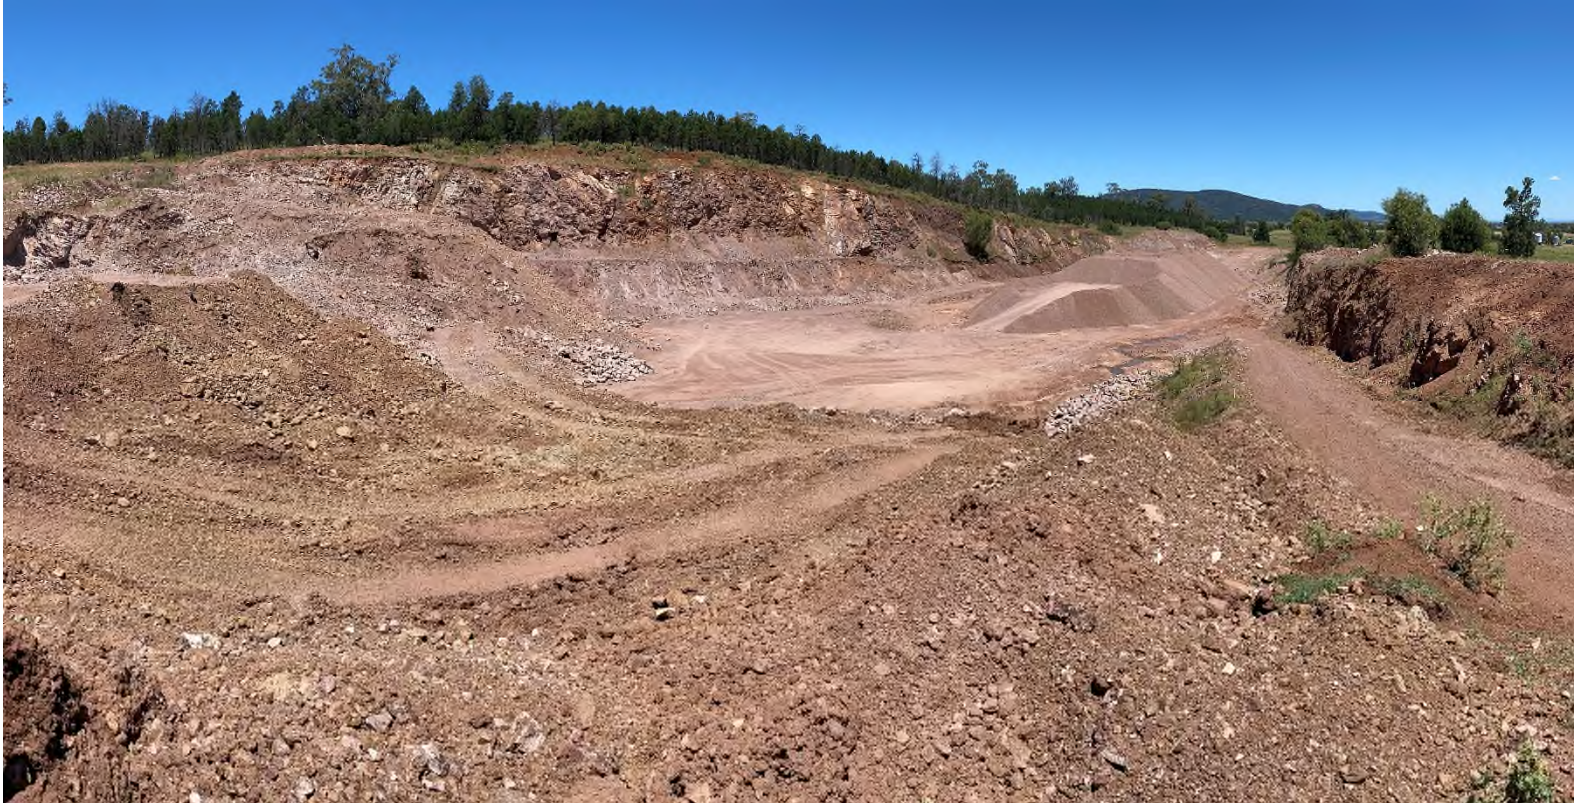
**Photograph 1**, shows the existing Bolgers Pit and the extraction area in the north of the pit, left side of photograph, and current stockpile of crushed gravel material on southern base of the pit.

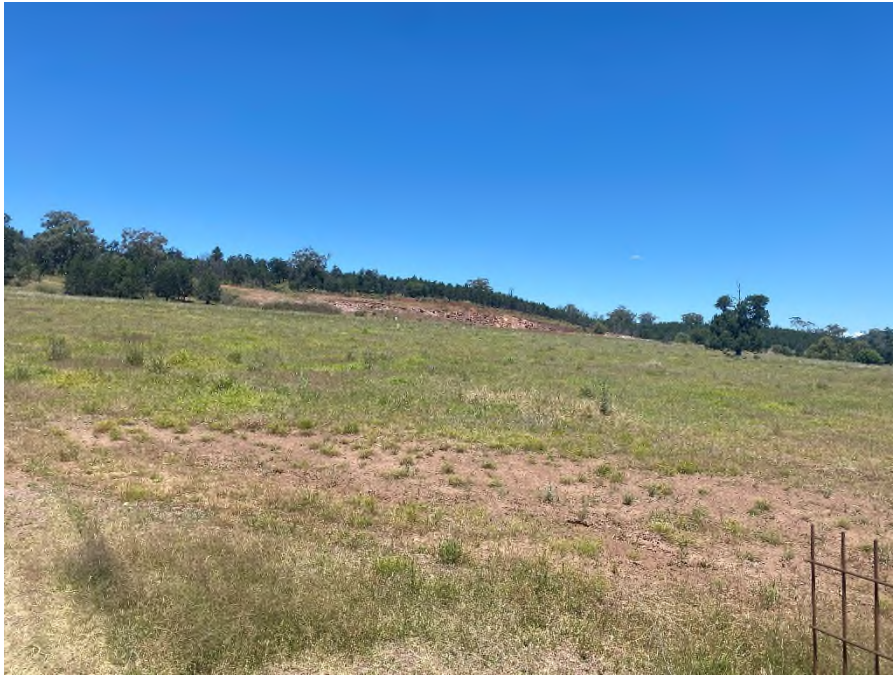
**Photograph 2**, shows the view of the quarry from the entrance gate adjacent to Oakey Creek Road, viewed towards the east.

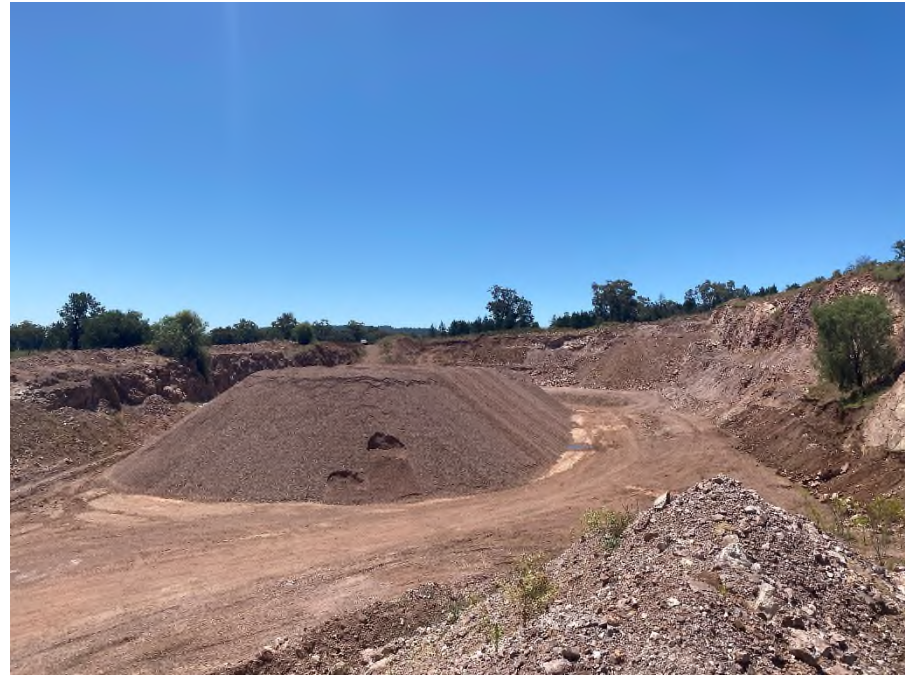
**Photograph 3**, shows view inside the quarry pit, viewed towards the north.

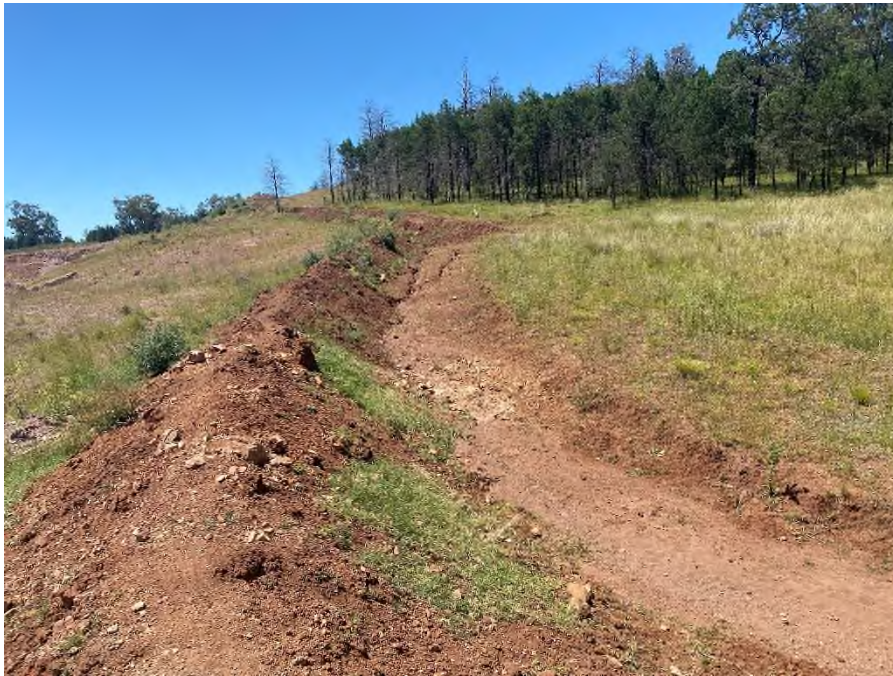
**Photograph 4**, shows the cleared eastern side of the quarry viewed towards the north. An earthen bund wall has been constructed to divert runoff water away from the quarry pit to the south.

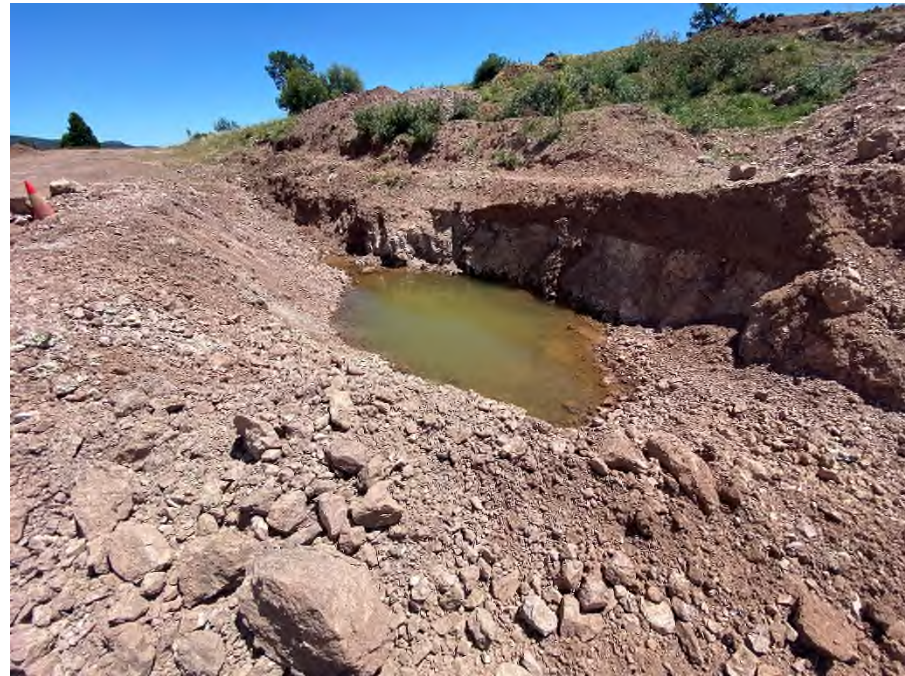
All runoff within the pit was directed to the south into the lowest point, which acts as a sump collecting and storing runoff, see photograph 5. At the time of our walkover there was minor surface water observed flowing into the southern portion of the pit.

**Photograph 5**, shows small diversion sump which has been excavated in the southwest corner of the quarry, viewed towards the south.

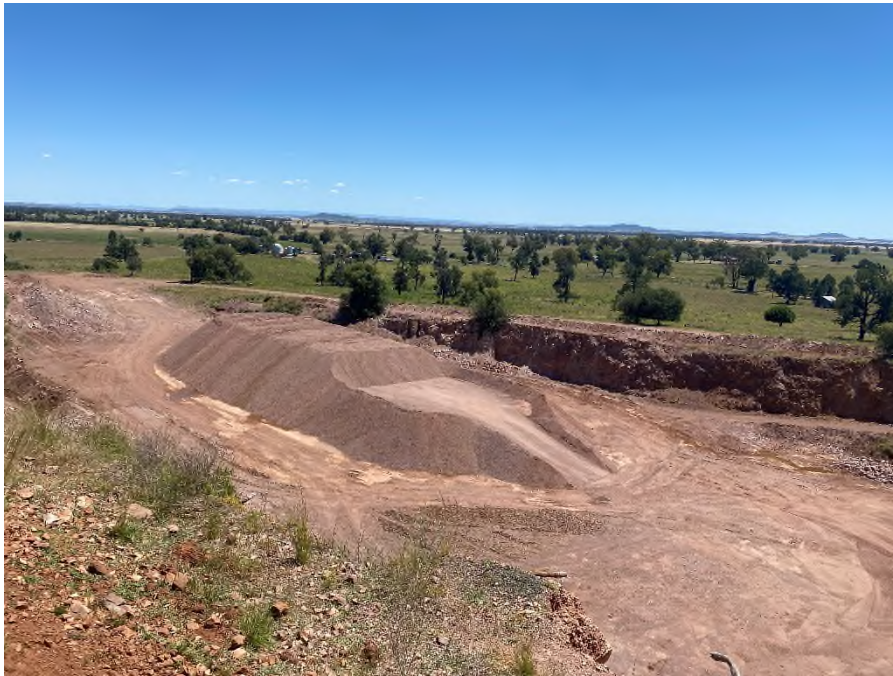
**Photograph 6**, shows the quarry pit and proximity to the nearest farm sheds and residence in the background that are about 400m to the southwest.

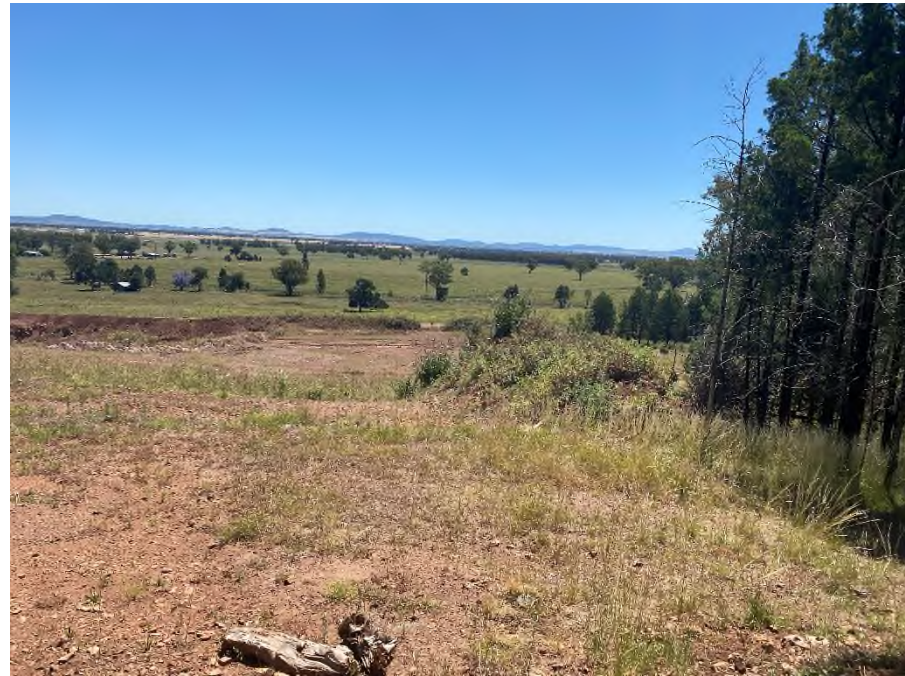
**Photograph 7**, shows the cleared northern side of the quarry and two earthen bund walls, viewed towards the west.

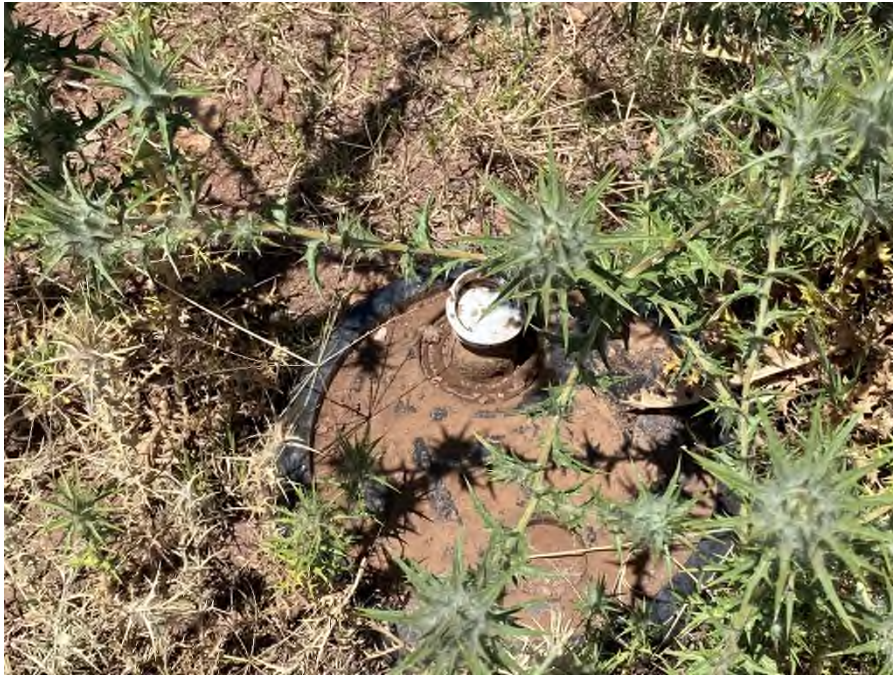
- Inert waste (lid of plastic drum) was visible on the ground surface near the northwest entry to the quarry, see photograph 8. Inert waste (scrap metal) was observed partially buried in an earthen bund to the south of the quarry pit, see photograph 9. No visible signs or indicators of contamination, such as oil staining, were observed during the walkover.

**Photograph 8**, shows inert waste (plastic drum top) observed near the northwest entry to the quarry pit.

Some inert waste materials were observed during the site walkover including scrap metal to the south of the quarry pit and part of a plastic drum near the northwest entry to the quarry. It is recommended that these inert waste materials are collected and removed from this site for recycling (e.g., scrap metal) or to an appropriate NSW EPA licensed waste facility which can accept this waste.

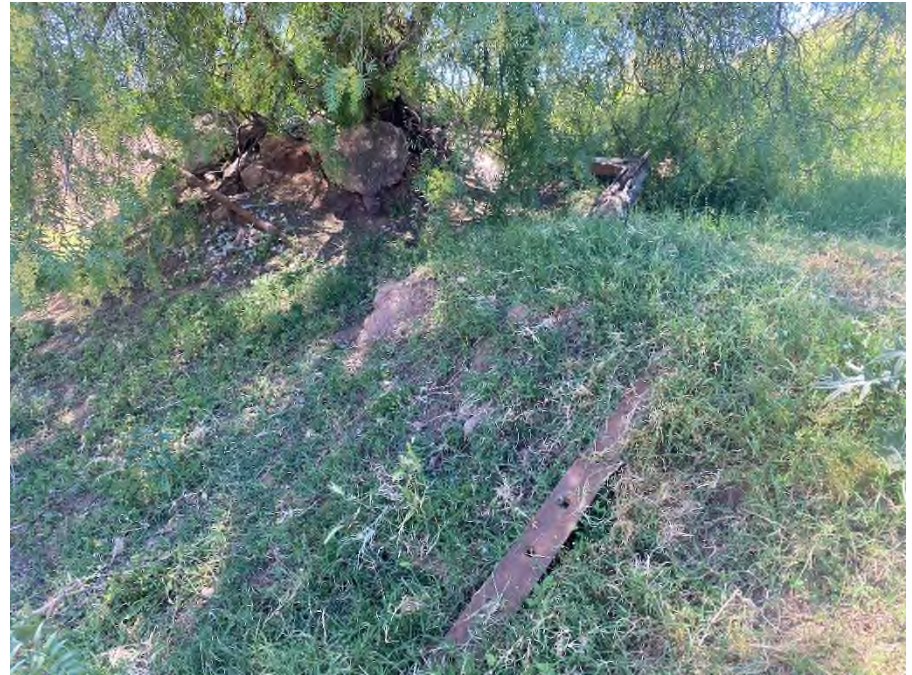
**Photograph 9**, shows inert waste (scrap metal) partially buried on earthen bund to south of the quarry.

- AEC 2 – Presence of inert waste from historical poor waste disposal practices, including scrap metal observed on the earthen bund to the south of the quarry pit. It is recommended that these inert waste materials are collected and removed from this site for recycling (e.g., scrap metal) or to an appropriate NSW EPA licensed waste facility which can accept this waste.

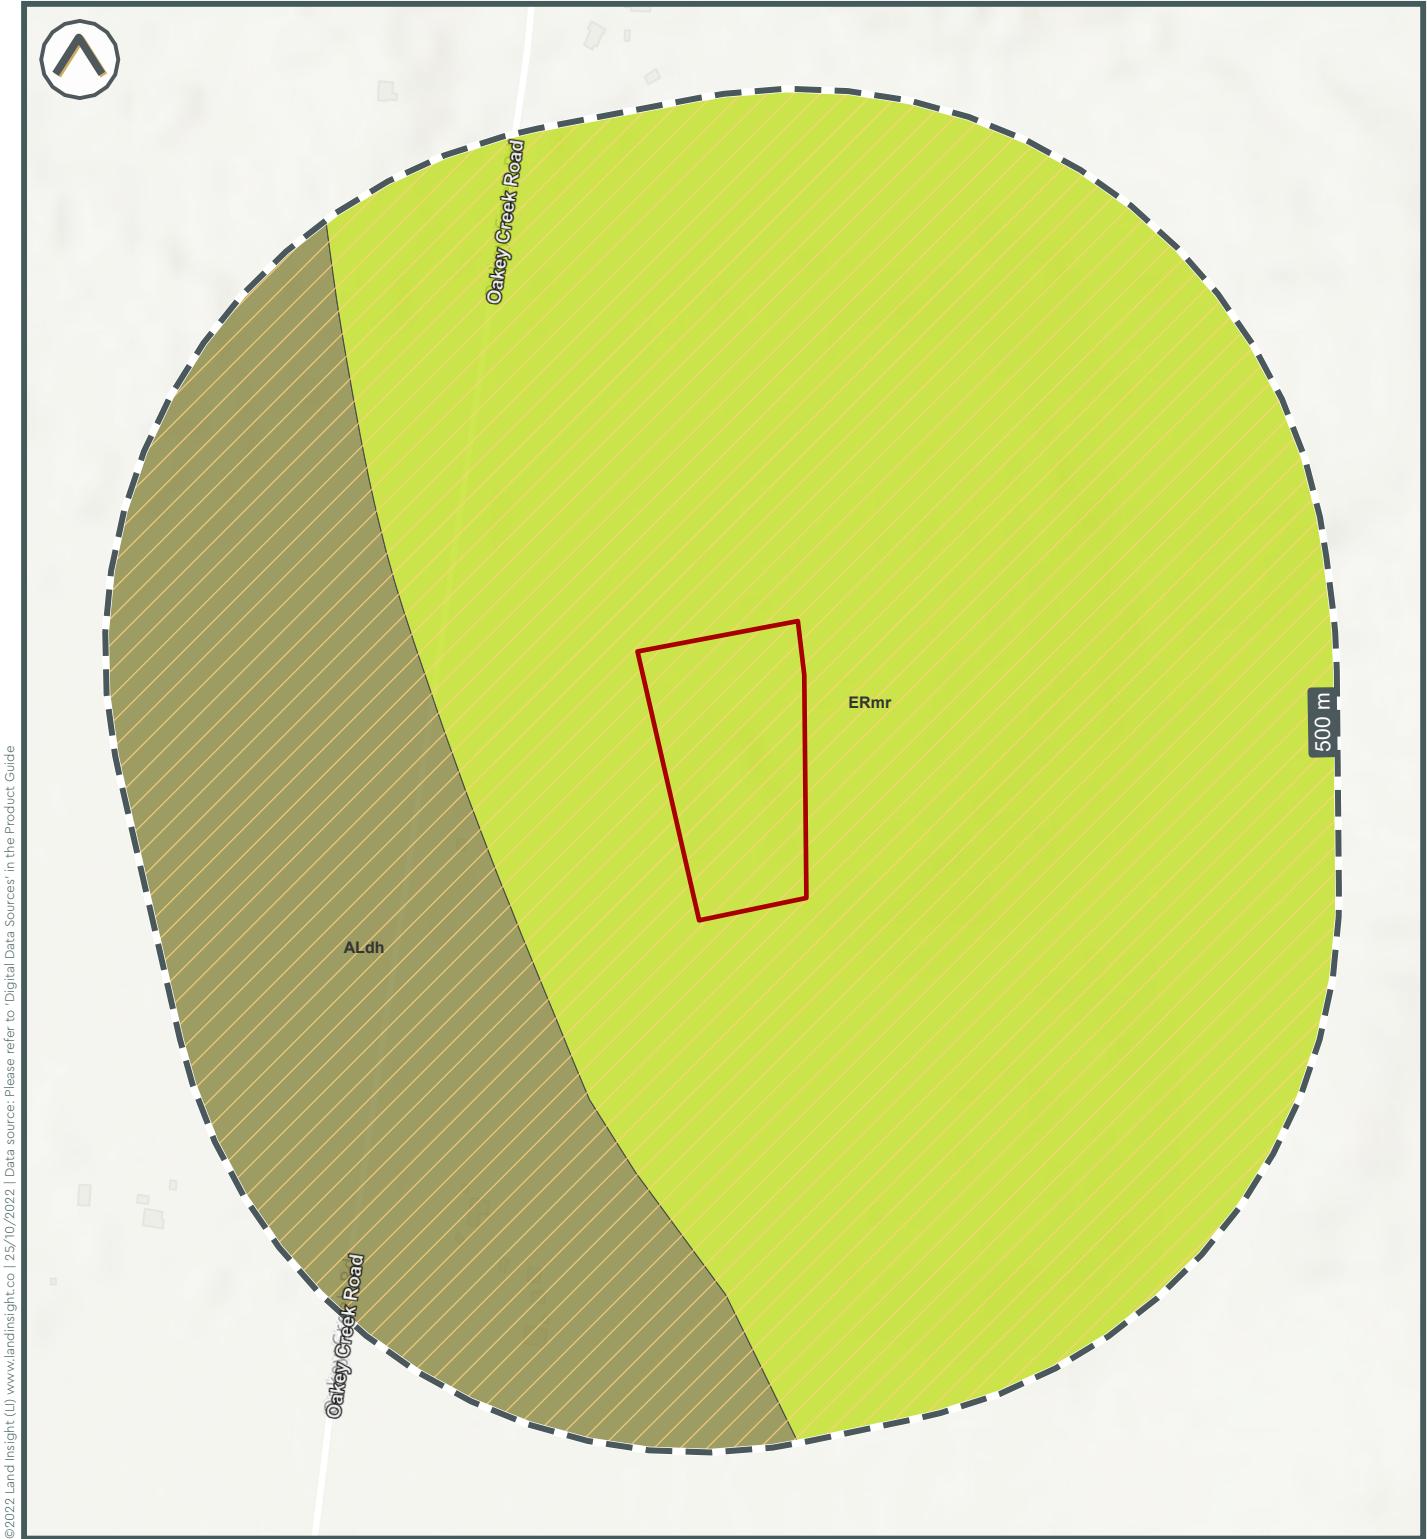
Soil Landscape and Salinity

- Subject area
- Radon Level (Bq/m<sup>3</sup>)  
5-19
- Soil Landscape  
ALdh, Alluvial  
ERmr, Erosional

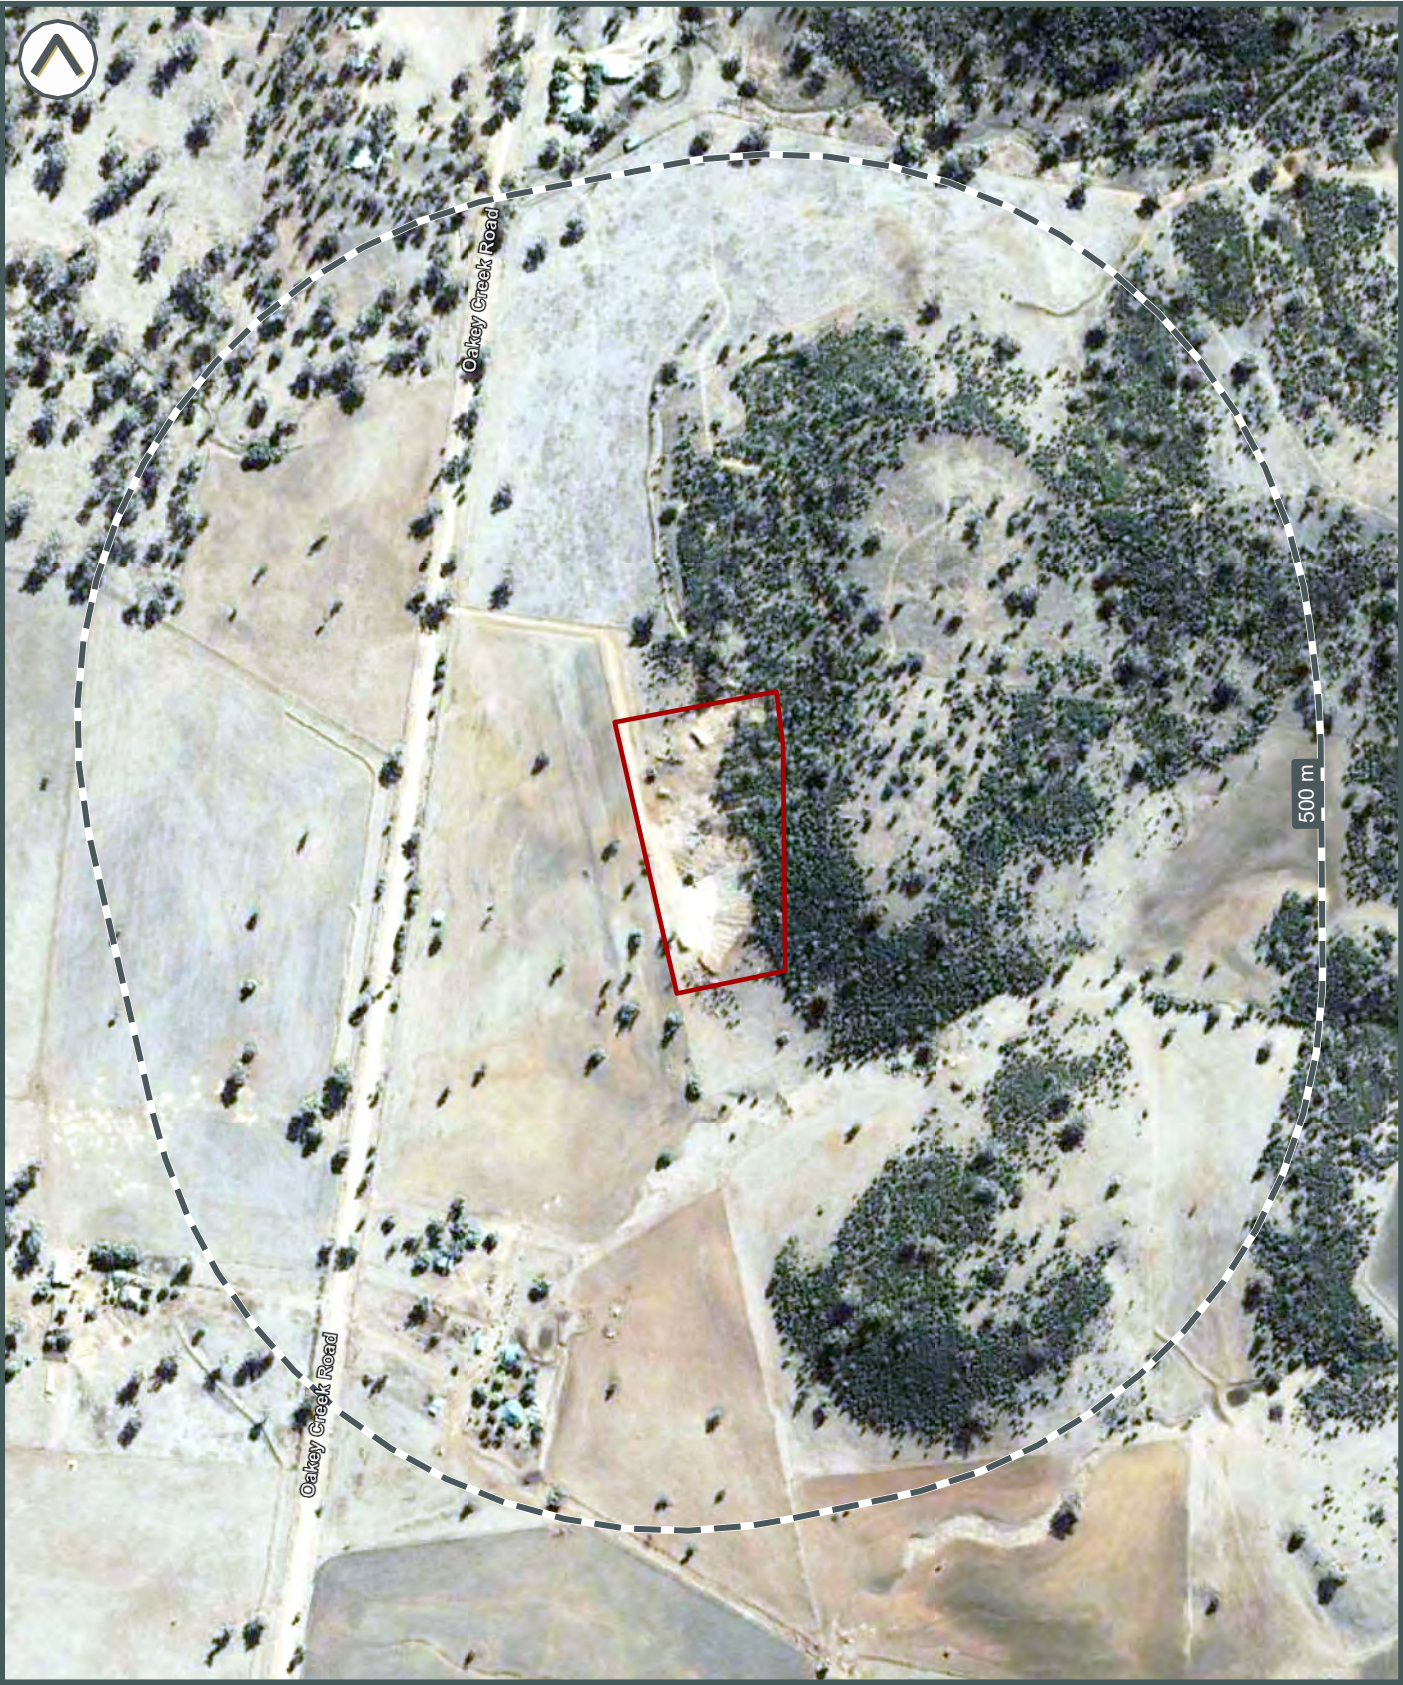
Historic Aerial Photograph - 2002

- Site disturbance from current quarry activities is visible in the 2002 aerial photograph. Prior to this date the historical aerial photographs show areas of minor ground disturbance has been present since 1974.
- No buildings or structures were constructed on this site and therefore it is unlikely that waste building materials, including asbestos, are present on this site.
- Observations made during the site walkover found that previous poor waste disposal practices have resulted in the partial burial of inert waste, including scrap metal on the southern margins of the quarry pit.
- A review of the initial Conceptual Site Model (CSM) prepared for this PSI found no areas of environmental concern have been identified on this site.
