**Stage 1 Site Contamination Assessment**

**Proposed Aquatic Facility**

**Gordon Street, Port Macquarie**

Report No. RGS21005.6-AC

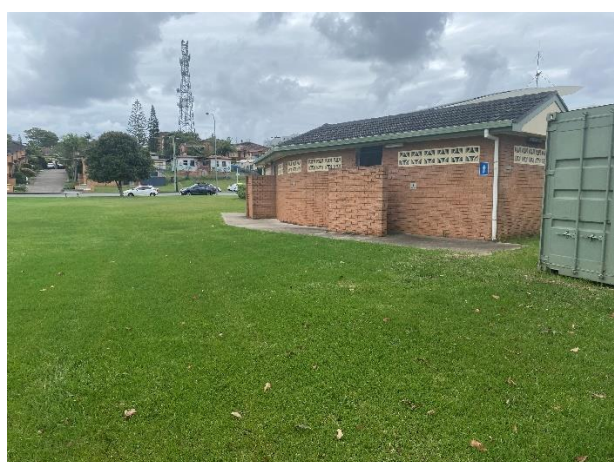
*Looking north east towards brick amenities block and metal shipping container in north east corner of site.*

- Considering the age of the existing amenities block (pre 1991) there is the potential for asbestos type building materials to have been used in its construction. Prior to site demolition works a hazardous material inspection should therefore be undertaken to determine if hazardous materials including asbestos are present;

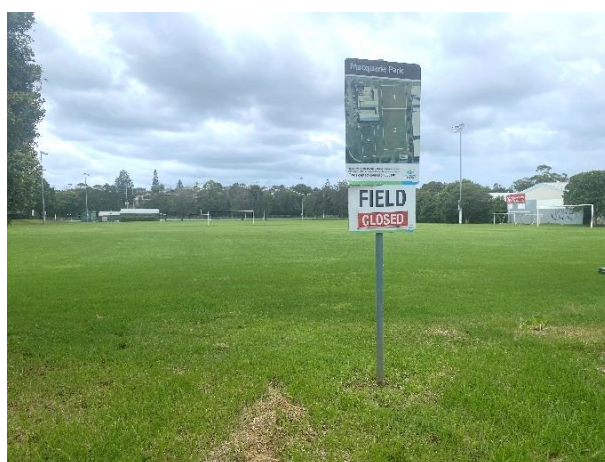
*Looking south across playing fields. Site has been modified by filling works to create a near level surface. Lighting poles line the perimeter of the sporting fields.*

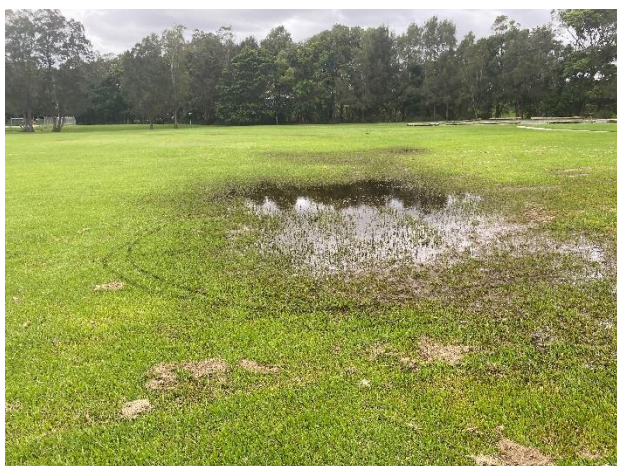
Drainage of the site would be via a combination of overland flow towards the south and surface infiltration. Some localised depressions were present in the southwest of the site and contained surface water at the time of the assessment on 18 March 2021. Wrights Creek is located on the southwestern boundary of the site and flows to the west. It is subject to limited tidal exchange at the Lake Road culvert crossing. Vehicle access to the site was restricted to tracked plant when fieldwork was undertaken on 18 March 2021 due to surface water and slippery conditions.

*Looking south across open grassed area in southwest of site on 18 March 2021.*

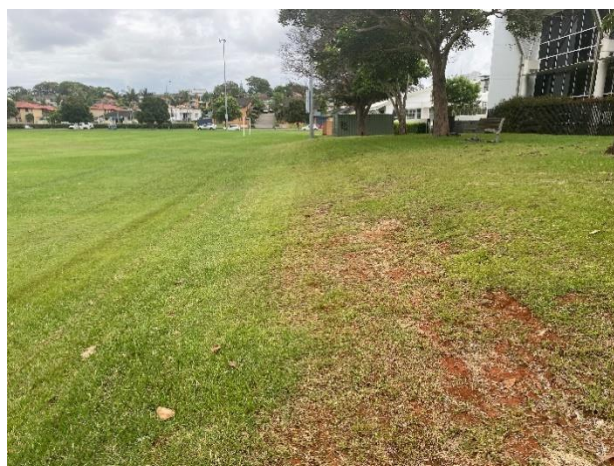
*Raised spectator mound on eastern site boundary. Some red clay soils exposed on side of mound.*

- AEC2 – Existing spectator mound where excavations are proposed within areas impacted by historical filling works. A sampling grid is recommended in accordance with the NSW EPA *Sampling Design Guidelines* (2022) to delineate the potential extent of contaminants which may include asbestos containing materials (ACM), heavy metals and PAHs associated with imported fill of unknown origins; and

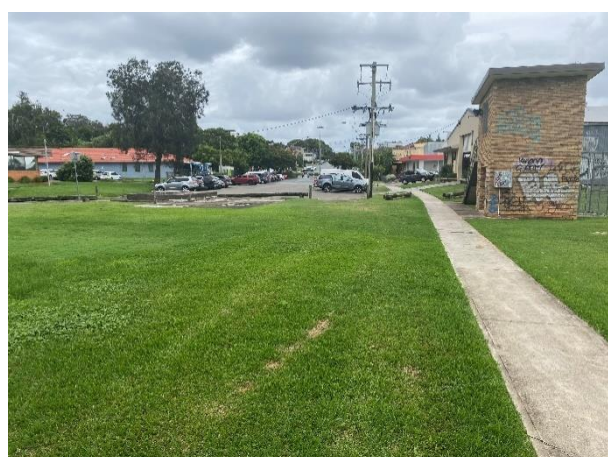
*Looking north towards sewer pump station located on western site boundary adjacent to Munster Street.*

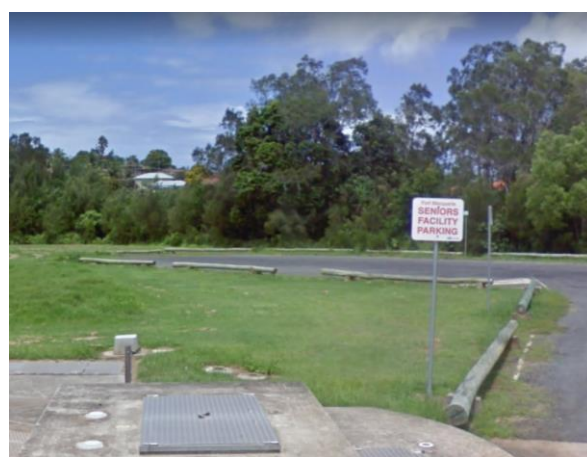
The site also includes a portion of an existing car park, located in part of Lot 7063 at the southern end of Munster Street. The car park has a two-coat seal and the pavement condition is variable with some patching and an uneven surface. A north – south concrete footpath is also present within Lot 7063.

*Looking south over pump station and car park. The car park is partially located within the site.*

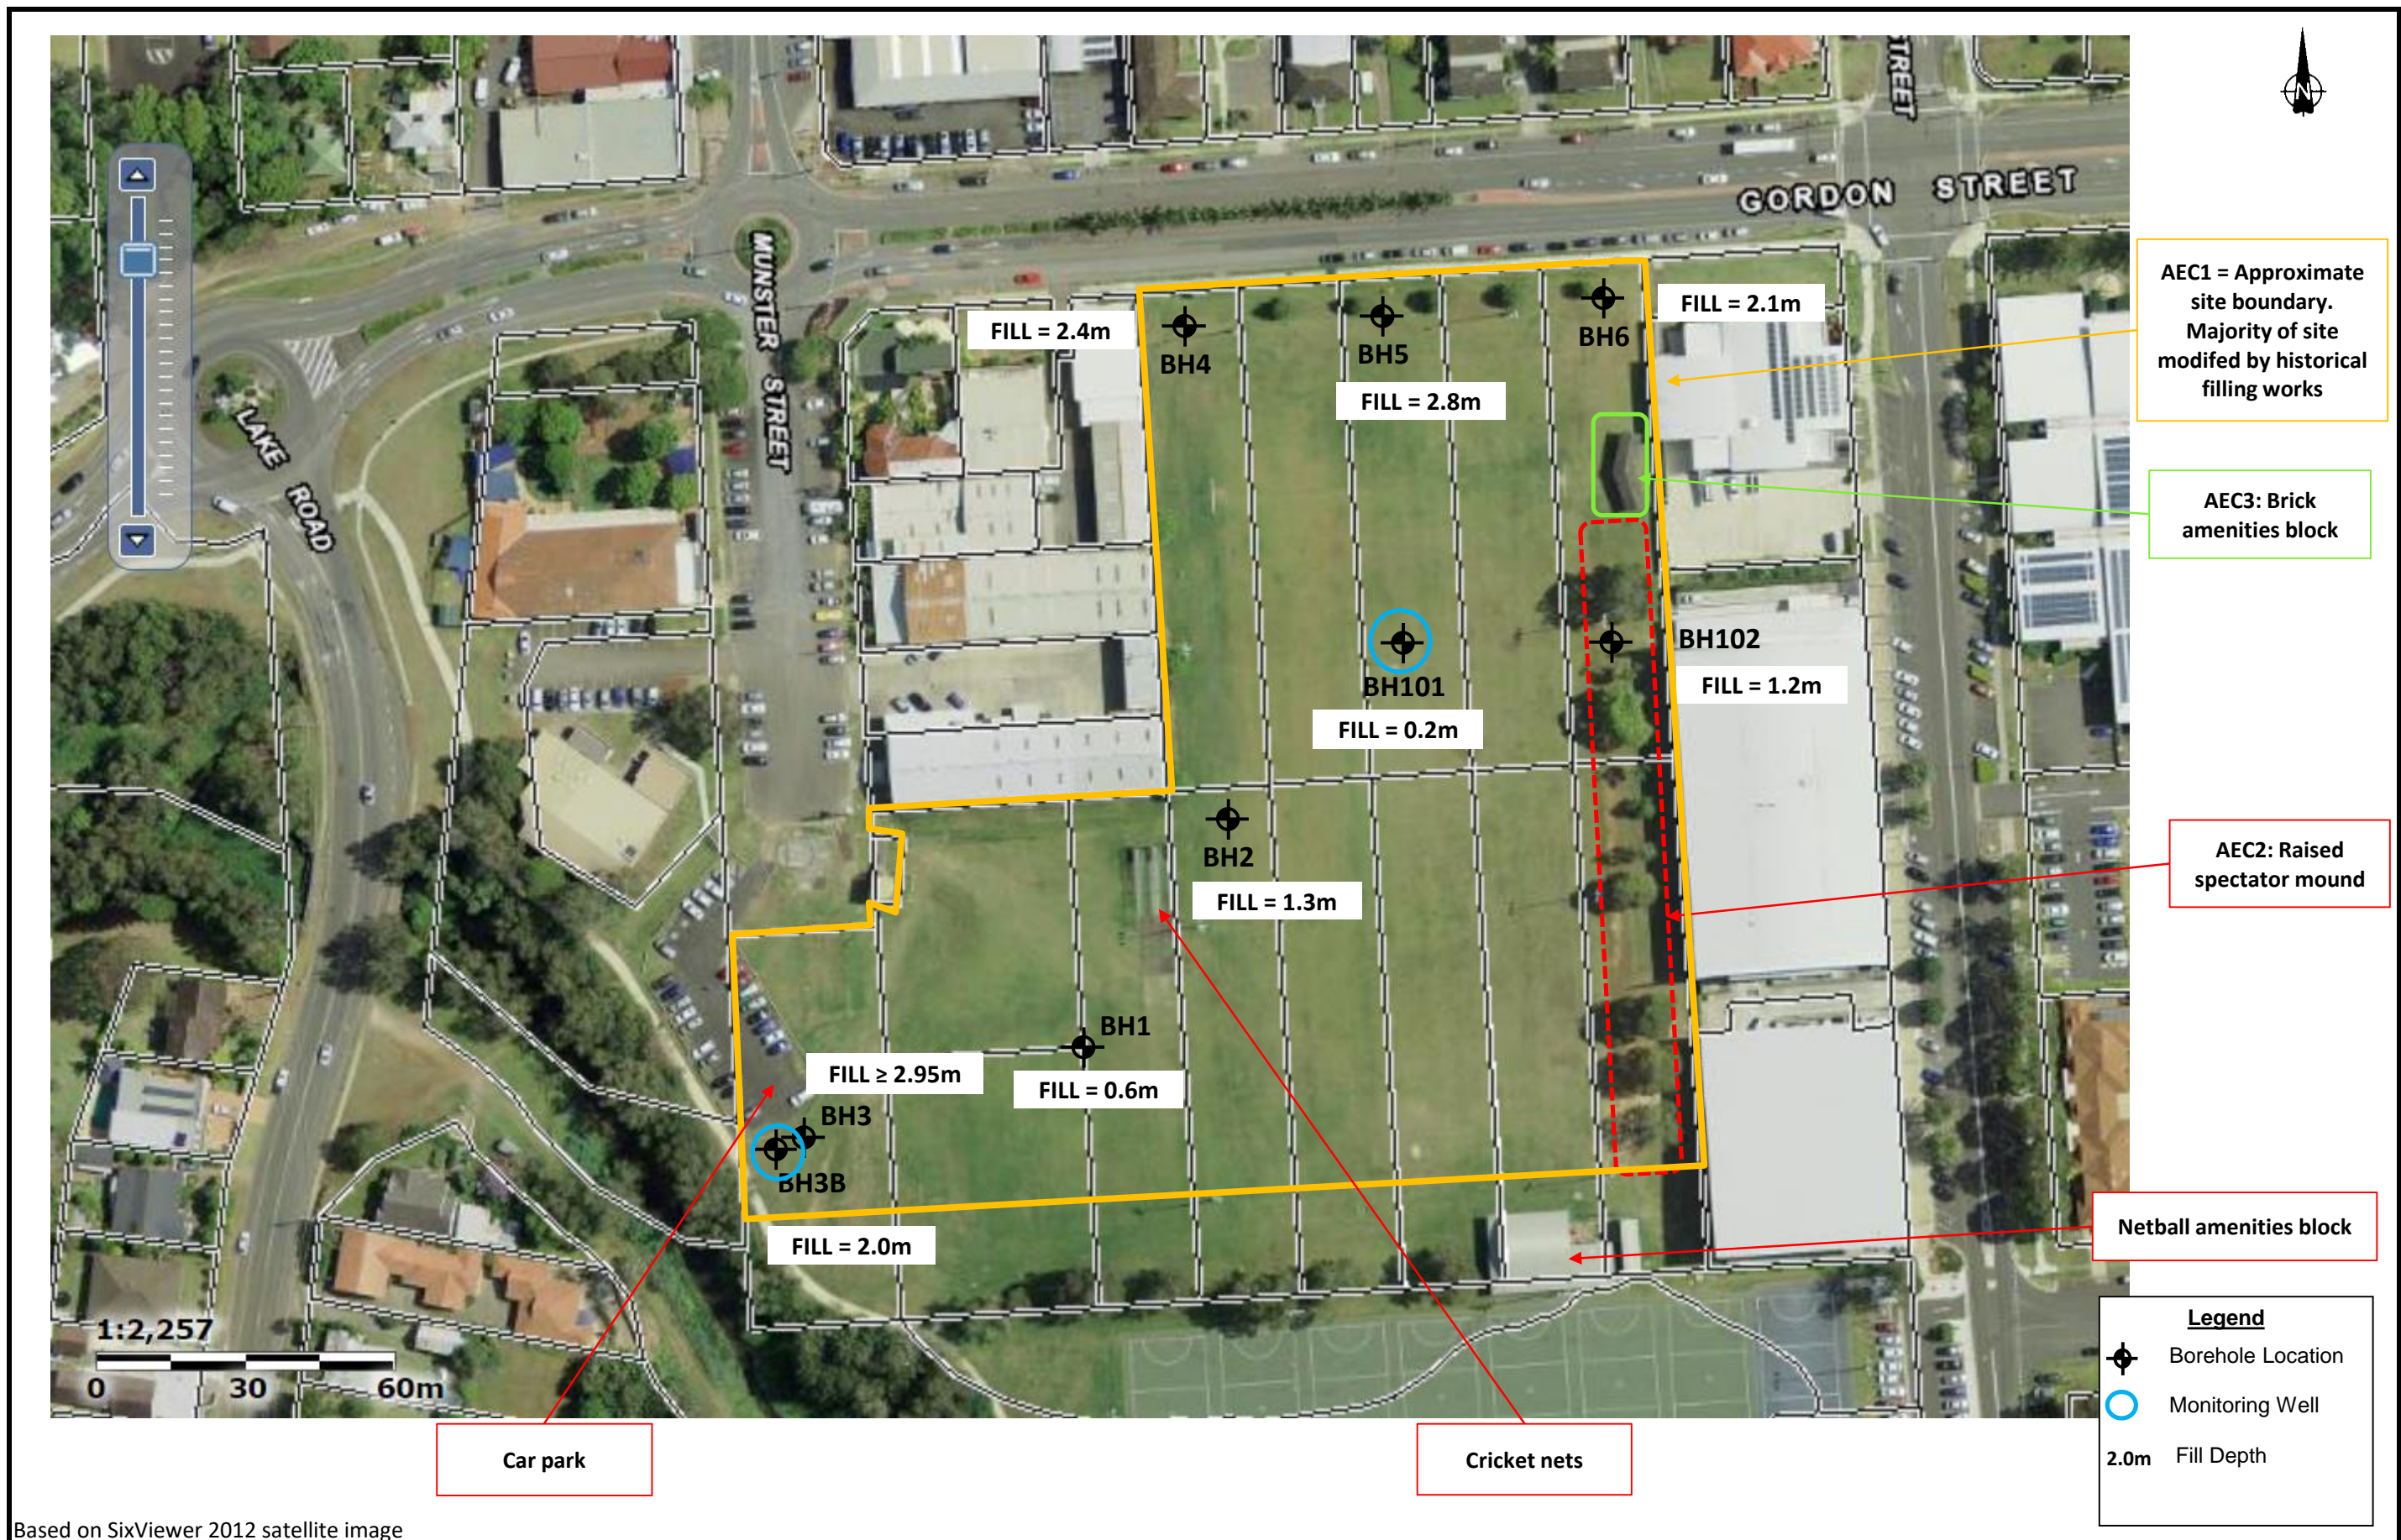
<b>Client:</b>	CO-OP STUDIO	Job No.	RGS21005.6
	<b>Project:</b>	PROPOSED AQUATIC CENTRE	Drawn By:	TM
		MACQUARIE PARK, GORDON STREET, PORT MACQUARIE	Scale:	NTS
	<b>Title:</b>	INVESTIGATION LOCATION PLAN	Date:	11-May-23
			Figure No.	2

Based on SixViewer 2012 satellite image

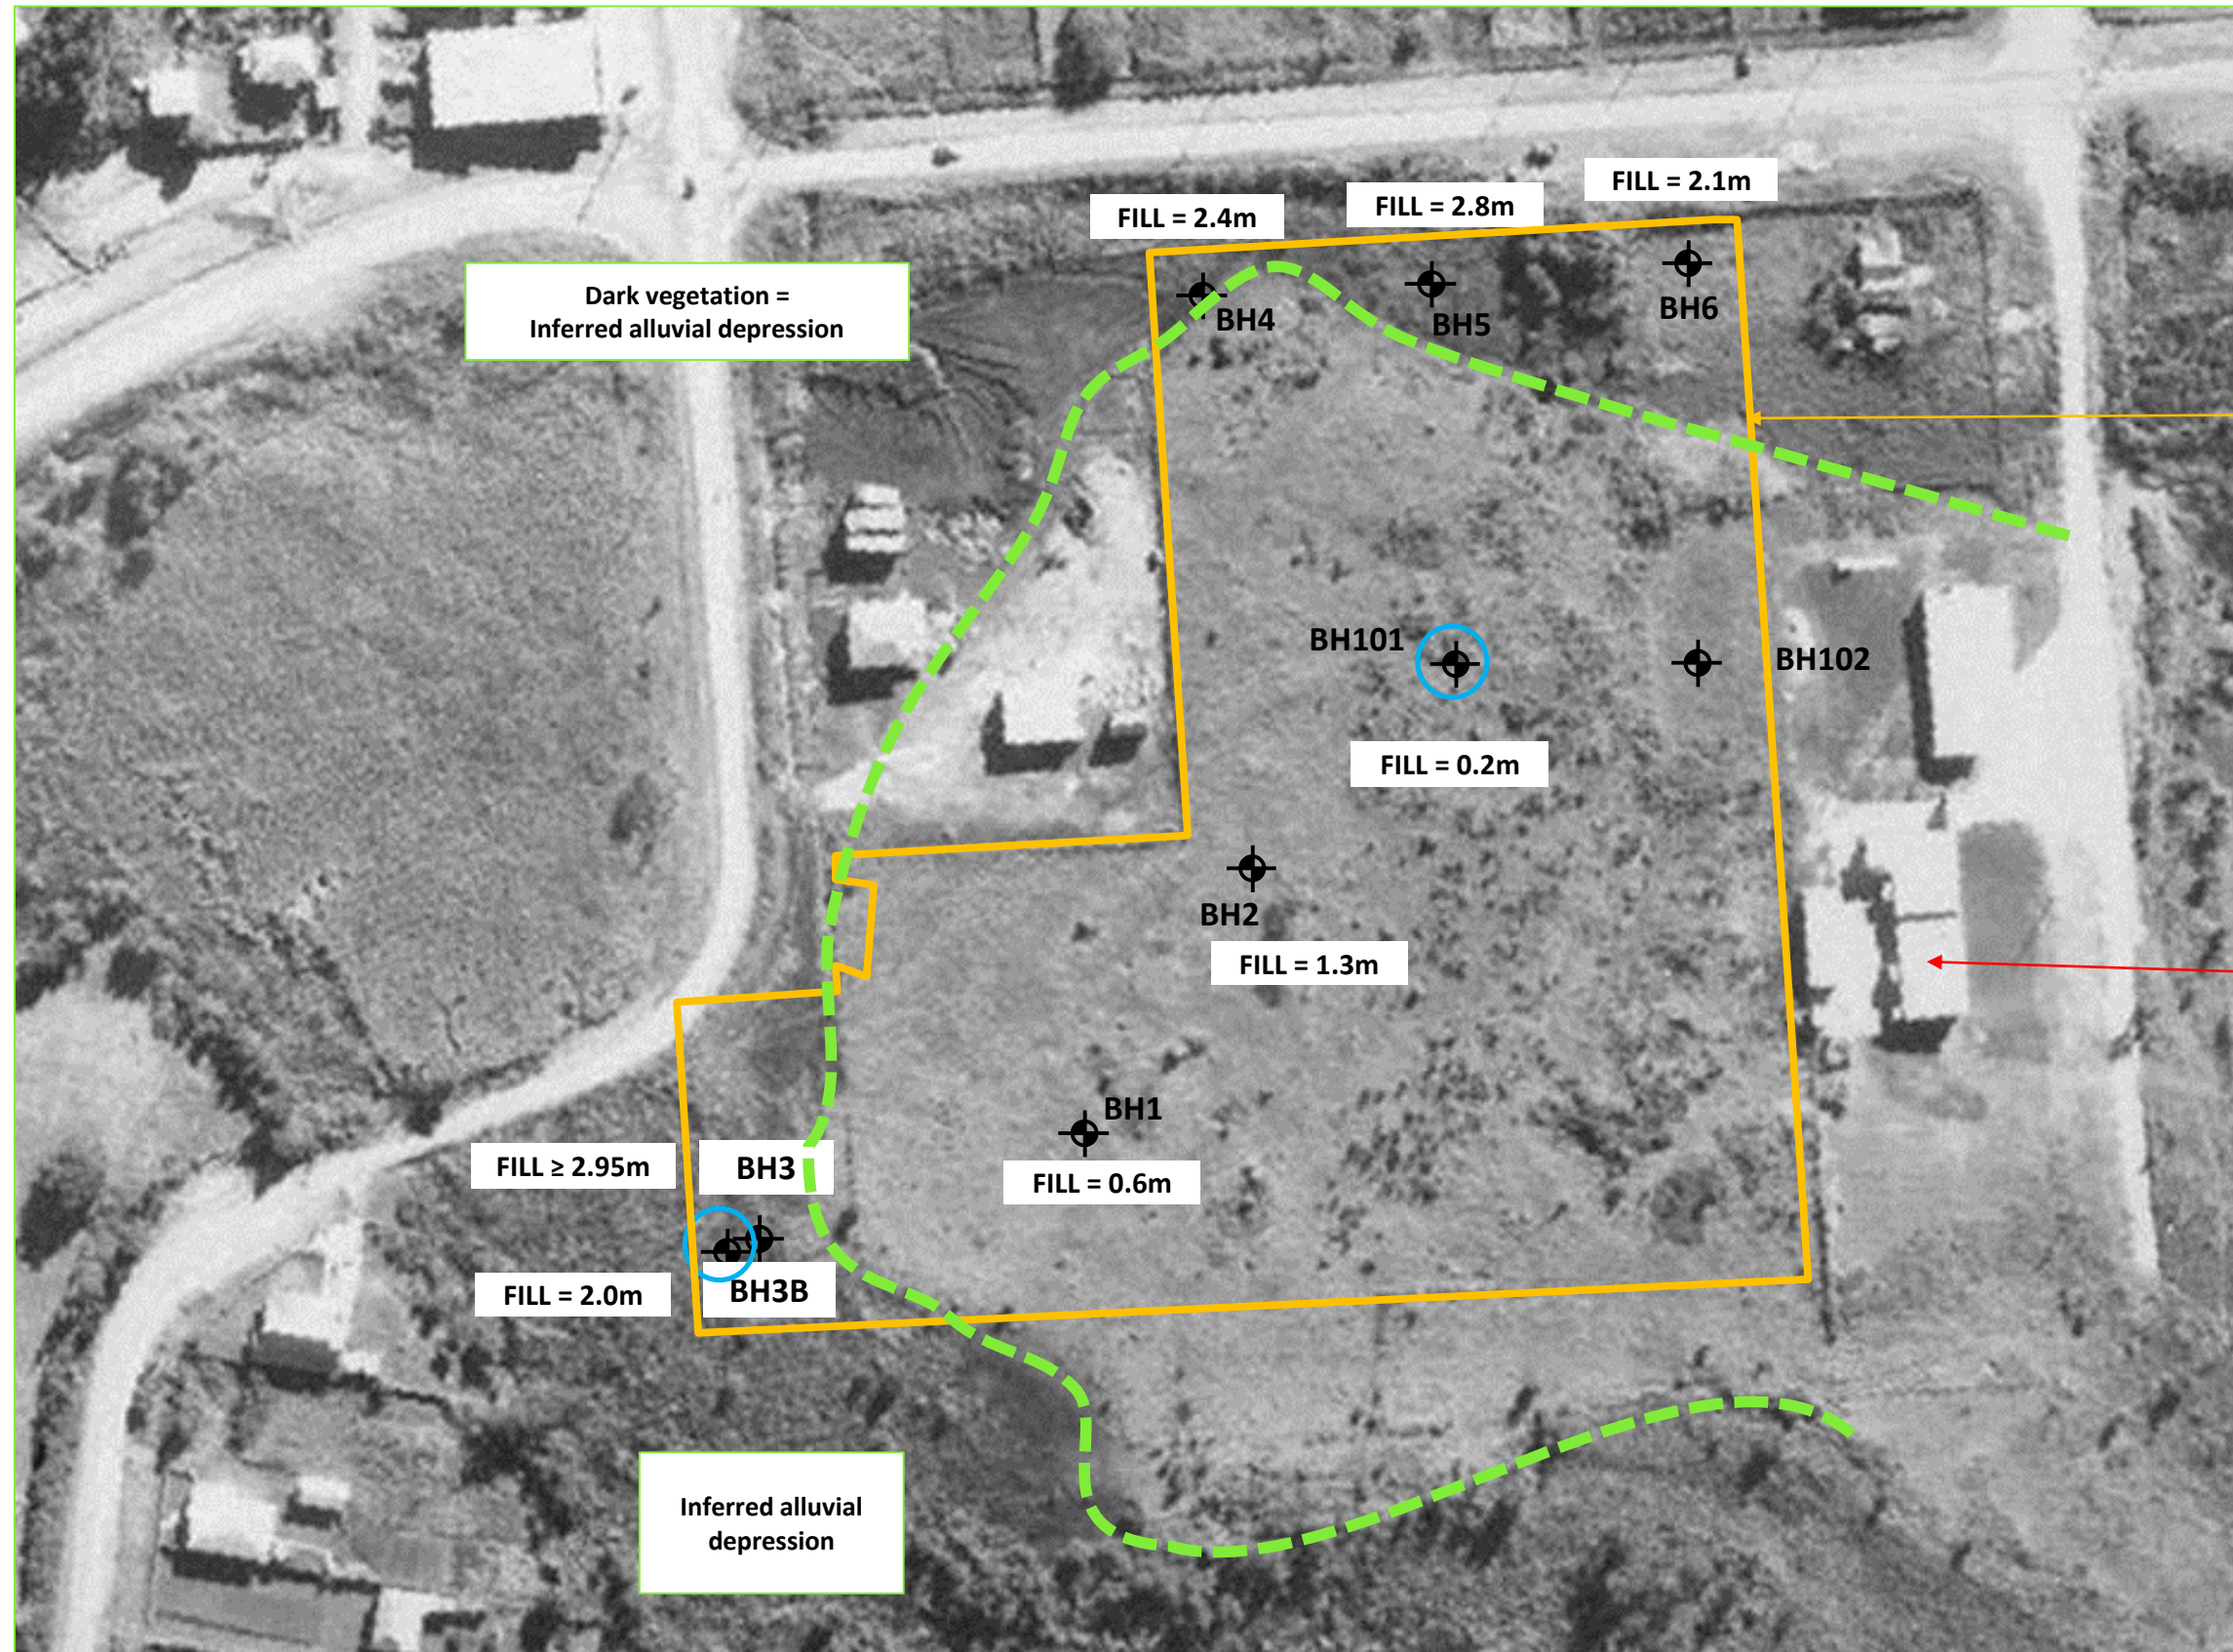
<b>Client:</b>	CO-OP STUDIO	Job No.	RGS21005.6
	<b>Project:</b>	PROPOSED AQUATIC CENTRE	Drawn By:	TM
		MACQUARIE PARK, GORDON STREET, PORT MACQUARIE	Scale:	NTS
		INVESTIGATION LOCATION PLAN - 1959 AERIAL PHOTOGRAPH	Date:	11-May-23
	<b>Title:</b>		Figure No.	3

Based on supplied 1959 aerial photograph

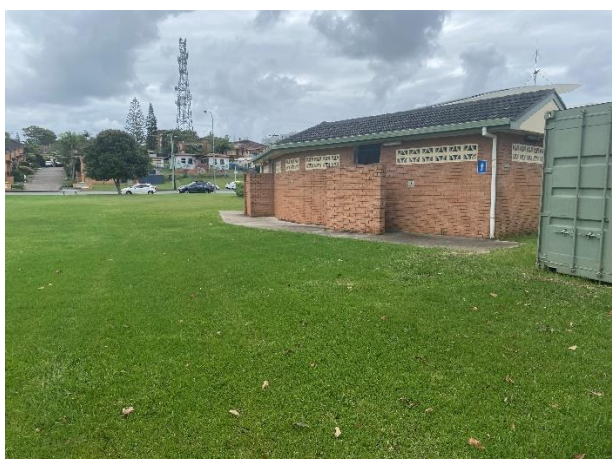
*Looking north east towards brick amenities block and metal shipping container in north east corner of site.*

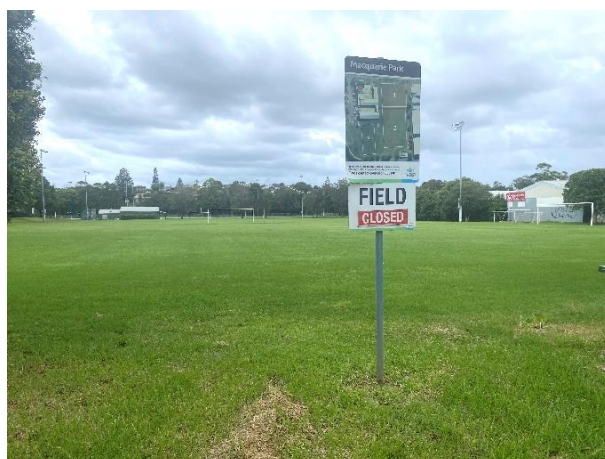
*Looking south across playing fields. Site has been modified by filling works to create a near level surface. Lighting poles line the perimeter of the sporting fields.*

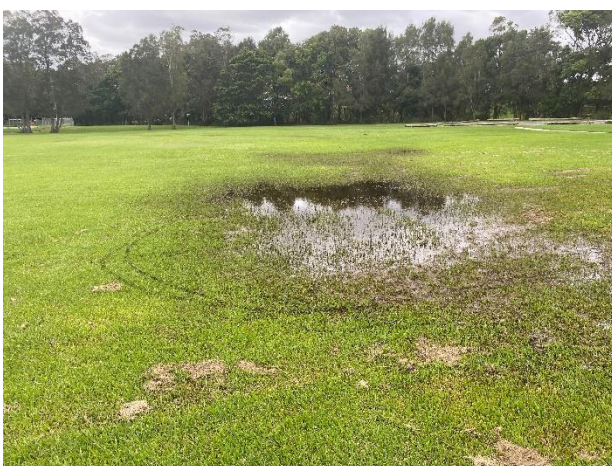
*Looking south across open grassed area in southwest of site on 18 March 2021.*

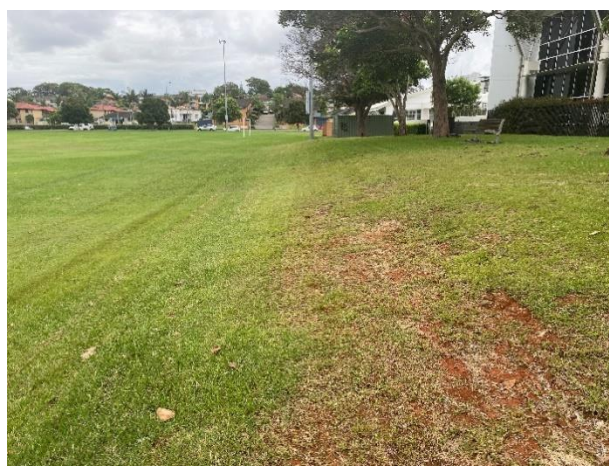
*Raised spectator mound on eastern site boundary. Some red clay soils exposed on side of mound.*

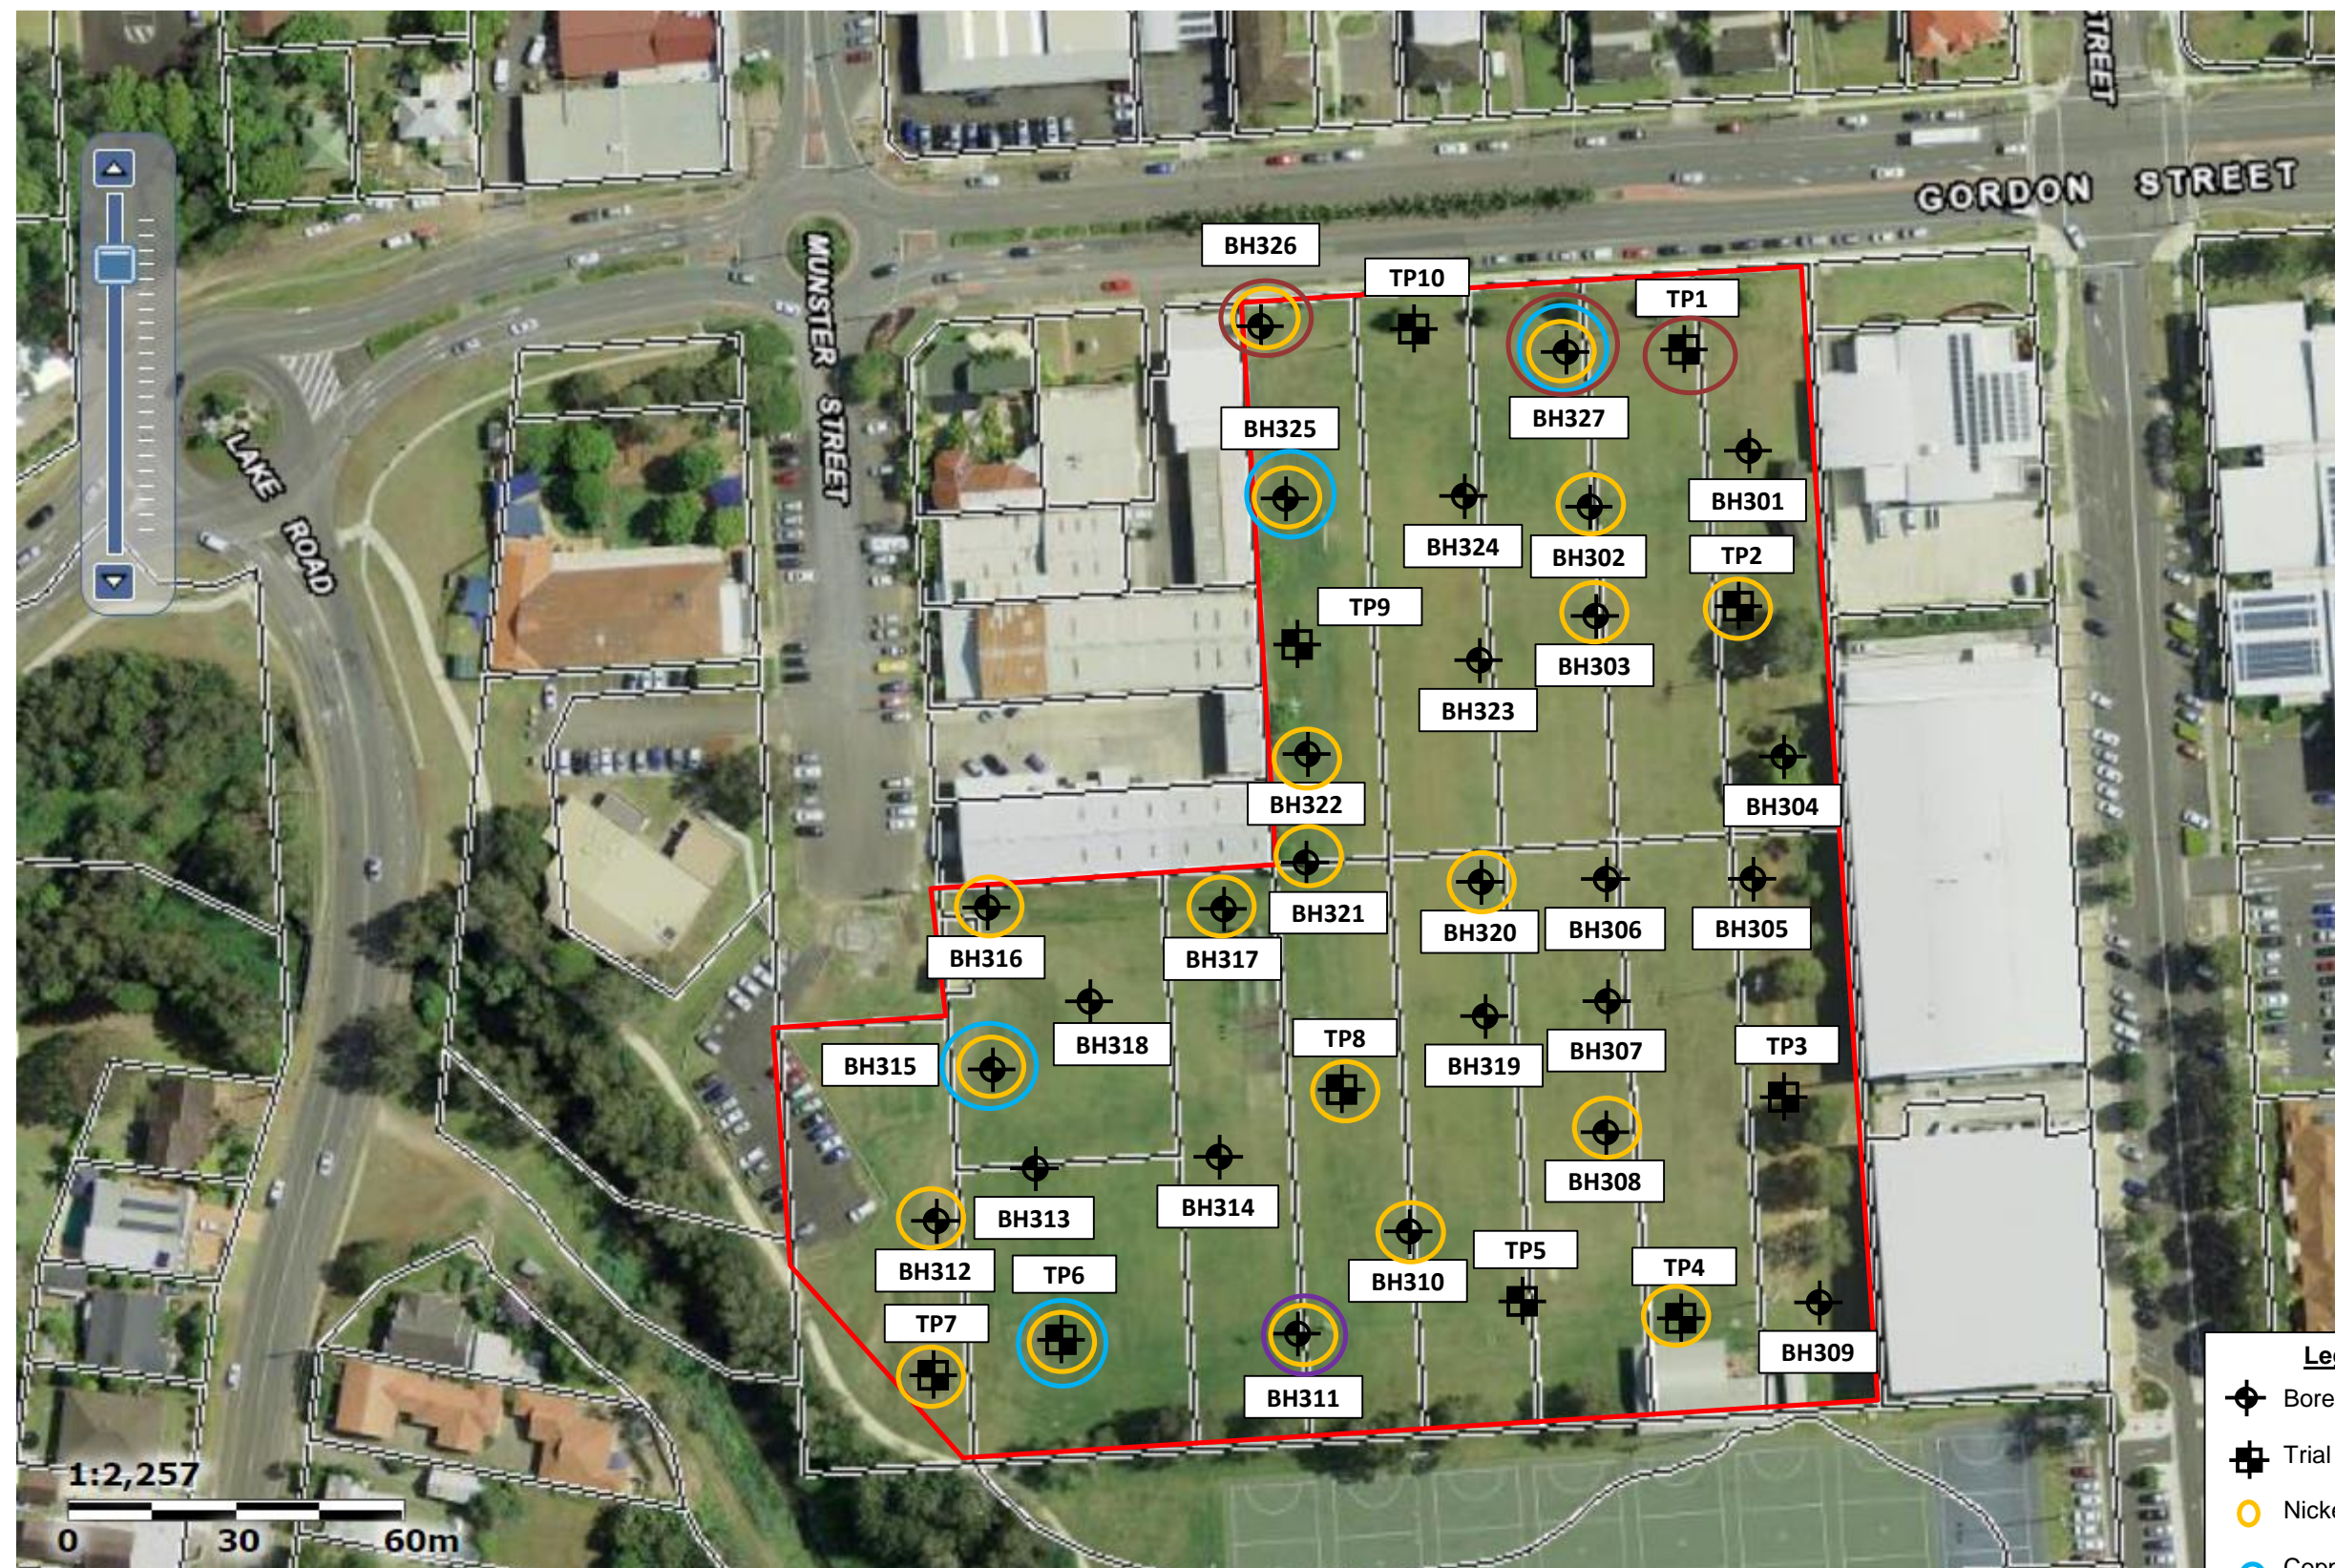
Presented herein is a summary of the work undertaken, the findings of the Stage 2 site contamination assessment and a review of the laboratory test results compared to the NEPM (2013) guidelines. The assessment found elevated concentrations of copper, chromium, nickel and total recoverable hydrocarbons in several locations across the site that exceeded the adopted Ecological Investigation Levels (EILs) for Recreational land use.

- Borehole Location
- Trial Pit Locations
- Nickel Exceedance
- Copper Exceedance
- TRH Exceedance
- Chromium Exceedance

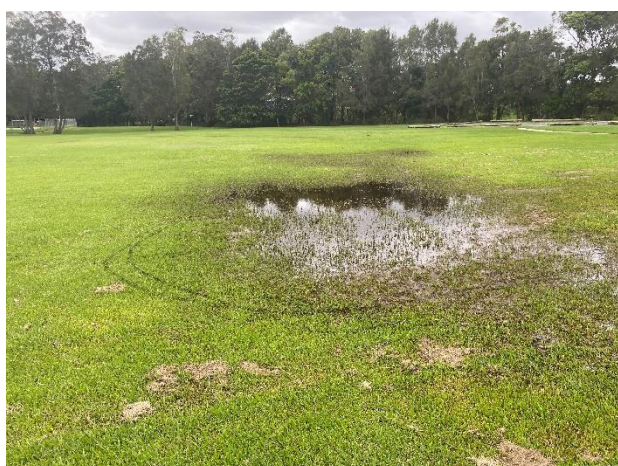
Looking south across open grassed area located in southwest corner of the site.

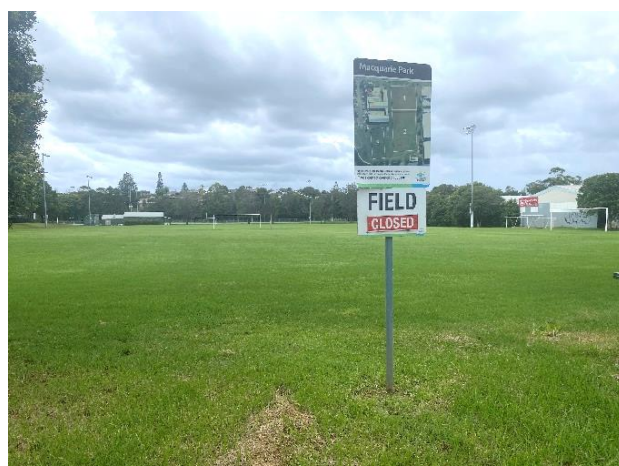
Looking south across playing fields. Site has been modified by filling works to create a near level surface.

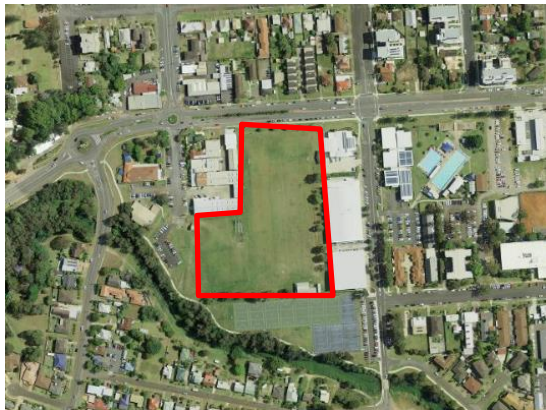
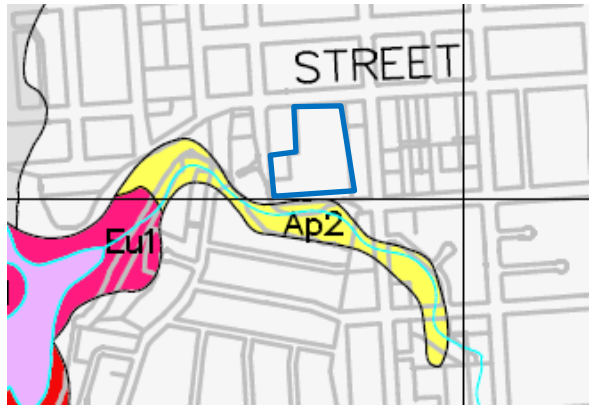
Reference to the Port Macquarie ASS Risk Map (DLWC, 2000) indicates there is a low probability of ASS between 1m and 3m below the ground surface in an alluvial plain located near the southern boundary of the site as shown in Plate 3. There is no known occurrence of ASS in the remainder of the site, however, it is noted that the ASS in the area appears to be associated with alluvial depressions that have been subsequently filled which is not shown on the mapping.

<p>Approximate location of the site is shown in red as indicated by Six Maps image.</p>	<p>Extract from the Port Macquarie ASS Risk Map (DLWC, 2000) indicates there is a low probability of ASS between 1m and 3m below the ground surface in an alluvial plain located near the southern boundary. Approximate location of the site is shown in blue.</p>
