Preliminary Site Investigation

'TAMINDA BUSINESS & LIFESTYLE PARK'

LVL 2 UNIT 10 1A WIRRAWAY STREET TAMINDA,

January 2023.

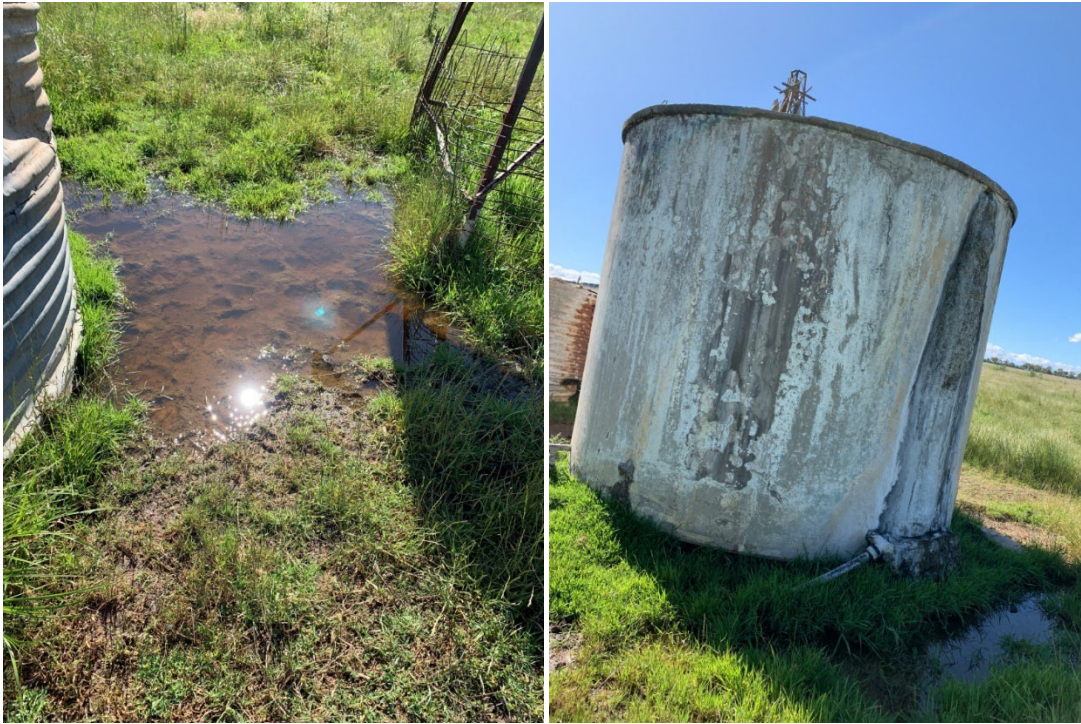
The southern boundary of Site A showed characteristics of low water-holding capacity soils which was identified to be in proximity to the gully line. The areas around the water tank around the existing farm shed on site also appeared to be waterlogged during the investigation. Although, there was a 51mm rainfall event within the preceding 24 hours of the site visit, and the waterlogging may also be most likely be due to loss of soil structure from hoof compaction. The ground surface was wet during the visit as water was evident on the surface.

Figure 2-10: Photos showing water logging characteristics on Site A

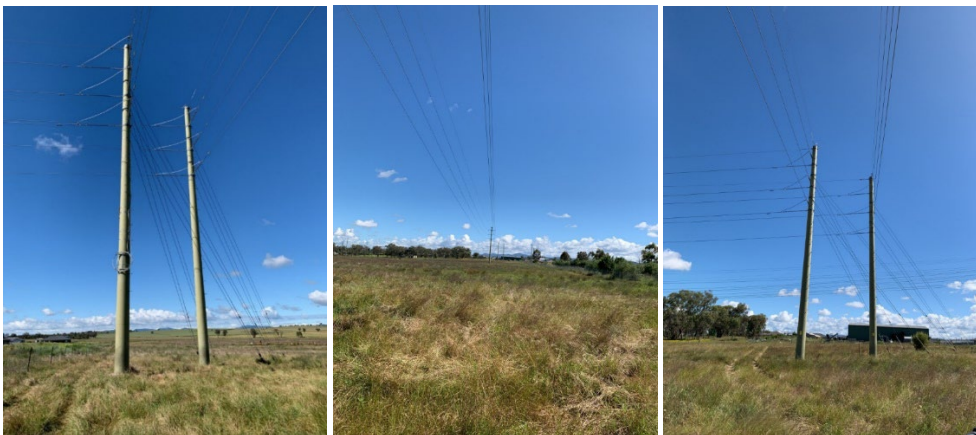
Figure 2-13: Images showing overhead poles on site

A number of overhead poles were identified mostly on lot boundaries during the site visit.

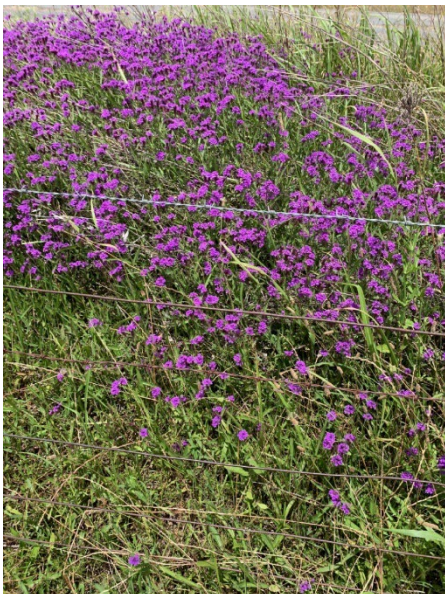
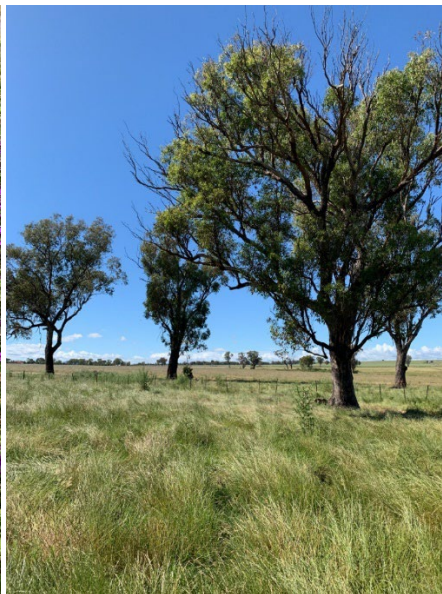
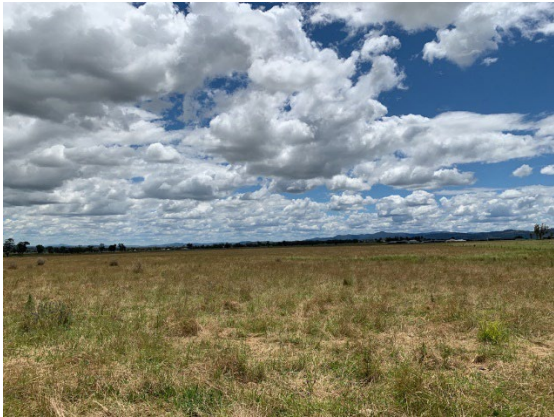
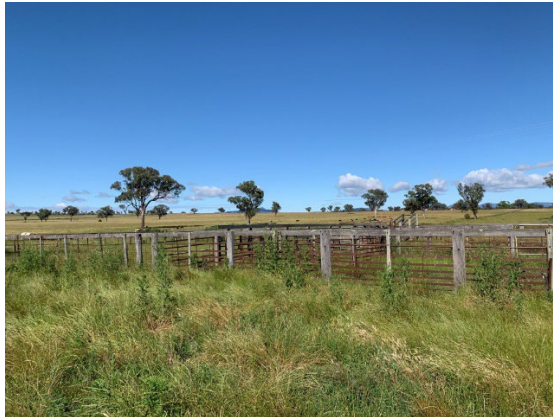
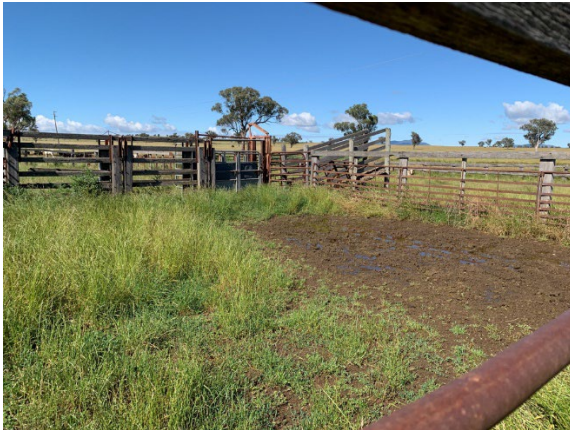
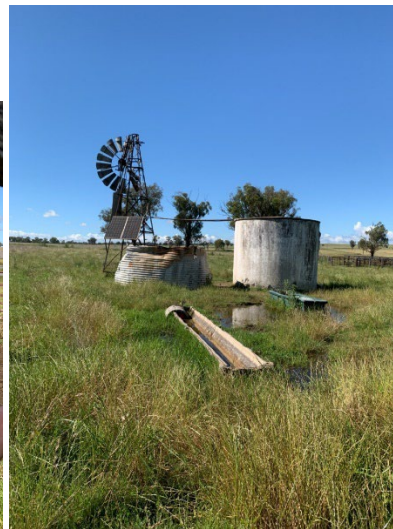
About 95% of this site appears vegetated except for a few access tracks on the southern boundary of the lot area. The site has scattered strands of Eucalyptus trees and shrubs with an approximate number of 40 throughout the site. They have an average height of 13-15m and an average circumference breast height (cbh) of 2-2.5m. Each tree has a dense canopy cover with one of them observed to have nests indicating a habitat tree.

Major ground cover includes a mixture of grasses species and crops utilized for grazing by livestock. Weeds identified include Slender Vervain, Hare's - foot clover, False oatgrass, Wild Oats, Aaron's rod, Prickly lettuce etc.

Figure 3-2: Images showing site conditions.

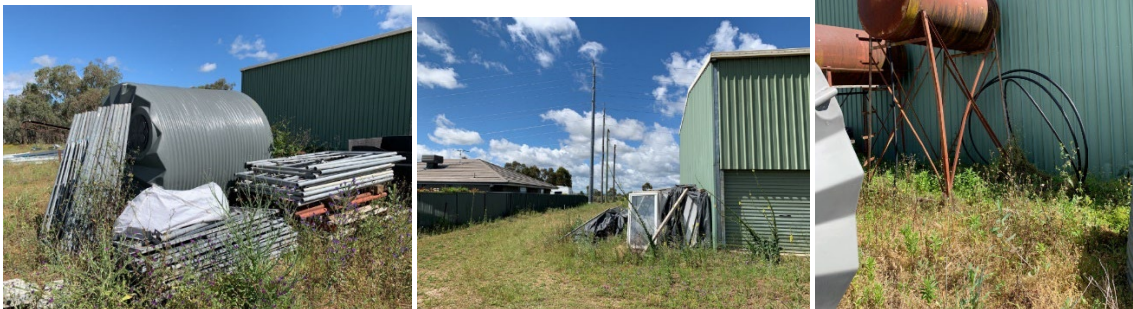
Site B (Lot 1 DP 233288) was also assessed, and it contained a shed, plastic rainwater tanks, metal tanks, metal rods, window frames made of glass and metal, window frames, containers containing adhesives, paints etc. Two soil samples were taken from the front of shed and back of shed using judgemental sampling locations based on the presence of above ground storage tanks (ASTs) and used chemical containers.

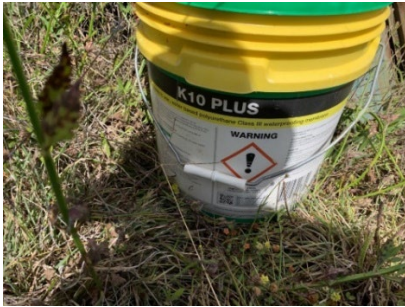
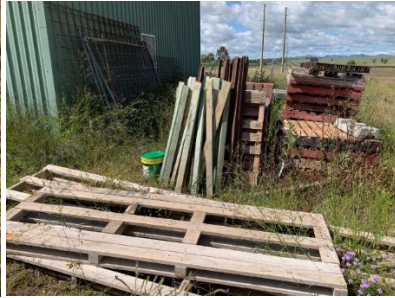
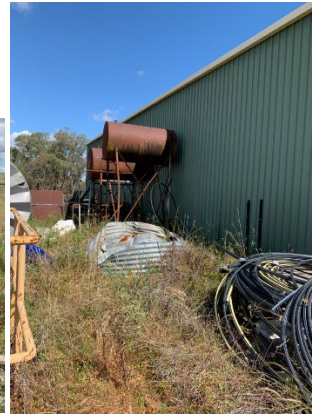
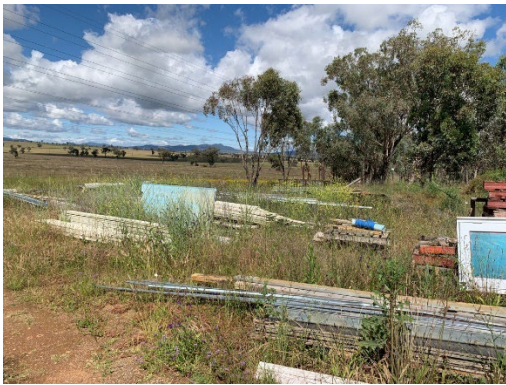
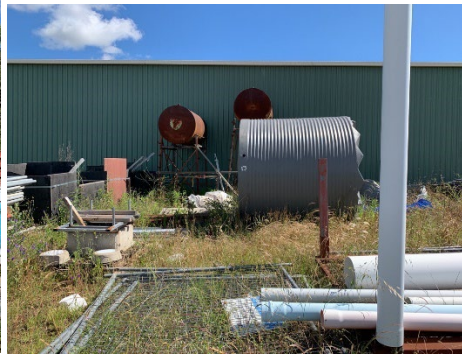
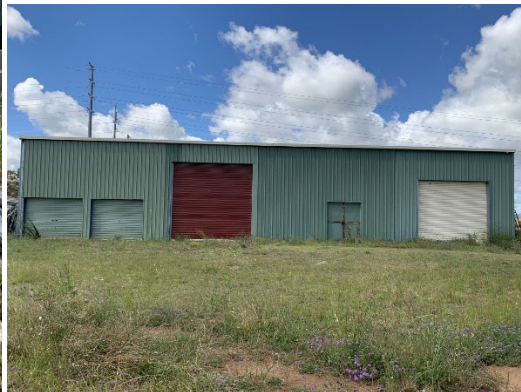
Figure 3-3: Images showing conditions of additional lot

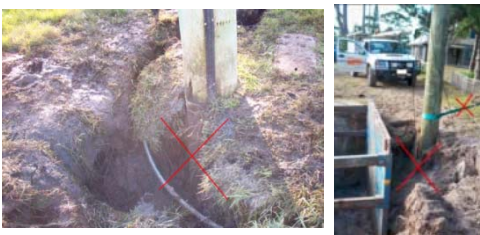
- > Underground cables should never be moved or relocated unless under the express authority of the organisation or person responsible for the powerlines
- > The excavator shall report all damage made to Essential Energy assets immediately. Damage includes: gouges, dents, holes and gas escapes
- > Never undermine poles, cables, earthing cable, pad-mount and kiosk substations.

Above: Poles with become unstable if undermined
