7213-05\_21\_09\_07 Basement CMP\_Rev2.docx

7th September 2021

**RE: CONSTRUCTION MANAGEMENT PLAN FOR BASEMENT SHORING  
PROPOSED STAGE 5  
HABITAT DEVELOPMENT, BYRON BAY**

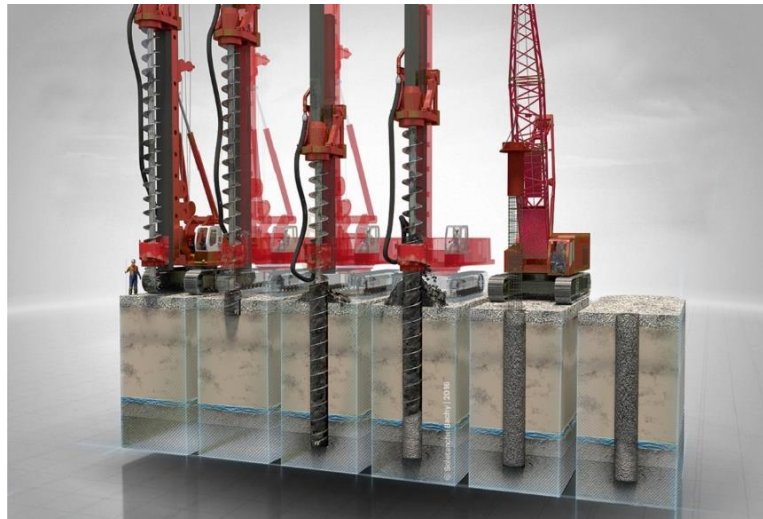
*Figure 2 - CFA Piling Installation*

Continuous Flight Auger (CFA) Piling - CFA piles are cast in place piles formed by drilling with a machine called a Continuous Flight Auger. The auger is drilled into the soil and/or rock to the design depth in a single pass. Once the design depth/criteria has been achieved, the auger containing the drilled material is then slowly removed as cement-sand grout or concrete is pumped through the hollow stem. This process pressurises the hole to prevent wall collapse and continues until the auger is completely removed and the hole filled. A reinforcing cage may then be lowered centrally into the liquid grout or concrete pile as required.

CFA piling is considered the most suitable method of piling for this project due to their non-displacement, minimal vibration and ability to be installed in saturated soils (below groundwater level) without collapse or requirements for shoring. CFA piling can be utilised for different types of shoring and retention solutions including secant piling.

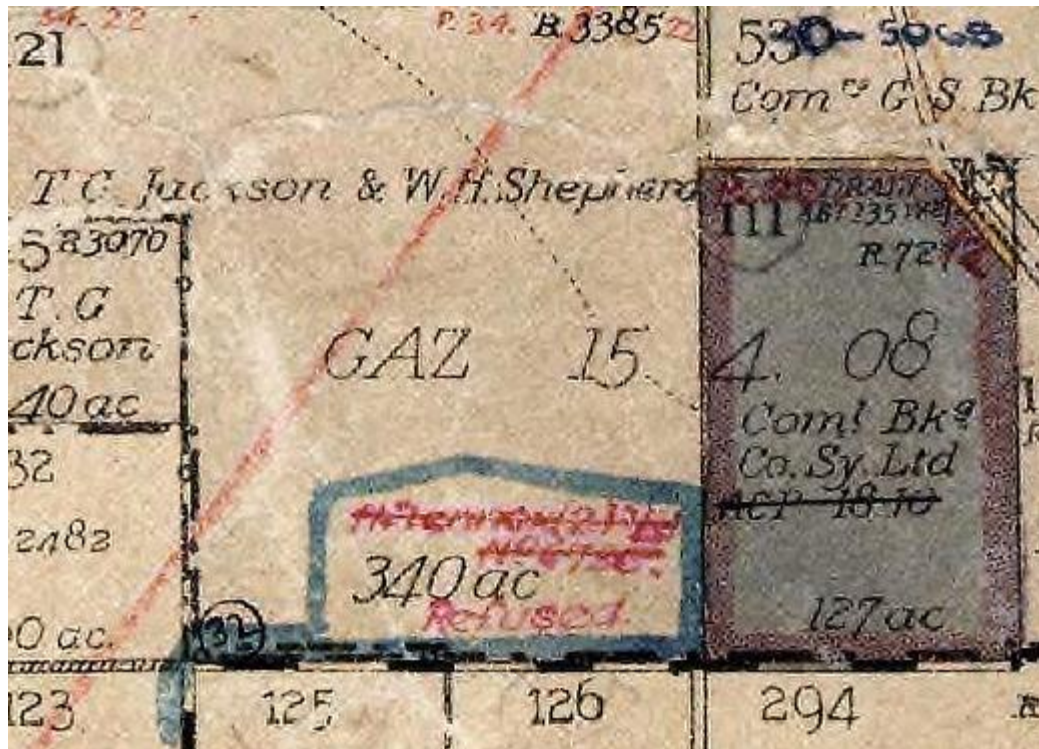
Figure 12: Newrybar Parish Map 1937

Newrybar Parish map from 1937 shows a gazettal of a Public Road on the subject land (**Figure 12**). The dotted line through the property is the drainage line which still exists today.

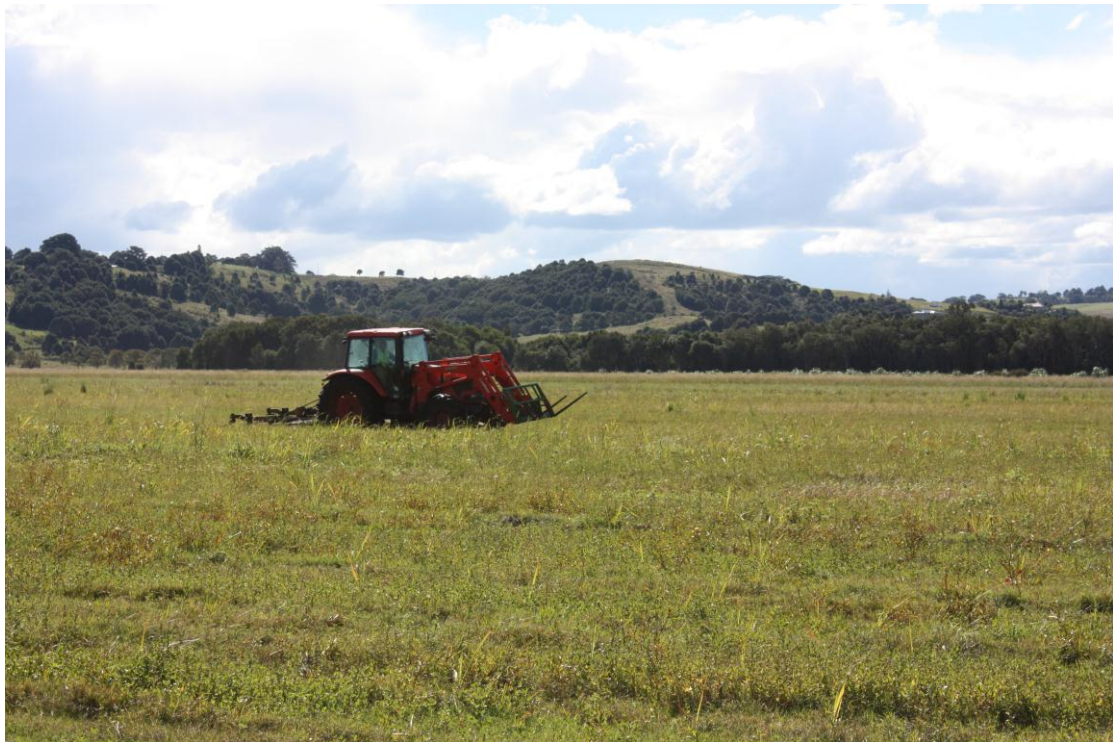
Figure 16 – Photo showing site area being slashed with hills behind.

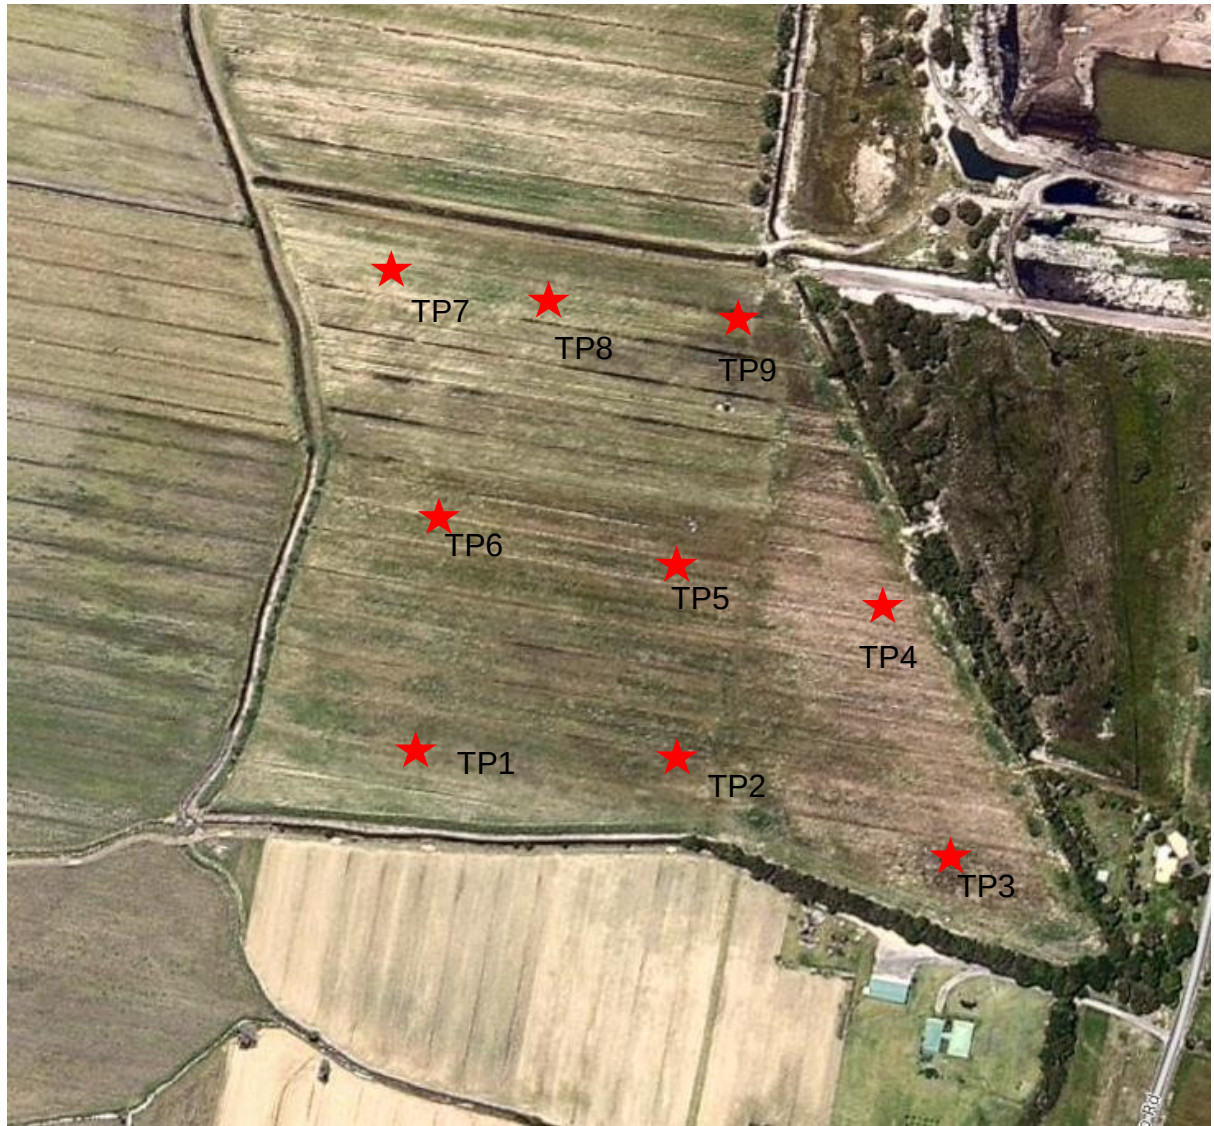
**Figure 17: Soil Sample Locations**

The field sampling investigation was conducted on the 11<sup>th</sup> May 2012. This involved the collection of 9 samples. The location of the sampling is shown in Error! Reference source not found.. The samples were collected from below the root zone to 150mm below ground level in accordance with the *Sampling Design Guidelines* (EPA, 1995). Soil borehole logs are provided in **Figure 18** below. Compositing details are shown in Error! Reference source not found..
