GRAFTON BASE HOSPITAL REDEVELOPMENT
EARLY WORKS
ABORIGINAL CULTURAL HERITAGE (DUE DILIGENCE)
ASSESSMENT

April 2024

Mace/ GeoLINK

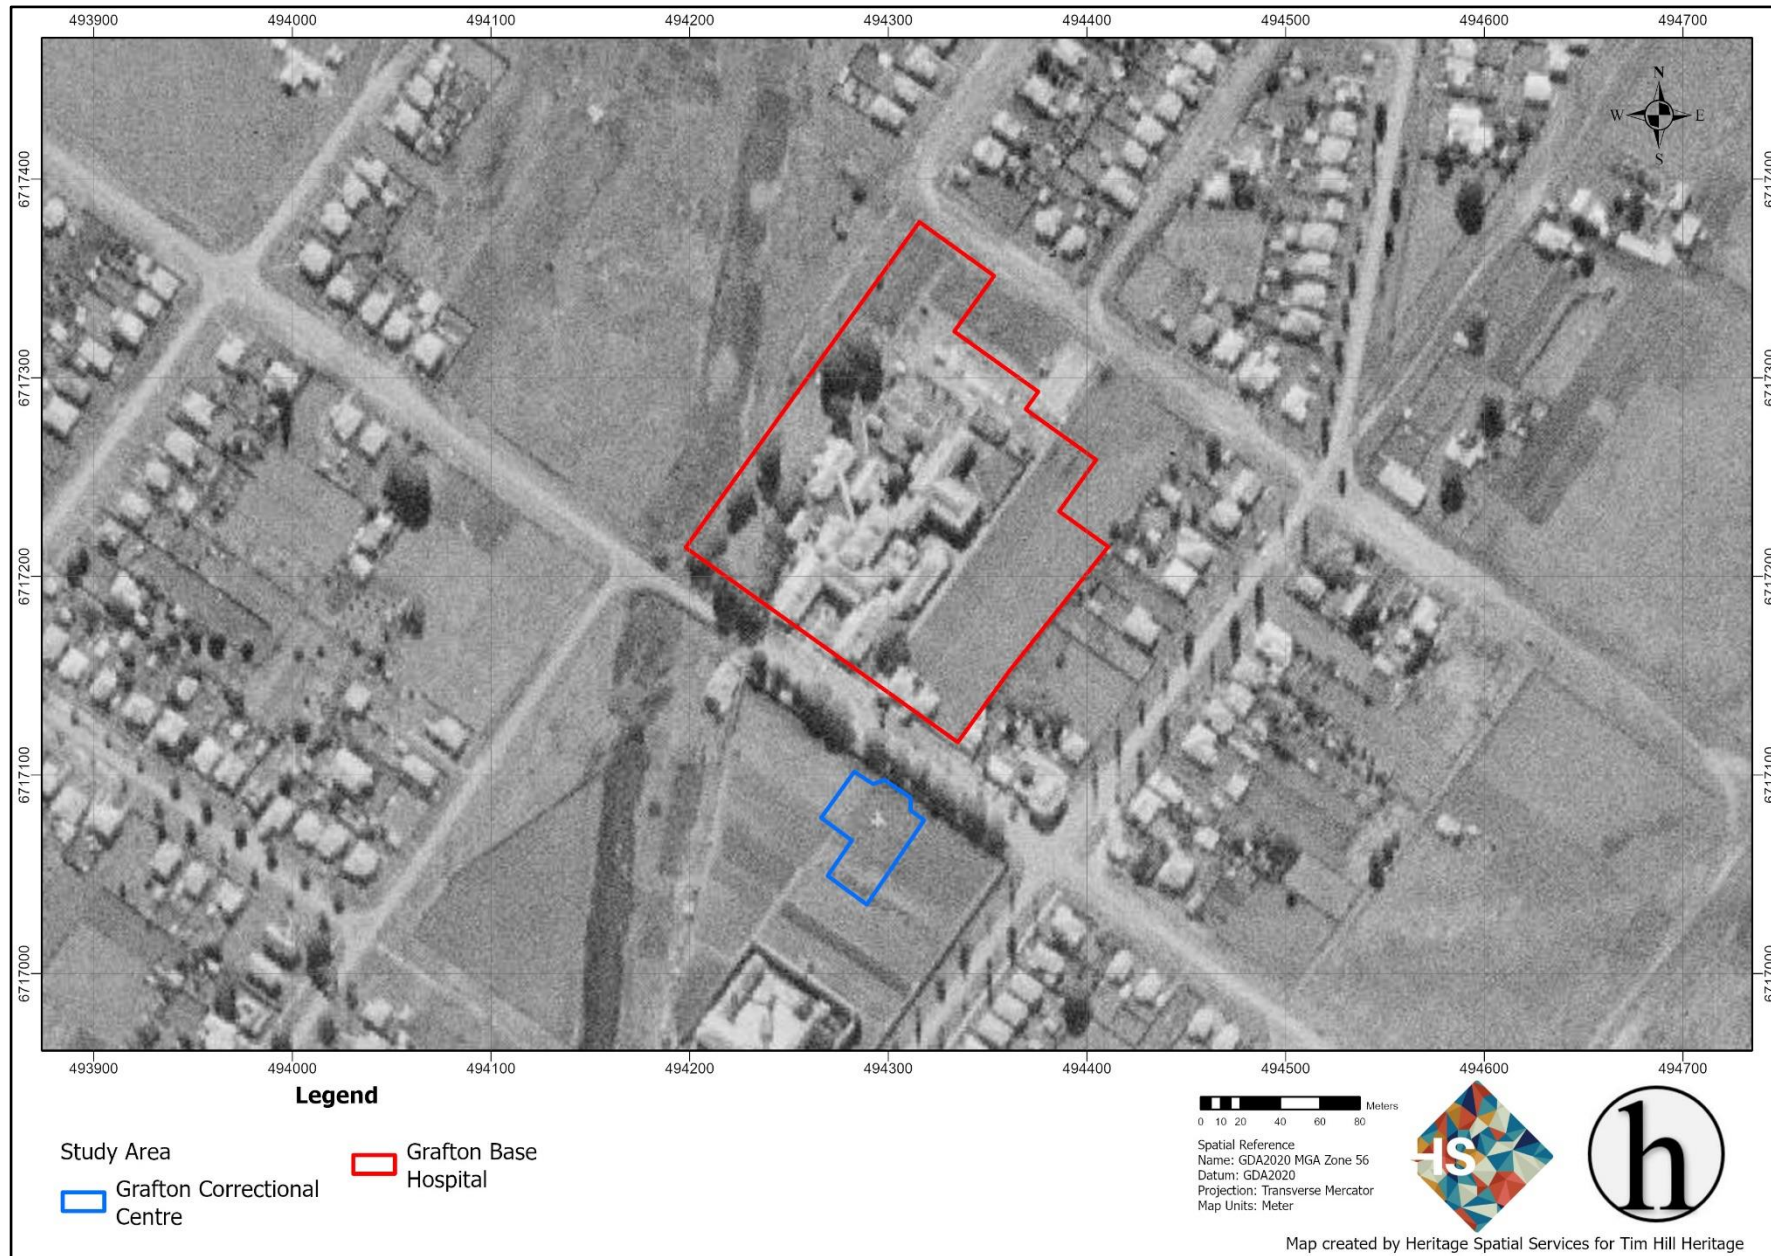
1953- the Study Area comprises an area of market gardens associated with the old Grafton Gaol (**Figure 11**).

1953- the area of the early works, located on the eastern boundary of the Study Area, comprises a vacant land with the two private dwellings, visible on the 1925 Crown plan, fronting the boundary with Arthur Street (**Figure 11**).

Figure 11: Grafton Base Hospital Early Works- 1953 aerial photo (NSW Spatial Collaboration Portal)

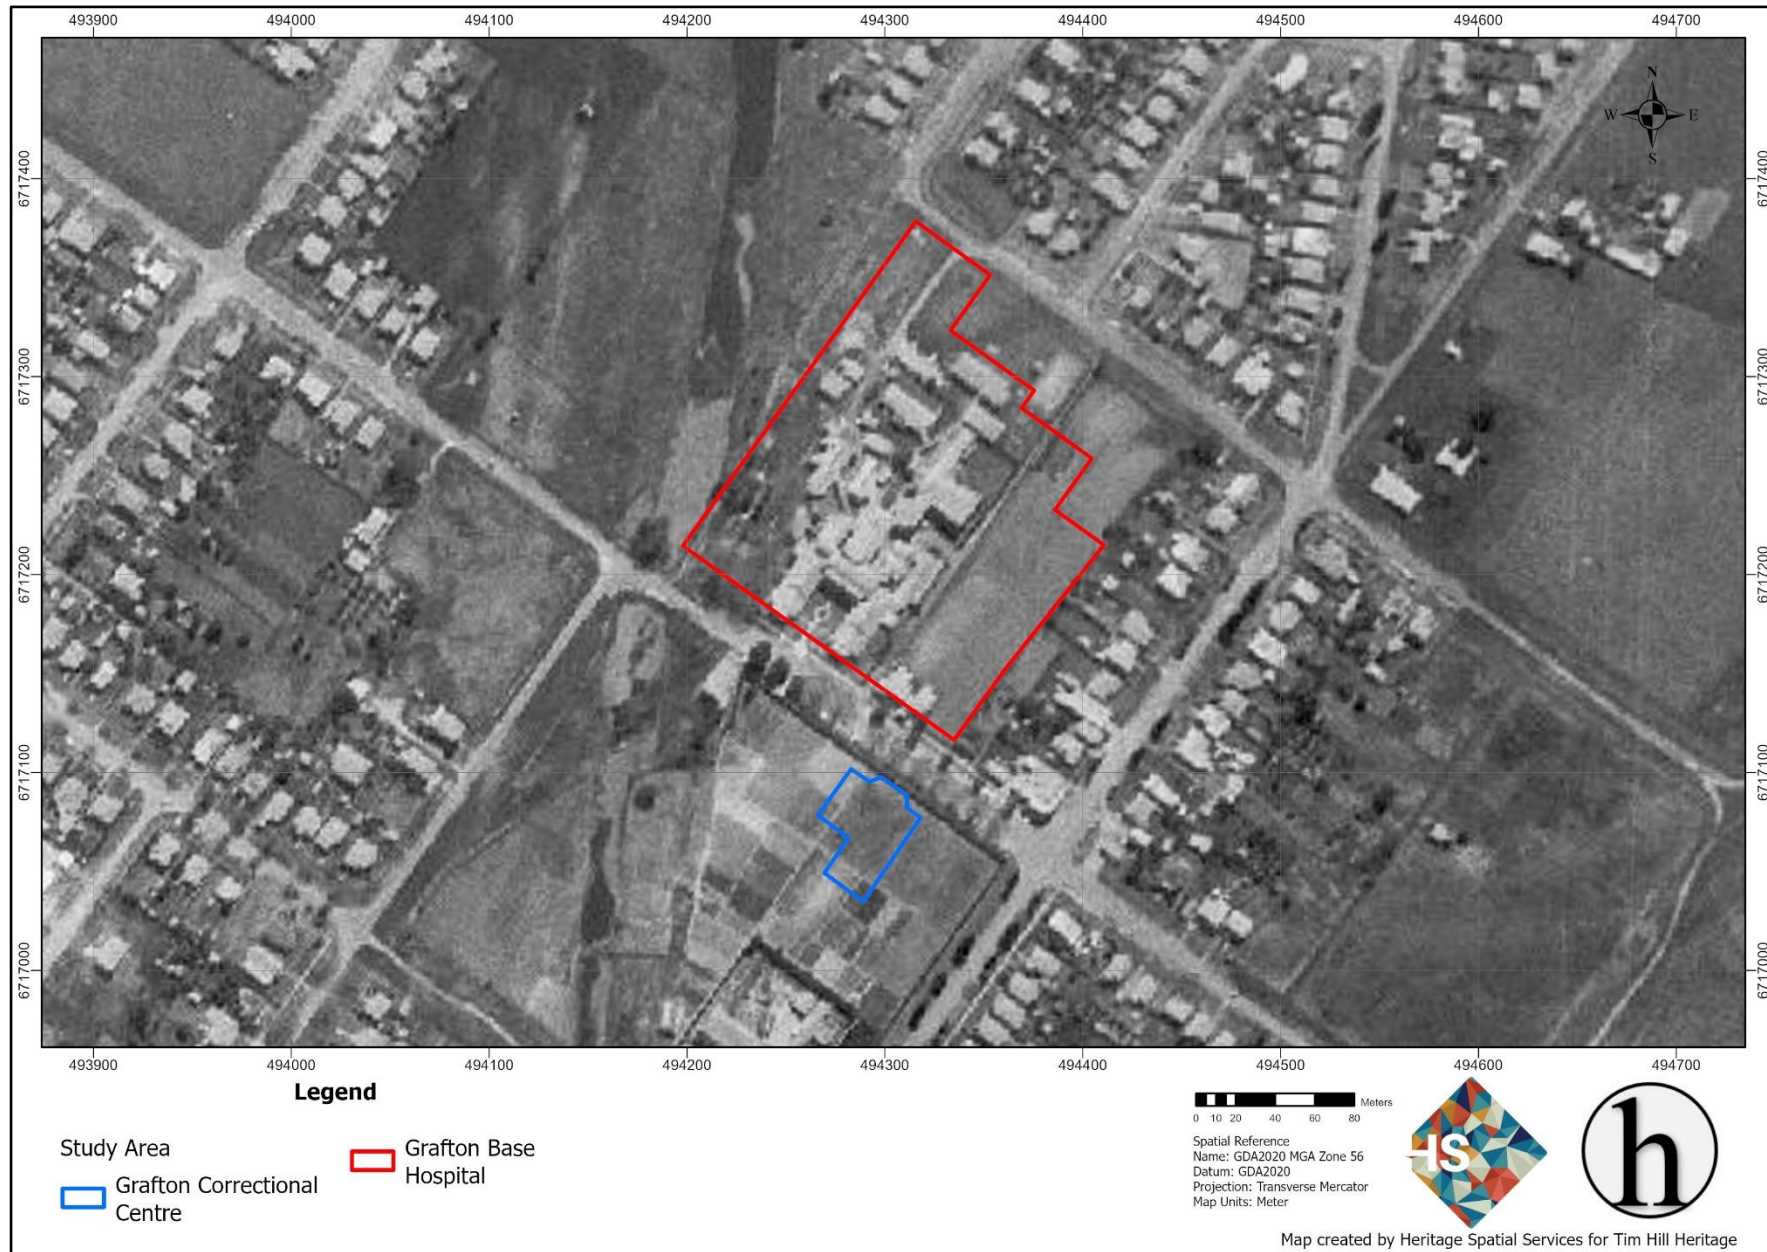
1963- the Study Area is substantially unchanged (**Figure 12**)

1963- the section of the hospital subject to the early works is substantially unchanged (**Figure 12**)

Figure 12: Grafton Base Hospital Early Works- 1963 aerial photo (source NSW Spatial Collaboration Portal)

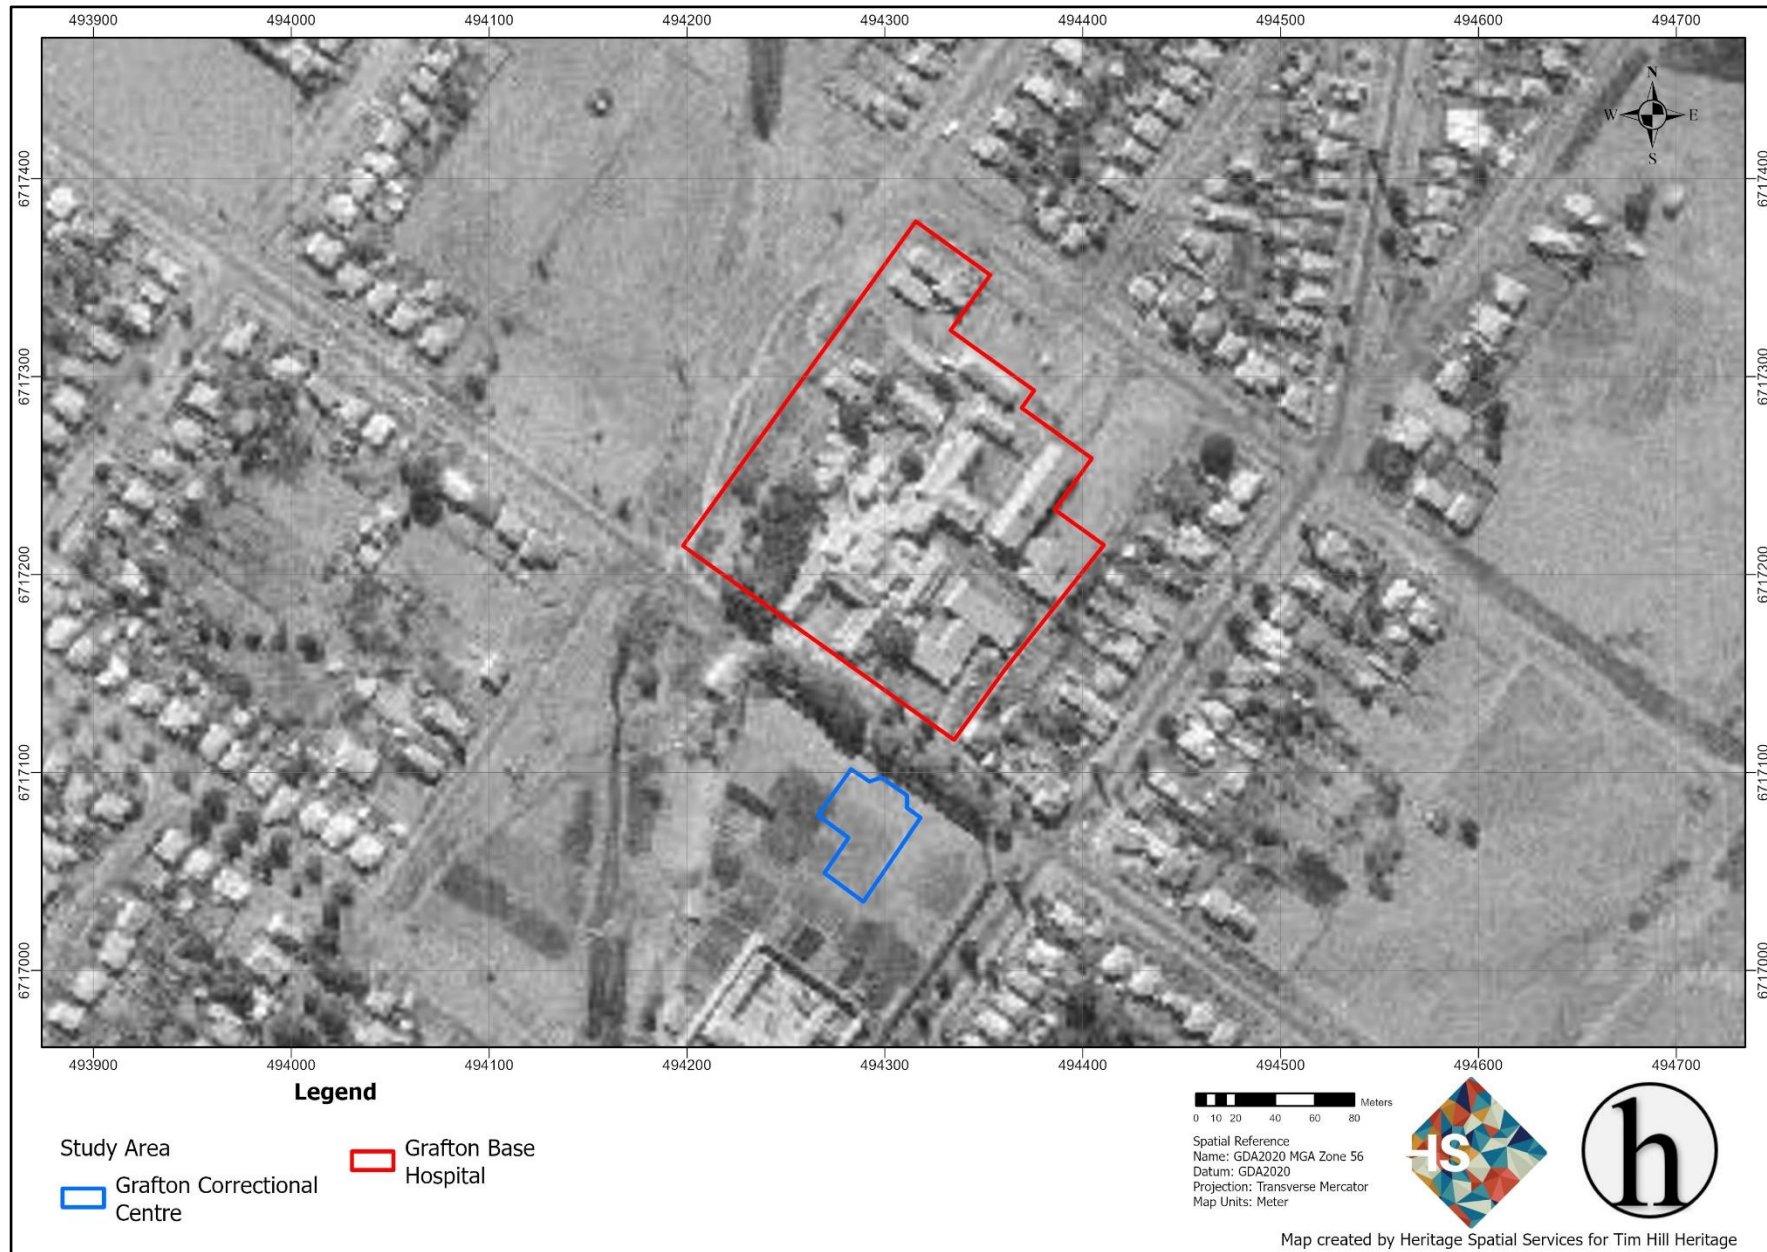
1970- the Study Area is substantially unchanged (**Figure 13**)

1970- the two smaller buildings on Arthur Street have been demolished and two large buildings have been constructed over the formerly vacant land (**Figure 13**)

Figure 13: Grafton Base Hospital Early Works- 1970 aerial photo (source NSW Spatial Collaboration Portal)

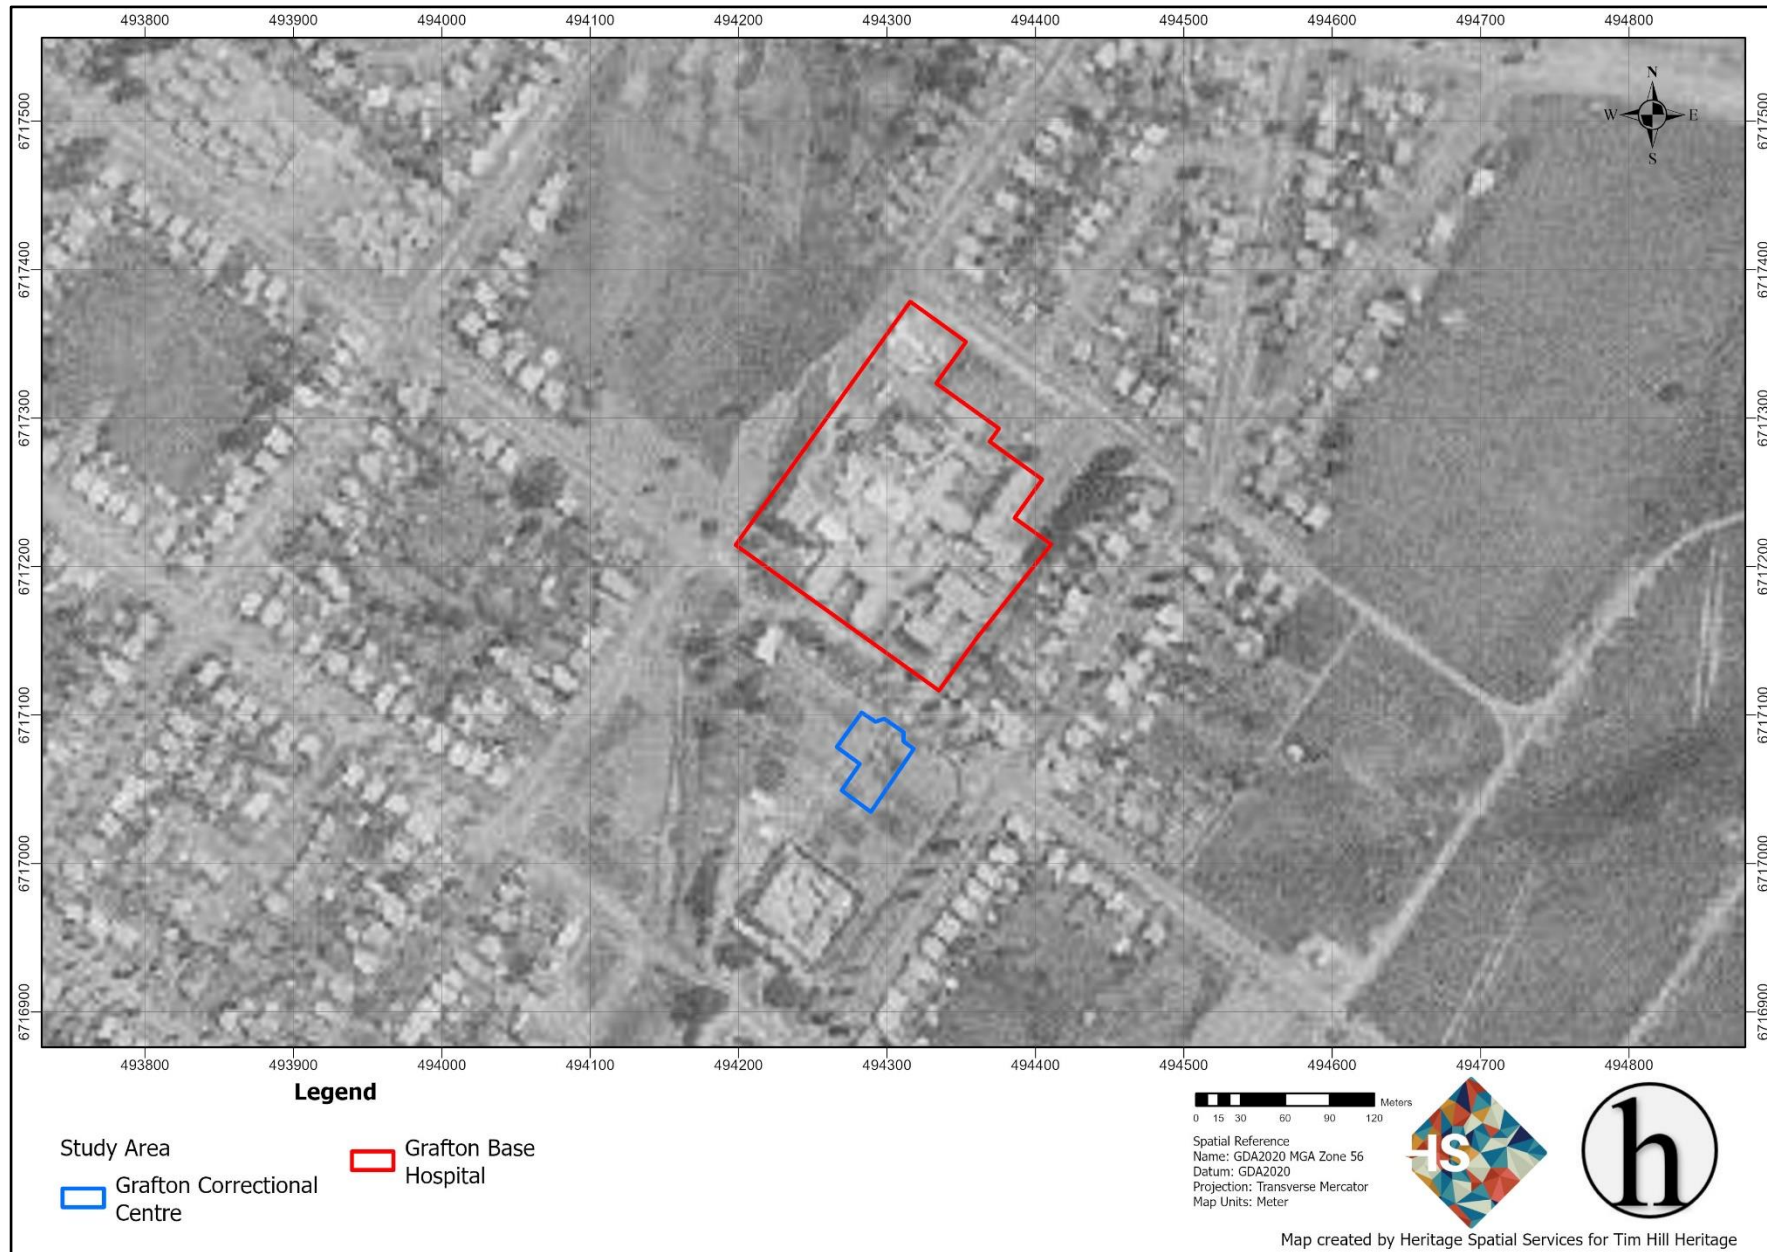
1978- The deputy superintendents' residence is visible in the location of the current entrance (Block A and Block B) (**Figure 14**)

1978- the section of the Study Area subject to the early works is substantially unchanged (**Figure 14**)

Figure 14: Grafton Base Hospital Early Works- 1978 aerial photo (source NSW Spatial Collaboration Portal)

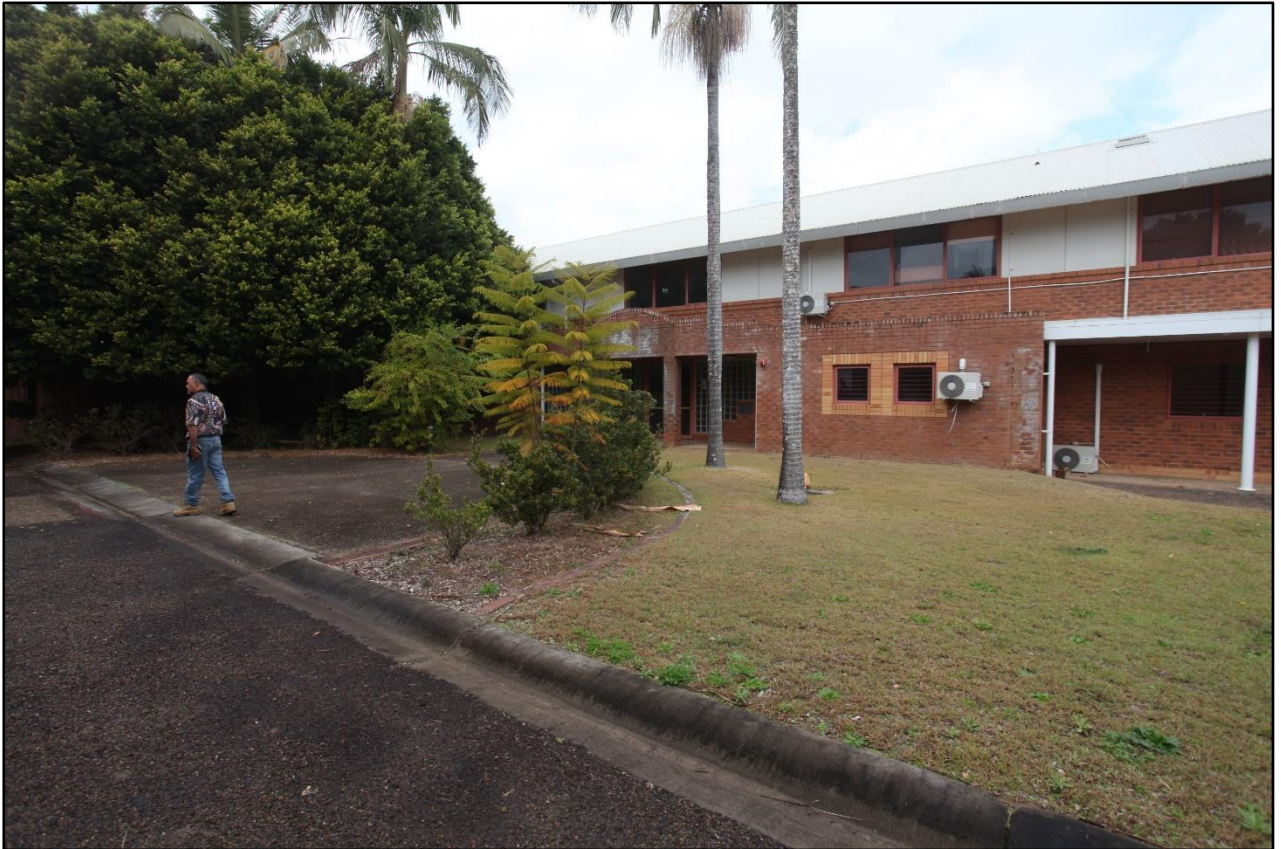
Figure 17: Grafton Correctional Facility- The front courtyard and the main entrance to Block A

Based on the review of historical aerial photos it is reasonable to proceed with the assessment on the basis that the Grafton Correction Facility has been subject to significance ground disturbance as defined by the Due Diligence Code of Conduct, being disturbance that is "clear and observable". The nature of this ground disturbance would significantly reduce the likelihood that Aboriginal archaeological sites will be retained within the Study Area. As such, no additional archaeological investigation is required to comply with the requirement of the Due Diligence Code of Practice (DECCW 2010A). Photos of the Study Area are provide to inform this assessment (**Figure 17-Figure 20**).

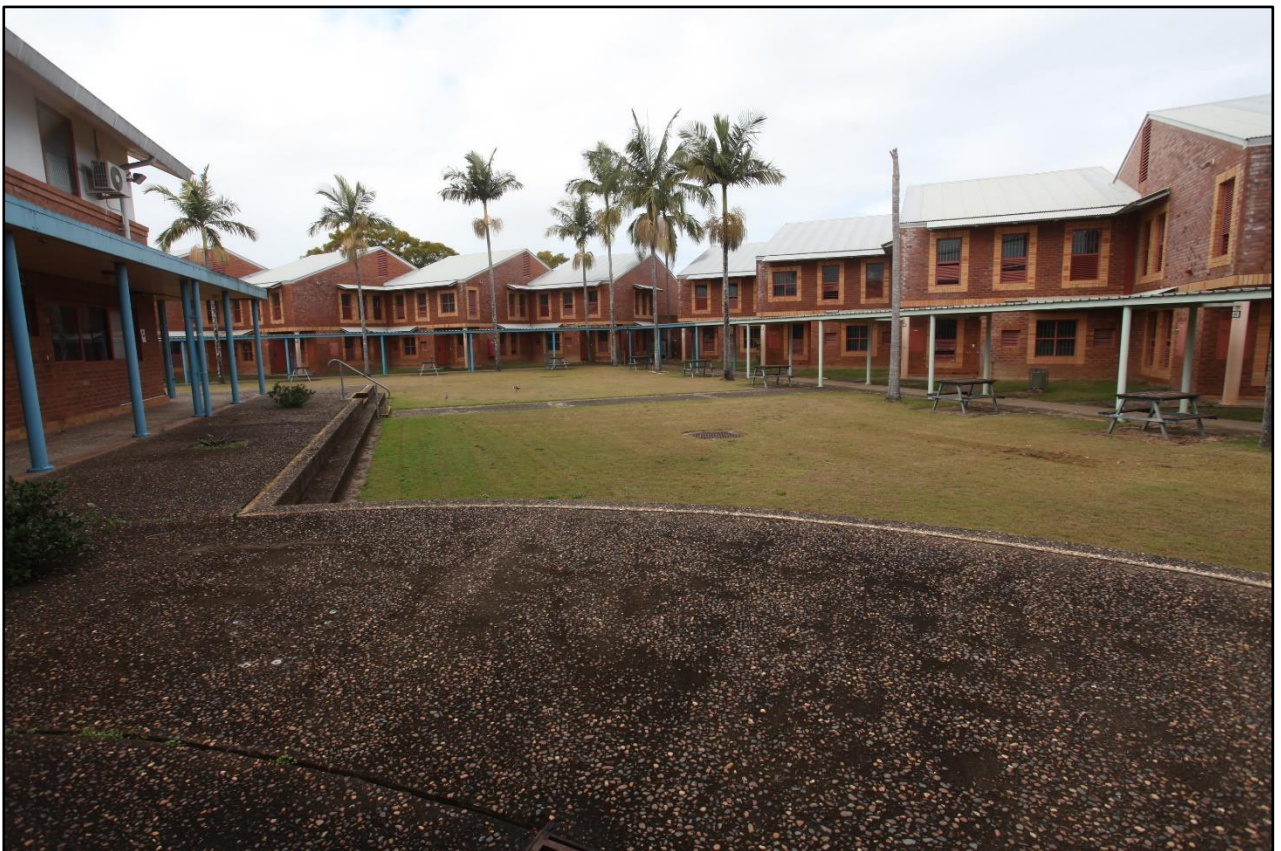
Figure 18: Grafton Correctional Facility- The internal courtyard south of Block B

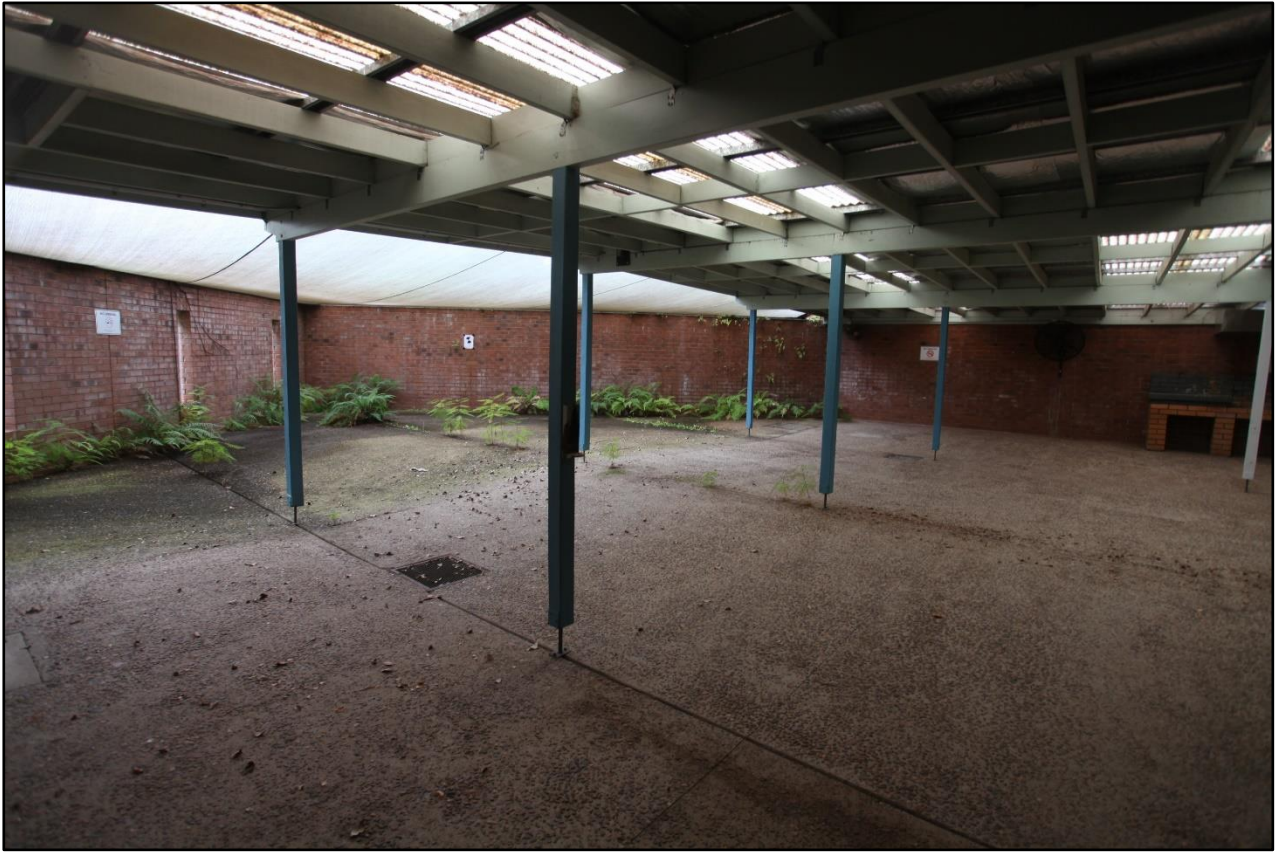
Figure 19: Grafton Correctional Facility- The former visitors courtyard

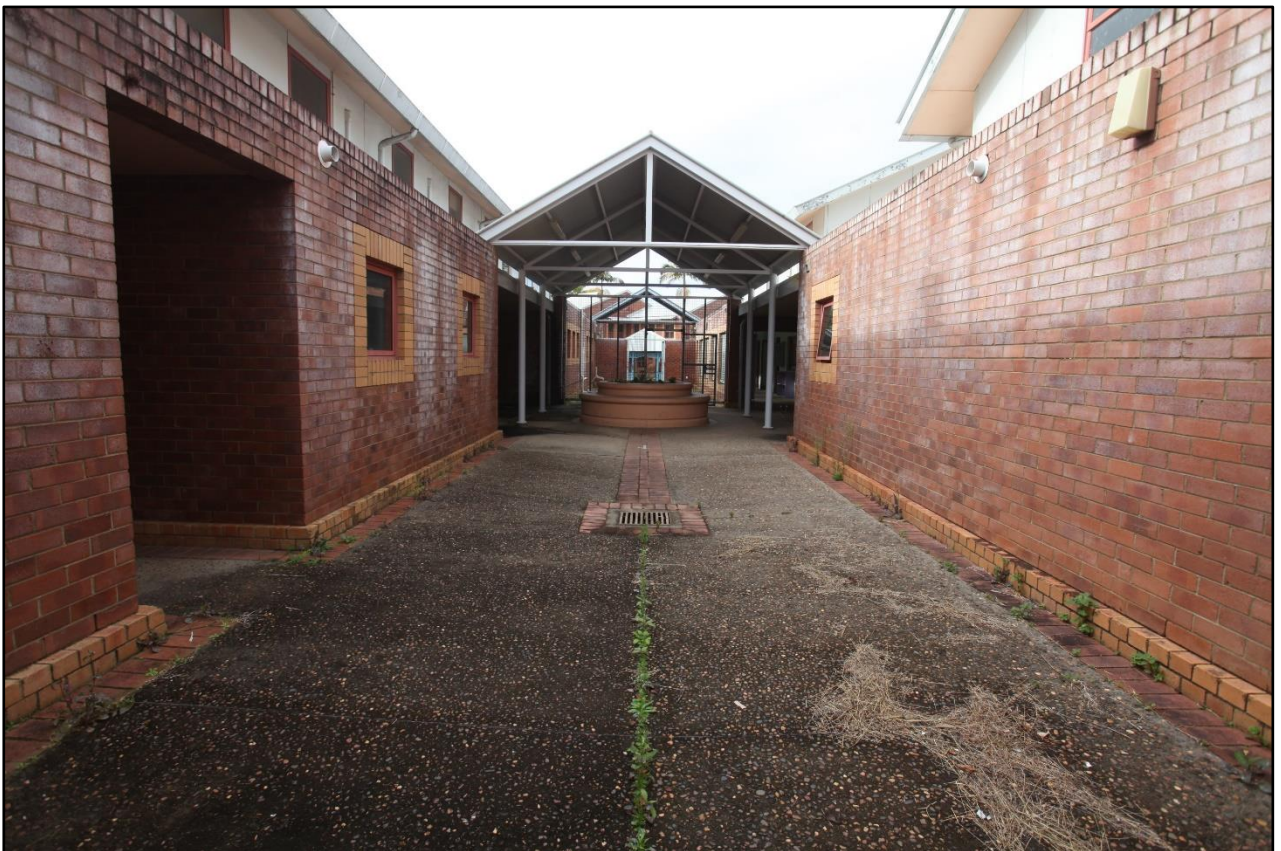
Figure 20: Grafton Correctional Facility- Example of typical ground finish between buildings

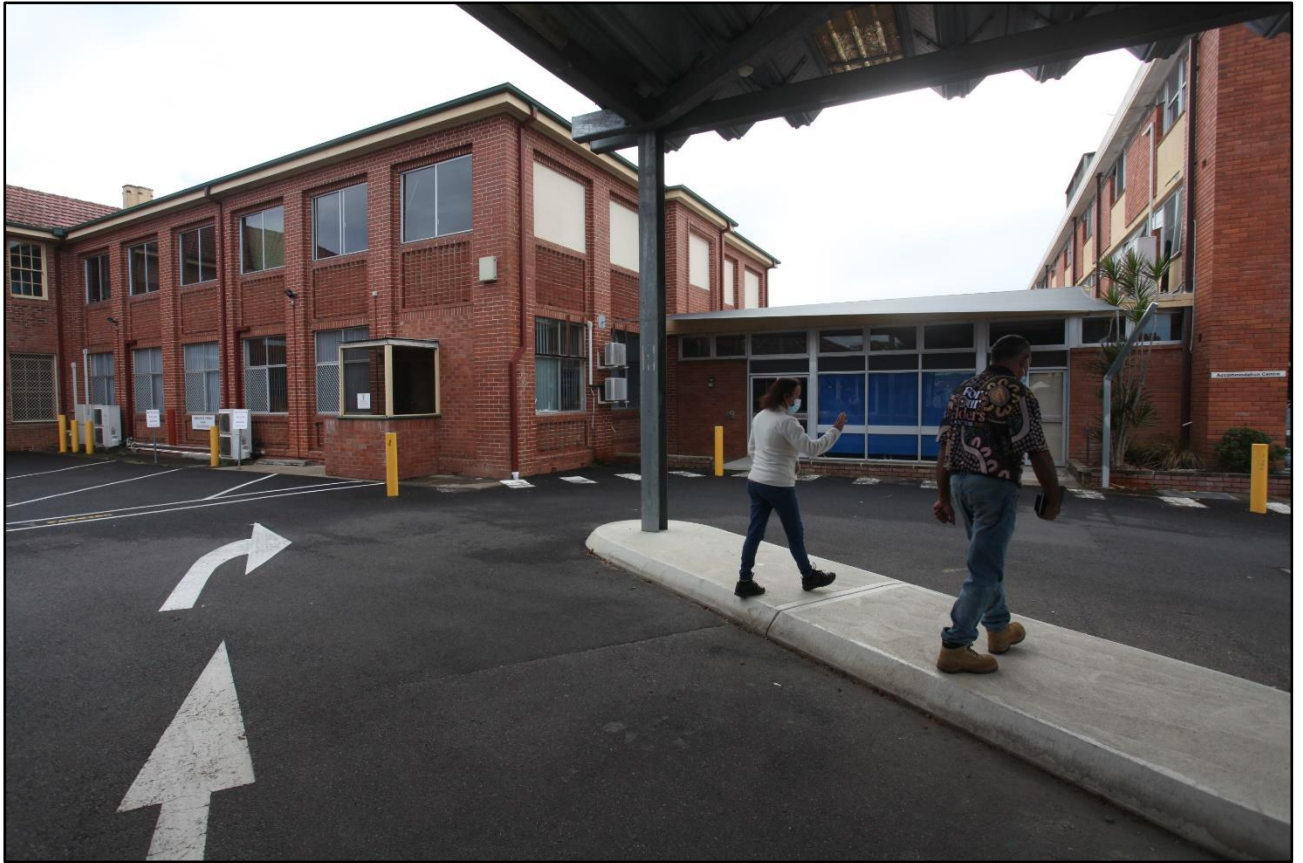
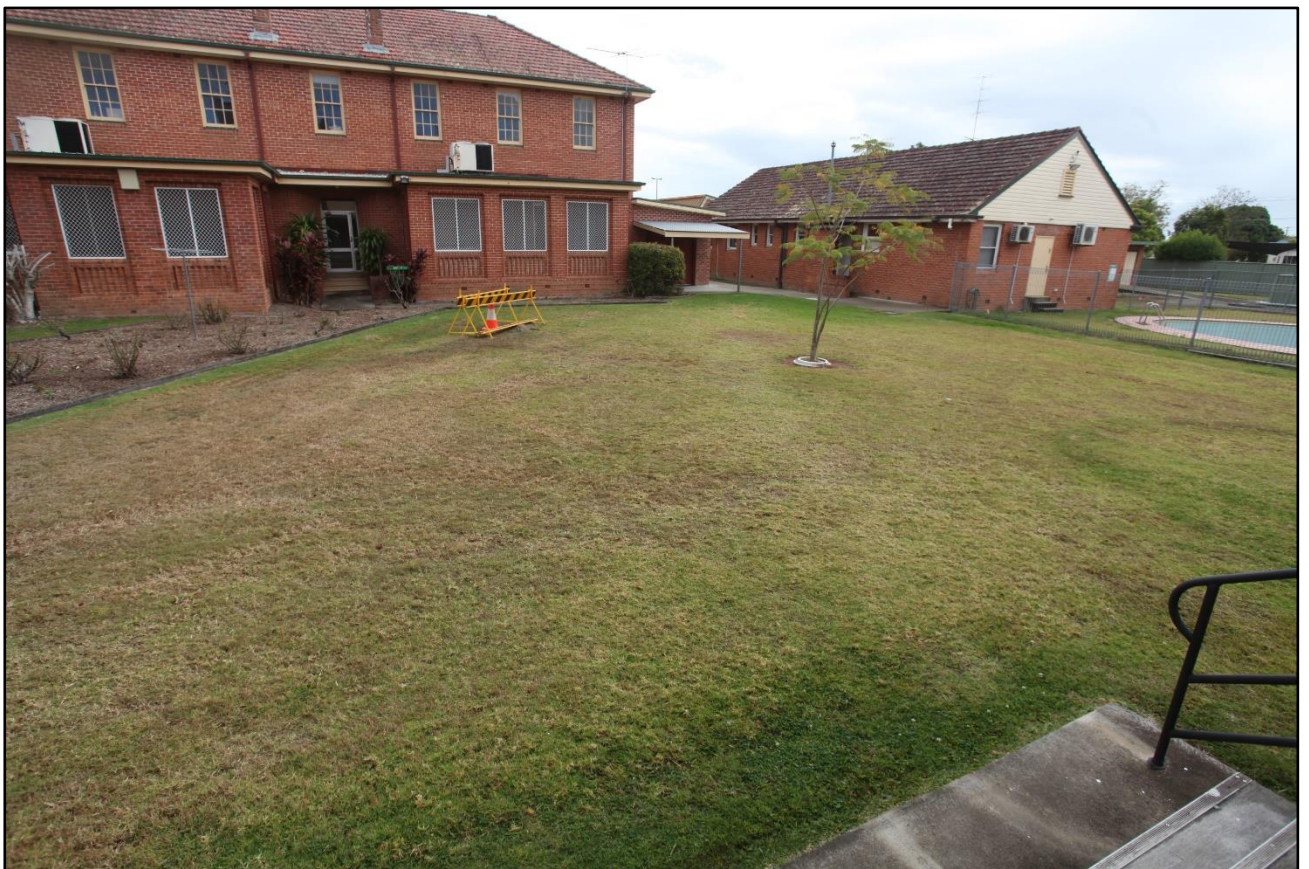
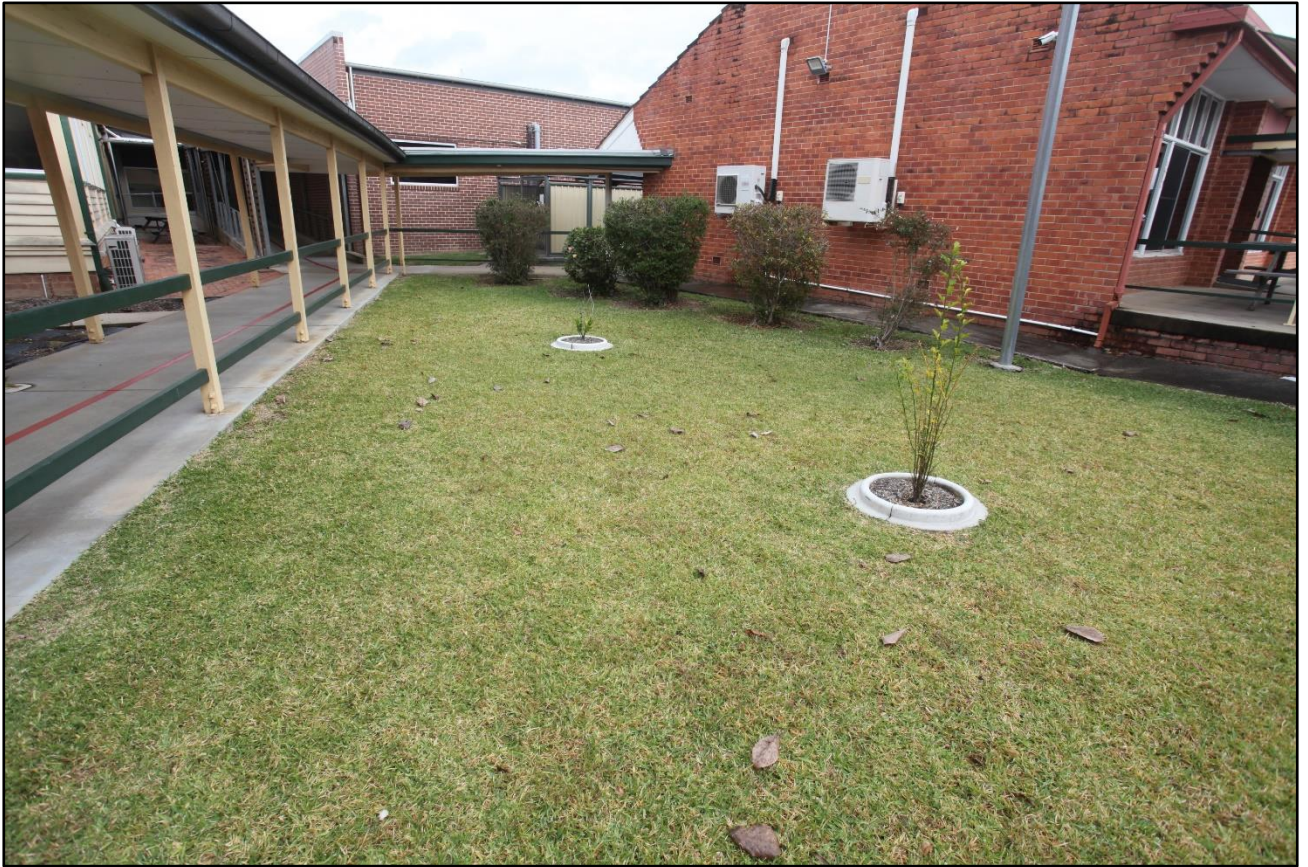
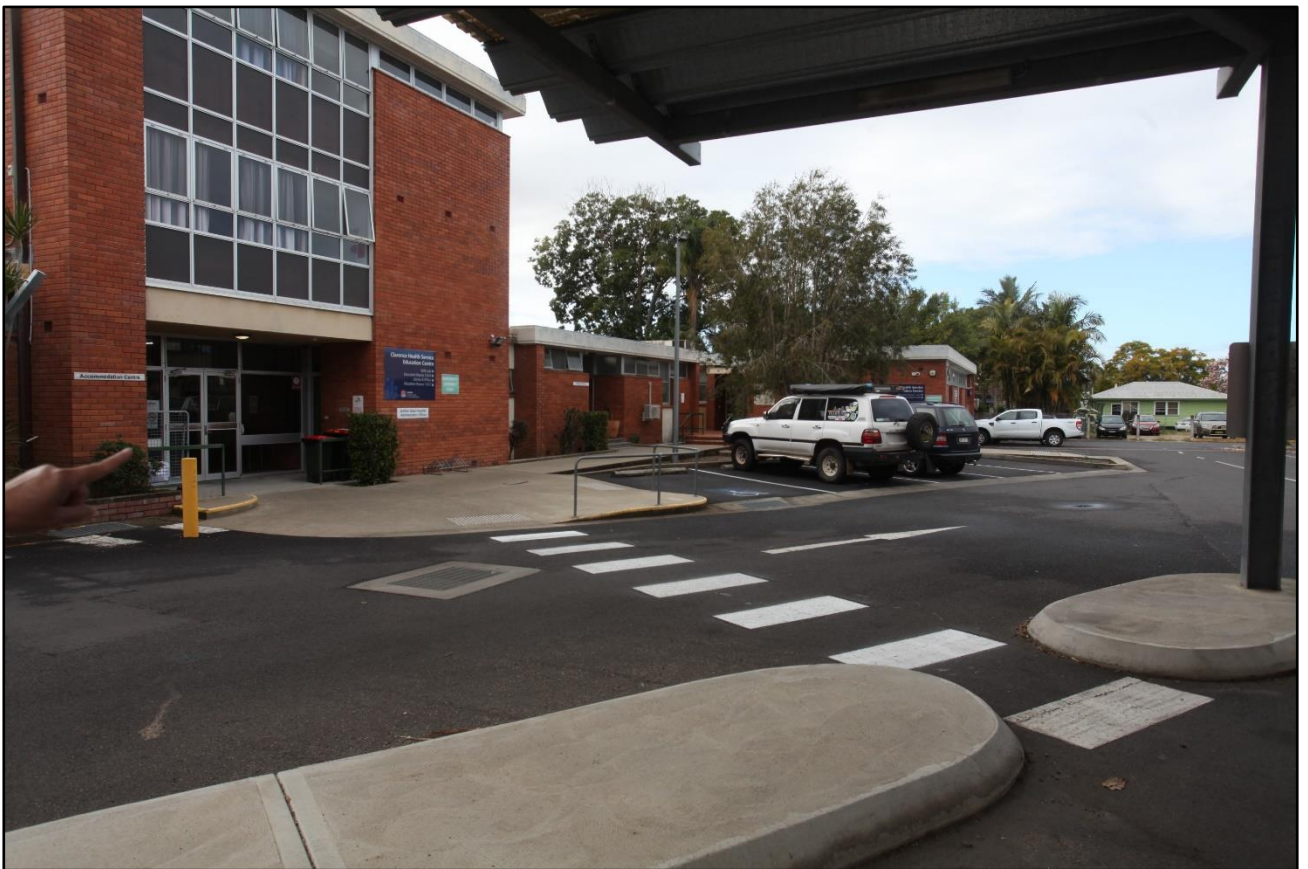
Figure 21: Grafton Base Hospital- Entrance to the former ward and nurses quarters- now bitumen.

Figure 22: Grafton Base Hospital- The old courtyard in front of the former wards and nurses quarters

Figure 23: Grafton Base Hospital- A small garden behind the former nurses quarters

Figure 24: Grafton Base Hospital- Typical bitumen road and parking off Arthur Street

Based on the review of historical aerial photos it is reasonable to proceed with the assessment on the basis that the Grafton Base Hospital has been subject to significance ground disturbance as defined by the Due Diligence Code of Conduct, being disturbance that is "clear and observable". The nature of this ground disturbance would significantly reduce the likelihood that Aboriginal archaeological sites will be retained within the Study Area. As such, no additional archaeological investigation is required to comply with the requirement of the Due Diligence Code of Practice (DECCW 2010A). Photos of the Study Area are provide to inform this assessment (**Figure 21- Figure 24**).
