Remediation Action Plan

Tamworth Regional Aquatic Centre

Jack Smyth Drive, Hillvue NSW

Project 226965.01

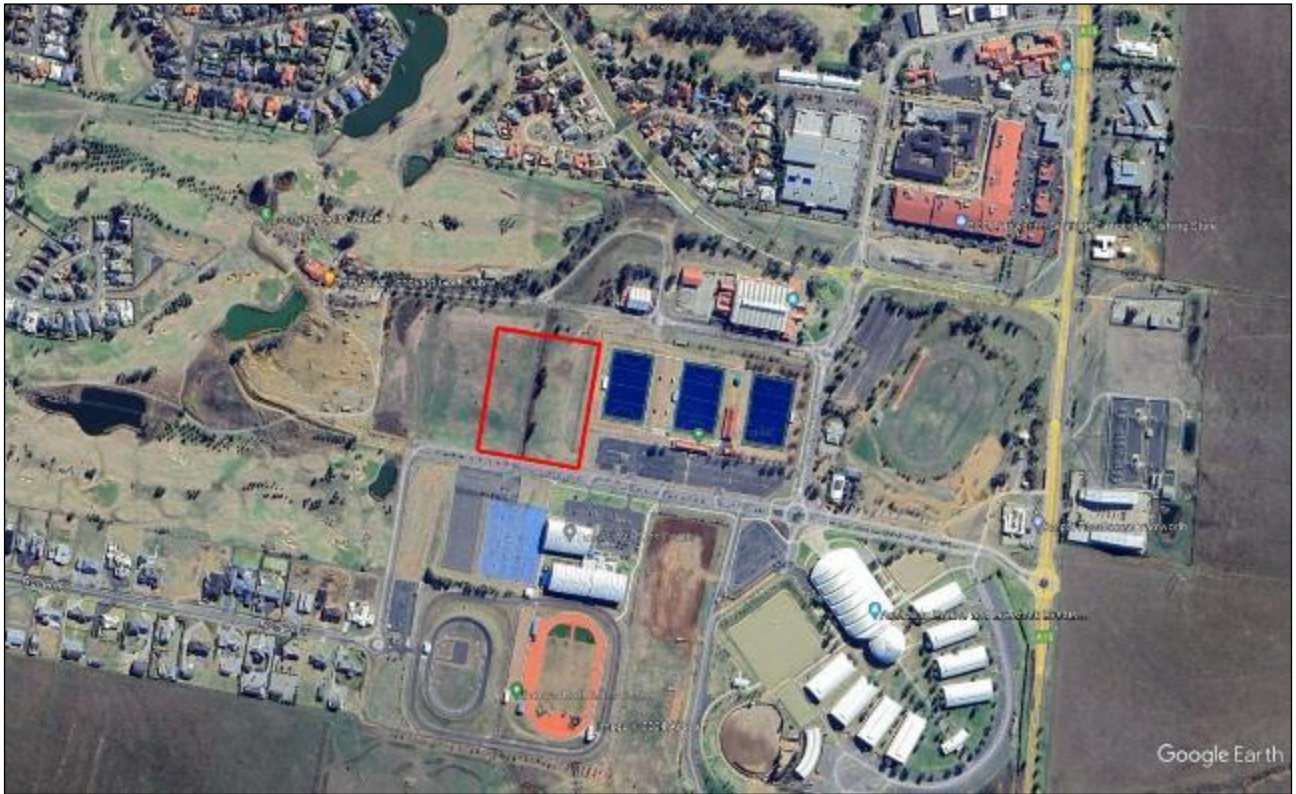
Figure 1: Approximate site extent, shown in red

The approximate site extent/development area is shown on Figure 1.

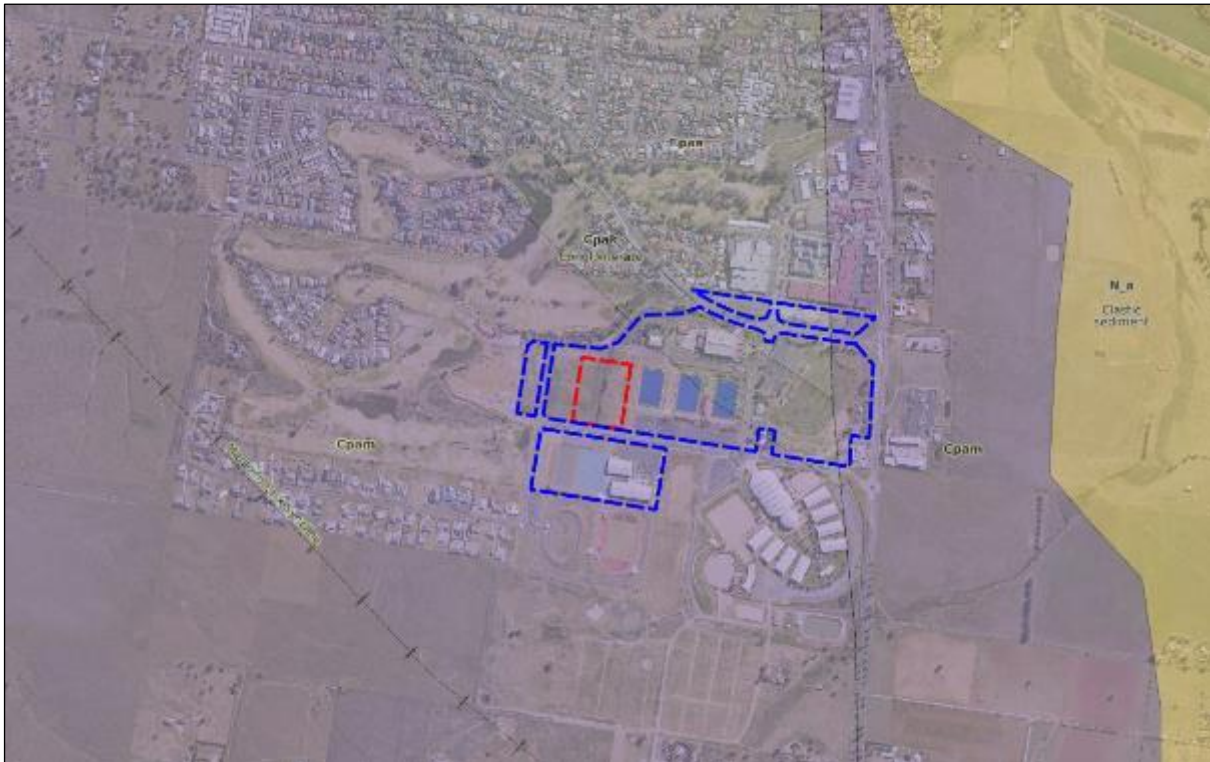
Figure 2: Seamless geology dataset with approximate site location (red outline) within the greater facility location (blue outline)

Likely groundwater flow would be to the north to north-west towards Barnes Gully approximately 500 m north of the site.

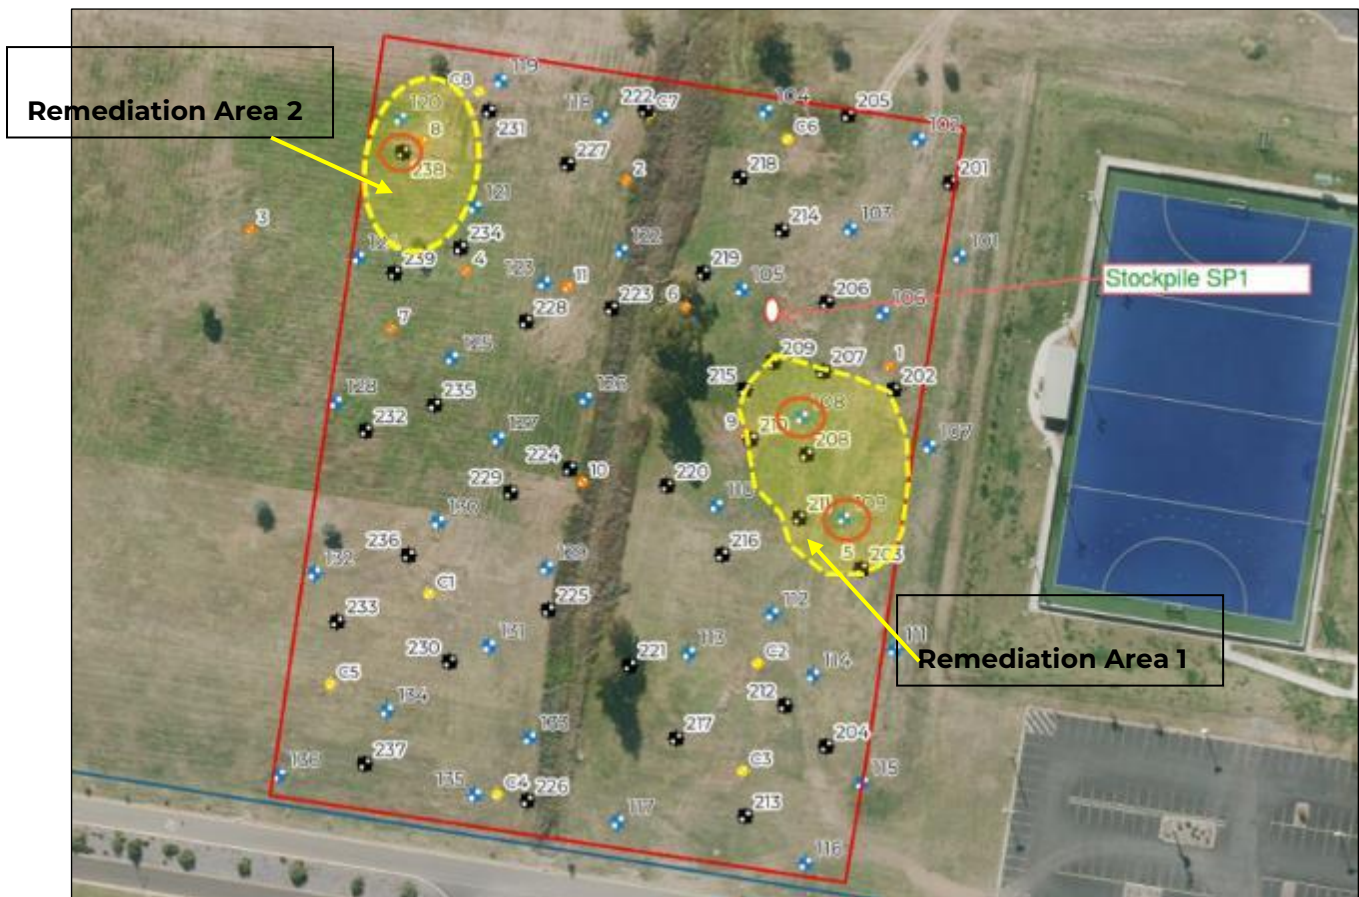
Figure 3: Approximate extent of Remediation Areas in yellow, Jack Smyth Drive, Hillvue NSW

The approximate extent of Remediation Areas, based on an interpretation of the available test pits and sampling data are shown on Figure 3 below. It is noted that as a conservative estimate, the area of impact was taken to be the closest 'clean' test location. ACM impact was observed in Pits 108, 109 and 238, with possible impact to approximately 1.4 m to 1.6 m depth based on the impacted fill depth. The actual extent (ie the final remediation extent) will be established during excavation of the areas (ie under full time inspection).

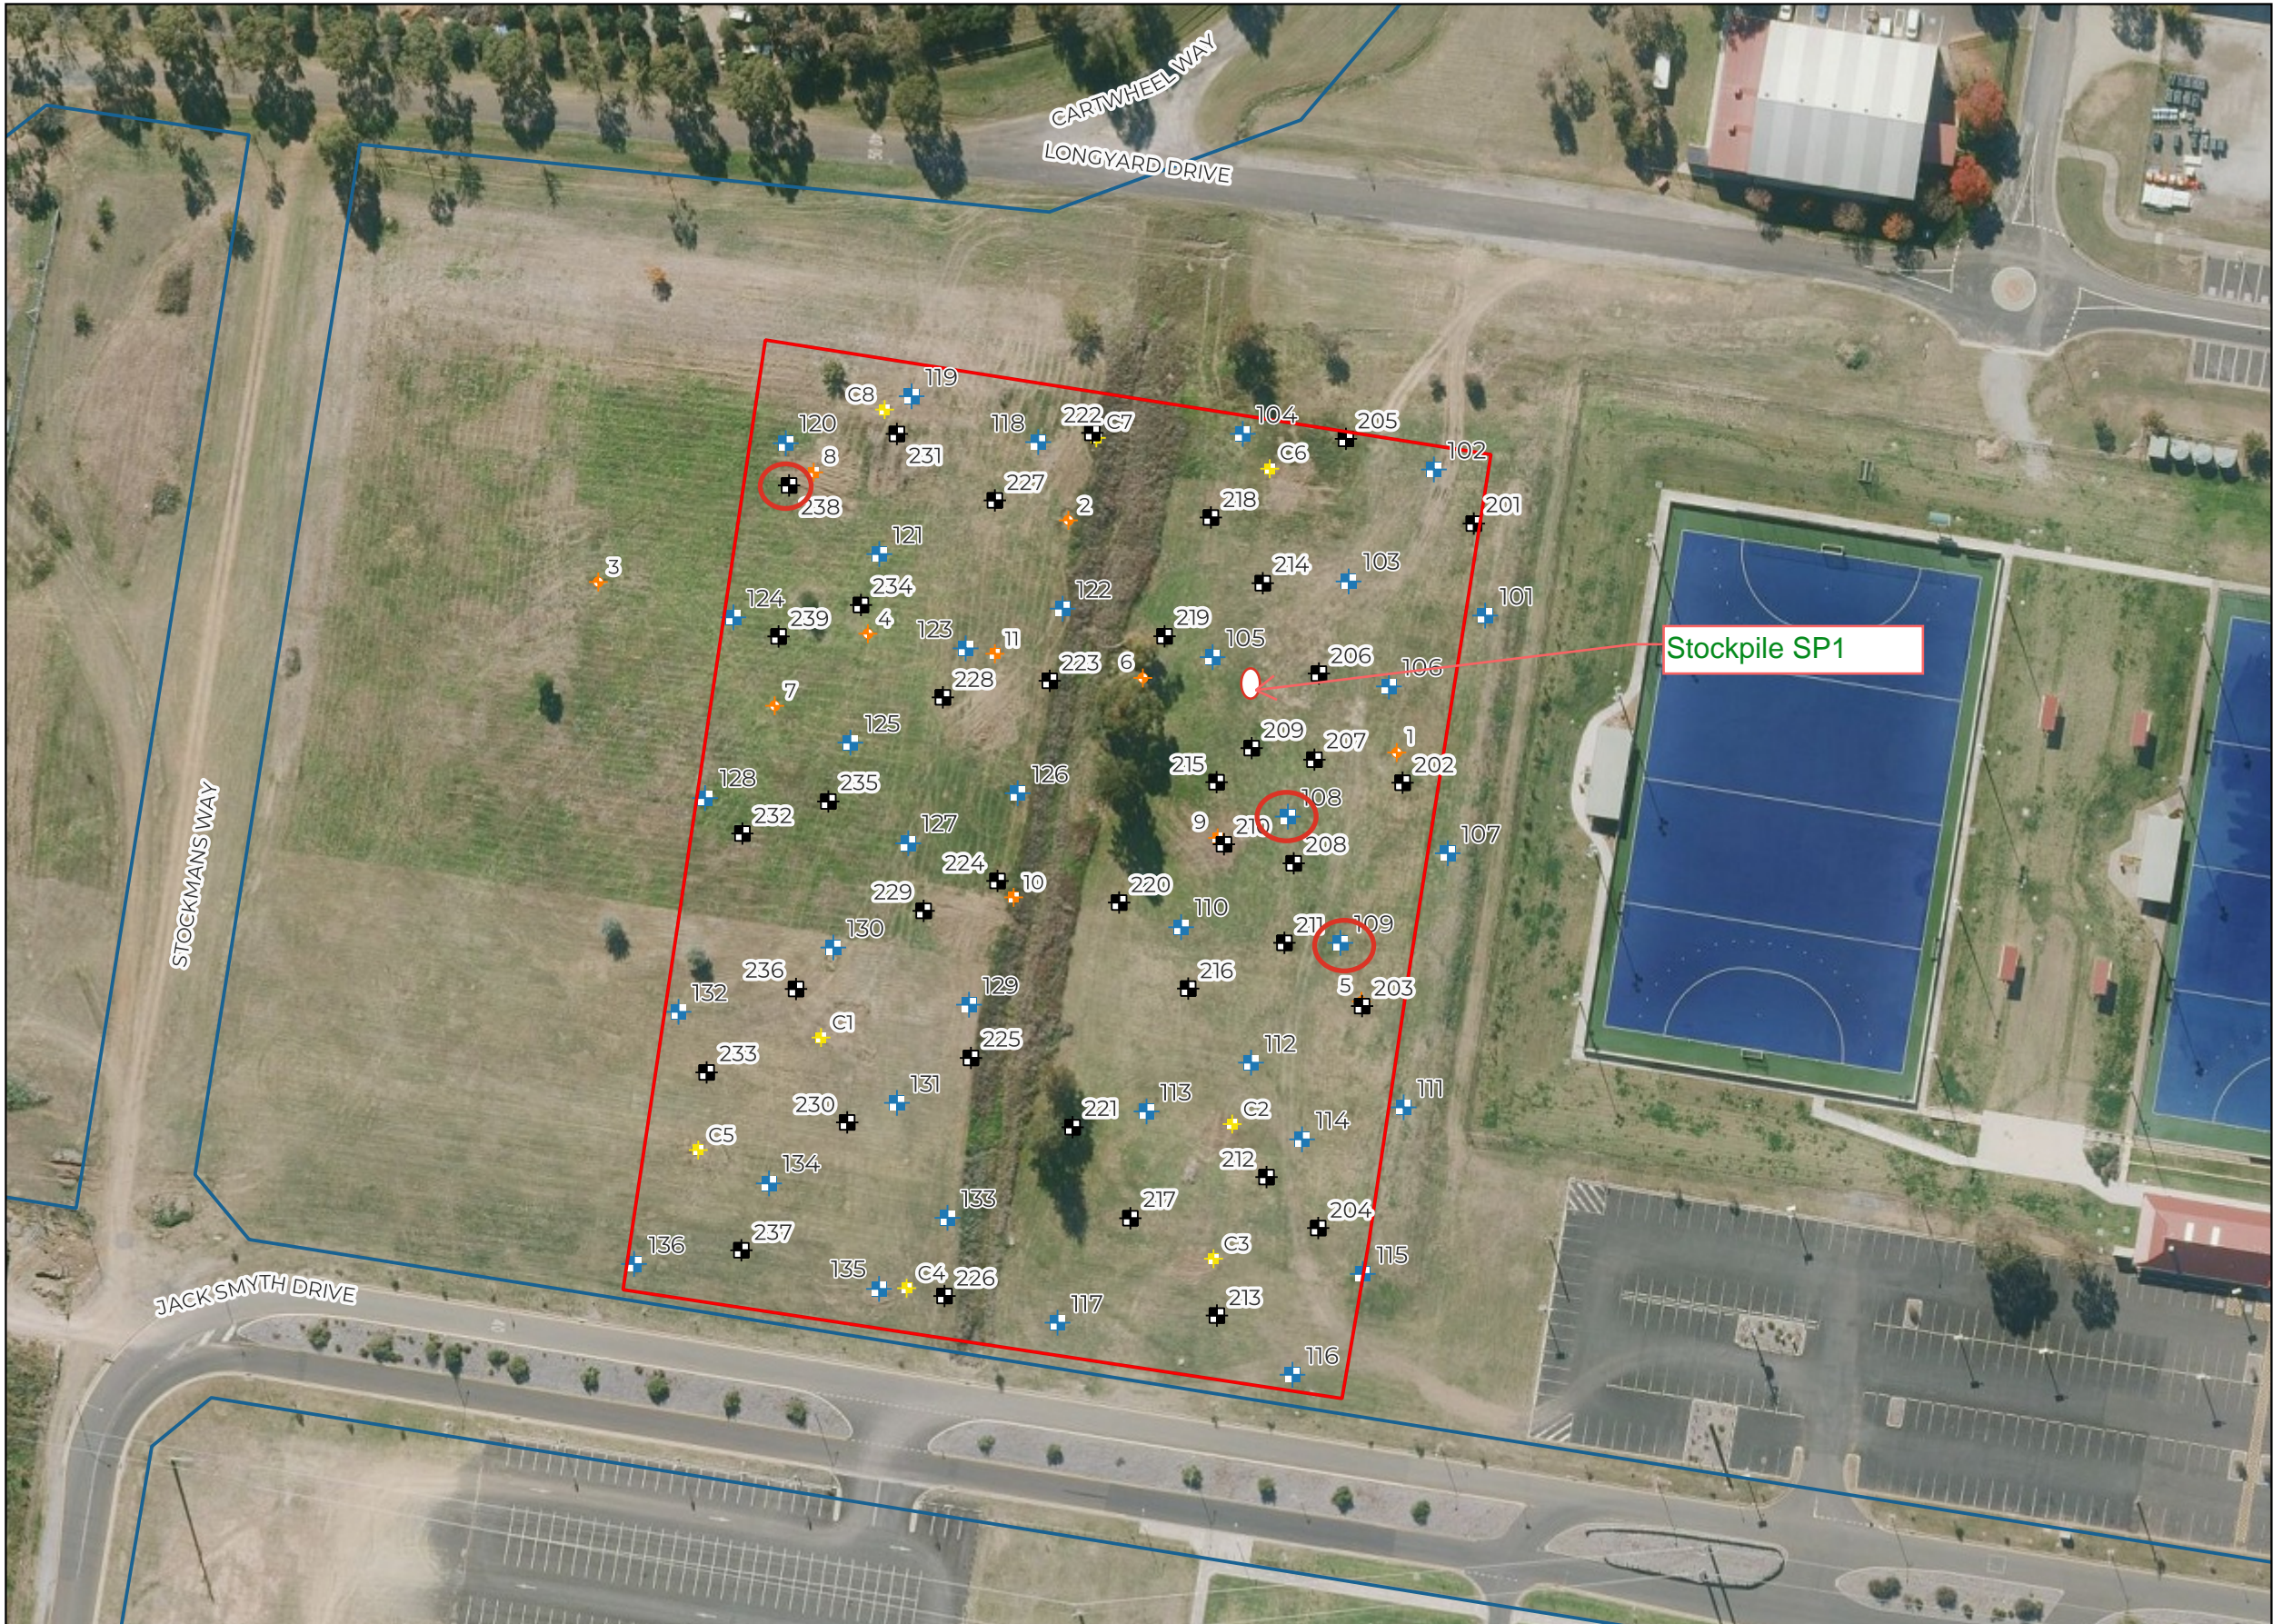
Drawing 1 – Test Location Plan

location of confirmed asbestos containing materials
