# Detailed Site Investigation

Sellicks Dip  
44 Bristol Circuit, Goonellabah NSW

June 2023, Ref. 22030

Detailed Site Investigation

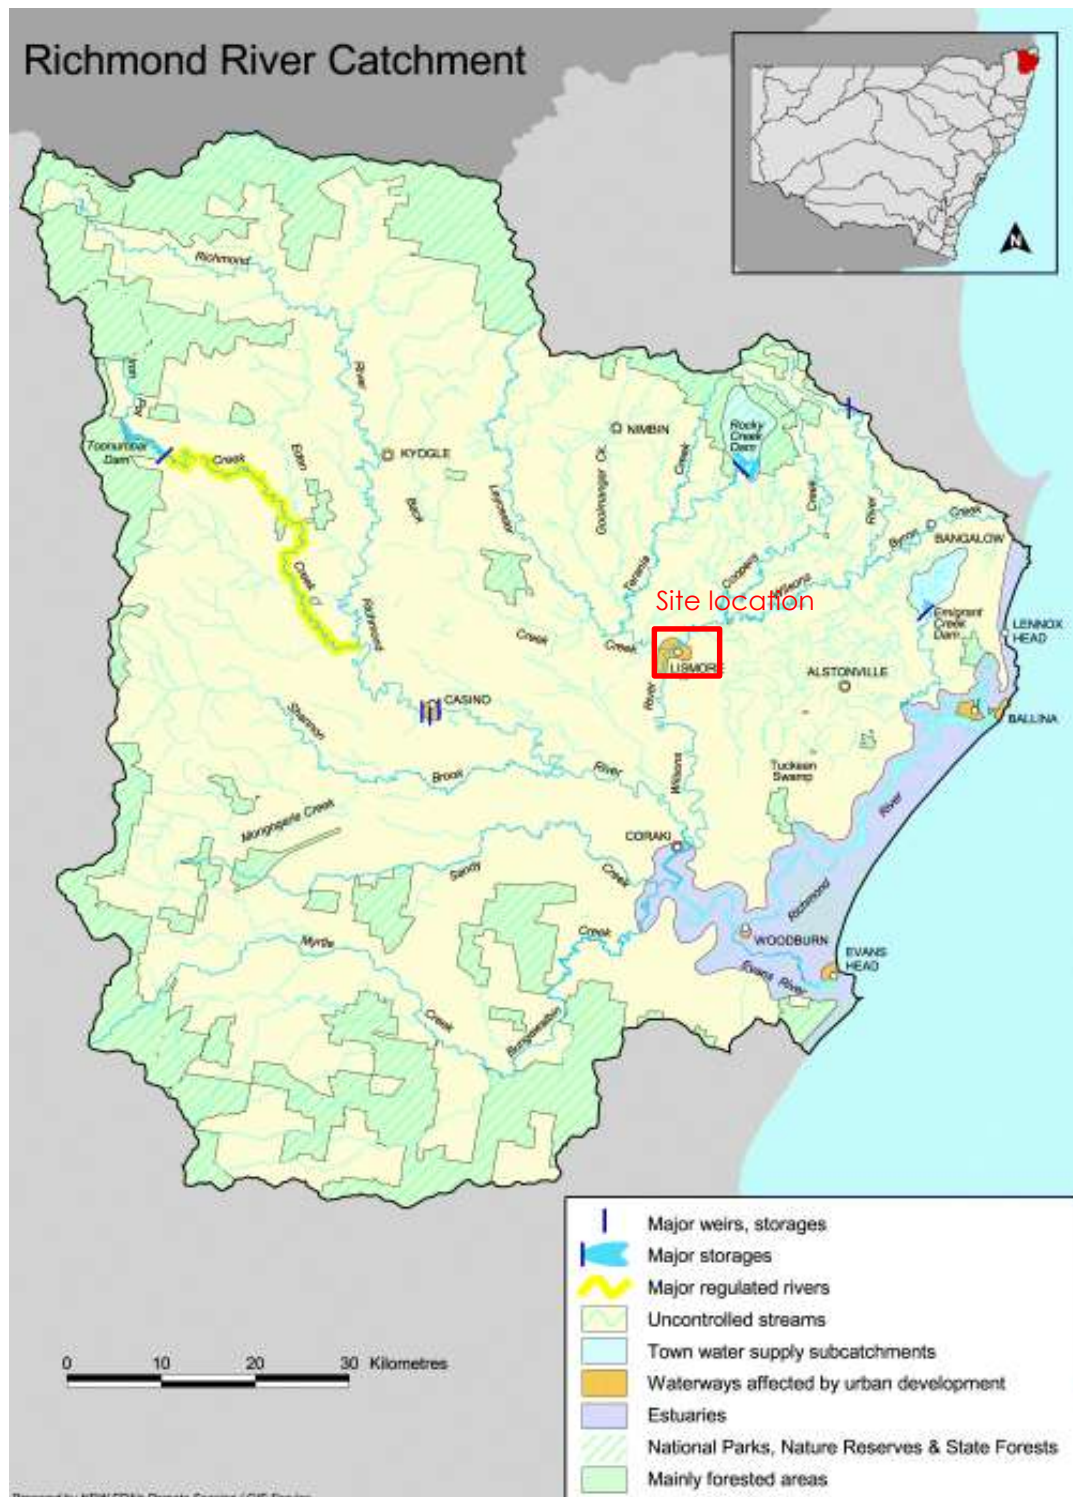
The Richmond River Catchment is shown below in Figure 2.1. As can be seen, the site is in an area of *uncontrolled streams* and *waterways affected by urban development*, with specific WQOs for each shown below:

**Figure 2.1: WQOs for the Richmond River Catchment**  
(Source: [Richmond River catchment map \(nsw.gov.au\)](http://Richmond River catchment map (nsw.gov.au)))

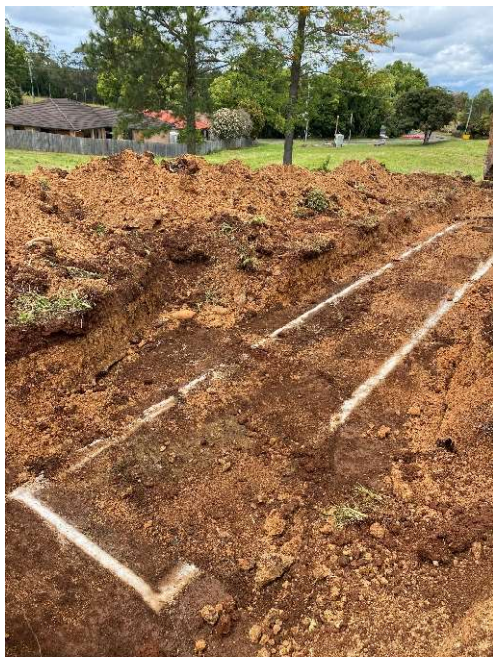
The following summarises the subsurface conditions related to the dip bath, as observed during the preliminary dip bath investigation, with photographs shown in Plates 8.1 and 8.2:

- The dip bath was located approximately 12 m west of Bristol Circuit, measured from the from road gutter.

**Plate 8.1: Top of the dip bath. The imported fill/cap profile is visible above.**

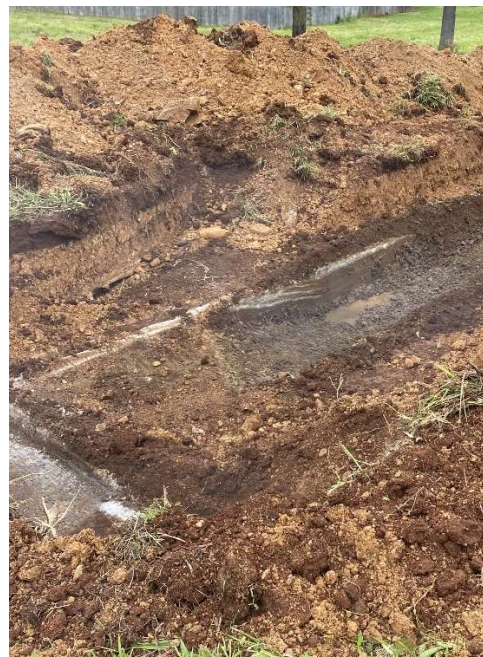
**Plate 8.2: Northern end of dip bath showing exposed saturated gravel contents**

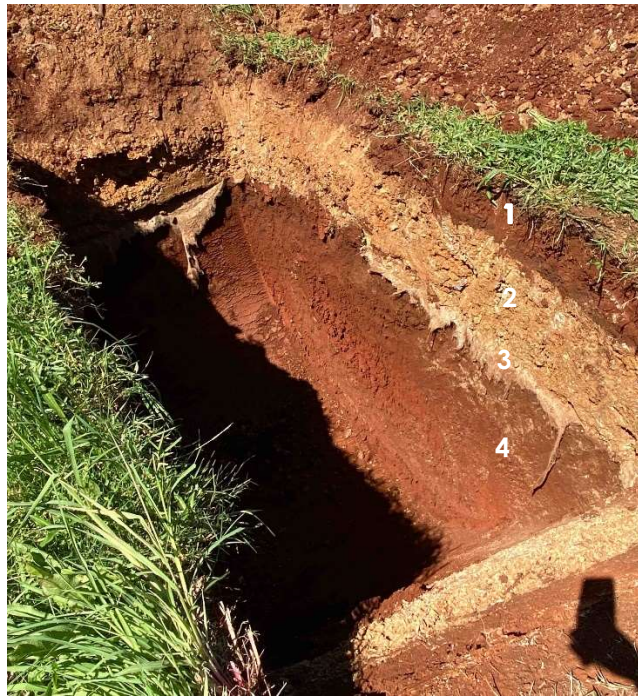
**Plate 8.3: General profile across dip bath area, TP04**

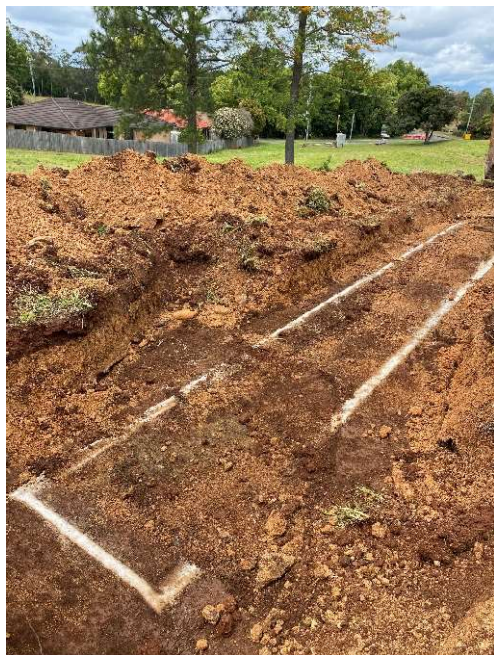
**Photograph 2.1: Top of the dip bath.**

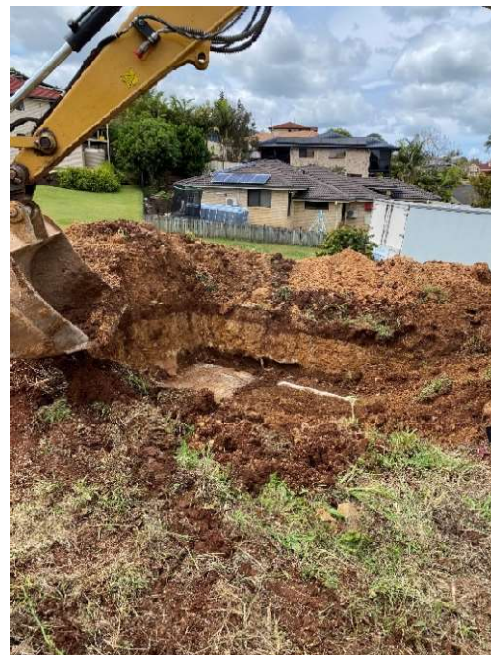
**Photograph 2.2: Northern end of dip bath and dip pad exposed, with imported fill profile visible above.**

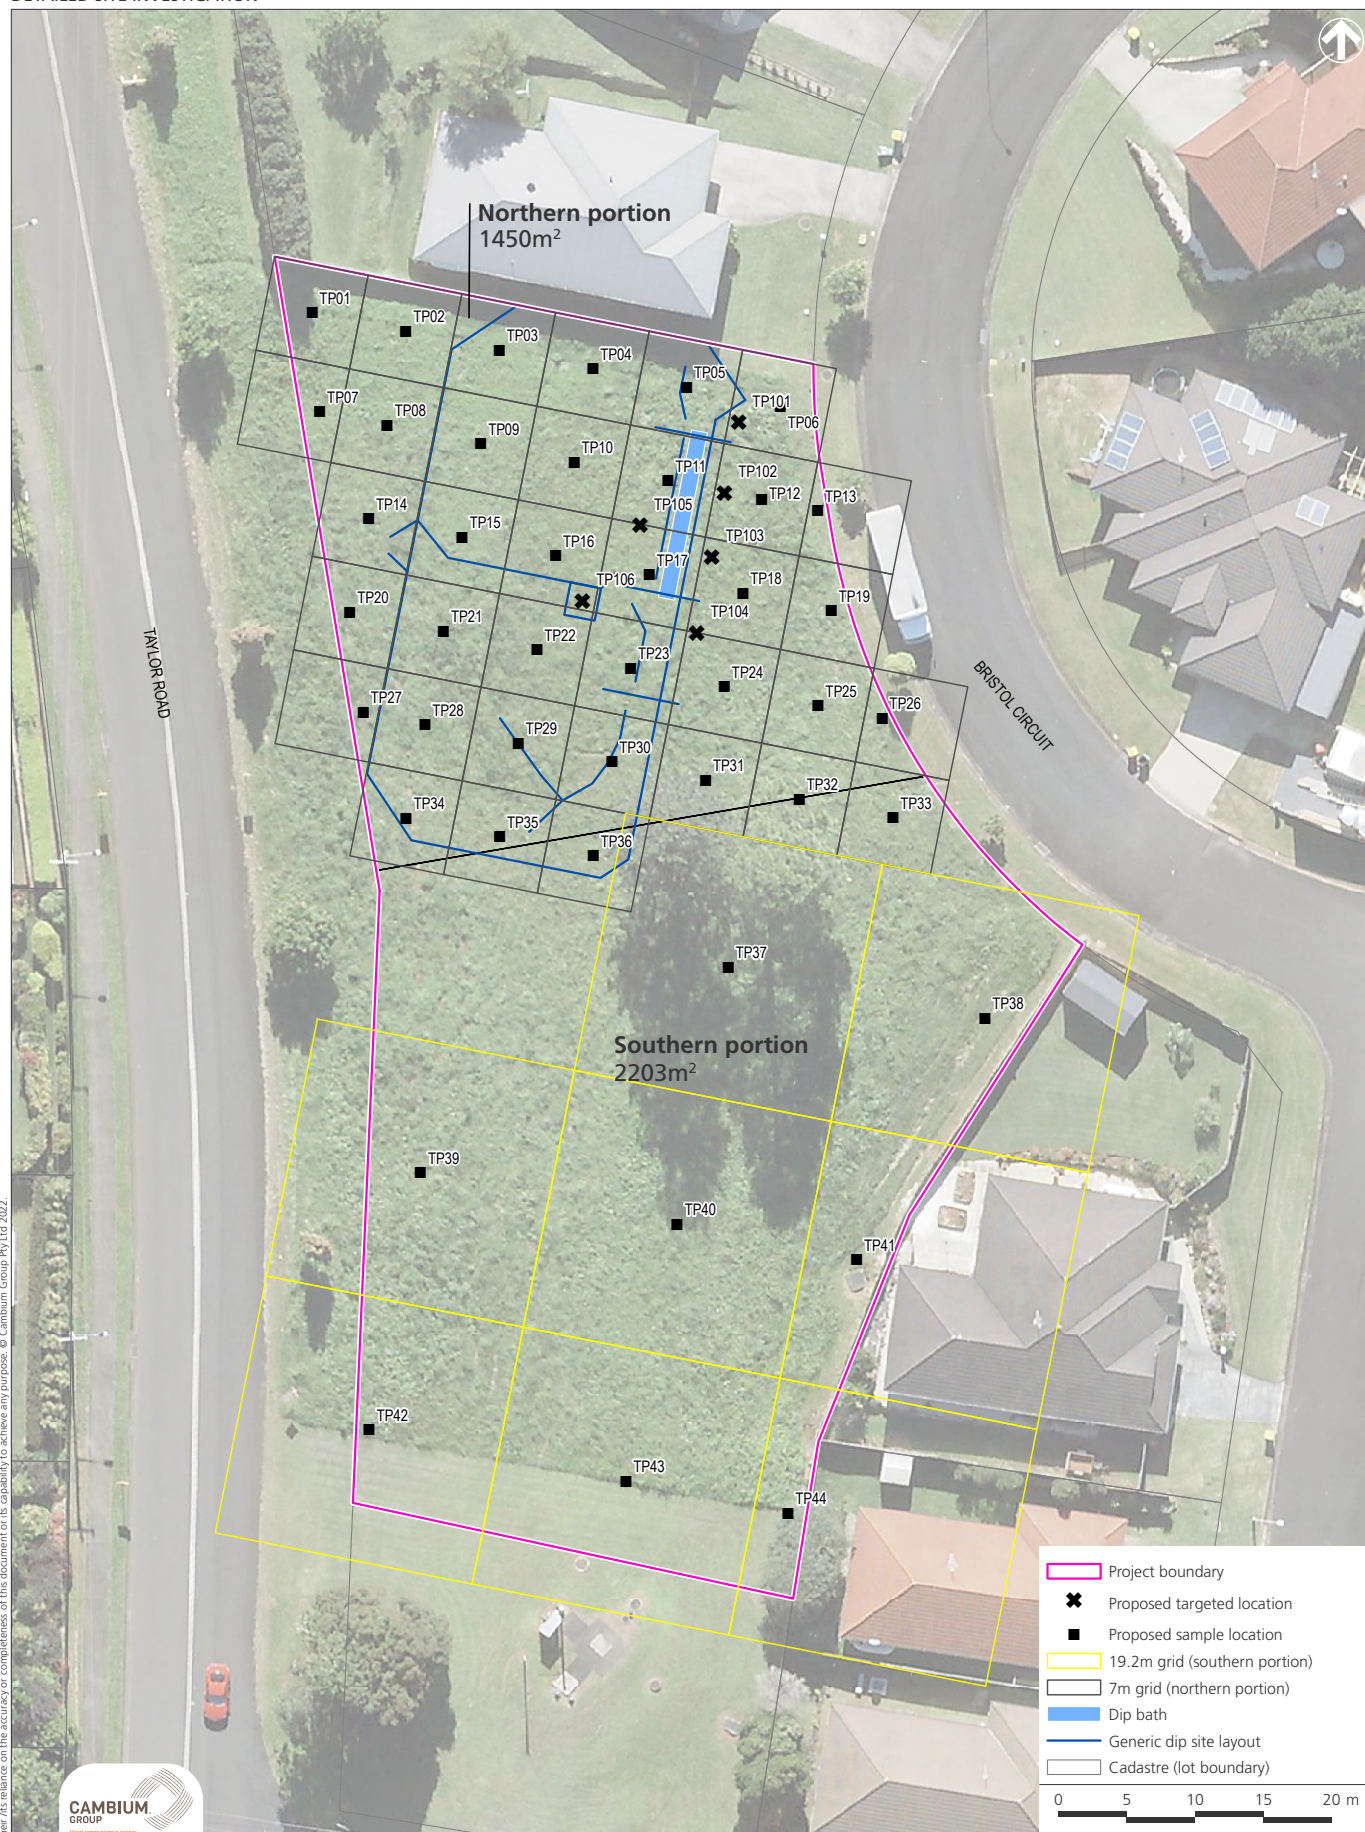
Figure 3  
Proposed sample locations

Based on the site history and use of the site, the site has been stratified, denoted the 'Northern Portion' which encompasses the dip bath, and the 'Southern Portion', where no contaminating activities have been identified to date. The stratified areas are shown in Figure 2, and grid and targeted sampling locations are shown in Figure 3, attached.

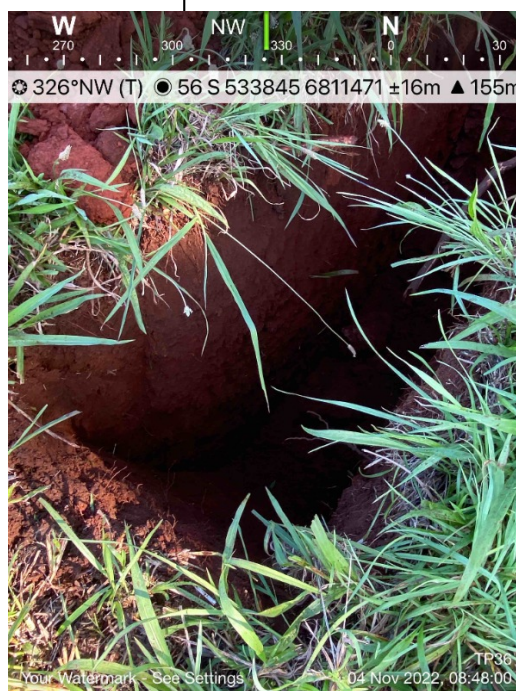
## ENVIRONMENTAL TESTPIT TP37

| Depth (m) | Samples | Graphic Log | USCS | Material Description | Additional Observations |
|---|---|---|---|---|---|
| 0.5 | TP37_0.0 - 0.1 | | | Grassy surface.<br>Dark reddish brown clay loam, with weakened basalt gravels. | Worn piece of tarpaulin. |

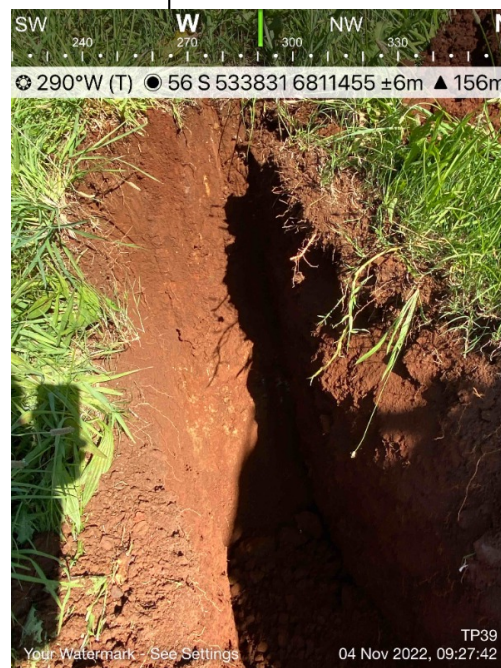
# ENVIRONMENTAL TESTPIT TP40

| Depth (m) | Samples | Graphic Log | USCS | Material Description | Additional Observations |
|---|---|---|---|---|---|
| 0.9 - 1.4 | | | | Moist, lighter brown clays. | |

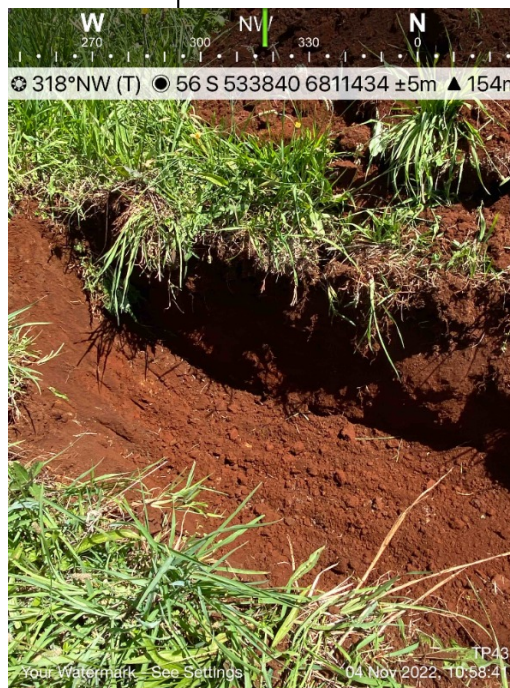
## ENVIRONMENTAL TESTPIT TP44

| Depth (m) | Samples | Graphic Log | USCS | Material Description | Additional Observations |
|---|---|---|---|---|---|
| | | | | Brown silty clay, with light grey/orange/dark grey mottling. Moist to wet. | |

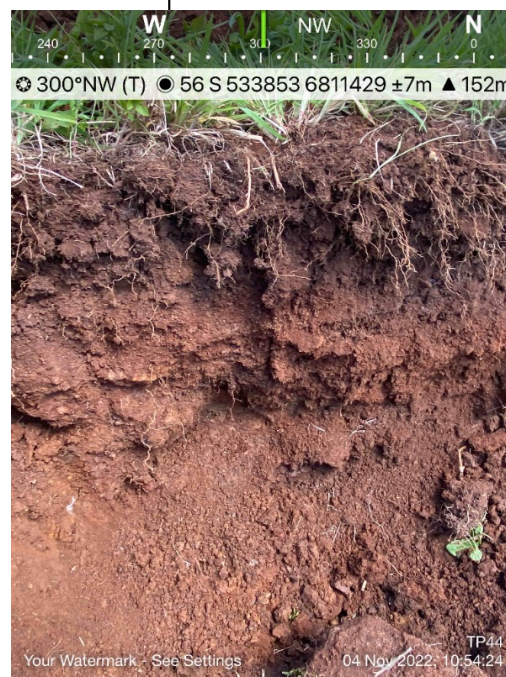
# ENVIRONMENTAL TESTPIT TP101 - Targeted

| Depth (m) | Samples | Graphic Log | USCS | Material Description | Additional Observations |
|---|---|---|---|---|---|
| 0.5 | TP101_0.7 - 0.8<br>TP101_D (bath drain pipe targeted sample) | | FILL | Capping layer: Tan gravelly clay capping layer.<br>Geofabric layer. | Very strong cattle odour.<br>O-ring from drum , loose wire. |
| 1 | TP101_1.3 - 1.4<br>(0.5 m below top of bath) | | | Brown silty clay, less dense.<br>Moist.<br>Area next to bath drain pipe:<br>Dark brown sandy clay, moist, strong odour. | Very strong cattle odour.<br>Top of dip bath on western edge of TP at 0.7 m.<br>Metal drain pipe near top of bath in concrete. Sample taken 20 cm from top of concrete. |

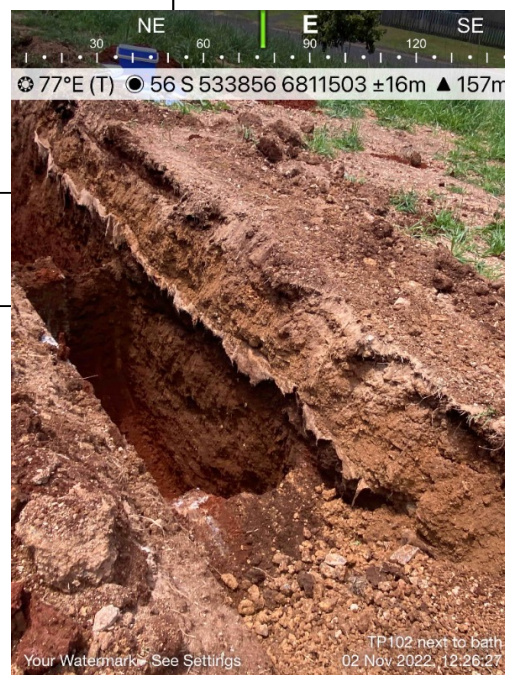
# ENVIRONMENTAL TESTPIT TP103

| Depth (m) | Samples | Graphic Log | USCS | Material Description | Additional Observations |
|---|---|---|---|---|---|
| | TP103_2.7 - 2.8 | | | Grading to darker red clay.<br>Moist. | |

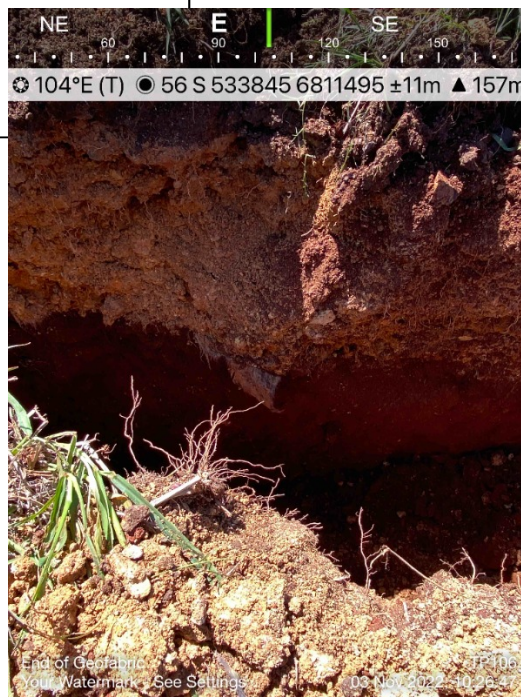
## ENVIRONMENTAL TESTPIT TP107

| Depth (m) | Samples | Graphic Log | USCS | Material Description | Additional Observations |
|---|---|---|---|---|---|
| | | | | EOH @ 1.3 m | Large, decomposing campher laurel root found at end of drip pad.<br>Strong campher laurel/menthol odour. |
