RE: Stringybark Solar Farm DA - 112-2019 - Request for additional information

Appendix A Intersection Concept Design

Stringybark Solar Farm Preliminary Site Investigation

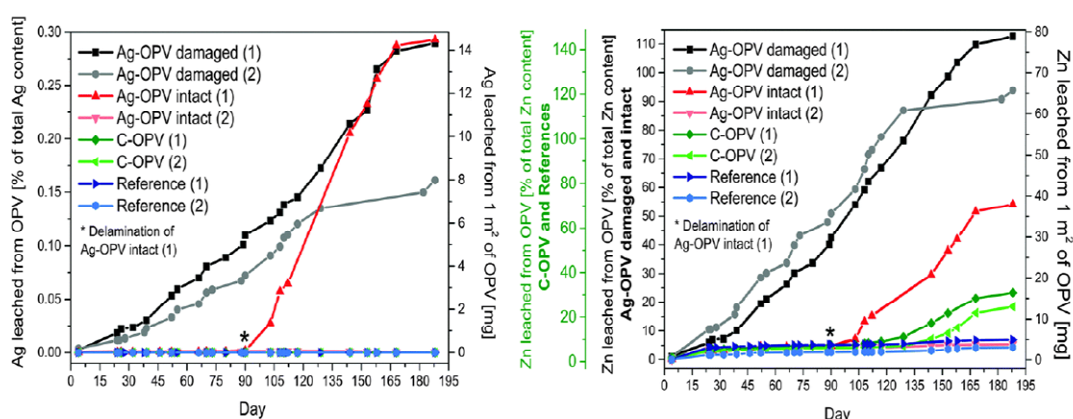
Figure 1: Cumulative silver (left) and zinc leaching from the samples in the rain run-off experiment conducted in duplicate. The amounts are expressed in mg per m² of Organic photovoltaics (OPV) (right axis) and the corresponding share of leached material (left axis).

Lastly, it should be noted that Organic Solar Panels (referred to in Figure 1 in the correspondence provided by Council) are not available for commercial use for utility scale solar farms due to a current lack of commercially viable technology and would not be considered for the Proposal.
