Geotechnical Investigation

24 Coronation Road, Congarinni North, NSW

Report No: E24901.G03

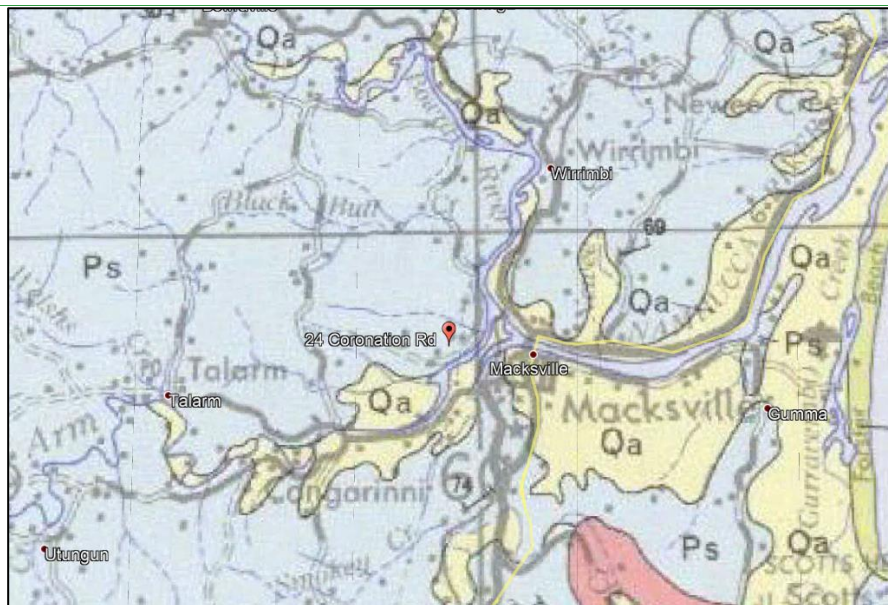
Plate 2: Excerpt of geological map showing location of site.

Attribute	Description
Topography	The site is located on the high west side of the road within gently (0° to 10°), to moderately (10° to 18°) north to northeast dipping, undulating topography. The site levels vary from R.L. 2.61m to R.L. 30.54m along the eastern site boundary and from R.L. 0.44m to R.L. 1.28m along the western site boundary.
Regional Geology	Information on regional sub-surface conditions, referenced from the Geological Survey of NSW and Geology Department, University of New England Geological Map Dorrigo – Coffs Harbour 1:250,000 Geological Series Sheet 56 – 10 & 11 (First Edition, 1971) indicates the site is underlain by Undifferentiated Formation (Ps), which typically comprises Slate, Phyllite, schistose Sandstone, schistose Conglomerate and basic Volcanics (Psb)..

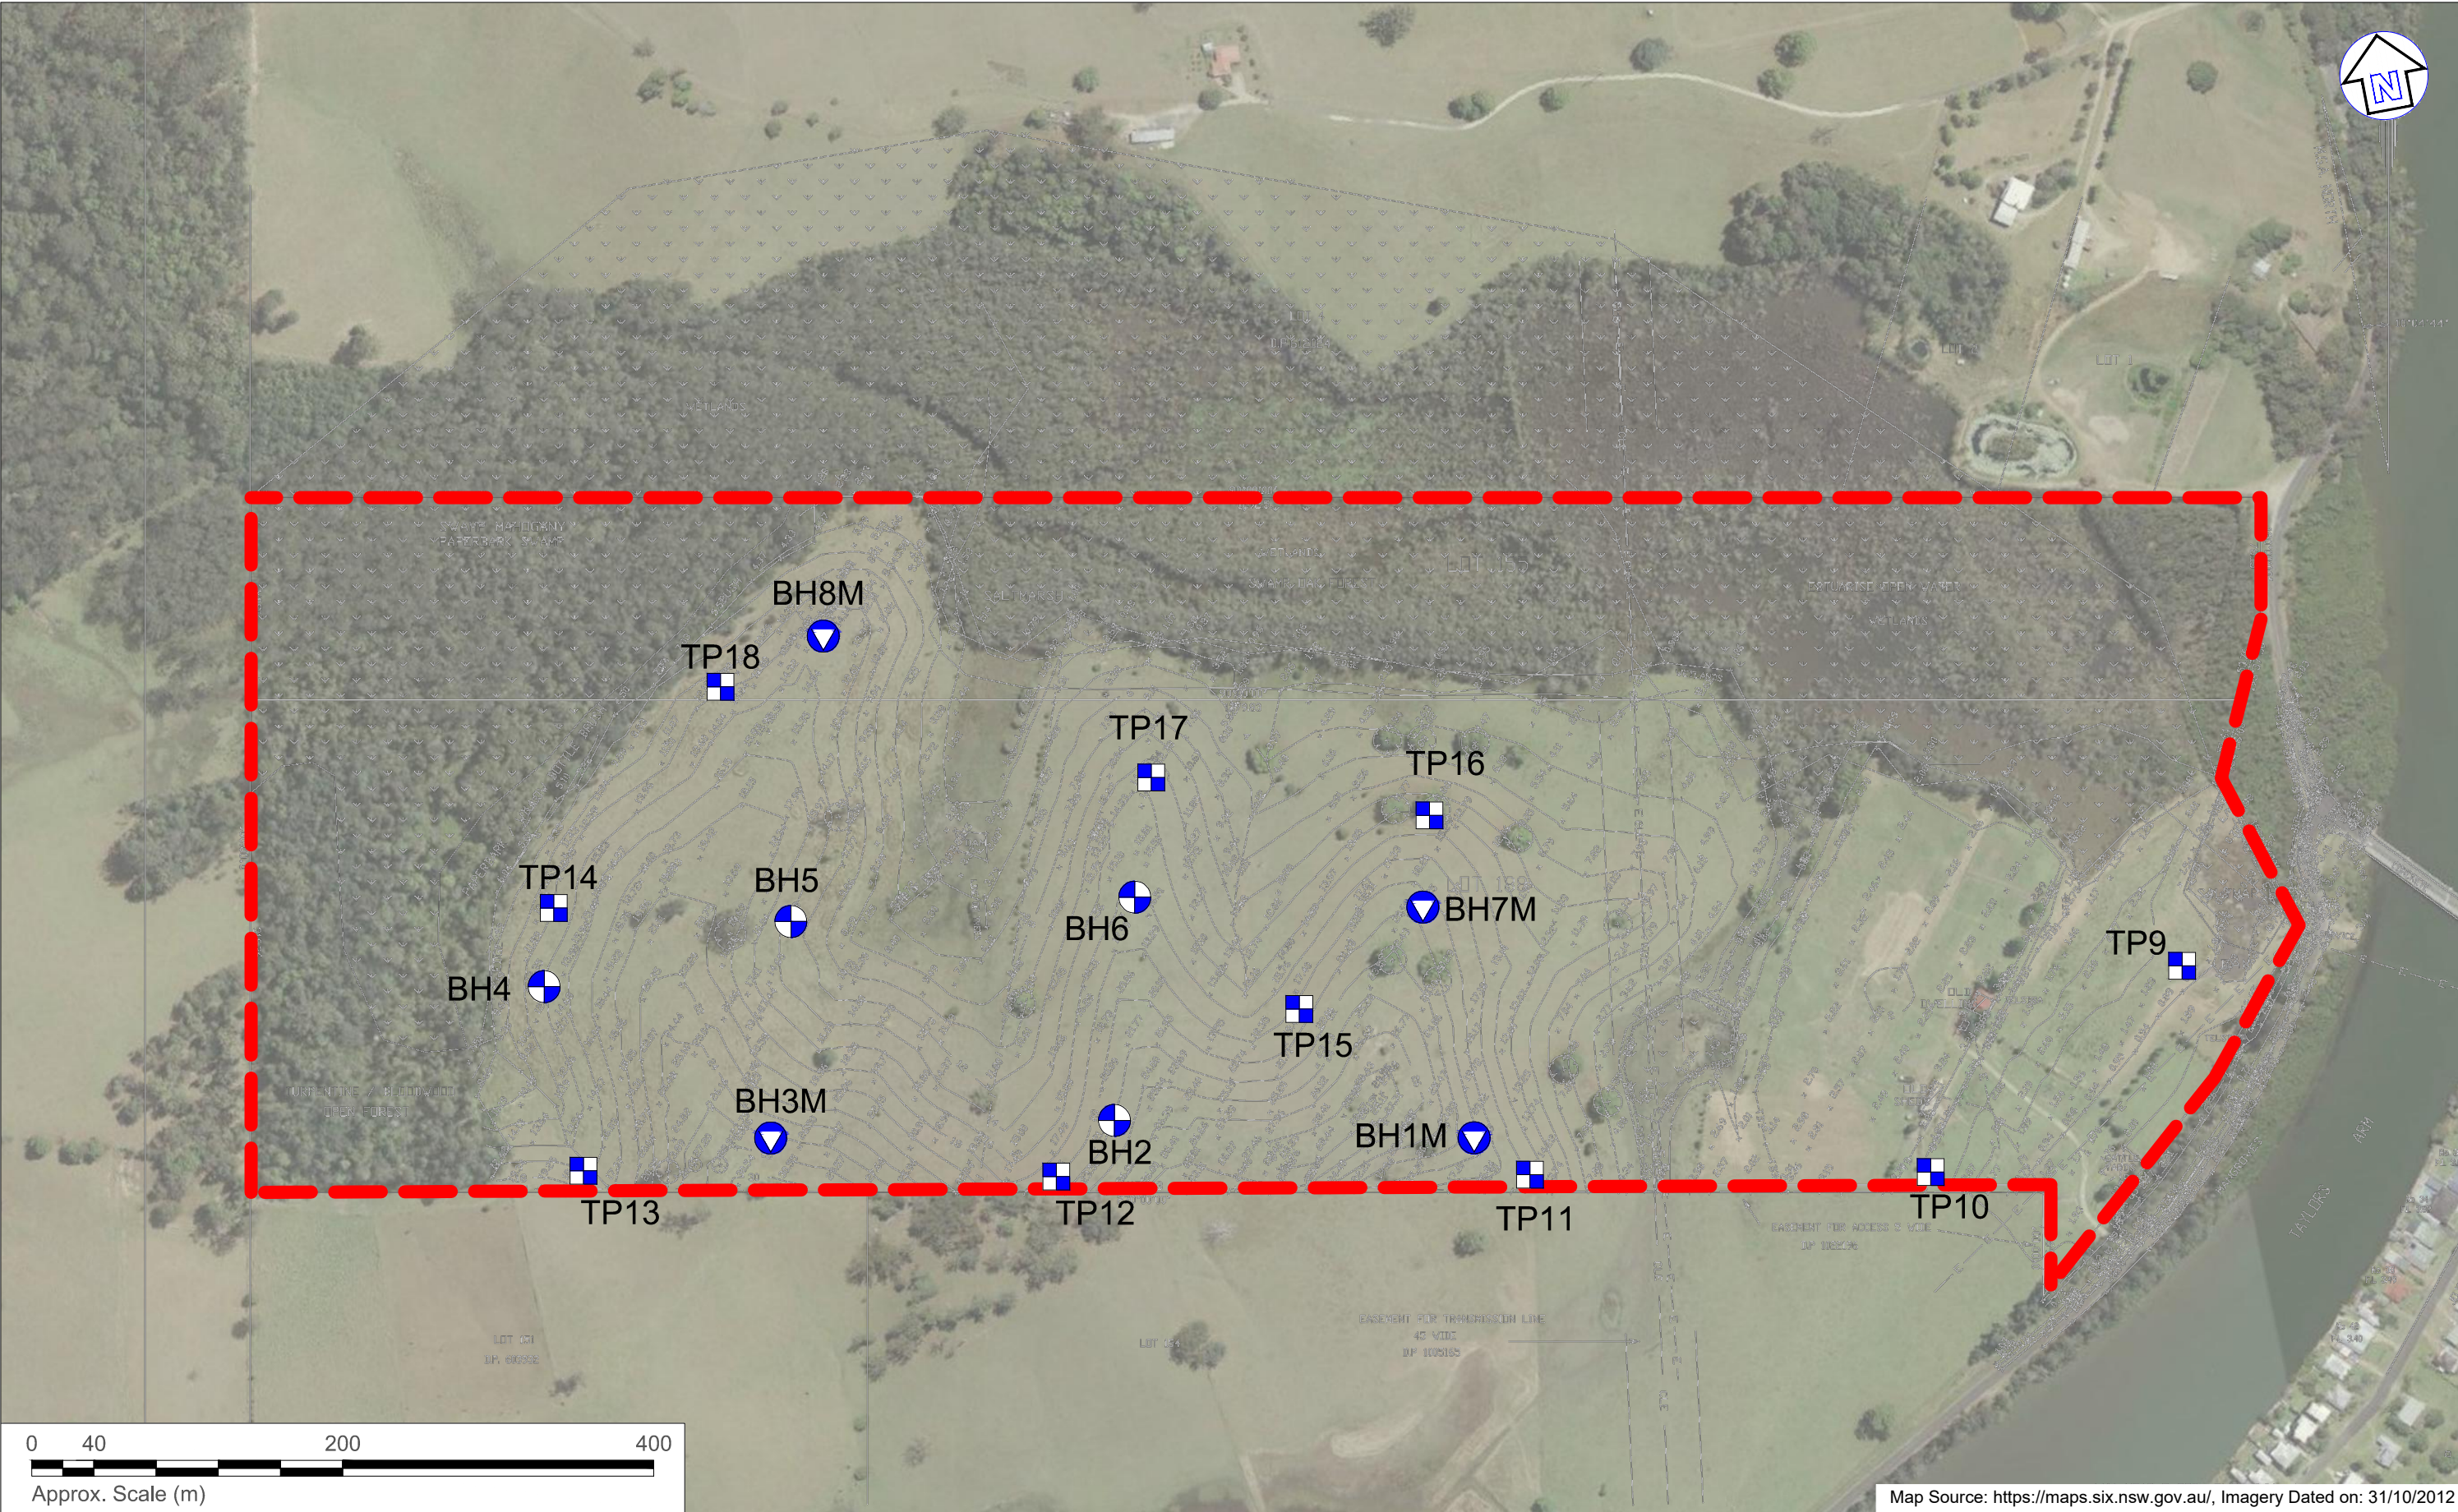
Figure 2 Borehole Location Plan

- - - Approximate site boundary
- Approximate borehole location
- Approximate borehole/monitoring well location
- Approximate test pit location

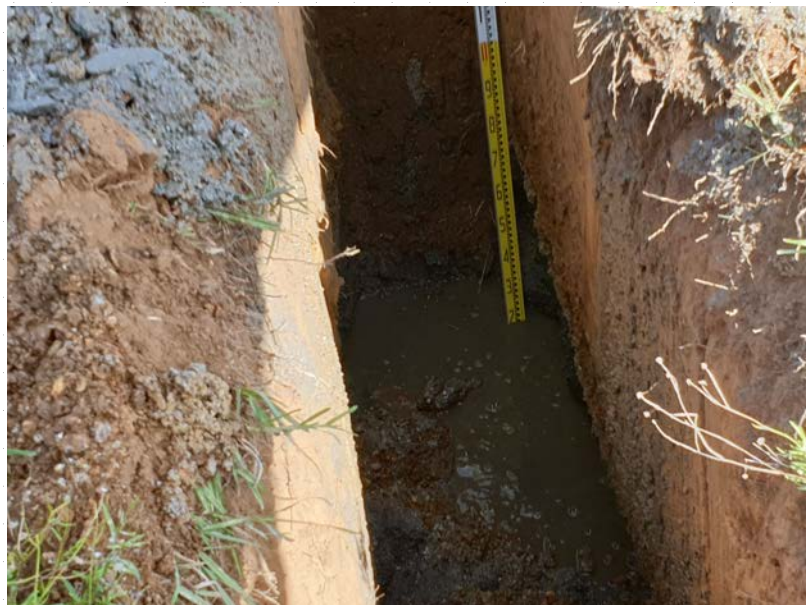
Sketch & Other Observations

2.15					Hole Terminated at 2.15 m Test Pit Collapse.	W	
			3

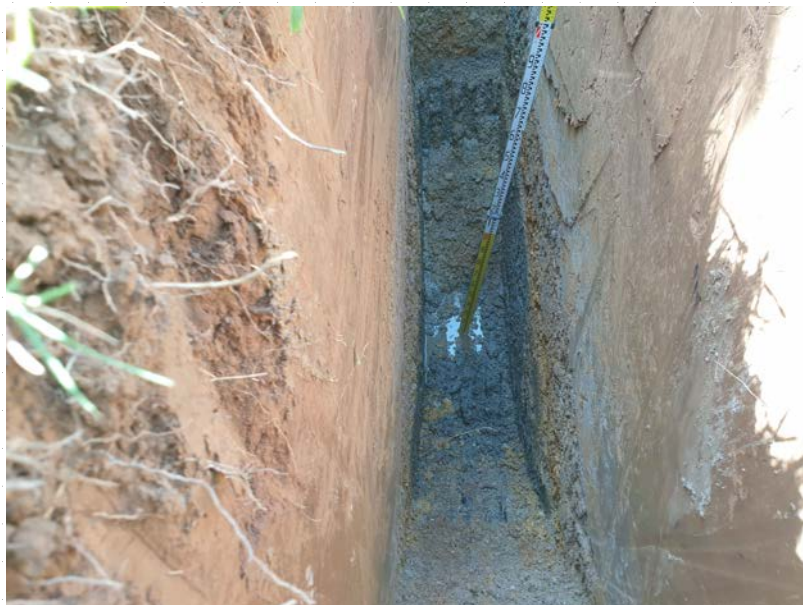
Sketch & Other Observations

SP	Gravelly SAND; medium to coarse grained, grey, medium to coarse, sub-angular to rounded quartzite gravels, trace sub-rounded quartzite cobbles.	M	D	
			3	3.00				Hole Terminated at 3.00 m Target Depth Reached.

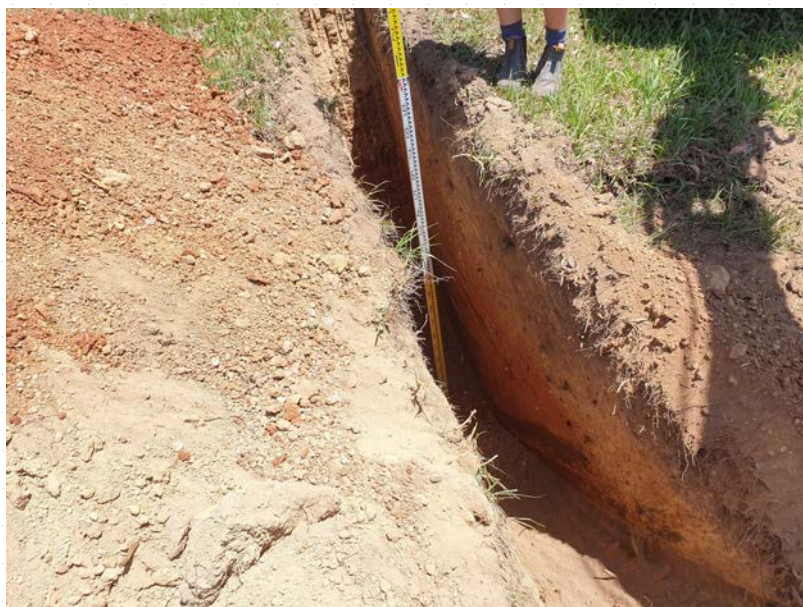
Sketch & Other Observations

-	TOPSOIL: Clayey SILT; low plasticity, brown, with root and rootlets, trace fine to medium, sub-angular to sub-rounded quartz gravels.	-	TOPSOIL
			0.20	20.30			CI	Gravelly CLAY; medium plasticity, red-brown, trace medium to coarse grained sand.	St	FLUVIAL SOIL
			1	1.40			CH	CLAY: high plasticity, red-brown mottled orange-brown, with fine to coarse sub-angular to angular quartz gravel	Vst-H	
	M		1.80	19.10					H	
			2					Hole Terminated at 1.80 m Refusal.		
			3

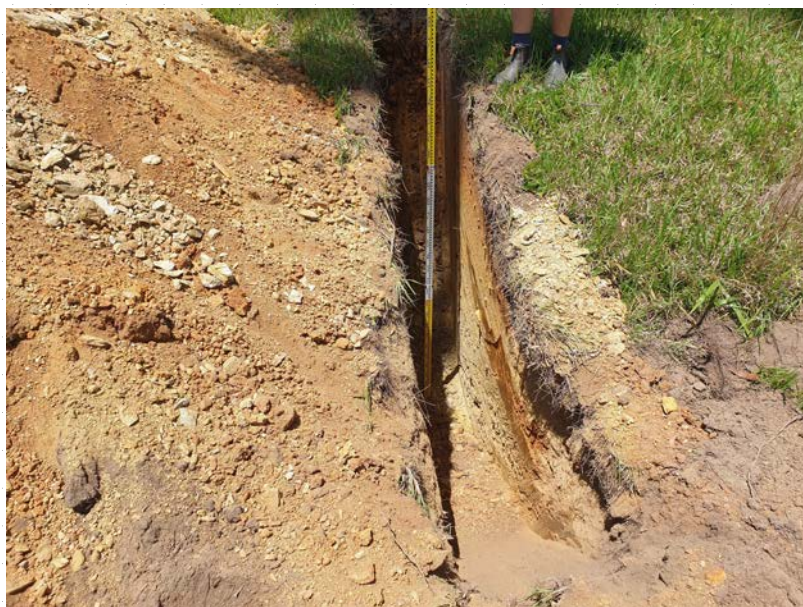
Sketch & Other Observations

-	TOPSOIL: Clayey SILT; low plasticity, brown, with root and rootlets, trace fine to medium, sub-rounded quartz gravel.	M (<PL)	-	TOPSOIL		
			0.25	15.75			CI	Silty CLAY; medium plasticity, orange-brown.		F - St	FLUVIAL SOIL		
			1							VSt - H			
	M	1.70	14.30	CI-CH			Silty CLAY; medium to high plasticity, orange-brown mottled pale grey, remnant rock structure visible.			RESIDUAL SOIL			
		2	2.10 13.90				From 2.1m: grading into dark grey	H					
			2.45					Hole Terminated at 2.45 m Refusal.					
			3

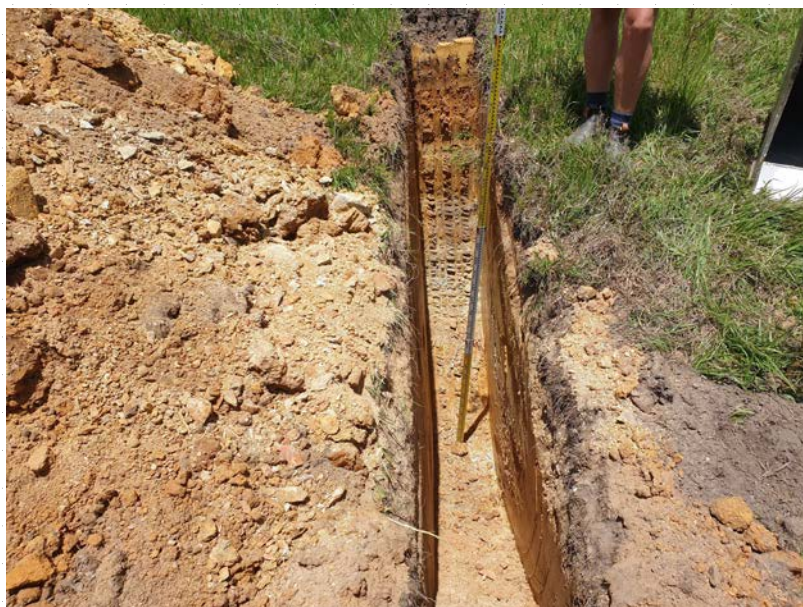
Sketch & Other Observations

-	TOPSOIL: Clayey SILT; low plasticity, brown, trace fine to medium, sub-rounded quartzite gravel.	M (<PL)	-	TOPSOIL	
			0.20	11.80				CI	Silty CLAY; medium plasticity, orange-brown mottled yellow-brown.		F - St	FLUVIAL SOIL	
			1	1.20				CI-CH	Silty CLAY; medium to high plasticity, orange-brown mottled pale grey, remnant rock structure visible.		VSt - H		
			10.80										
	M			2.60									
									Hole Terminated at 2.60 m Refusal.				
			3

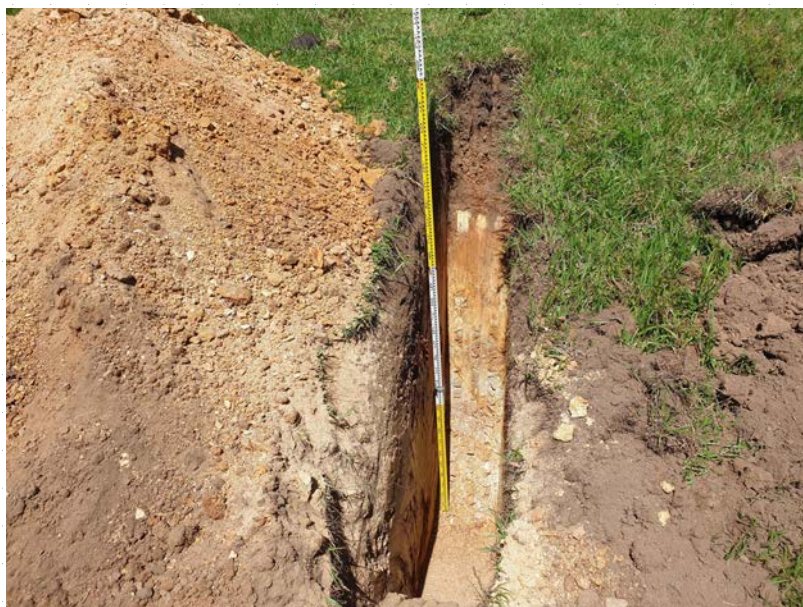
Sketch & Other Observations

-	TOPSOIL: Clayey SILT; low plasticity, brown, with roots and rootlets, trace fine to medium sub-rounded quartz gravel.	M (<PL)	-	TOPSOIL	
			0.30	18.70			CI	Silty CLAY; medium plasticity, orange-brown-red, trace fine to medium grained sand.		F - St	FLUVIAL SOIL	
			0.70	18.30			CI-CH	Silty CLAY; medium to high plasticity, pale grey mottled red-brown, remnant rock structure visible.			RESIDUAL SOIL	
			1									
			2									
	M			2.90								
			3					Hole Terminated at 2.90 m Refusal.

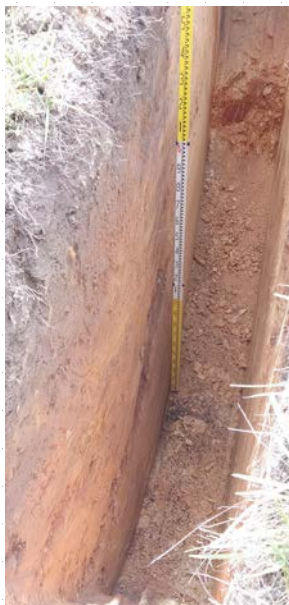
Sketch & Other Observations

Excavation				Sampling				Field Material Description			
METHOD	EXCAVATION RESISTANCE	WATER	DEPTH (metres)	DEPTH RL	SAMPLE OR FIELD TEST	RECOVERED	GRAPHIC LOG	GROUP SYMBOL	SOIL/ROCK MATERIAL DESCRIPTION	MOISTURE CONDITION	STRUCTURE AND ADDITIONAL OBSERVATIONS
E	L-M	GWNE	0	12.00				-	TOPSOIL: Clayey SILT; low plasticity, dark brown, with roots and rootlets.		TOPSOIL
			0.40	11.60	TP16_0.5-1.0 CBR 0.50-1.00 m			CI-CH	Silty CLAY; medium to high plasticity, orange-brown mottled pale brown, with fine to medium, sub-rounded to sub-angular pale brown-grey, medium to coarse, sub-angular to sub-rounded quartz gravel.	F	FLUVIAL SOIL
			1							St	
			2							VSt	
			3	3.00					Hole Terminated at 3.00 m Target Depth Reached.

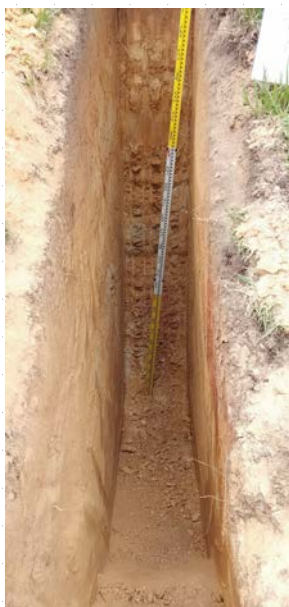
Sketch & Other Observations

St		
								VSt				
								H				
			2.85									
			3					Hole Terminated at 2.85 m Refusal.

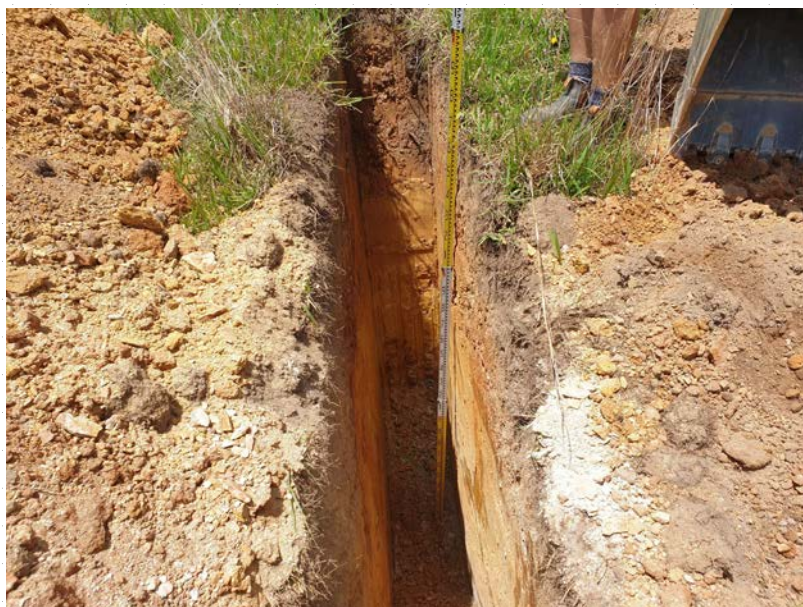
Sketch & Other Observations

Excavation				Sampling		Field Material Description				
METHOD	EXCAVATION RESISTANCE	WATER	DEPTH (metres)	DEPTH RL	SAMPLE OR FIELD TEST	RECOVERED GRAPHIC LOG	GROUP SYMBOL	SOIL/ROCK MATERIAL DESCRIPTION	MOISTURE CONDITION	STRUCTURE AND ADDITIONAL OBSERVATIONS
E	L	GWNE	0	11.50			-	TOPSOIL: Clayey SILT; low plasticity, dark brown, with roots and rootlets, trace fine to medium sub-rounded quartz gravel.	-	TOPSOIL
			0.30	11.20	TP18_0.4-0.5 CBR 0.40-0.50 m		CI	Silty CLAY; medium plasticity, red-brown mottled orange.	F - St	FLUVIAL SOIL
			1						M (<PL)	VSt - H
			1.80	9.70			CI-CH	Silty CLAY; medium to high plasticity, red-brown mottled pale grey, remnant rock structure visible.	H	RESIDUAL SOIL
	M		2							
			2.70					Hole Terminated at 2.70 m Target Depth Reached.		
			3

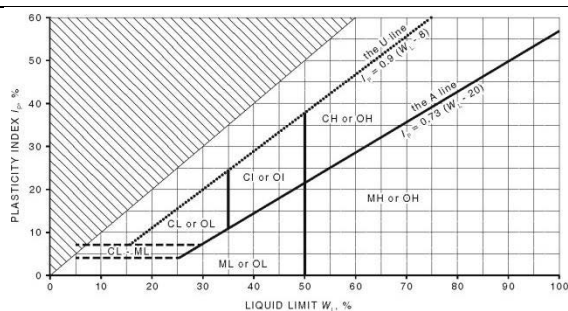
PLASTICITY PROPERTIES

CL, CI Inorganic clays of low to medium plasticity, gravelly clays, sandy clays, silty clays, medium to high dry strength.
		OL Organic silts and organic silty clays of low plasticity, low to medium dry strength.
	Liquid Limit > 50%	MH Inorganic silts of high plasticity, high to very high dry strength.
		CH Inorganic clays of high plasticity, high to very high dry strength.
		OH Organic clays of medium to high plasticity, medium to high dry strength.
Highly Organic soil	PT	Peat muck and other highly organic soils.
