Interim Report on  
Geotechnical Investigation and Acid Sulfate Soil  
Assessment

TAFE CLC Tranche 3  
Bayshore Drive, Byron Bay

Prepared for  
Brewster Hjorth Architects

Project 201414.00  
April 2021

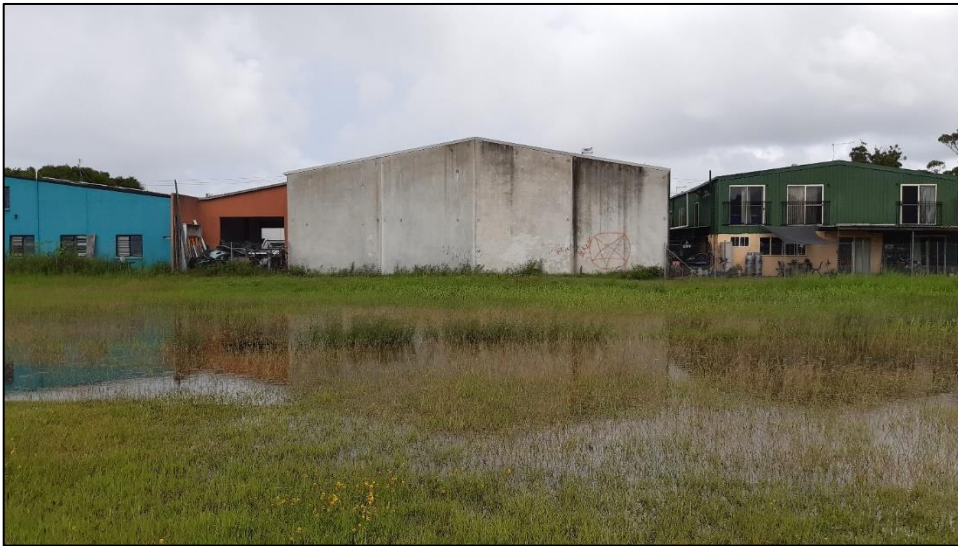
Figure 1: Typical site conditions facing southward near Bore 6.

At the time of investigation, the site was generally level and comprised a gravel access track, surrounded by well-maintained grass and scattered building materials. Photographs of the typical site conditions at the time of investigation are shown in Figures 1 and 2.

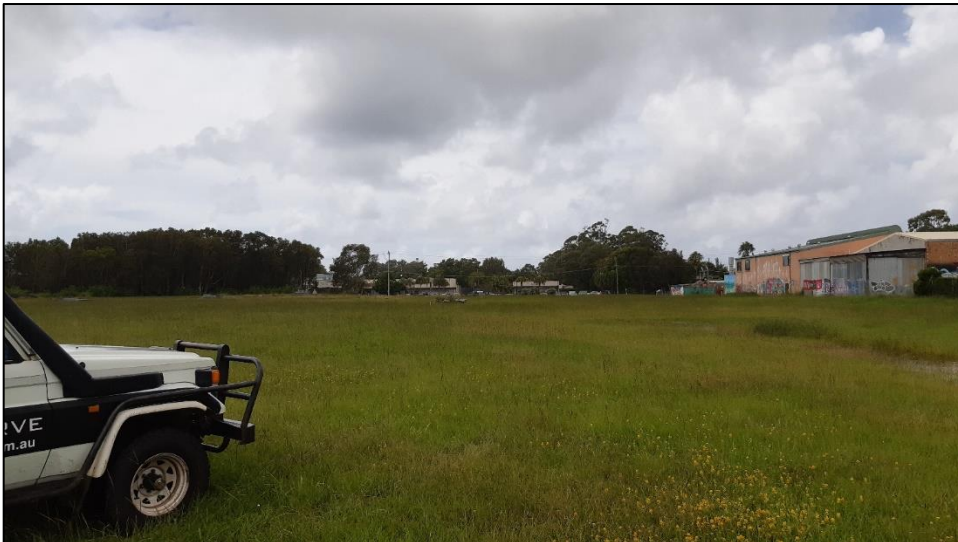
Figure 2: Typical site conditions facing eastward Near Bore 6.
