Preliminary Site Contamination Report

**Proposed TAFE Connected Learning
Centre
Lot 12 DP 1189646,
No 42 Wallum Place Byron Bay**

Prepared for: Byron Shire Council

Date: 18 May 2021

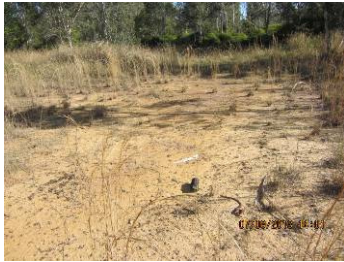
Plate 3

That said, there has been significant site disturbance, particularly in the eastern and central sections. Elsewhere natural levels have been altered through stripping of topsoils and importation and placement of clay fill to cover the in-situ sands over a large portion of the site. This is not local material and its appearance is consistent with anecdotal evidence that site topsoil was stripped and the clay material imported from construction of the Pacific Vista Estate in Byron Bay, with the local topsoil believed to have been taken to replace the clay as topsoil on newly created residential allotments (Plates 3 to 10).
