Report on
Preliminary Site (Contamination) Investigation

Granville Park Oval Pavilion
2 Montrose Avenue, Merrylands

Prepared for
Cumberland Council

Project 86543.01
November 2018

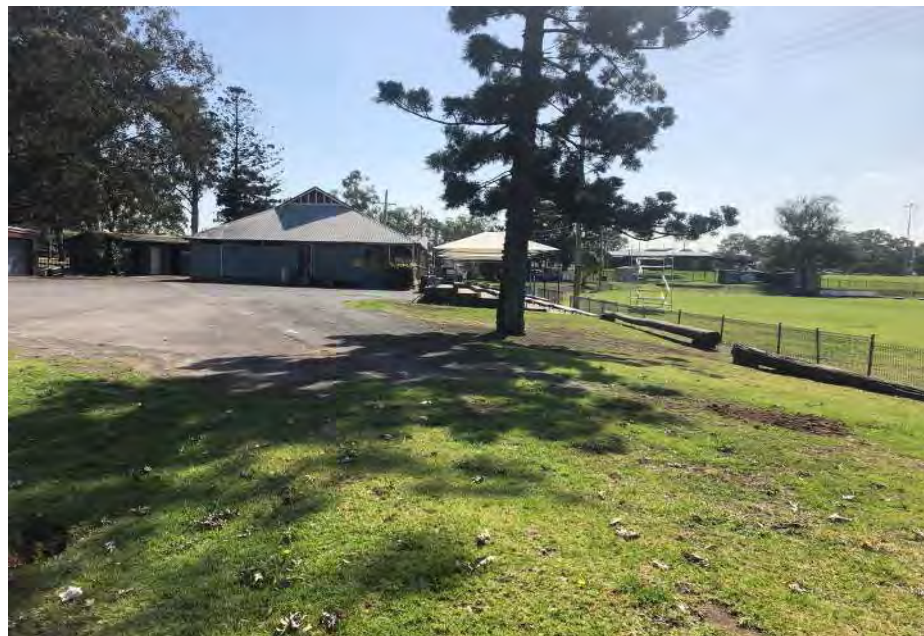
Photograph 2: Grandstand/clubhouse building - looking north

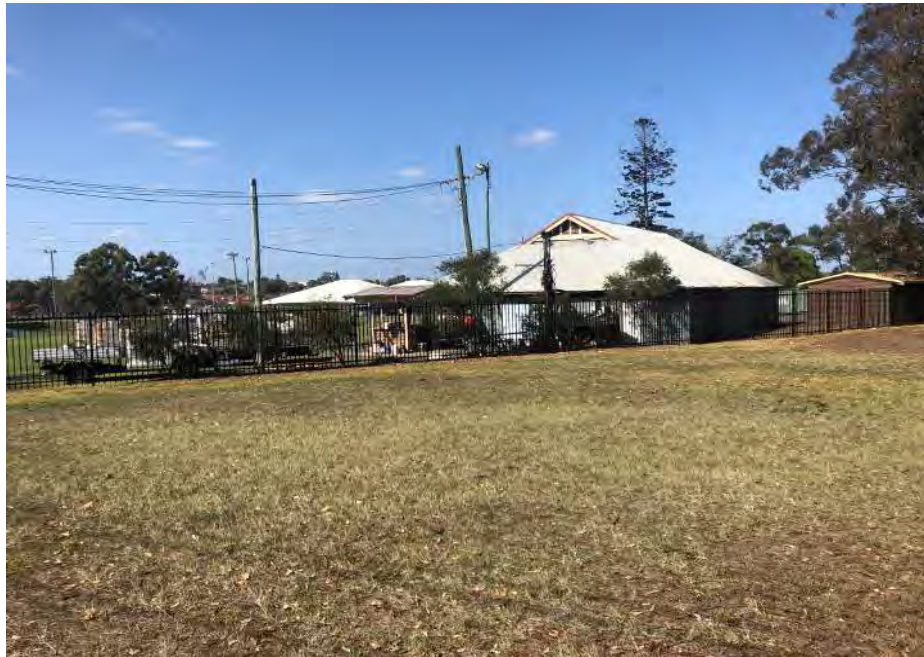
Photograph 3: Proposed recreation facility - looking south east

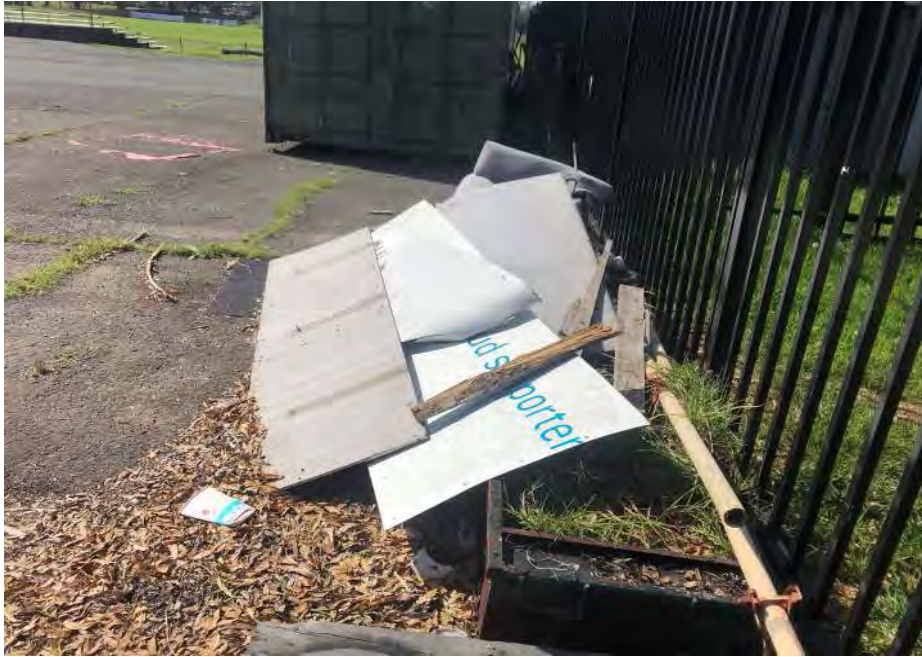
Some potential fly tipping was observed to the south and south west of the clubhouse/grandstand area (refer Photographs 7 and 8). Much of the material appeared to have been sourced from the clubhouse building, however, it may contain hazardous materials which were observed in the building materials of the clubhouse.

Photograph 7: Possible fly tipped rubbish to south of grandstand/clubhouse - looking east

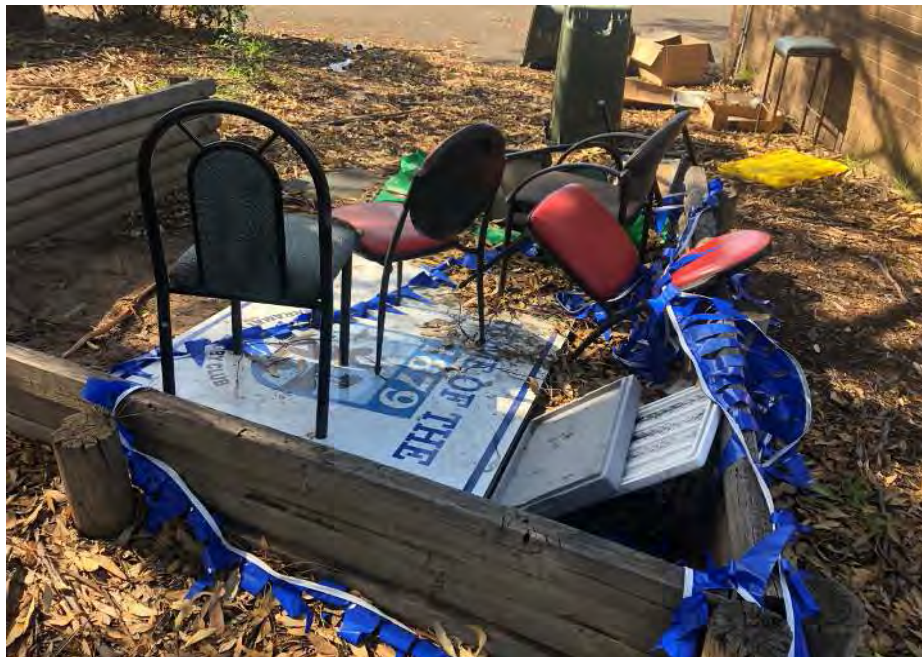
Photograph 8: Stored furnishing and associated rubbish to south west of grandstand/clubhouse - looking east

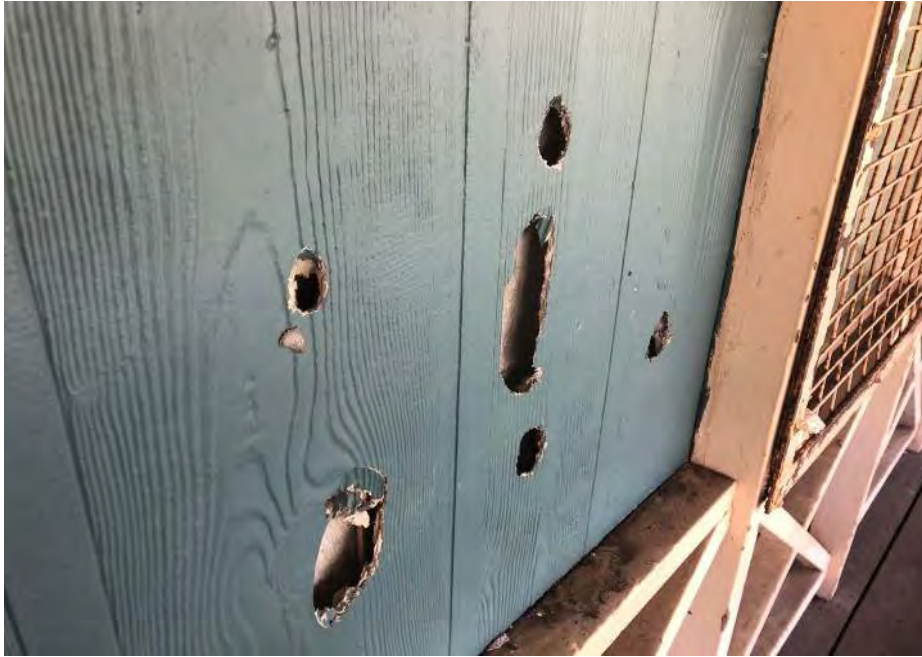
Suspected hazardous building materials were observed in the external walls of the grandstand/clubhouse building. External damage and associated debris was observed to the exterior eastern and western panelling of the grandstand/clubhouse building. Samples were collected from:

Given the age and materials used for construction, it was considered likely that a number of buildings on the site contained hazardous building. Sample BMS04 (from the western external wall of the grandstand building) returned a positive result for chrysotile asbestos and sample BMS05 (from the western wall lining of the grandstand building) returned a positive result for chrysotile and amosite asbestos.

Photograph 9: Possible vandal damage to east of grandstand/clubhouse - sample BMS04 taken

Hazardous building materials were encountered and observed on the exterior of the grandstand/clubhouse building. Asbestos was detected in two samples of material collected from the grandstand/clubhouse building. Given the age of the building and surrounding structures, it is likely that further hazardous materials will be encountered. It is therefore recommended that a pre-demolition hazardous building materials survey is conducted at the site to assess the location, extent and condition of hazardous building materials and subsequent appropriate removal of the identified materials is undertaken prior to demolition. Moreover, following removal of site structures the soils in the footprint of these structures (and adjacent areas) are to be inspected, validated (including sampling) and cleared for the presence of hazardous building materials.

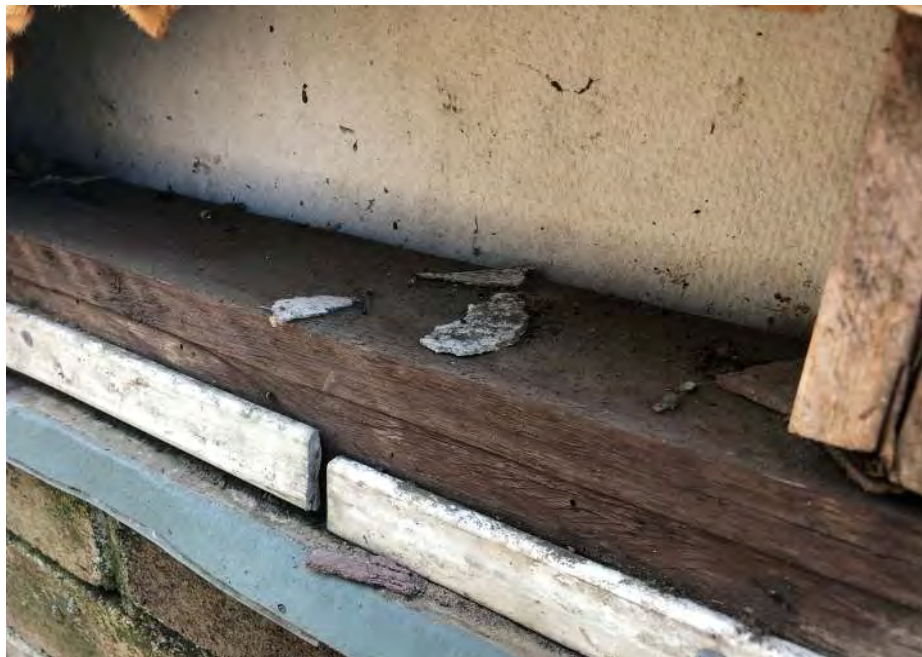
It was observed, that the clubhouse/grandstand had sustained superficial damage, possibly from vandals, which had damaged and further exposed the hazardous materials. Some likely asbestos-containing fibre cement fragments were observed on the ground surface adjacent to the western elevation of the building.

Photograph 10: Possible vandal damage to west of grandstand/clubhouse - sample BMS05 taken

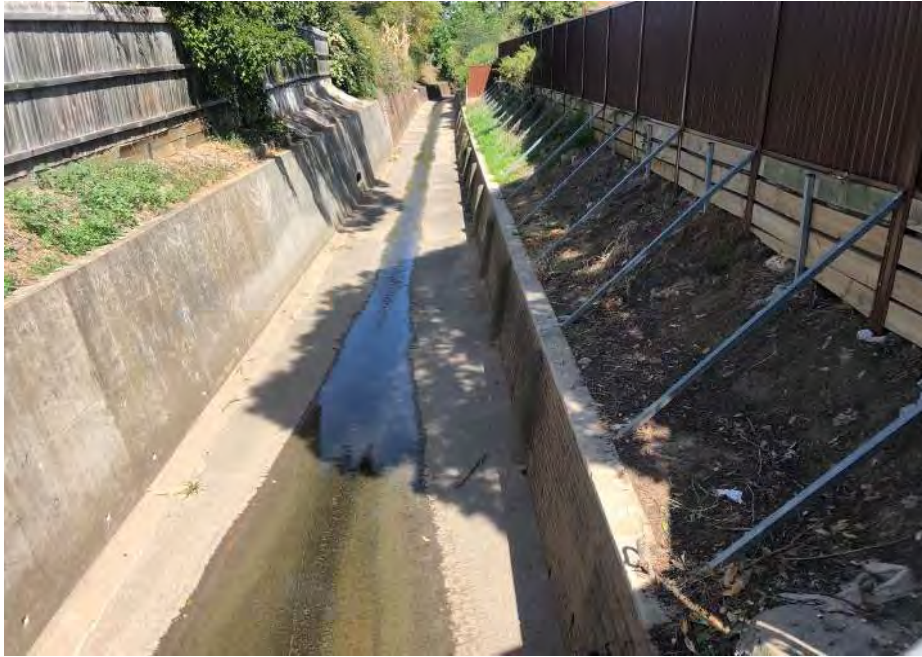
A stormwater channel was observed to the east and south east of the site (Photographs 11 and 12).

Photograph 11: Stormwater drain and channel, Claremont Street - looking south

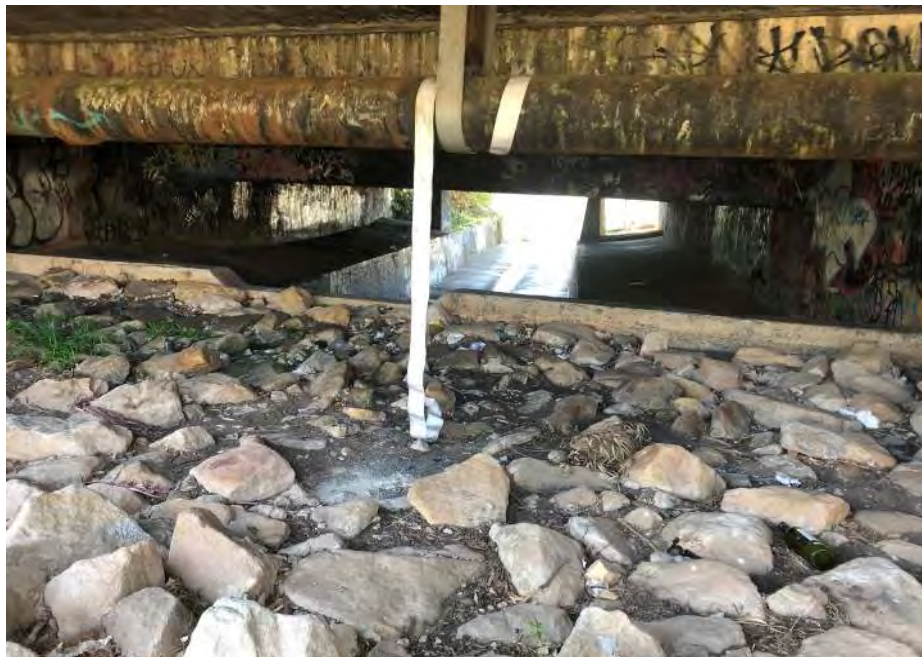
Photograph 12: Stormwater drain and channel, Woodville Road - looking east
